**LYDIARD PARK,
SWINDON**

Archaeological Investigation Report Series AI/27/2003

County: Wiltshire
District: Swindon
Parish: Lydiard Tregoze
NGR: SU 102 848
NMR No: SU 18 SW 71
Date of survey: May -August 2003
Surveyed by: John Lord and Graham Brown
Report author: John Lord
Illustrations by: John Lord
Ground Photography by: John Lord
Aerial Photography by: Damian Grady and Bob Bewley

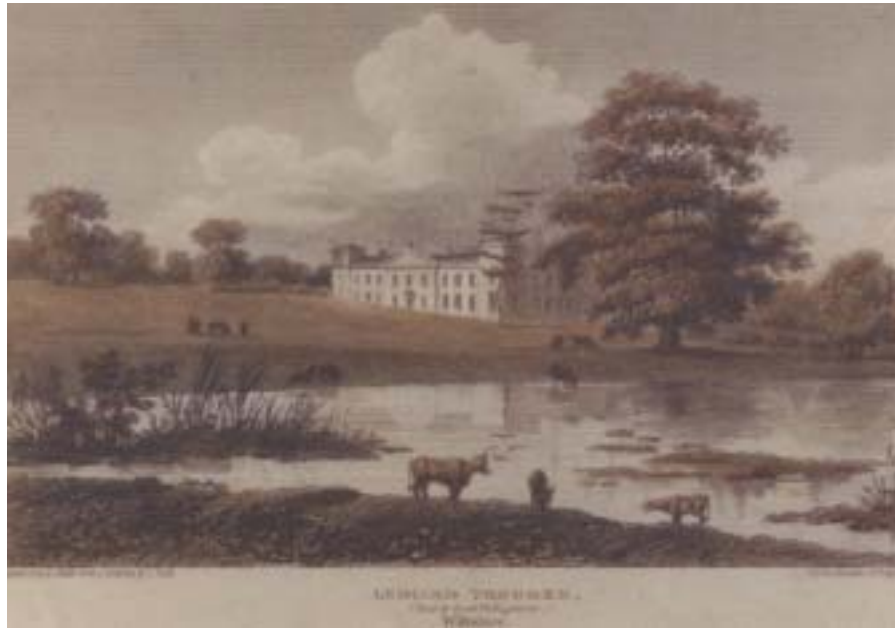
Figure 4 1808 view of the house, lake and grounds (reproduced by kind permission of Nicholas Pearson Associates)

that the grounds were remodelled at this time as well. The view of the house depicted in an engraving of 1808 (Fig 4) probably reflects the views created by this remodelling.

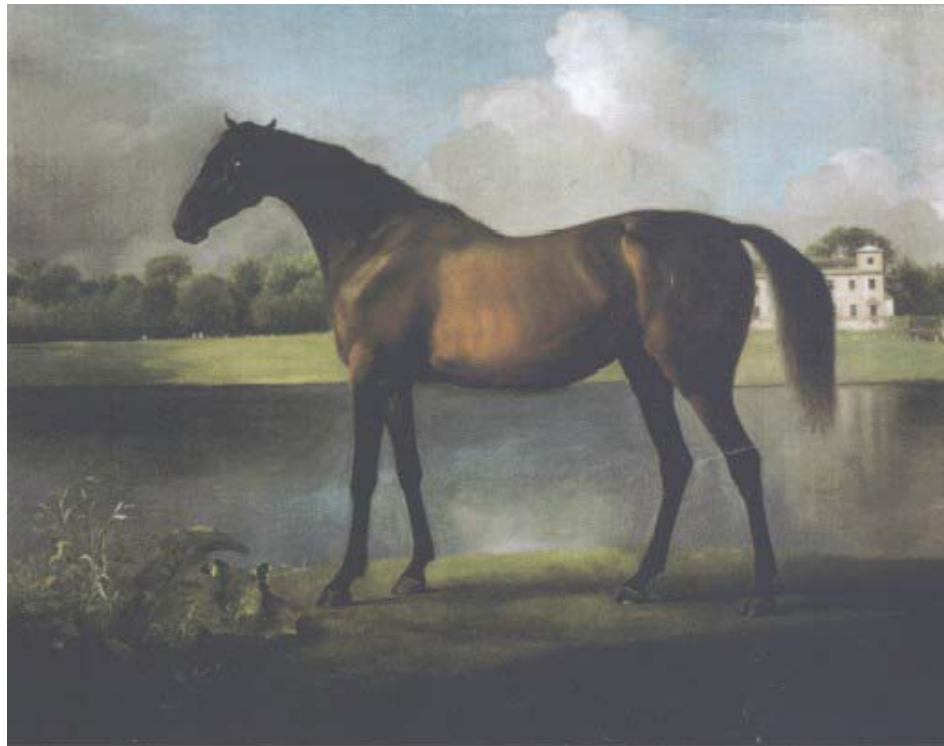
Figure 5 1765
Painting by
George Stubbs
of one of
Viscount
Bolingbroke's
hunters, shown
from the east
side of the lower
pond (reproduced
by kind
permission of
Nicholas
Pearson
Associates)

Frederick was a keen gambler and horseman, and commissioned George Stubbs to paint his favourite hunter in 1765. This painting (Fig 5), a copy of which hangs at Lydiard, shows wooden railings around the mansion, the mansion itself, remodelled to its current form, the church, lower pond and part of the parkland with mature trees, painted from the viewpoint of the east side of the lower lake, looking west.

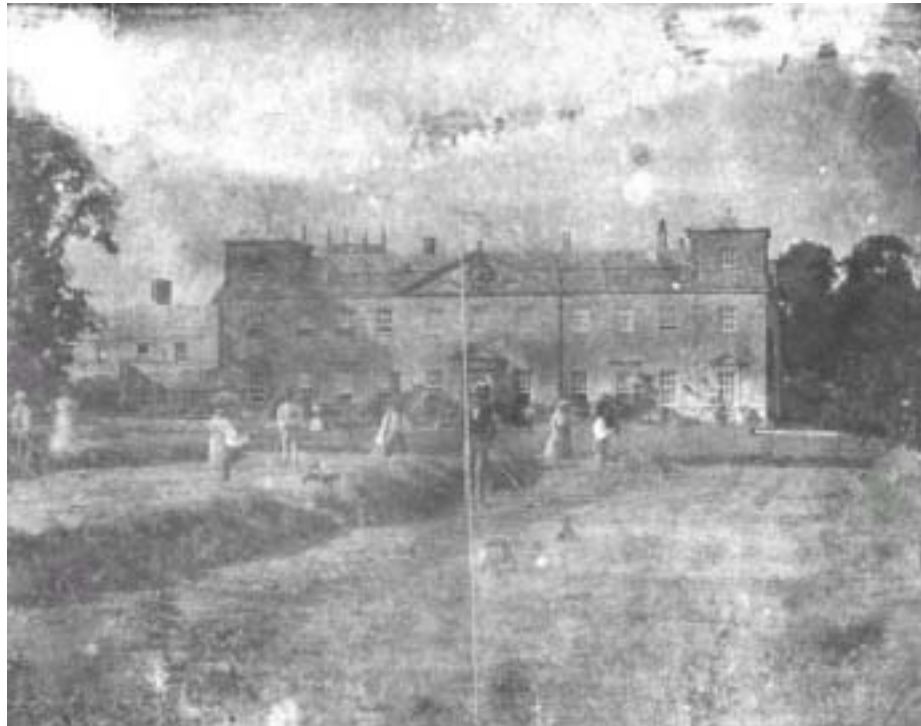
Figure 6
Photograph of 1846
by Neville Story
Maskelyne

An early photograph, taken in 1846 by Nevil Story Maskelyne (Fig 6), shows haymaking in front of the house. A line of iron railings separates the area immediately in front of the house from the hay field. This line seems define the area immediately in front of the house that was depicted as being enclosed on the 1766 and 1773 plans. To the west of the house is a glass house.

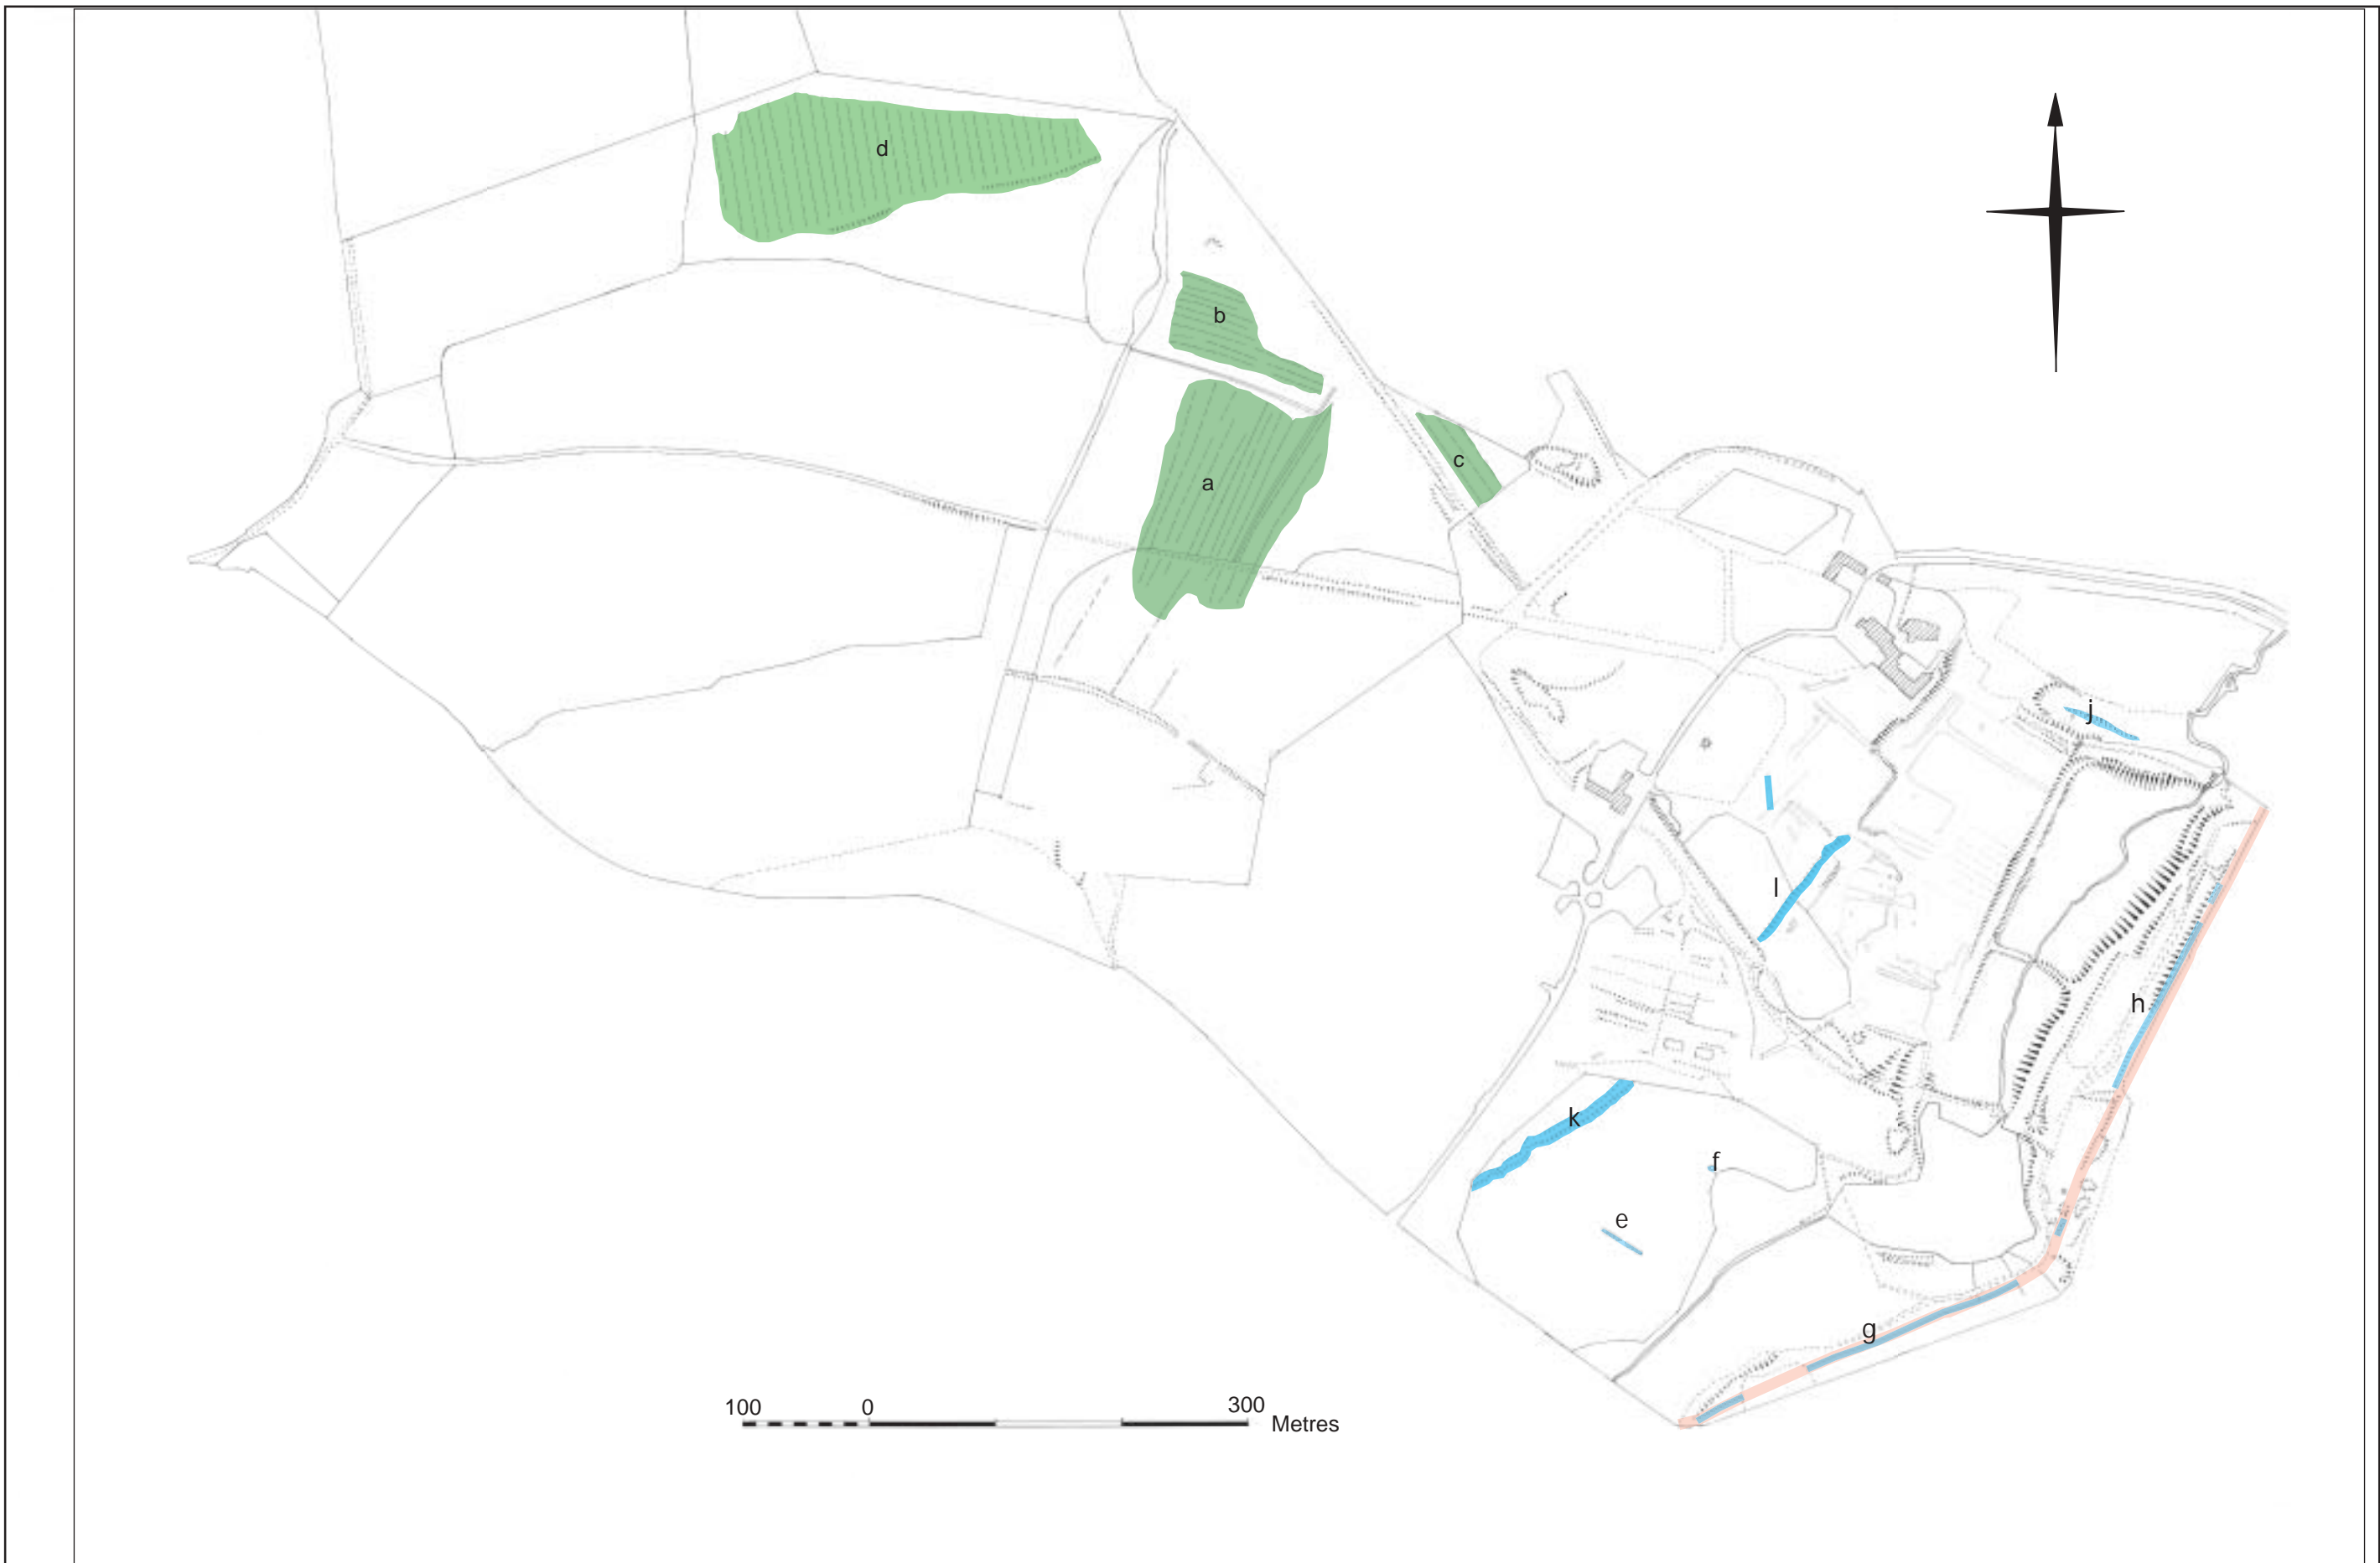
Figure 7
Lydiard Park pre-17th century

The earliest identifiable phase is likely to be associated with medieval agriculture. Although denuded and difficult to define in places, ridge-and-furrow is evident throughout much of the north-west part of the park. Most of it appears to be single phase, but one area, (Fig 7, **a**), may have at least two phases. Although there is other agricultural activity of a similar period in this area, the surviving earthworks have no physical relationship with any of the likely contemporaneous activity, so it is impossible to define with certainty the sequence of the activity within these blocks. Some of the ridge-and-furrow associated with (**a**) is cut by a modern field boundary. Also within this area are two further areas of ridge-and-furrow, (**b** and **c**), although again it is impossible to define the relationships between them because of later activity. Further to the north west beyond Ash Copse, is another block of ridge-and-furrow, (**d**). Within this block the ridge-and-furrow is aligned north to south. To the southern end is a heavily eroded furlong bank, extending approximately east to west. This is truncated in several places across its axis. Within blocks (**a**, **c** and **d**) the furrows are all *c* 10m apart, whilst in block (**b**) the furrows are *c* 8m apart.

Since (**k**), a substantial scarp *c* 0.5 m high and *c* 140m long with a smaller back scarp *c* 0.1m high, and (**l**), another substantial scarp *c* 0.8m high and *c* 100m long are not aligned

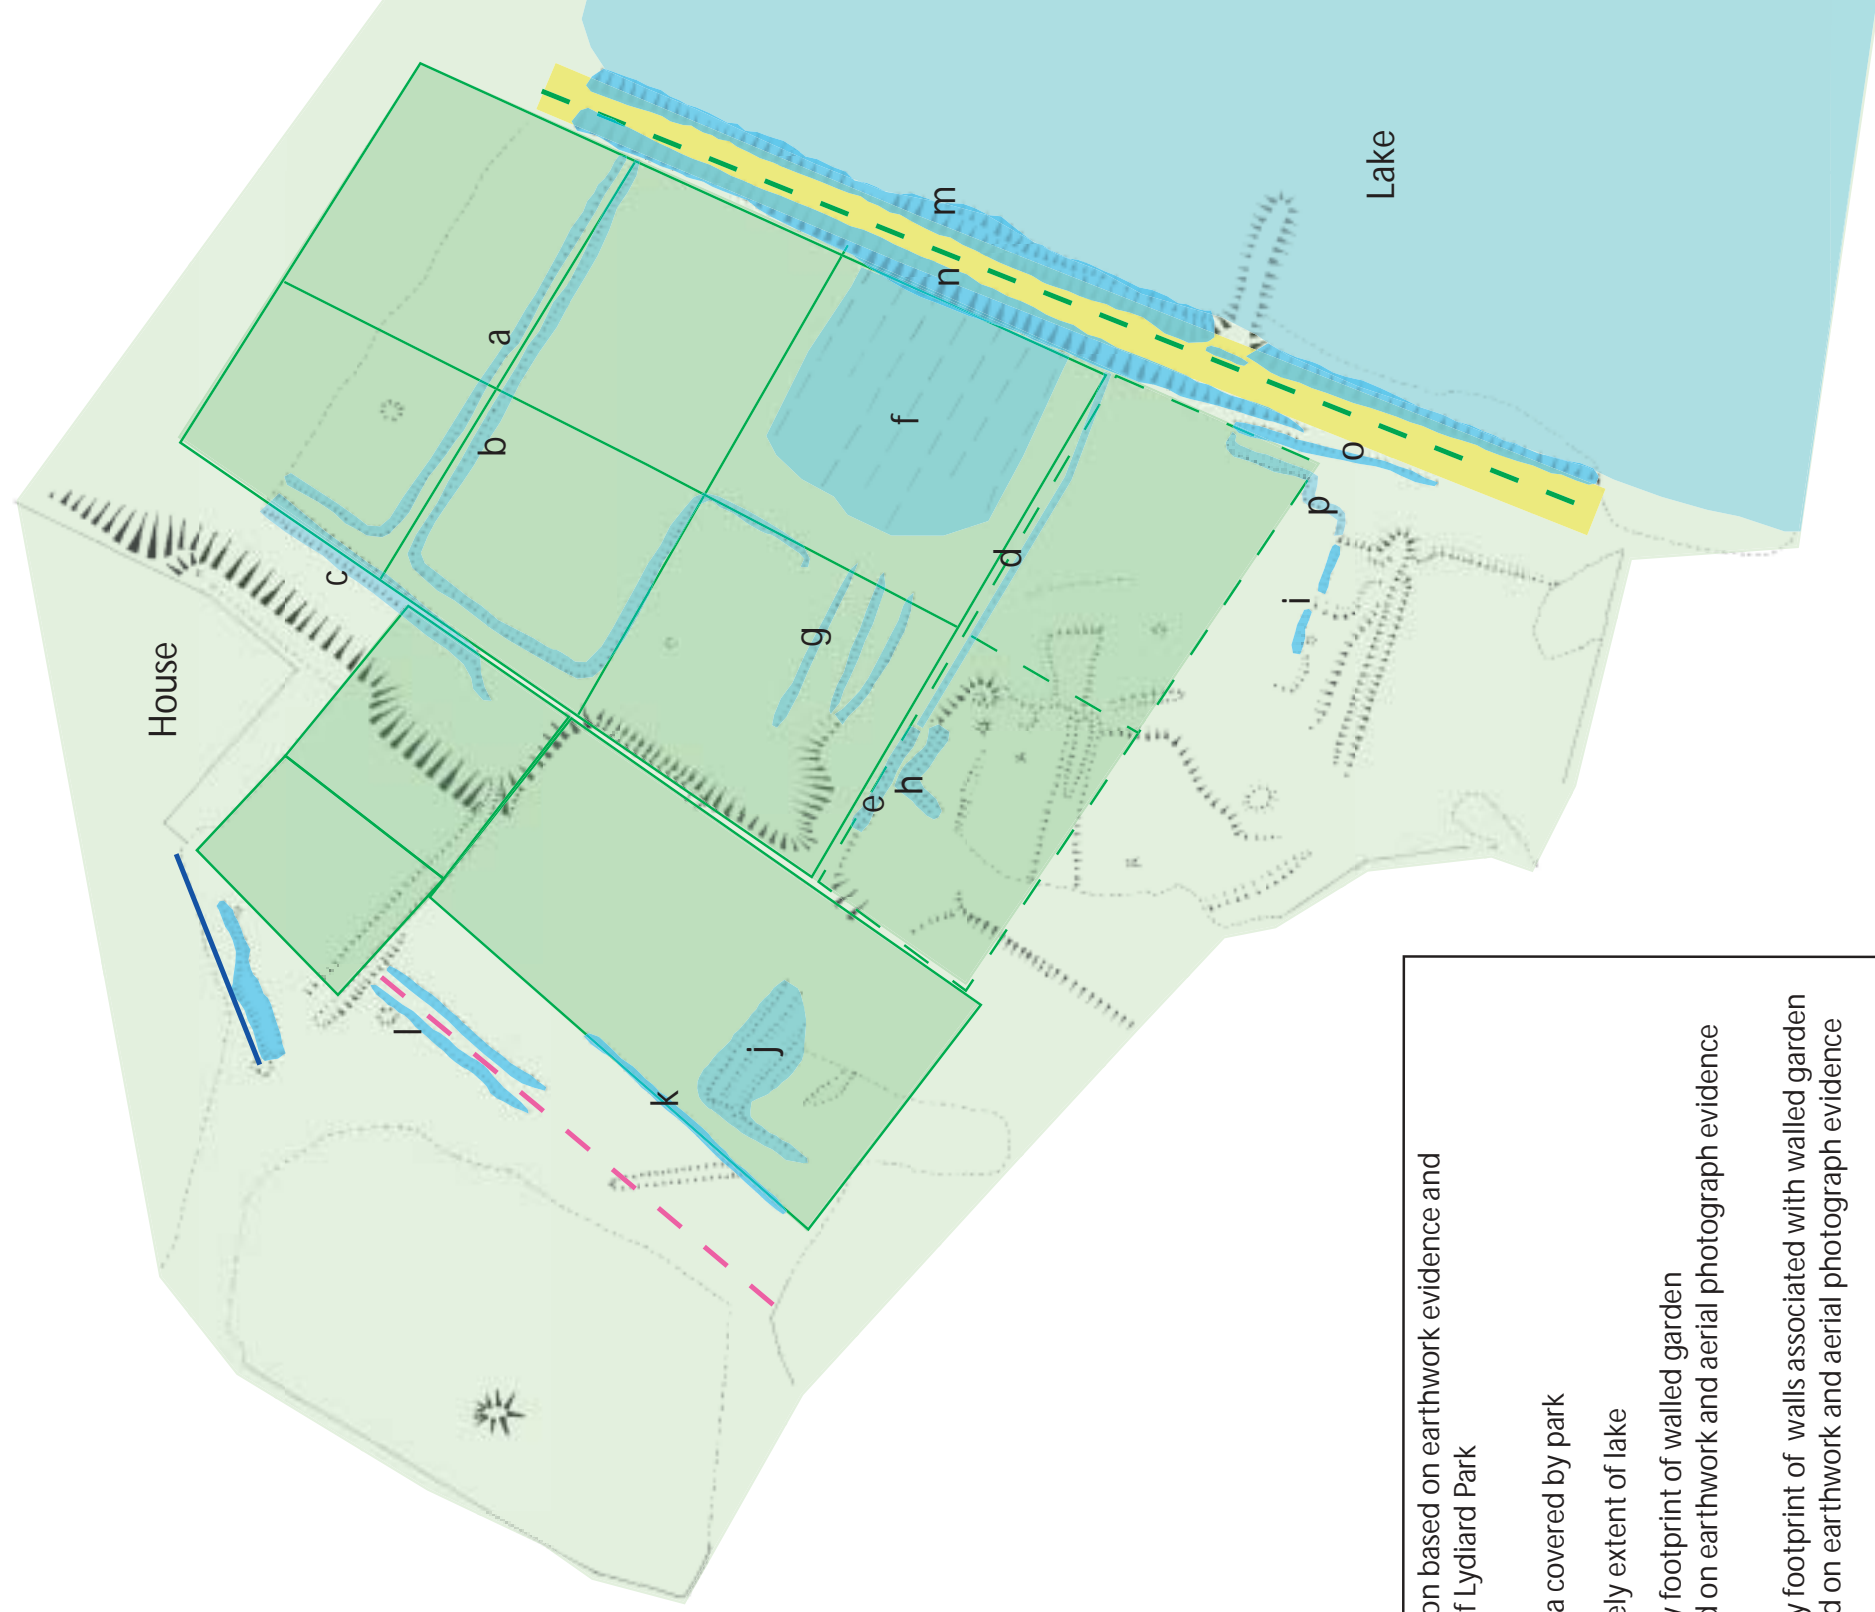
Figure 9
The area around the house at Lydiard Park in the 17th and early 18th centuries

alignment of the remaining garden features and are likely to be the remains of planting beds. Beyond the limits of (d and e), the remains of the garden become less apparent, probably due to later disturbance. However, there are two small scarps (h and i), with (h) likely to be the north-western corner of the final compartment, and (i) likely to be the remains of the southern extreme of the walled garden. The collection of small scarps at (o), although not appearing on the 1700 plan, do respect the alignment of the rest of the garden, and are therefore likely to be part of it. No earthwork evidence has survived of the two enclosed areas immediately in front of the house, although a low scarp (k) is likely to be the remains of the boundary wall of the bowling green shown on the 1700 plan. A number of scarps (j), a low bank and shallow ditch, although not appearing on the 1700 plan, do respect the alignment of the remainder of the garden.

To the east of the remains of the earthworks is a flattened area between two substantial scarps (m and n) forming the western bank of the lake. These are both well-defined scarps, (m) being c 0.3m high, (n) being between c 0.8m and c 1.1m in height. Although this former scarp is partly truncated by the addition of a low dam wall in the 1970s that split the lower lake into two, it can still be traced for c 250m, until it eventually disappears into thick vegetation. Scarp (m) extends for c 200m, and can be traced as a continuous line round to the base of the earlier dam wall, where it forms the earthen bank of the wall itself. Scarp (n) turns and joins (m). Scarp (m) is truncated just after it turns by a ruined rectilinear stone built feature, which contains a set of steps. This has been interpreted as either a boathouse (Bowden *et al* 2000), or a fernery. These two scarps are likely to be the boundary of the

tree-lined formal walk depicted on the 1700 plan that separated the walled garden from the lake, with the flat area that separates the two scarps being the walk.

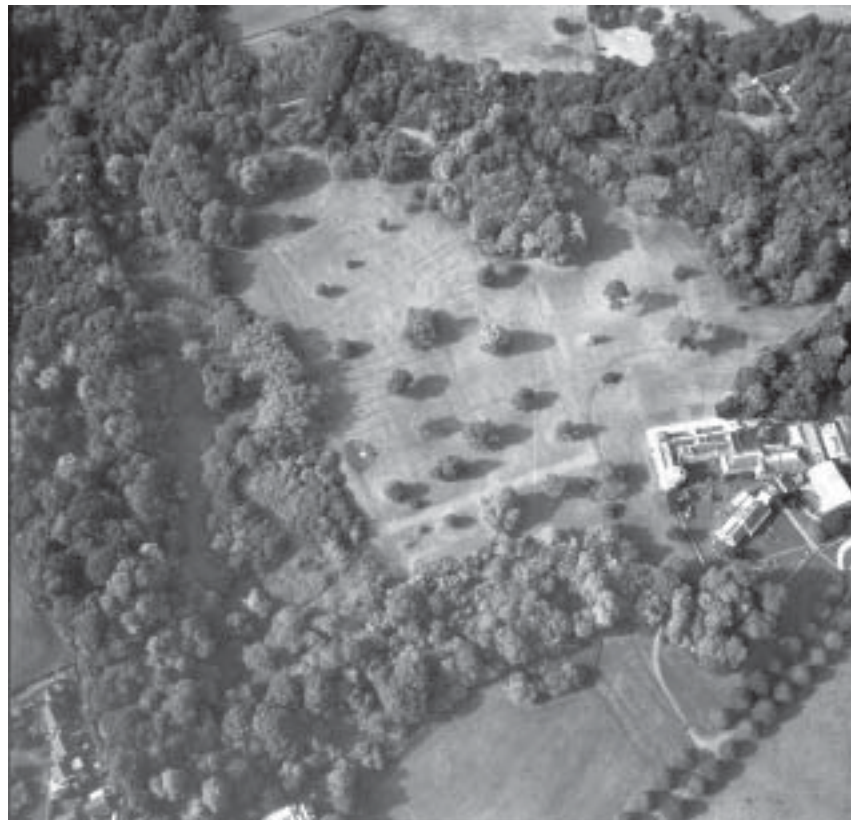
Figure 10
Aerial
Photograph
showing
parch marks
related to 17th
century walled
garden (NMR
23243/3)

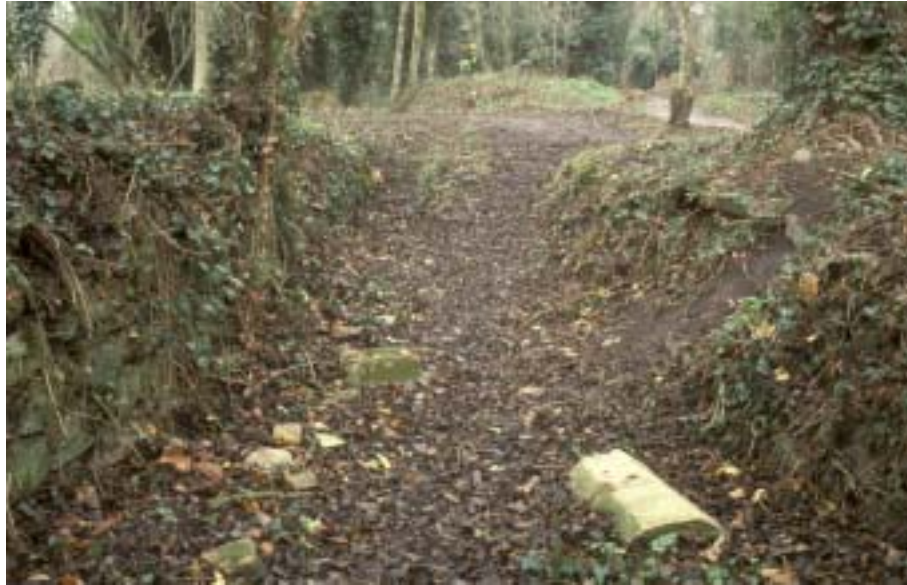
Figure 11 View of boat house/ fernery on the west side of the lower lake

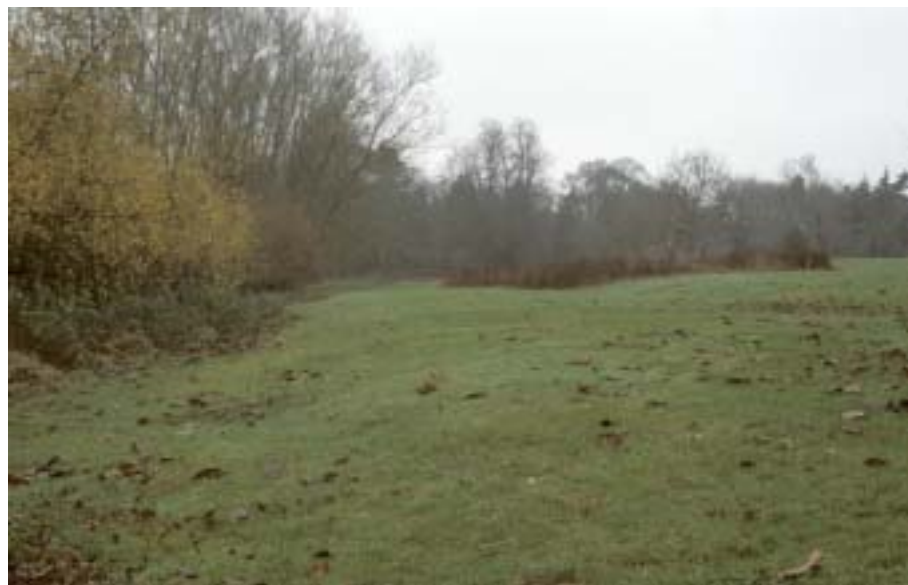
Although no mention is made of terracing on the strip of land between the lake and the eastern boundary of the park in the surviving documentation, portions of what appear to be terrace-retaining banks (Fig 8, **p**, **s**, **t**, **u** and **v**) exist. Scarp (**p**) probably formed the up slope boundary of a path that may have run along the edge of the lake when it was the sub-rectangular shape depicted on the 1700 plan, and would have been the lake-side boundary of the plantation also shown on this plan. It is c 130m long, and c 0.3m high at its northern end, rising to c.1m high at its southern end. To the west of these features is a scarp (**q**), c 1m high and c 100m long, that now forms the eastern bank of the lower lake. This is likely to have been the same bank depicted on the 1700 plan of the park. At the southern end of

Figure 12 View along the formal walk next to the lower lake, looking south

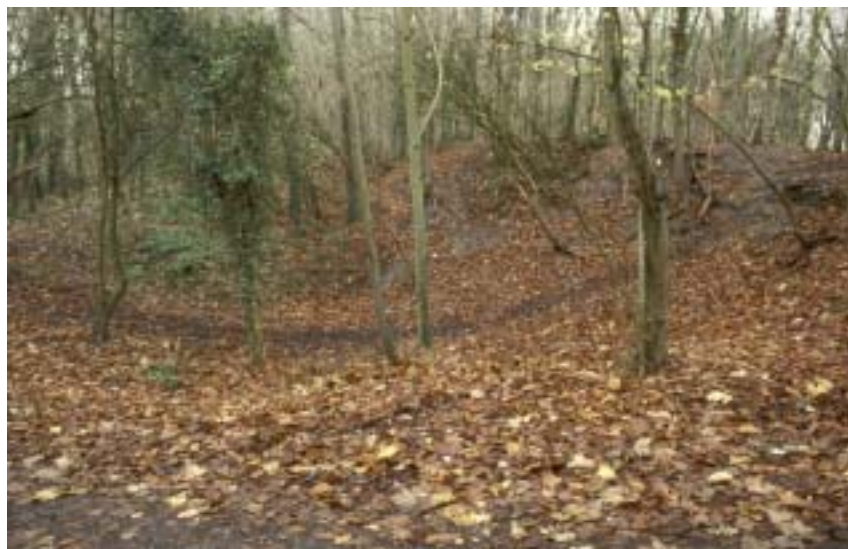
(p) is a large sub-circular quarry, (o), cut into the natural slope, which is probably the remains of a grotto. This is c 3m deep at its highest point, c 1m deep at its lowest and c 10m in diameter. This area is shown as being a plantation on both the 1700 and 1766 plans of the park, which may account for the absence of this feature in the documentary evidence. It is certainly in a prominent position, being at the end of the crossing point between the two lakes, particularly if approached in an anti-clockwise direction from the house and being roughly halfway round any perambulation from the house around the lake. Dividing the upper and lower lakes on the 1700 plan is what appears to be a land bridge. This still survives in part (i). This then turns and disappears into heavy vegetation cover, to re-emerge again (Fig 9, m). The scarp that forms the boundary of the walled garden (Fig 9, n) disappears to reappear again as (Fig 8, h). This only runs a short distance before being truncated by the ha-ha to the north and by a substantial scarp forming a platform to the south. This latter scarp will be discussed below.

Figure 13 Likely location of the grotto

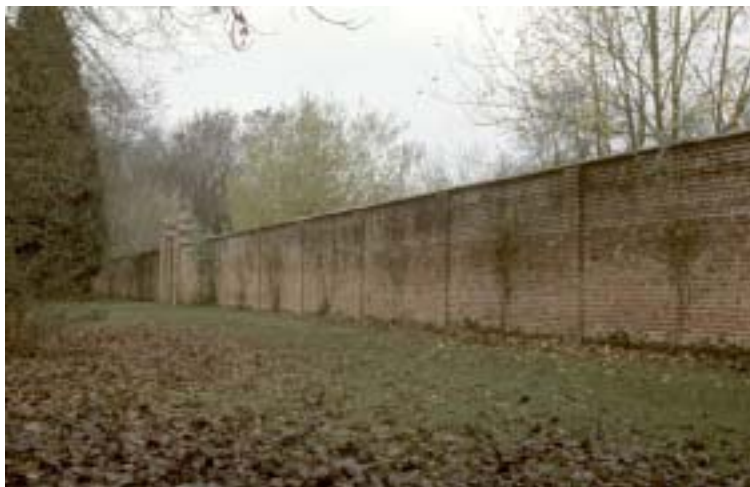
Figure 16 The Walled Garden

The entire walled garden to the east of the house was demolished, and another, smaller one, rhomboid in plan, was built to the north-west of the house. This survives to this day. The red bricks that make up the majority of the wall on all four sides are 22 cms long, 10

cms wide and 5.5 cms thick (Phillips 2001, 8). They are laid in English Garden Wall bond. This pattern is repeated for 34 courses. An offset exists for four courses above the foundation level. All the corners are angled, except for the north-eastern one, which is rounded. The original angled corner may have been truncated by the modern car park (Bowden *et al*

2000). Certainly on the plan of 1766 this corner is depicted as being angled rather than rounded. The rebuilding appears to have taken place between 1839 and 1886, as depicted on the Tithe Map OS first edition 1:25". The longer sides are made up of 21 bays, the shorter of 13 bays. The build is likely to be primarily of 18th-century date, with 19th- and 20th-century repairs and alterations, primarily the doorways and main gateway. This latter feature has either been inserted or entirely rebuilt. No earthwork survey was carried out within the garden as the area was entirely levelled.

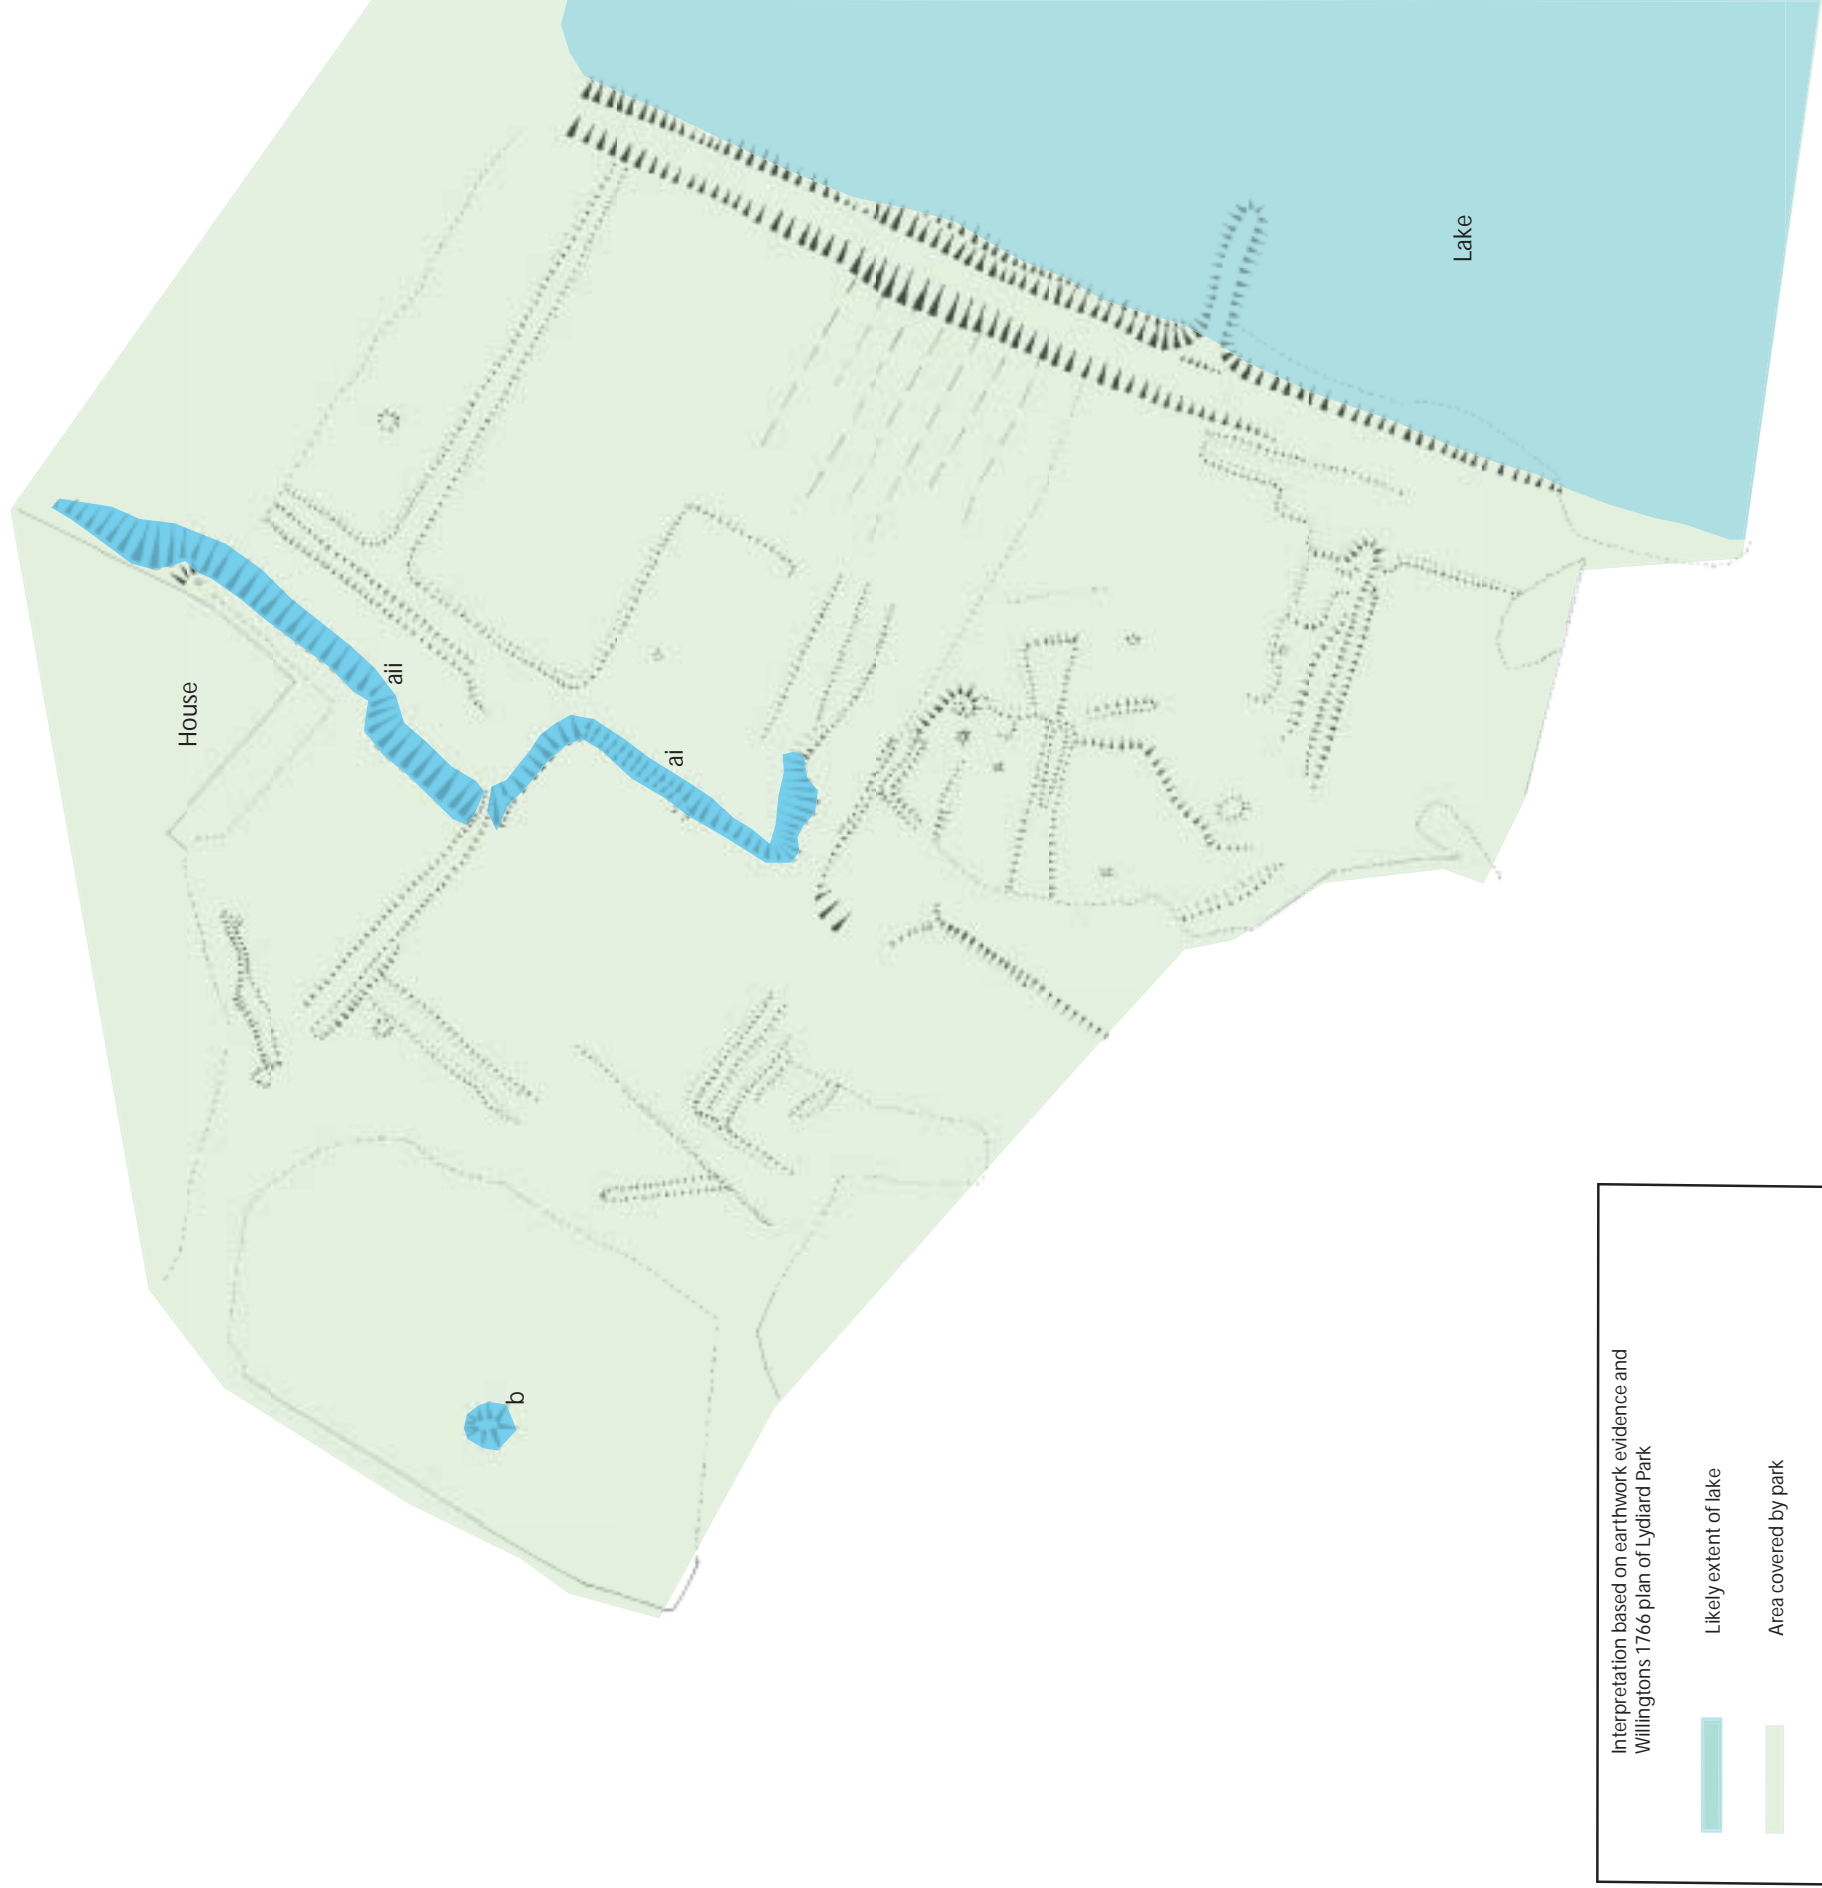
Figure 18
The area around the house at Lydiard Park in the late 18th and early 19th centuries

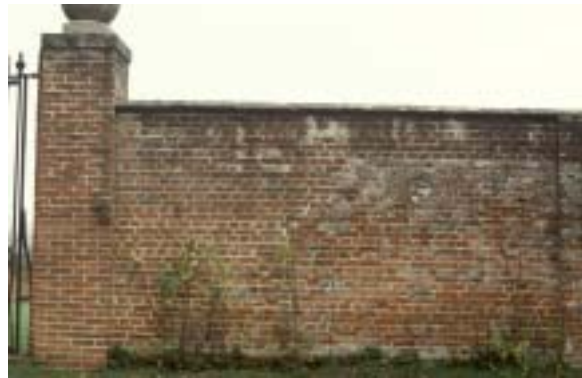
Figure 19 Detail of the walled garden, showing some of the builds

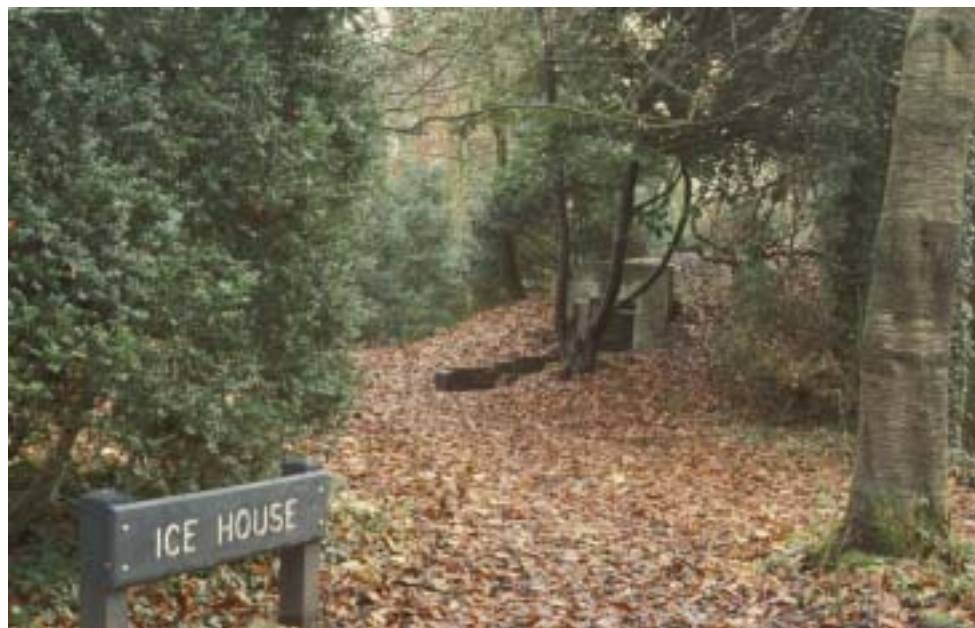
Figure 20 The ice house as seen from the nearby drive way

Situated approximately 110m south-west of the house lies the ice house (b). The external appearance of it is as a modern concrete and brick dome with its entrance facing north. Although not specifically mentioned, it has been considered likely that it was also built

during the remodelling of the house and parkland (Beamon and Roaf 1990, 450). Although it has been heavily repaired, with the addition of two concrete lintels set over the opening, and the entire structure being encased in concrete with a modern brick entranceway being constructed, the interior remains unaltered (*ibid*).

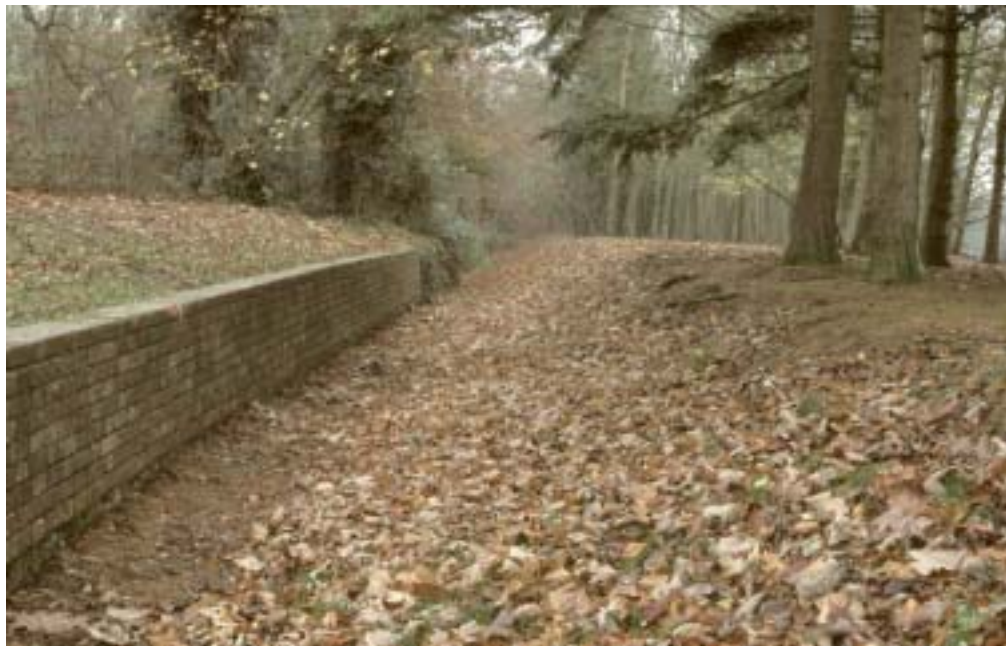
The most significant and obvious feature surviving from this period is the ha-ha. Although the ha-ha itself does not appear in the documentary record until the tithe map of 1839, it is likely that it was constructed in the late 18th-century, probably after the Willington plan had been produced. Its bottom two courses consist of irregular stone bonded with lime mortar, pointed in cement. These are capped by 11 courses of Flemish bond brickwork with modern cement. There is evidence for a number of different builds along its length, suggesting that the retaining wall has been rebuilt several times. The last build appears to be of 19th-century date. The lowest two courses are of a similar appearance and have the same mortar type as the retaining wall running along the outside of the ditch that defines the eastern boundary of the park (Fig 7, h) in the pre-parkland section above.

Figure 21 The ha-ha and associated bank and ditch, looking east

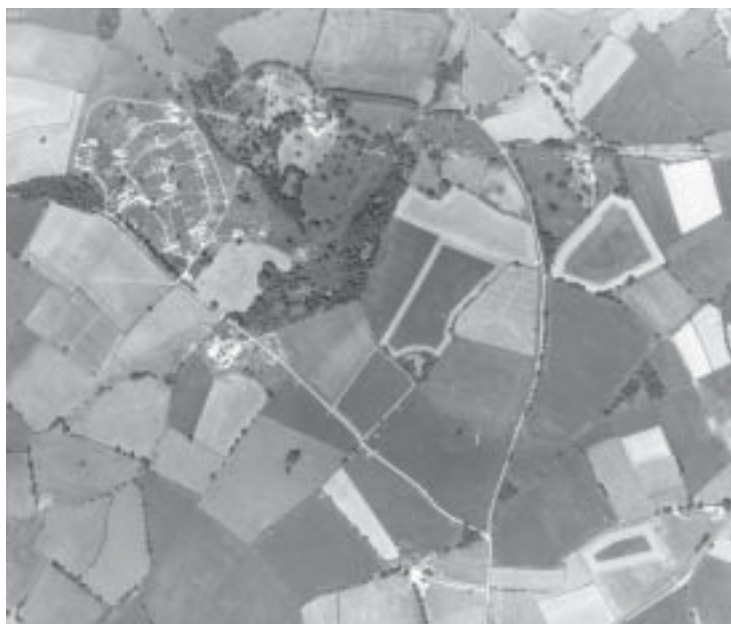
Figure 27
*Aerial
Photograph
showing the
extent of the
1950's
residential
complex*

What is evident in the area to the south of the ha-ha, and to a lesser extent on the area of the playing fields are earthworks, in places slightly amorphous, that are associated with the 302nd Field Hospital and the subsequent residential complex (Fig 26, a). Although they are present on the current playing field, they have been denuded to such an extent that they are unsurveyable at 1:2500. This is because the area has been graded to create a flat surface suitable for ball games. The fence that encloses the western field in this area is a post-1960 arrangement. It follows the line of the perimeter roadway or pathway (AP RAF/58/3612 20 June 1960, Fig 27). This photograph also shows the layout of the hospital during its latest phase as housing, and correlates with the earthworks observed on the ground. The fence to the west that encloses the playing field is a later addition to the landscape, constructed after the demolition of the hospital and residential buildings.

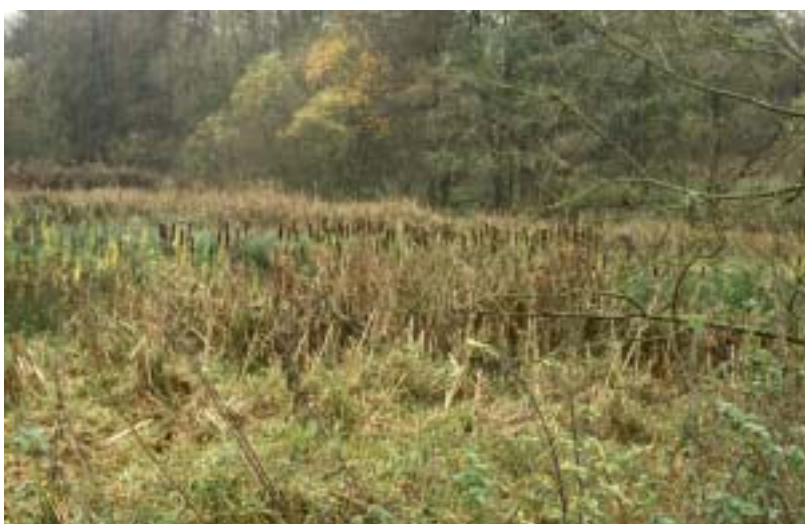
Figure 29 The lower lake today

The lower lake appears to have been dammed approximately half way along its length, possibly in the 1970s (Sarah Finch-Crisp, pers comm; NMR SU 18 SW 71). This earthen dam wall (Fig 26 b) is still in existence, and contains a sluice constructed of railway sleepers approximately half way along its length.
