## LONGTOWN, HEREFORDSHIRE

### A medieval castle and borough

Archaeological Investigation Report Series AI/26/2003

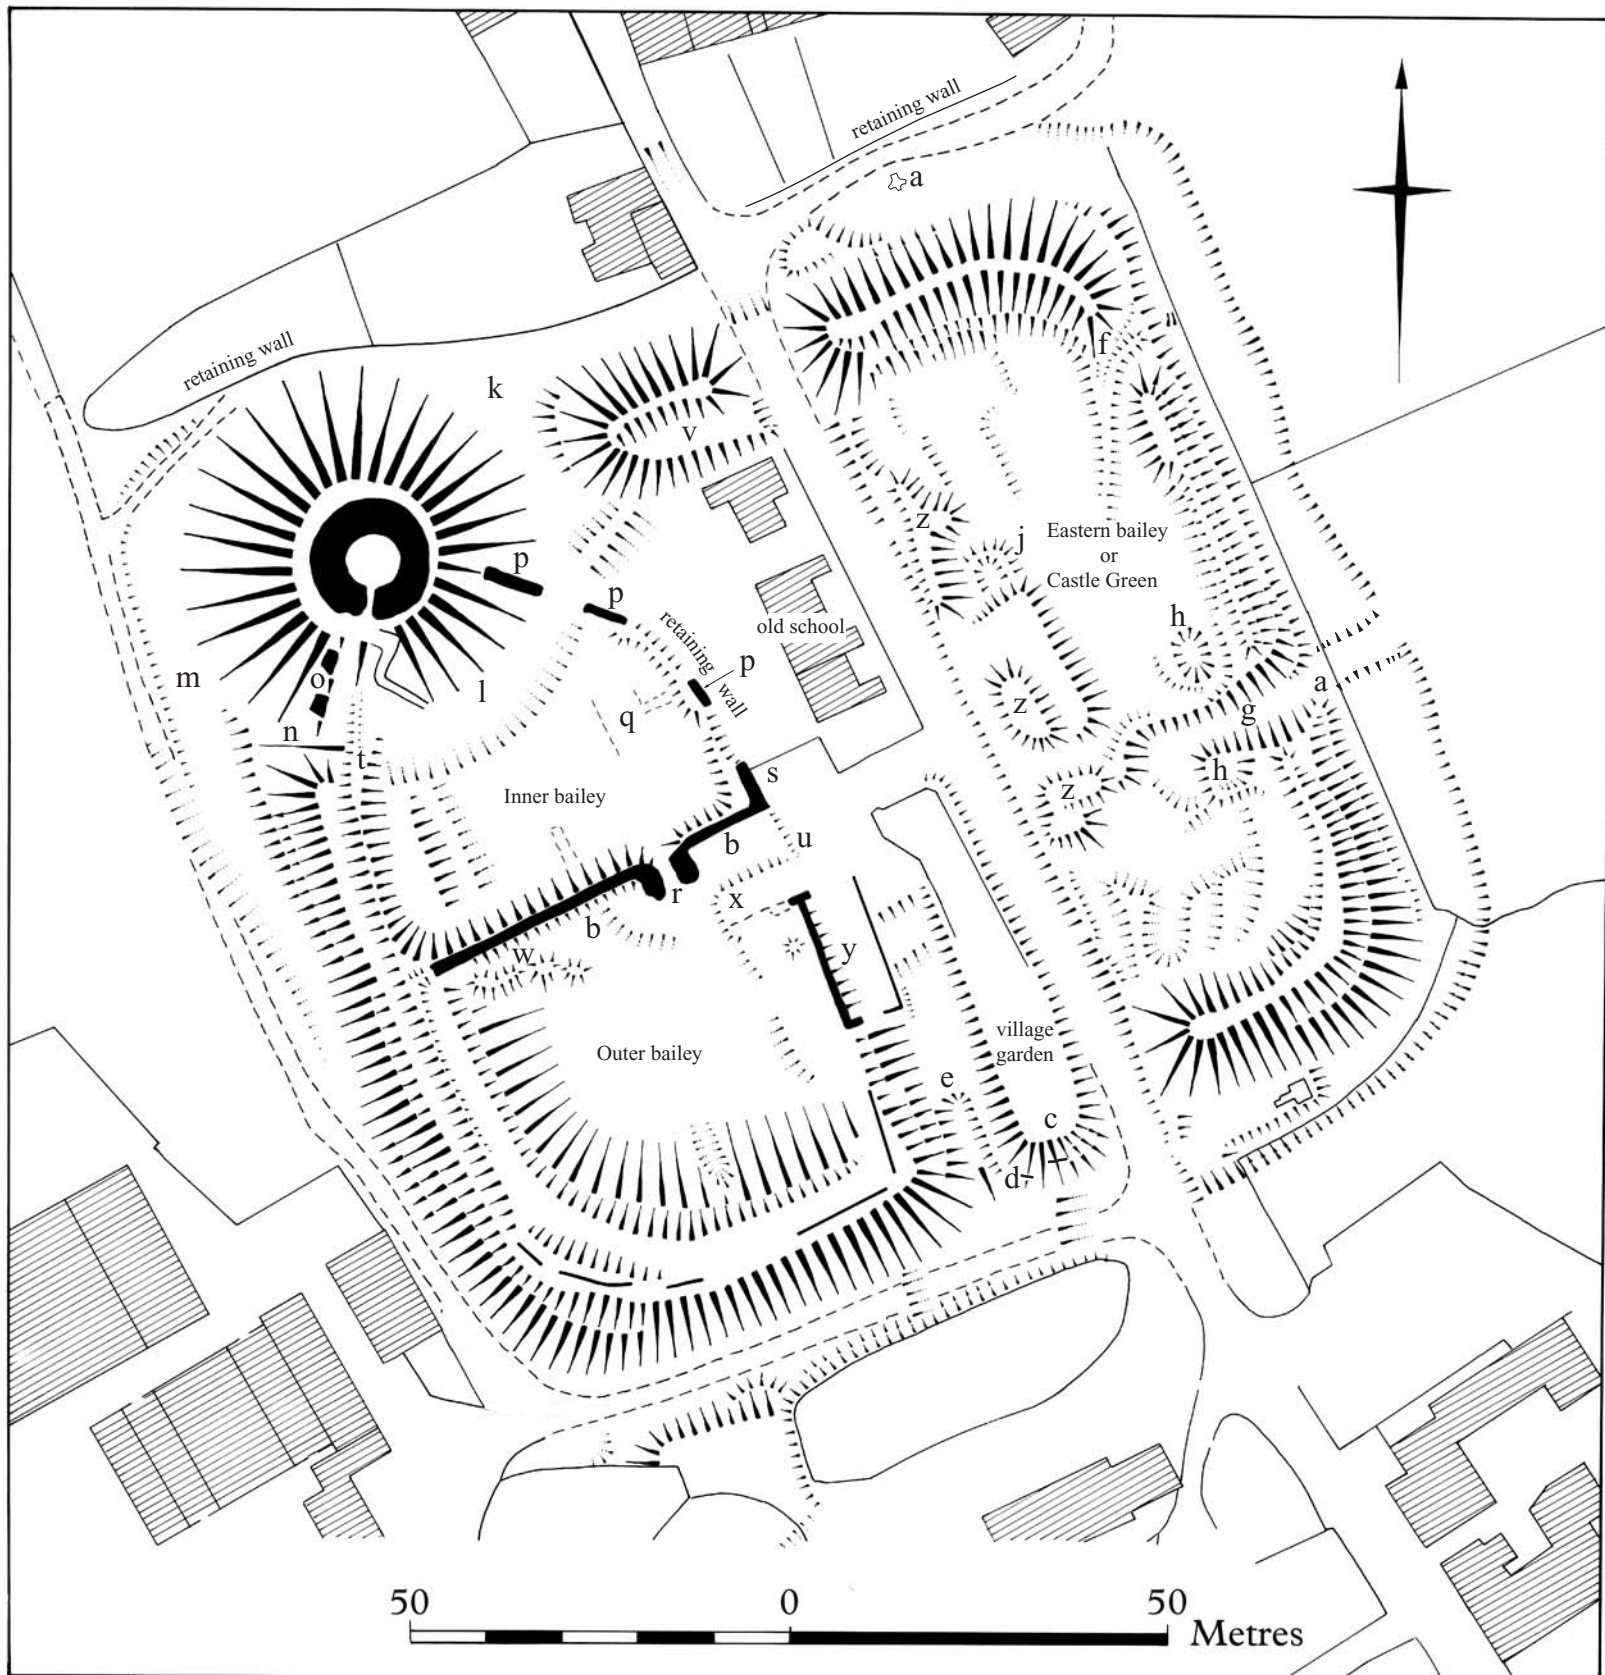
Figure 3: Longtown Castle, English Heritage Survey 2003

There are six gaps in the rampart. In the eastern side, one lies close to the north-eastern corner of the enclosure, where a small footpath (figure 3, f) from the direction of Llanwonog and the Salem Baptist Chapel cuts across the rampart diagonally and leads towards the present village. To the south of this is a larger breach (Figure 3, g) flanked by inturned ramparts and a corresponding causeway across the ditch. From its asymmetric position and form it seems unlikely that this is an original entrance to the enclosure, although it could still be of some age. It now has no obvious purpose, other than as a farmer's entrance, but it is flanked by two small building platforms (Figure 3, h) and leads towards a complex of probable settlement earthworks (Figure 3, j). A further breach (Figure 3, k) lies immediately east of the motte and was probably created when the motte ditch was cut. Two breaks in the rampart exist where the main village road runs through the enclosure breaching its northern and southern sides. Stonework on the western side of the road at the southern

breach has been interpreted as part of a possible gateway (RCHM 1931, 183). Further stonework was seen protruding in two places in this area (Figure 3, c & d), one at the foot of the rampart and one close to its top. These appear to be the remains of a revetment wall. Close to the centre of the southern rampart, only 20m west of the break through which the road passes, is a further gap in the rampart. This carries a hollowed track-way (Figure 3, e) which runs in a northerly direction into the centre of the enclosure. It is the only one of the breaks in the rampart which lies symmetrically with the enclosure, being situated centrally in its southern side. The fact that it also carries a hollowed track-way and is flanked by imposing ramparts on either side suggests that it may have been the original entrance.

The steep conical castle motte straddles the north-western corner of the enclosure. It is an imposing feature, standing approximately 11m high, with a circular stone keep on its summit. Its ditch has been filled in but traces of it can be seen in the inner bailey where a broad shallow depression (Figure 3, l), at most 0.3m deep, curves around the foot of the mound. Further traces can be seen to the west, where a further shallow ditch (Figure 3, m) lies between Jews Lane and the mound and also where the enclosure rampart has been cut immediately to the south of the mound (Figure 3, n). As with the main enclosure ditch, the motte ditch carries a track on its northern side which has been partly filled in to accommodate houses and gardens behind a wall. This wall retains an external ground level of 1.7m.

was built. Most of the curtain wall has collapsed, but three sizeable portions (Figure 3, p) survive on its eastern side. These probably owe their survival to later use as walls for lean-to buildings. Internally they have collapsed rubble at their foot, while externally the ground drops away 2m beyond a vertical retaining wall. A fourth fragment of collapsed curtain wall (Figure 3, s) joins a cross-wall (Figure 3, b), which divides the outer bailey from the inner bailey, continues almost as far as the western rampart of the earlier earthwork enclosure before which it has been reduced to earth-covered rubble. There is no indication of any return of the wall towards the keep to form a western side to the enclosure. A low bank (Figure 3, t) could be an indication of its former course, but is probably the remains of a later wall. The cross-wall, unlike the wall fragments to its east, is completely straight in plan and survives remarkably well compared with the rest of the curtain. It still stands up to 4m high and, like the curtain wall, is built of thin slabs of roughly coursed local stone. It is constructed on level ground with no underlying earthwork. On the eastern side of the outer bailey a further fragment of the curtain wall remains and there is a fall in ground level from the outer bailey to the entrance hollow-way (Figure 3, e). The surviving wall fragment has been incorporated into a narrow wall, placed along the top of the rampart. This bears no resemblance to the remains of the curtain wall and is likely to be a post-medieval garden boundary. Further traces of curtain wall, 2.4m wide, have been reported on top of the rampart on the western side of the outer bailey (Ellis 1997, 71). These were not apparent during the present survey, but the rampart is heavily overgrown.

The gateway from the outer to the inner bailey (Figure 3, r) has a round-headed arch, flanked by two solid half-round towers. These form its passage, which is flanked by 3m thick walls. It also has a portcullis groove. The gateway does not resemble usual castle entrances. It is extremely small, measuring only 1.8m wide and c2.5m high. However, if the 1m overburden of debris recorded during excavations in the bailey is taken away it would have been high enough for a horseback rider to pass through, although still have been too narrow for any but the smallest of horse-drawn vehicles. It would have offered little defensive potential and has been described as '*perhaps the simplest and smallest example of a twin-tower gatehouse, hardly more than a doorway*' (Cathcart-King 1988, 117).

The main gateway into the castle does not survive. It is usually assumed to have been adjacent to the modern entrance (Figure 3, u), although this is by no means certain. If it was situated here, and if it led towards the present inner gateway, entry to the castle must have involved a right-angled turn in a restricted space between the outer and inner gates, which would have made access particularly difficult. Nevertheless, it is fairly certain that the outer gate was not on the same alignment as the entrance to the inner bailey since the enclosure rampart immediately opposite it shows no indication of ever having been breached. The scale of the ramparts on the western side of the castle also makes it unlikely that an entrance could have existed there. A position close to the modern castle entrance thus seems the most likely site for the main entrance to the masonry castle, although this may

Within the 'eastern bailey' there are at least three small building platforms (Figure 3, h & j). Their date is uncertain, but judging by their appearance and the fact that no buildings are featured here on 18th- and 19th-century maps, they are likely to be of an early period and could well be medieval. The eastern bailey has the same scooping of the centre

seen in the inner and outer baileys, while a series of amorphous mounds (Figure 3, z) beside the road are probably spoil from road construction. A large sub-rectangular platform defined by a scarp 1m high has been overlain by one of these spoil heaps, as has the small building platform (Figure 3, j) on its northern side.

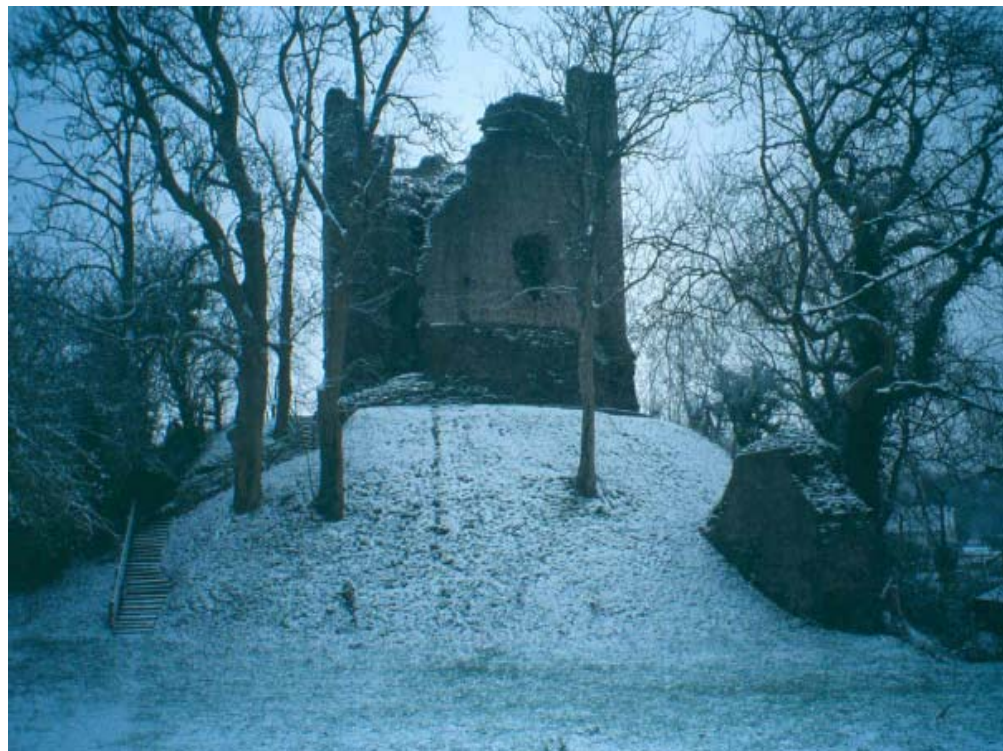
**Figure 4:**  
*Longtown  
motte and  
keep*

The keep is a massive round structure constructed of local shale-like sandstone rubble with ashlar dressings. It has been the subject of several detailed studies (eg Morriss & Williams 1991; Remfry 1997, 34-35, 39). Its walls, 4m thick, survive two storeys high above an under-croft which penetrates its earthen mound. It has suffered partial collapse on its south-western side, where two large fragments of masonry (Figure 3, o) lie on the slopes of the motte. The positions of the floor levels are marked by ledges in the interior. Three half round turrets are equally spaced around the outside face of the tower, one containing a fireplace, one a spiral staircase leading to the upper floors and one situated next to a projecting garderobe. The turrets do not show on the ground plan because the keep has a chamfered plinth. This is now robbed of its facing stone. The first floor windows have been enlarged at some point and decorated with fragments of re-used 12th-century mouldings. The 13th century, the date of the earliest fabric of St Peters Church, would seem a likely date for these modifications because episodes of church re-building may coincide with modifications to the seignorial site, perhaps using the same craftsmen (Creighton 2002, 110). The re-used masonry may have come from a 12th century chapel, perhaps situated within the castle. Chapels tended first to be in the keep and from the 13th century onwards at the side of the bailey and against an exterior wall (Pounds 1990, 240). Round keeps are rare and the example at Longtown is one of a group of 19 such keeps to have been recognised in the Brecon region (Shoesmith 1996, 170).

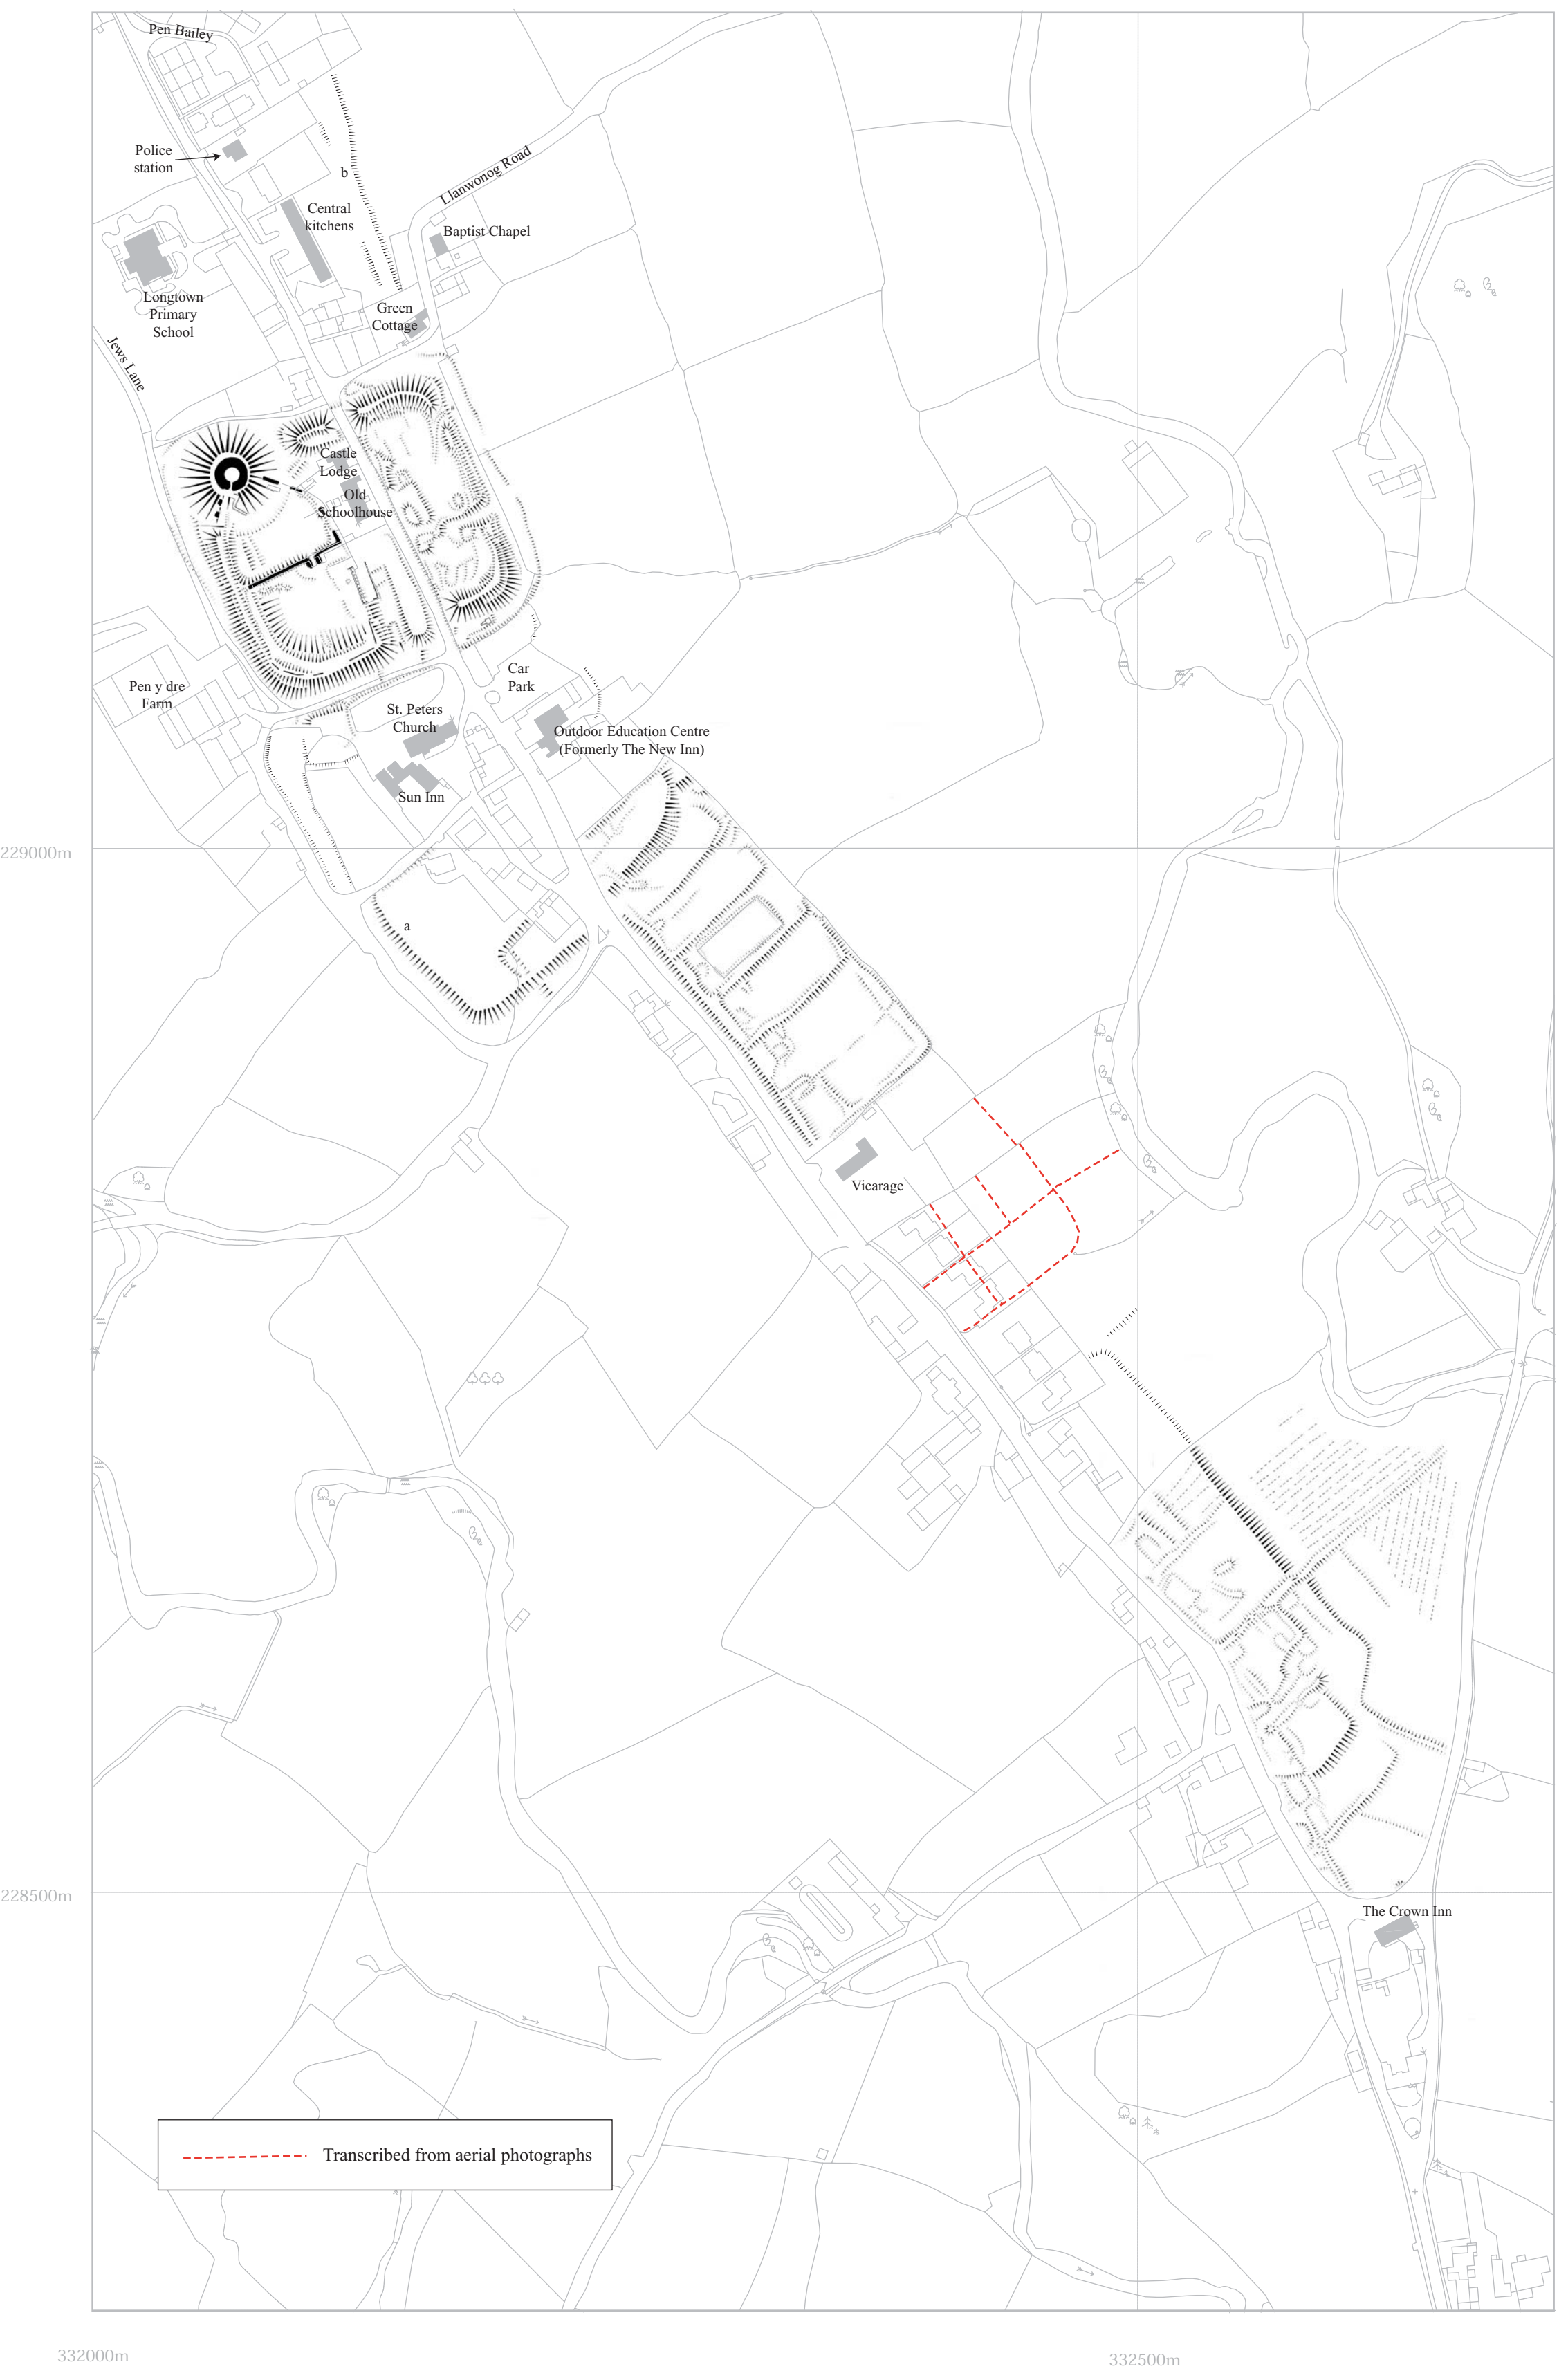
Figure 8: Longtown Castle and borough, 1:2500 survey, English Heritage 2003 (Based on Ordnance Survey map sheets SO 3228 & SO 3229. Crown copyright reserved)

The earthworks of the medieval borough can be seen in many parts of the present village and its surrounding fields. Adjoining the south of the castle is a sub-rectangular enclosure (Figure 8, a) mirroring that of the castle's earthwork enclosure. It is defined by a scarp still standing to over 1m in height for most of its southern side, and 1.5m high on its eastern side, with shallower scarps and banks forming its western side. It is usually regarded as a defensive enclosure around the medieval borough (eg Buteux 1996, 5). Within it lies the core of the medieval town, now largely built over by later houses and their gardens. The church stands in a prominent position upon an area of raised ground immediately outside the old entrance to the castle and at the head of the former market place to its south. Much of the market place has been encroached upon, creating two narrow roads running parallel with each other. The western of these roads leads towards the church, which lies across it in front of the castle entrance, while the eastern road by-passes the masonry castle but cuts through the sub-square earthwork enclosure.

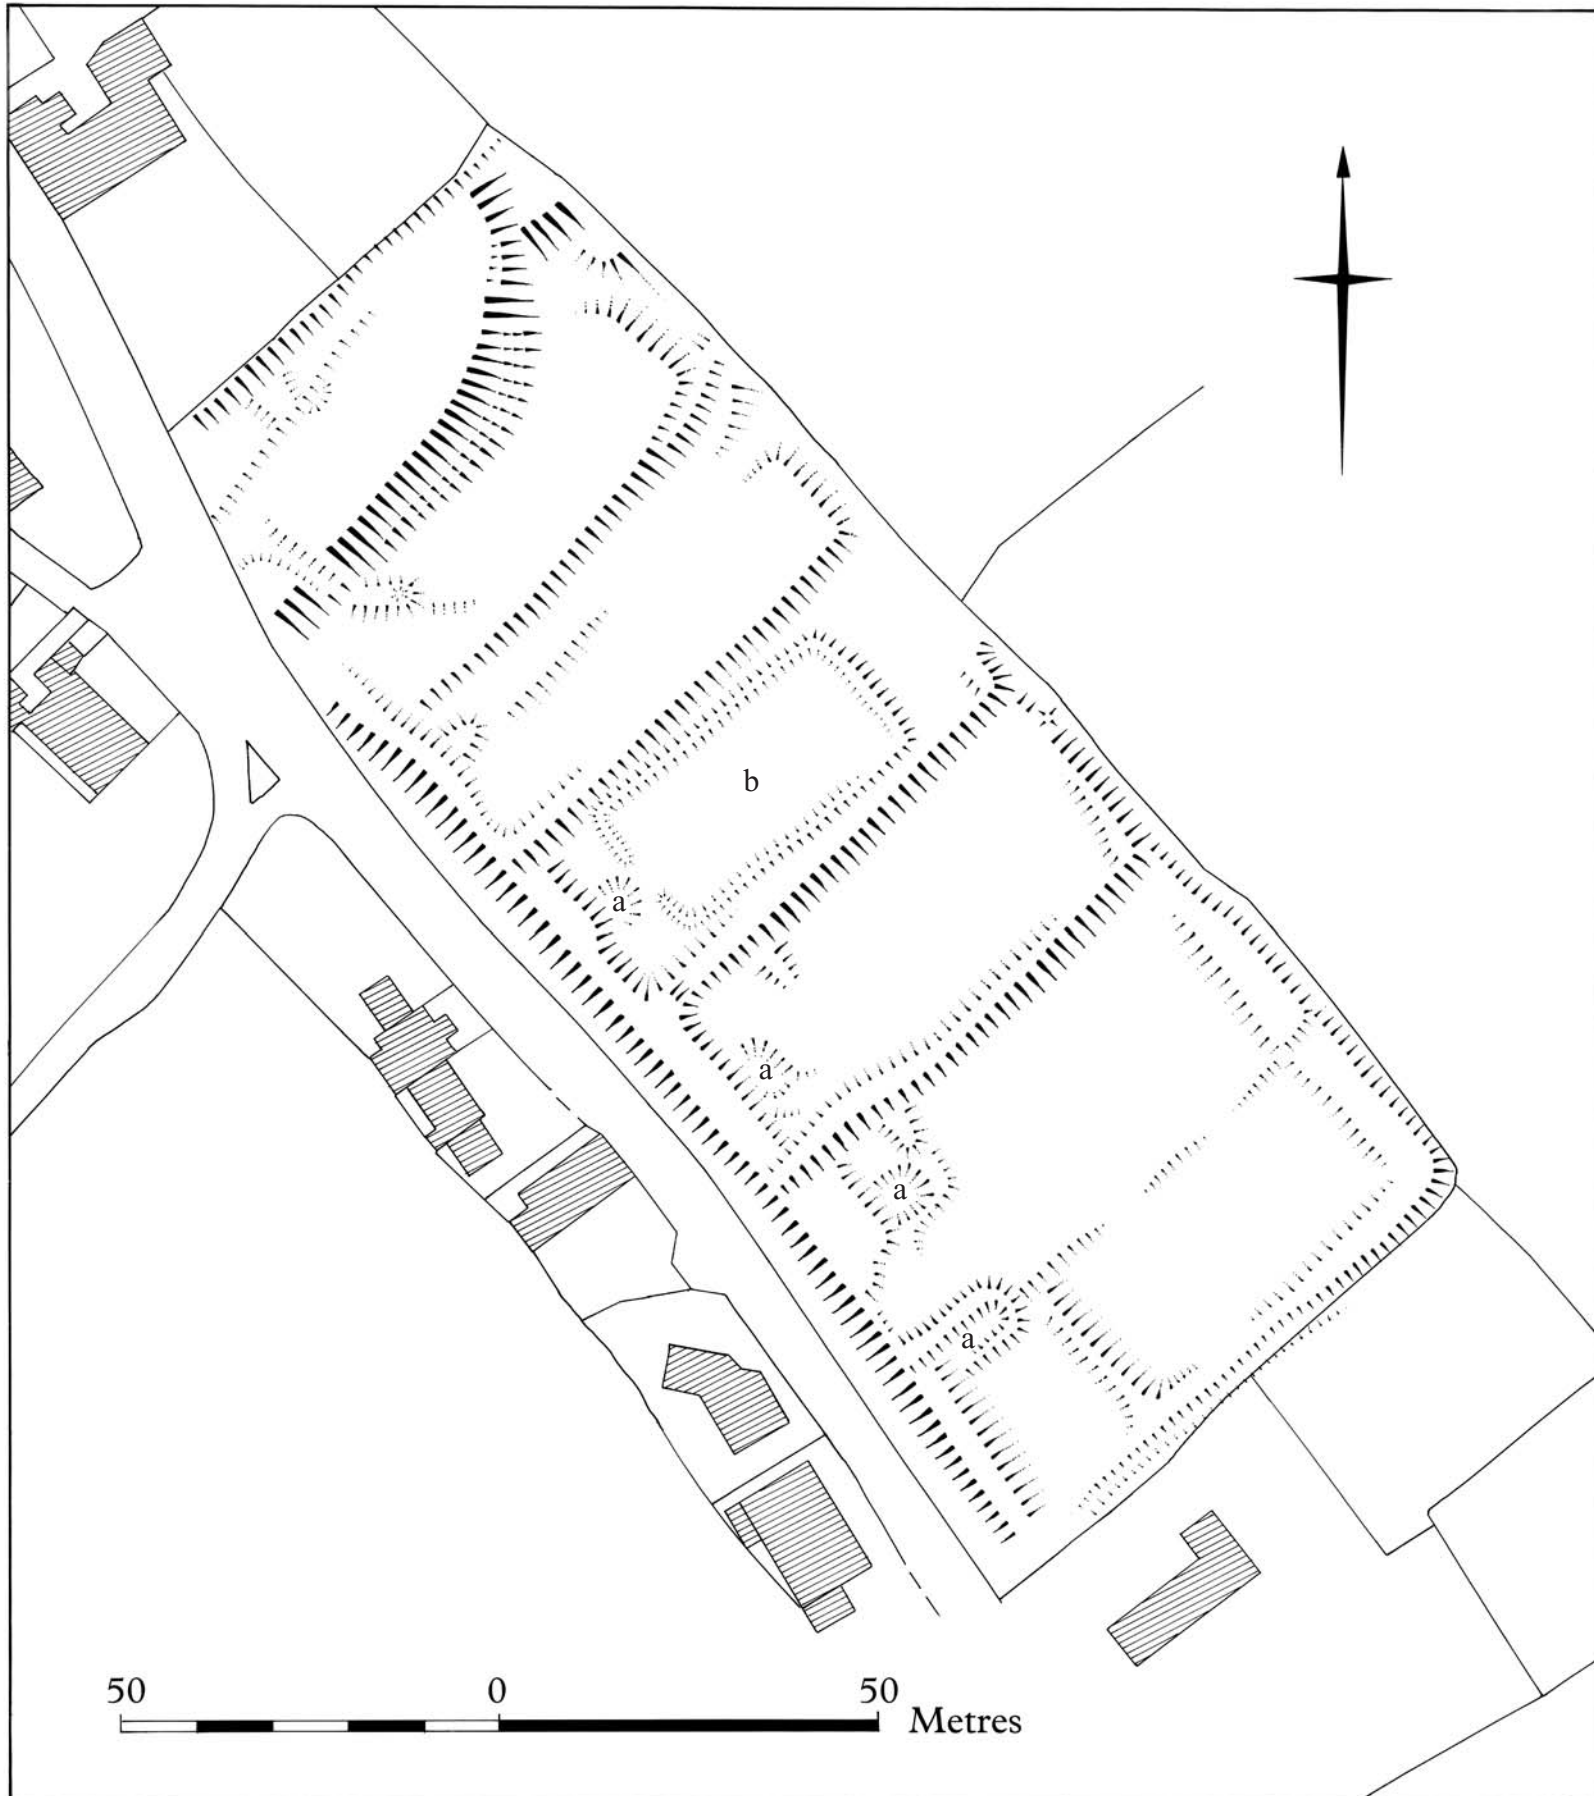
Figure 9: Settlement earthworks, Outdoor Education Centre. English Heritage survey 2003

The best settlement earthwork remains lie south of, and outside, the suggested borough defence enclosure. Two fields of well-defined earthworks were surveyed. The first of these fields lies to the south of the Outdoor Centre at SO 32312895. Here scarps and low banks define seven narrow, conjoined crofts, each of similar size and plan, leading back from the edge of a hollow-way which skirts the present road. A terminal bank just inside a modern hedge line, delimits their eastern extent. They are remarkably regular in size. At least four have building platforms (Figure 9, a) next to the hollow-way, while a modern rectangular enclosure (figure 9, b) is situated within one. The date of these building platforms and crofts is not known but there is no reason why they should not be medieval. They are not shown as buildings in the late 19th century (Ordnance Survey 1888) and since the settlement was called 'Longtown' by the 16th century, this shows that it had expanded along the road by that time. The regular layout of the earthworks would also be consistent with that of a planted town, where land was divided into long burgage plots at right angles to streets. The plots, occupied by burgesses paying a standard annual rent, usually 1/- a year, were of standard width, using the perch, rod or pole, usually 5m x 5m or 5m, as a unit of measurement (Hindle 1990, 52-4) .

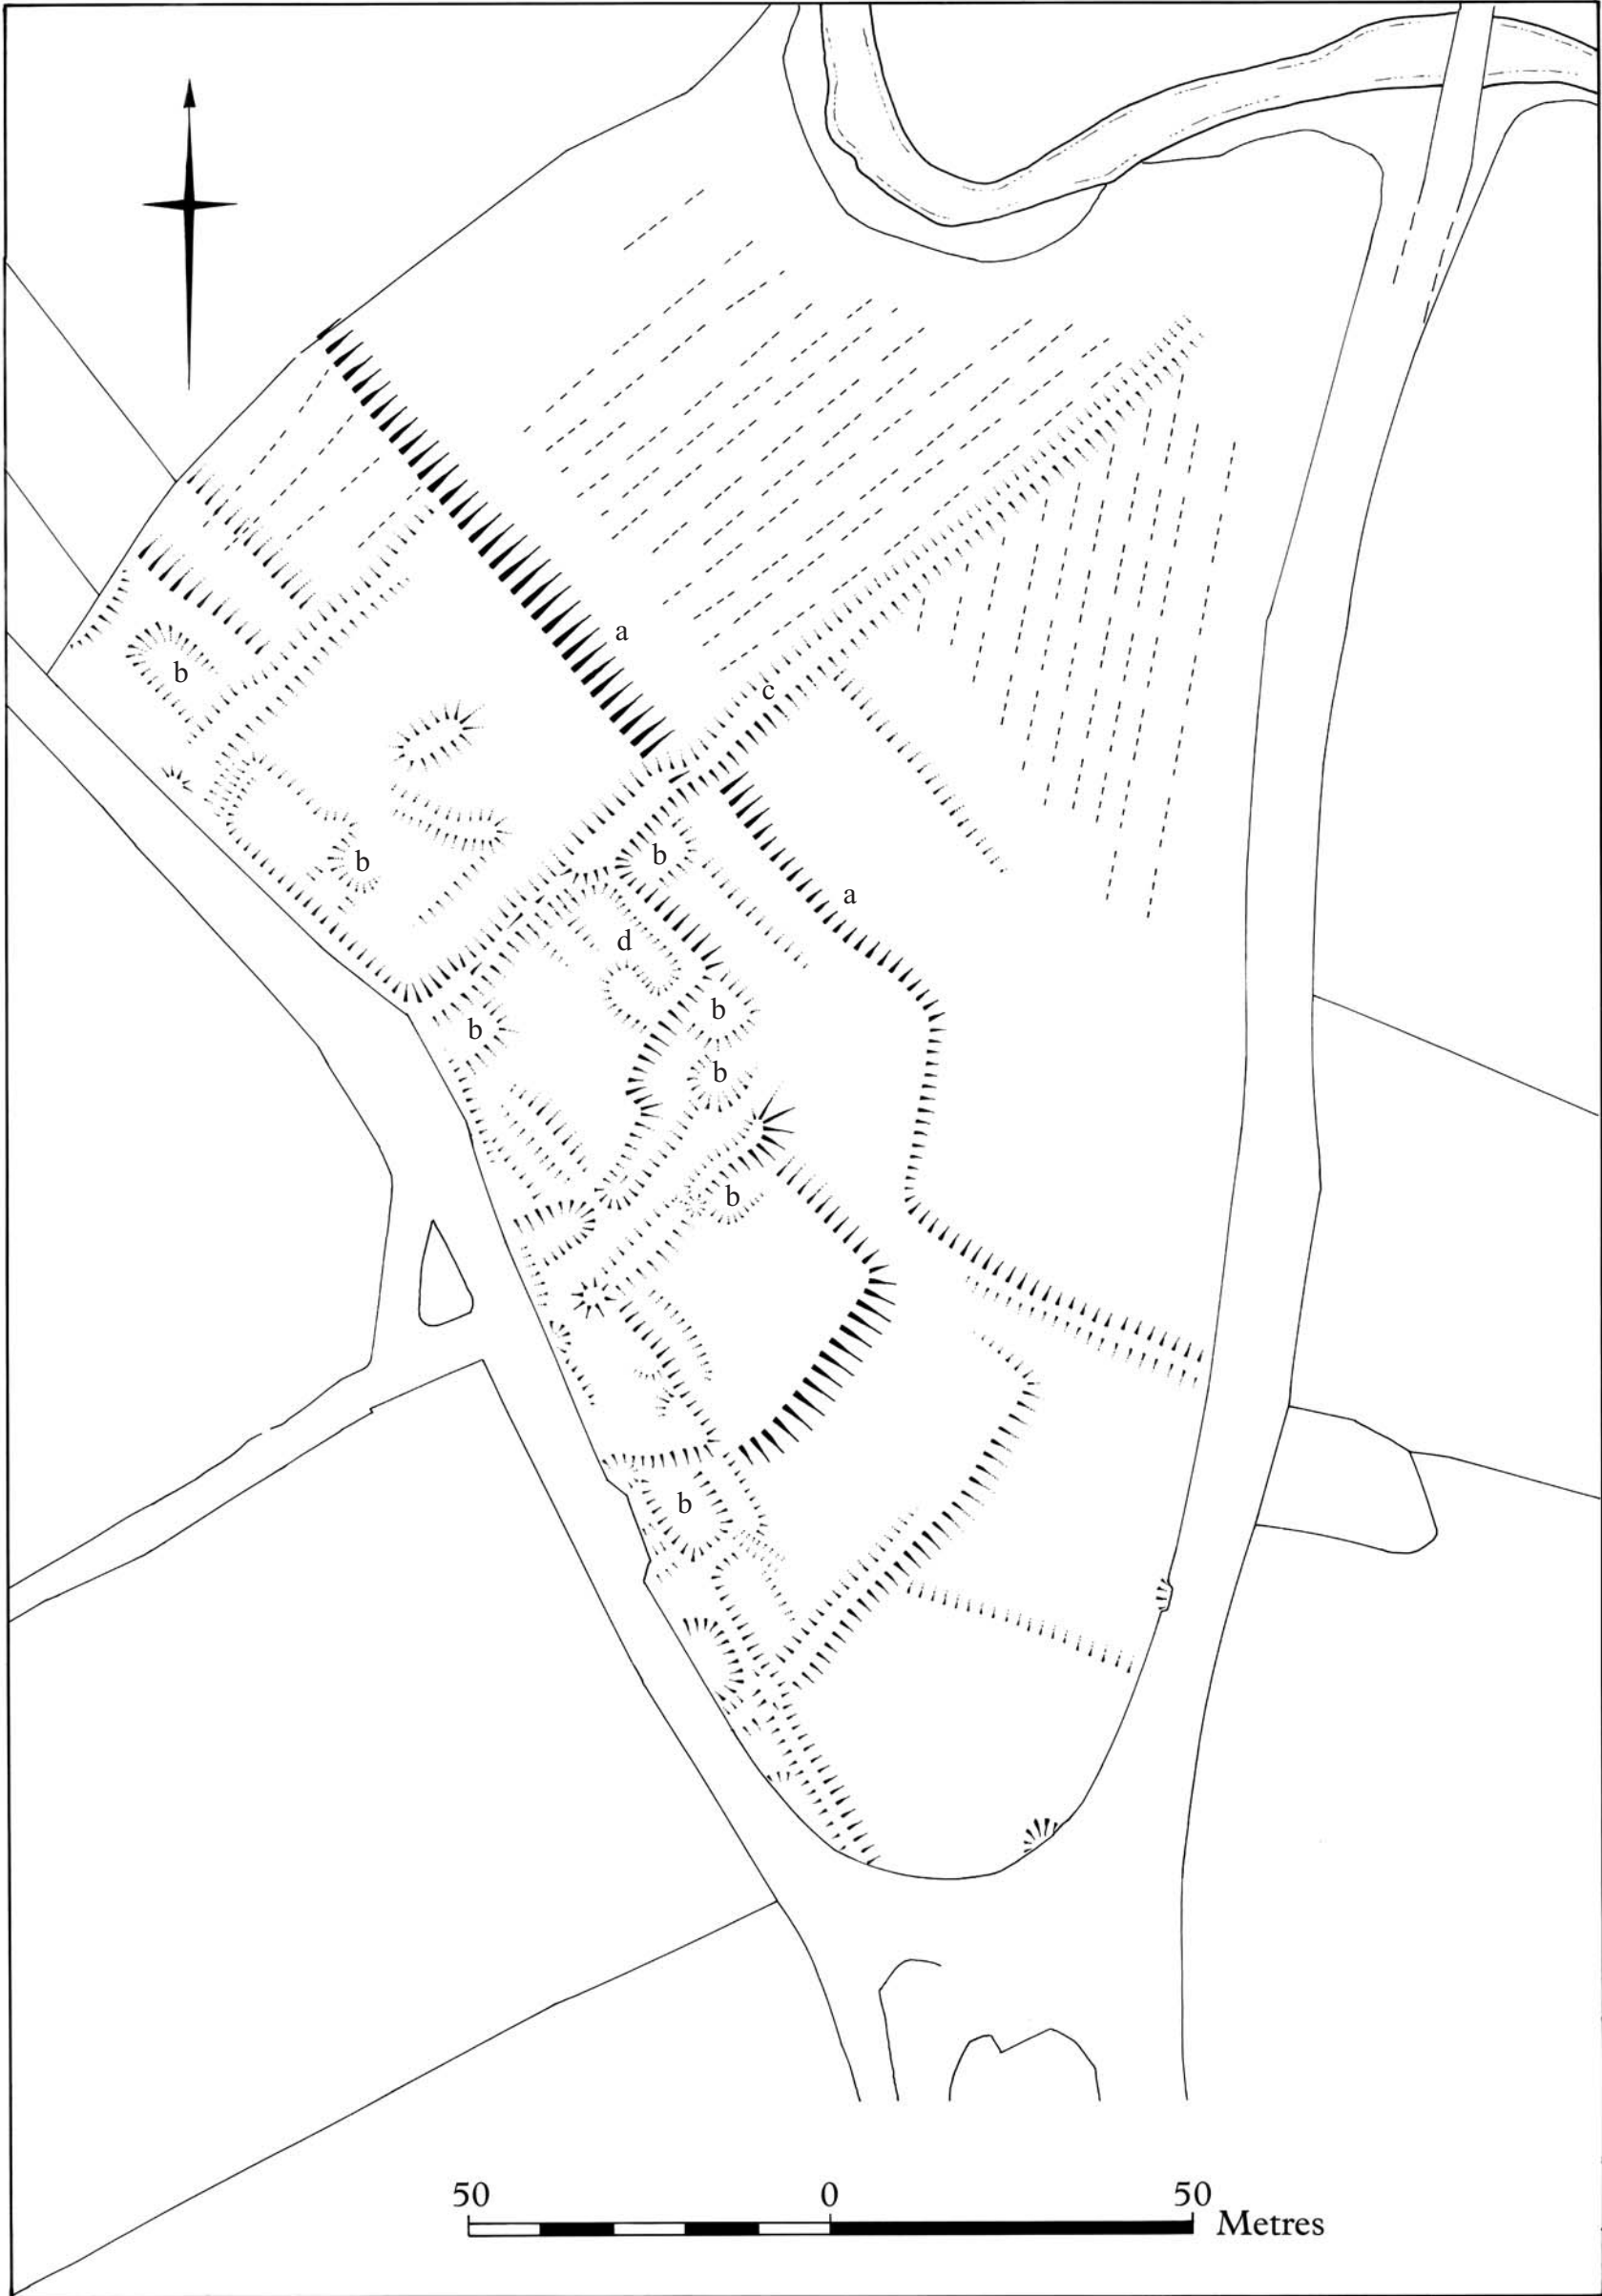
Figure 10: Settlement earthworks, Pigeon House Field, English Heritage Survey 2003

The second field lies further south, in the V-junction opposite the Crown Inn, centred at SO 32602855. Here there is a further series of earthworks, this time less regular. They consist of low banks and scarps forming a system of enclosures between the road and a substantial lynchet (Figure 10, a) which forms their back scarp, at the junction between level ground on the ridge and ground sloping down to the River Monnow. Numerous small building platforms (Figure 10, b & d) are dotted irregularly amongst these enclosures. Despite the irregularity of the earthworks, traces of divisions of the type found in the field to the north may still be seen amongst the less regular features which probably result from later activity. Although the field is now under pasture the earthworks have seen several episodes of ploughing in the past. Narrow ridge and furrow cuts across them, running over the boundary lynchet and downhill into the valley. A field boundary, now a bank c0.5m high (Figure 10, c) was evidently in use to a later date since it demarcates the junction between two different alignments of narrow ridge and furrow. It also overlies the backscarp to the settlement, partly overlies a small building platform and a larger rectangular building platform. The field was under plough in 1946 (AP RAF 106G/UK 1652/July 1946 5178) and is known to have been the subject of land drainage in the 1970s. All the pottery visible in molehills during the English Heritage fieldwork was of 19th or 20th century date, but this may have been spread with manure since no buildings are shown on any early maps of the area. In c1840 the field is named 'Pigeon House' field (Tithe Award HRO 57/1-4), so one of the building platforms is almost certainly the site of a dovecote. Although dovecote buildings varied considerably in shape and size, descriptions of examples in Herefordshire (Stainburn 1979) indicate that they were generally no more than 6m in length or diameter, so several of the small rectangular

building platforms are possible candidates. Even if the dovecote was of later date, it is likely to have been built by the 16th or early 17th centuries. Later dovecotes were usually built from brick and an octagonal plan was the most likely form (Stainburn 1979, 8), of which there is no trace on the ground today.

In 2000 an area measuring 60m x 90m in the north-western corner of the field was the subject of a geophysical survey by Herefordshire Archaeology. The survey recorded areas of high resistance associated with one building platform (Figure 10, d) and also found the field bank (Figure 10, c) to contain buried stone (Hoverd 2000).

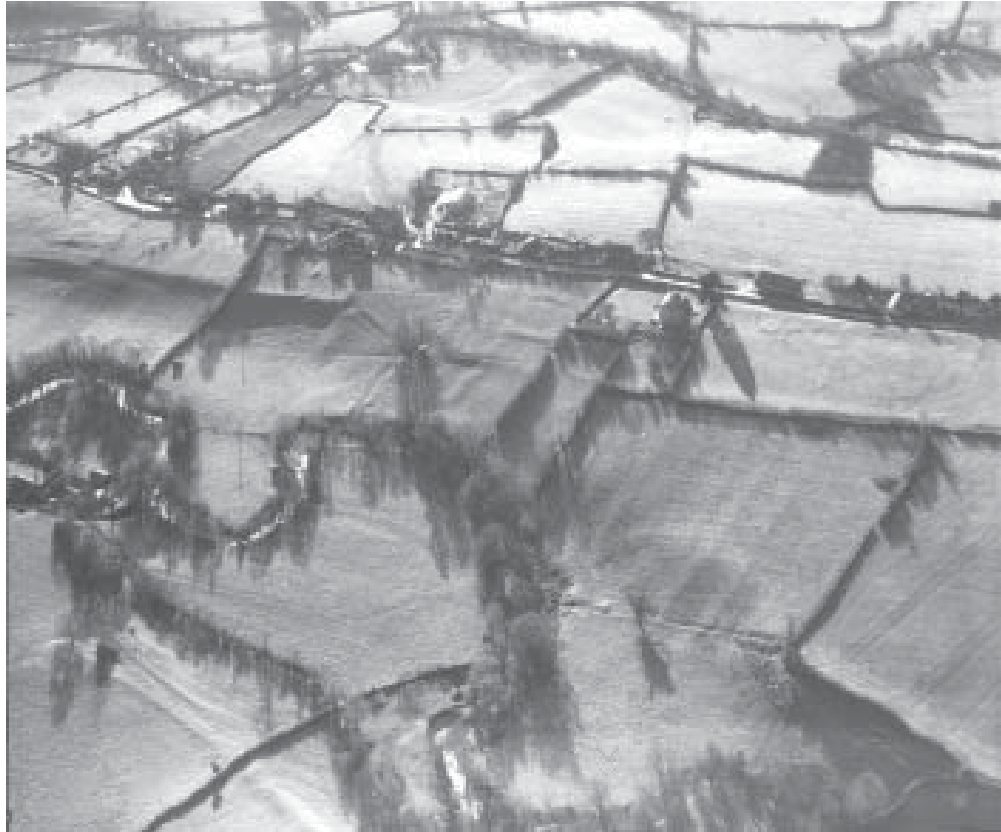
**Figure 12:** settlement earthworks in 1965, now partially destroyed (Copyright reserved Cambridge University Collection of Air Photographs AMQ 66)

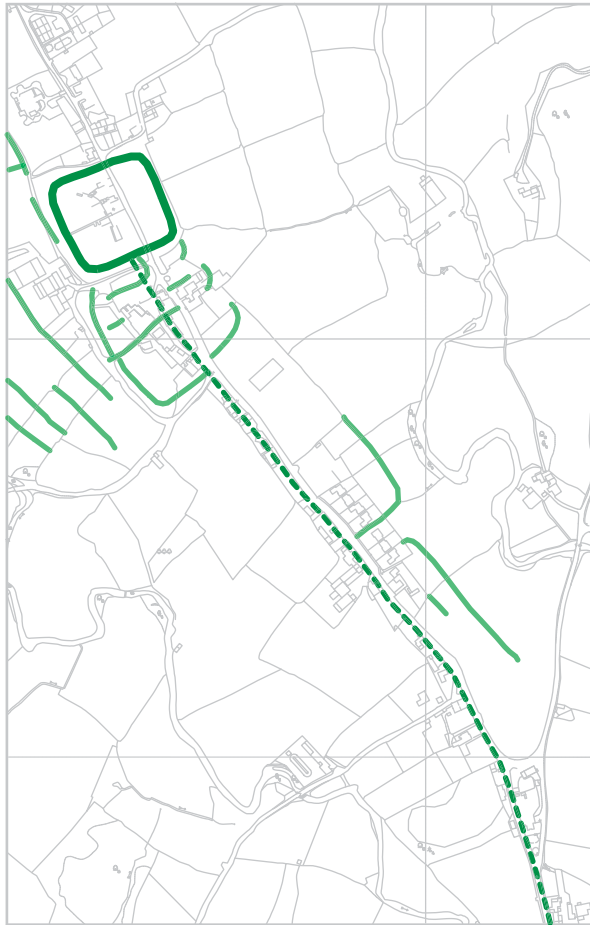
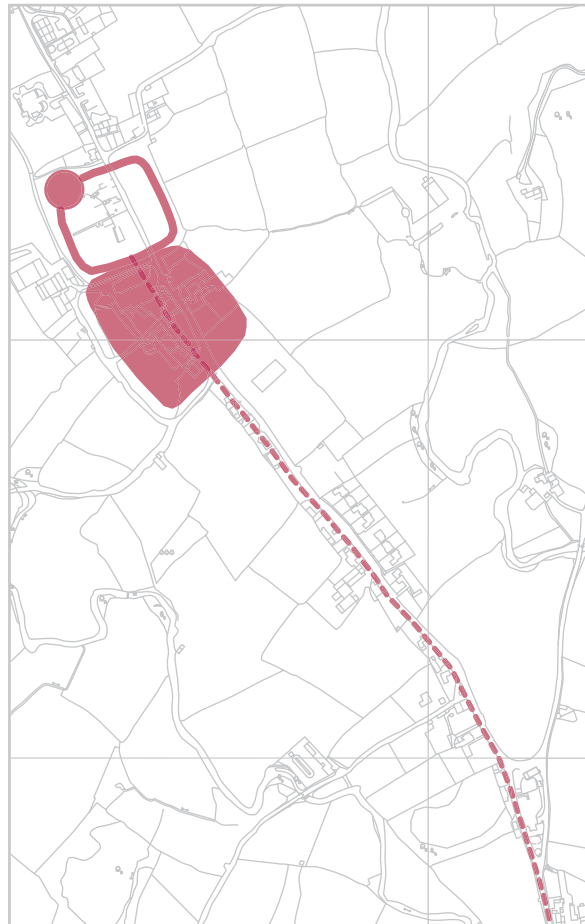
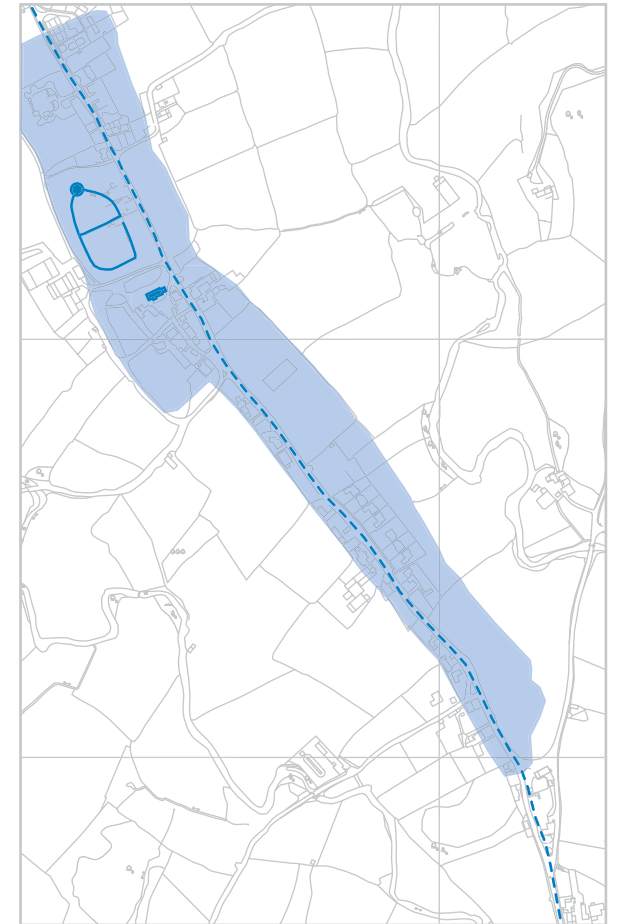
Figure 13: Probable sequence of development at Longtown (based on Ordnance Survey maps sheets SO 3228 and SO 3229. Crown copyright reserved)

Romano-British to Early Medieval

Earthwork castle and early borough  
(late 12th century to 13th century)

Masonry castle, chapel and developed borough  
(13th century to post medieval period)

As the foci of smaller Marcher baronies, castle boroughs were important tools of colonisation in the border zone long after much of lowland England had been pacified (Creighton 2002, 170) and the settlement at Longtown thus forms part of a wider pattern of borough creation (eg Brown 2000). Founding a new town was also profitable for lords because the burgage rents, tolls from outsiders to use the market and rents for market stalls all provided income. Early phases of settlement growth outside castles often took place within embanked precincts appended physically to the seignorial site - often called '*burgus*' settlements (Creighton 2002, 159). In a few instances the borough was located inside the castle bailey, but it was generally close by. Its plan usually consisted of a broad street stretching away from the castle gate, wide enough for a market place and bordered by burgage plots leading back to the edge of a surrounding field (Pounds 1990, 218). Aspects of this layout can be seen in the earthworks and topography of Longtown, but there are still questions to be answered not only about the size and extent of the medieval borough, but also about its development and the nature of its defences. Both earthwork and excavated evidence has indicated that during its heyday in the 13th century the borough extended to the north of the castle and earthwork evidence further shows possible settlement within the eastern bailey. Straggling along the eastern side of the road, south of the borough's core and beyond the earthwork believed to represent its defensive boundary are more settlement earthworks, but nothing is to be seen to the west of the road. It is not certain whether this is because there was never any settlement there or whether its remains have been destroyed. If the figure of 100 burgesses recorded in 1310 is at all accurate, this number could not have been located within the *burgus* enclosure alone, so the town must have covered a larger area by that date. The settlement remains to the south may represent later expansion, while the probable enclosure to the north of the castle may have been a further *burgus* defence. The large number of burgesses recorded coincides with the period of peace in the early 14th century (above p8), when an undefended, and perhaps short-lived, extra mural suburb may have been added.

From the earthwork plan it could be argued that the enclosure adjoining the southern boundary of the castle was a southern bailey of the castle, with the chapel inside it, rather than a '*burgus*' enclosure. Alternatively a southern bailey could have been abandoned and the medieval town laid out within it. It may even be proposed that a southern bailey was constructed over part of the medieval borough as at Ludgershall, Wiltshire (Ellis 2000, 111-113). This does not, however, seem likely. There is no historical context for such an expansion of the castle, which would also have cut the medieval settlement in two. The market place also lies within the enclosure, indicating that the enclosure was indeed part of the settlement.
