# TUDOR HOUSE SOUTHAMPTON

PRELIMINARY NOTES ON THE HISTORICAL  
DEVELOPMENT OF THE BLUE ANCHOR LANE AND  
GEORGIAN WINGS

Historical Analysis & Research Team  
*Reports and Papers 66*  
2002

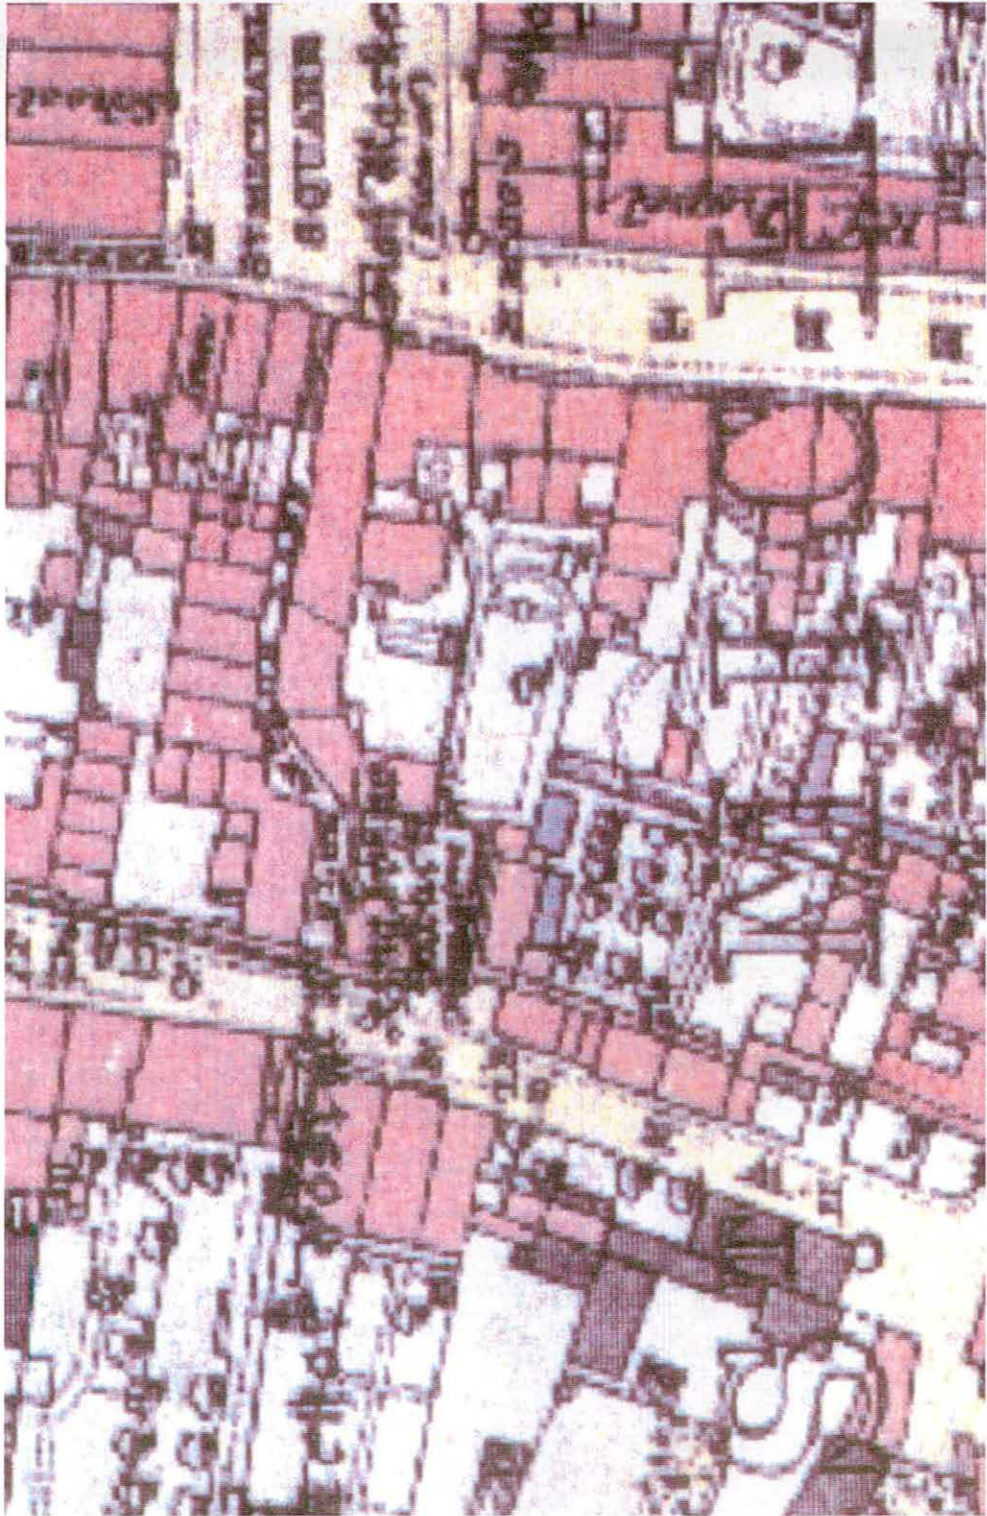
Figure 1, a detail from the 1<sup>st</sup> edition of the Ordnance Survey map of Hampshire, 1848. Reproduced here with east at the top (Southampton Record Office).

The first edition Ordnance Survey map of 1848 shows the site subdivided by simplified property boundaries, Figure 1. The east frontage, excluding the cottage, is divided into two. The northern property is shown extending along Blue Anchor Lane, beyond the 'Georgian Wing' which is shown as a separate entity.

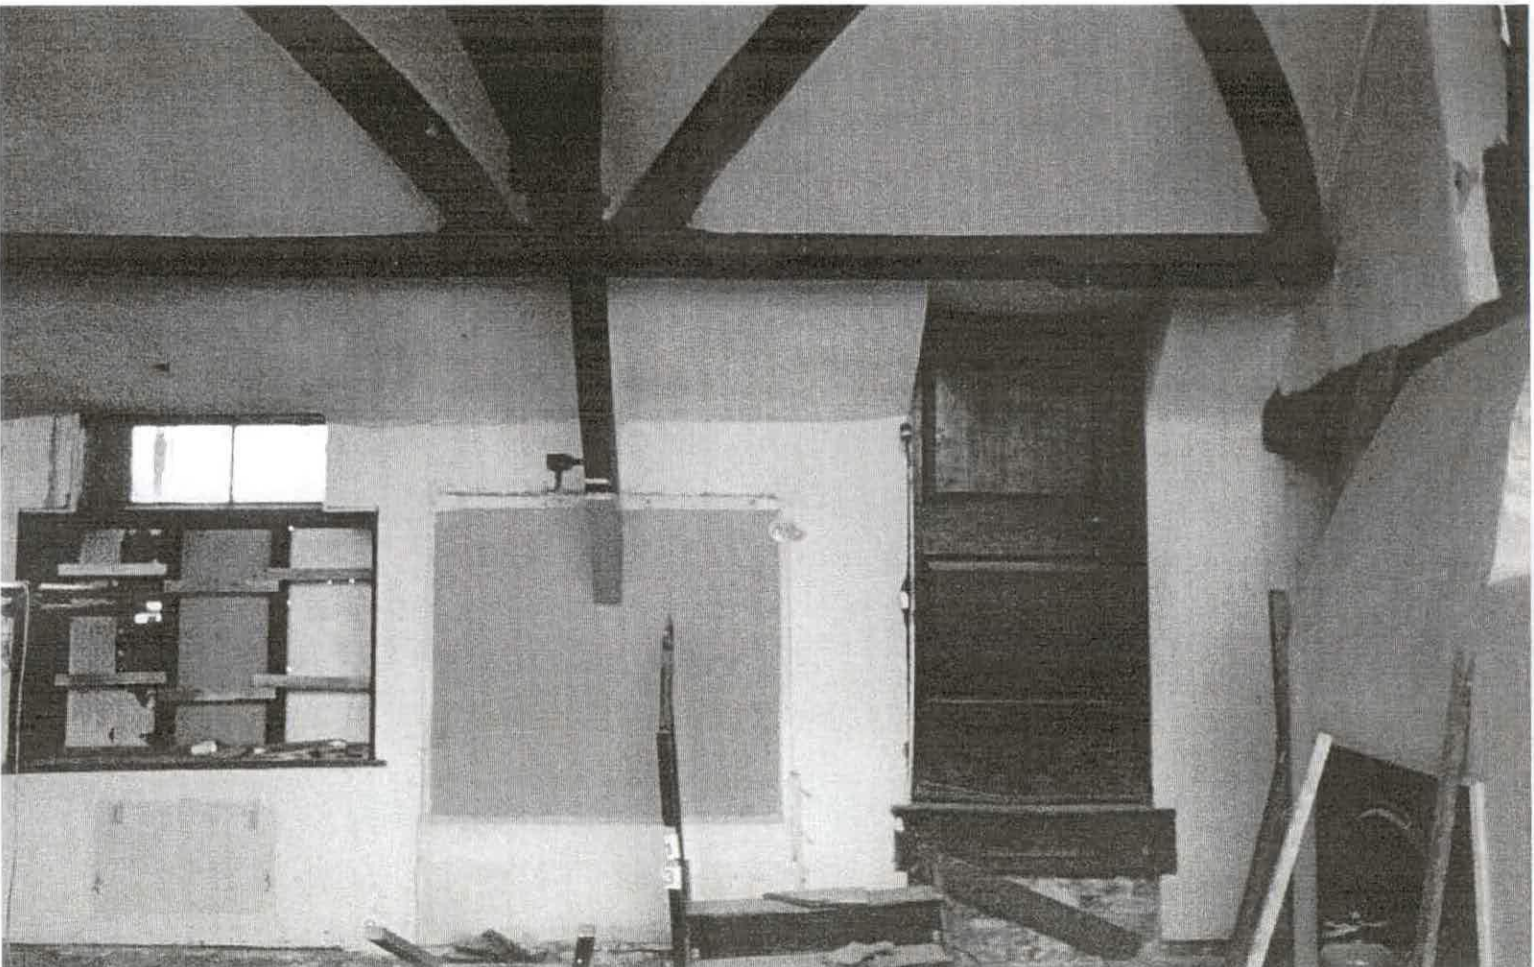
Figure 16, Room 23, east of central stack, looking south, during restoration works of 1984-5 (Conservation Manager, Southampton Council).

In 1984-5, further stripping out took place in the Blue Anchor Lane Wing as part of a four phase repair programme, under the direction of Mr Bob Thomson, Ancient Monuments Officer for Southampton Council, Figure 16 and Figure 17.<sup>6</sup>

The photographs taken in 1984/5 show the floorboards removed and some of the roof covering at the east end of the Blue Anchor Lane Wing, Figure 16 and Figure 17. It seems that in Room 23, during these works, the wall plate, the roof truss tiebeam and the window were replaced, Figure 55, Figure 56 and Figure 57.

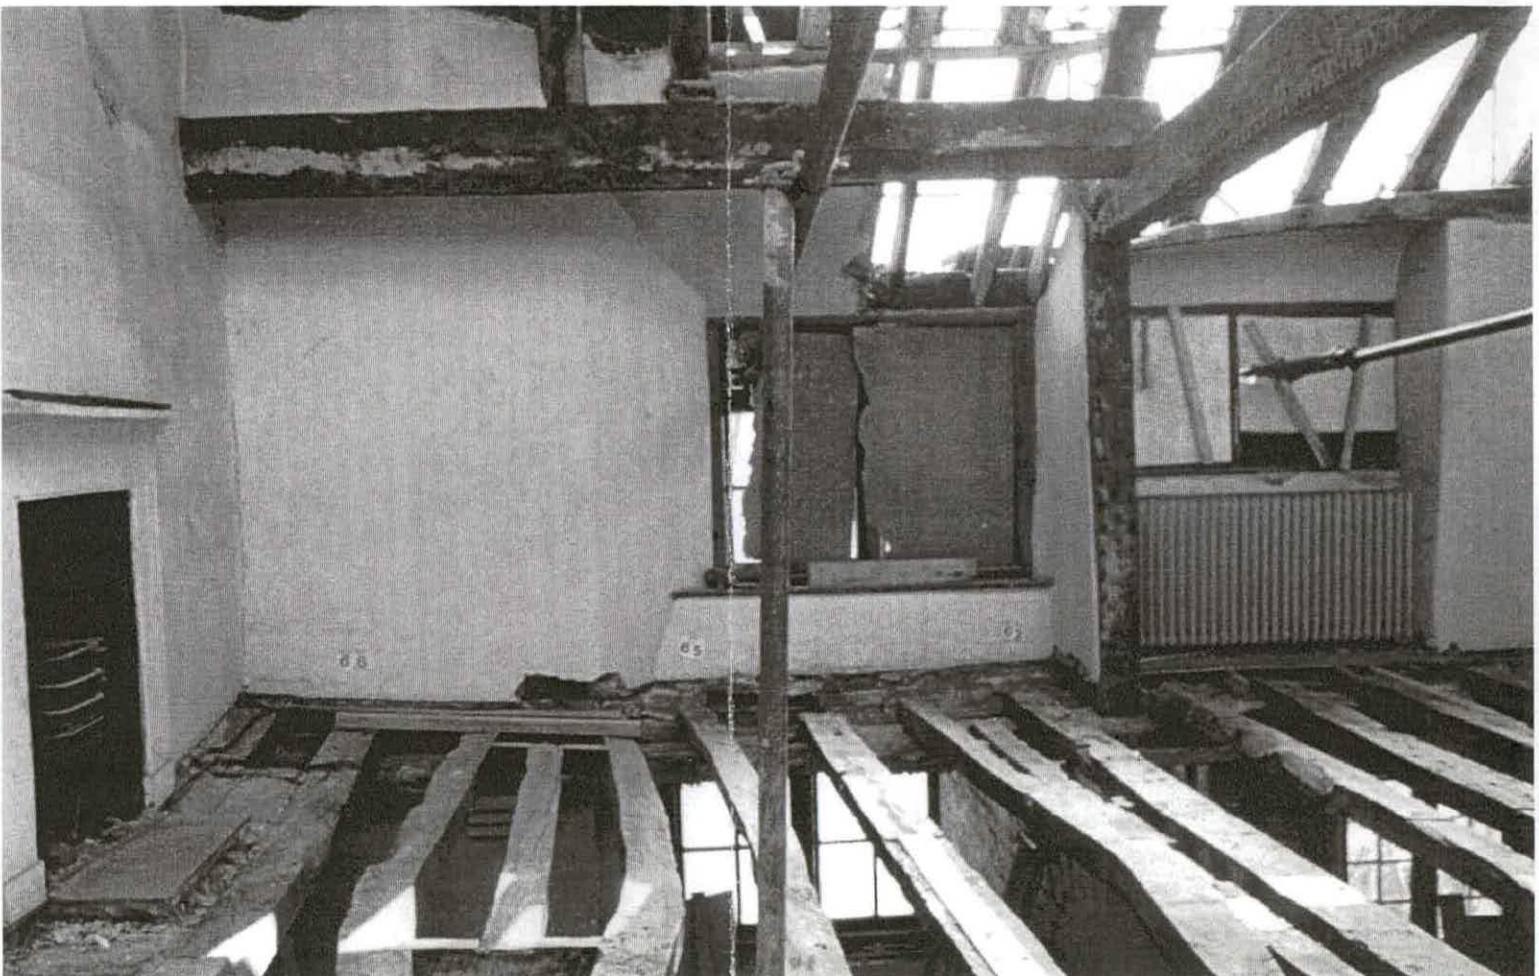
Figure 17, Room 23, west of the central stack, looking south during restoration works of 1984-5 (Conservation Manager, Southampton Council).

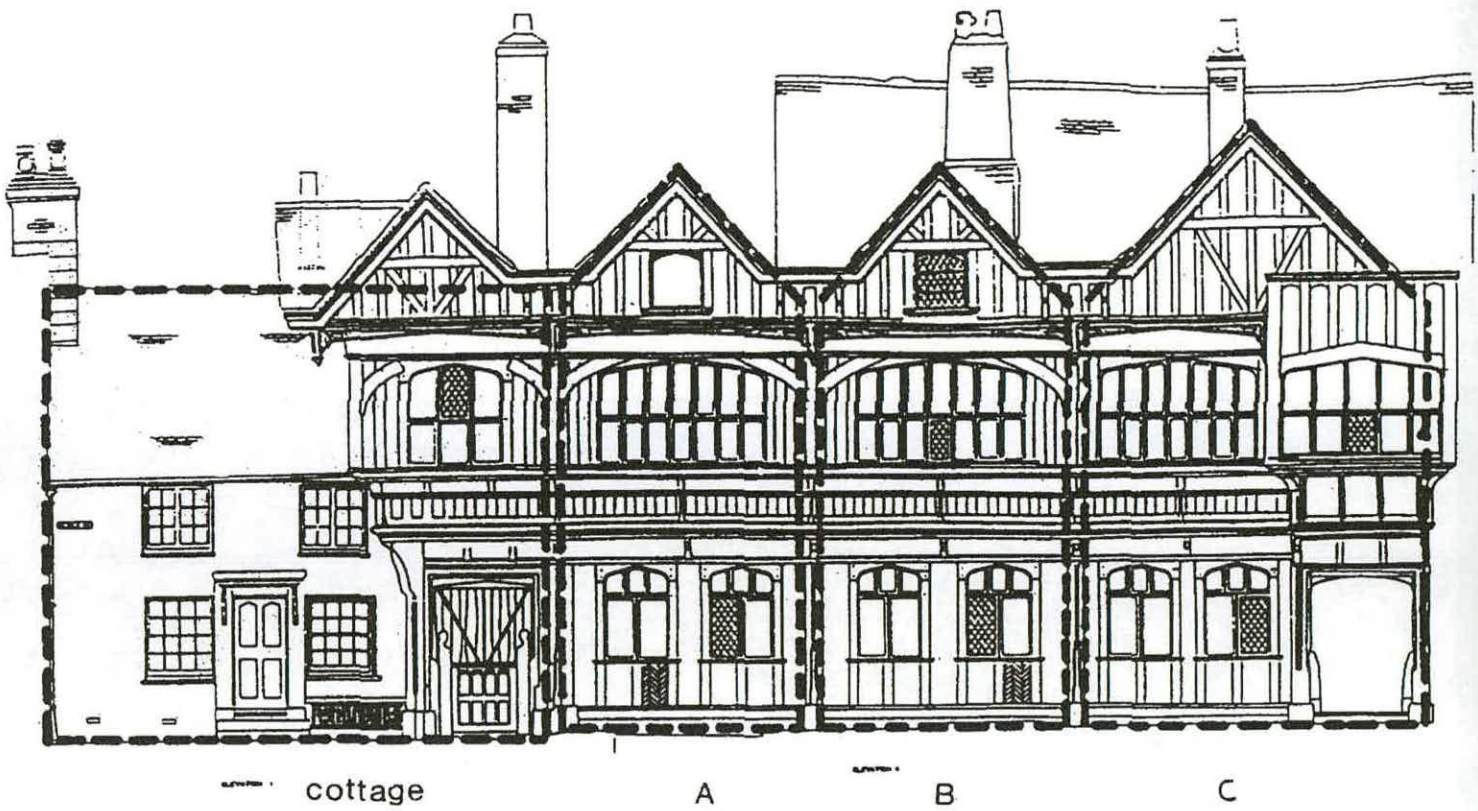
Figure 25, the elevation of the main east façade with property outlines marked in heavy dashed line by PN Davies, 1988.

Soon after this survey, Peter Davies, Chief Historic Buildings Inspector for Southampton, published preliminary findings based on the archaeological investigations following further stripping out in the second floor above the hall.<sup>8</sup> The brief report included an elevation of the east front and a ground plan marked up with the outlines of the supposed medieval tenements, Figure 24 and Figure 25.

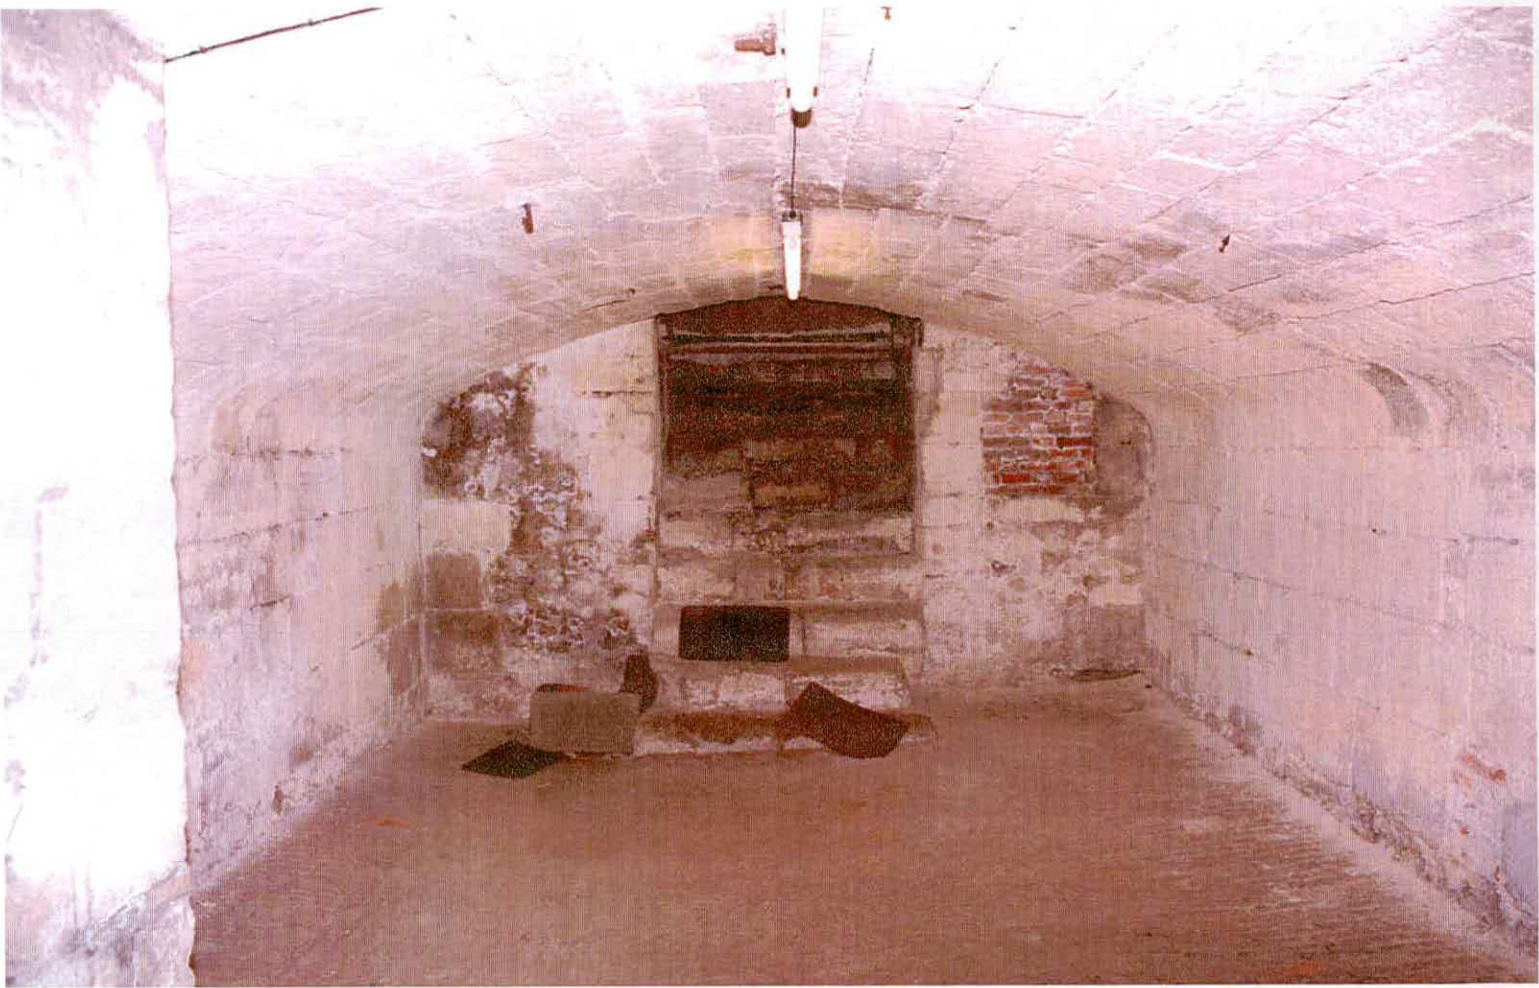
Figure 29, the undercroft beneath 59 Bugle Street, known as The Cottage, Room 1, looking east.

The southern undercroft, Room 1, has a low four-centred tunnel vault and is constructed with neatly coursed ashlar, Figure 29 and Figure 30. This contrasts significantly with the construction of the undercrofts lying to the north, which are built with uncoursed rubble and show no sign of any vaulting. The undercrofts contain very little datable fabric. The doorways in the southern vault, Room 7, Figure 30, and between the long north undercroft and its southern extension, Figure 32, provide the primary stylistic dating evidence. Faulkner assigns them to the early fifteenth-century.<sup>12</sup>

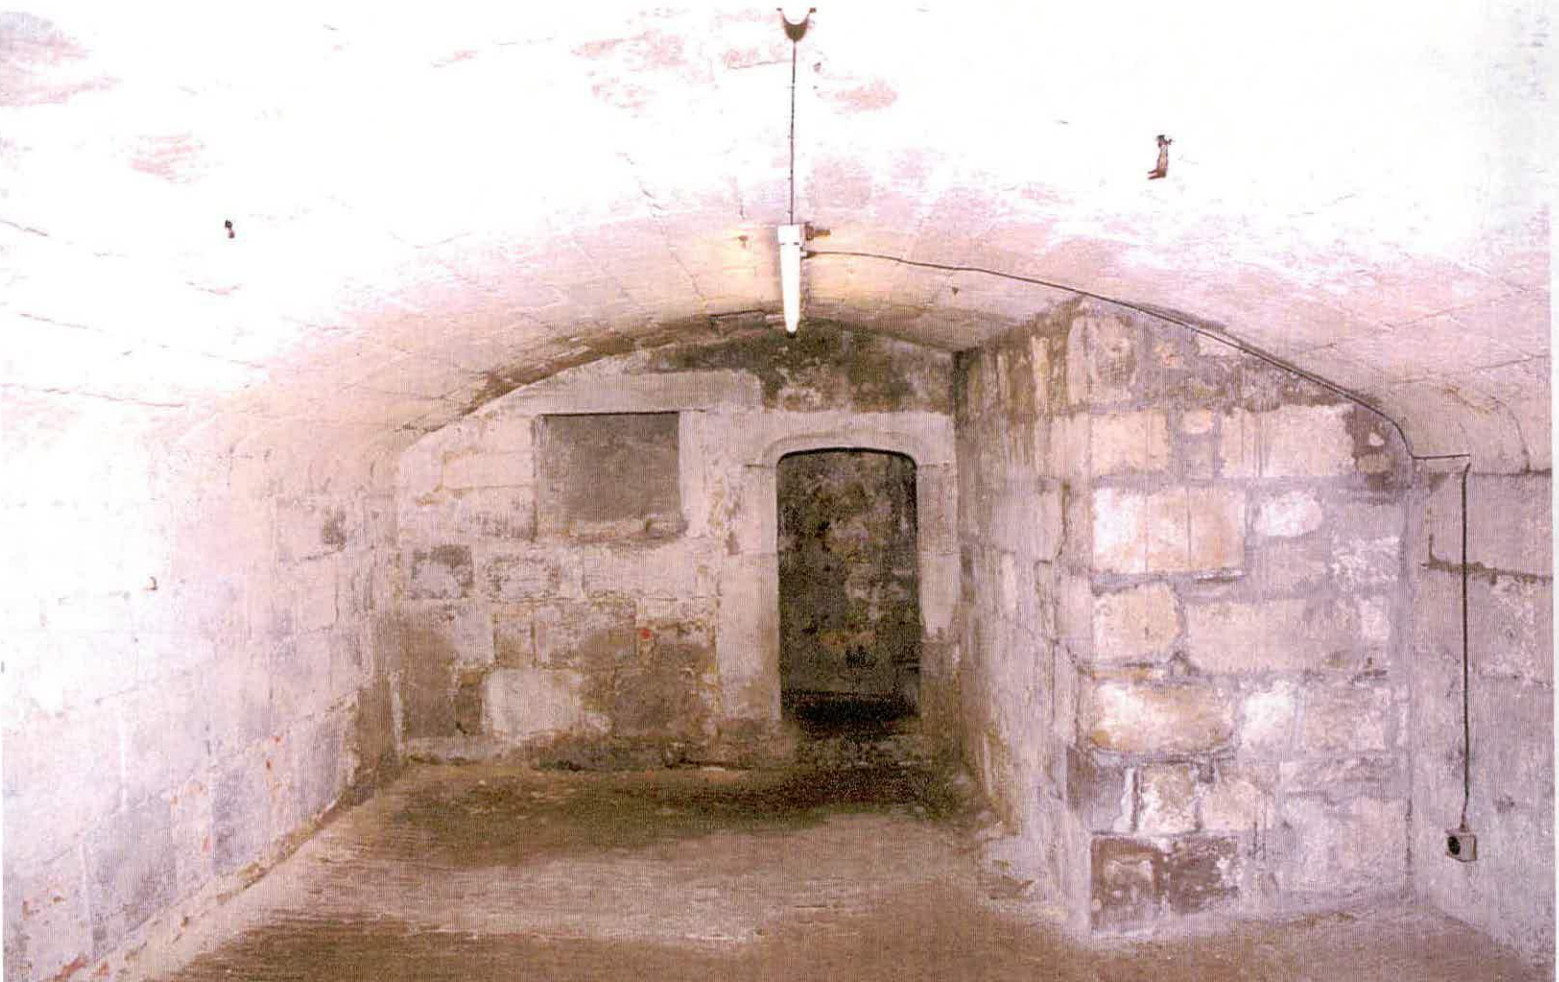
Figure 30, the undercroft beneath 59 Bugle Street, known as The Cottage, Room 1, looking west.

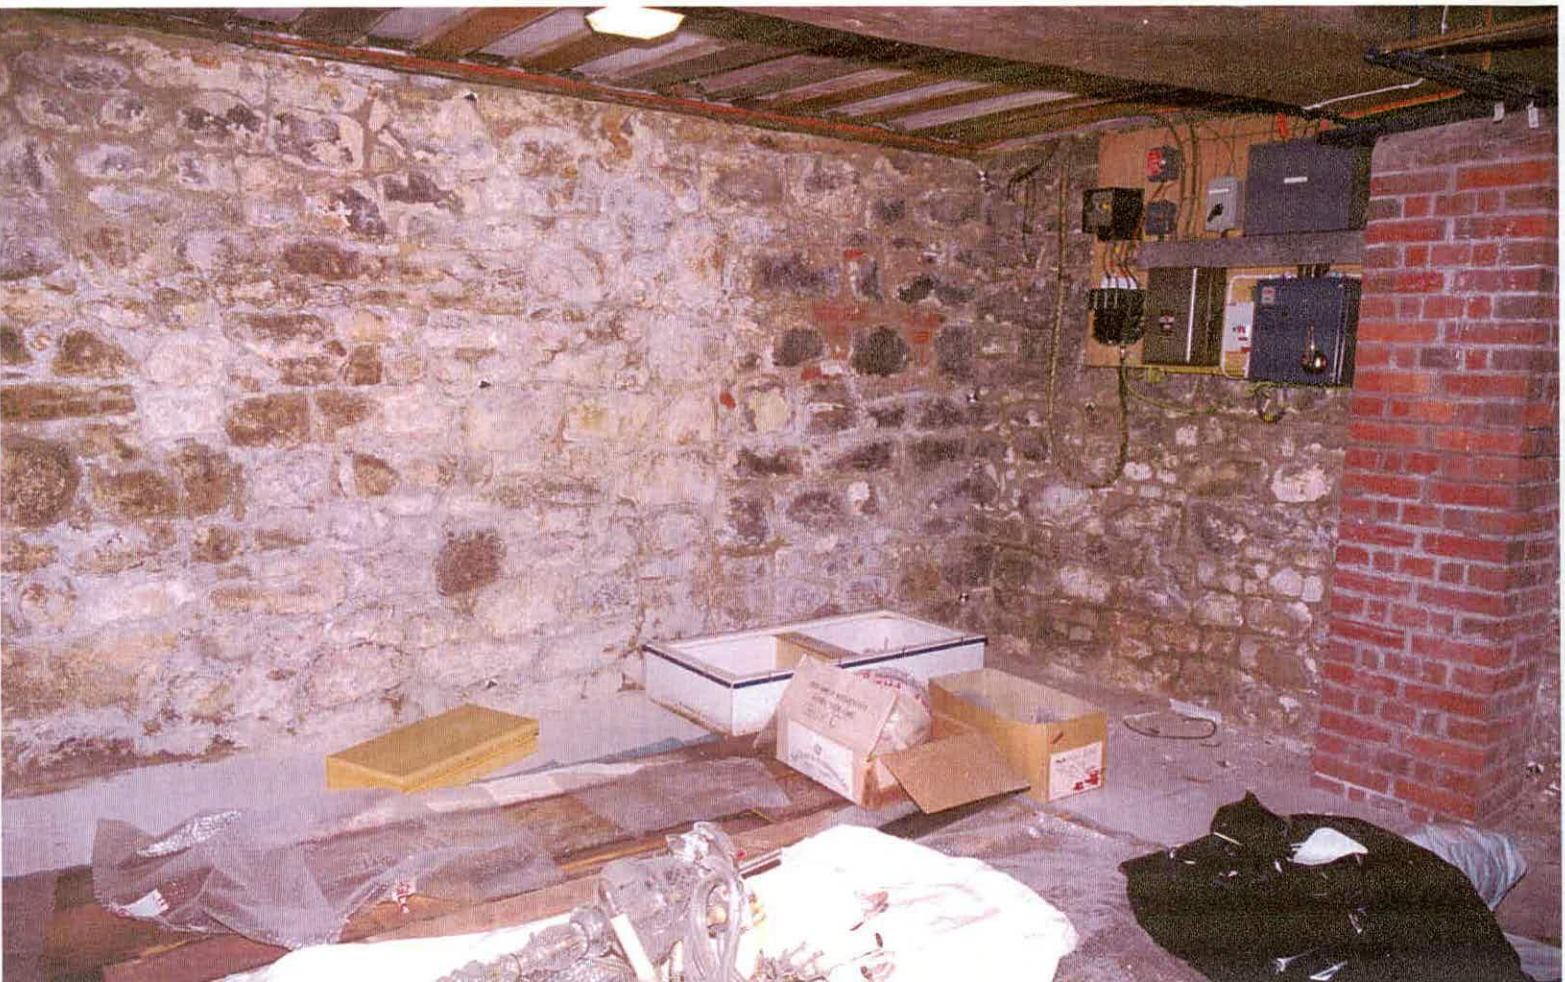
Figure 31, the north-east corner of the northern undercroft, Room 5. A possible building break in the north wall appears about two meters from the north-east corner.

A possible building break in this construction is visible in the north-east corner of the northern undercroft, Room 5, Figure 31. This could perhaps relate to the reference to John Dawtreys's documented enlargement of his house seven feet 'into the Strete' in 1492-3.<sup>13</sup> A better understanding of the construction of these structures may become apparent when the drawn survey of the cellar walls is analysed.

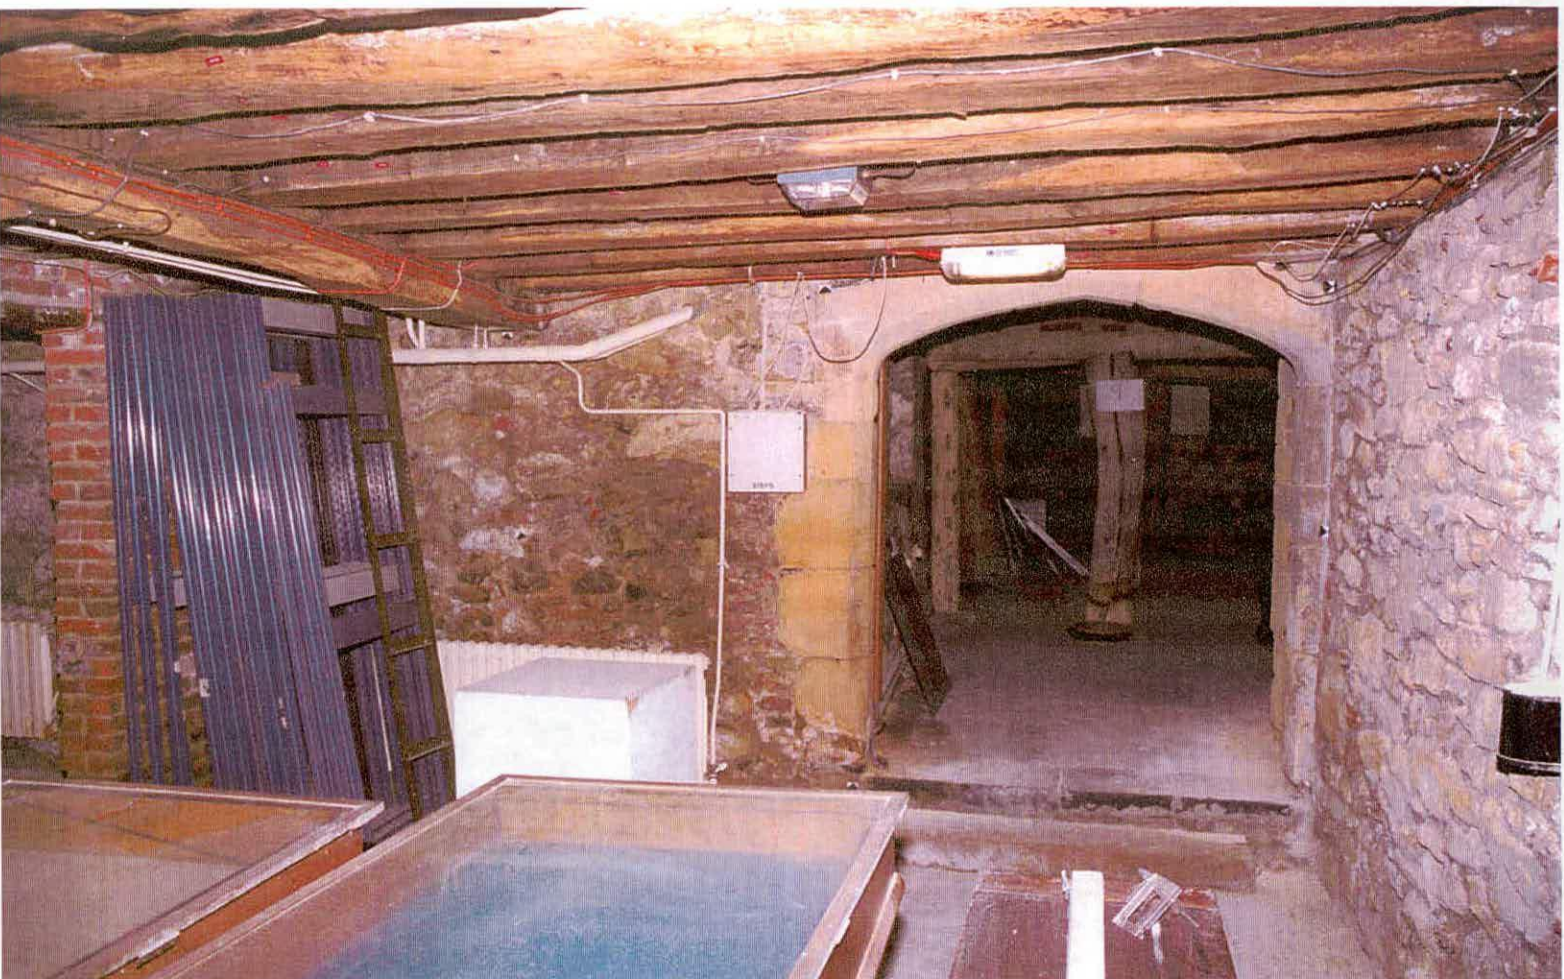
Figure 32, the doorway between the long northern undercroft, Room 8, and its southern extension, Room 9.

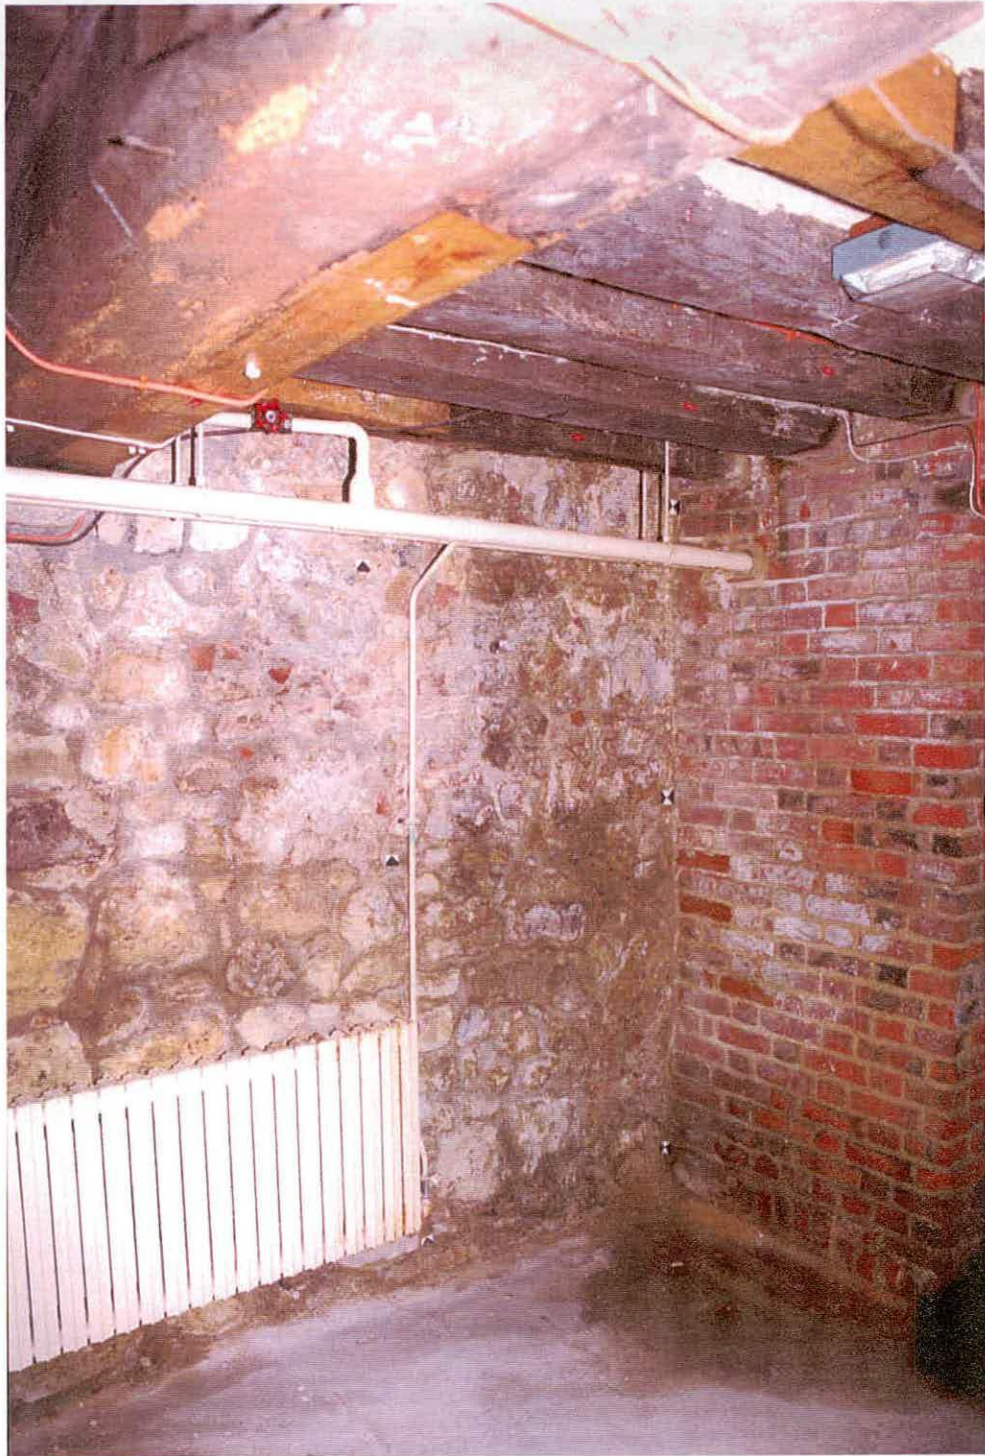
Figure 33, the south wall of the undercroft, Room 7. The larger blocks of stone above the radiator suggest an alteration or repair when compared with the blocks to the west.

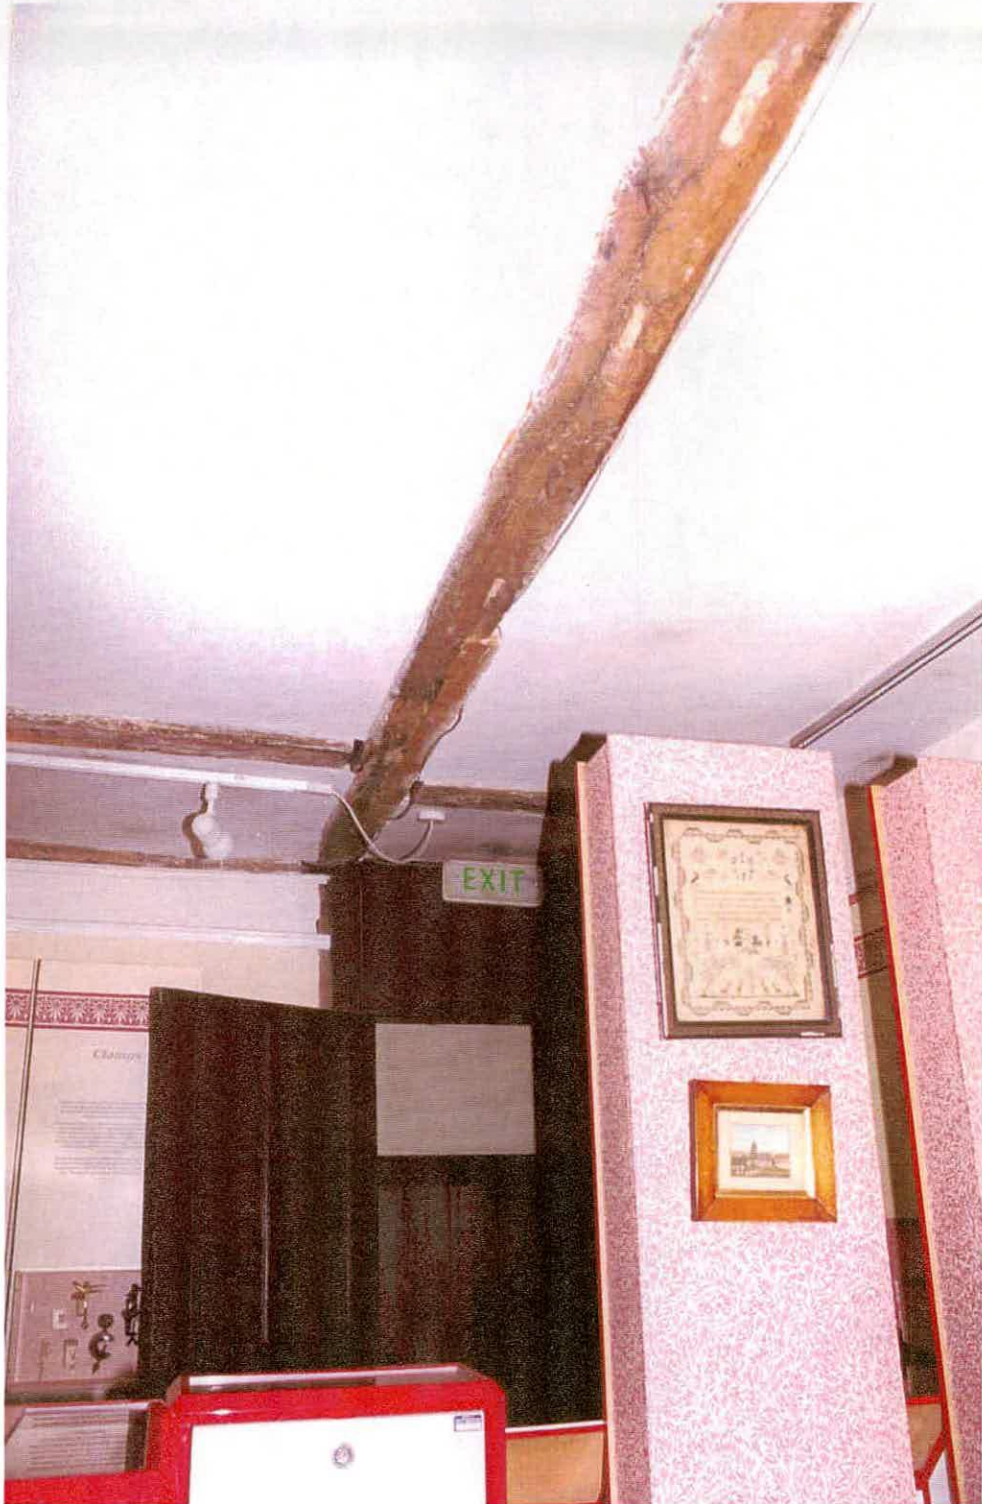
Figure 34, the ceiling of Room 13 looking north. The large beam, running north south is on the line of the roof truss and is morticed for an internal partition.

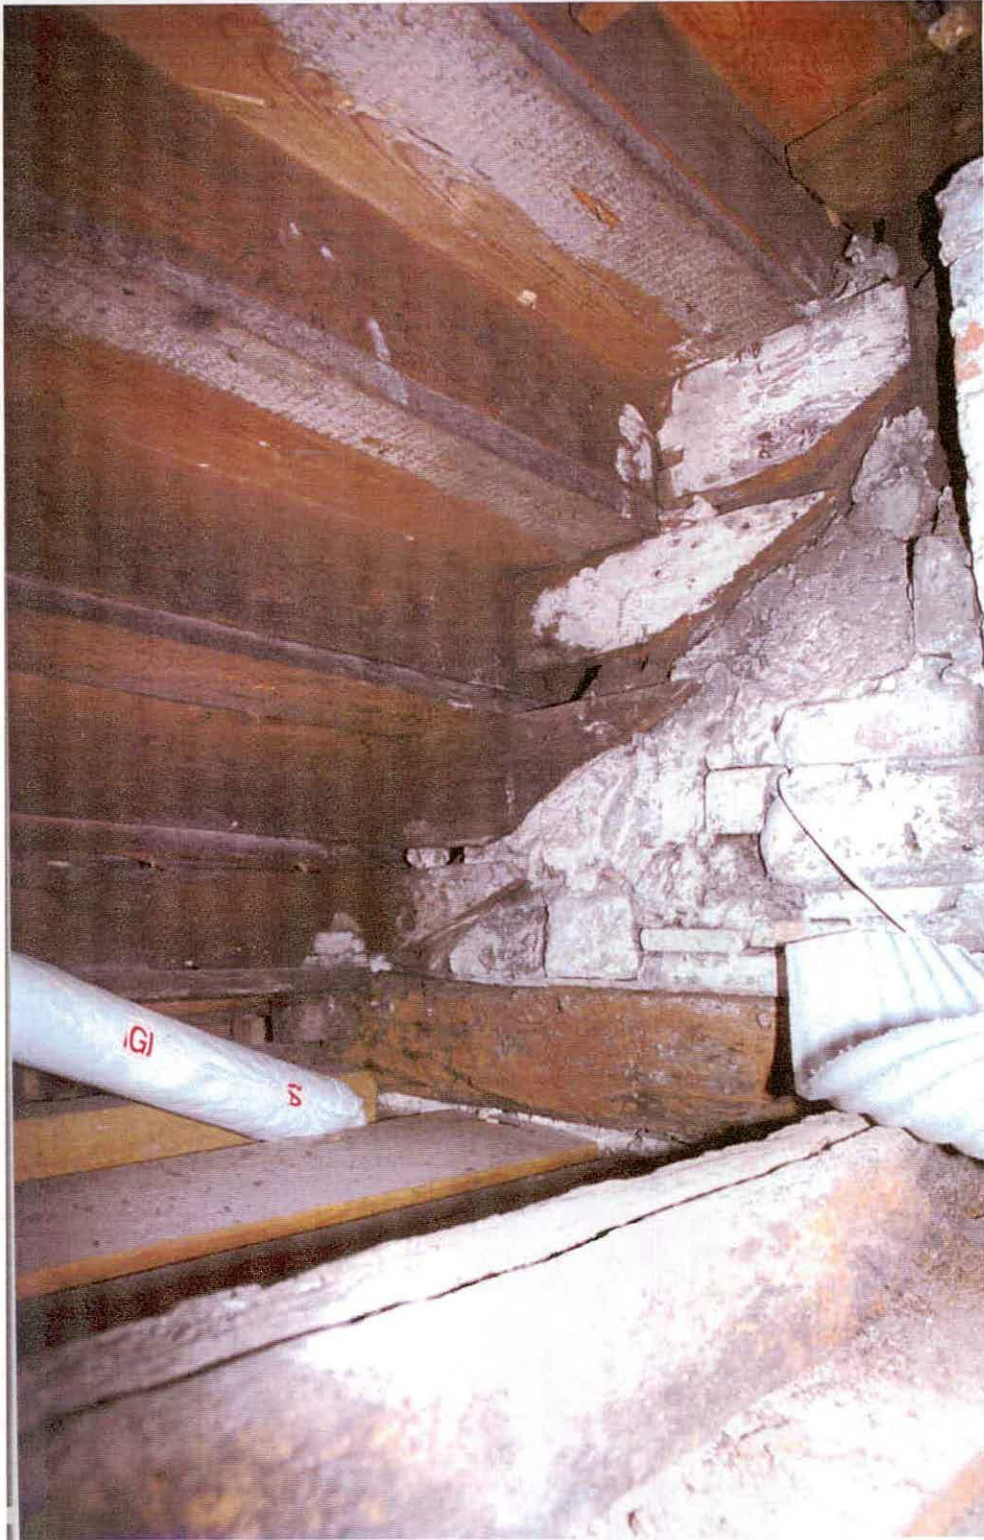
Figure 35, the area under the stairs looking east. The horizontal timber at the foot of the wall has a peg set in it. The horizontal timber in the foreground is grooved to receive a wattle and daub infill.

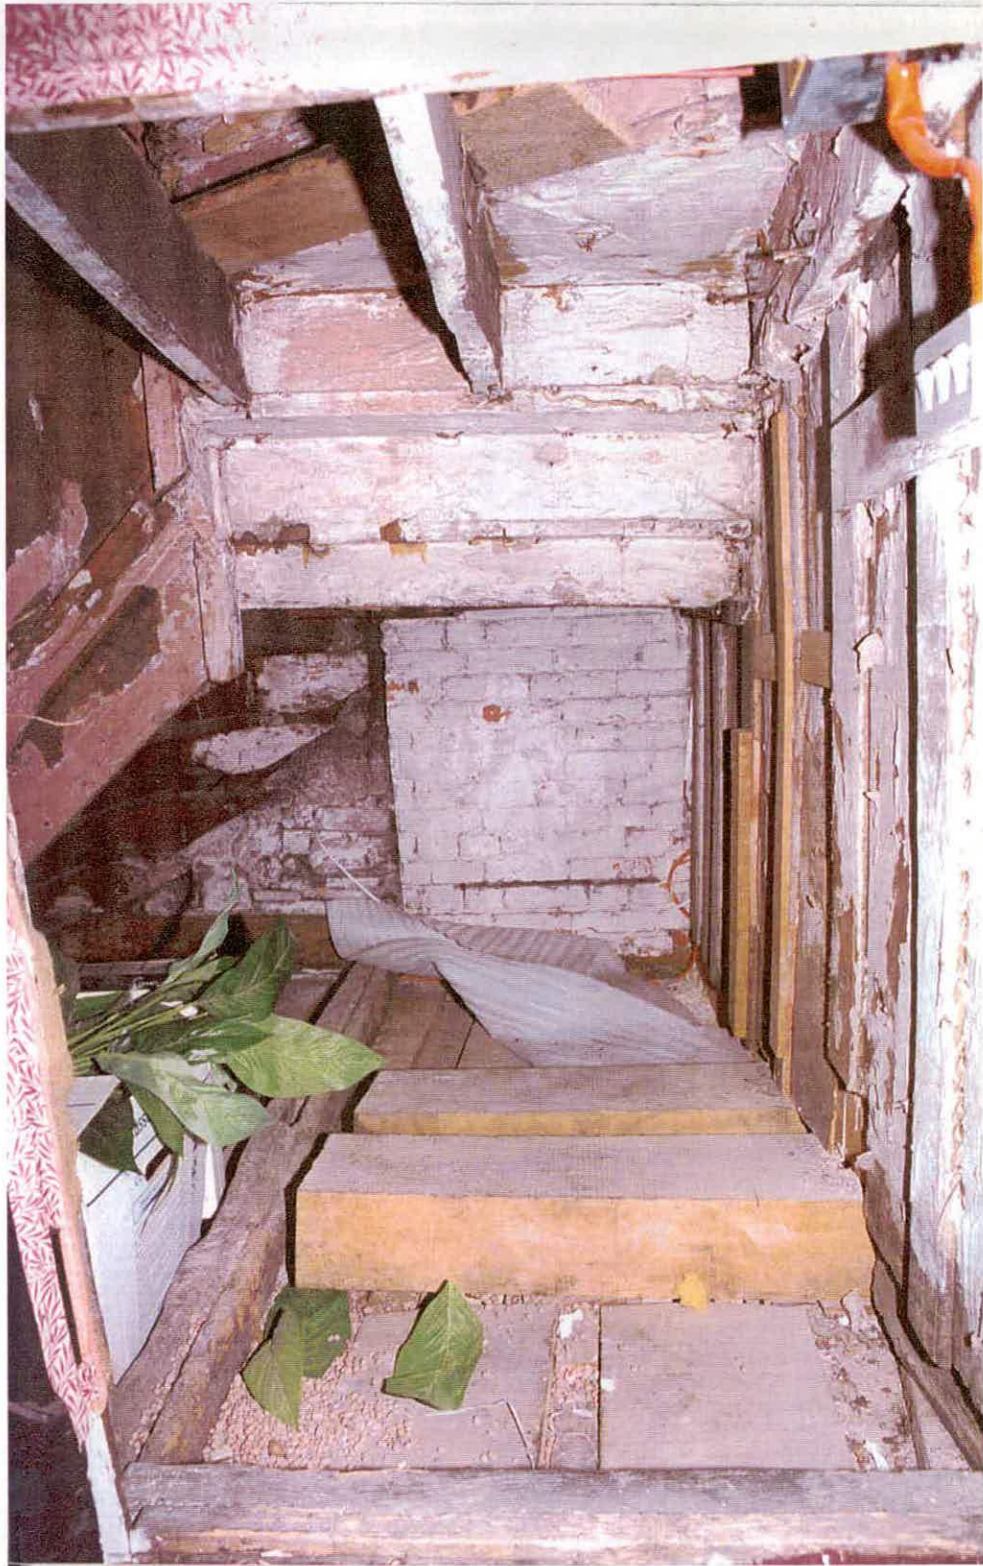
Figure 36, the understair cupboard in Room 13 looking east. The horizontal timber set on the floor and running east west has a mortise in its upper surface for an upright and a groove for wattle and daub infill.

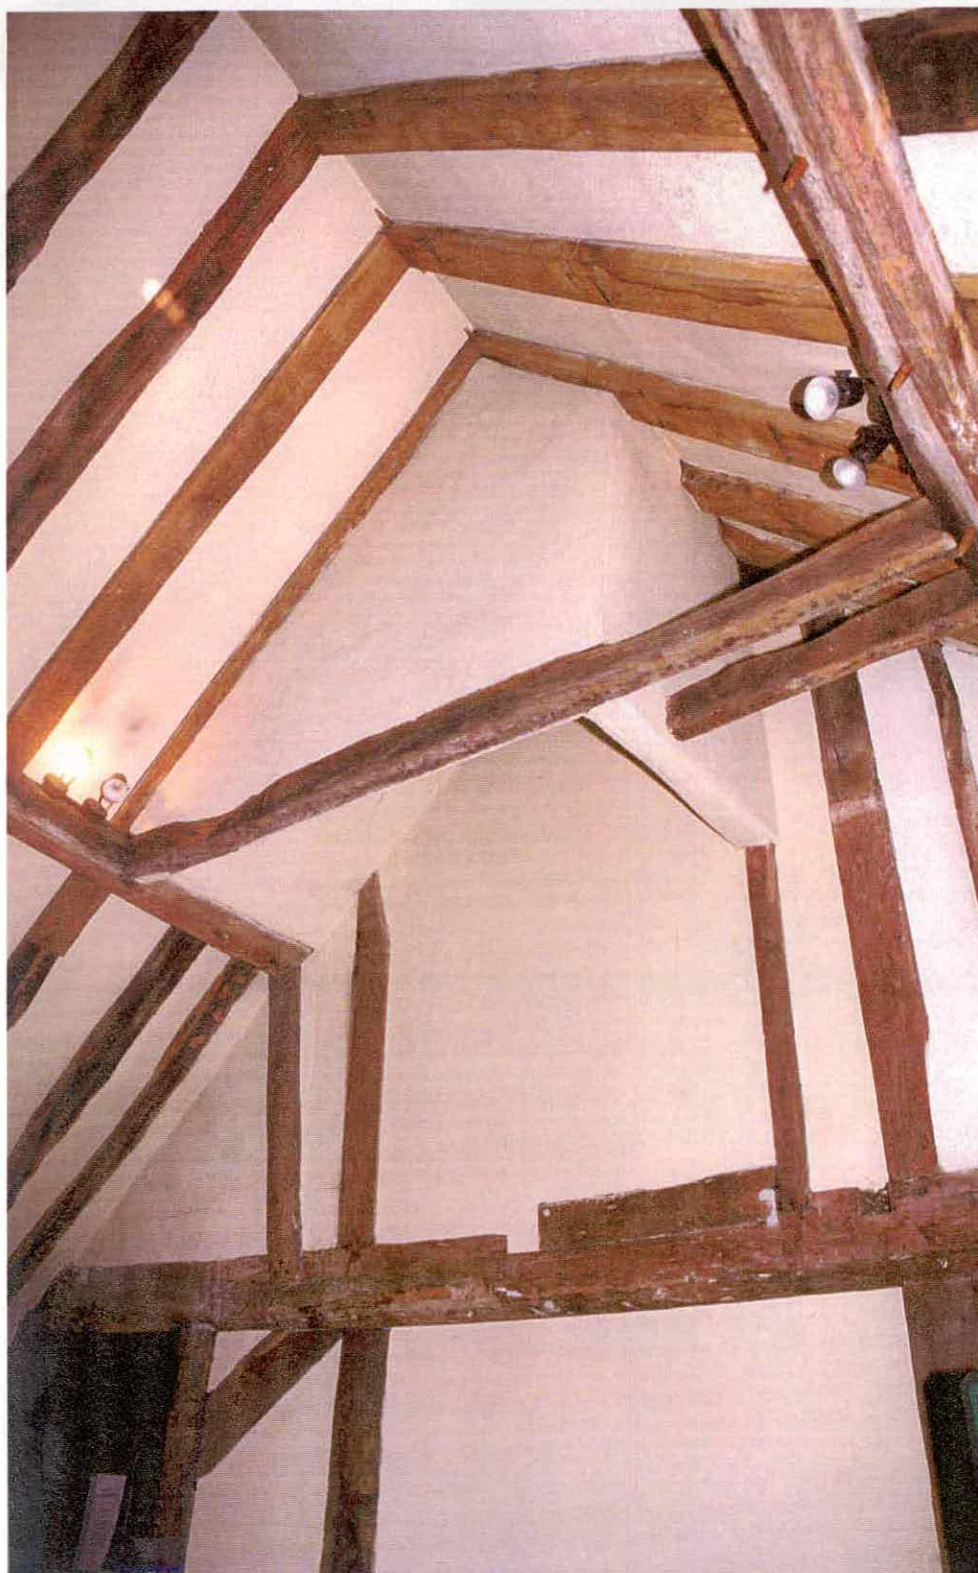
Figure 38, the smoke hood in the roof at the east end of the Blue Anchor Lane Wing, now in Room 23.

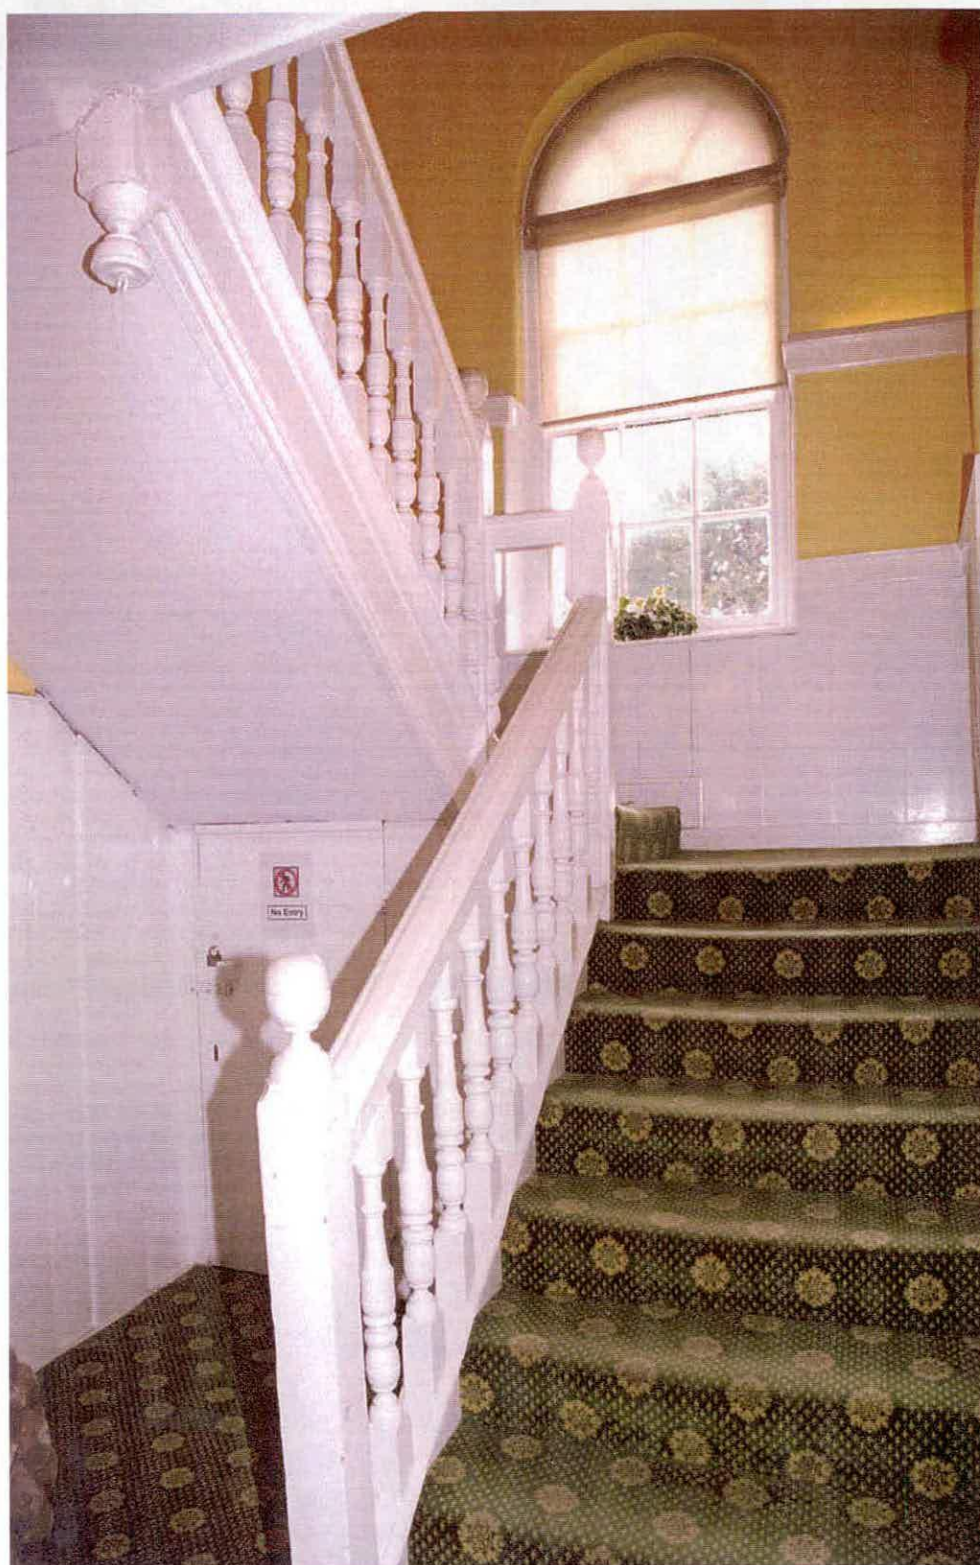
Figure 43, the seventeenth-century closed string geometric staircase in the Georgian Wing, looking west.
