# TUDOR HOUSE SOUTHAMPTON

PRELIMINARY NOTES ON THE HISTORICAL  
DEVELOPMENT OF THE BLUE ANCHOR LANE AND  
GEORGIAN WINGS

Historical Analysis & Research Team  
*Reports and Papers 66*  
2002

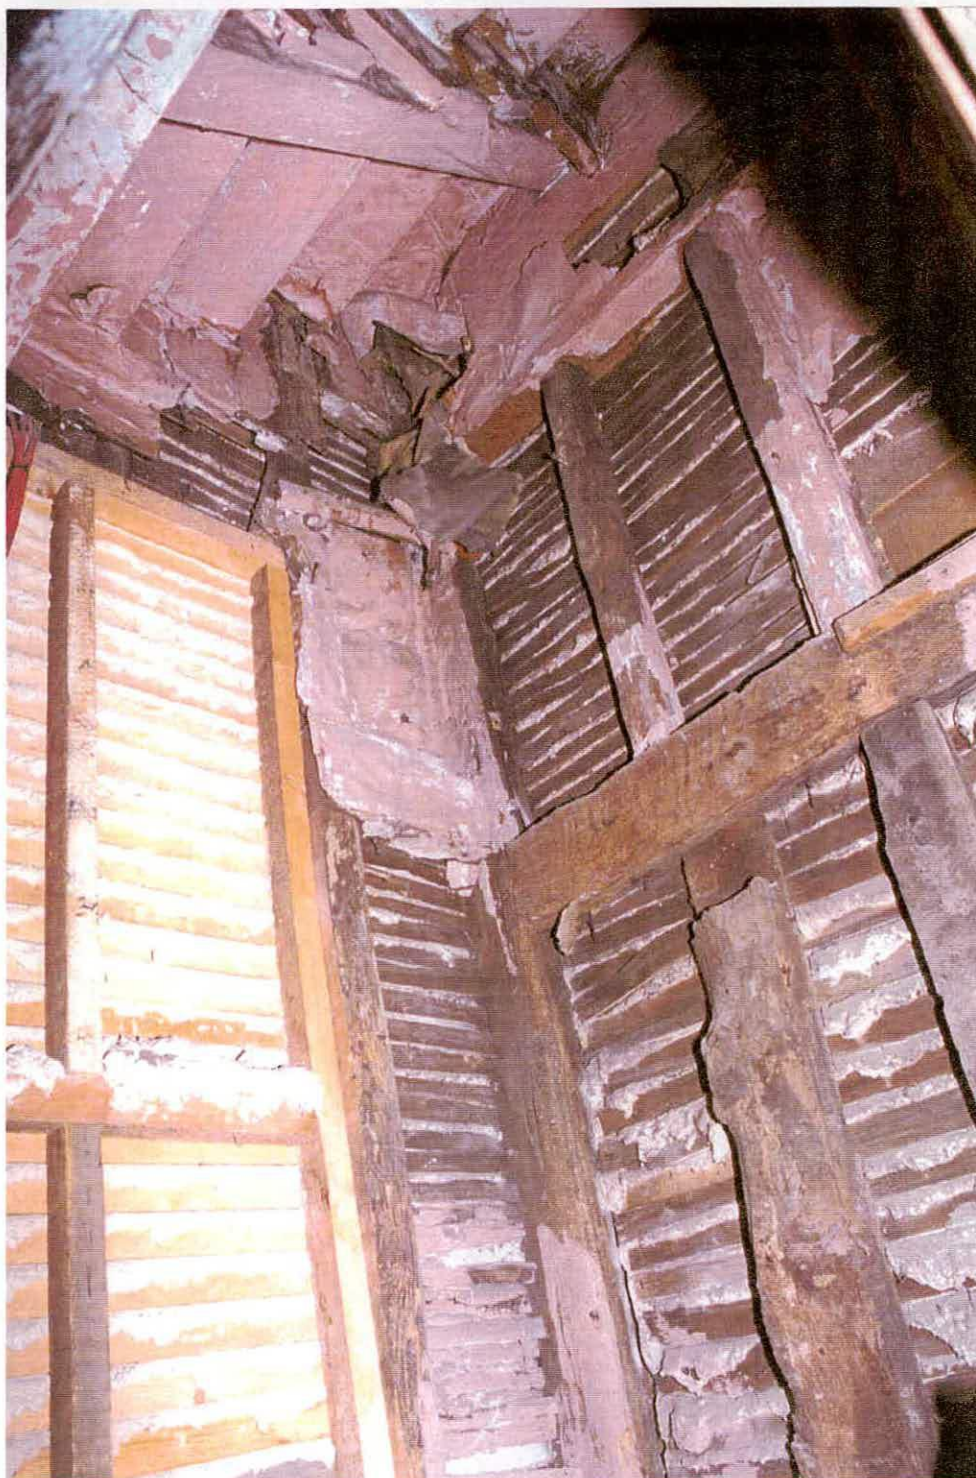
Figure 48, under the stairs at the east end of the Blue Anchor Lane Wing, looking north-west. Note the recently blocked door sized opening to the left and the staircase panelling extending for a short distance below the treads of the upper flight.

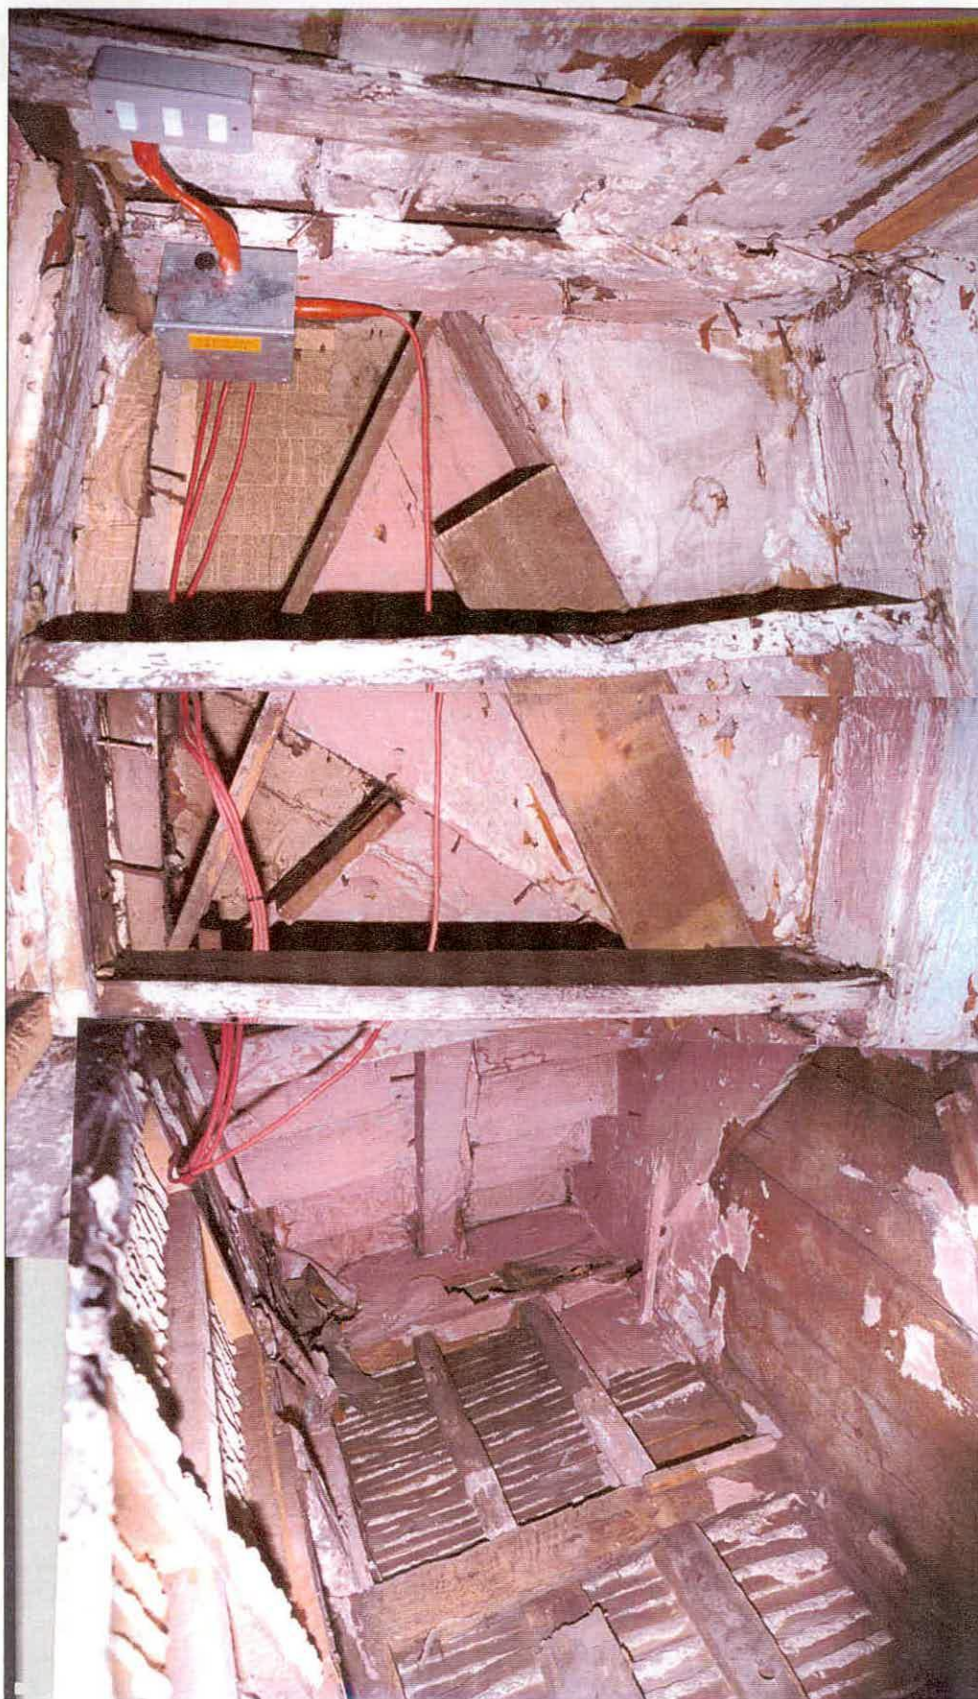
Figure 53, a panoramic photomontage of the underside of the winders and the upper flight of the stairs at the east end of the Blue Anchor Lane Wing, looking up. Note the newspapers glued to the soffit of the winders.

The stair and the panelled staircase walls are of pine construction, which suggests a seventeenth-century date or later. All exposed timber details but not those under the stairs, are stripped of historic paint and coated with a brown stained varnish. This appears to have been applied in at least two stages because, where the central section of each riser was left bare for a stair carpet, it has since been coated with a slightly darker brown stain varnish. The treads are currently carpeted with a beige carpet and the nosing of each tread is covered with protective rubber. The understair area is rough finished and clearly not designed to be seen, Figure 48. The absence of traces of plaster and lath applied to the underside of the stairs suggests that the space under the stairs has always been contained. The paper and limewash applied to the underside of the stairs appears to date from the 1830s, see below.

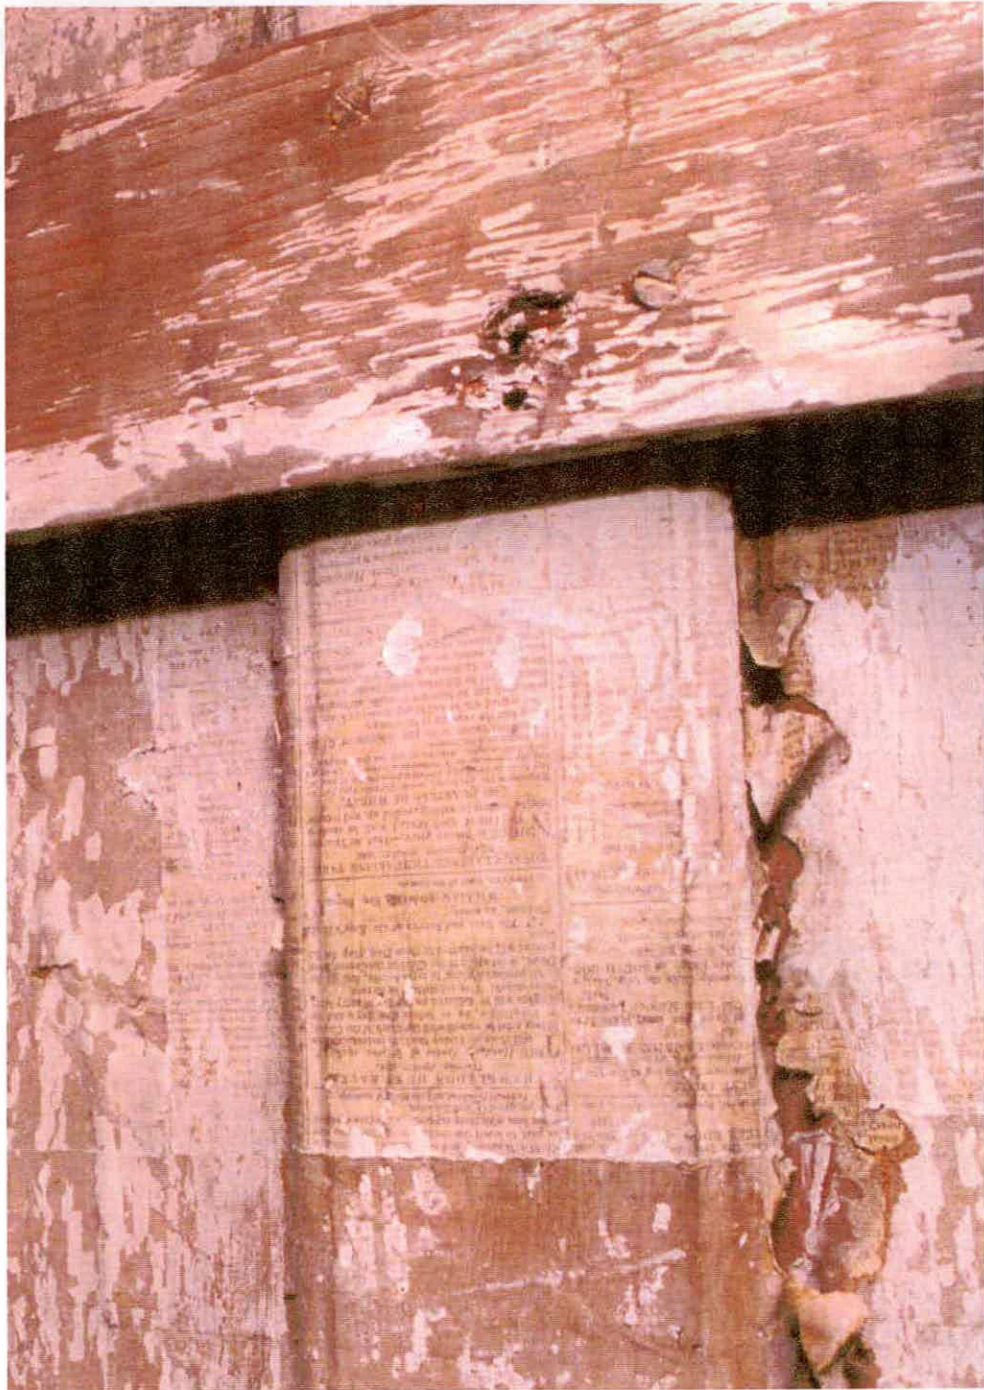
Figure 54, a detail of the newspaper, dated 1836, glued to the panelled south wall of the staircase, underneath the stairs at the east end of the Blue Anchor Lane Wing.

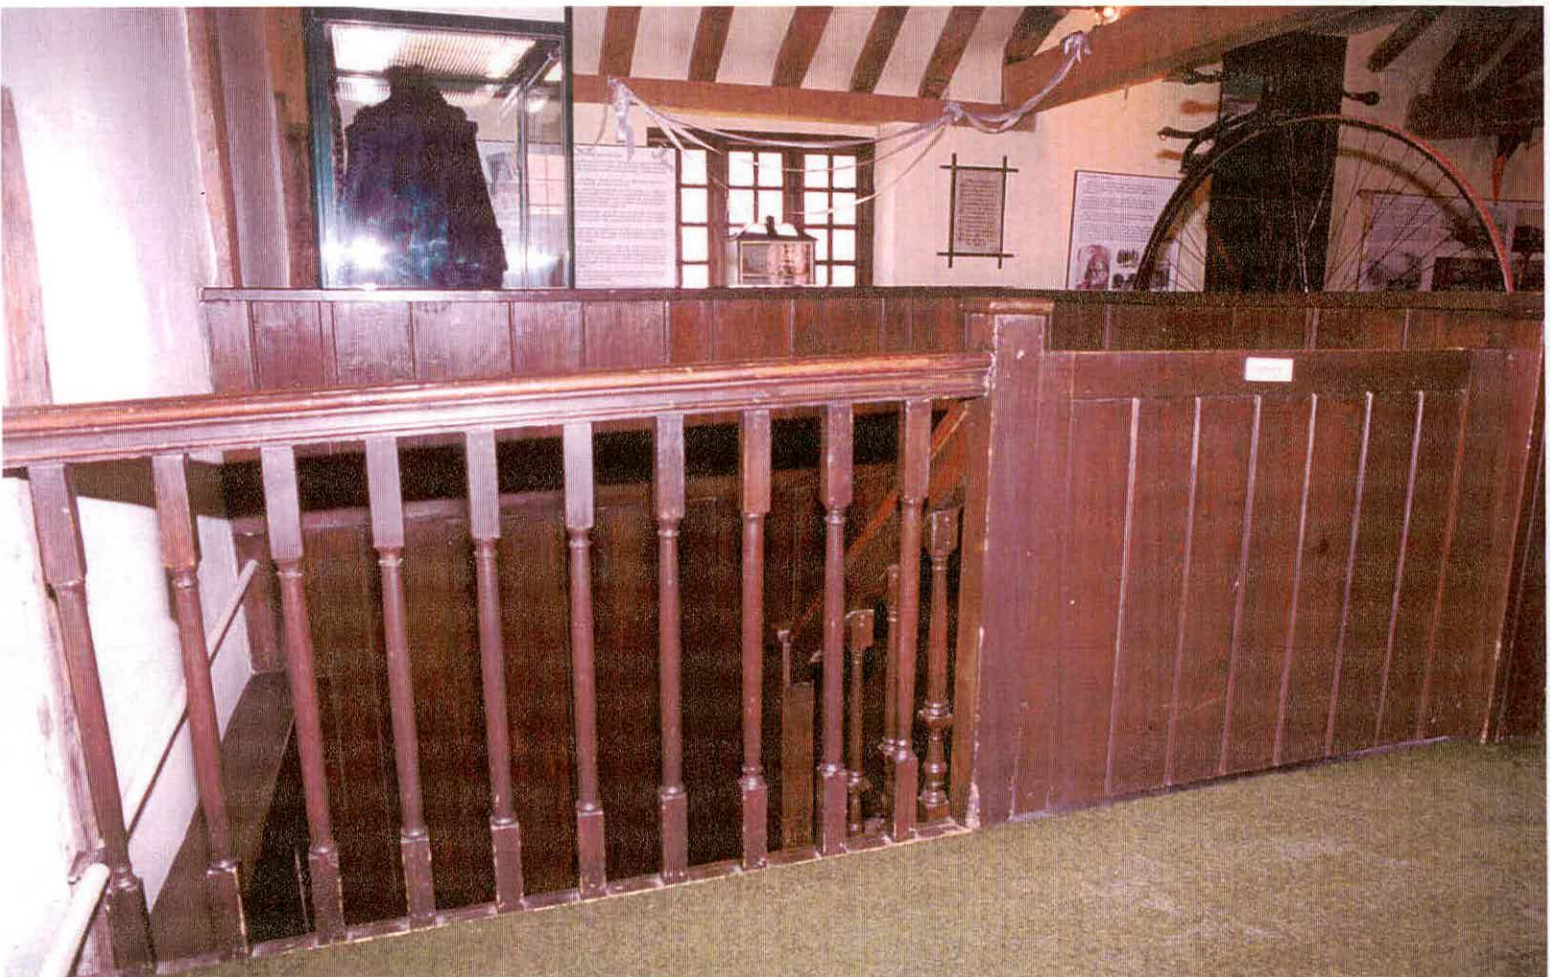
Figure 55, Room 23, looking south, with the staircase in the foreground, and the replaced window, wall plate and tie beam beyond.

The photographs taken in 1984/5 show the floorboards removed and some of the roof covering at the east end of the Blue Anchor Lane Wing, Figure 16 and Figure 17. It seems that in Room 23, during these works, the wall plate, the roof truss tiebeam and the window were replaced, Figure 55, Figure 56 and Figure 57.

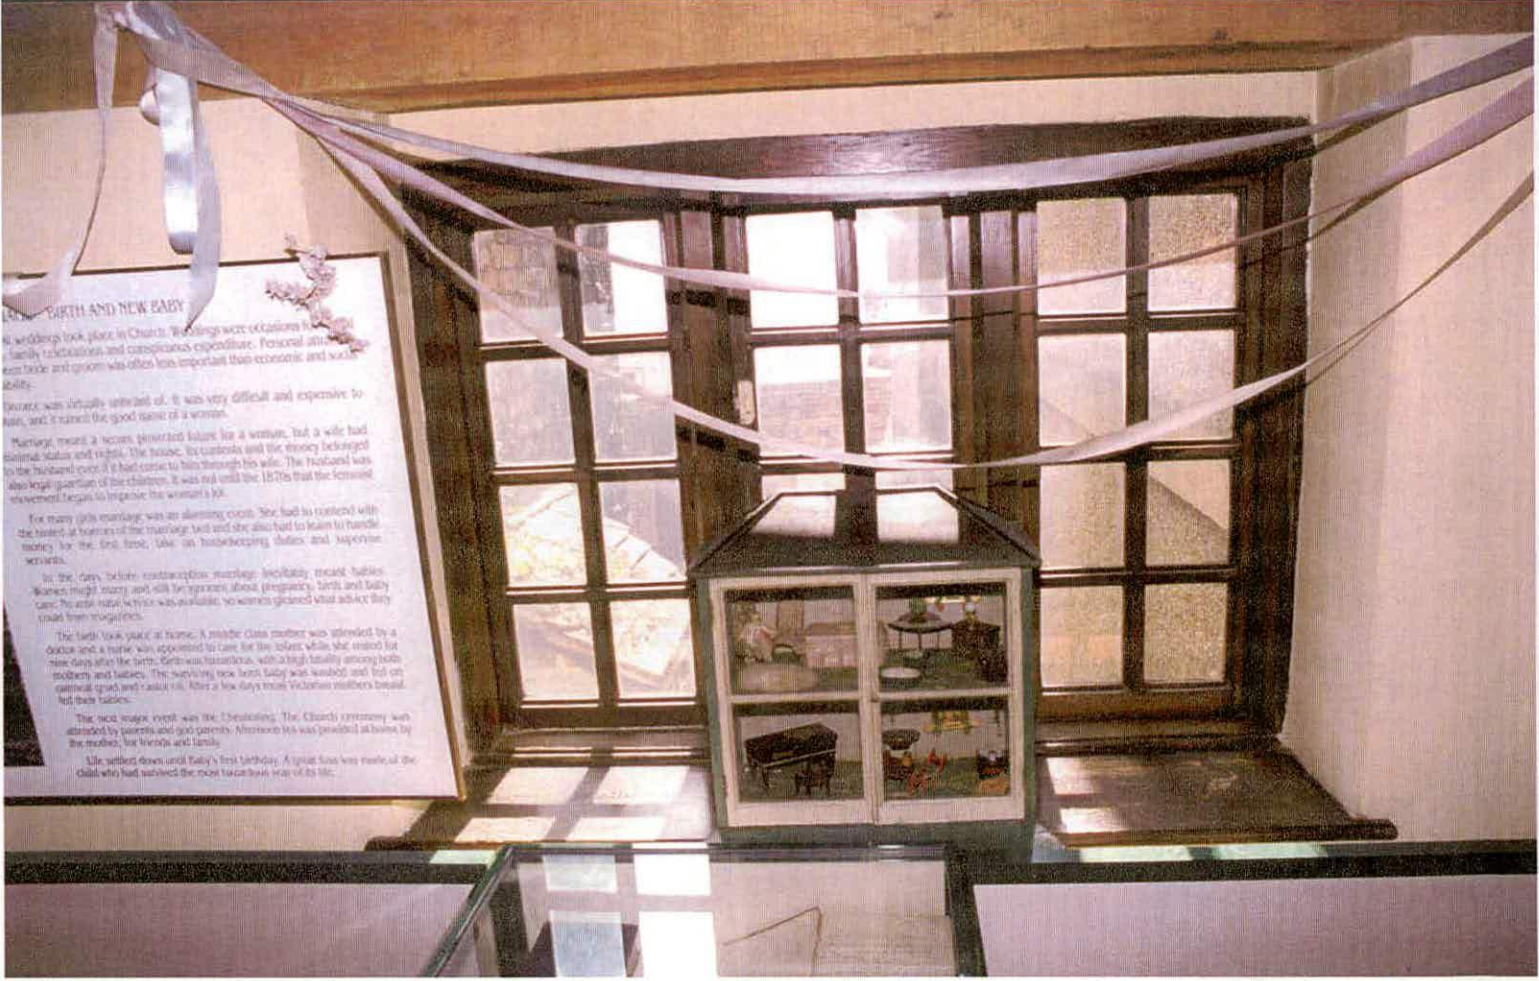
Figure 56, the new window in the south wall of Room 23.

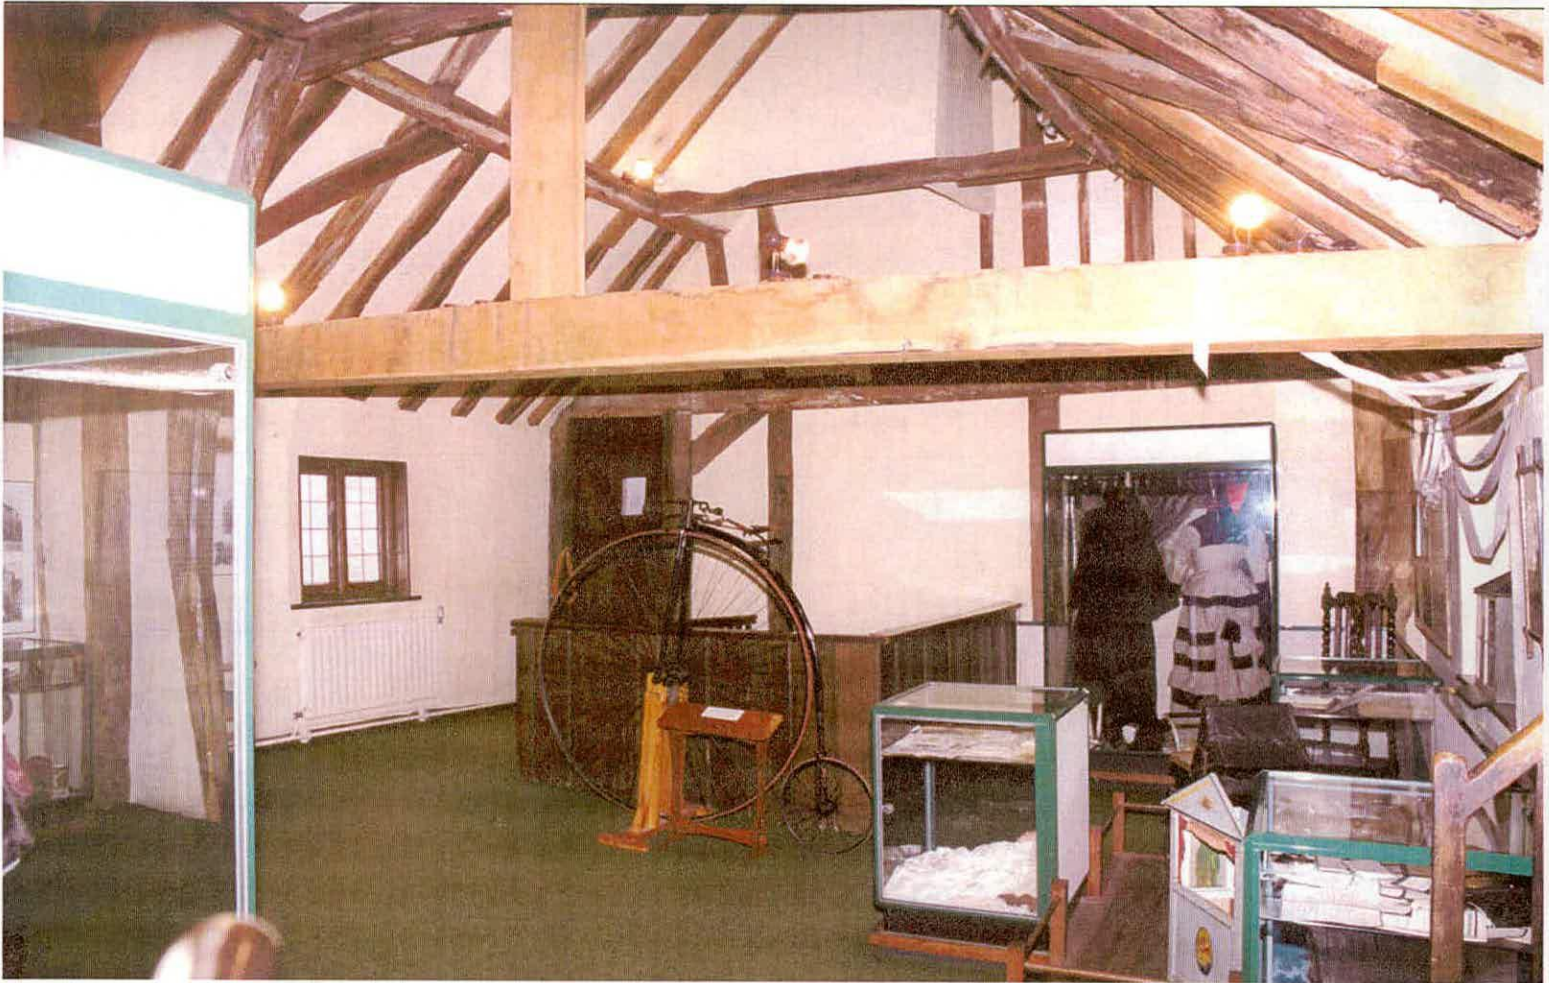
Figure 57, Room 23 looking east with the replaced tie beam in the foreground.
