The Missing Ceiling Panel Decoration in the Saloon at Danson

*Notes on the available evidence and the
viability of its restoration*

Reports and Papers 62

2002

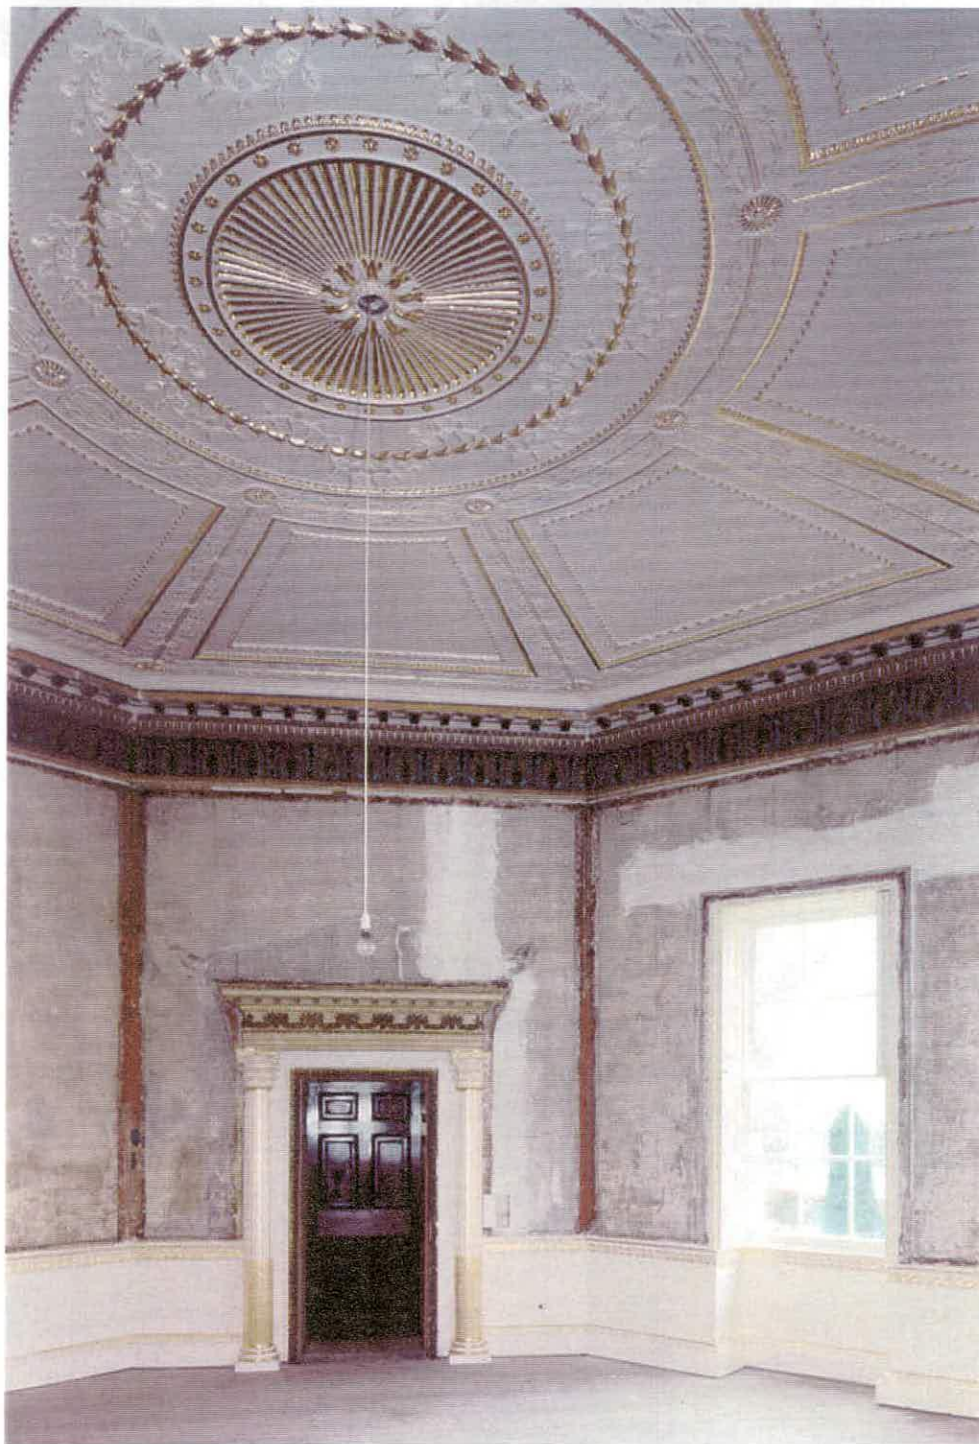
Figure 1, the saloon in its present condition, after partial restoration by English Heritage. Photograph: English Heritage.

English Heritage began the restoration of the saloon at Danson, along with the other principal rooms between 1997 and 1998. The aim was to return the room to its original appearance in the 1760s, Figure 1. However, until the 1920s, the eight ceiling panels contained plaster or composition decoration, Figure 10, which was removed some time after 1932, Figure 14.

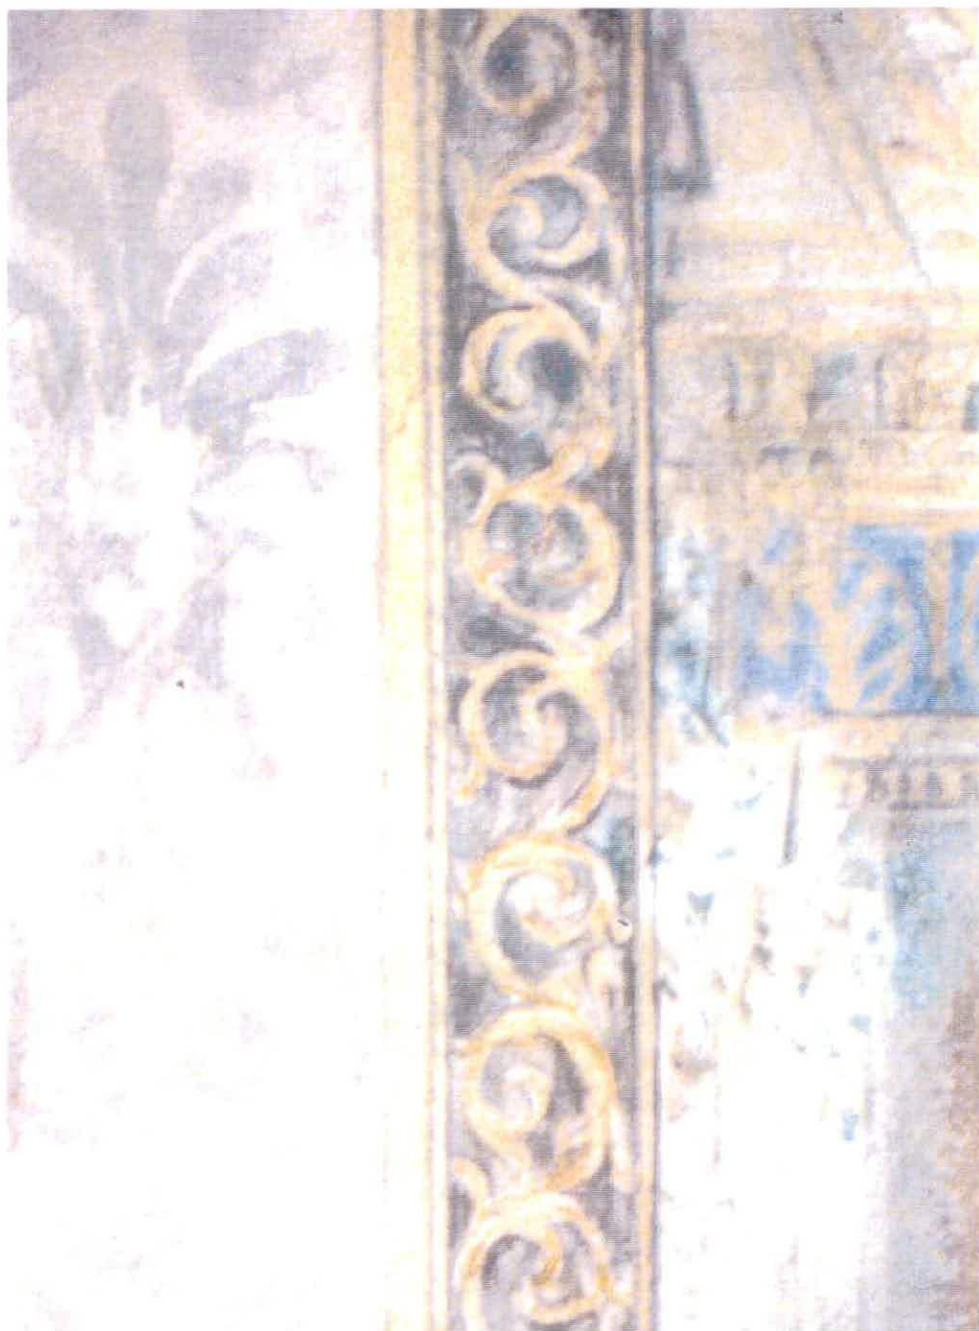
Figure 3, a detail of the watercolour by Sarah Johnson, Figure 2, showing the ceiling reflected in the mirror. The decoration of the panelled part of the ceiling appears to have been gilded.

The earliest image we have of the interior the saloon is the watercolour painted by Sarah Johnson in 1860, probably soon after the death of her grandmother and prior to the sale of the house in 1863, Figure 2. Unfortunately, very little of the ceiling is shown and this only as a reflection in a mirror, Figure 3. However, from this reflected view, not only is it clear that it predates Bean's refurbishment of the 1860s but that the decoration of the panelled parts of the ceiling was gilded.

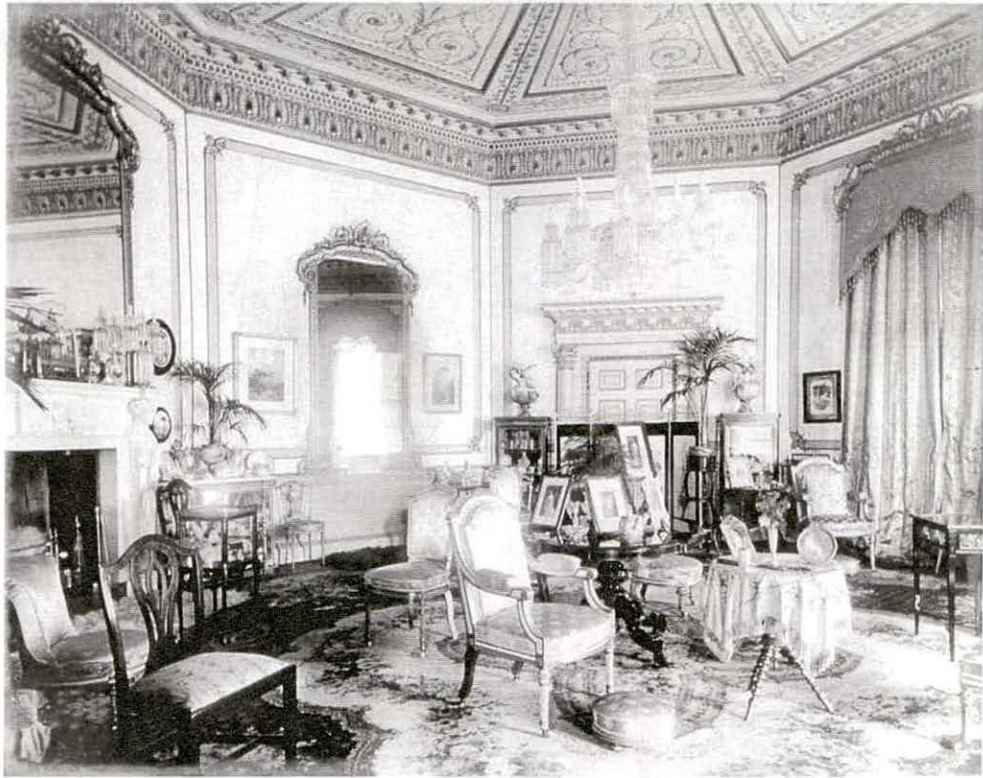
Figure 6, the second photograph of the saloon from c1922, looking east.

The earliest photographs of the interior of the saloon date from about 1920, Figure 4 and Figure 6. One of them, Figure 4, was reproduced in the sale catalogue of 1922. Both show the interior still furnished as a private residence, presumably as left by Alfred Bean's widow when she died in 1921. They show the ceiling panel decoration *in-situ* although Figure 4 only shows them reflected in the mirror above the fireplace, Figure 5. The second photograph, Figure 6, shows the ceiling decoration in more detail and from this it is clear that the ceiling was designed with alternating patterns of panel decoration. The two patterns are described in this report as pattern A and Pattern B. Pattern A was used in the panels above the diagonal walls and pattern B in the panels adjacent to the main axial walls. The two patterns are essentially Roman in character and display an interest in third- and fourth-century Roman wall decoration in the wake of archaeological discoveries in Rome in the middle of the eighteenth-century.

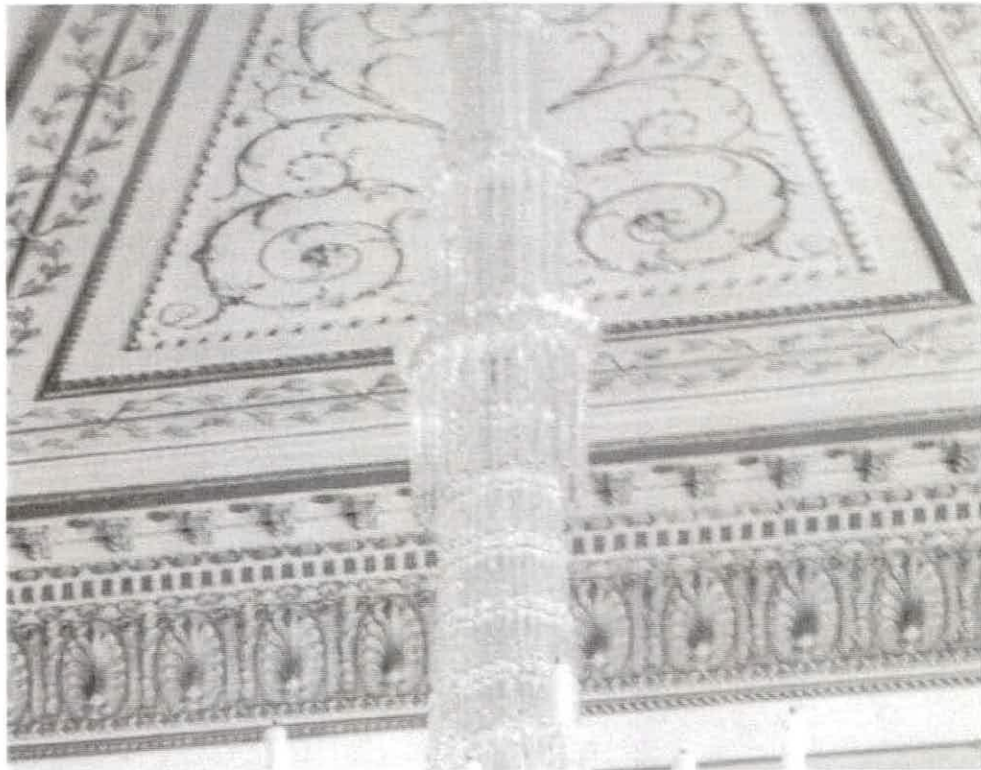
Figure 9, a detail of the 1920 photograph, Figure 6, showing the ceiling panel decoration above the east wall of the saloon, pattern B.

The outlines of the stains clearly do not relate exactly to the design of the ceiling panel decorations, but they do provide an approximate guide. From the two sets of photographs of the stains for the pattern B panels that were taken flat on, Figure 13 and Figure 16, it is possible to trace the outlines and aggregate the evidence, Figure 18. The details of the mouldings evident in the oblique views, Figure 9 and Figure 12, can therefore be plotted, using the outlines in Figure 18 as a base plan, Figure 19.

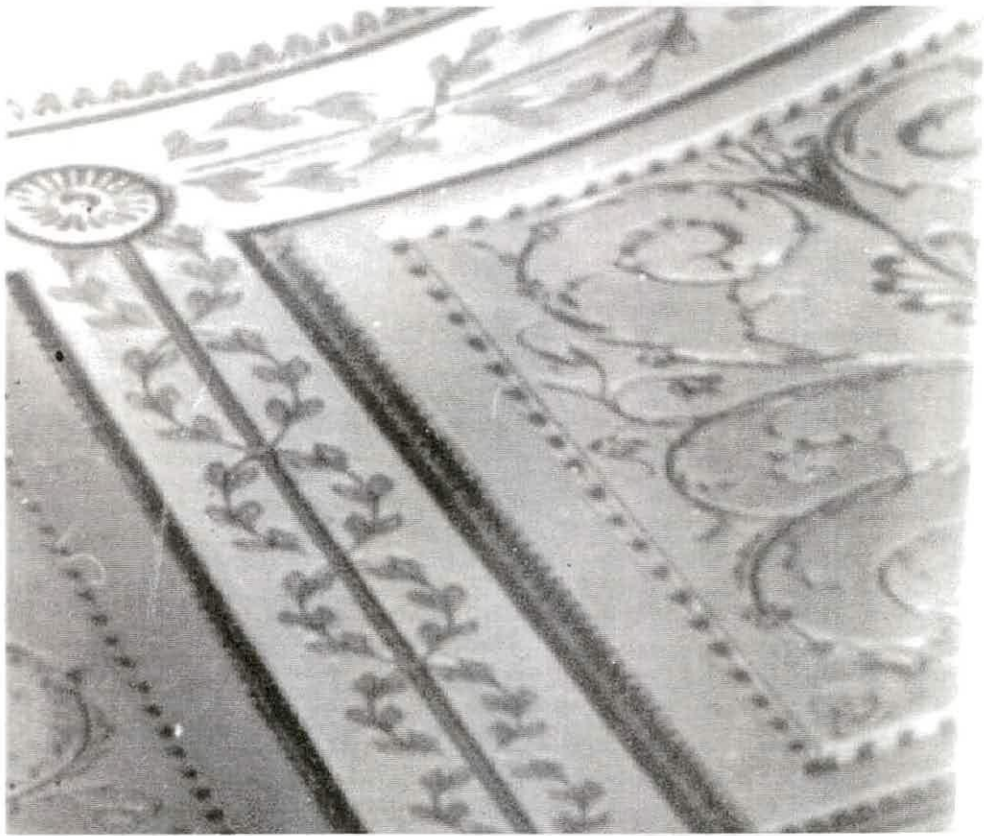
Figure 12, a detail of Figure 10, showing the ceiling panel decoration, pattern type B, above either the north or east wall.

According to a photograph taken in 1932, the panel decoration remained *in-situ* in 1932, Figure 10. It shows the decoration in more detail than the earlier images, Figure 11 and Figure 12.

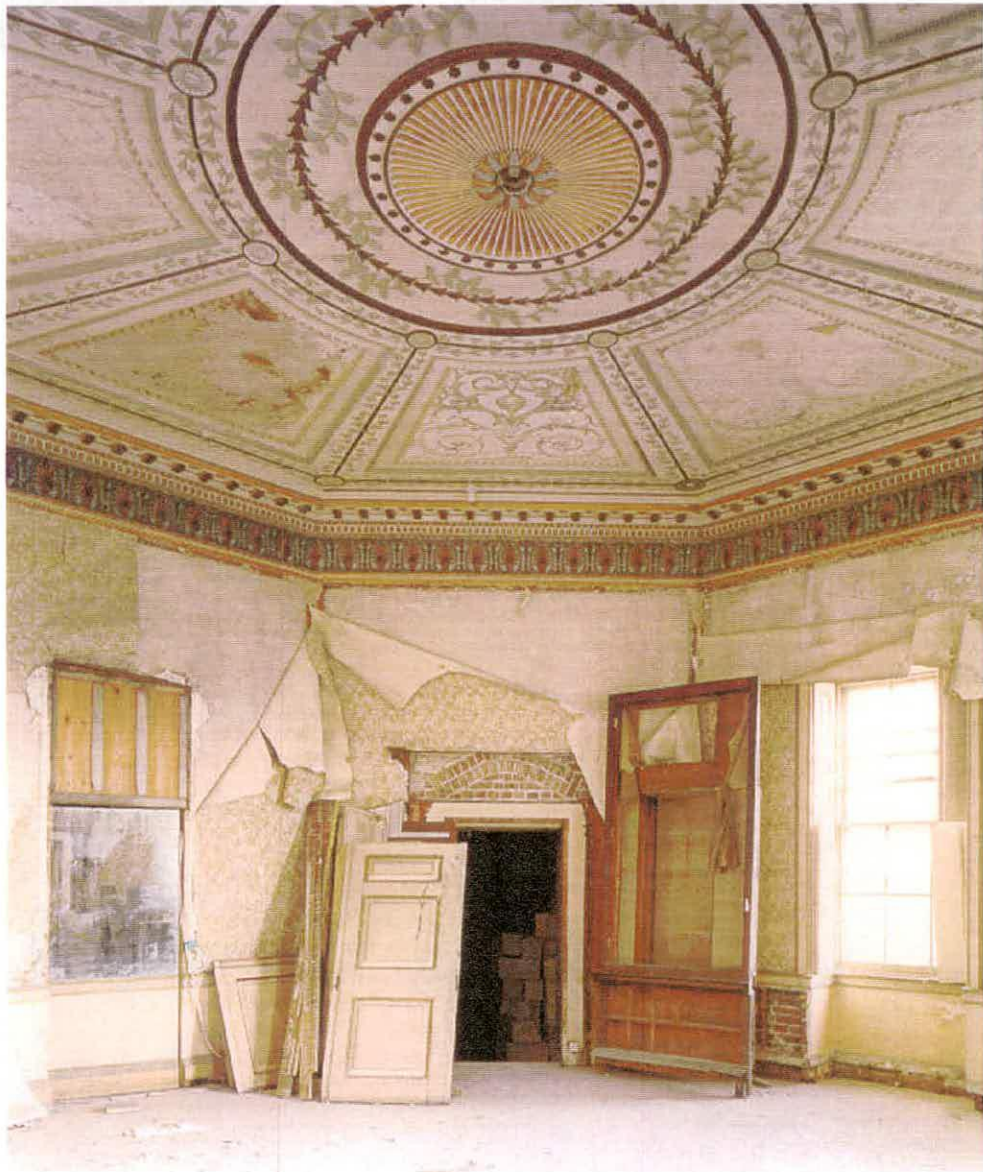
Figure 14, the saloon in 1995, prior to English Heritage's acquisition of the building. The wallpaper applied to the ceiling has either been removed or fallen away. Photograph: Paul Dixon for English Heritage.

By 1997, the wallpaper applied to the ceiling panels had been removed and the only physical evidence for their design consisted of patterns of staining in the original ceiling plaster, Figure 14.

The cause of the staining is not obvious but microscopic analysis of the affected plaster areas indicates that the stained parts of the ceiling had not been painted.² This suggests that the panel decoration was applied as part of the original fitting out before any painting took place. This is significant because it associates the work with Robert Taylor rather William Chambers who is known to have advised on some alterations to the interiors within a few years of the completion of the interiors in 1766.³

It is suggested here that the staining was caused by the use of animal glue or size to fix the mouldings, which were probably cast, to the soffit of the ceiling. If the mouldings were of composition, it is perhaps possible that glue was used alone. Alternatively, the mouldings might have been fixed in place with a lime plaster mix that included animal size as a secondary ingredient. The plasterer William Millar recommended this process in 1897:

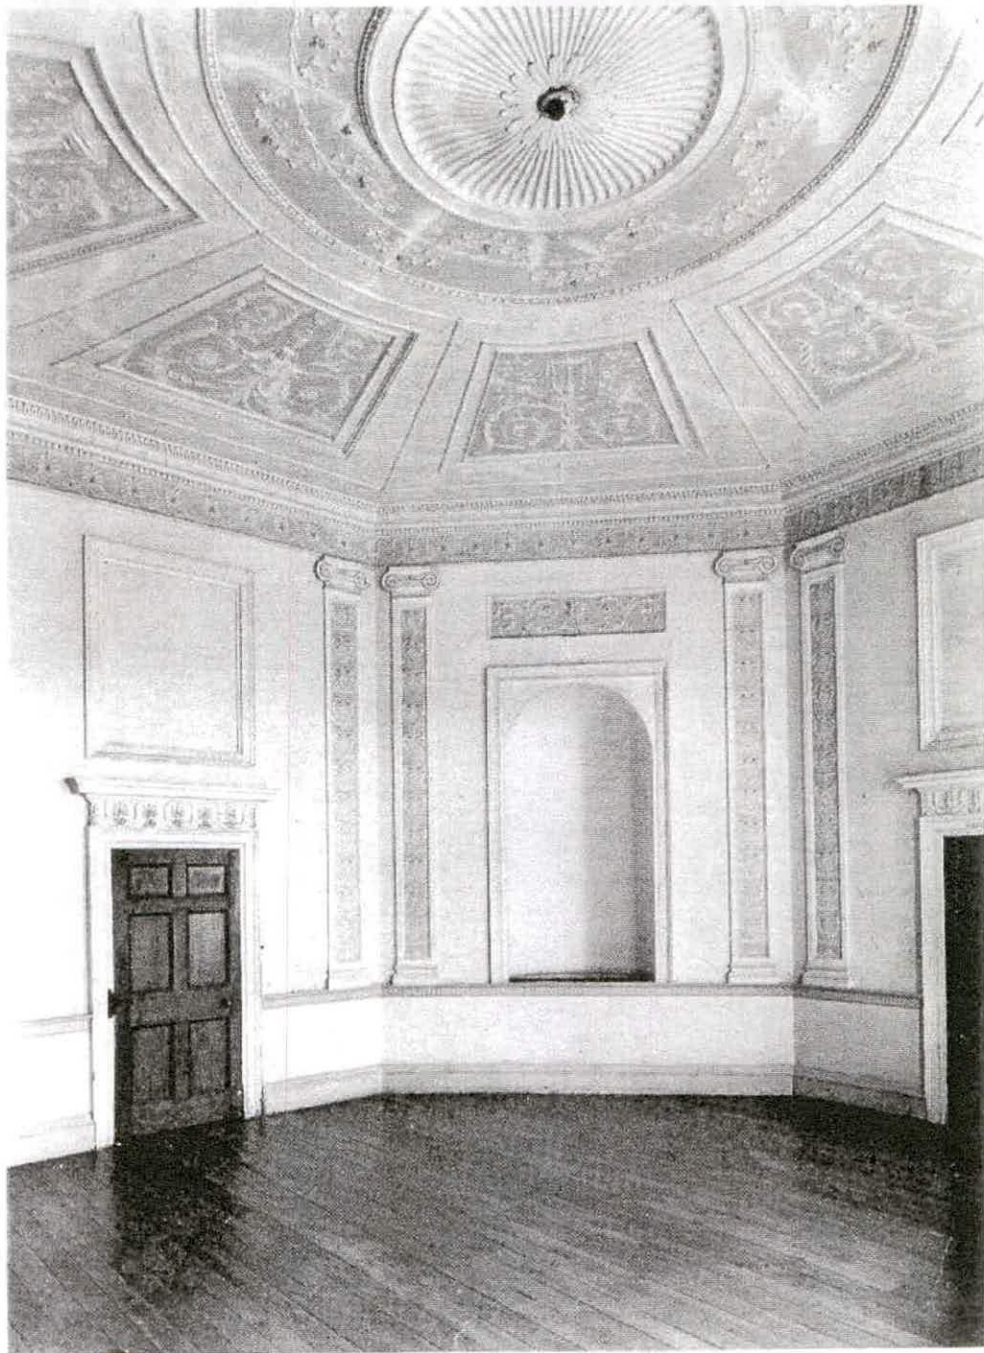
Figure 15, the saloon or drawing room at Chute Lodge, Wiltshire (photograph *Country Life*, reproduced in Binney 1984)

Chute Lodge, built by Robert Taylor for John Freeman, under construction in 1768, has an octagonal saloon and is generally very similar to Danson, although it is executed in brick. The design of the ceiling of the saloon is very similar to that at Danson and the corresponding panels are decorated with foliage, flowers, and urns, Figure 15.

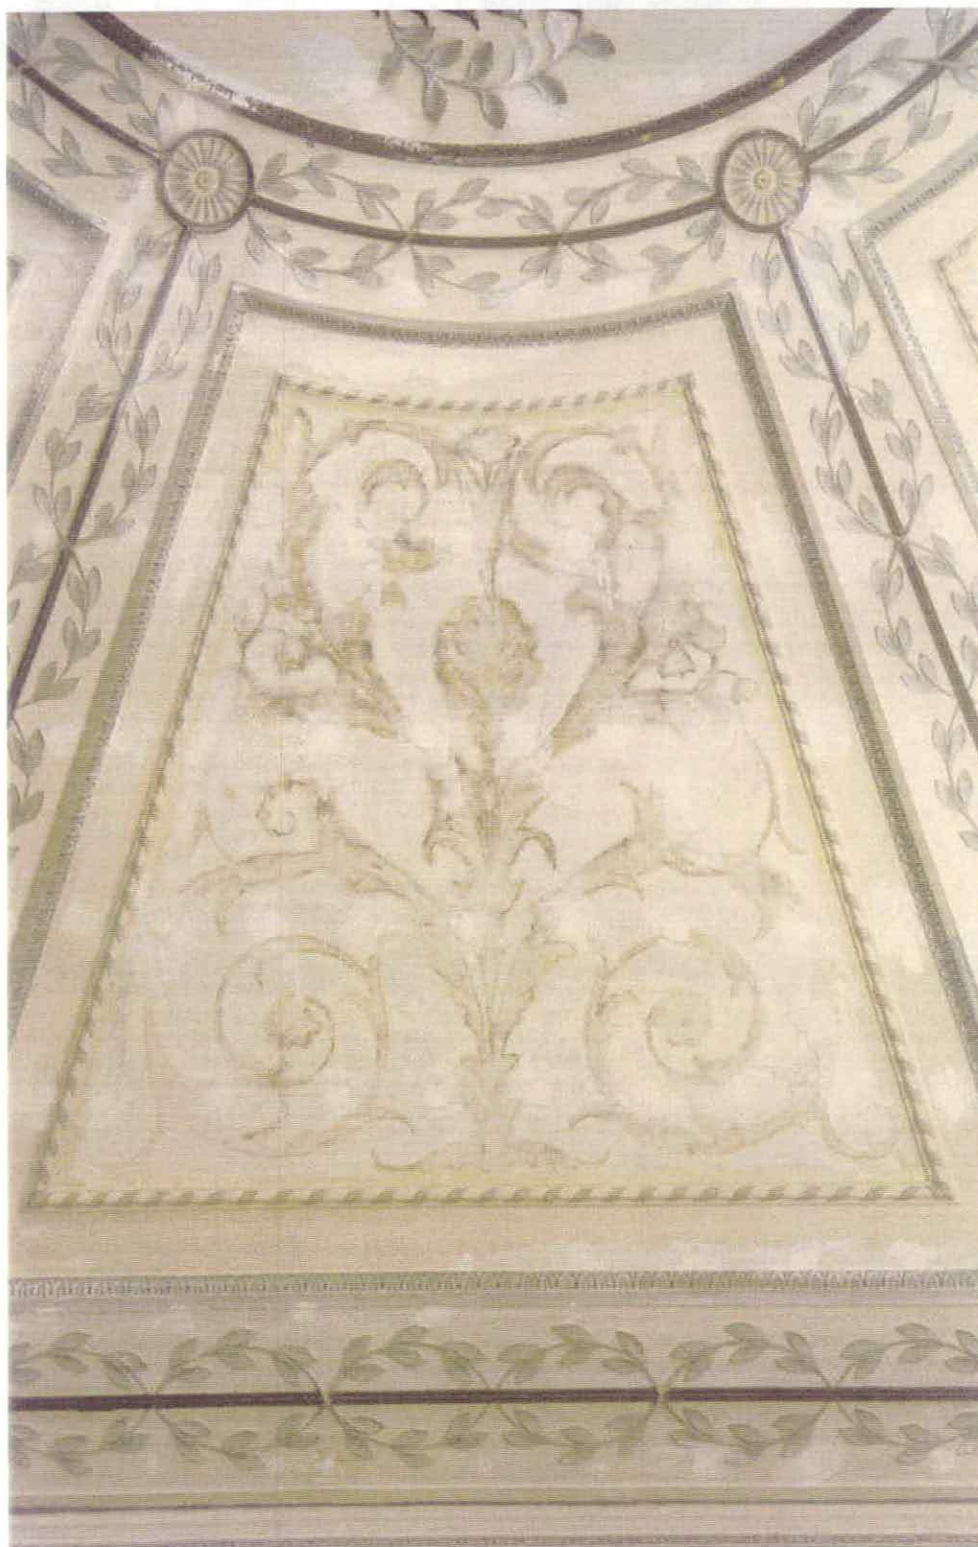
Figure 17, the ceiling panel above the door to the dining room, photographed in 1997 after the wallpaper had been removed and the plaster surface prepared for repainting. The decoration is pattern type B. Photograph: English Heritage, Historical Analysis and Research Team.

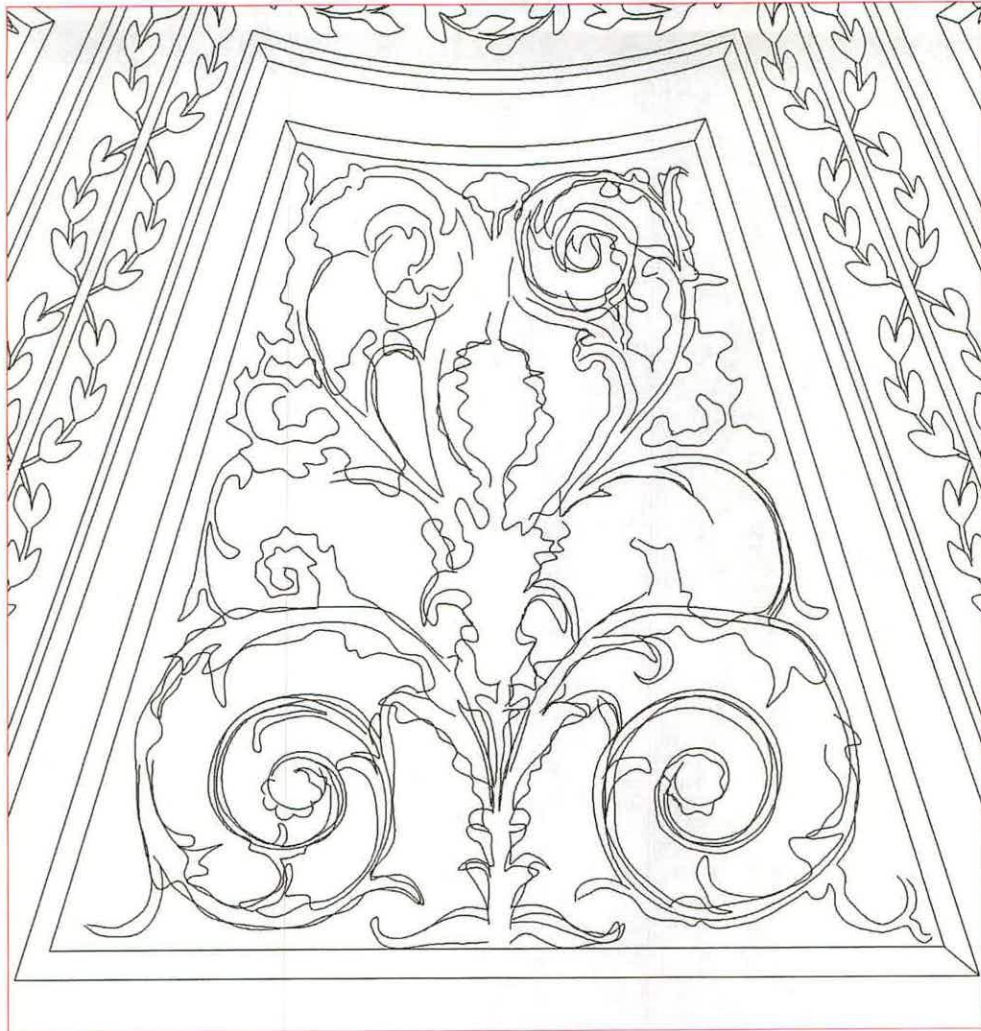
Figure 18, a composite drawing of the outlines of the ceiling panel decoration pattern B, used in the panels adjacent to the diagonal walls, based on photographs taken flat on to the ceiling, Figure 13 and Figure 17.

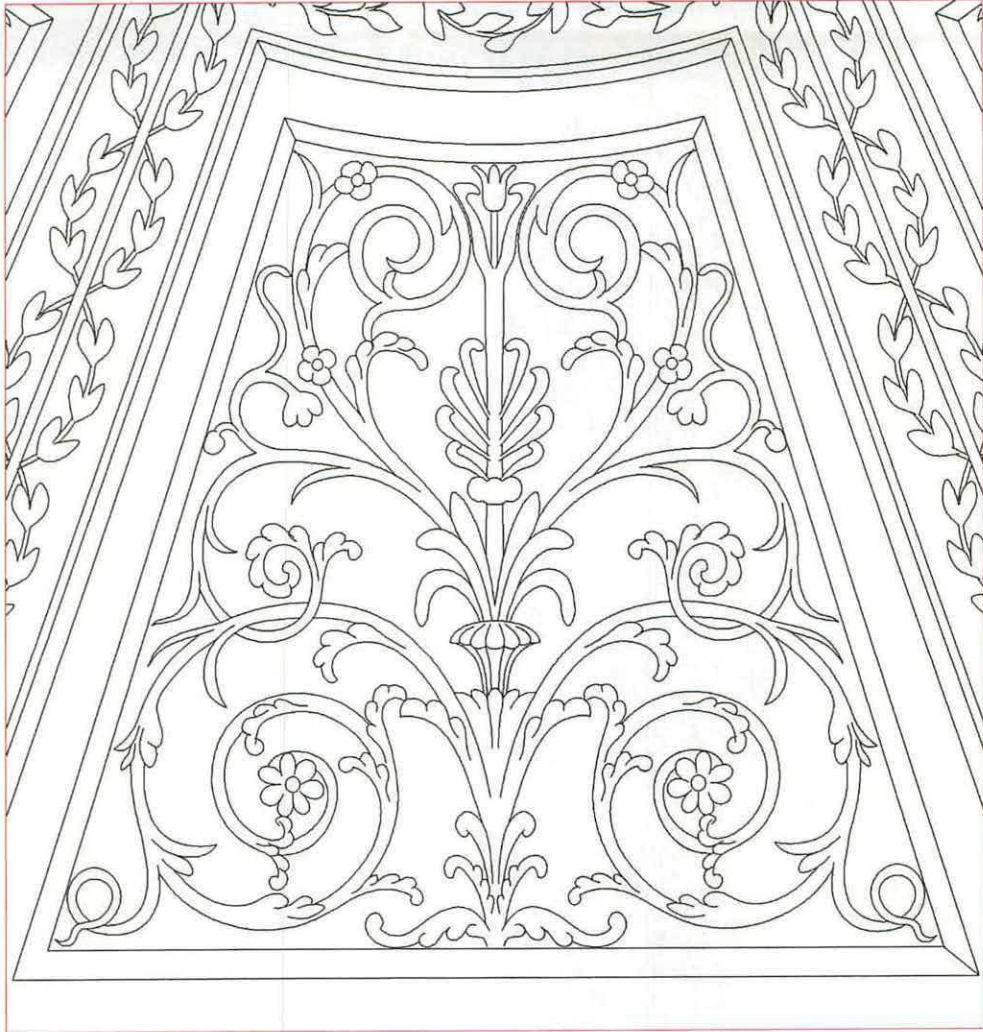
Figure 19, a reconstruction of the ceiling panel decoration, pattern B, based on Figure 18, Figure 9 and Figure 12.

Both of the reconstruction drawings, Figure 19 and Figure 22, are informed by the detail

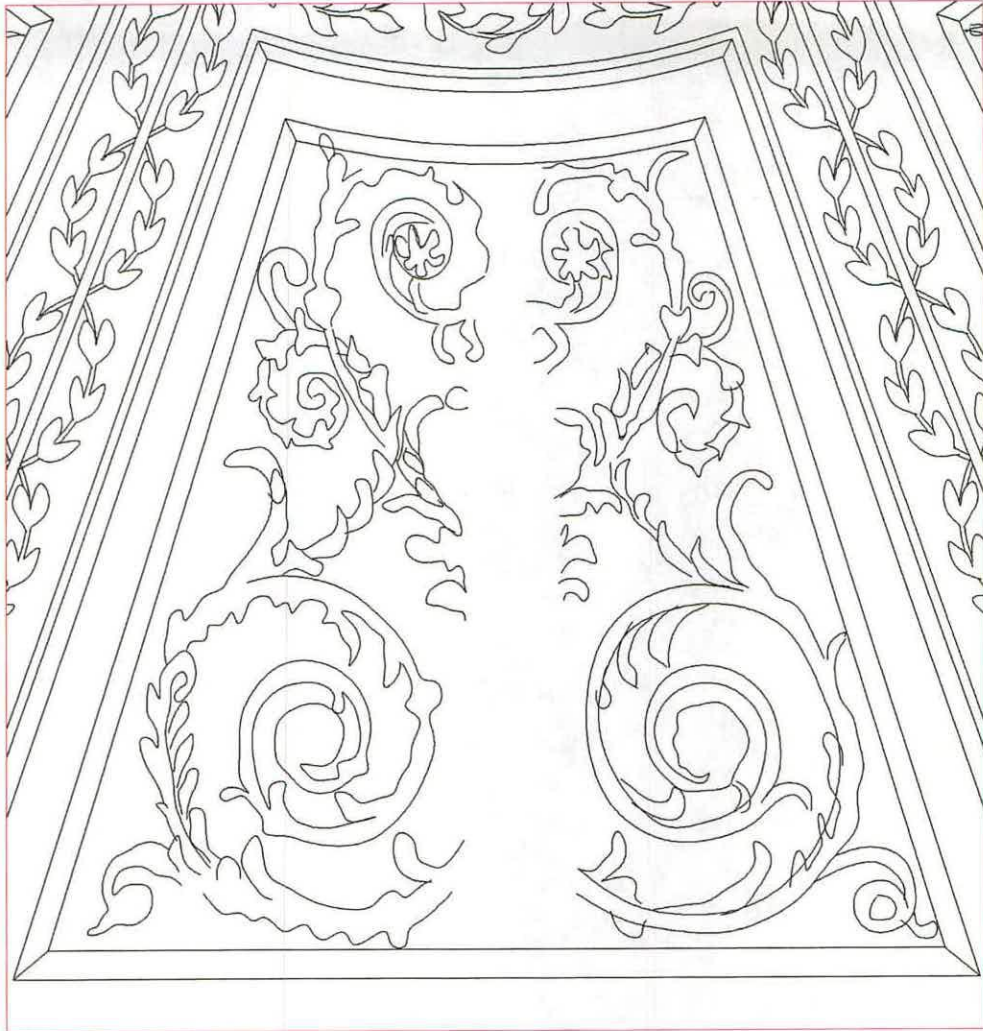
Figure 21, a drawing of the outlines of the ceiling panel decoration, pattern A, used in the panels adjacent to the diagonal walls, derived from the 1932 photograph, Figure 10, via the crudely rectified image, Figure 20.

Pattern A, unfortunately, is more problematic because we do not have any photographs that were taken flat on. This is because the staining of the plaster was not as clear as that of the pattern B panels. However, the detail in the 1932 photograph is sufficiently sharp and the panel is square enough to the line of sight to allow a crudely rectified image, Figure 20. From this rectified image, a scaled drawing of the panel can be produced, Figure 21. Like pattern B, the missing detail is supplied by the oblique photographs, Figure 5 and Figure 7, resulting in the reconstruction, Figure 22.

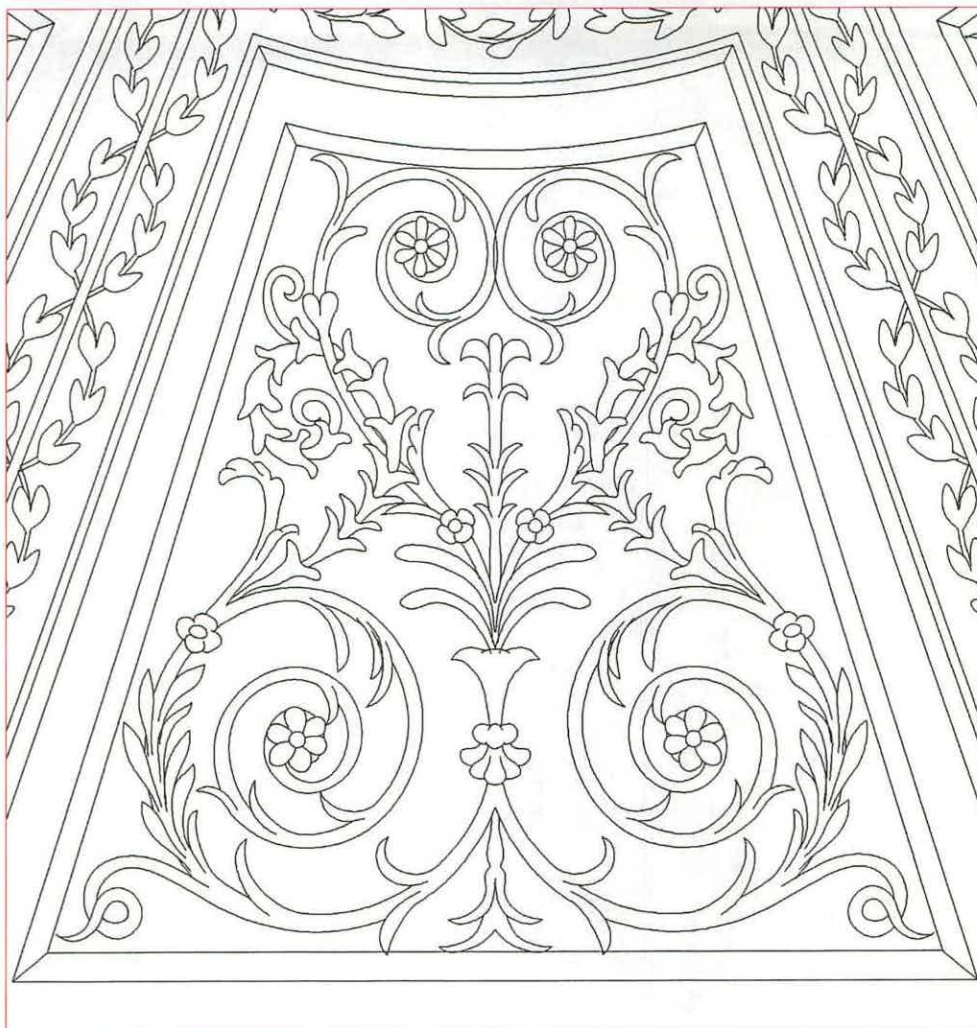
Figure 22, a reconstruction of the panel decoration, pattern A, based on the outline shown in Figure 21 and the details shown in Figure 5 and Figure 7.
