**A circular enclosure  
at  
Redmarley d'Abitot,  
Gloucestershire**

AI/43/2002

County: Gloucestershire  
District: Forest of Dean  
Parish: Redmarley d'Abitot  
NGR: SO 758 309  
NMR No: SO 73 SE 19

Survey: D Wootton and D Field  
Report: D Wootton and M Bowden  
Illustrations: D Cunliffe

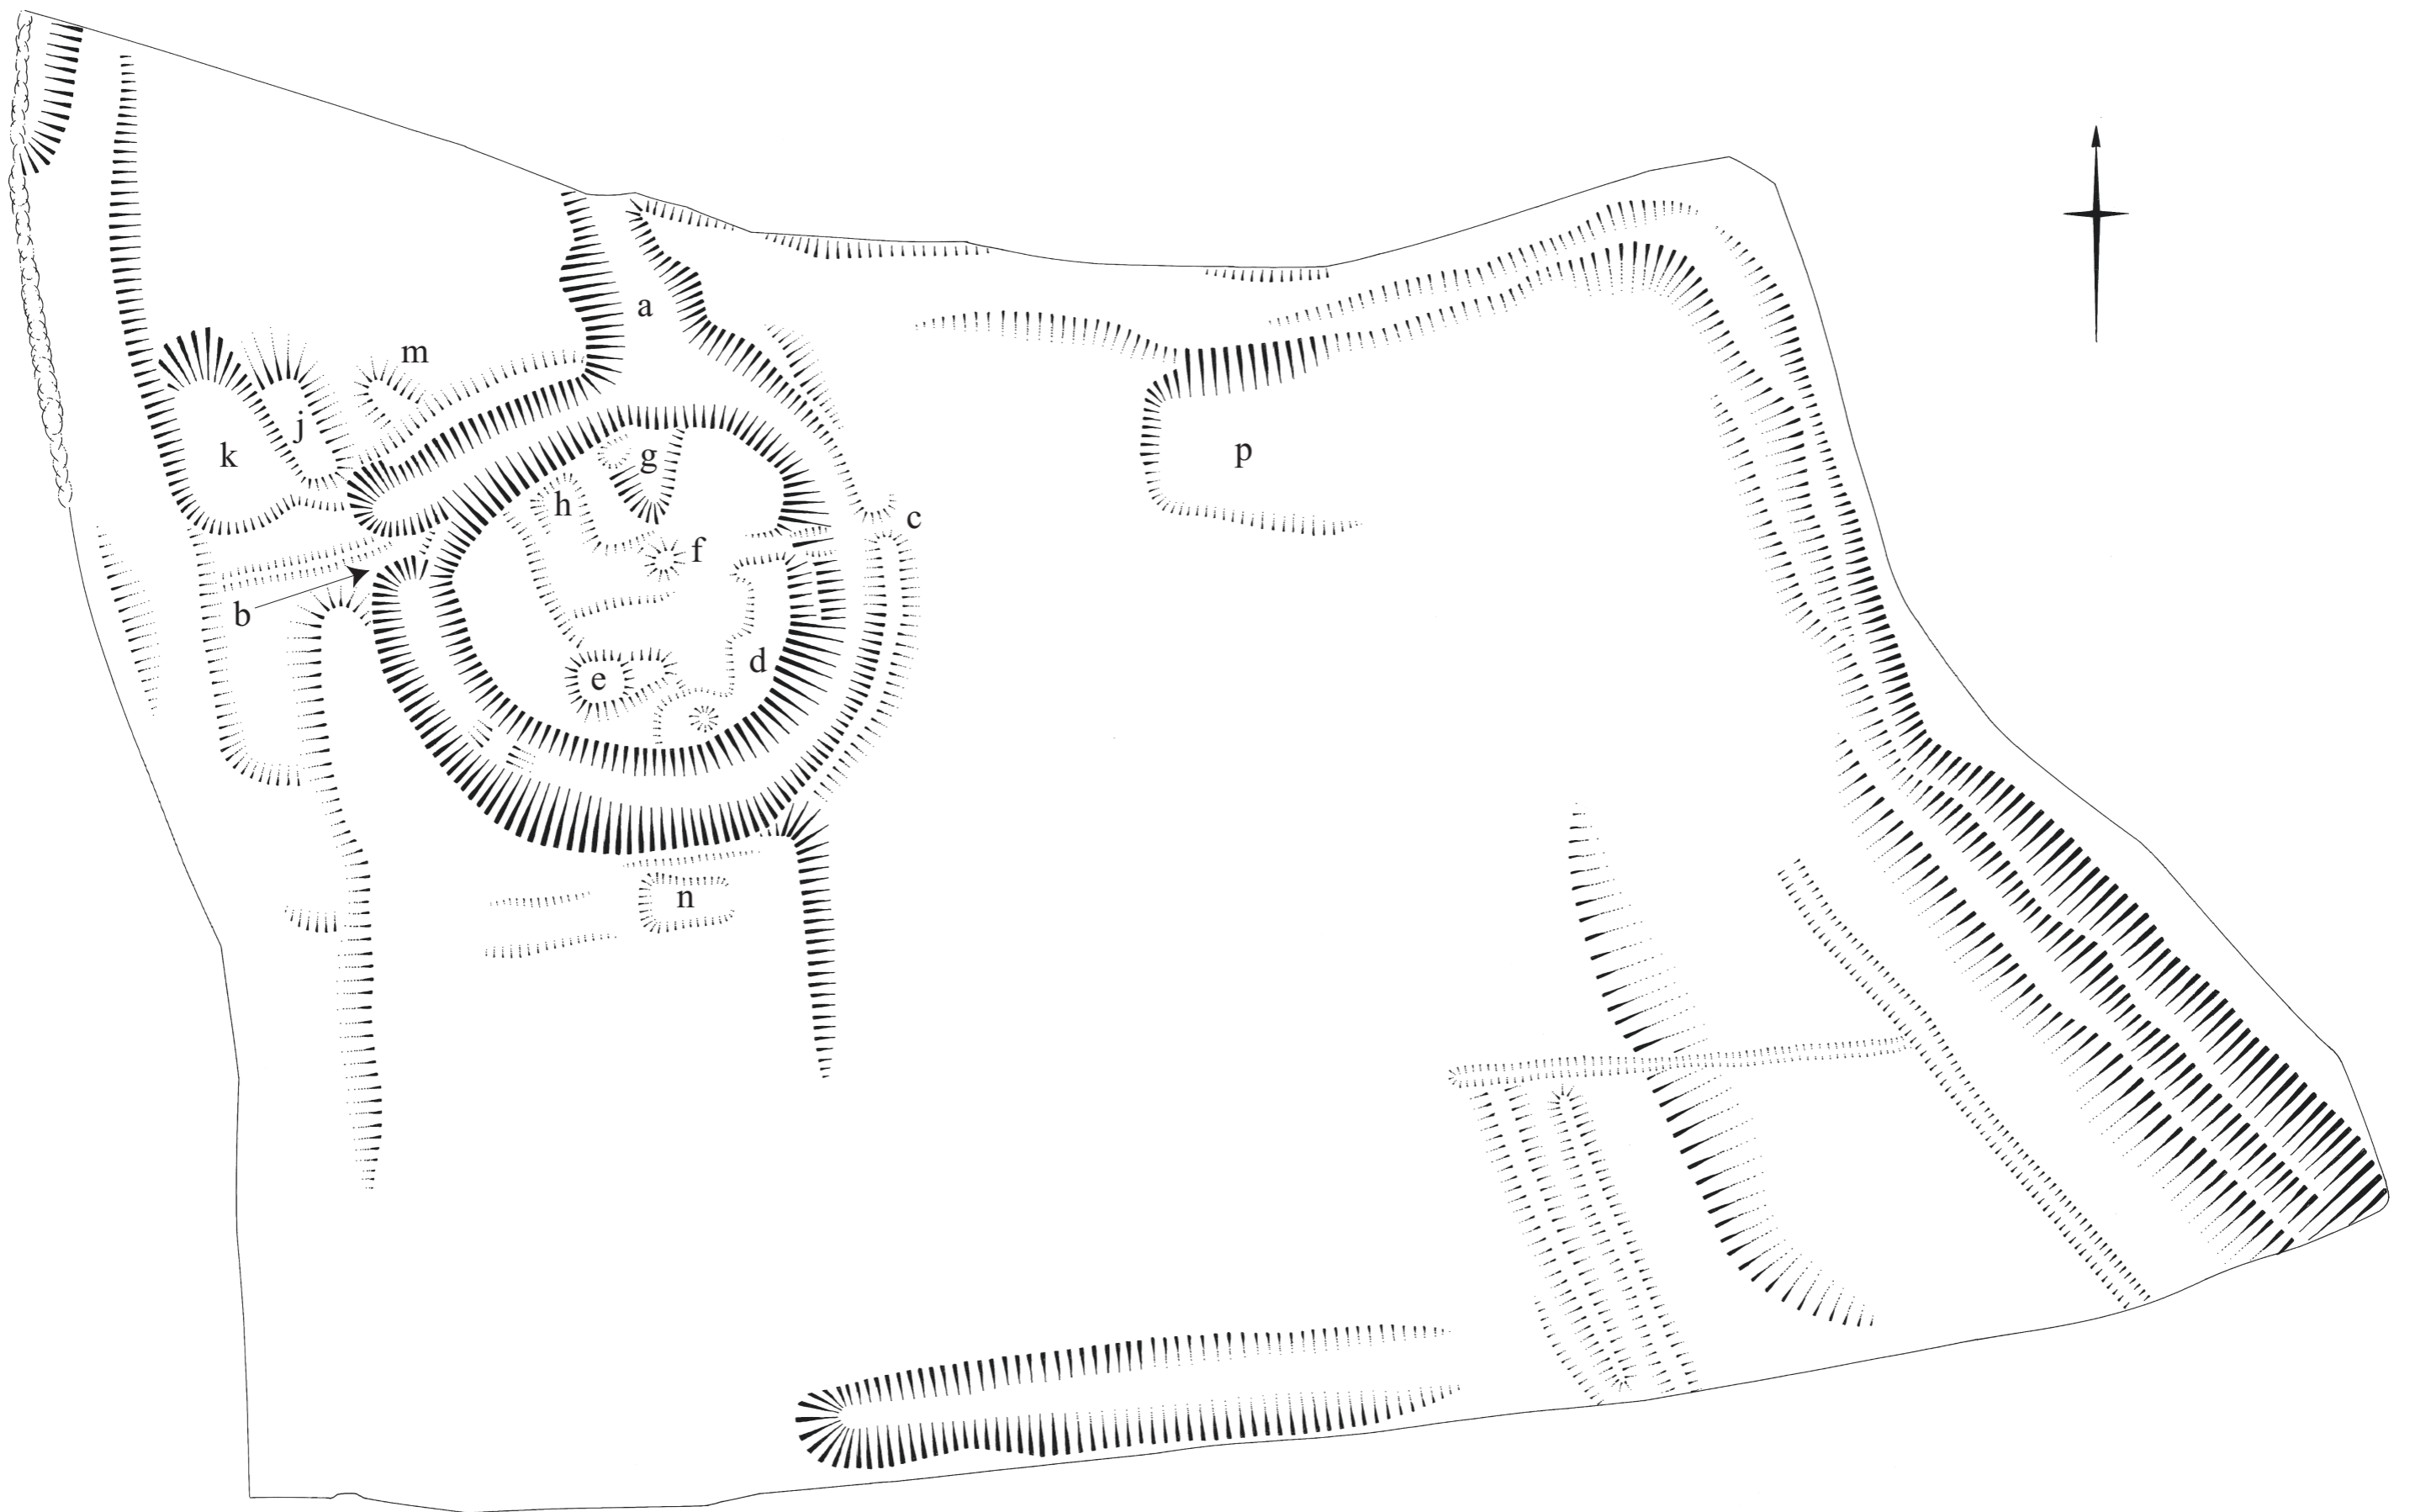
The enclosure is circular in plan with a gently sloping ditch of U-shaped profile measuring 1.75m in depth, and about 3m in width at the bottom. Around much of the circumference of the outer side of the ditch there is a slight bank which is raised 0.2-0.3m above ground level. There are no traces of it to the south-west or the west. This bank may have built up as a result of the cleaning out of the ditch.

To the north, a ditch 12m wide (**a**) has been cut from the moat to the stream. The west side of this ditch appears to cut the external bank of the enclosure on its north-west side. However, the bank on the north-east apparently respects the line of the ditch from the stream on its east side, its bank perhaps resulting from later cleaning. This probably demonstrates the widening of the ditch at a later phase, which, as it was widened, cut out some of the original moat to the north-west. In addition, the north-east section of the

There are two possible entrances to the moat. There is a gap 2.5m wide in the ditch on the west side (**b**) making the circuit incomplete. It is possible that the destruction of a rectangular building and the digging of a subsequent earthwork (see below) led to later dumping in this area, causing the deceptive appearance of an entrance. This however, does not explain why the terminals of the ditch appear to be so neatly rounded off; any dumping would surely be less precise. This may, therefore, have been a permanent entrance causeway.

There is another possible entrance, 2m wide, at the east (**c**) where the ground immediately outside the moat is sunken. This hollow continues on the interior of the moat ditch. It is possible that a bridge was placed here. There may also have been a gatehouse here, as there are slight earthworks, which butt against either side of the hollow. However, the hollow is very narrow and it is possible that it has been caused by later activity.

The earthwork (d), which butts onto the south side of the possible gatehouse on the east, forms an irregular line to the south. Lying within this earthwork is a small circular depression measuring 3m in diameter. It is, unfortunately, impossible to tell if these features are contemporary with each other. As the circular earthwork is slight, it is impossible to tell if it demarcates a small building, or is no more than later cattle disturbance.

Further earthworks (e) form a square measuring  $7.5 \times 7.5$ m with rounded corners, raised slightly above the surface level. Immediately to the east of this is a semi-oval earthwork measuring  $5.0 \times 7.5$ m. This is also slightly raised above surface level, but not as high as the square mound. The west side of the semi-oval may have been cut into by the subsequent building of the square platform. However, as the north and south sides of both earthworks respect the same line, it is more likely that the two are contemporaneous. The change in level, or step down into the semi-oval earthwork perhaps demarcates a different level of status between the two buildings.

There is a small circular raised earthwork (f) slightly north-east of the centre of the island, measuring 3.75m in diameter. It probably represents some kind of building, but its function remains unknown. The building may have been a dovecote or perhaps a store or small barn. It may be significant that it is set a little back from, but opposite to, the possible eastern entrance, but without further evidence it would be unwise to speculate further.

On the extreme northern edge of the island there is a small sub-circular earthwork (g), which is hollowed slightly below surface level. This is probably damage caused by cattle, as it is relatively irregular and the ground surface here is pocked.

Small irregular linear earthworks are visible on the north west of the island (**h**); they may be the remains of fences, but without further evidence, it is impossible to establish what they are.

To the north west of the enclosure are two earthworks. The one nearest to the moat (**j**) is rectangular with rounded corners, measuring  $c3 \times 17\text{m}$ ; it is probably a building platform. It is raised a little, and gradually slopes to ground level, except for the whole of its west side, which once probably extended further westwards. This now appears to have been cut by the adjacent earthwork (**k**). This is a shallow depression, measuring  $13.5 \times 24\text{m}$ , the bottom being sub-oval in shape, whilst the top is more rectangular. This may have been a cellared building or a pond. It is positioned conveniently close to the stream, and is deep enough to hold a substantial amount of water.

Immediately to the east of these earthworks there is a smaller earthwork (**m**) measuring  $c5.5 \times 7.5\text{m}$  wide. This is raised a little, with a gradual downward slope to the surface level. It is narrow and rectangular in form, but its relationship to the moat is unclear. It could have butted up against the outside of the ditch, or it may be that the earthwork predates the moat, being cut into when the moat was dug. However, the earthwork is slight and may simply have occurred due to cattle disturbance or other later farming activity.

To the south is a small sunken earthwork (**n**), rectangular in shape, measuring  $10.0 \times 8.5\text{m}$ , with the east side open. This may be a building, or small enclosure. It is impossible to determine a date or original function.

Further east and down slope from the moat are the three sides of a large sunken rectangular earthwork (**p**), measuring  $13.5 \times 22.5\text{m}$ . It probably marks the site of a building, but is of undeterminable date. The fourth side has probably been ploughed out.

The site is privately owned, although there is a public footpath across it. At present, the land is under a grass crop, though the east side of the moat has some bushes growing on it. There is evidence of some cattle damage on the northern side of the moat ditch, and also on the north side of the platform.

As some of the earthworks are likely to be the remains of buildings, geophysical survey may be able to provide a clearer picture of the arrangement, and therefore the nature of the buildings, both on the platform, and around the outside of the enclosure. As discussed above, the enclosure could be a recent feature. However, it could potentially be an early circular moat, and one of very few examples throughout the Malvern Hills area, or even a prehistoric site. It is important, therefore that a date is established. Ultimately, only excavation can provide such dating evidence.
