COCKHAM WOOD FORT Hoo St Werburgh, Kent

A 17th-century battery
for the defence of the
Medway and Chatham
Dockyard

SURVEY REPORT

**ARCHAEOLOGICAL INVESTIGATION REPORT SERIES 20/2002
ISSN 1478-7008**

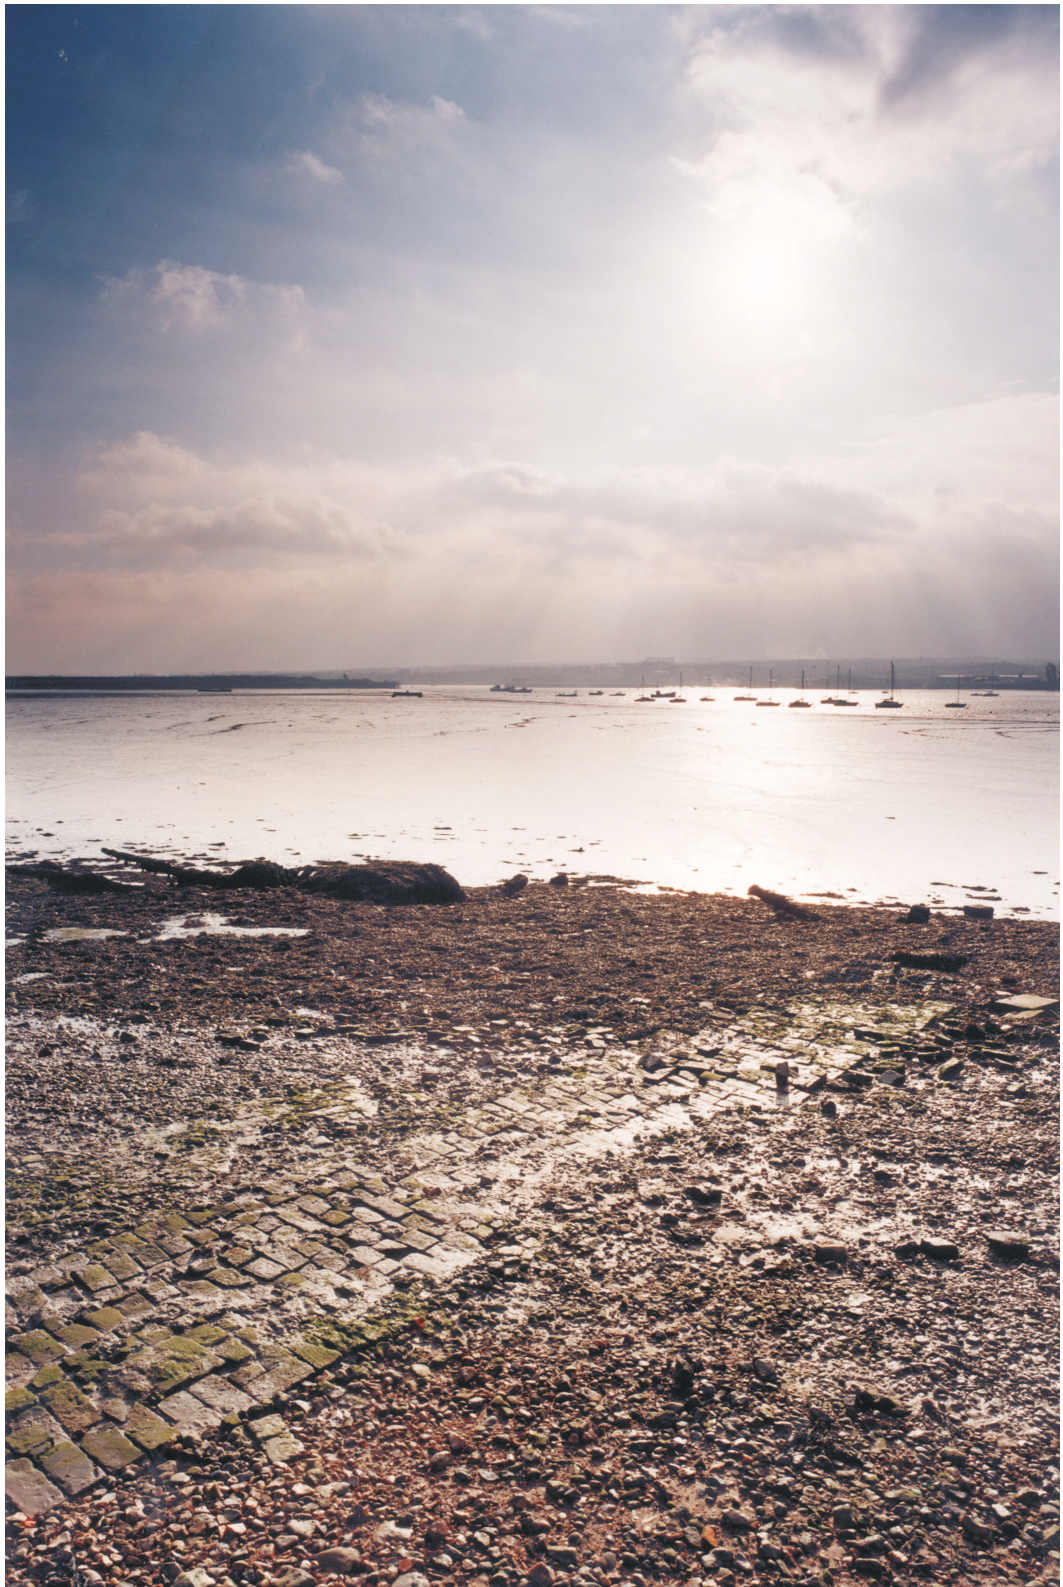
*The foundations of the east bastion of the lower
gun line, looking down river
(NMR: AA031331)*

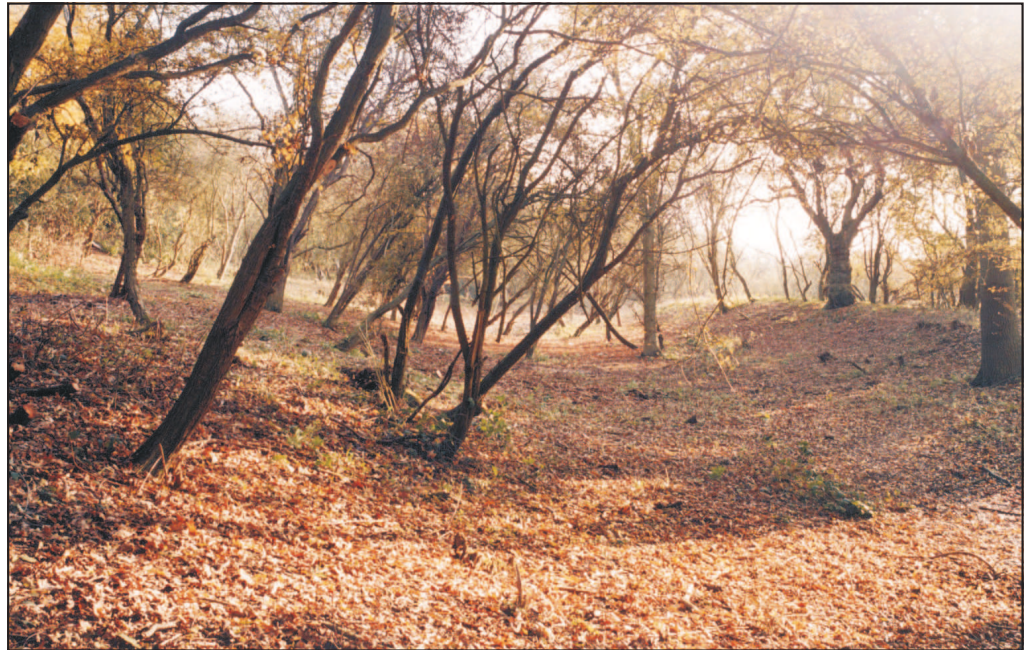
Figure 12
*The gorge ditch
from the west*
(NMR: AA031354)

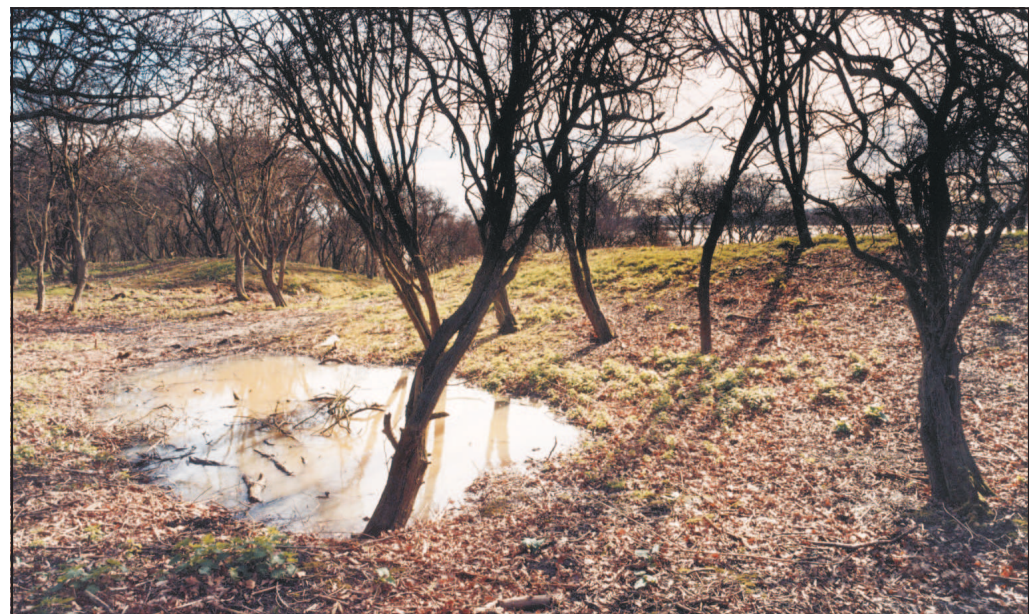
The rampart survival varies, with the gorge section the best preserved, especially to the west of the redoubt where it stands some 3m high and 20m wide (Fig 14). East of the redoubt, the north face survives, standing 0.9m high along most of its length before dropping to 0.6m as it turns south: the internal face can only be traced for some 20m from the redoubt, east of which a series of scarps represent the collapsed and eroded rampart material.

Figure 14
*The gorge rampart
from the north-west.
The water filled
depression is in the
ditch bottom
(NMR: AA031358)*

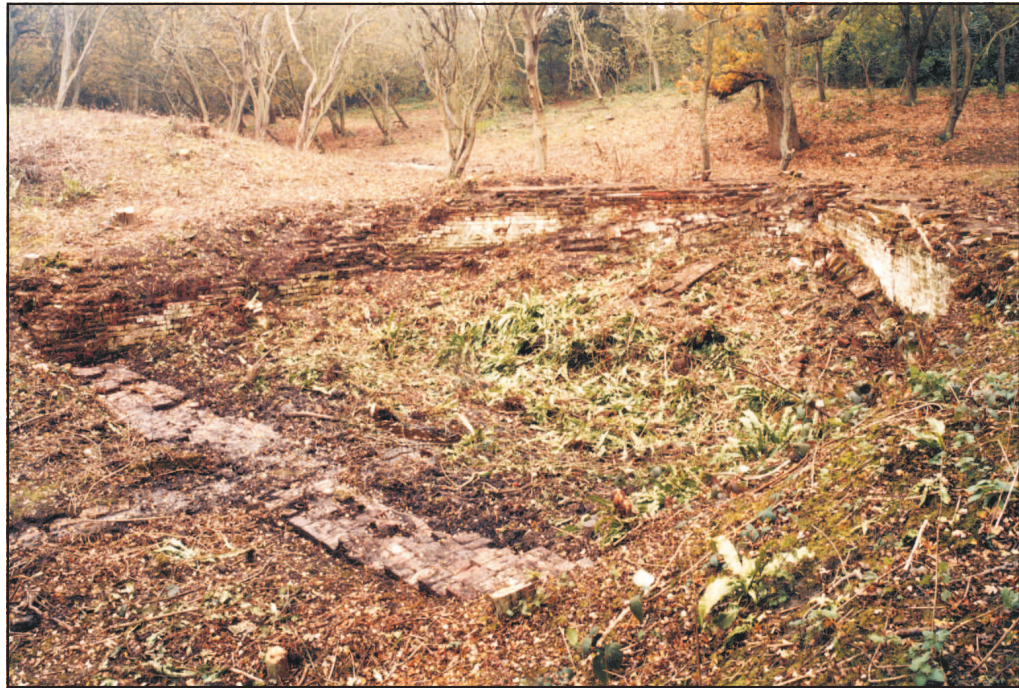
rampart terminals above. The south wall survives to a maximum height of 0.25m and was 0.92m thick, with a gap in the centre allowing the passage of a conduit, described below. Very little internal detail survives, as much of the area is covered with rubble, although there is evidence of whitewash on the interior faces of the walls (Fig 16).

Figure 16
*The redoubt from
the south-east
(NMR:
AA031356)*

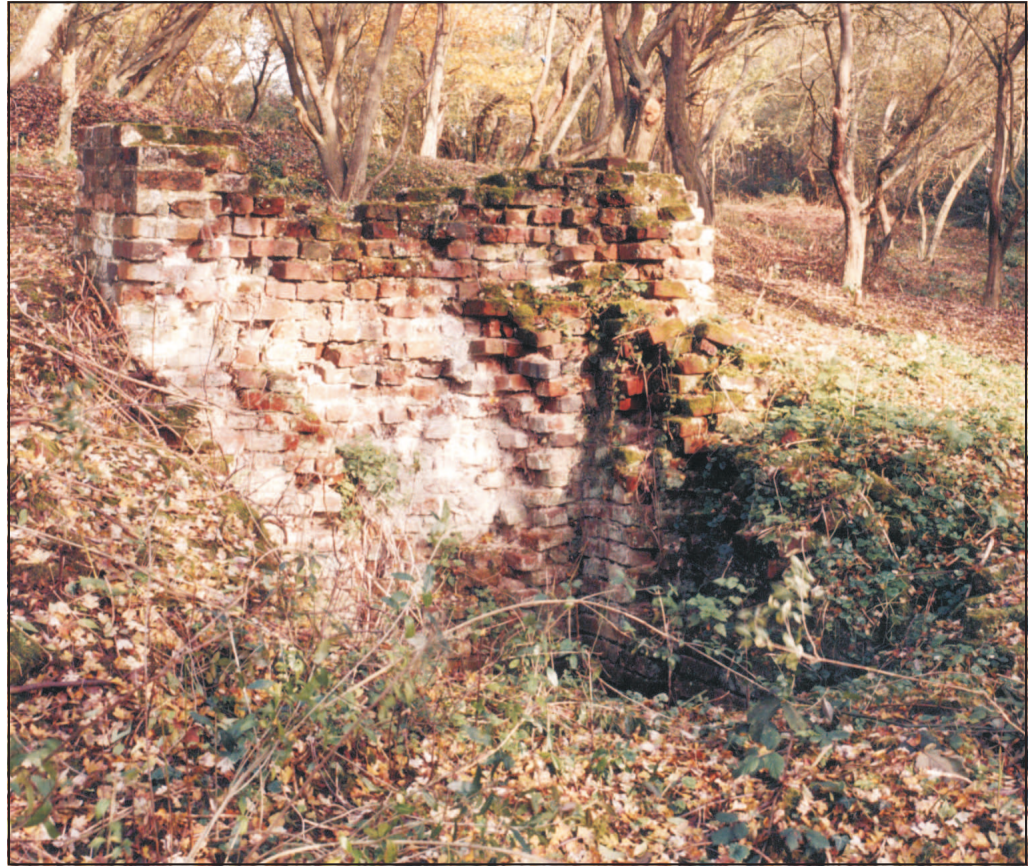
In the north-east angle of the fort, a small red brick-lined shaft is thought to be the top of the well that serviced the fort (Fig 19). It is roughly 3m square, the north wall surviving to a depth of 2.4m and a wall thickness of 0.7m. All the wall faces are bowing inwards under the pressure of the surrounding earth. It is likely that this is the well first mentioned in December 1670 (PRO: WO/51/52).

Figure 19
*The well from the
south-west*
(NMR: AA031352)

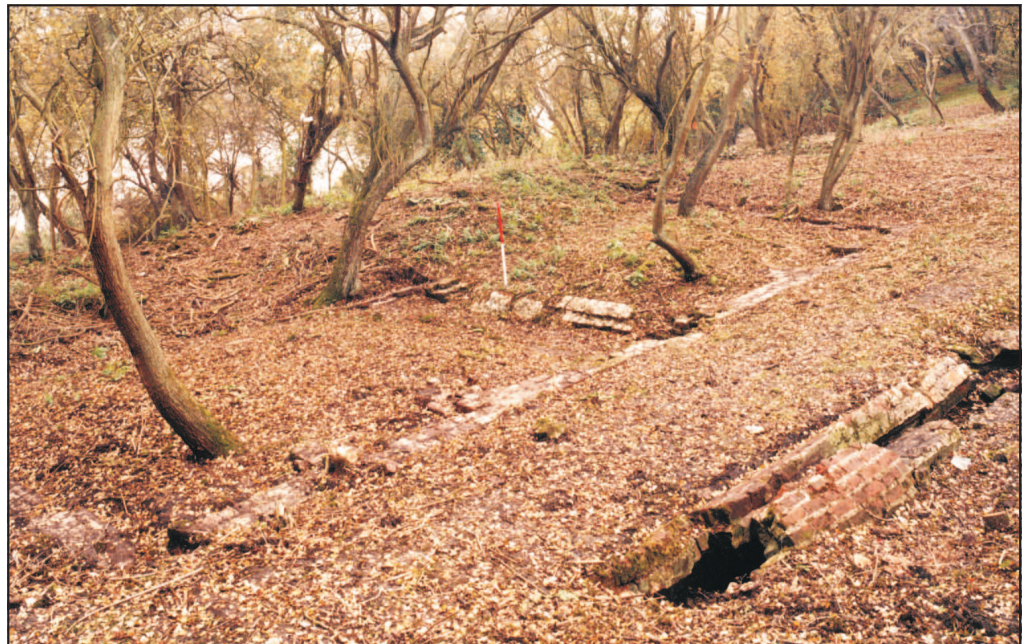
Figure 21
The late 18th -
century gunner's
house from the
north-east. The
brick conduit lies to
the lower right
(NMR: AA031357)

The house foundations survive, to a maximum height of 0.55m, in red brick some 0.43m thick. The whole north and east walls can be seen, together with sections of those on the south and west. Five '*buttresses*' each 0.5m square, abut the inside of the north wall and are likely to have been the supports for the floor joists. Few other details are visible, although there is some evidence of whitewash on the internal brickwork. A *rubble spread* 1.7m wide runs down the centre of the structure and is likely to represent the collapsed remains of the internal passage, of which a 0.75m length of wall face survives (Fig 21). It is possible to see where the upper gun-line was modified by the addition of material on the south to provide a larger platform for the house, as well as to enable a more gentle approach from the south. This is now largely obscured by two mounds of rubble.

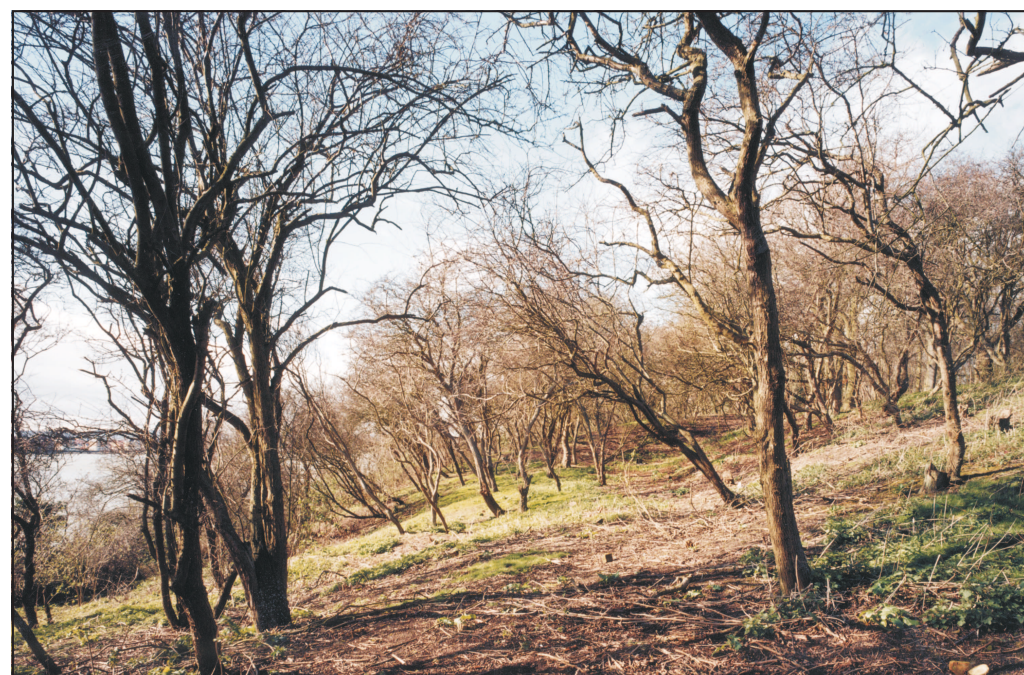
Figure 23
The upper gun line from the east, showing (at centre) the flat terreplein (NMR: AA031313)

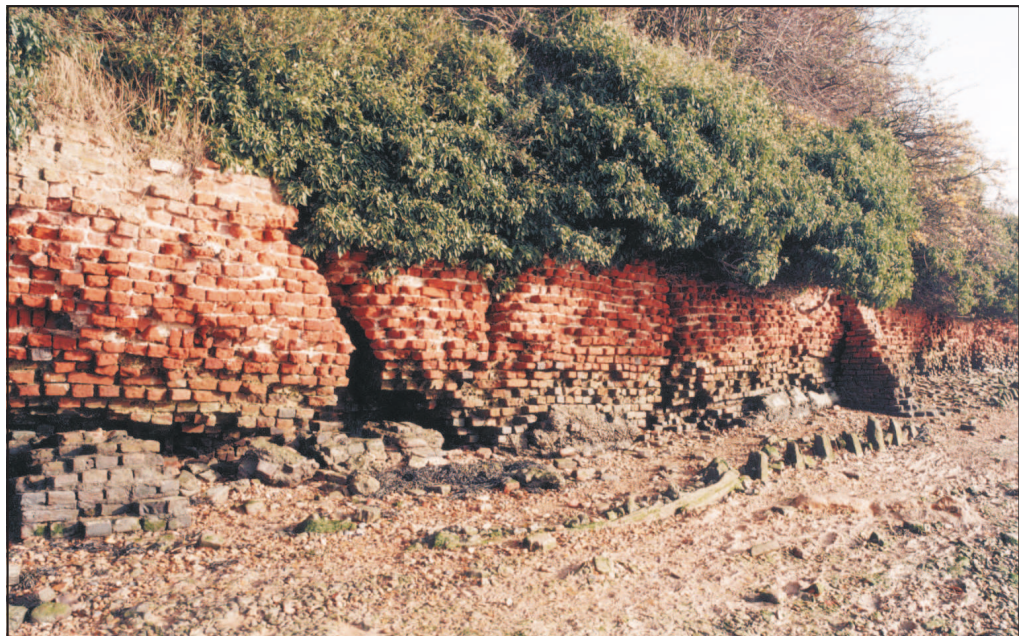
Figure 25
*The revetment wall
of the lower gun
line with the
timber remains of
the tidal defences
in front (NMR:
AA031343)*

Substantial parts of the lower gun line survive, albeit in a deteriorating condition. The red brick revetment, laid in English bond, can still be traced along much of the original frontage. Excluding the west bastion it stands to a maximum height of 2.3m, with no facing bricks surviving, though it is possible to see the back face of the revetment in a few places where areas of overlying soil have been removed. The east bastion is barely visible as a brick foundation at beach level; with the tide washing away much of the earth platform behind (frontispiece). The gun line did not front squarely onto the river for its entire length, as some 40m along the curtain from its western end, the line turns into the river. This has resulted in the location of the eastern corner some 16m further south than its western counterpart. This is confirmed by the 1742 plan and is presumably connected with both the line of fire and the course of the river. Several small buttresses, each *c*1.1m long by 0.6m wide, are placed at intervals along the line to provide extra support (Fig 25). Pebble concrete lying over the lower brick levels is a result of underpinning carried out at a later date, probably in the 20th century.

In the river mud some 2m south of the revetment wall of the lower gun line, and in a line projecting upstream from the corner of the west bastion, are the remains of timber piles and boarding, which survive to a maximum height of 0.2m (Fig 25). These are the remains of defences constructed to minimise the destructive effect of the tide on the brickwork of the lower gun line. It is possible that they are the small piles which were first recommended in a Royal Engineers perambulation report of 1853:

‘the brickwork which at present preserves the property from the inroads of the river is being daily undermined and it is recommended that small piles should be driven into the clay and ragstone filled in between them and the brickwork’ (RE Perambulation Reports, Aug 1853-Nov 1885).

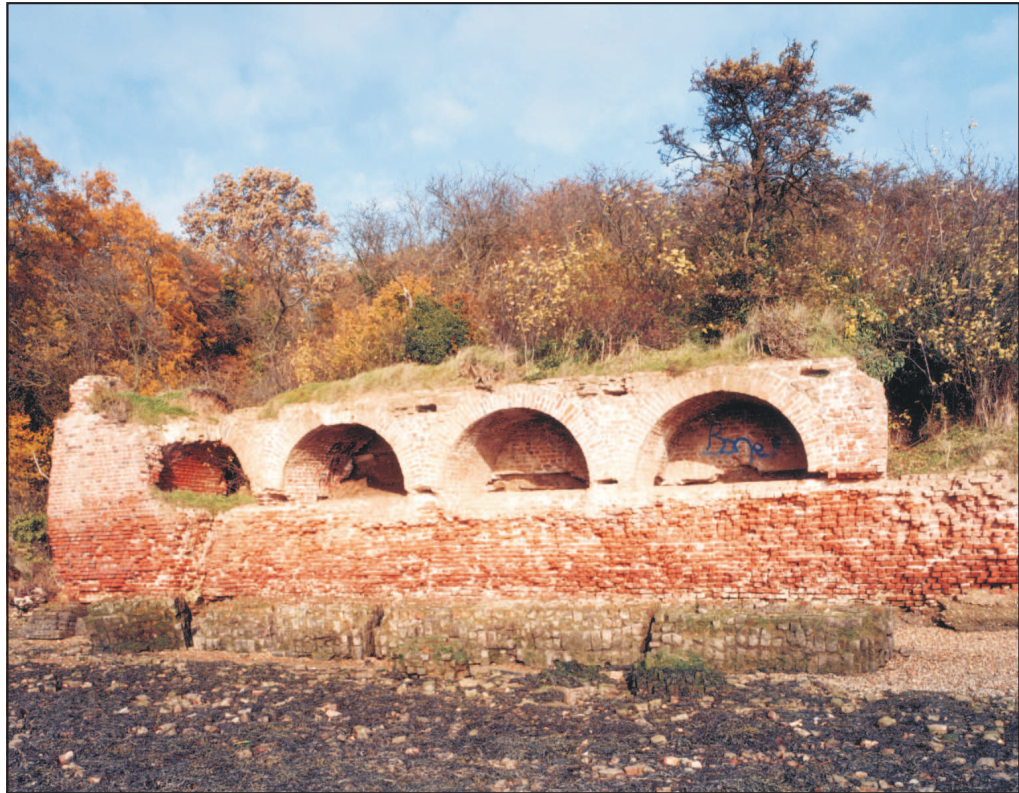
Figure 26
*The counterforts of
the west bastion*
(NMR:
AA031340)

The brickwork of the west bastion is comparatively well-preserved, standing some 5.5m high on its west side, as well as retaining some of the original facing bricks. Much of its front face has collapsed onto the beach, revealing four internal arched counterforts, which spring some 2m from the ground and to which the face of the wall had evidently been bonded (Fig 26).

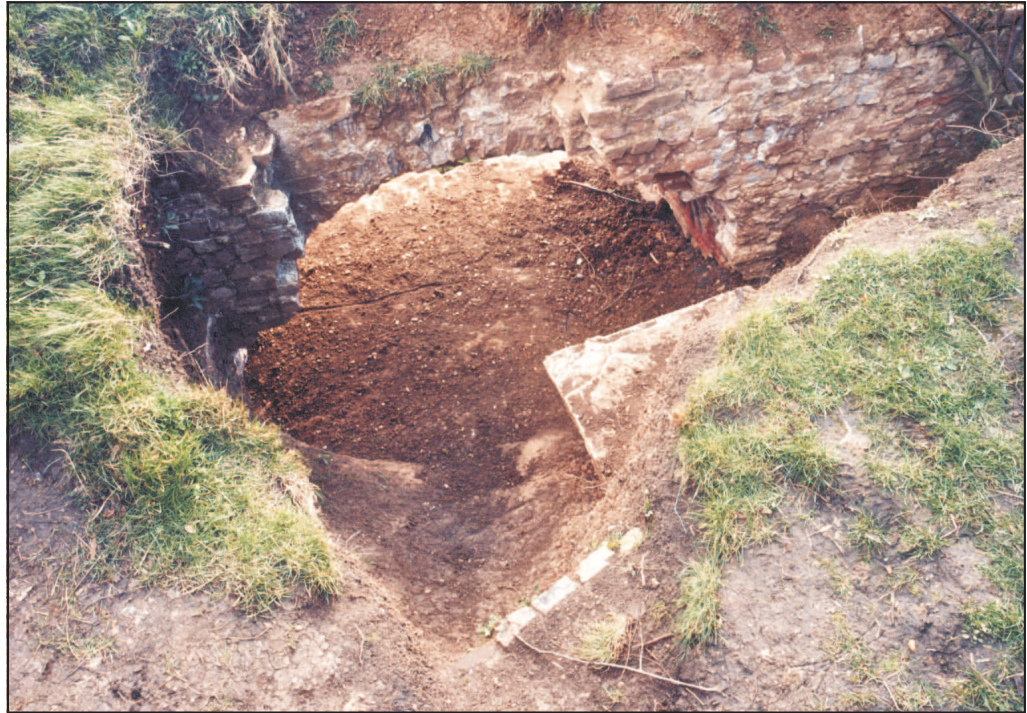
Figure 27
The rear face of a counterfort with a surviving stone of the gun floor in the west bastion (NMR: AA031332)

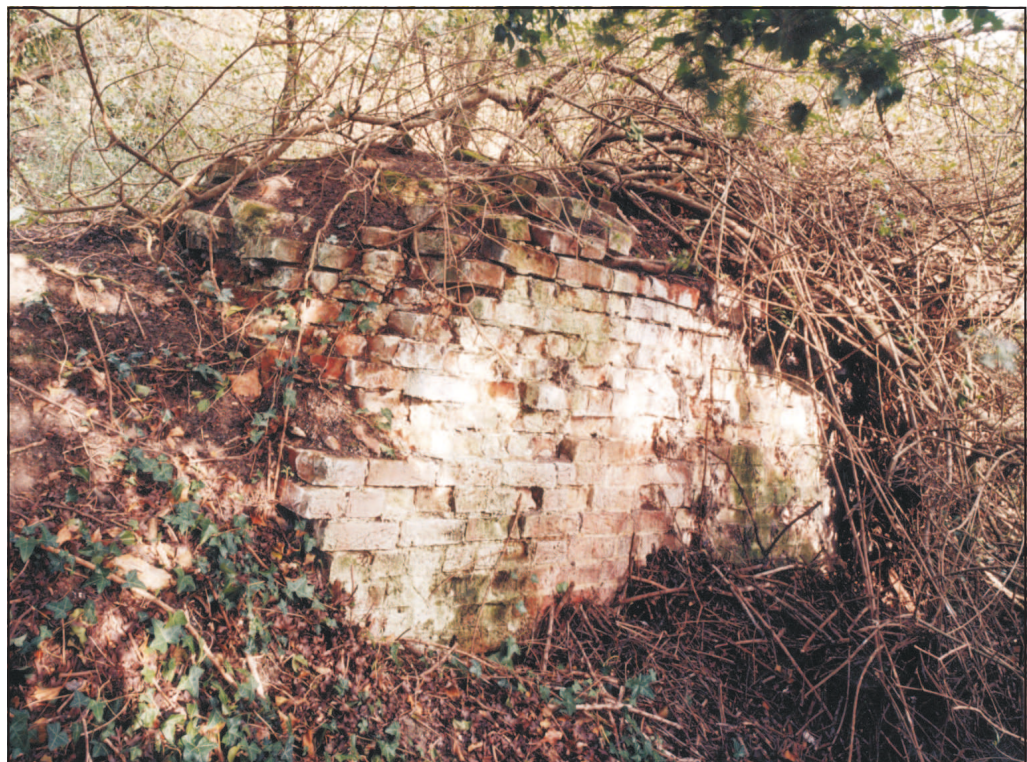
Behind the revetment, it is likely that much of the *terreplein* survives below ground, partly covered by eroded material from above, encouraged by the collapse of the rear revetment wall. An erosion scar at **a**, has revealed two in-situ flagstones from the gun floor of the west bastion, now covered by 0.8m of soil (Fig 27). A bank along the back of the revetment at **b**, is likely to be part of the rampart behind. Two sections of wall, at **c** and **d** are the remains of the rear revetment wall, although only **d** appears to be in-situ, suggesting a wall 1.3m thick that was whitewashed on its southern face (Fig 28).

Figure 28
A section of the rear revetment wall of the lower gun line (NMR: AA031334)
