Archaeological Investigation Report Series
AI/23/2002

Dowsborough Camp,
Holford, Somerset

SURVEY REPORT

Dowsborough Camp, Holford, Somerset
An archaeological survey by English Heritage

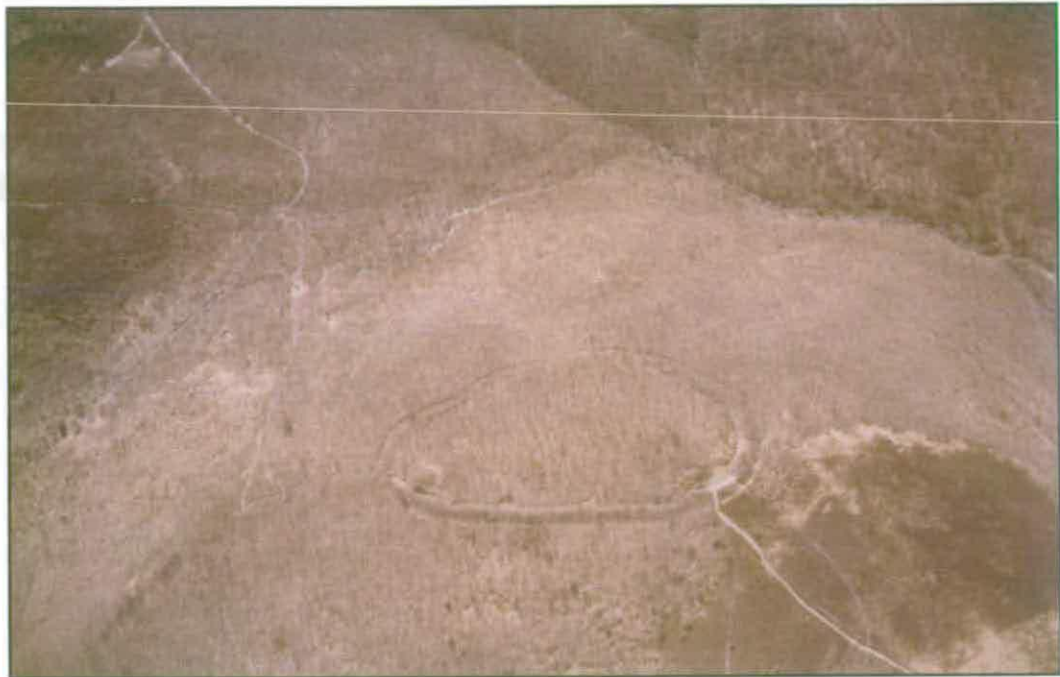
Fig. 2. Air photograph of Dowsborough Hill looking south. NMR 21136/02. © Copyright English Heritage.

Dowsborough Camp lies towards the eastern edge of the Quantock Hills AONB, centred at ST 160 391. It encloses the summit of a domed hill, one of the most distinctive topographical features of this part of the commons. The site occupies one of the highest parts of the Quantock Hills, at an altitude of over 330m OD. The hill falls away steeply on all sides. The head of Holford Combe lies to the west and south, with Bincombe to the south-east. The northern and eastern sides form part of the eastern escarpment of the Quantock Hills. The hill is covered for the most part in coppiced sessile oak. A clear area on the north-western edge of the site affords views across the Bristol Channel to Wales. Before the woods were planted there would have been

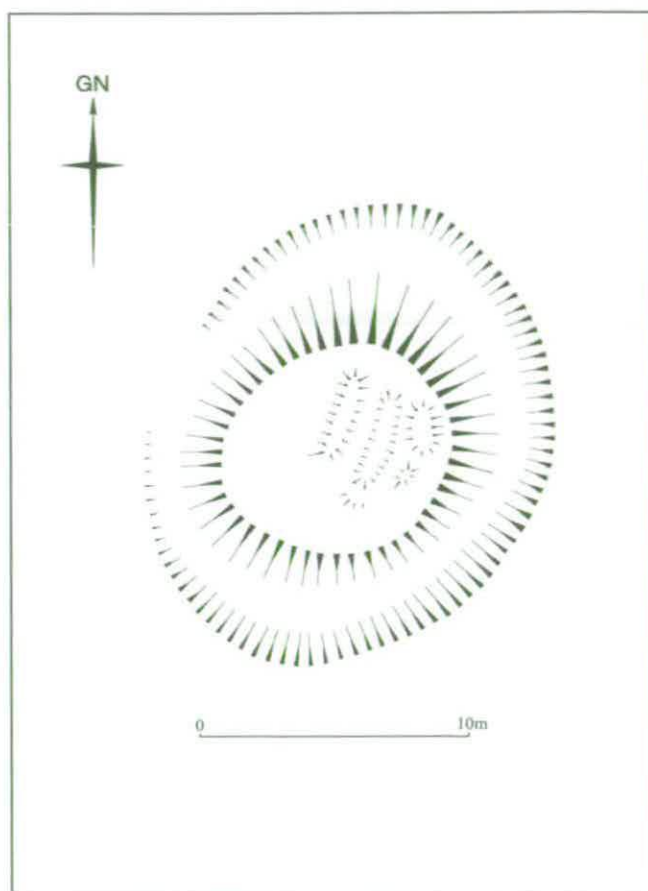
Fig. 4. The barrow in the north-western corner of Dowsborough Camp: English Heritage 1:200 scale earthwork plan (reduced).

THE BARROW (Fig 4)

The earliest archaeological feature to survive on the hill is a large Bronze Age barrow in the north-western corner of the hillfort, at ST 1590 3915. It is a roughly circular, flat-topped mound, with an encircling ditch. The mound measures 12m in diameter and stands some 1.1m high. Some scrub oak has recently been cleared from the mound. The ditch is 1m wide at its base and 0.7m deep, and is well-defined, apart from on the western edge where a track encroaches on it. The southern part of the ditch is particularly sharp and has the appearance of being relatively recently re-cut or cleaned out. The top of the barrow has a small rectangular hollow in it, measuring some 4m x 0.6m and 0.2m deep, with associated stony mounds of spoil. The sharp appearance of this hollow suggests a recent origin, rather than antiquarian excavation. It could be associated with the use of the hillfort and its environs in the Second World War (below). A small slit trench lies just to the east of the barrow.

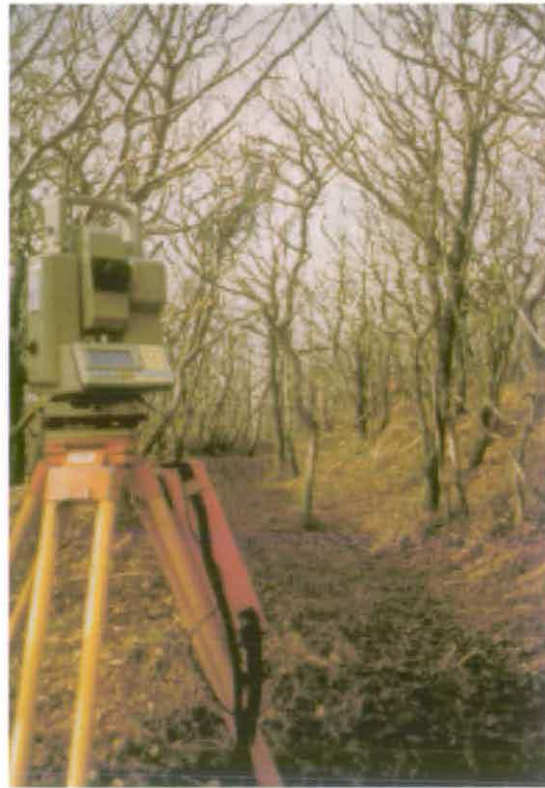
Fig. 7. Dowsborough Camp: surveying the earthworks.

The earthwork survey was undertaken by the Exeter Office of English Heritage, as part of the archaeological survey of the Quantock Hills AONB. The survey was begun in September 2001, in order to record the position of consolidation work carried out on the northern ramparts by Somerset County Council and English Heritage. The survey work was completed in January 2002. The earthwork detail was recorded using a Leica 1610 total station theodolite and completed in the field using graphical methods (Fig 7). The site was located to the National Grid (OSGB36) using Leica single frequency differential GPS (Global Positioning System) equipment.
