# FRAMLINGHAM CASTLE

# SURVEY REPORT

**FRAMLINGHAM CASTLE,  
FRAMLINGHAM, SUFFOLK**

ARCHAEOLOGICAL INVESTIGATION REPORT SERIES 24/2002

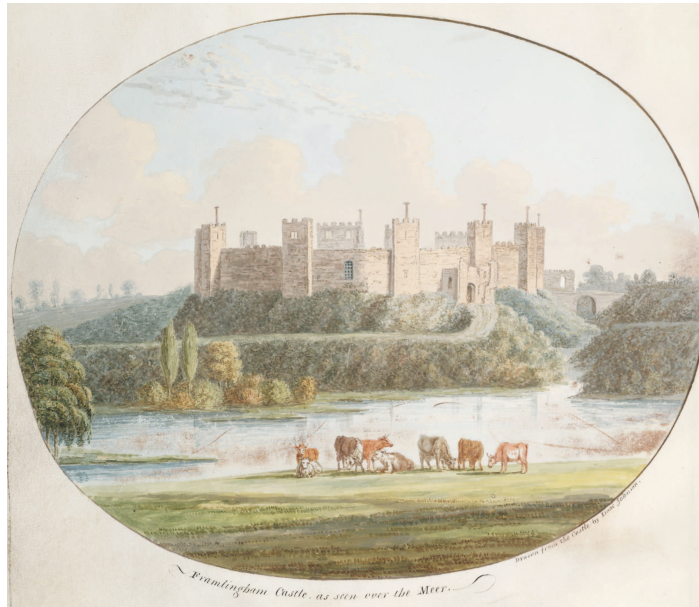
**Figure 10**

*A view of Framlingham Castle across the Mere in 1790, by Isaac Johnson. This romantic view of the castle has always been popular and remains so today. (Pembroke College MS Ltheta, reproduced by permission of the Master and Fellows of Pembroke College, Cambridge)*

121). This view, often repeated, shows the earthworks much as they appear today but covered with thick low vegetation and portraying a romanticised view of the castle, as shown in this view by Isaac Johnson dated 1789-90 (Figure 10; British Museum Maps K. Top. 39.17.b.1).

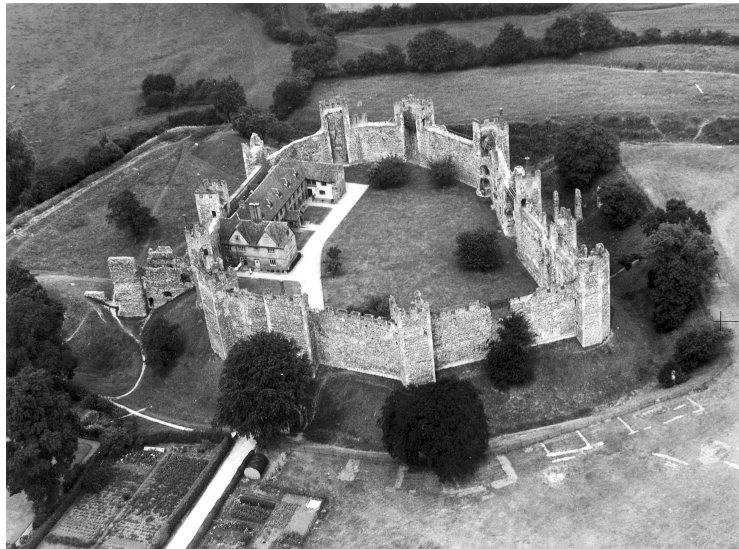
**Figure 15**  
*An aerial photograph of Framlingham Castle clearly illustrating the relationship between the curtain and the surrounding earthworks (EH Historic Plans Collection A397/9)*

occupies the whole of the platform (Figure 14). The wall is on average 10.5m high by 2.3m thick, with thirteen projecting mural towers (Figure 15). It is constructed mainly from roughly-coursed stonework, with sandstone ashlar quoins at all corners and salient points, though the fabric has innumerable patches and repairs of various dates. It has been suggested that the projecting south-eastern corner was to accommodate a square keep tower, although there is no evidence that such a tower ever existed (Renn 1976, 61). The mural towers, which are generally 3.8m higher than the main wall walk, were mostly open to the rear, and did not provide any form of accommodation (Figure 16). Access to the bailey is provided across a **bridge (1)** on the southern side of the castle, rebuilt between 1524 and 1547 (Figure 17; Knocker 1958, 66).

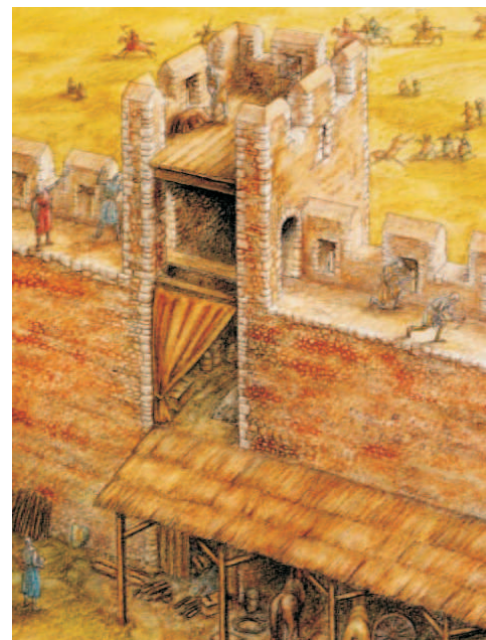
**Figure 16**  
*An interpretation of how the mural towers looked and operated, with removeable sections across the open-backed towers to isolate parts of the wall walk in the event of capture by an enemy (English Heritage 1988)*

The wall incorporates a continuous wall walk with crenellated battlements and arrowslits, supplemented by similar arrangements at the top of each tower. Access across the open-backed towers was probably provided by wooden planks

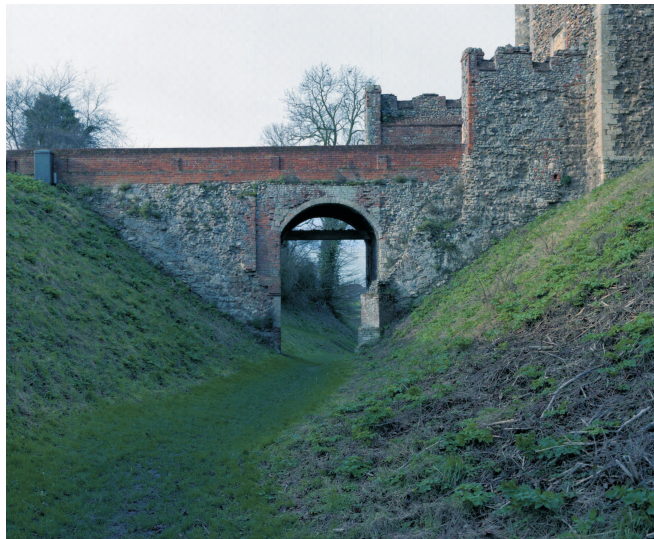
**Figure 17**  
*The main bridge  
from the bailey to  
the Inner Ward,  
probably rebuilt  
between 1524 and  
1547 (NMR:  
AA028420)*

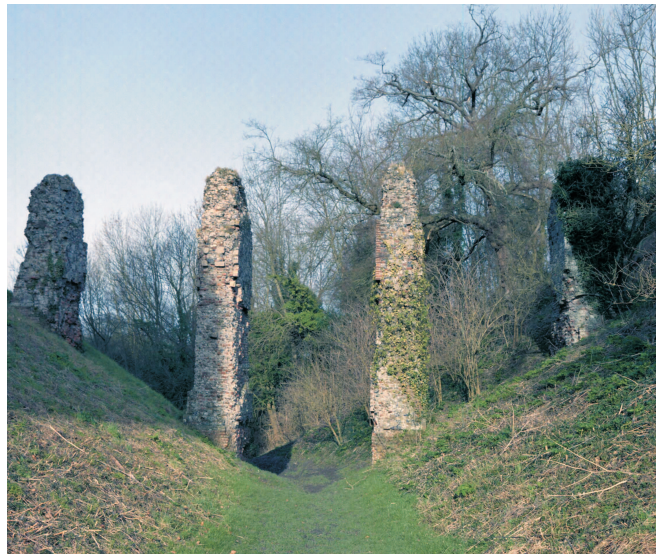
**Figure 19**  
*The brick-and-flint piers of the late 15<sup>th</sup>/early 16<sup>th</sup>-century bridge which provided direct access from the Inner Ward to the northern part of the bailey (NMR: AA028419)*

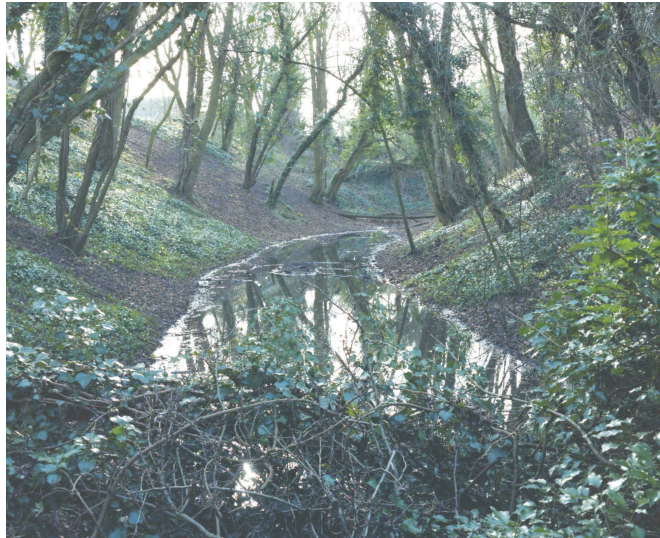
**Figure 22**  
*The bailey ditch,  
now partly  
waterlogged. Note  
the vegetation  
cover which has  
appeared since the  
Second World War  
(NMR: AA028417)*

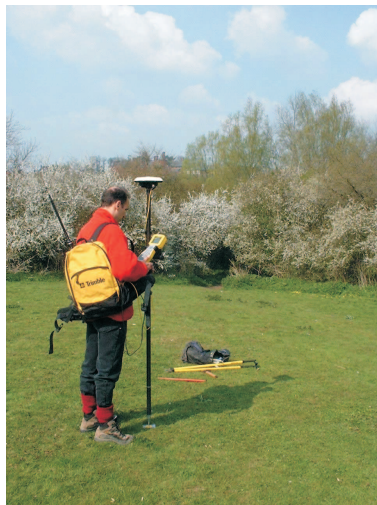
**Station 3**  
*view from the east*

At the western end of the Back Meadow, roughly 20m from the gap in vegetation leading to a small wooden bridge across a N-S running field drain. *NB No measurements are provided because there are no hard features to lock onto.*

Eastings	Northings	Height
628673.740	263838.888	35.675

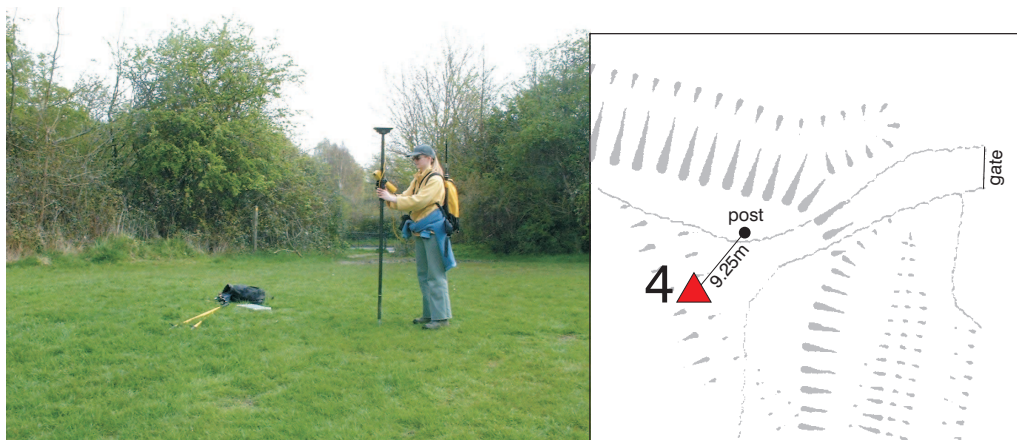
**Station 4**  
*view from the west  
and measurements  
for locating the  
station*

In the north-east corner of Back Meadow, in the gap between the northern and eastern sections of the Town Ditch, on the bank/headland.

Eastings	Northings	Height
628837.051	263768.748	46.965

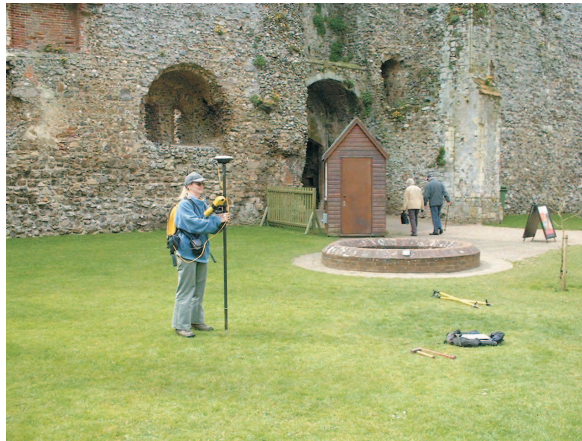
**Station 7**  
*view from the east  
and measurements  
for locating the  
station*

Within the Inner Ward of the castle, west of the well.

Eastings	Northings	Height
628673.573	263700.500	45.044
