SURVEY REPORT

**LONG LOW BANK BARROW,
ILAM, STAFFORDSHIRE**

ARCHAEOLOGICAL INVESTIGATION REPORT SERIES 41/2002

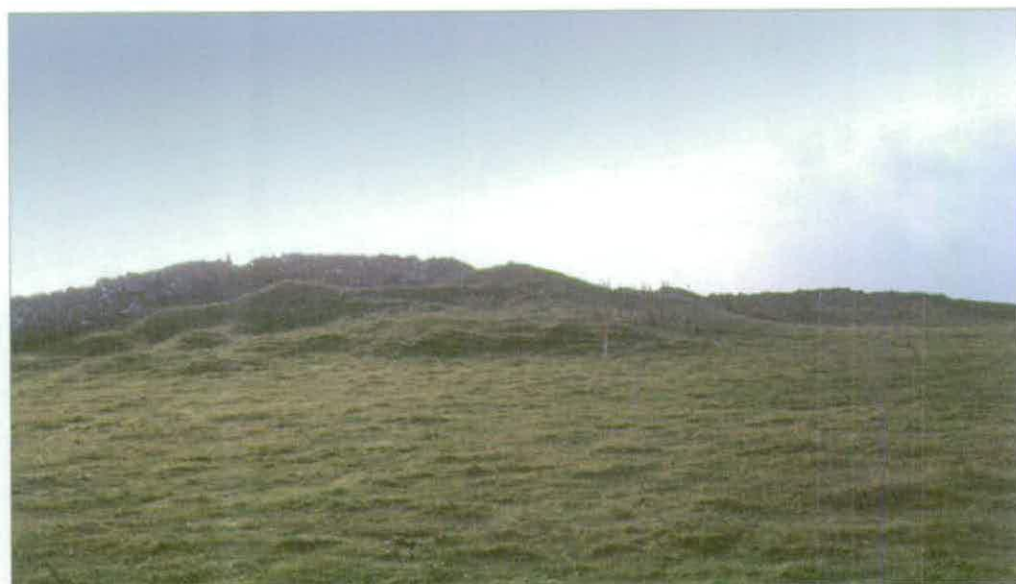
Plate 1:
View of the north-eastern terminal of the bank barrow from the north. The mounded nature of this terminal shows clearly as do the surface mutilations.

The mound rises to a height of 2.5m above ground level (fig. 6, 'E-F'; Plate 1) and although the summit has been heavily disturbed it is likely to have been in the order of 15m in diameter originally. A slight step in the mound profile on the south (at its intersection with the bank barrow) mirrors the levelling off associated with the suggested looped forecourt and may point to a heightening of the mound at some stage, possibly with material derived from the shaft sinking or mining waste – the profile steepens above the break in slope.

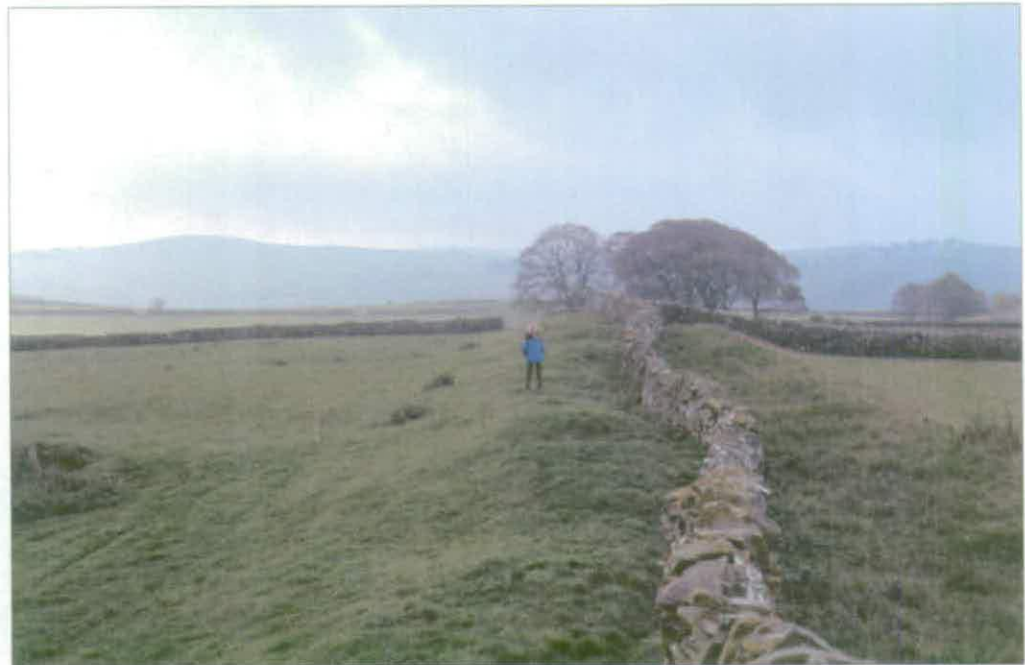
Plate 2:
*View looking south-west
along the line of the
Bank barrow. The
pitted surface, the result
of stone robbing, can be
seen clearly.*

A broad spread bank extends to the south-west of the cairn for a distance of at least 166m (Plate 2). It is a largely uniform structure but with a bulbous southern terminal. Its chronological relationship with the northern cairn is ill-defined due to the effects of later damage and digging. The elongated bank follows a generally straight course on an axis of 40° to the east of north though a slight deviation to this line can be seen *c* 45m from the southern terminal. This alteration in its course may, however, result from the encroachment of cultivation at some stage. In cross-section the linear mound can be seen to be broad based with a flattened top—the crest has, however, been extensively mutilated during the episodes of stone-robbing (fig. 6, 'C-D'). The basal width of the mound varies between 18.5m and 13.0m and the larger dimensions are noted close to its connection with the round barrow. The mound survives to a height varying between 1.2m and 1.8m along the western flank but its carefully chosen position, at the break of slope on the eastern side of a knoll, ensures that the ground drops off sharply along this side.

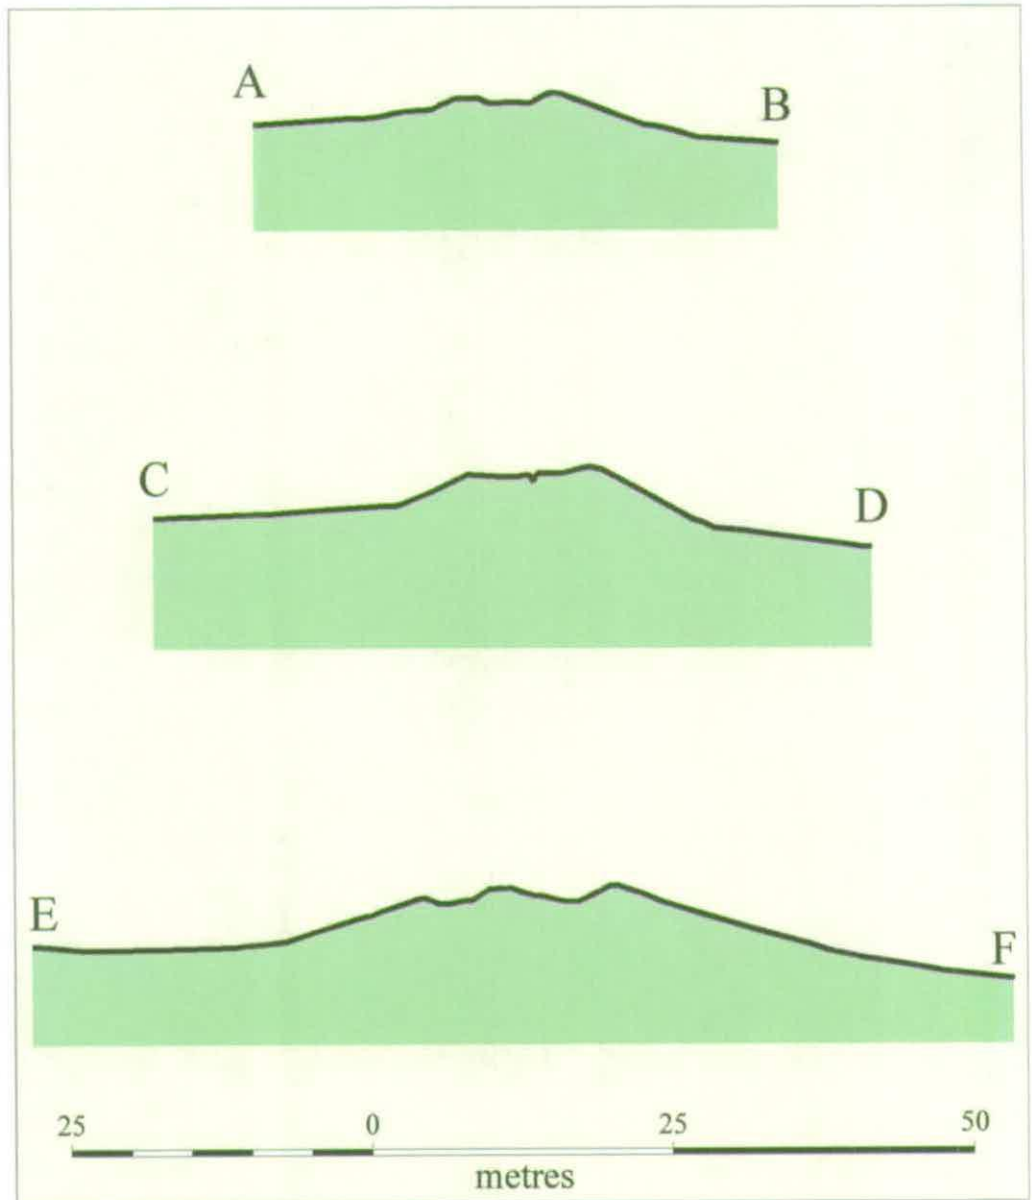
Figure 6:
Sections across the monument - South-western terminal (A-B); central portion of the linear bank (C-D); and the north-eastern barrow (E-F).

This mound is located at the southern terminal of the bank barrow and has long been recognised as a separate component superimposed upon an earlier linear mound (fig. 6, 'A-B'; Plate 3). Carrington provides the earliest mention of this barrow and its integrity has been confirmed by every commentator since then. The southern end of the bank barrow lies at a lower altitude than the northern end and there is a drop-off of nearly 3.5m from north to south along the line of the monument. Therefore, the southern end presents itself as a much less prominent section of the earthwork. Nonetheless, it does stand proud and lateral views of the mound do emphasise the peaked nature of either terminal. In terms of scale and monumentality, however, the southern mound does not match its northern neighbour and stands, at best, to a height of 1.6m above ground level. The slope down to the bank barrow is very slight indeed with a step 0.3m high marking their elision. The mound is very clearly later than the elongated section of the barrow and there are hints that it also overlies the disturbance left after the episodes of stone-robbing. If so, this would certainly cast some doubt on the antiquity of the terminal mound. It is circular in outline with a basal diameter of c 18m and the flat-topped, heavily disturbed, summit reaches a maximum diameter of 7m. A well defined ledge 1m wide and 1m above the base is apparent around the majority of the circumference of the mound but is absent on that sector which connects with the linear mound. The gradient of the barrow lessens somewhat below the ledge and this suggests that either it owes its origin to the encroachment of ploughing or that it has been rebuilt at some stage. A small rectangular water tank now occupies the summit of the mound and this has been placed here, presumably, to take advantage of this section of raised ground. It may be suggested that the construction of a small reservoir here required the further enhancement of the ground at this point but it is certain that the mound existed before the tank was installed as it lies

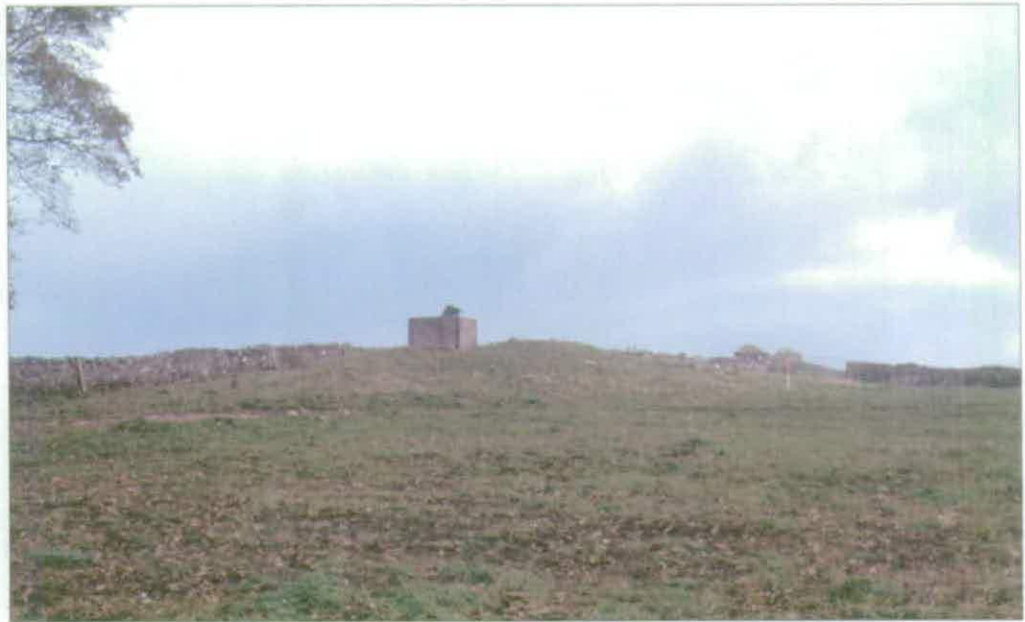
Plate 3:
View of the south-western terminal of the bank barrow from the south.
