Norham Castle, Northumberland

SURVEY REPORT

Archaeological Investigation Report Series AI/25/2002

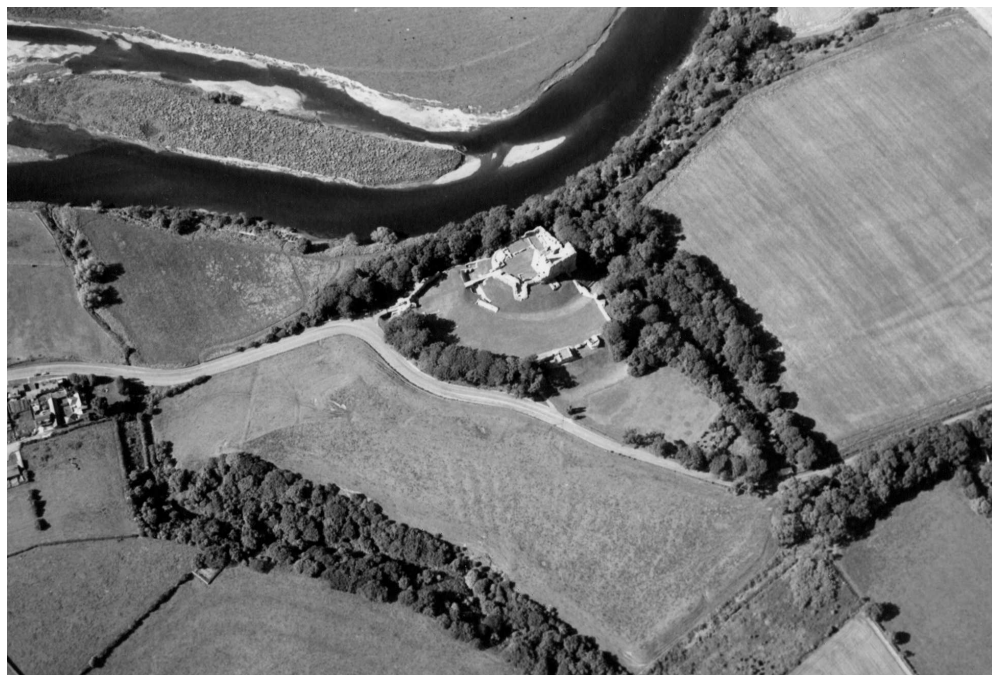
*Figure 3.
Aerial photograph
showing the castle from
the south-east
(reproduced by
permission of Tim Gates)*

2. GEOLOGY, TOPOGRAPHY AND LAND USE (Figures 3-5)

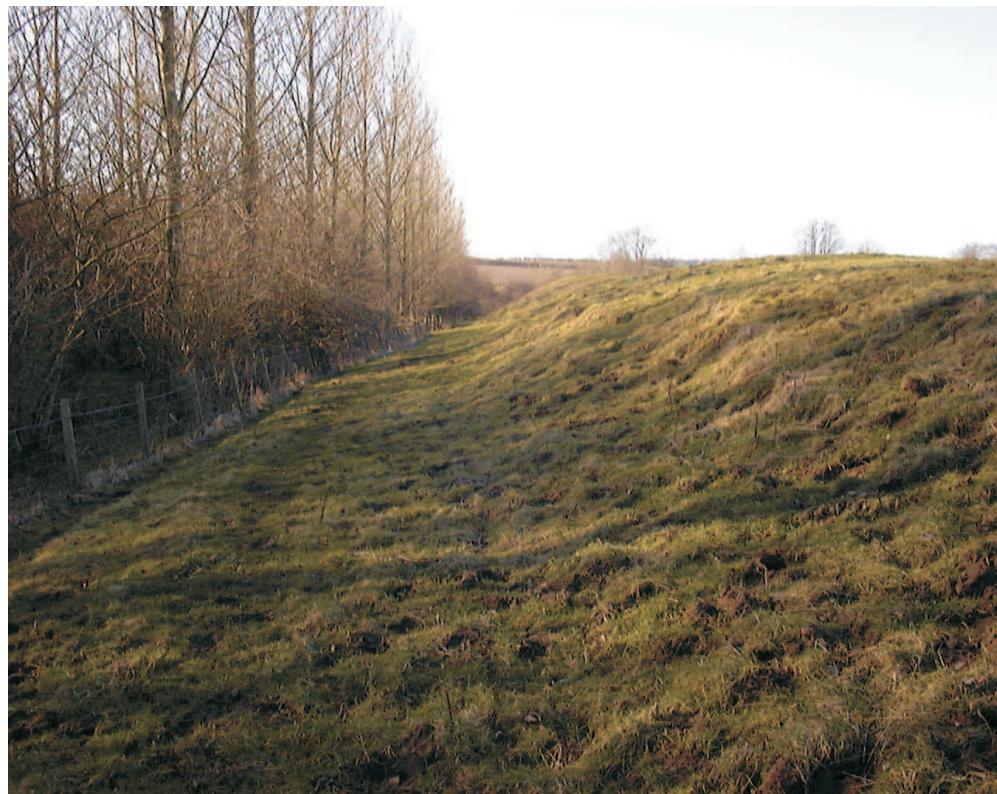
*Figure 13.
The pre-medieval
rampart viewed
from the
north-east*

The results of the field investigation indicate that the medieval castle occupies the site of an earlier fortification of which the most obvious surviving element is the 130m-long stretch of rampart on the east side of the field to the south of the road (1). This is not the first time that a pre-medieval date has been suggested for the earthwork, as over a century ago Clark suggested it indicated a Roman fort, however there is no field evidence to support this particular date (Clark 1876, 309).

The rampart south of the modern road is a substantial upcast bank up to 2.5m high and 18m wide aligned along the crest of the south-east valley, with an additional 1m-2m height externally gained by cutting back the underlying natural slope. Several slight parallel steps in the outer face of the rampart are not constructional, but have been caused by slippage. However they mask any clear surface indication of the junction between the upcast bank and the lower, cut slope. The rampart declines in prominence northwards as the natural slope below the bank fades away. About half way along its length, the rampart is cut by a 5m wide gap (3) which is not an original entrance, but a later opening, possibly connected with opening up a view of the castle for visitors in the 19th century. The section of rampart to the south of this opening appears to have suffered relatively little disturbance and has a rounded terminal at the south on the edge of the slope down to the Mill Burn. The existence of this terminal establishes that the rampart did not turn to the west to run along the edge of the Mill Burn valley. This might otherwise have been difficult to prove because of losses to the south side of the promontory caused by the erosion and slumping of the valley side.

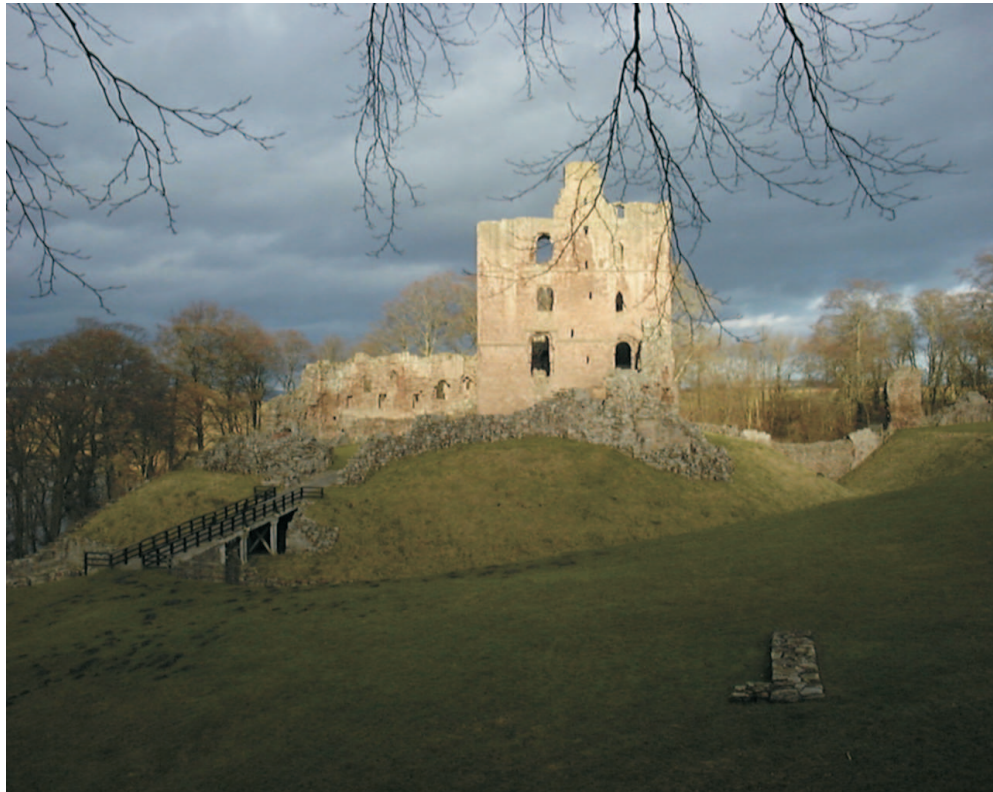
*Figure 14.
The inner
bailey viewed
from the
south-east*

The inner bailey is on the north-east corner of the promontory and is defined by a deep, curving ditch on the west and south and by steep, natural slopes on the other two sides which have been artificially steepened to make an oval-shaped perimeter. The area enclosed by the curtain wall amounts to some 0.26ha (0.64 acres). The keep is situated at the south-east corner and there is a single entrance on the west side. The inner bailey was almost certainly laid out as part of the first documented phase of castle construction in 1121 in order to protect Bishop Flambard's stone ceremonial hall, and his private chambers are believed to have been to the north where now only

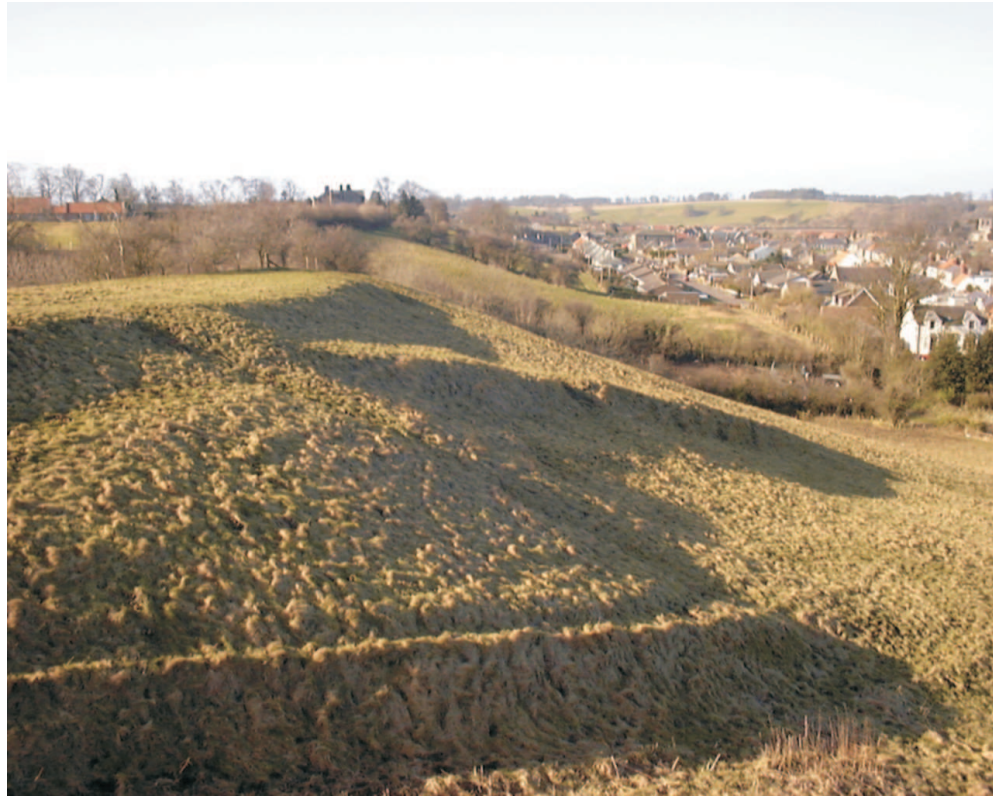
*Figure 16.
The two triangular
emplacements on the
west escarpment
viewed from the
north-east*

To the south, on the opposite side of the hollow way, are two triangular-shaped enclosures, regularly laid out with their longer sides aligned along the crest of the escarpment and with straight sides running obliquely down the slope. The regularity of their plan, and the fact that they are laid out on quite steeply sloping ground, means they can be dismissed as livestock enclosures. Their shape, and topographic location instead points to a military origin, their prominent scarp-edge position giving them a commanding view westwards over Norham town and northwards across the approach

to the castle. There is nothing in the interior of either enclosure to indicate how they were used, but the gradient of the slope precludes their use by artillery. Most likely is that they were for the protection of infantry.

The second emplacement, immediately to the south-west (33), is similarly defined by a continuous flat-topped bank and is about three times the size of the first. It may have been constructed after the first emplacement as its east apex clearly overlies the perimeter of its neighbour. The bank is curved around two of the points of the triangle but on the south continues on straight for another 10m to the top of the slope overlooking the Mill Burn, presumably in order to complete the defence of the escarpment. The banks around the emplacement are too low to have afforded any protection and therefore were presumably surmounted by a wooden stockade which has left no visible remains. On the interior, there are slight traces of a quarry scarp on the west side to provide material for the adjacent bank but other slight scarps are likely to be natural in origin. To the north, the west side of the emplacement continues down the slope as a prominent west-facing scarp with a slight ditch and counterscarp bank on the outside (20). This continuation was probably not part of the fortifications but may have been added much later to demarcate the parish boundary
