Ring Chesters, Northumberland: an Iron Age hillfort and its environs

SURVEY REPORT

Archaeological Investigation Report Series AI/3/2002

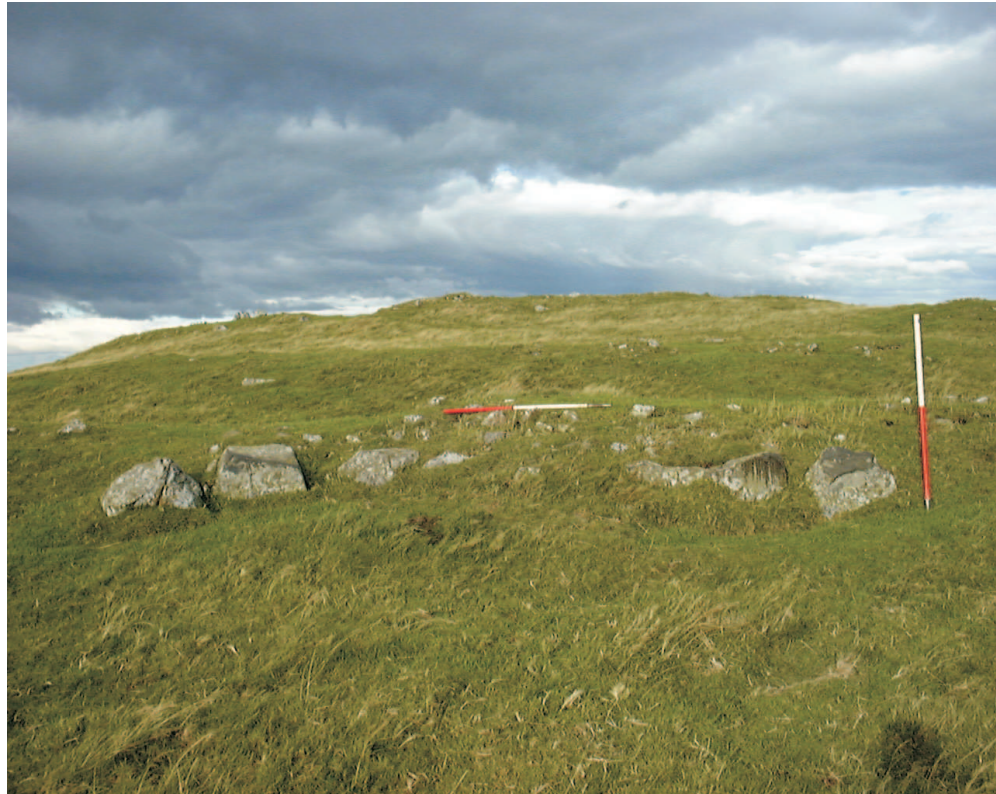
*Figure 9.
View northwards
towards
facing stones
at the southern tip
of the
outermost circuit*

banks; at two points, erosion has exposed two courses of smaller stones, but there is no evidence that such coursing was extensive. Some of the largest stones were used at the southern tip of the outermost circuit (Figure 9). This may be accounted for either by the greater vulnerability of this stretch of the defences (which runs across the tail of the knoll and does not make best use of the topography) or simply by the proximity of the small-scale quarries which were probably the source of the blocks. The facing stones define the original breadth of the earthworks, indicating that the banks were once about 2m narrower. In both cases, the facing stones seem to have formed a low revetment retaining the outer foot of the bank, rather than representing the remnant of an actual coursed wall. Seen from the exterior, the ramparts appear impressively massive, with external faces up to 1.2m high, but this belies the fact that both earthworks are for the most part formed by a slight enhancement of the naturally

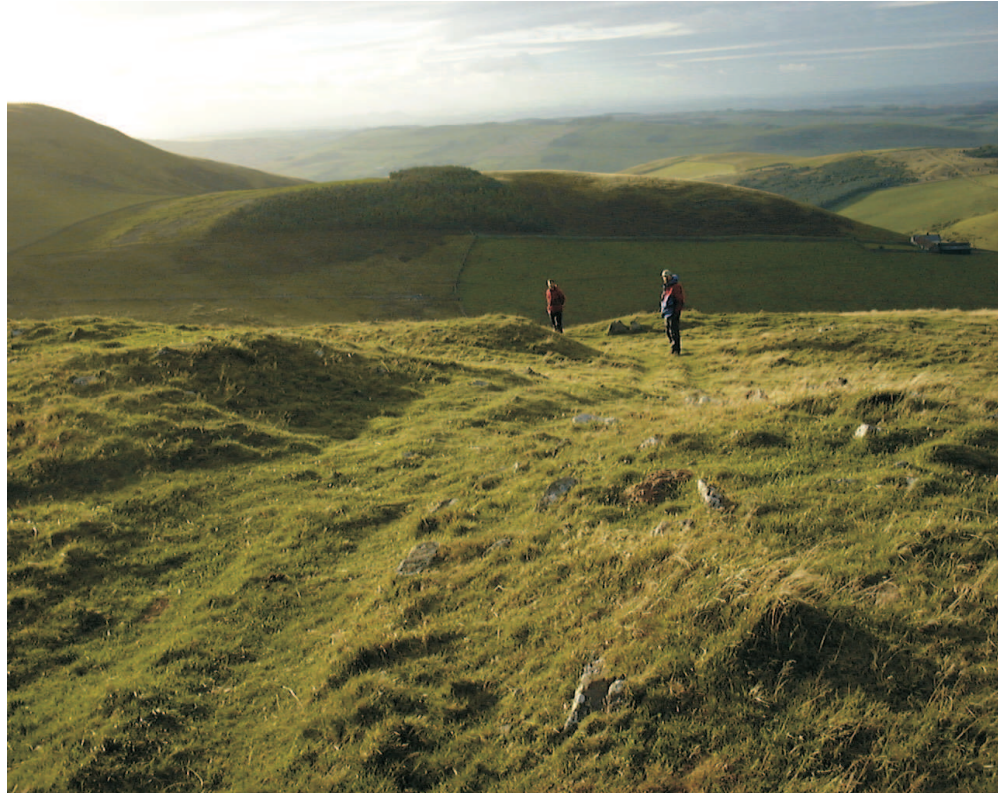
*Figure 10.
View westwards
towards the
north-western
entrance (A),
seen from the
entrance into the
stone-built
circuit (C)*

What seems to have been the more important of the two original entrances through the circuits, labelled A on Figure 7, is located on the north-western side of the hillfort (Figure 10). It has been regarded by most previous investigators as a 'minor' entrance and was apparently dismissed by George Jobey as being entirely the product of later damage (see Figure 4). To a large degree, this conclusion follows from the acceptance that all three ramparts were built in a single constructional episode and the recognition of the more conspicuous south-eastern entrance (labelled B). However, the English Heritage investigation suggests that, contrary to Jobey's suggestion, there is conclusive evidence in the form of entrance A itself that it is original and that it was probably the more important of the two. Firstly, the terminals on either side of the gaps in both circuits are off-set from each other by about 2m. This slight but distinct mismatch, which is not apparent on Jobey's own survey, clearly indicates that the gaps are original rather than later breaches. Secondly, there is an unusually high concentration of large facing stones on either side of the gaps in both circuits, many of which are still *in situ* or only slightly displaced, and the terminals of the banks flanking the gaps are slightly broader and higher, leaving an entrance passage only *c* 2m wide. Thirdly, the gap in the inner of the two circuits is some 5m further to the

north, producing a staggered approach. Lastly, the ditch/quarry hollow between the two ramparts appears to have terminated just short of the approach on both sides. These characteristics, which would have served to strengthen and emphasise the position of the narrow entrances, are typical of other Iron Age gateways.

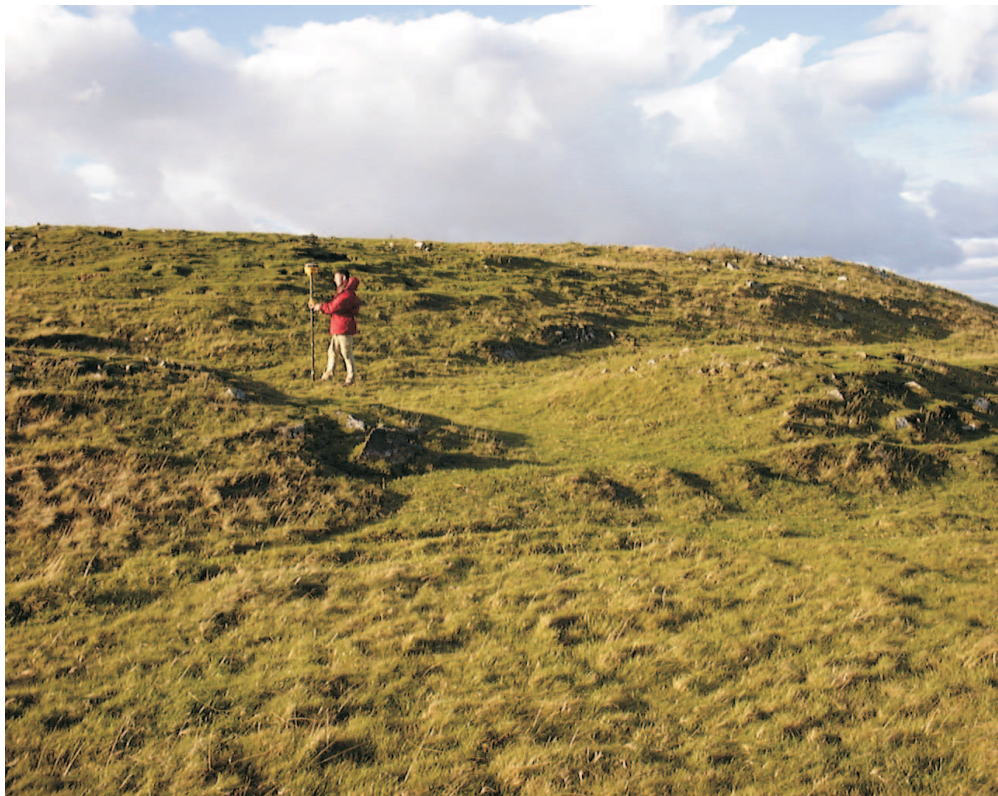
*Figure 11.
View
north-westwards
towards the
south-eastern
entrance (B)*

By contrast, while it seems highly probable that Entrance B is original, close examination casts doubt on the suggestion that it was the 'main entrance' and leaves slight uncertainty as to whether there may have been a more complex sequence of construction. The entrance in the outer circuit seems to have been less elaborate than that at A, with only a single small facing stone and no off-set at all between the terminals (Figure 11). At the very least, this relative lack of architectural elaboration tends to suggest that this was a less important entrance than that at A. In addition, the enlarged terminals of the bank on either side of the gap could be interpreted as the result of the deposition of spoil produced by the cutting of a breach in the bank, rather than as original features. On the other hand, the terminals of the bank of the inner of the pair of circuits were probably originally staggered by some 5m, implying that this was definitely an original entrance. Therefore, if this hypothesis is followed to its logical conclusion, the inner of the two circuits must have been added after the outer, with a south-eastern entrance that required the creation of a breach in the outer circuit. This proposal runs contrary to the fairly strong evidence put forward above that the two circuits are contemporary, so on balance it seems more likely that the entrance through the outer circuit at B was simply less elaborate than that at A. Finally, it should be noted that the original form of the entrance through the inner circuit was modified, apparently in the Romano-British period. This involved the foreshortening of the southern terminal by several metres and the addition of a bank connecting the truncated terminal to outermost circuit; the original extent of the rampart can just be discerned as a slight scarp. The superimposed bank cannot be interpreted as the remnant of a structure contemporary with the original gateway as suggested by Caroline Hardie (English Heritage 1994a).

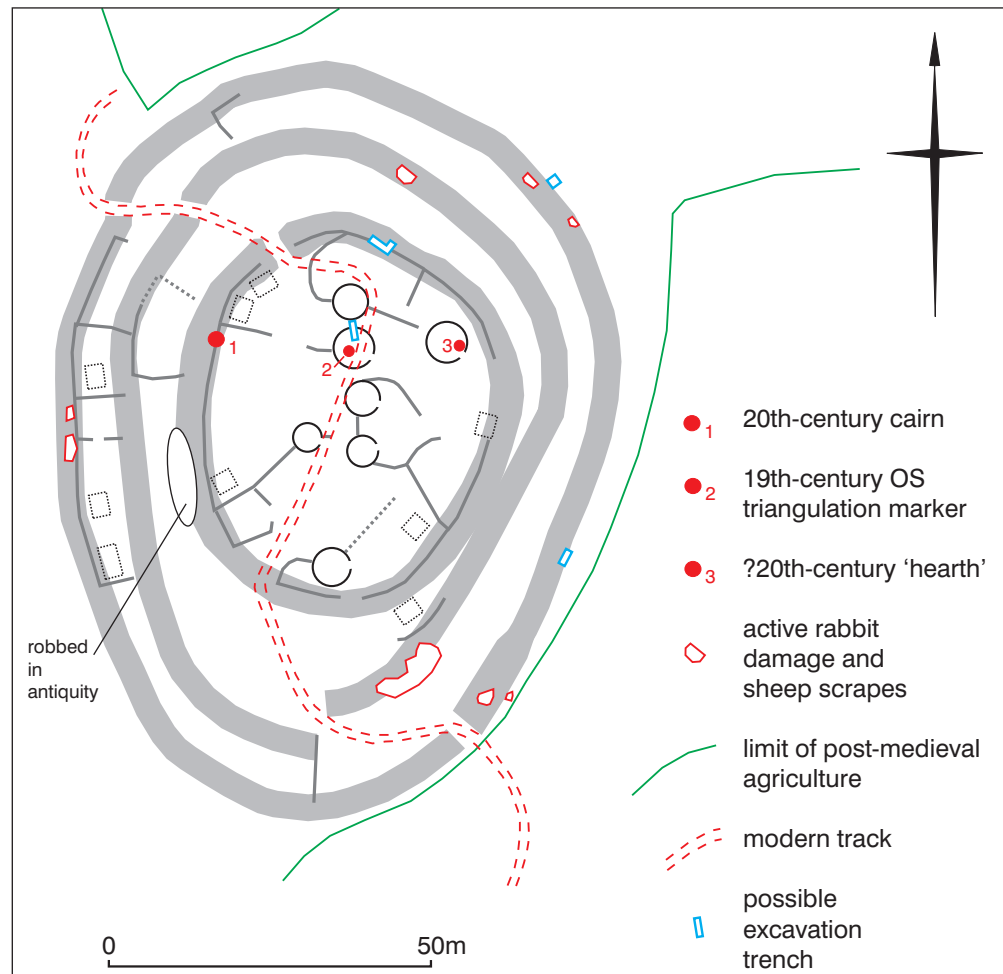
*Figure 12.
Location of
excavation trenches
and other features*

A shallow L-shaped cutting was recorded on the north-east of the circuit (see Figures 7 and 12). This cannot easily be dismissed as merely erosion caused by livestock, for it is straight-sided and regular, as though deliberately dug. The cutting is aligned so that its longer arm extends along the central line of the rubble bank and the shorter arm extends outwards at right angles towards the outer face. As with the two possible examples on the outer bank of the bivallate fort, it is not inconceivable that this cutting is the outcome of small-scale archaeological excavations, although no excavations have been documented. The form and arrangement of the trench does not seem to have been intended to examine the stone-built rampart itself (a section dug at right angles to the rampart would be standard practice for this). Rather, the trench may have been intended to investigate a stretch of the ground surface beneath the rampart, possibly to search for traces of a palisade.

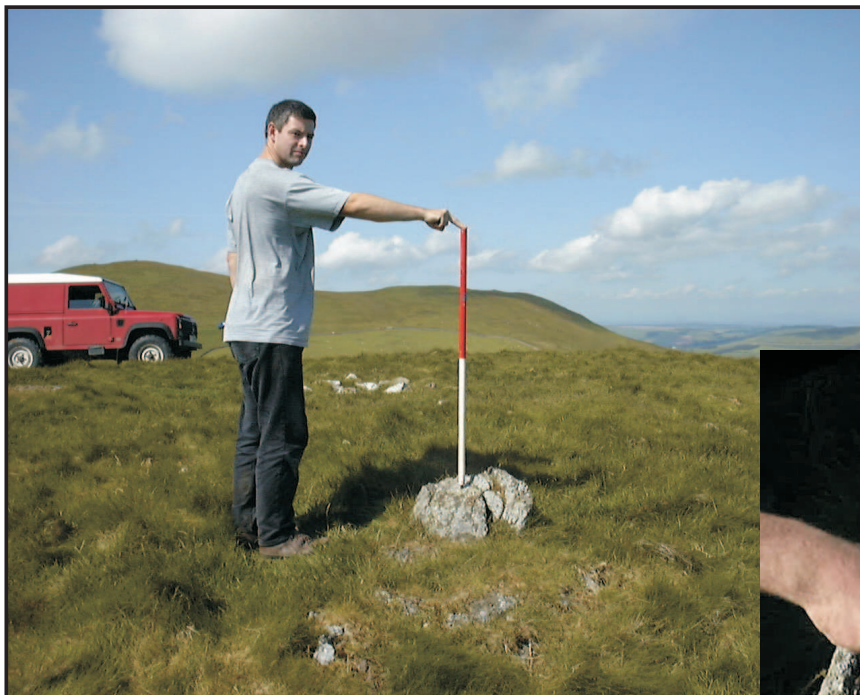
SITE NAME	Ring Chesters hillfort, Northumberland		
Station number	ST 01	Status	Permanent
Type of Mark	Brass rivet in rock outcrop	NMR number	NT 82 NE 24
Date of Survey	20-NOV-2001	RSM number	24575
Office of origin	York	Surveyors	AO; TP; SA
OS National Grid	Eastings	Northings	Height
	386713.863	628920.161	341.390

view from east

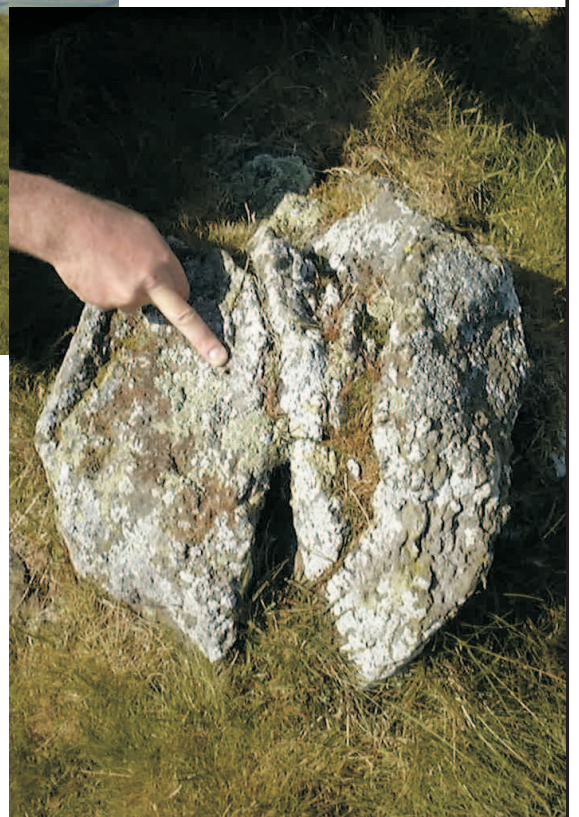
position of rivet

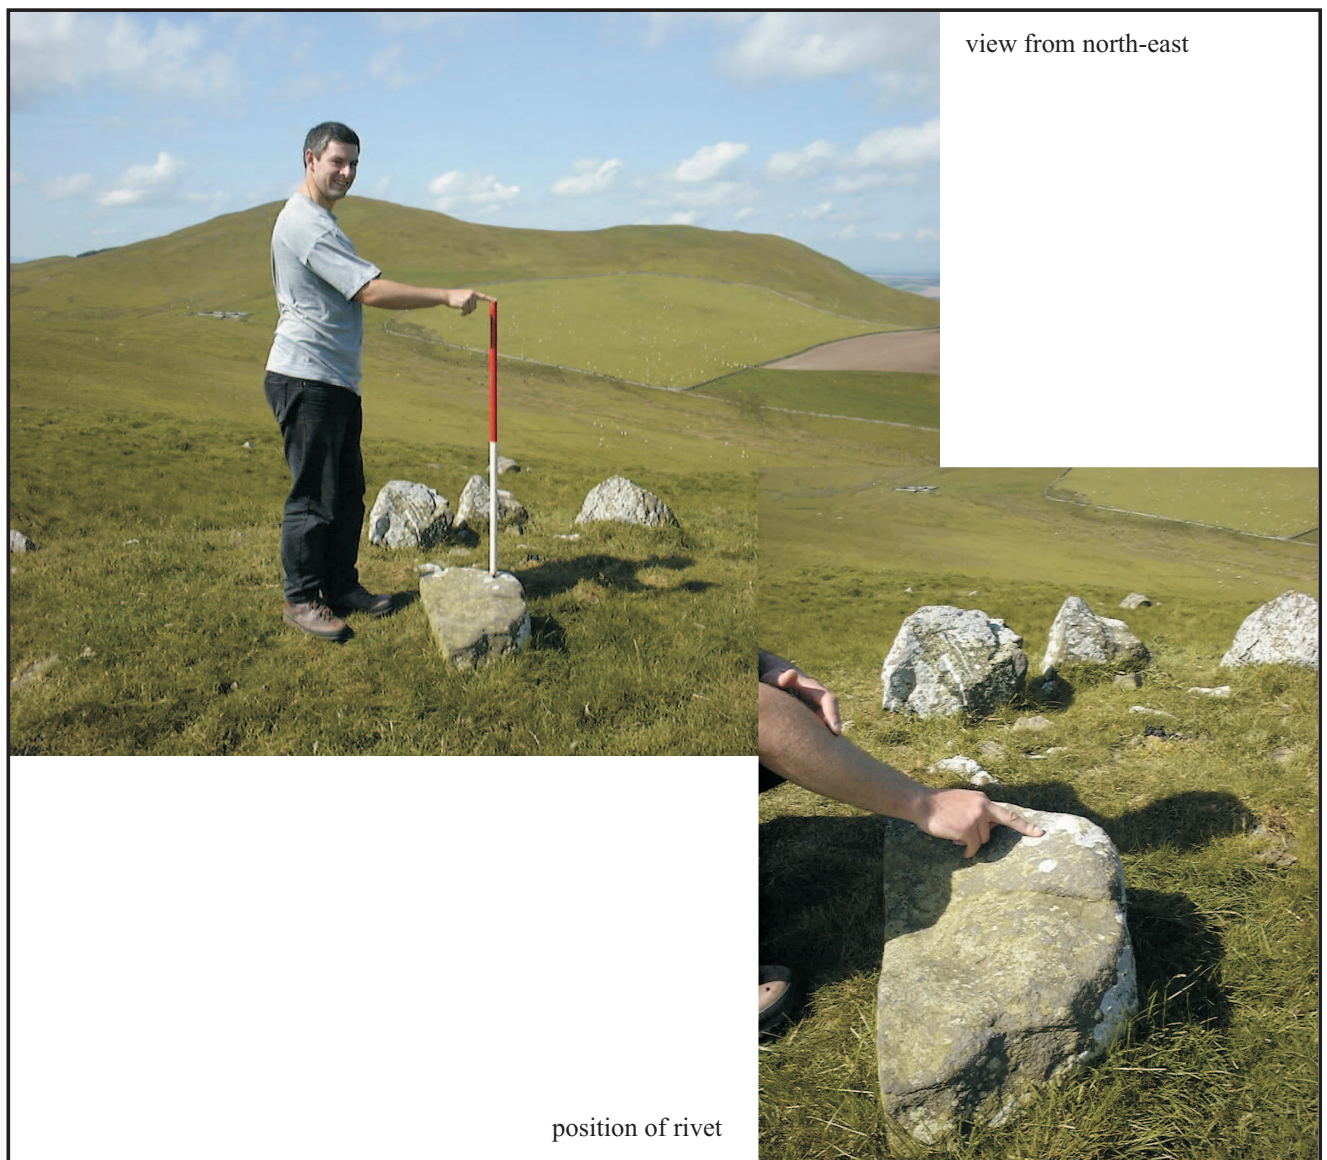
SITE NAME	Ring Chesters hillfort, Northumberland		
Station number	ST 02	Status	Permanent
Type of Mark	Brass rivet in large boulder	NMR number	NT 82 NE 24
Date of Survey	20-NOV-2001	RSM number	24575
Office of origin	York	Surveyors	AO; TP; SA
OS National Grid	Eastings	Northings	Height
	386692.258	628886.232	340.731
