An Iron Age hillfort at Glead's Cleugh, Northumberland

SURVEY REPORT

Archaeological Investigation Report Series AI/9/2001

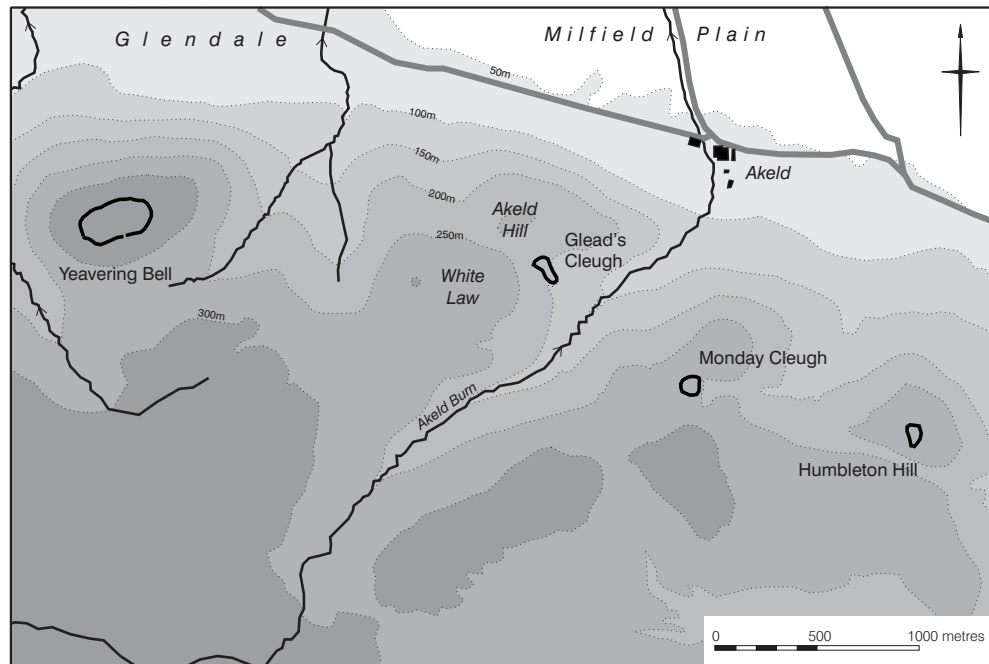
Figure 4.
The environs of
the site showing
neighbouring
hillforts

No other hillforts are clearly visible from the promontory (Figure 4) although that at Monday Cleugh is less than 1km to the south-east on the opposite side of the Akeld Valley, whilst Yeavinger Bell, the largest hillfort in the Cheviots, is 2kms to the west and hidden from view by the intervening summit of White Law. Around 200m to the east of the hillfort are the tumbled remains of several small rectangular buildings and associated paddocks with three or four cultivation terraces stretching westwards back towards the east ravine. These remains are all probably contemporary and of medieval or post-medieval date but the decision was taken not to extend the survey area eastwards to include them as they have no obvious association with the hillfort.

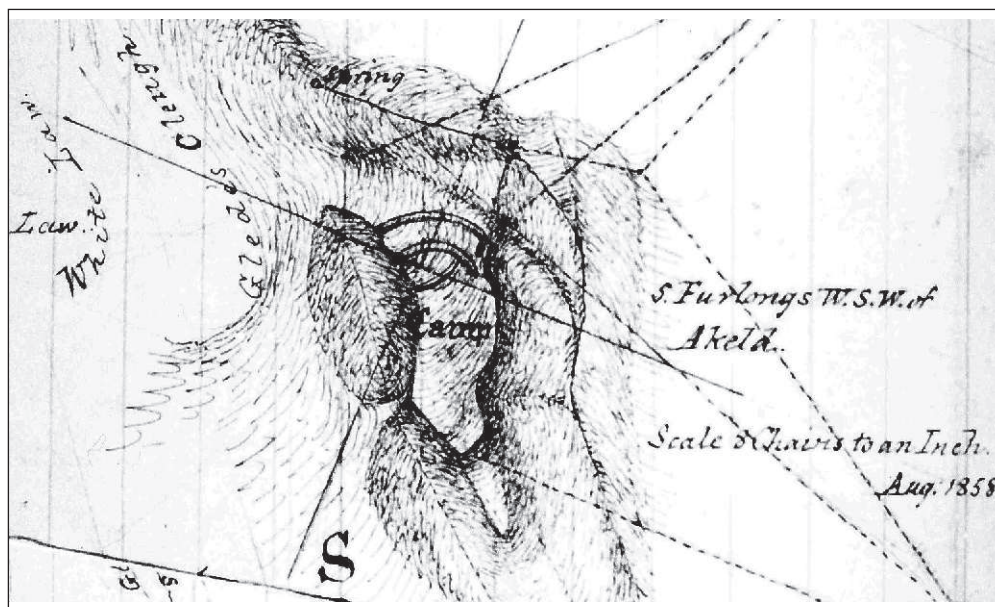
Figure 5.
MacLauchlan's
survey of 1858
(reproduced by
kind permission of
His Grace the Duke
of Northumberland)

The plan itself adds little to MacLauchlan's written account. He shows the middle and outer ramparts fairly accurately but wrongly depicts the inner rampart curving sharply northwards to join the rear of the middle rampart. Clearly he mistook the eastern, and most prominent, of a series of steps in the bottom of the inner rampart ditch for the actual rampart. In fact the inner rampart clearly curves southwards, although almost levelled flat. MacLauchlan appears to show a single continuous rampart around the remainder of the promontory despite the fact that, as the field survey has demonstrated, the breach on the south side and the large break on the east were definitely then in existence. MacLauchlan speculates that the hillfort is not as ancient as the neighbouring sites of Yeavinger Bell and Humbleton Hill because 'their construction is different'. He does not elaborate on this observation so it is difficult to be sure as to precisely what he meant. Presumably he was struck by the contrast between the stone ramparts at Yeavinger Bell and Humbleton Hill and the turf-covered defences at Glead's Cleugh. This is too simplistic a use of the field evidence and ignores the fact that, although not particularly visible on the surface, stone was extensively used in the construction of the ramparts at Glead's Cleugh.

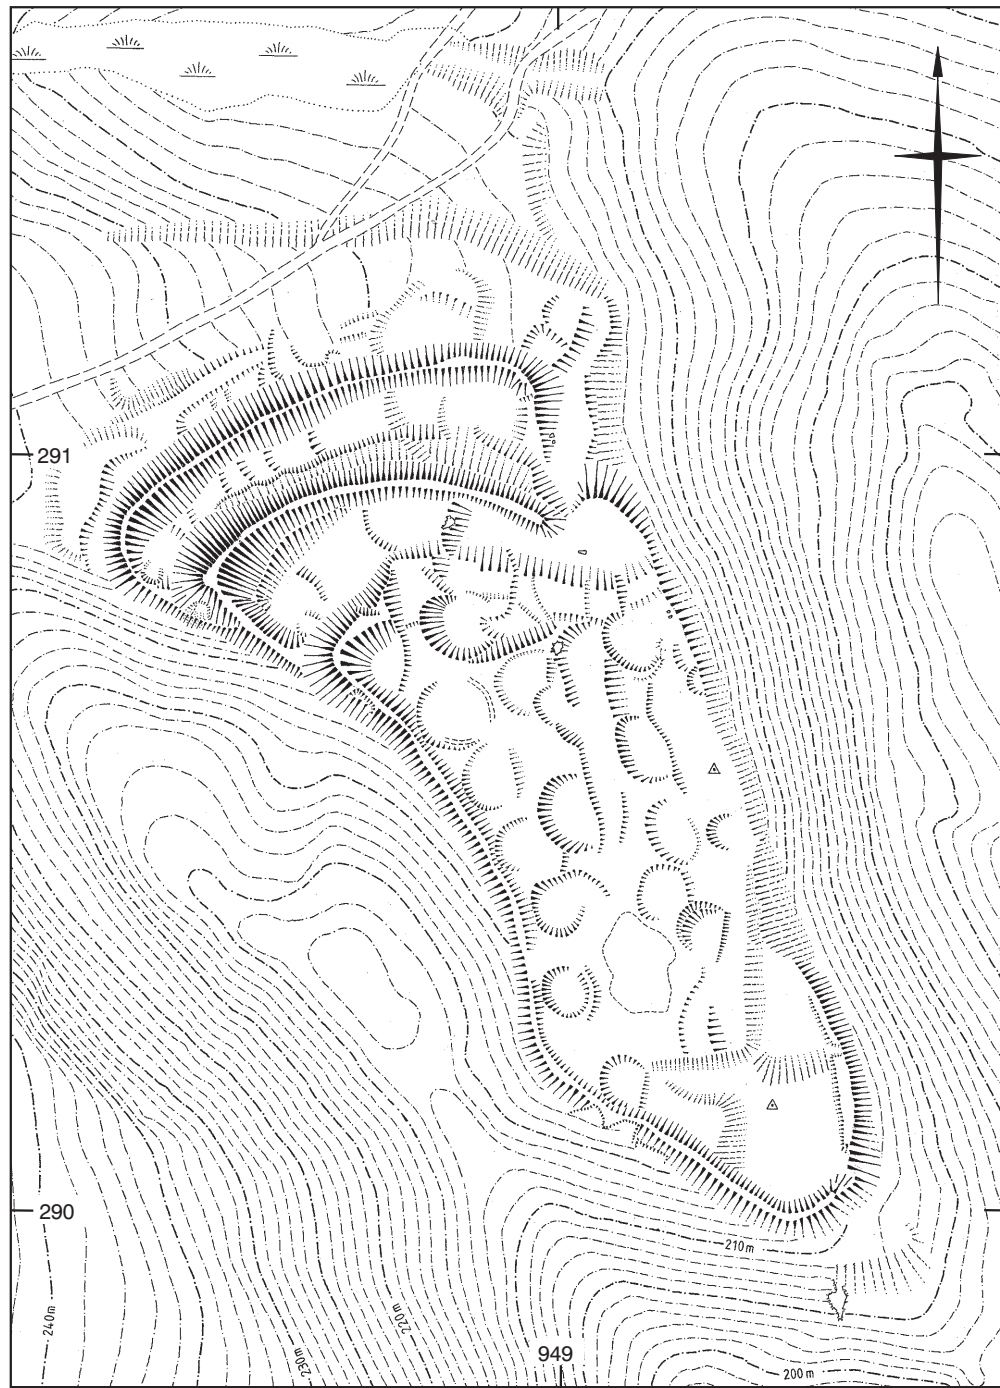
Figure 7. English Heritage plan of the hillfort (reduced from 1:500 scale original)

The hillfort measures a maximum of 95m x 35m internally and encloses an area of 0.3ha (0.74 acres), with its long axis aligned north-west to south-east following the orientation of the promontory. There are three ramparts on the north side of the hillfort (the inner one of which is partially levelled) with intermediate ditches cut down to bedrock. They protect the weakest side of the promontory whilst the slight remains of a ditch and bank beyond the outermost of these ramparts may represent a further line of defences. There is a single rampart around the remainder of the hillfort although all but 25m of this has disappeared on the east side. The main entrance is at the north-east angle facing towards the most level route onto the summit around the head of the east ravine, whilst a second gap in the rampart at the south-east angle is a later breach, although probably Iron Age in date.

The interior of the hillfort contains the remains of 14 sub-circular platforms cut into the natural slope. These probably define the sites of timber round houses although only one example of a ring-groove was noted which might indicate the actual perimeter of a timber building. The house platforms appear to fall into west and east groups arranged along the contours and separated by a pronounced terrace. This, and several lesser terraces, may have served as routeways across the interior of the hillfort. The only other Iron Age features noted in the interior were several quarry hollows on the east side whilst to the south, the absence of any visible structures in the area of the level shelf suggests it was left unoccupied, perhaps for use as an animal pen.

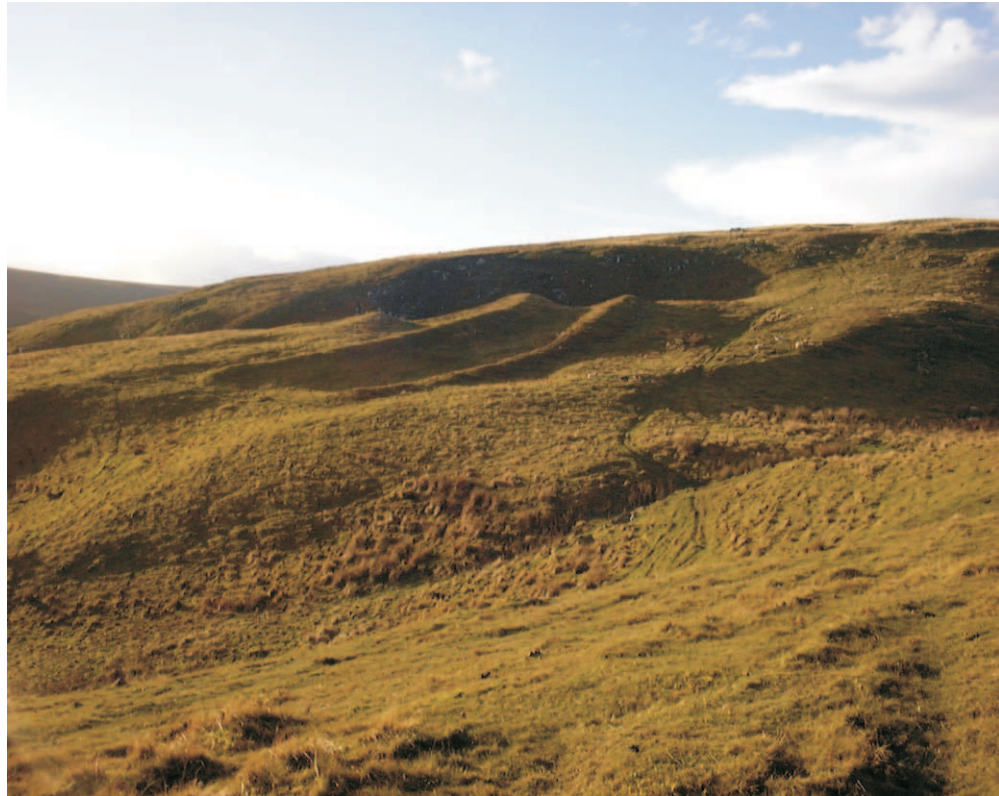
*Figure 9.
View of the site
from the
north-east*

A striking feature of the layout of the Phase 2 hillfort is that the middle and outer ramparts are highest around 10m back from the west side of the promontory where the ground starts to level off. There is no particular defensive reason why the two ramparts should be highest at this point. The explanation is probably that by siting the highest part of both ramparts over this break of slope, anyone approaching the hillfort

from the north-east is confronted by the silhouettes of the highest sections of both defences. This, rather than security, may also explain why the west part of the Phase 1 north rampart was retained, since it makes a third prominent silhouette when viewed from the north-east (Figure 9). Crucially, the planning to achieve this particular effect strongly suggests that the construction of the middle and outer ramparts and the transformation of the inner rampart occurred as a single event.

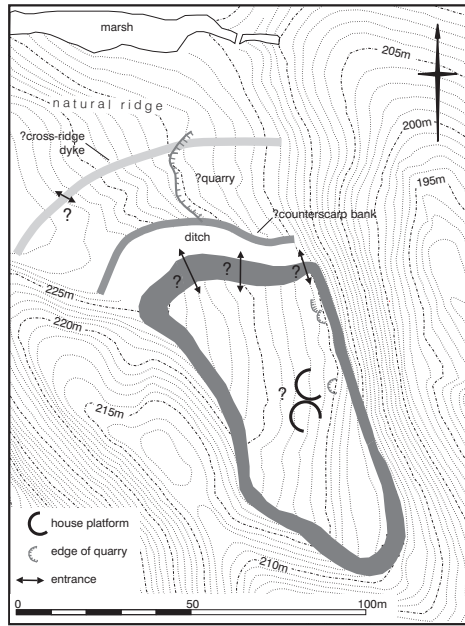
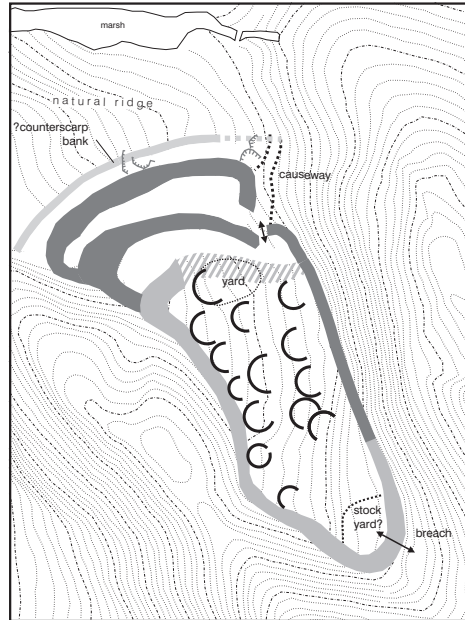
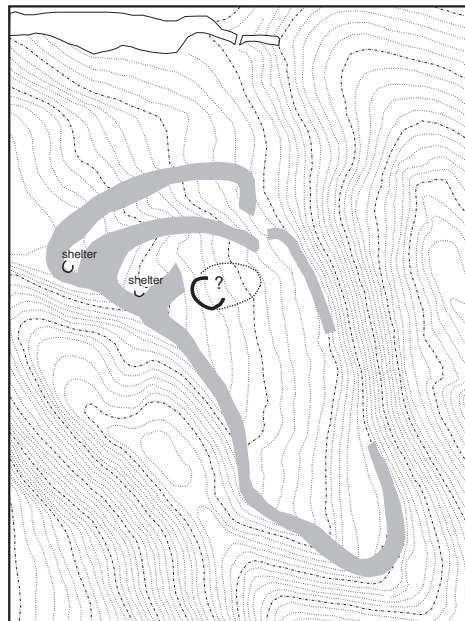
Figure 10.
Interpretative
plans showing
the development
of the hillfort

Phase 1

Phase 2

Post Iron Age features

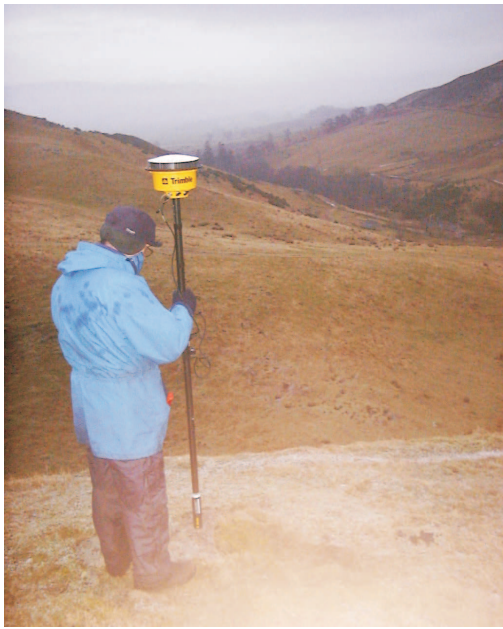
View of ST01 looking east

SITE NAME	Glead's Cleugh, Northumberland		
Station number	ST 01	Status	Permanent
Type of Mark	Brass rivet in rock	NMR number	NT 92 NW 15
Date of Survey	18-JAN-2001	Sam number	
Office of origin	York	RSM number	29308
Surveyor(s)	TP; SA	Neg number

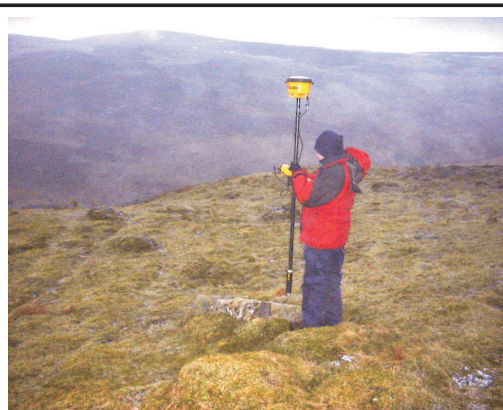
View of ST 02 looking east

SITE NAME	Glead's Cleugh, Northumberland		
Station number	ST 02	Status	Permanent
Type of Mark	Brass rivet in rock	NMR number	NT 92 NW 15
Date of Survey	18-JAN-2001	Sam number	
Office of origin	York	RSM number	29308
Surveyor(s)	TP; SA	Neg number
