An Iron Age hillfort
on Great Hetha,
Northumberland

SURVEY REPORT

Archaeological Investigation Report Series AI/3/2001

**AN IRON AGE HILL FORT
ON GREAT HETHA,
NORTHUMBERLAND**

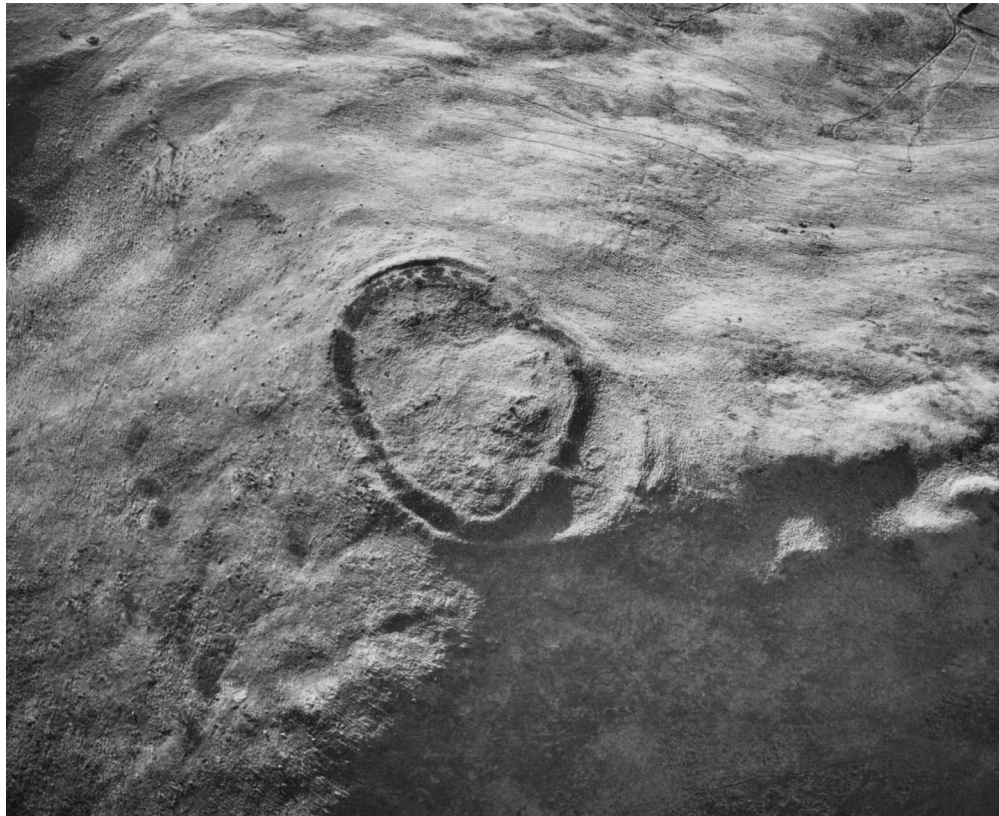
*Figure 2.
Oblique aerial
photograph of the
enclosure from the north
(© Tim Gates 1996)*

The crown of the hill is relatively level with a slight terrace on the east side just below the crest (Figure 2). The south and east sides of the hill fall steeply down to the floors of the Collee Valley and that of its tributary, the Trowup Burn some 200m below. The north side of the hill drops 150m from the top of Great Hetha to the lesser summit of Little Hetha, and beyond it to the floor of the Hetha Burn valley, but the gentlest descent is on the west. Three natural terraces interrupt the slope on this side of the hill before it levels out onto a broad, flat-topped ridge some 30m below the summit. The ridge extends for a further 500m south-west and then drops down to the head of the Hetha Burn valley. The natural route onto the top of Great Hetha is along this ridge followed by the relatively short ascent of the west side of the hill to the summit.

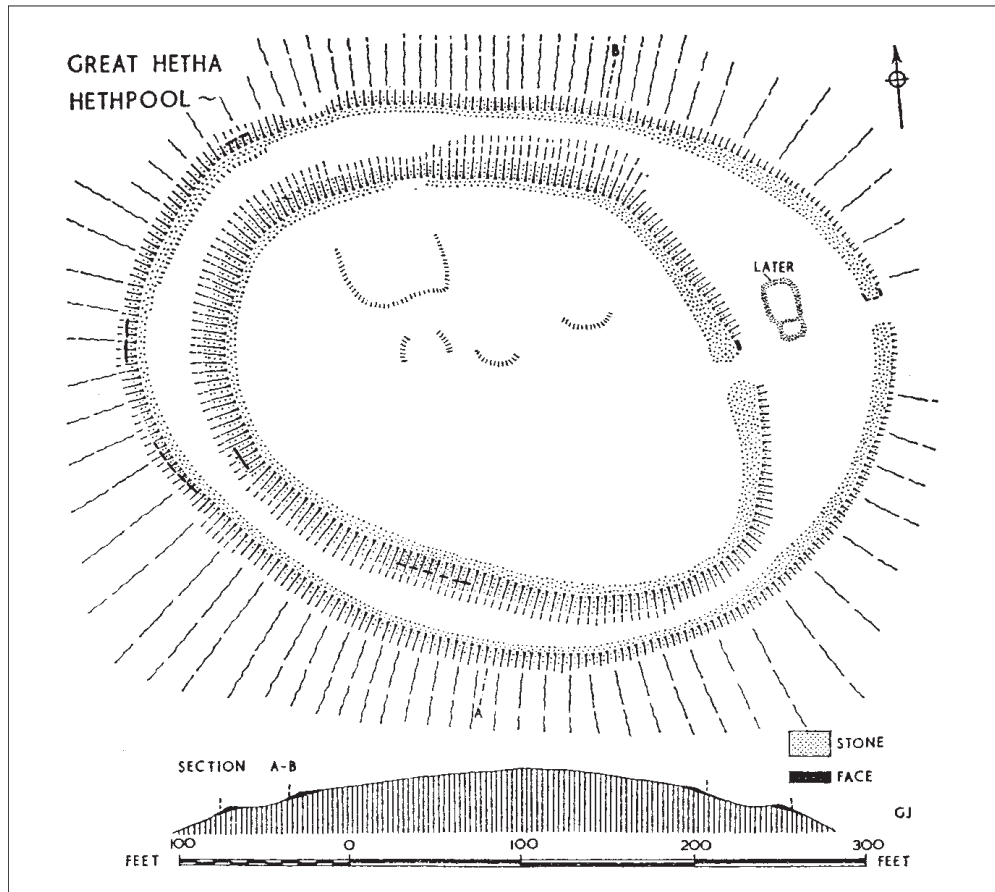
Figure 4.
Plan of the
hillfort surveyed
by George Jobey
(Jobey 1965, 42)

George Jobey published a plan (Figure 4) and brief description of the hillfort in 1965 in his overview of hillforts in Northumberland (Jobey 1965, 42-3). He made the general point that where hillfort ramparts diverge, as they do on the east side of Great Hetha hillfort, it may indicate the presence of a fold or corral for stock. He appears to have rejected the opinion of previous fieldworkers that the hillfort had two entrances by only showing the north-east entrance on his published plan. However, he does show the two ramparts narrowing at approximately the point where earlier plans show the north-west entrance and a gap is shown in the band of stone on the inside of the inner rampart. Jobey also shows several stretches of wall face in the body of both ramparts and a face defining the north side of the entrance through the outer rampart. On the inside of the hillfort, the only definite structure on Jobey's plan is the oval dwelling first depicted by MacLauchlan and which Jobey simply labels as 'later'. He also shows several curvilinear scarps within the inner rampart without offering an interpretation.

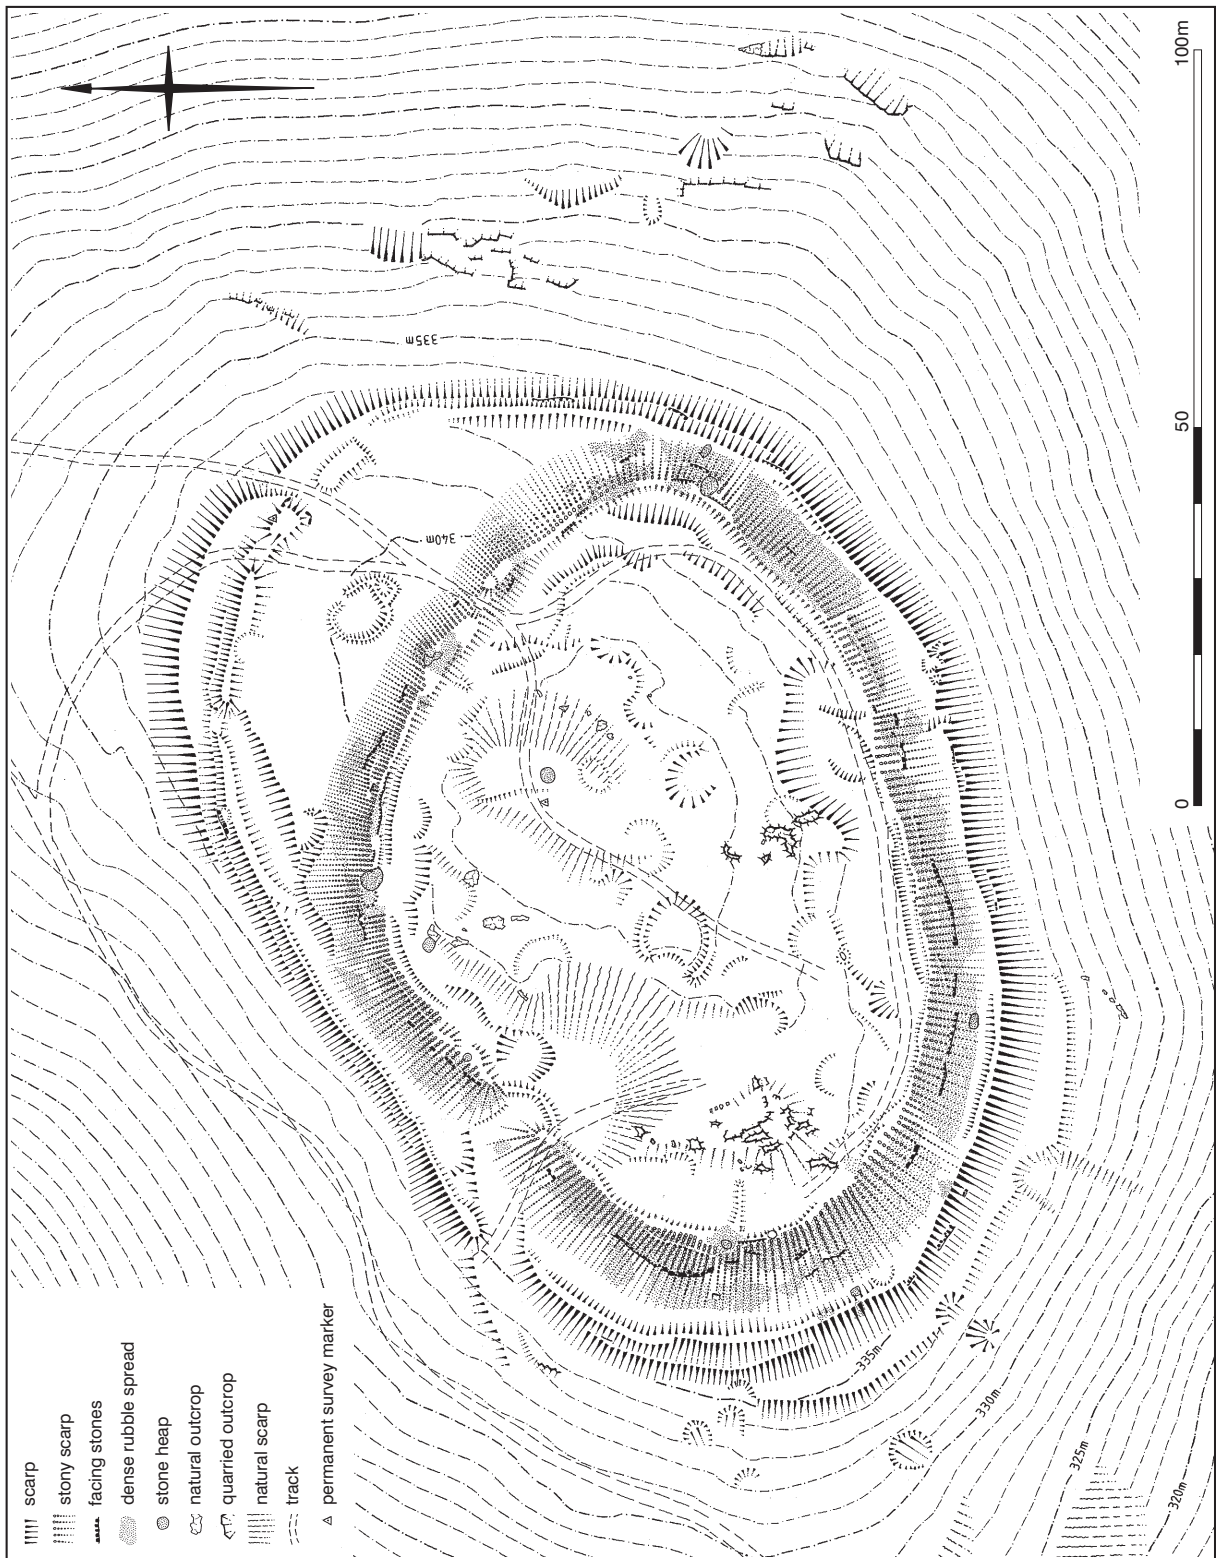
Figure 5. English Heritage plan of the hillfort (reduced from 1:500 scale original)

4. DESCRIPTION AND INTERPRETATION (Figures 5, 6 and 7)

The earliest enclosure on this hilltop appears to have been roughly oval shaped and aligned north-east to south-west following the orientation of the summit. The visible remains of this enclosure are defined by the two crescentic scarps that run out from under the base of the outer rampart and arc outside the north-east and south-west ends of the fort. Both scarps project up to 5m forward of the line of the outer rampart and are up to 1m high but are subtle and hard to detect compared to the more upstanding earthworks of the second and third phases. The rest of the perimeter appears to underlie the outer rampart but this relationship is only clearly visible on the east side of the hillfort where the scarp runs for a distance of 50m southwards along the base of the rampart. The maximum (inferred) internal dimensions of this early enclosure are

therefore around 145m x 95m with an area of 1.1ha (2.7 acres), the summit of the hill falling at the approximate centre. The perimeter of the enclosure mostly respects a natural break of slope where the steep sides of the hill begin to level off onto the summit. As a result, the perimeter follows a fairly level course, the east side being only about 2m higher than the west, but this slight west-facing tilt is not at all apparent on the ground.

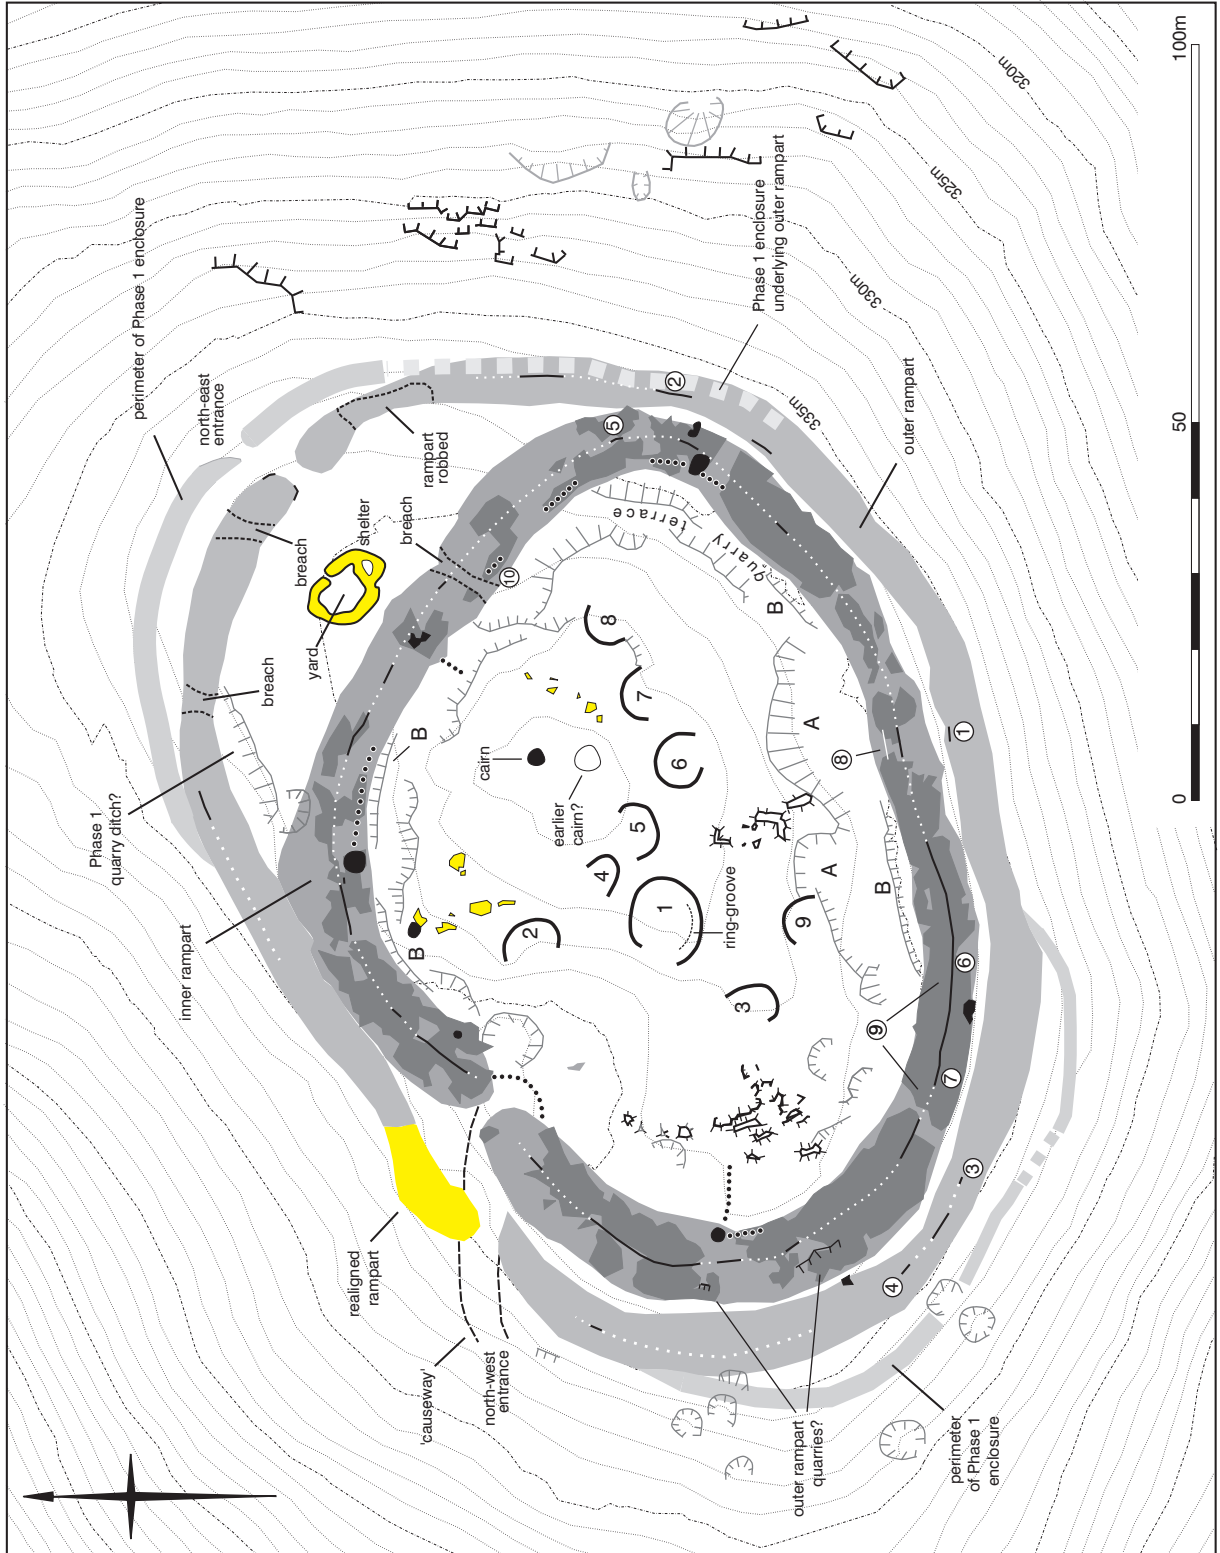
Figure 6. Interpretative plan of the hillfort

In places where the core of the wall has been exposed by erosion it appears to be mostly formed from small fist-sized stones. There is probably also a significant soil fraction explaining why the collapsed wall supports a healthy covering of grass. If this interpretation is correct, it suggests the material forming the core of the wall could have come from shallow surface scoops which is perhaps why there are no deep quarry features in close proximity to the outer defence to compare with those around the inside of the inner rampart (see 4.3). The only quarry trench noted in this position was on the north side of the hillfort where a 0.4m deep cut runs alongside the back of the outer rampart for a distance of 20m but as was discussed above, this may belong to the Phase 1 defences. It is also possible that material was robbed from the Phase 1 defences if, as seems probable, a bank surmounted the perimeter scarp. Also, at the west end of the hillfort, several small quarried outcrops are visible, partially buried below the later tumble of the inner defences. They could be contemporary with the construction of the outer defences as quarrying of rock exposures probably took place to get sufficient stones of the right size and shape to construct the outer face of the wall. This stonework ranges from small, roughly squared blocks to much larger flat slabs that clearly can only have been split from rock exposures. At the base of the wall, the flatter slabs are used in the manner of header and stretchers since they are either laid with their long axis parallel with the wall face or at right angles to it. On the south-east side of the fort, the foundations include a flat slab over 1m in length

laid along the line of the wall (Figure 6: no. 2) and on the south side two slabs overlying each other preserve a fragment of the original drystone wall face (Figure 6: no.3). Slabs laid longways along the wall face probably produced a less stable structure than when they were used as headers and were firmly embedded in the core as is the case on the south-west side (Figure 6: no. 4).

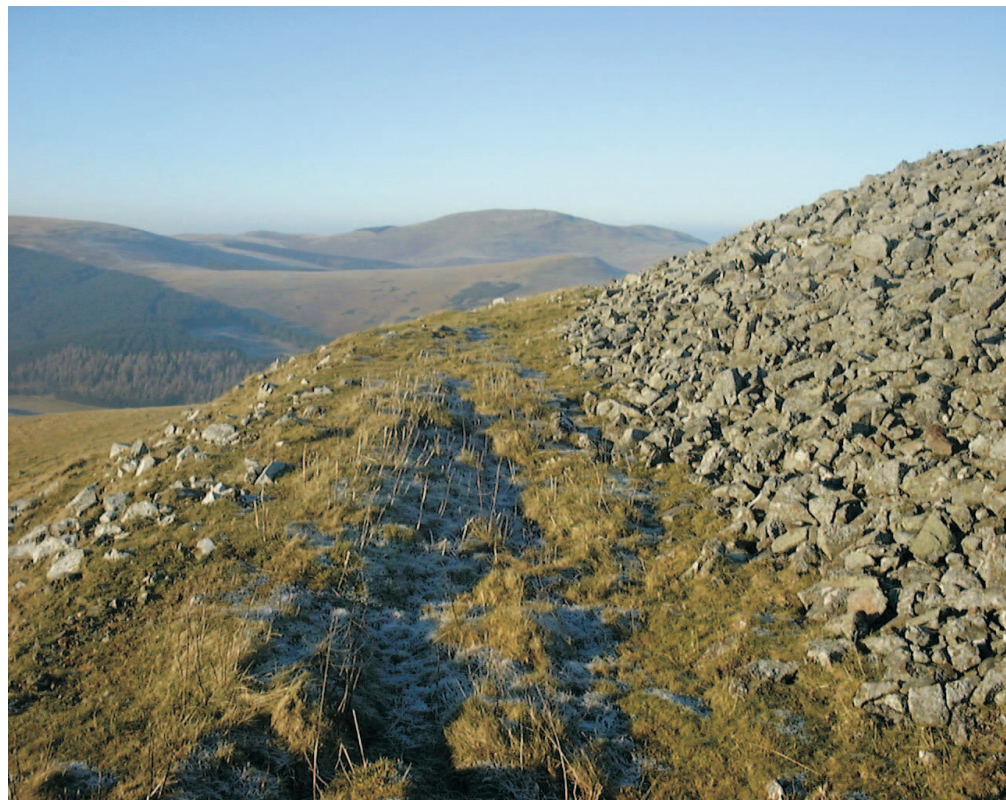
Where the inner and outer ramparts are contiguous (Figure 8) the Phase 2 rampart shows no signs of robbing and could have retained a defensive role. This is particularly demonstrated by re-alignment of the north-west entrance through the outer rampart described earlier which was to accommodate the oblique angle of approach to the inner entrance. However, the strength of the hillfort would have been severely compromised on the north-east by the comparative weakness of the outer rampart and by the 30m gap between it and the inner rampart. Also there is no evidence that the inner and outer ramparts closed at the north-east and north-west corners where the two defences diverge, thereby leaving the outer rampart vulnerable to being outflanked. Given these points, it is possible that the retention of the outer rampart in Phase 3 was less connected with defence as with creating a display of strength to the west which, as has already been discussed, was probably the main direction of approach to the hillfort.

*Figure 8.
View looking west of
the south side of the
hillfort showing the
outer rampart (left)
and the more massive
remains of the inner
rampart (right)*

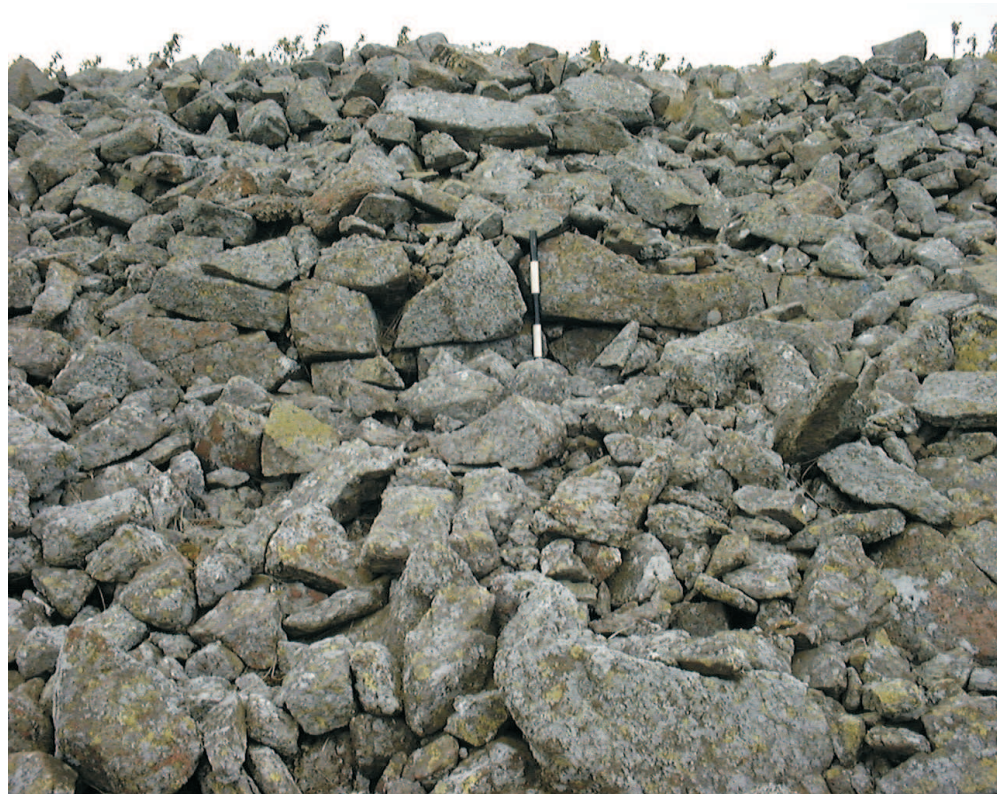
*Figure 9.
The external face of
the inner rampart
wall on the south
side of the hillfort
(for location see
Figure 6: no. 7)*

preserved section, which is on the south side of the hillfort, stands to a height of 0.7m and comprises three courses of closely interlocked square shaped blocks rather than flat slabs (Figure 6: no. 7; and Figure 9).

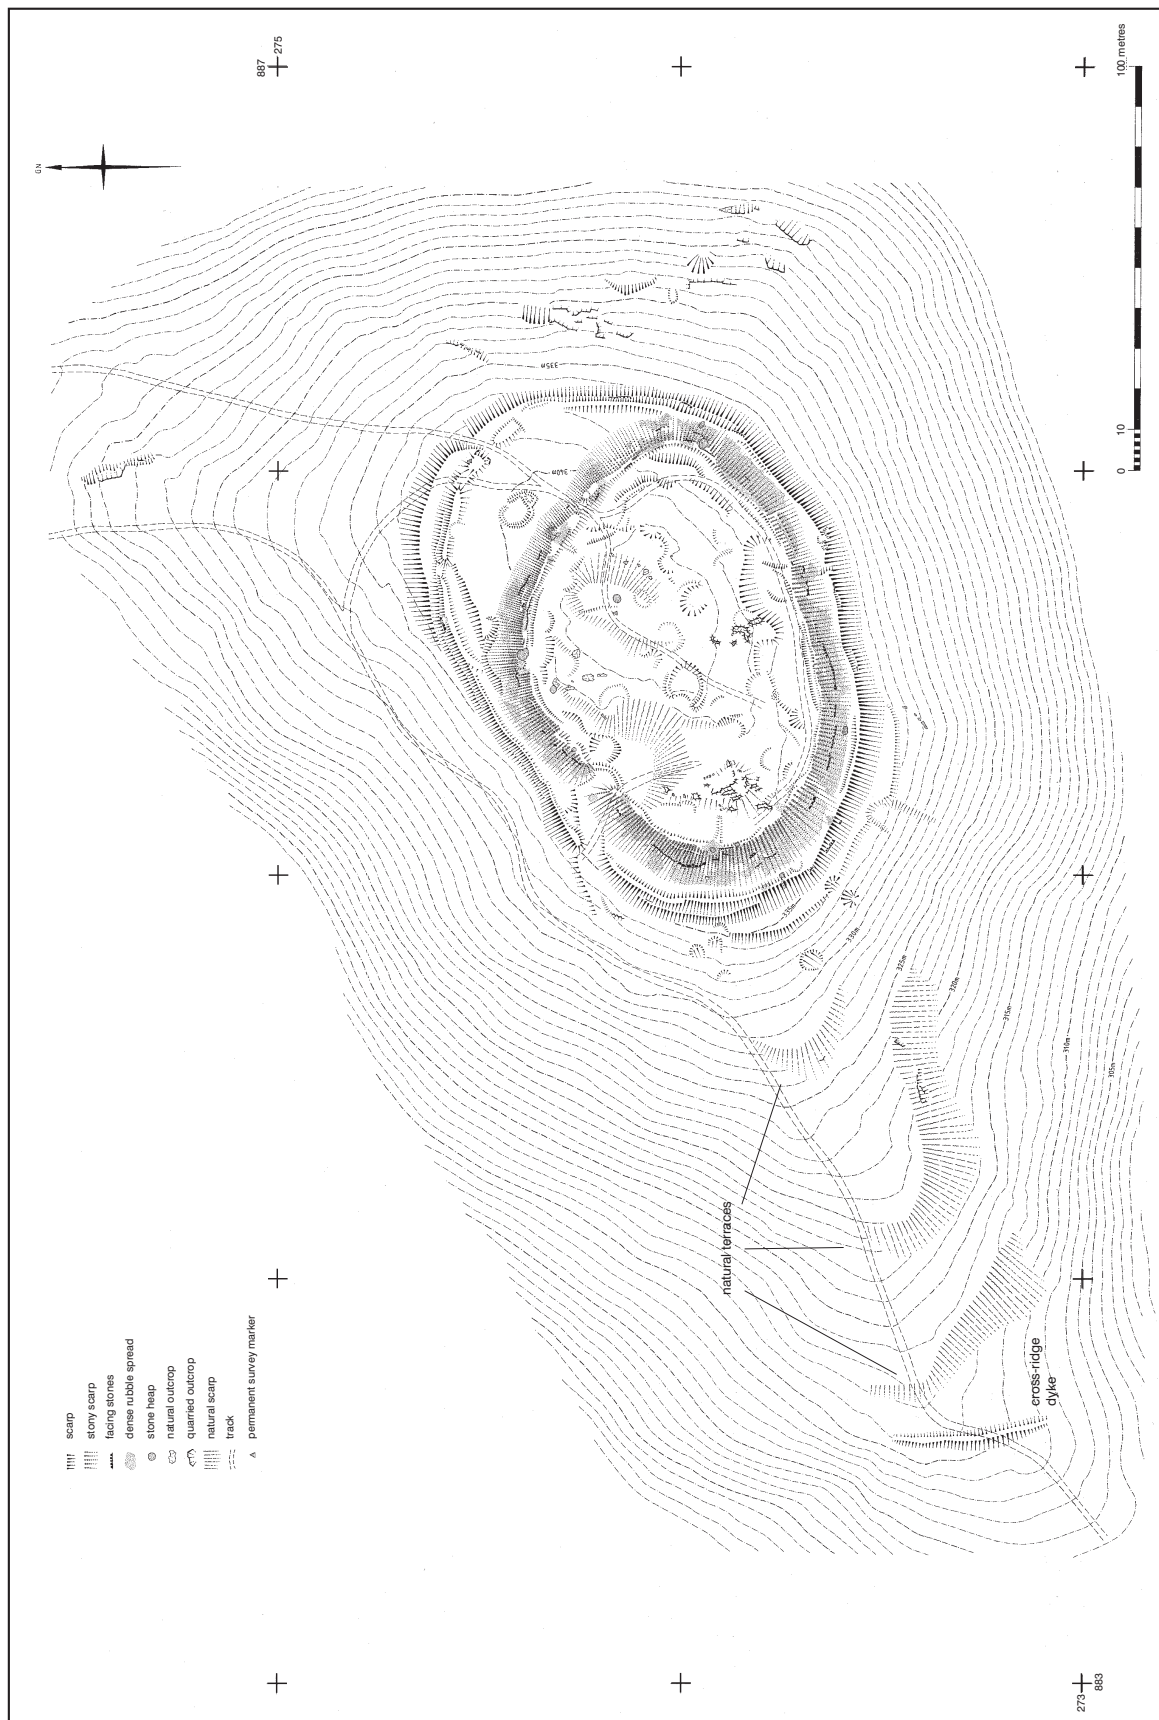
Figure 10. English Heritage plan of the hillfort and its immediate environs (reduced from 1:500 scale original)

4.6 The exterior of the hillfort (Figure 10)

Some 130m west of the hillfort, and 25m below the level of the outer rampart, are the solitary remains of a low bank. The west, downhill face of the bank is up to 0.4m high but only 0.1m on the opposite side. The feature is 40m long and is aligned north-south directly across the ridge defining the natural route of approach to the hillfort from the west. At either end, the bank disappears into the steepening slope of the hillside below the ridge and there is no evidence that it continued any further. It is too insubstantial to have had any defensive function and with no evidence of any other banks in the vicinity or any sign of cultivation, it is unlikely to be a field boundary. It is therefore best interpreted as a territorial boundary or cross-ridge dyke that by linking the north and south sides of the hill divided off the summit from the lower ground to the west. With no other evidence of activity in the vicinity, it is probably contemporary with the hillfort.

Quarrying outside the fort seems to have been most intensive on the east where a line of outcrops between 2m and 15m below the outer rampart has been exploited. The exposed faces are around 1-1.5m high and have a sharp angular appearance contrasting with the rounded profile of naturally weathered outcrops elsewhere on the hilltop. With no drystone walls in the vicinity it is reasonably certain that this quarrying took place to provide material for the construction of the hillfort defences, presumably providing some of the larger flat slabs used in the construction of the rampart faces.

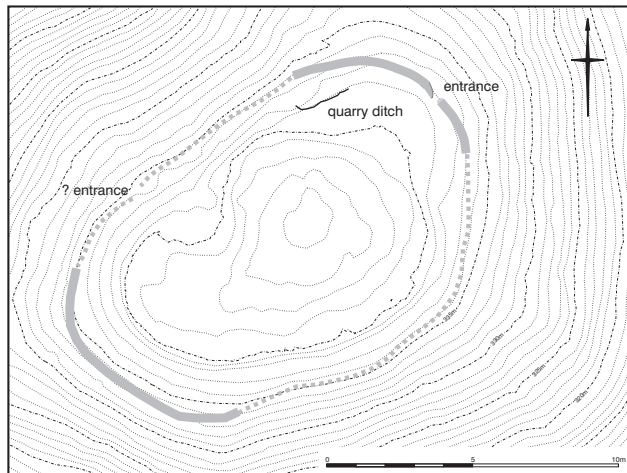
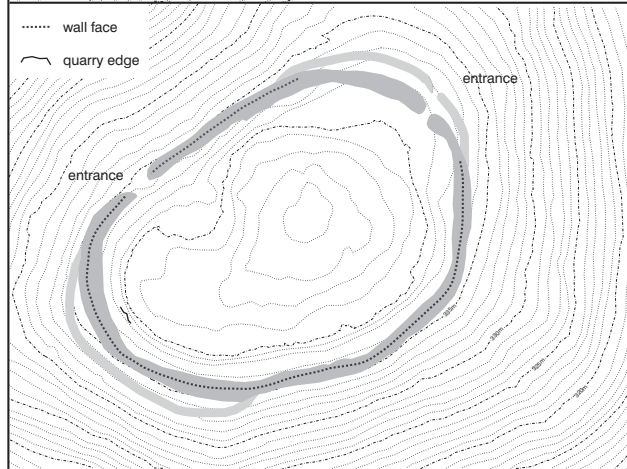
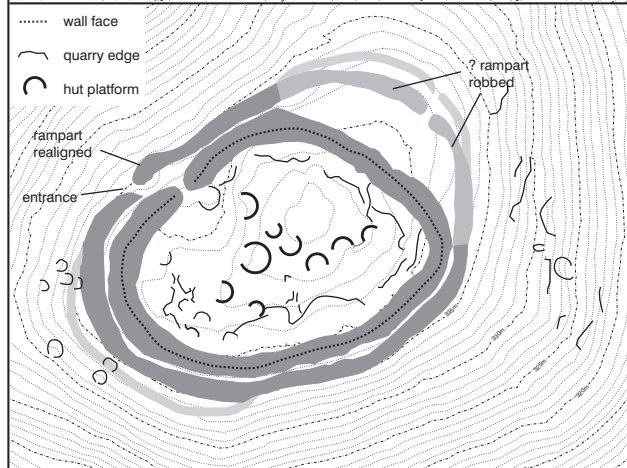
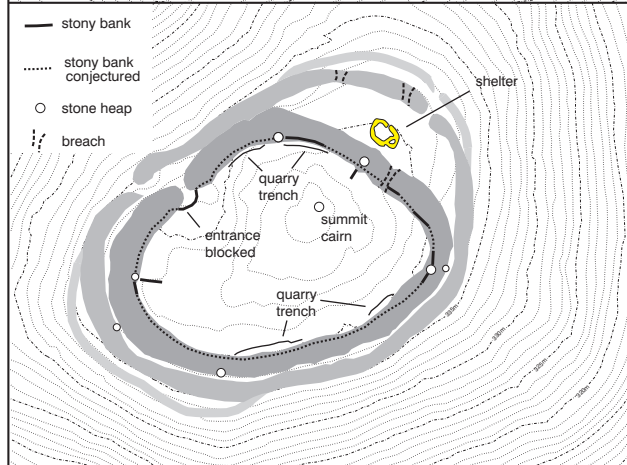
Figure 11.
Interpretative
plans showing the
development of
the hillfort

Although there is no unambiguous evidence for the relative dates of the inner and outer ramparts, the field investigation indicates that the outer is the earlier of the two and was closely aligned on the Phase 1 perimeter with entrances on the north-east and north-west. The divergence of the Phase 2 rampart from the earlier perimeter on the north-east and south-west remains unexplained although a slight increase in natural strength would have resulted from aligning the new rampart a short distance up slope. The surviving remains suggest that the Phase 2 rampart could have been as much as 3-3.5m high around most of the circuit with the top formed by a drystone wall. The exception was on the north-east where there appears to have been a comparatively

Phase 1

Phase 2

Phase 3

Post Iron Age features

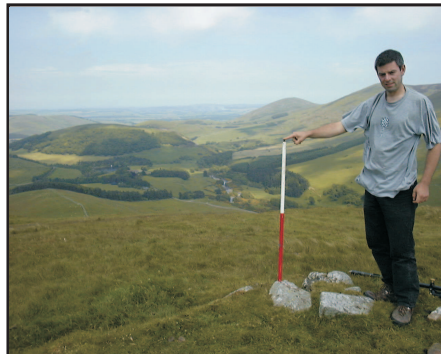
SITE NAME	Great Hetha, Northumberland		
Station number	ST 01	Status	Permanent
Type of Mark	Brass rivet in rock	NMR number	NT 82 NE 47
Date of Survey	4-JUL-2000	Sam number	
Office of origin	York	RSM number	24605
Surveyor(s)	AO; SA; BT	Neg number

Co-ordinate Scheme	Eastings	Northings	Height
OS National Grid	388 602.371	627 452.268	339.735
Divorced Site Grid

View of STN1 looking north-east

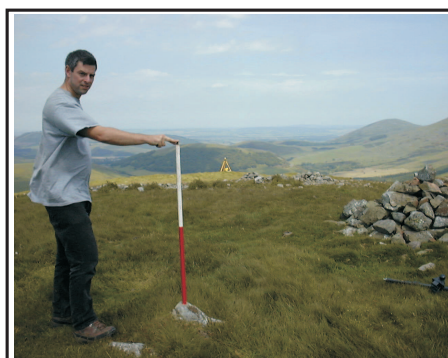
SITE NAME	Great Hetha, Northumberland		
Station number	ST 02	Status	Permanent
Type of Mark	Brass rivet in rock	NMR number	NT 82 NE 47
Date of Survey	4-JUL-2000	Sam number	
Office of origin	York	RSM number	24605
Surveyor(s)	AO; SA; BT	Neg number

Co-ordinate Scheme	Eastings	Northings	Height
OS National Grid	388 564.642	627 416.249	344.981
Divorced Site Grid

View of STN2 looking north-east with STN1 in background with tripod over.
