A prehistoric enclosure on Hethpool Bell, Northumberland

SURVEY REPORT

Archaeological Investigation Report Series AI/11/2000

NMR No: NT 92 NW 11
NGR: NT 9020 2881
SAM No: Northumberland 463
SMR No: 209/11

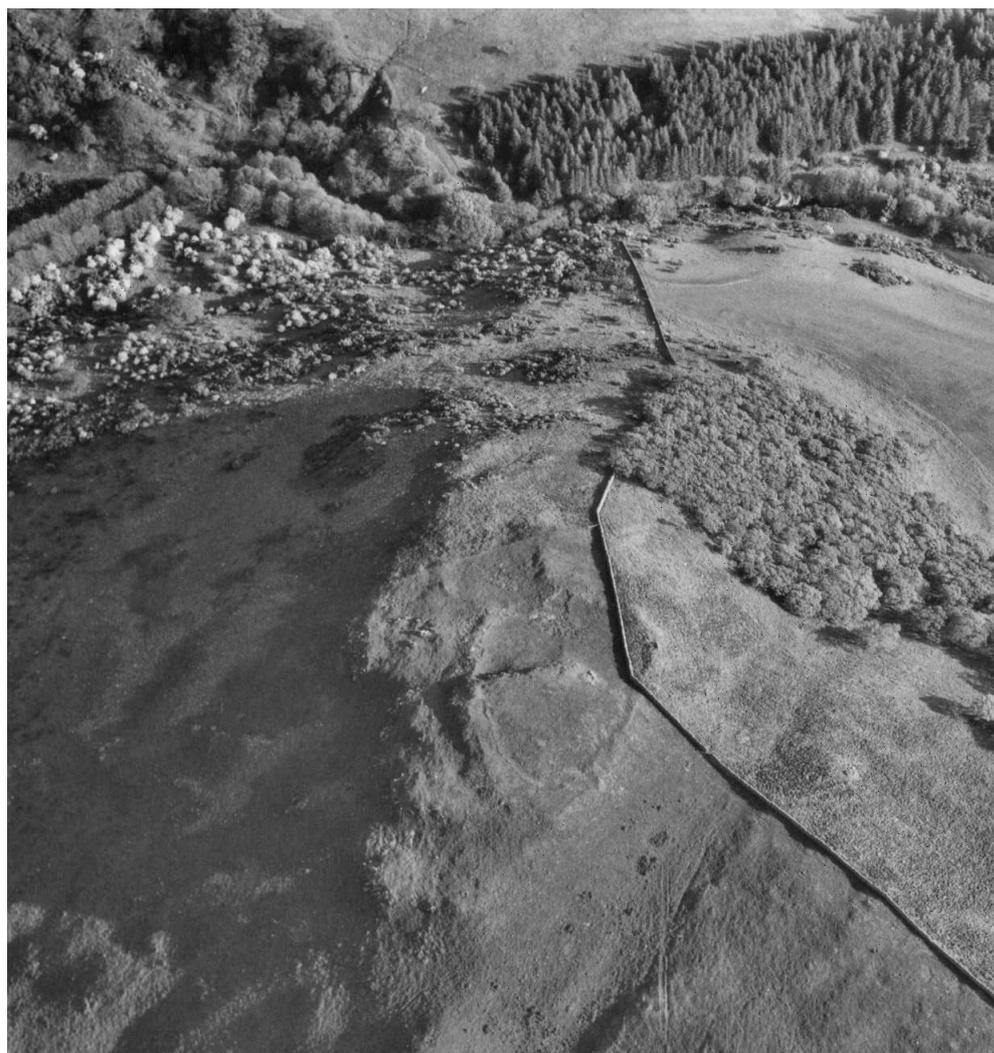
*Figure 2.
Oblique aerial
photograph of the
site from
the north.
(Photograph
Tim Gates*

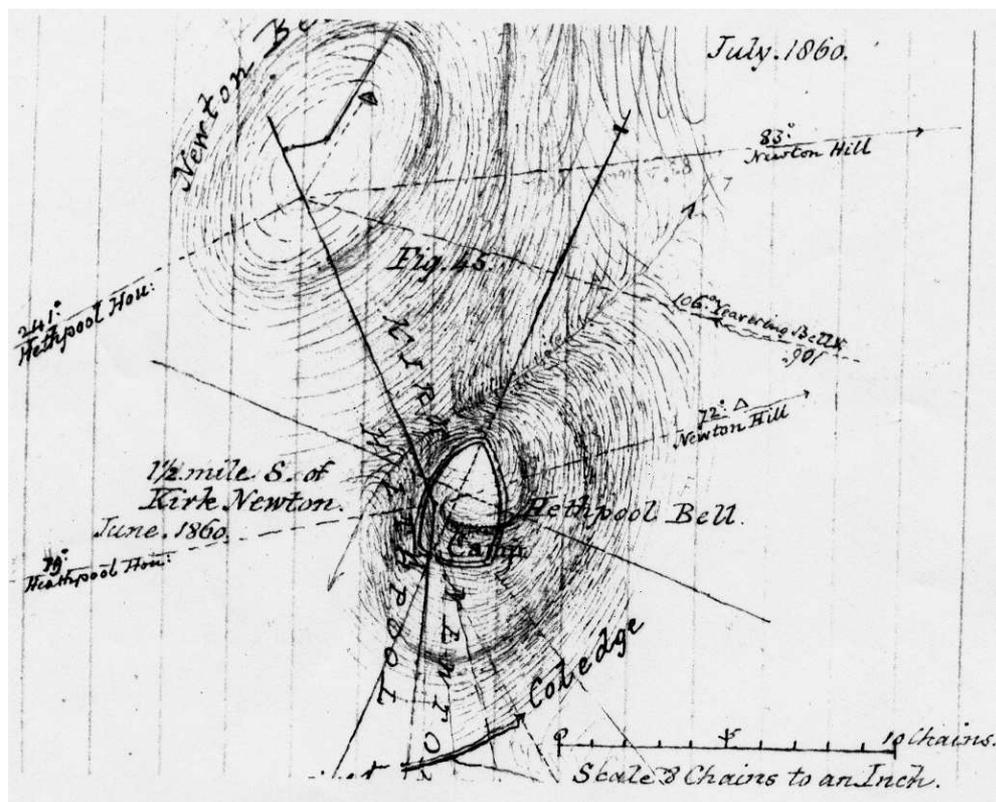
The earliest large-scale depiction of the site is from 1860 when both HH MacLauchlan and the Ordnance Survey mapped the site (MacLauchlan 1860; Ordnance Survey 1861). MacLauchlan's plan (at a scale of 8 chains to the inch -1:6336) shows a gap in the south bank close to the point where it is crossed by the drystone wall (Figure 3). He presumably considered this gap to be the entrance into the enclosure. No huts or other settlement remains are shown on the plan; this is significant because MacLauchlan was a skilled observer and would have shown such remains if he had encountered them. He depicted the change in ground level across the interior of the enclosure and despite the absence of settlement remains, labelled the enclosure as a camp. His plan shows a track crossing the hilltop following the saddle separating the shelf on which the enclosure is located from the main slope of Hethpool Bell. The existing gate through the drystone wall is on the line of this track. In his description of the site, which was published posthumously, MacLauchlan refers to the enclosure as a triangular-shaped camp noting also the ruined condition of the bank (MacLauchlan 1919-22, 469). The Ordnance Survey plan - published at 1:2500 scale - shows the outline of the enclosure as a continuous circuit with the drystone wall traversing the east side of the site. The second edition revised in 1896 adds nothing further to the depiction (Ordnance Survey 1897).

Figure 3.
MacLauchlan's
survey of 1860
(reproduced by
permission of His
Grace the Duke of
Northumberland)

The survey has established that apart from the enclosure the only other activity on the site relates to the robbing of the enclosure bank and the probable use of the site as a stock enclosure. The majority of the robbing is likely to be associated with the construction and maintenance of the adjacent drystone wall, which itself is probably of some antiquity as it divides the parishes of Kirknewton on the east from Hethpool on the west. However, all that can be said about its date for certain is that it is earlier than 1860 as it is shown on both the Ordnance Survey and MacLauchlan's maps of that year. That the enclosure had been robbed by this date to provide construction material for the wall is supported by the fact that MacLauchlan seems to have mistaken a stretch of robbed bank on the south of the enclosure as an entrance.

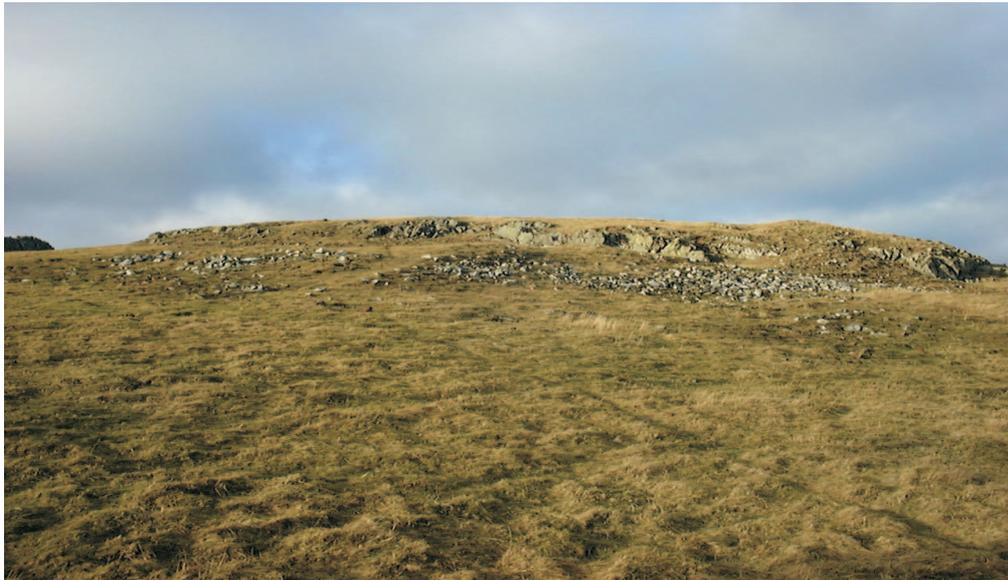
*Figure 4.
Ground
photograph
looking north
from the lower
terrace showing
the outcrop on the
south of the
summit*

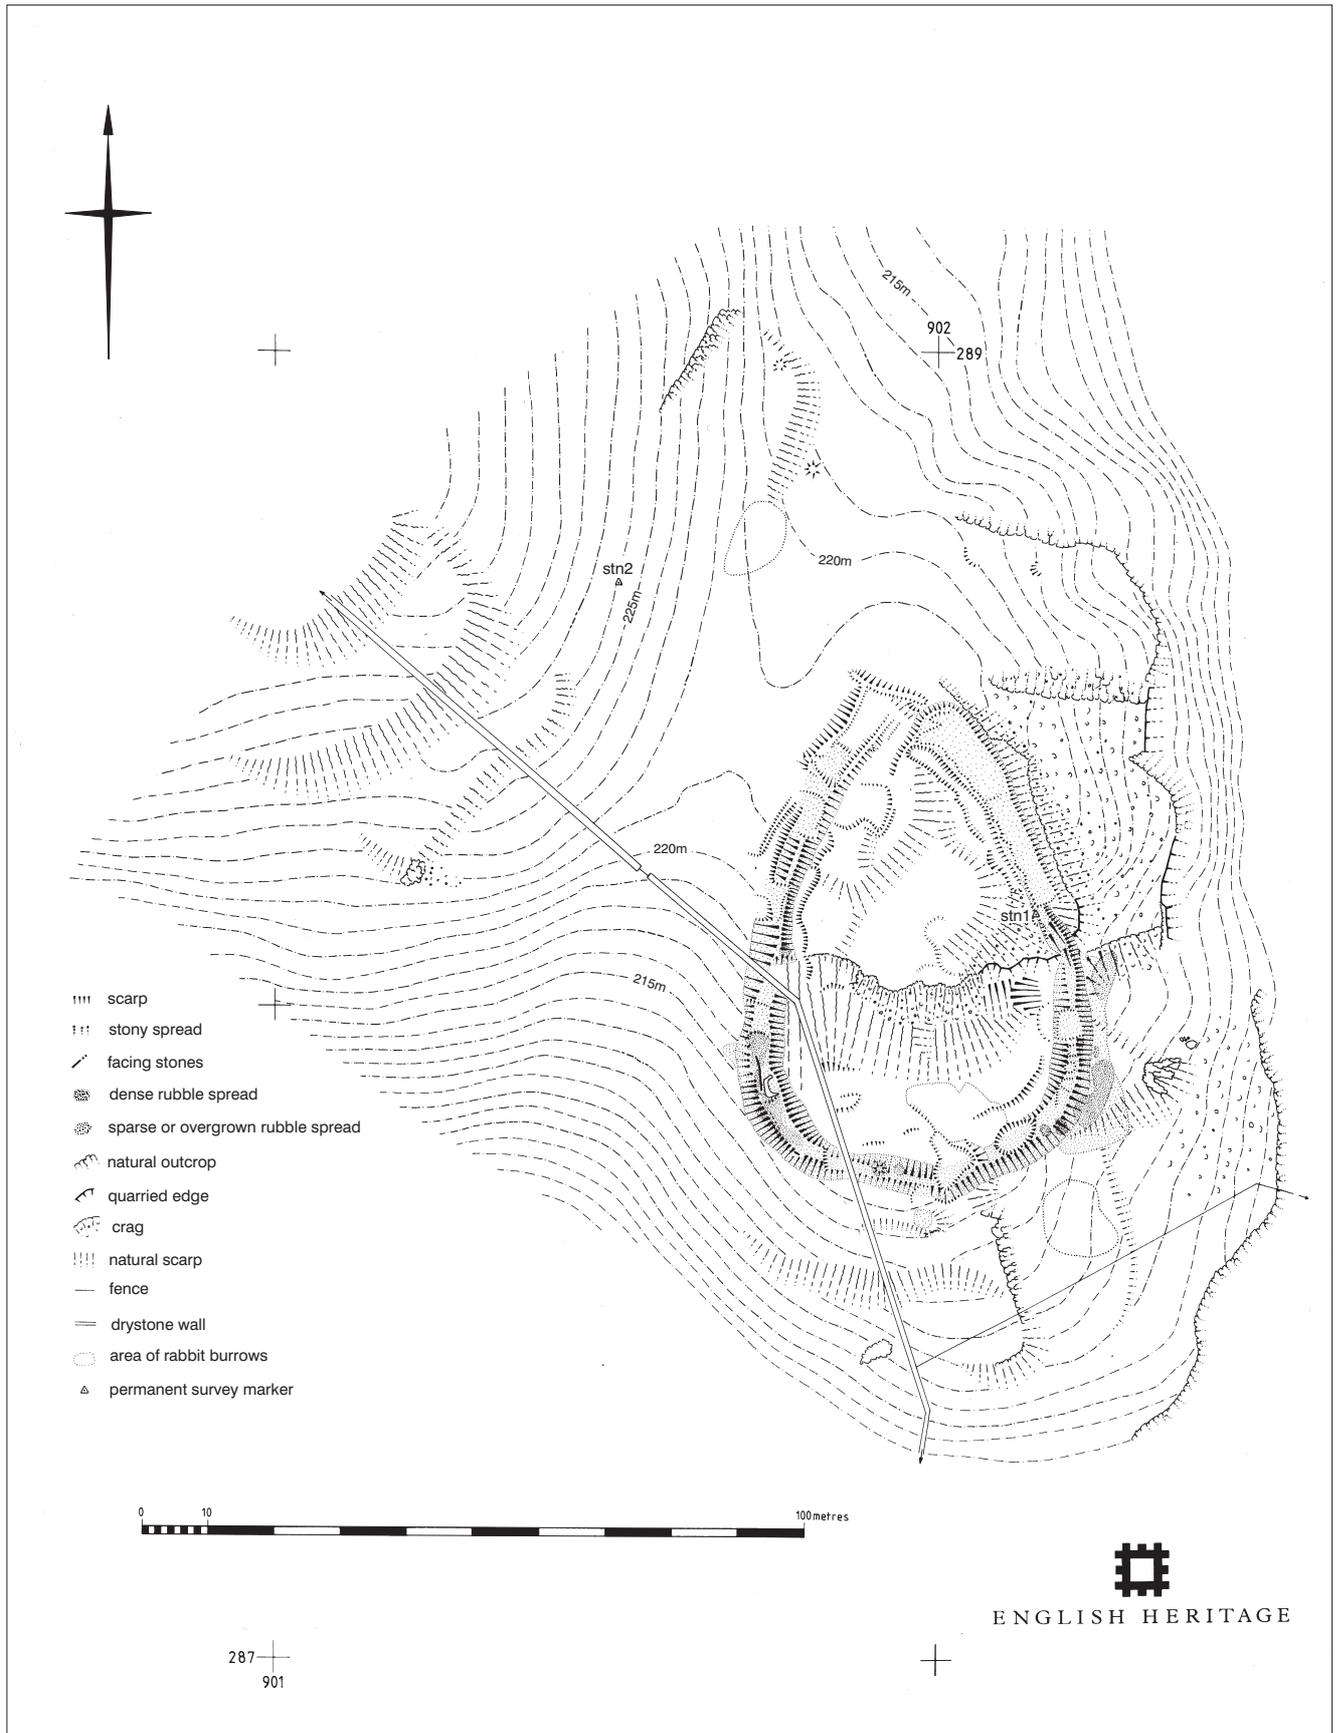
The enclosure is a strikingly symmetrical 'egg-shape' with the long axis aligned almost due north-south with the broad end on the south, tapering almost to a sharp point at the north. Its maximum internal dimensions are 64m north-south and 40m east-west and it covers an area of 0.2ha. It is bisected by the east-west rock outcrop (up to 3m high) which defines the south side of the shelf summit. Thus the enclosure is on two levels; the north part occupies the triangular shaped summit of the shelf whilst the south end encircles part of the terrace below (Figure 5).

Figure 5. English Heritage survey (reduced from 1:500 scale original)

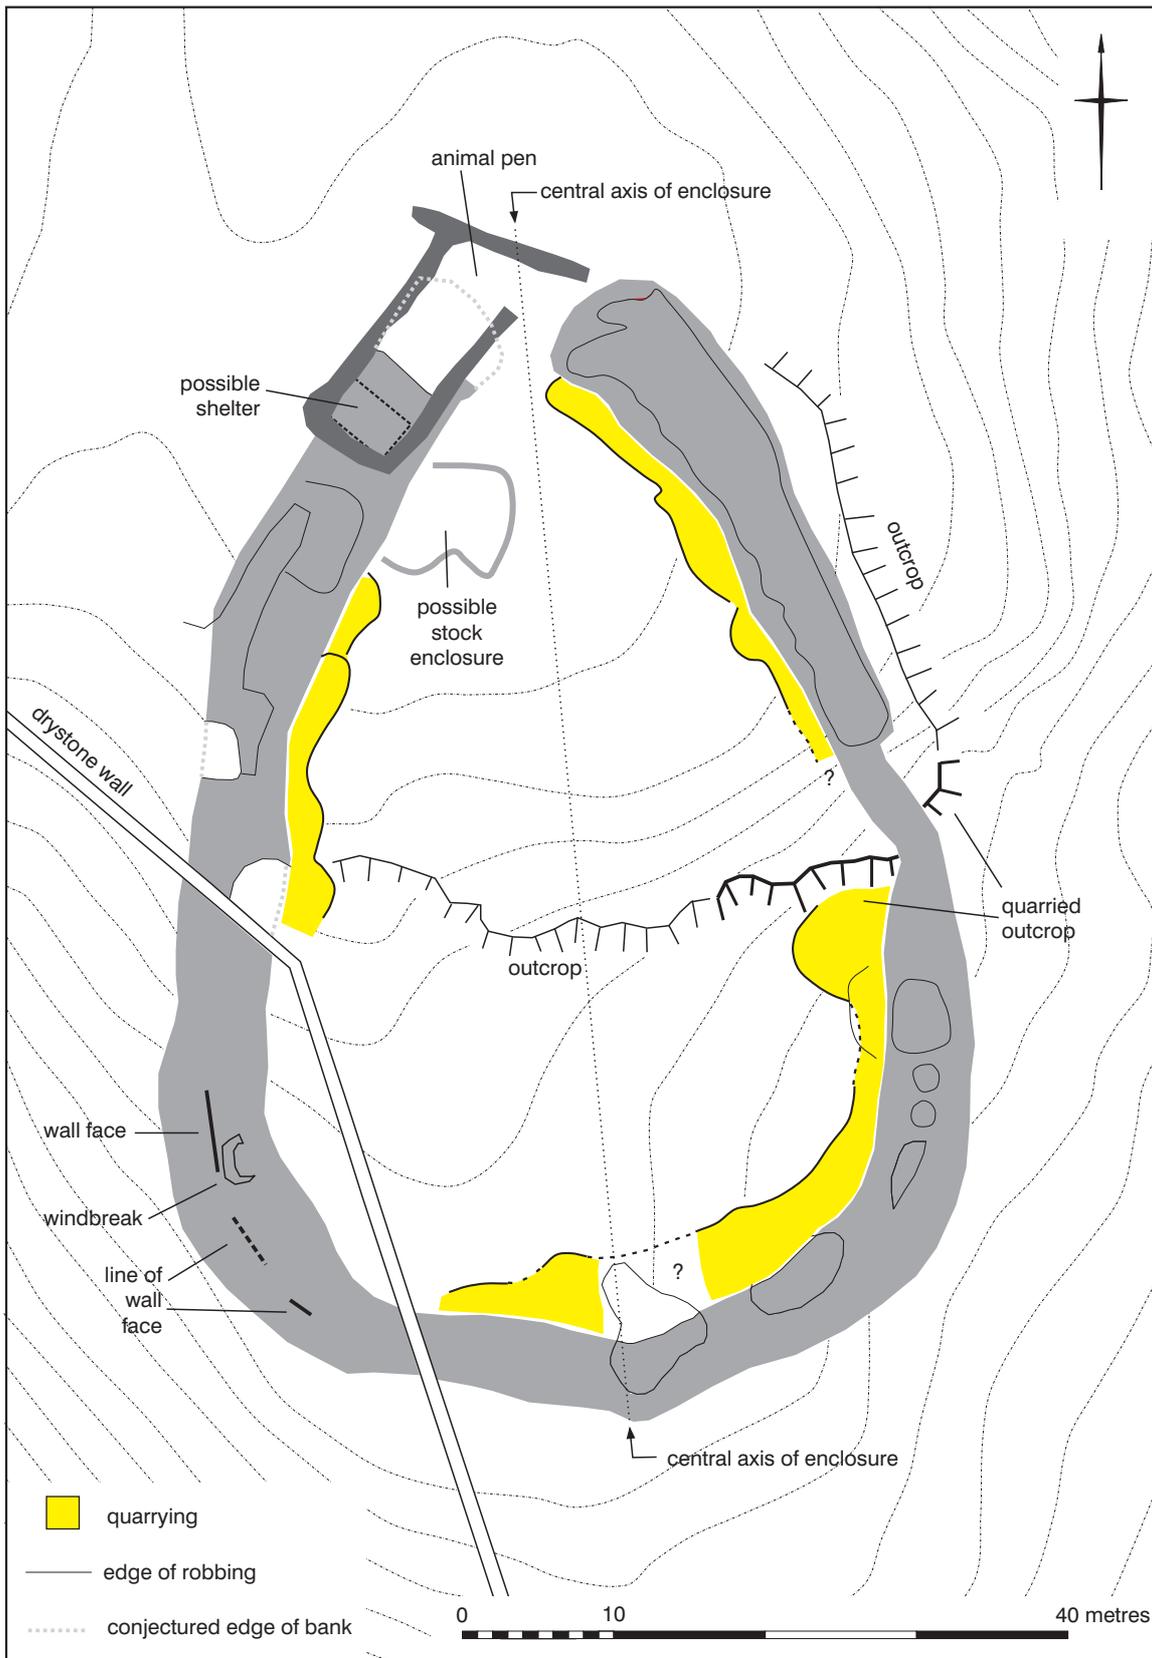
Figure 6. Schematic plan showing the main features of the site

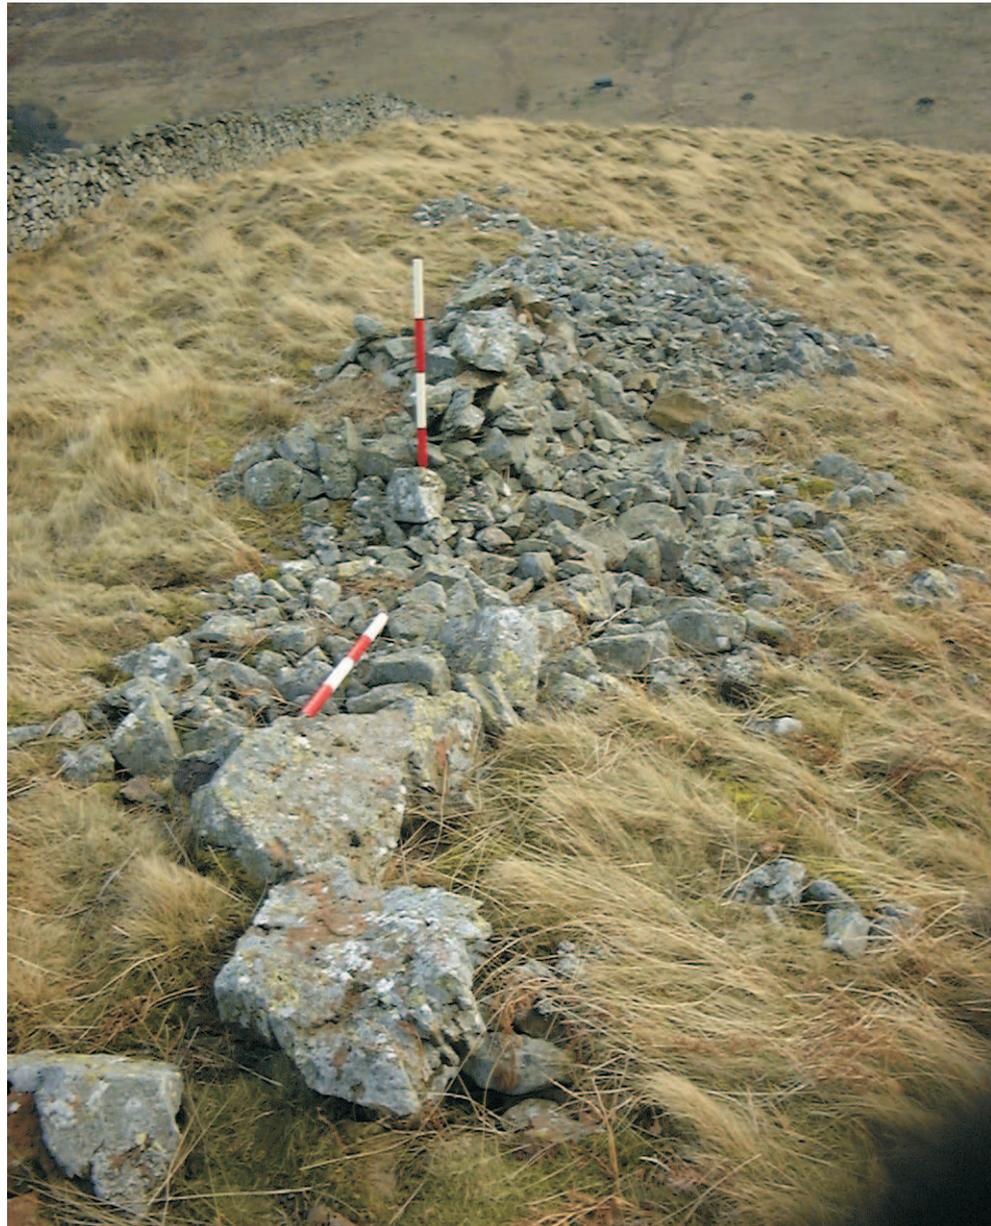
The enclosure is formed by a turf-covered, stony bank of variable character. The best preserved portion of the bank is on the south-west of enclosure on the west side of the drystone wall, where it survives up to 6.0m wide and the outside of the bank attains a maximum height of 1.5m. The bank here is not as extensively covered with turf as the rest of the perimeter and therefore some constructional details are exposed. The surviving core of the bank is made up almost entirely of small, fist-sized stones though it is possible that larger stones may have been lost due to later robbing. A line of larger angular boulders up to 0.5m in length near the top outside edge of the bank probably represents the base of an exterior wall face and the 2-3m spread beyond this line is therefore tumble from the outward collapse of the wall and its rubble core (Figure 7).

*Figure 7.
Ground
photograph of
the south-west
side of the
enclosure
showing the
possible wall
face within the
bank*

The line of the wall face is picked out further south by a straight edge among the otherwise random spread of stones perhaps indicating where boulders have been removed. Further south several isolated, well-set boulders mark the continued line of the wall face. With no evidence for an inside wall face, it is difficult to estimate the original width of the bank but allowing for some collapse on the inside, the evidence suggests the it was probably no more than 2.5m wide. There is no evidence for the original height of the wall but the fact that the bank is at its most massive in this sector suggests it was probably higher here than elsewhere around the circuit. This may have been to compensate for the fact that the enclosure drops down the shoulder of the hill at this point, or it may simply reflect less robbing has taken place west of the drystone wall (see below).

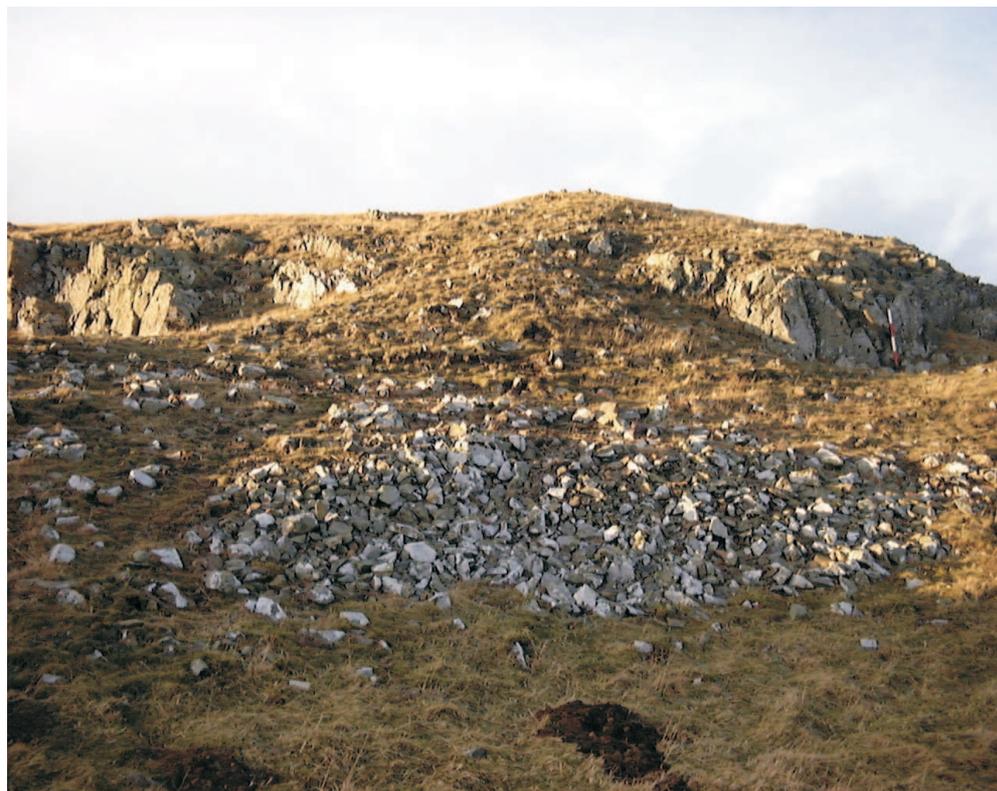
bank narrows to less than 2m wide and the volume of stone in the bank is the least of anywhere around the circuit (Figure 8). This could indicate that the wall was never built up to the same extent as the rest of the enclosure because of the difficulty of the terrain at this point or alternatively that it has suffered badly from erosion on the steep slope. Immediately to the south, stone rubble from the bank has spread up to 7m down the slope. This build up could be partly the result of erosion but may indicate the bank was founded on a rubble revetment.

There is evidence that the main rock outcrop on the south side of the shelf summit was quarried prior to the construction of the enclosure wall. The outcrop's vertical and relatively unweathered faces contrast markedly with the rounded appearance of naturally weathered exposures elsewhere, indicating it has been quarried; importantly, the bank on the east side of the enclosure clearly overlies the quarry face. This clearly demonstrates that this exposure was worked prior to the construction of this stretch of wall. The relationship could indicate this sector has been rebuilt but there is no evidence to support this. An alternative possibility is that the outcrop was worked to supply stone for the construction of another site in the vicinity pre-dating the enclosure but no such site is known to exist. It seems probable therefore that the outcrop was worked to provide stone for the enclosure wall, possibly early on in the construction, to provide some of the larger blocks needed for wall facings. Other quarried outcrops were noted to the east of the enclosure but there is no conclusive

*Figure 8.
Ground
photograph of
the east side of
the enclosure
showing the
bank ascending
the quarried
face of the
outcrop*

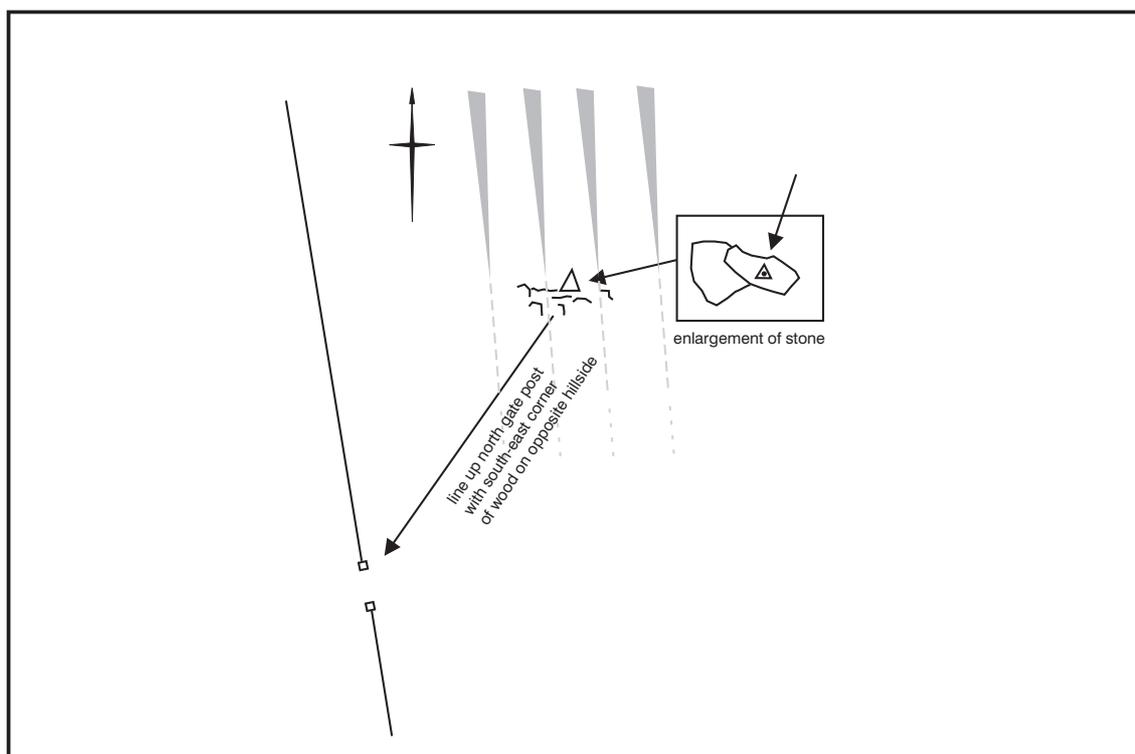
SITE NAME	Hethpool Bell, Northumberland		
Station number	Station Number 2	Status	Permanent
Type of Mark	Brass Rivet	NMR number	NT 92 NW 11
Date of Survey	Dec. 1999-Jan 2000	Sam number	Northumberland 463
Office of origin	York	RSM number	_____
Surveyor(s)	TP, SA, MJ, AO, BT	Neg number	_____

Co-ordinate Scheme	Eastings	Northings	Height
OS National Grid	390151.580	628864.775	225.800
Divorced Site Grid	_____	_____	_____
