WORKSOP PRIORY GATEHOUSE NOTTINGHAMSHIRE

*An Architectural History
with an Account of the Significance of its Fabric*

Richard Lea and David M. Robinson

Historical Analysis & Research Team
Reports and Papers 37
2000

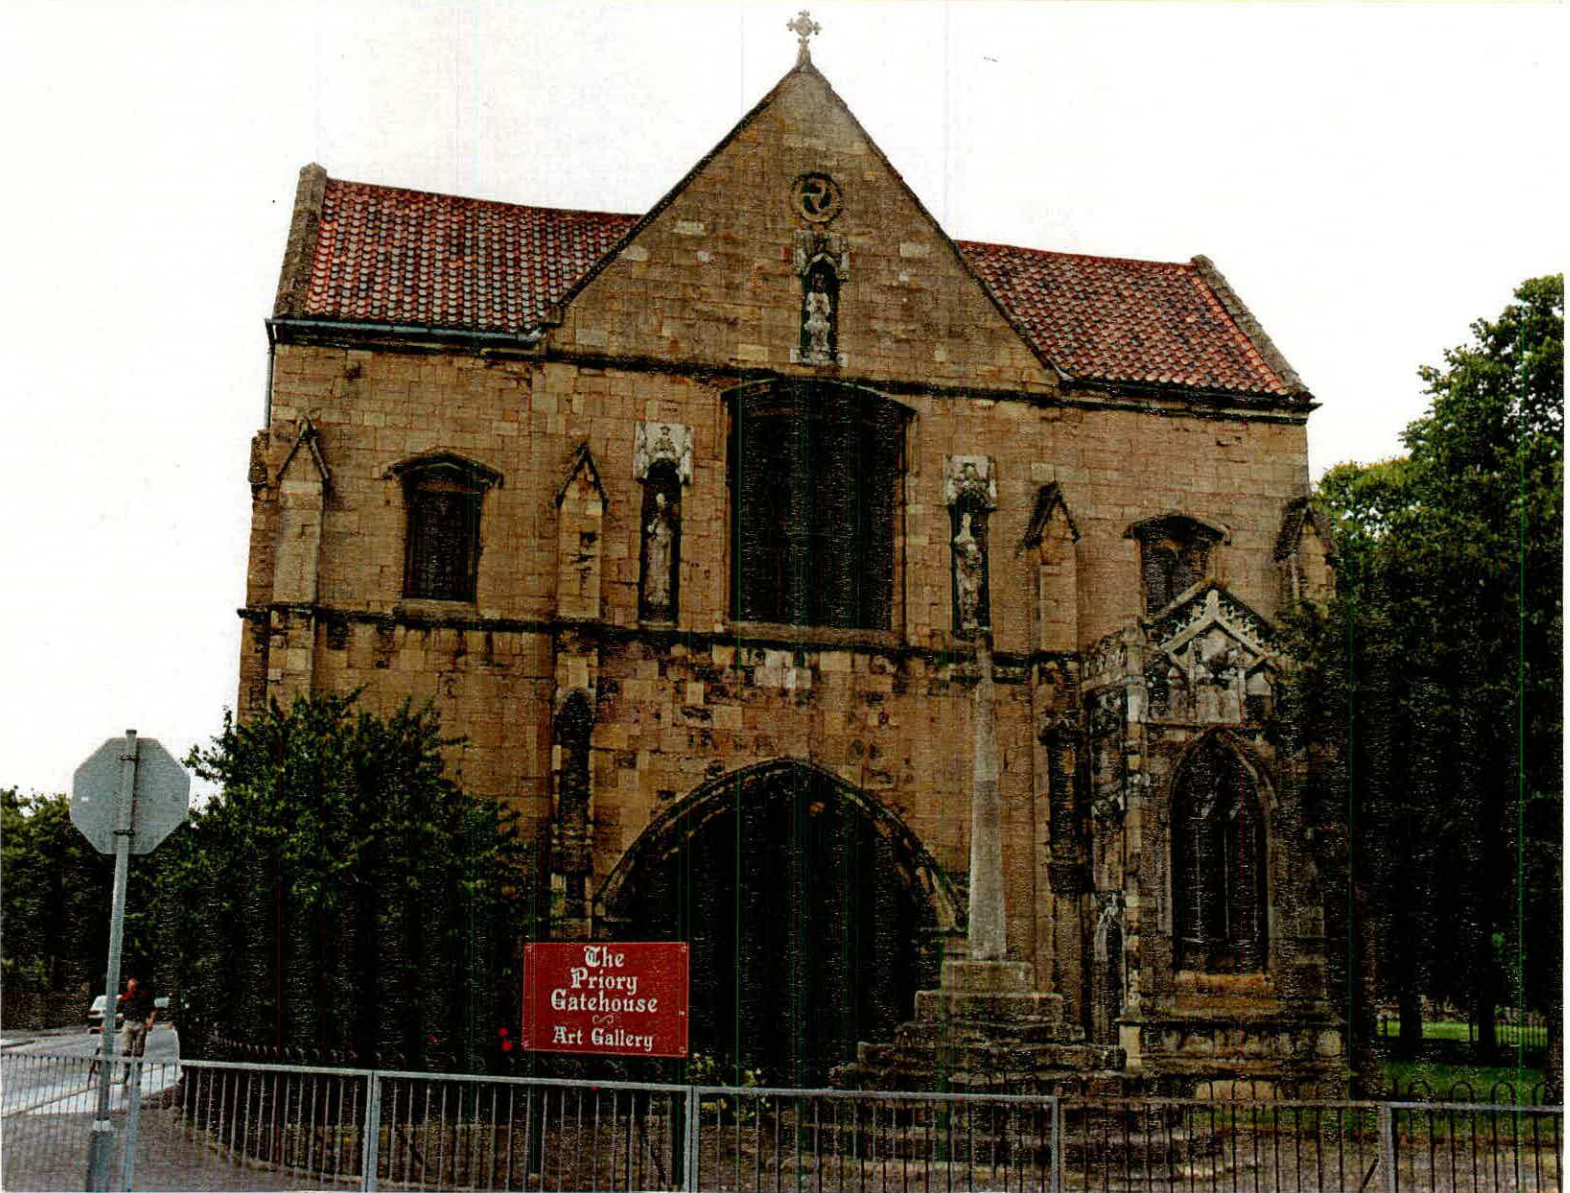
Fig. 1. A general view of Worktop Priory gatehouse from the south. This very fine fourteenth-century structure is a grade I listed building, currently in a poor state of repair and on the English Heritage register of buildings at risk (1999).

Now isolated and sadly forlorn, the once splendid medieval gatehouse attached to the Augustinian priory of Worksop in Nottinghamshire is a grade I listed building; it is also scheduled as an ancient monument (fig. 1). Alas, due to the circumstances surrounding its present state, coupled with the deteriorating condition of the fabric, it is currently included on English Heritage's register of *Buildings at Risk* (1999).

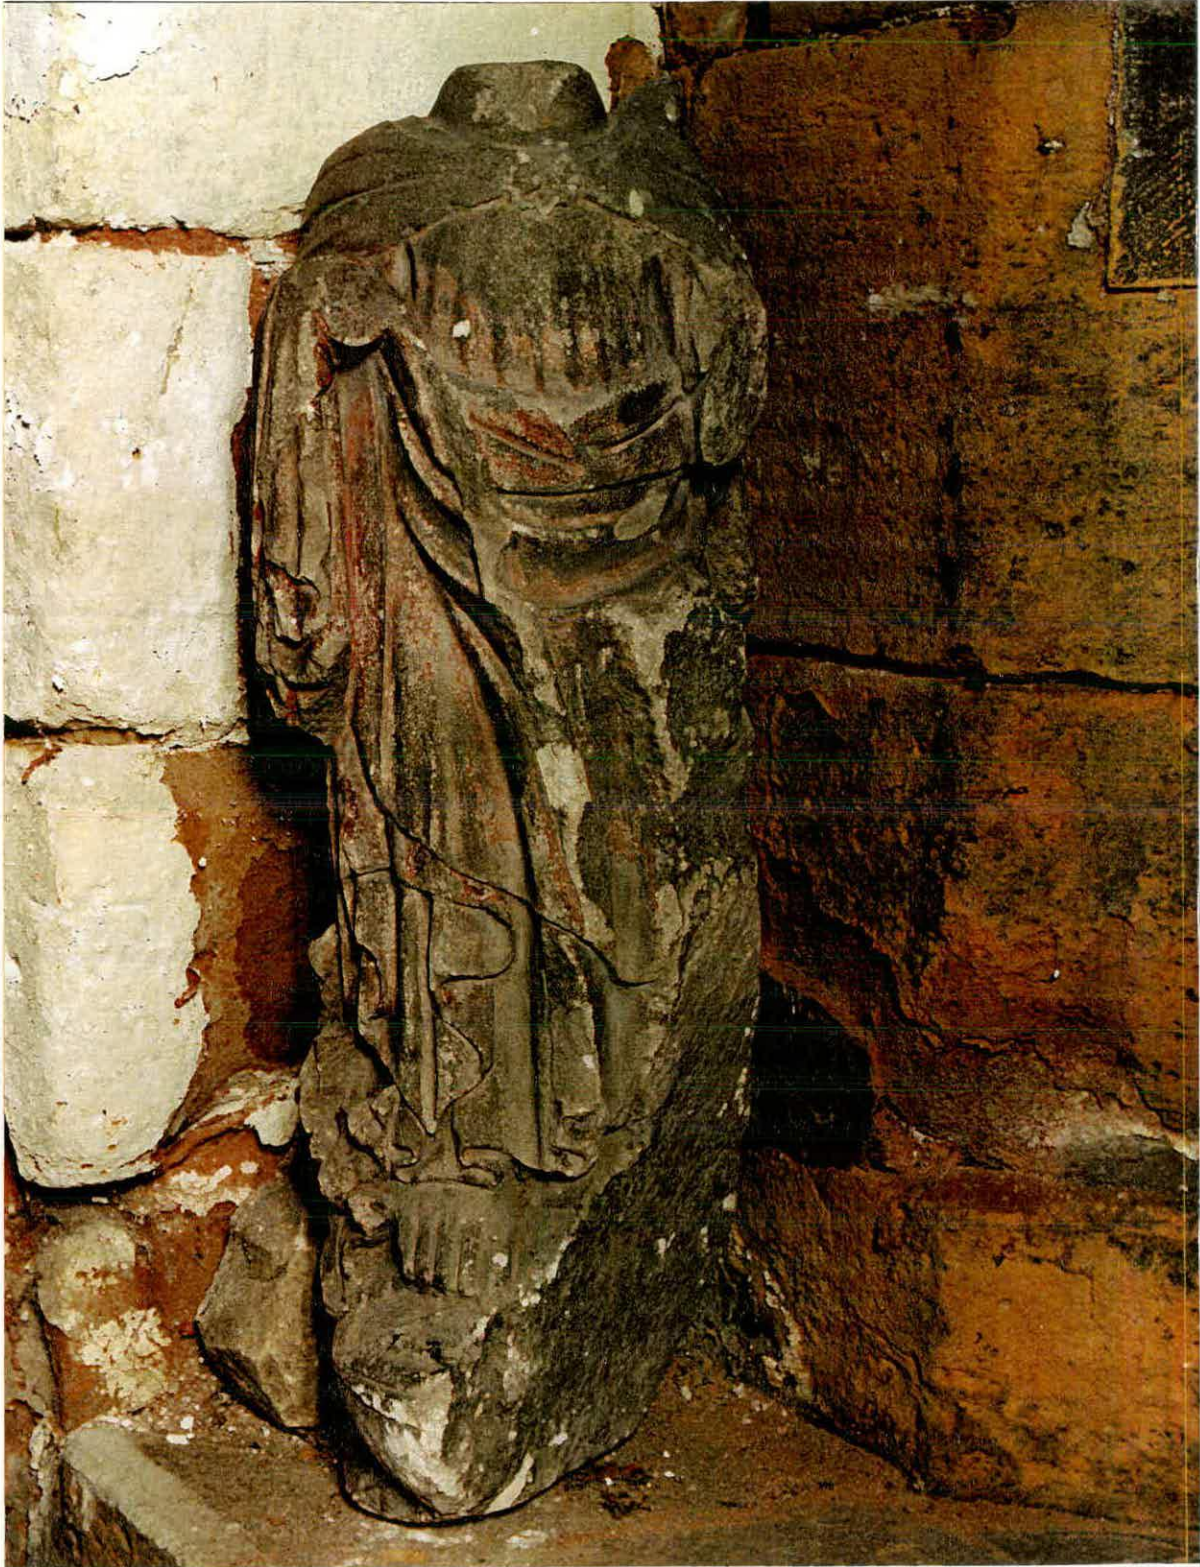
Fig. 9. The carved figure of an angel, probably discovered in the priory church at Worksop in 1847, and now located in the gatehouse.

127 The most obvious comparisons with triptych design might be drawn with the well-known Bishop John de Grandison ivories of c. 1330–40: see Alexander and Binski 1987, 465–67; also Stone 1972, 172–73. Accurate measurements have not yet been taken, but the fragments of figures found in the church in the 1840s (figs. 9 and 10) seem of a scale similar to what one might expect in the 'porch' sculpture.

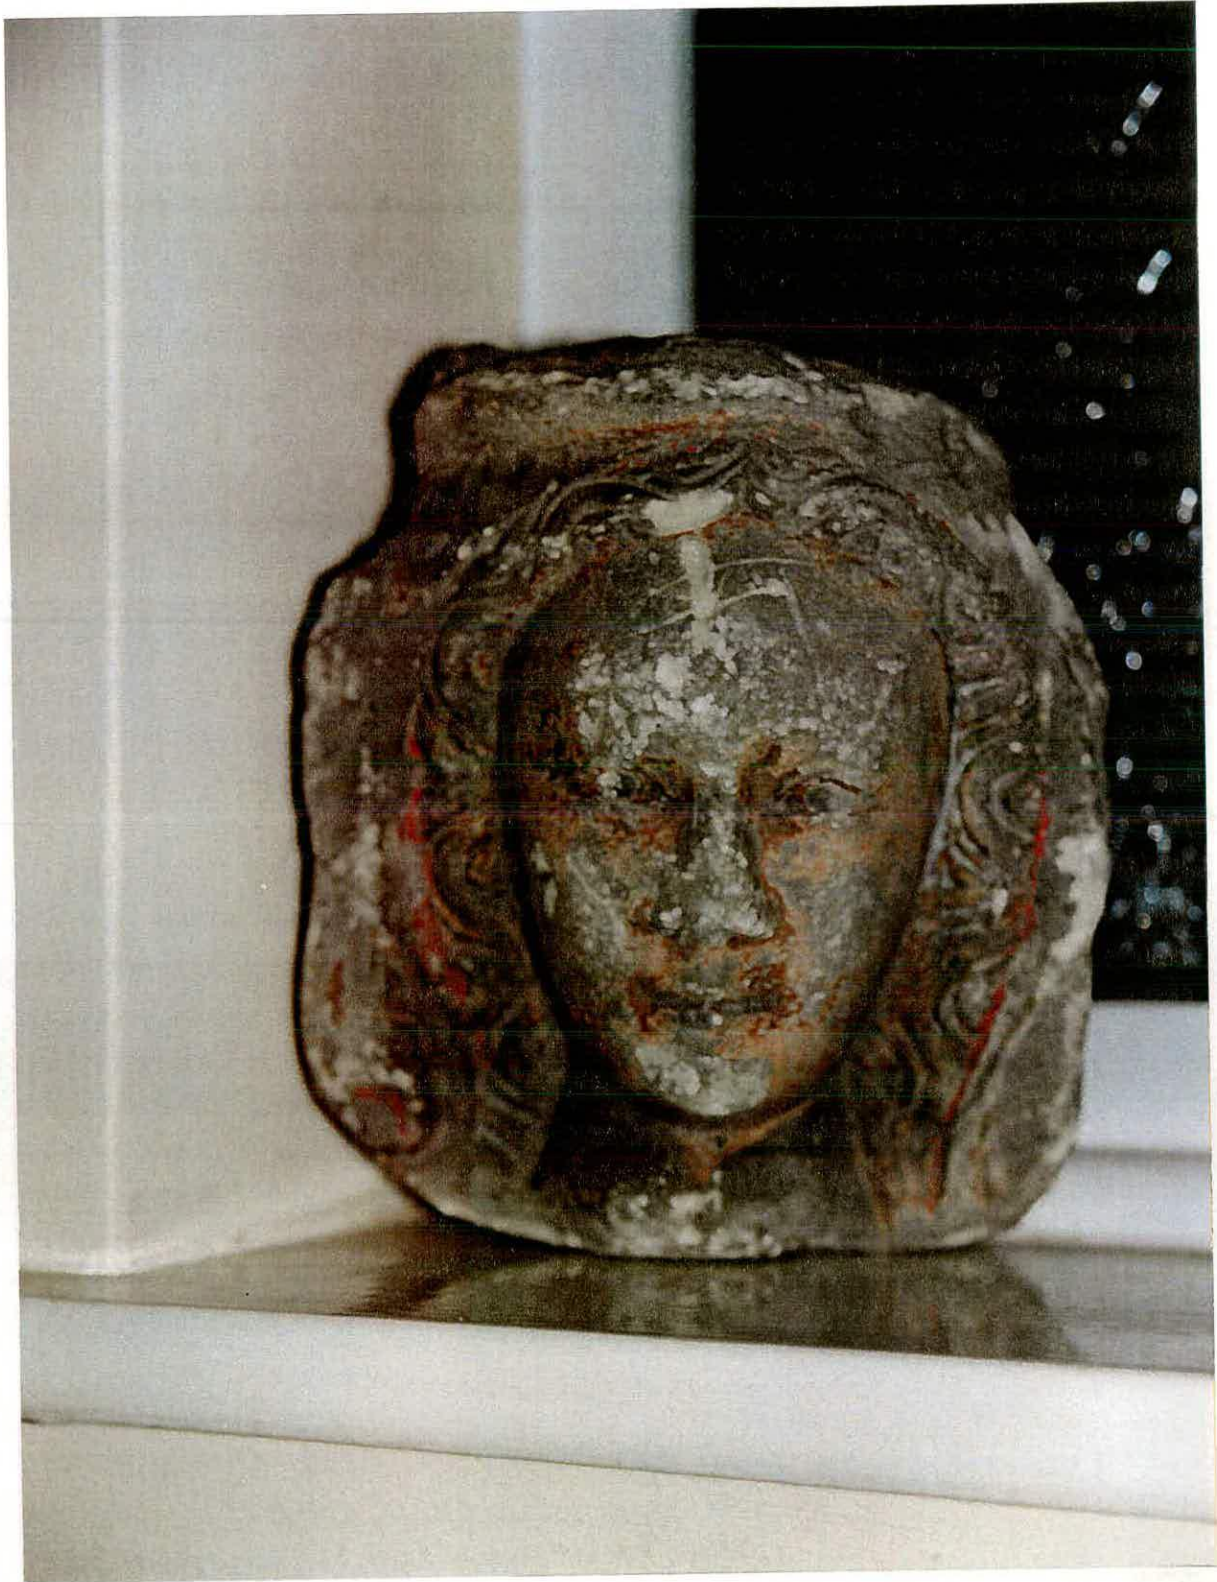
Fig. 10. Carved female head, probably discovered in the priory church at Worksop in 1847, and now kept at the vicarage.

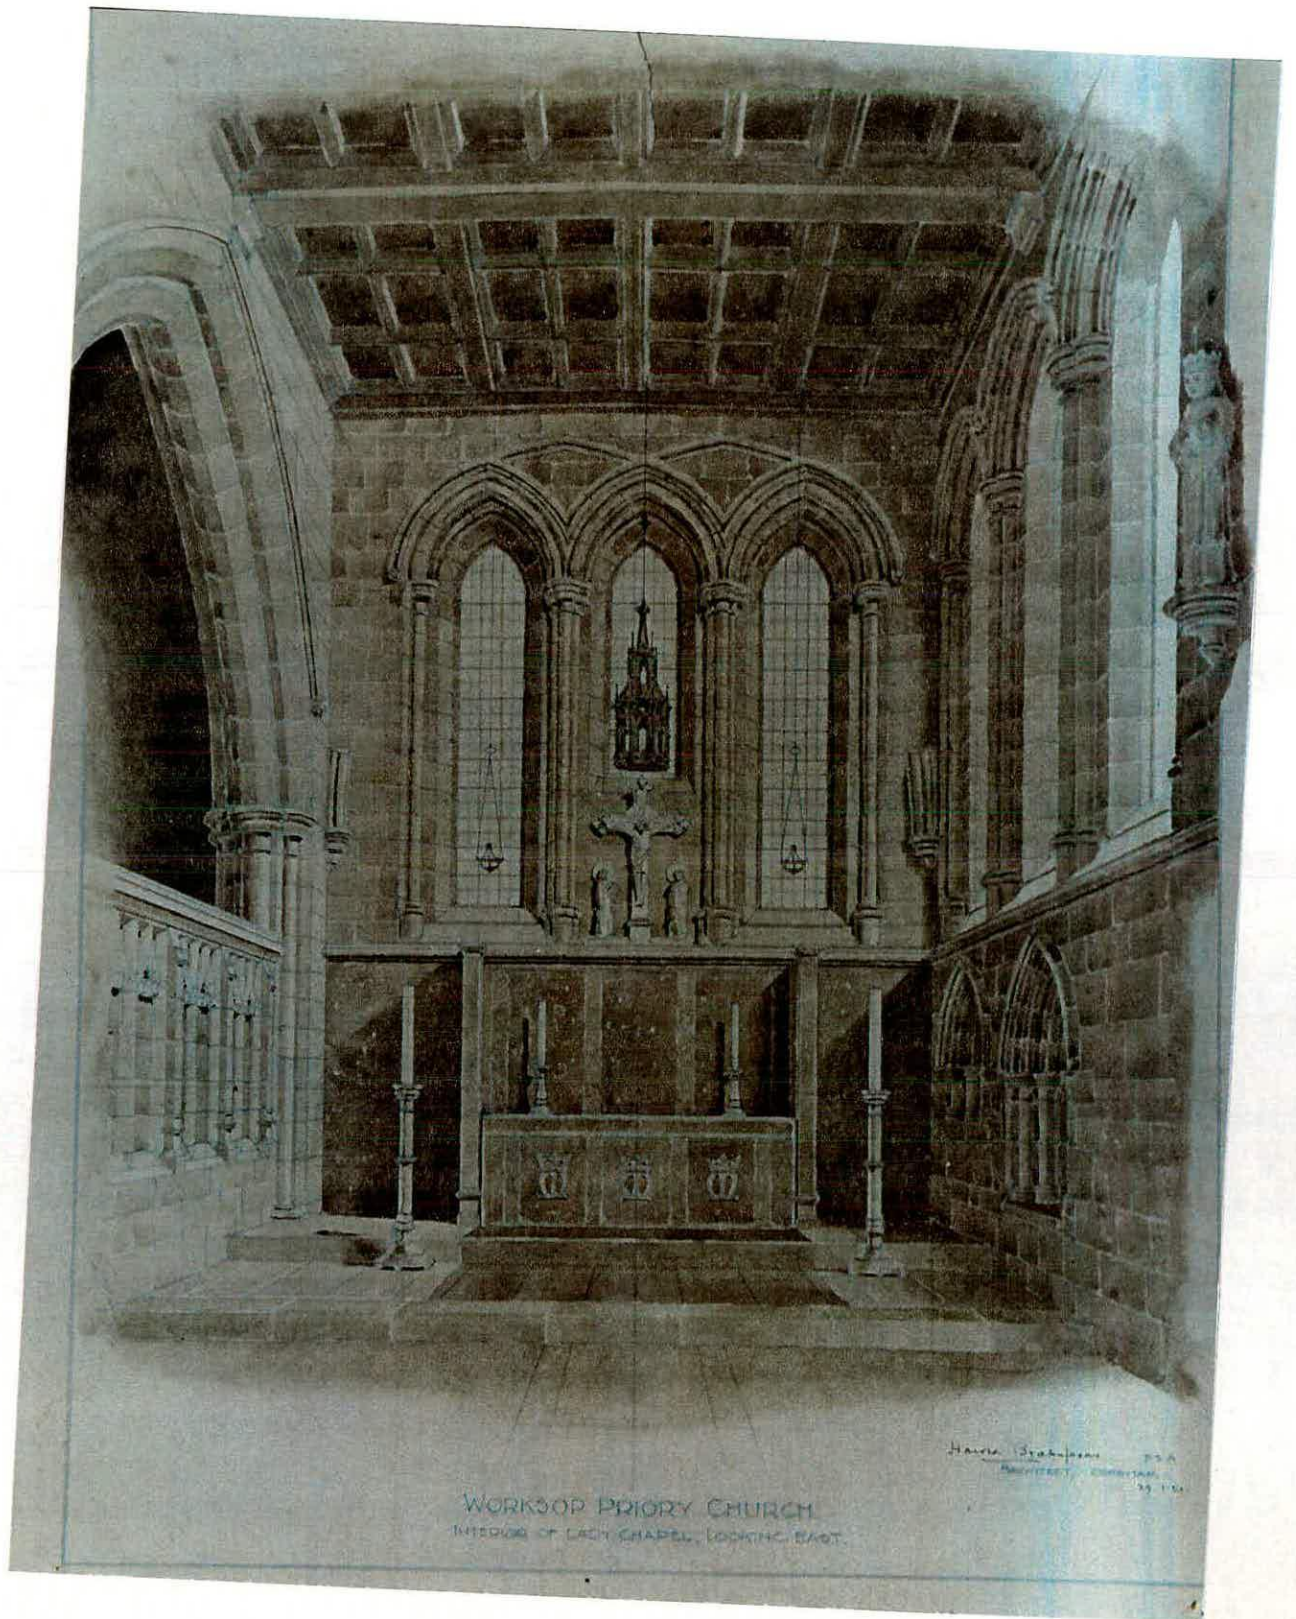
Fig. 15 Sketch of the restored Worksop Lady Chapel scheme by Harold Brakspear, 1919–22 (by courtesy of Mr Thomas Brakspear).

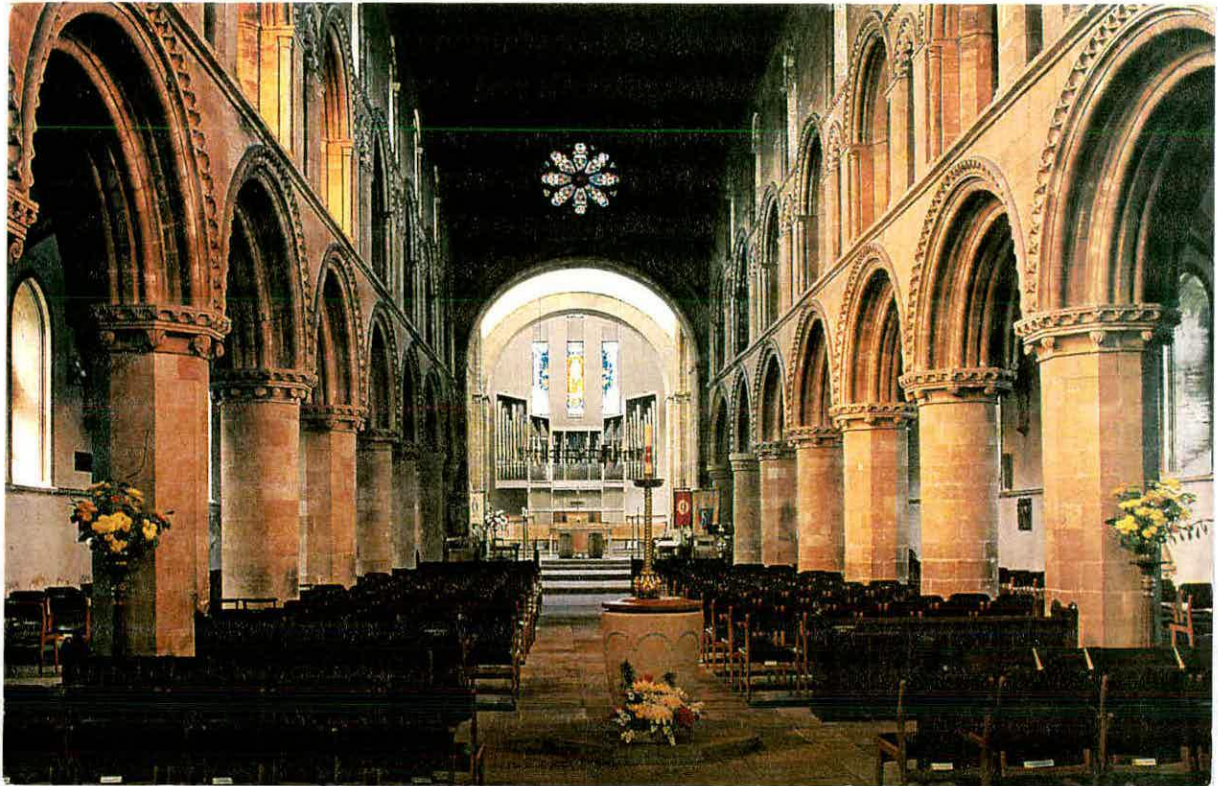
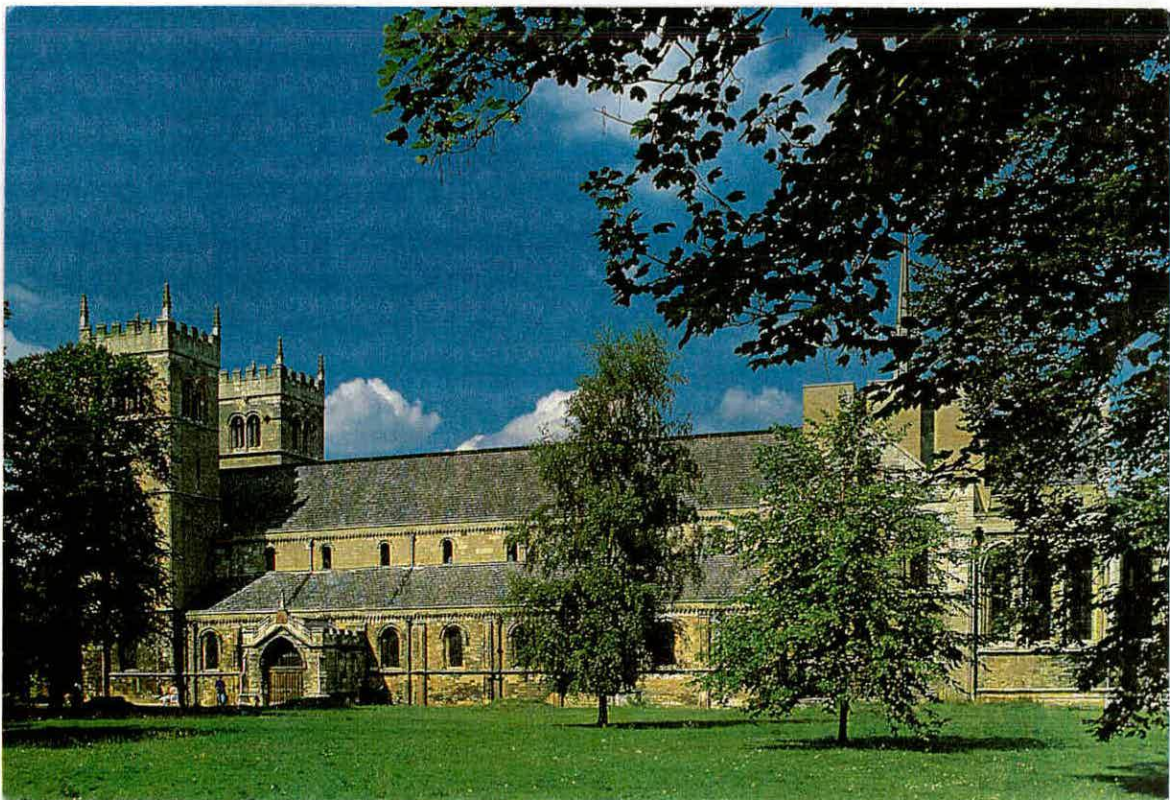
Fig. 17. Two views of Worksop Priory church today: the nave interior looking east (above) and the church from the south-east (below).

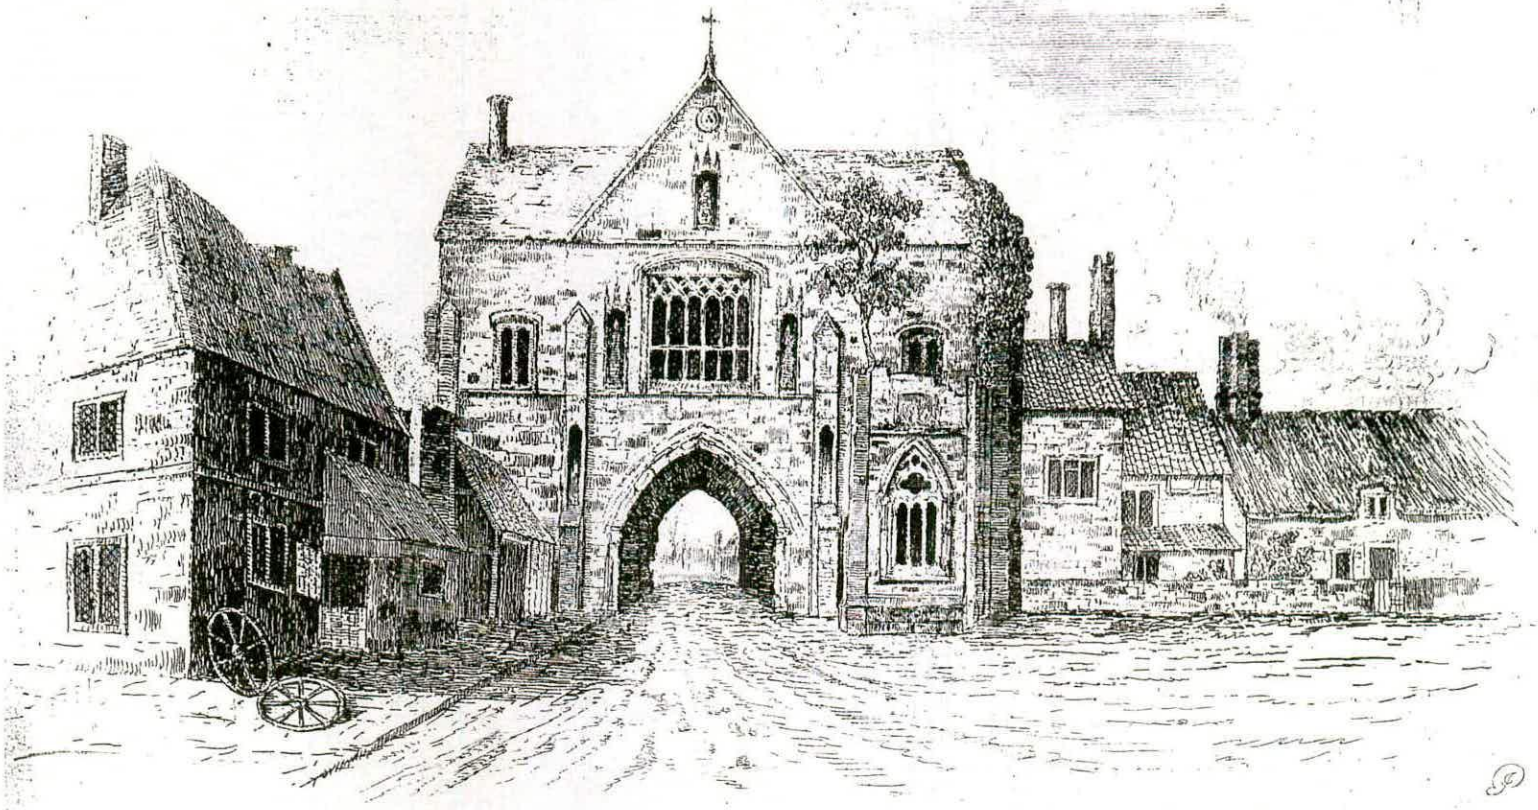
Fig. 19. Sketch showing the south side of Workshop Priory gatehouse, published by John Holland in 1826. Note the 'Old Parsonage' apparently attached to the east side of the building.

As part of the implied modifications, the segmental-headed window in the east wall of the chapel was partially blocked and converted to a two-centred arch. This arch would have allowed passage right through the wall, probably into a new building on this side of the gatehouse. Such a building might well have been covered with lead, perhaps at the level of the lower scar. Since access to this addition may well have been via the 'porch' and chapel, it seems reasonable to suggest an overall enlargement of the chapel, in which case the wall opening would have served as a chancel arch. The scar from the higher roof may relate to a subsequent increase in the height of this already enlarged chapel. The post-monastic legacy of this eastwards extension can be seen in early illustrations (fig. 19).

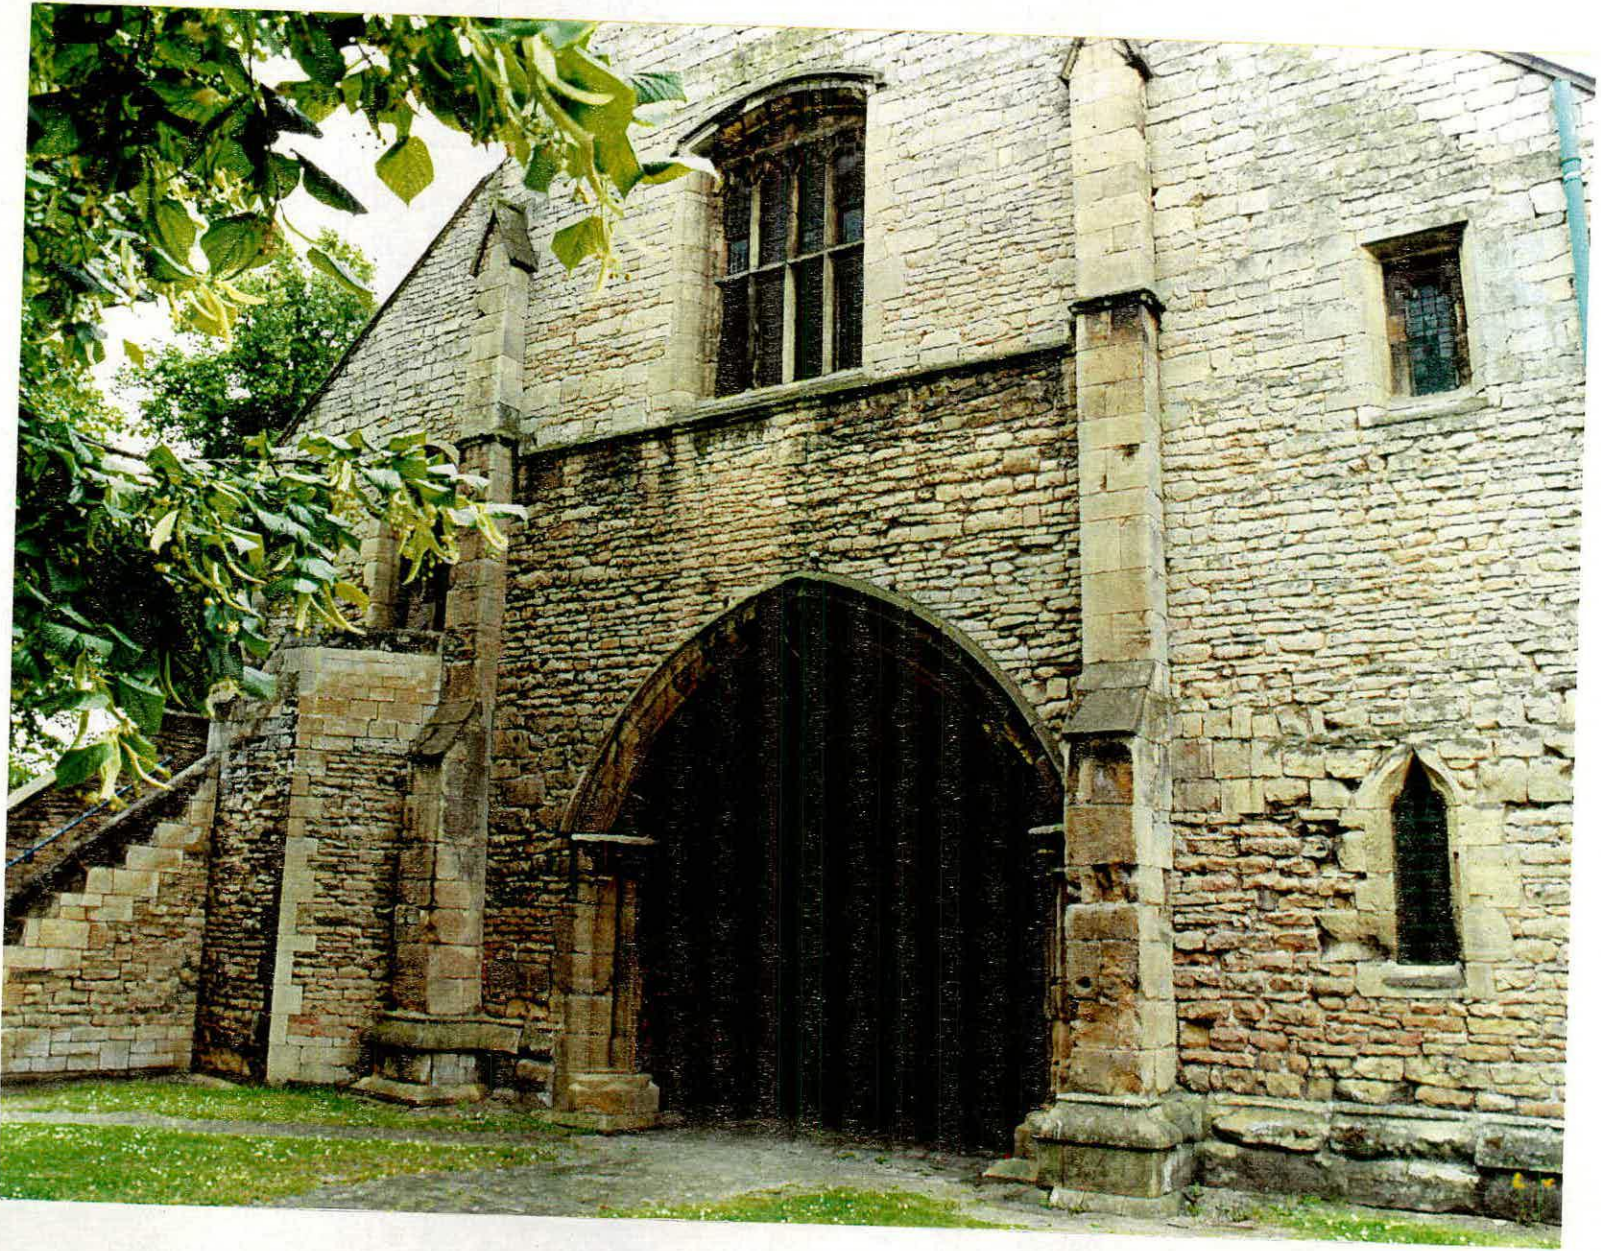
Fig. 34. General view of the north façade of the gatehouse.

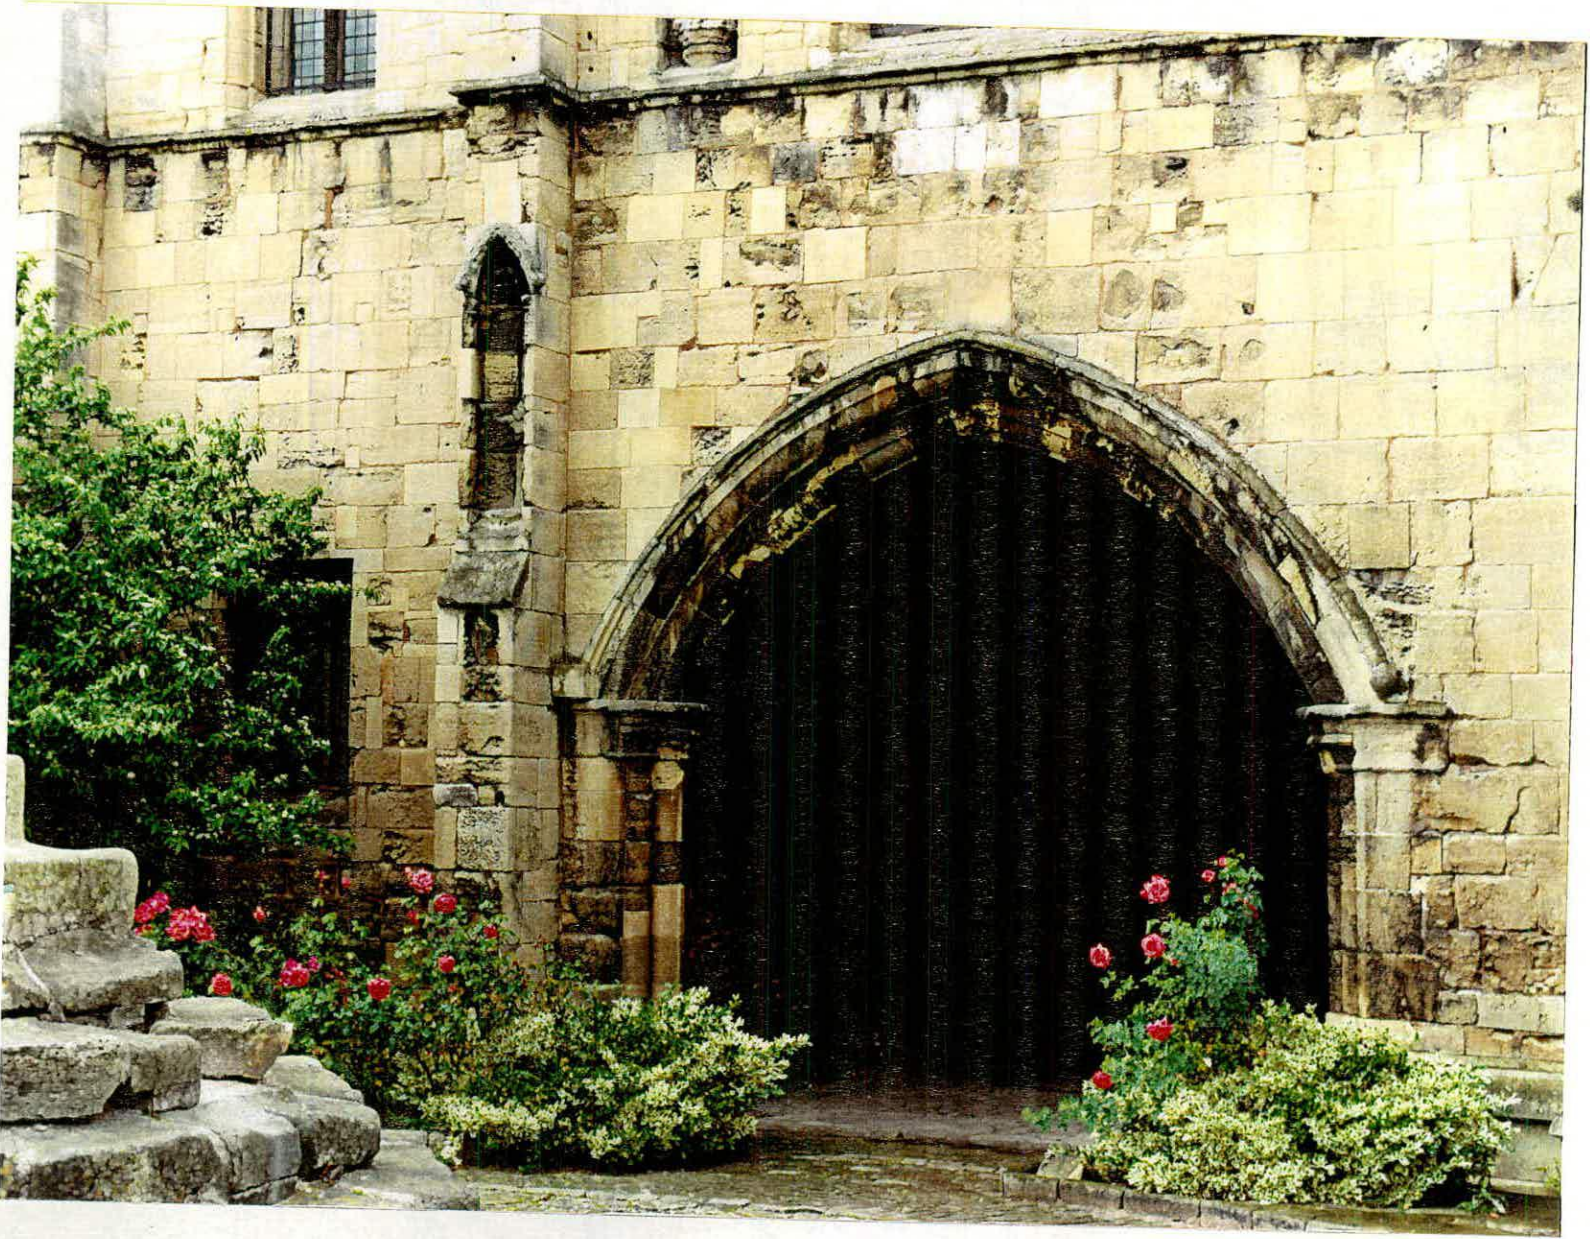
Fig. 35. A view of the southern gate-arch, with its triple shaft responds and wave-moulded head. Note the empty niche in the west buttress.

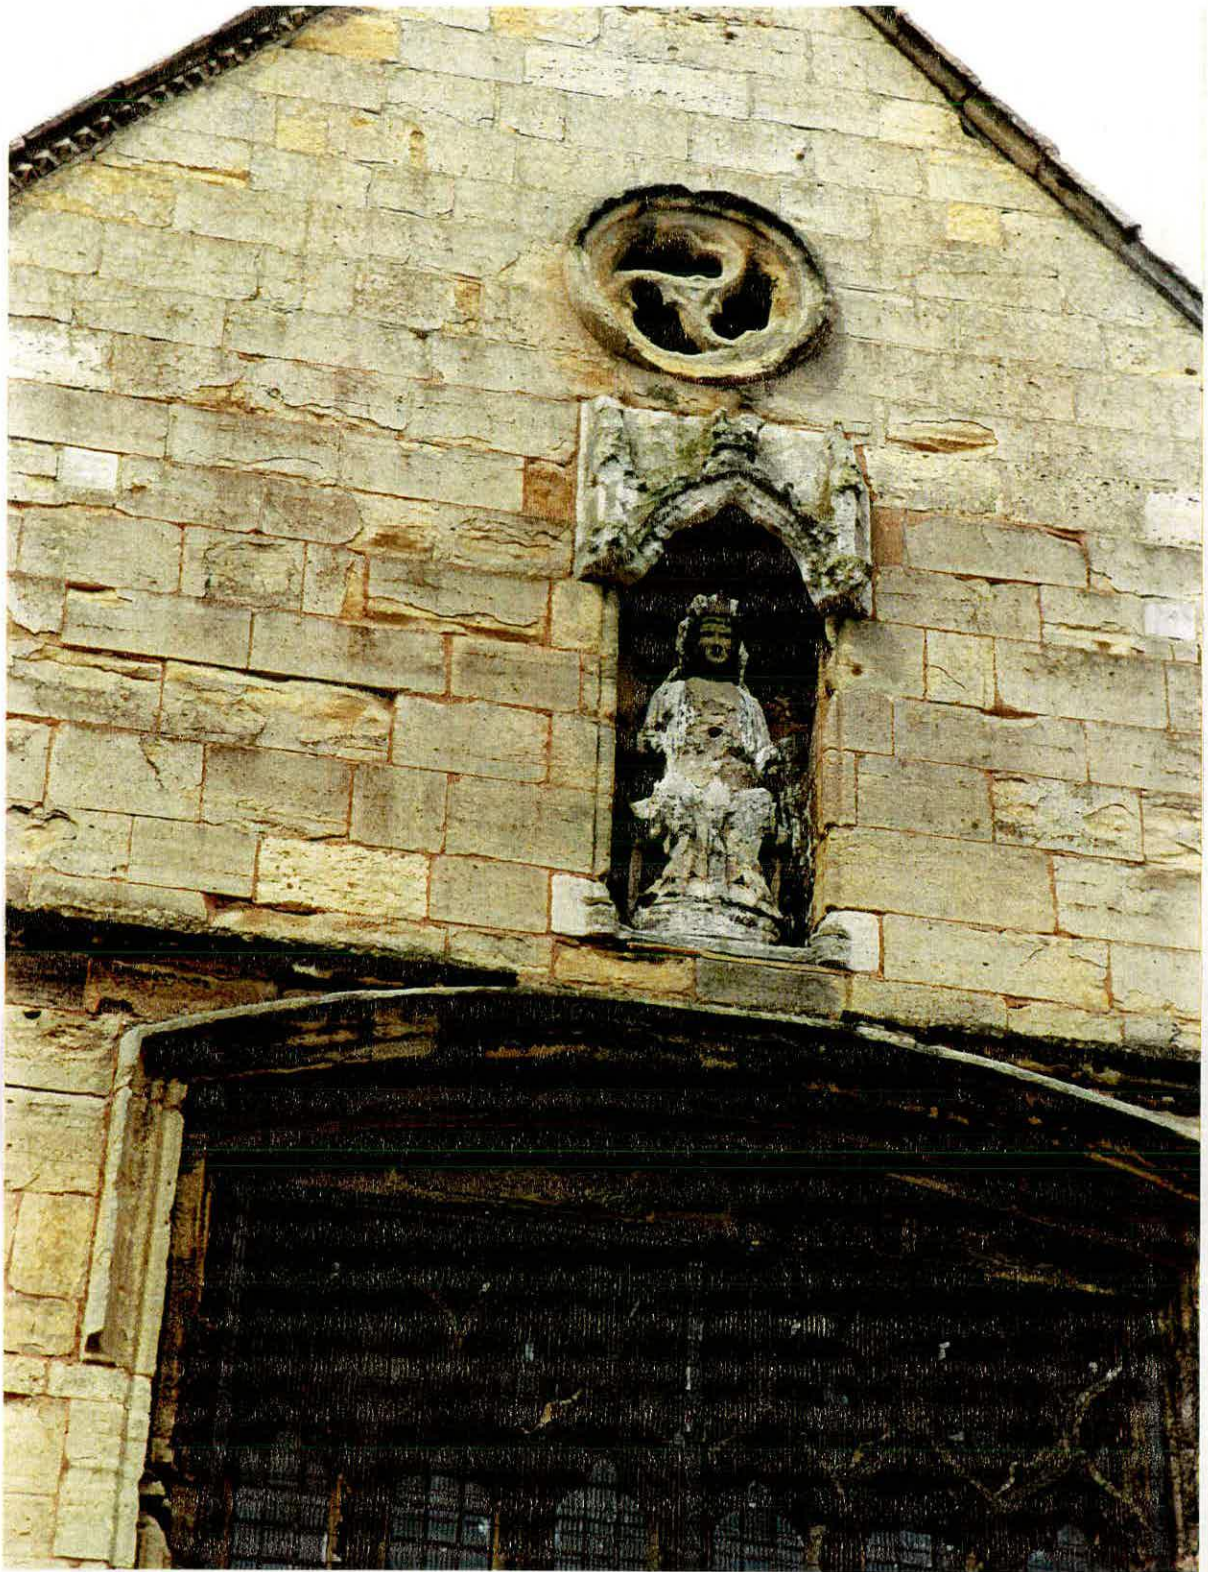
Fig. 37. Niche and figure sculpture in the south gable of the gatehouse. The niche has an ogee head, framed with pinnacles. The figure (with replacement head) has been identified as God the Father from a Trinity group.

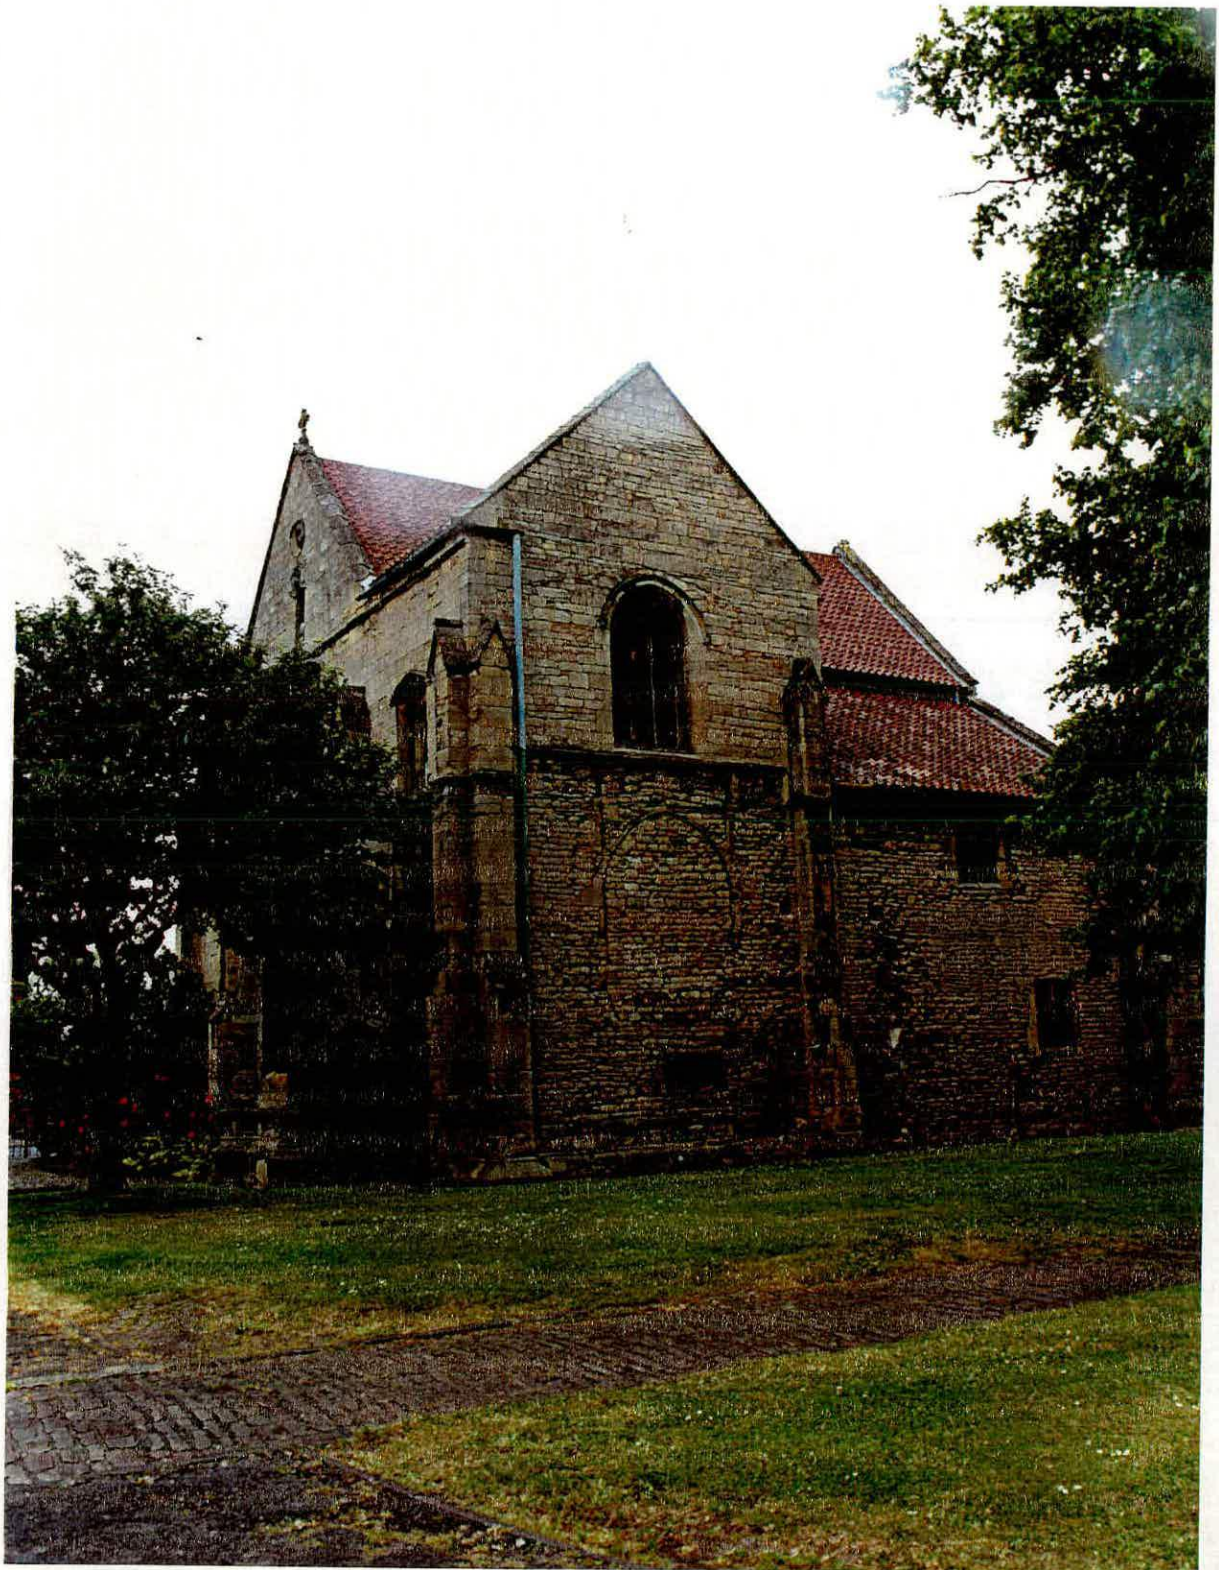
Fig. 40. A general view of the east façade of the gatehouse. In the left (south) bay there are traces of two phases of arch or window beneath the moulded string course. There are also two faint lines of lead roof creasing.

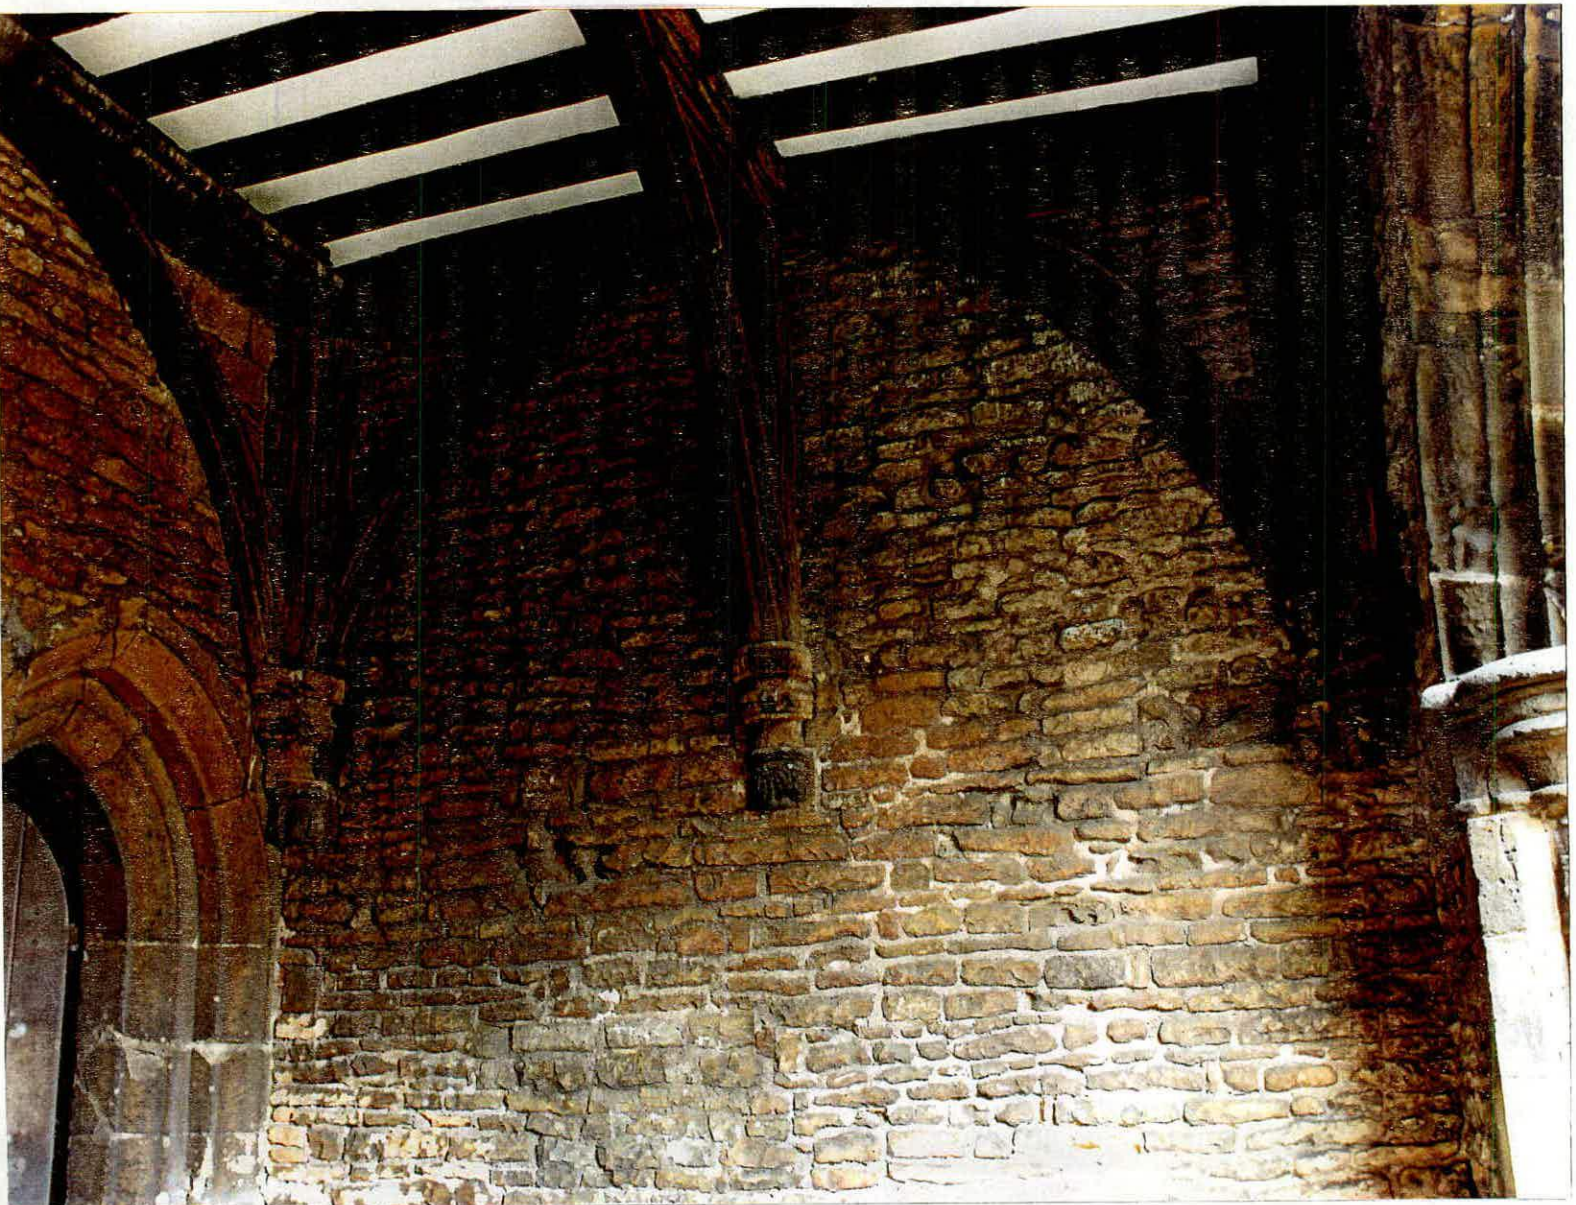
Fig. 41. Detail of the east face in the outer bay of the gate-passage. The narrow pedestrian gate-arch can be seen to the bottom left. The timbers of the ceiling have been dated by dendrochronology to between 1374 and 1409, with a likely felling date of c. 1389.
