WORKSOP PRIORY GATEHOUSE NOTTINGHAMSHIRE

*An Architectural History
with an Account of the Significance of its Fabric*

Richard Lea and David M. Robinson

Historical Analysis & Research Team
Reports and Papers 37
2000

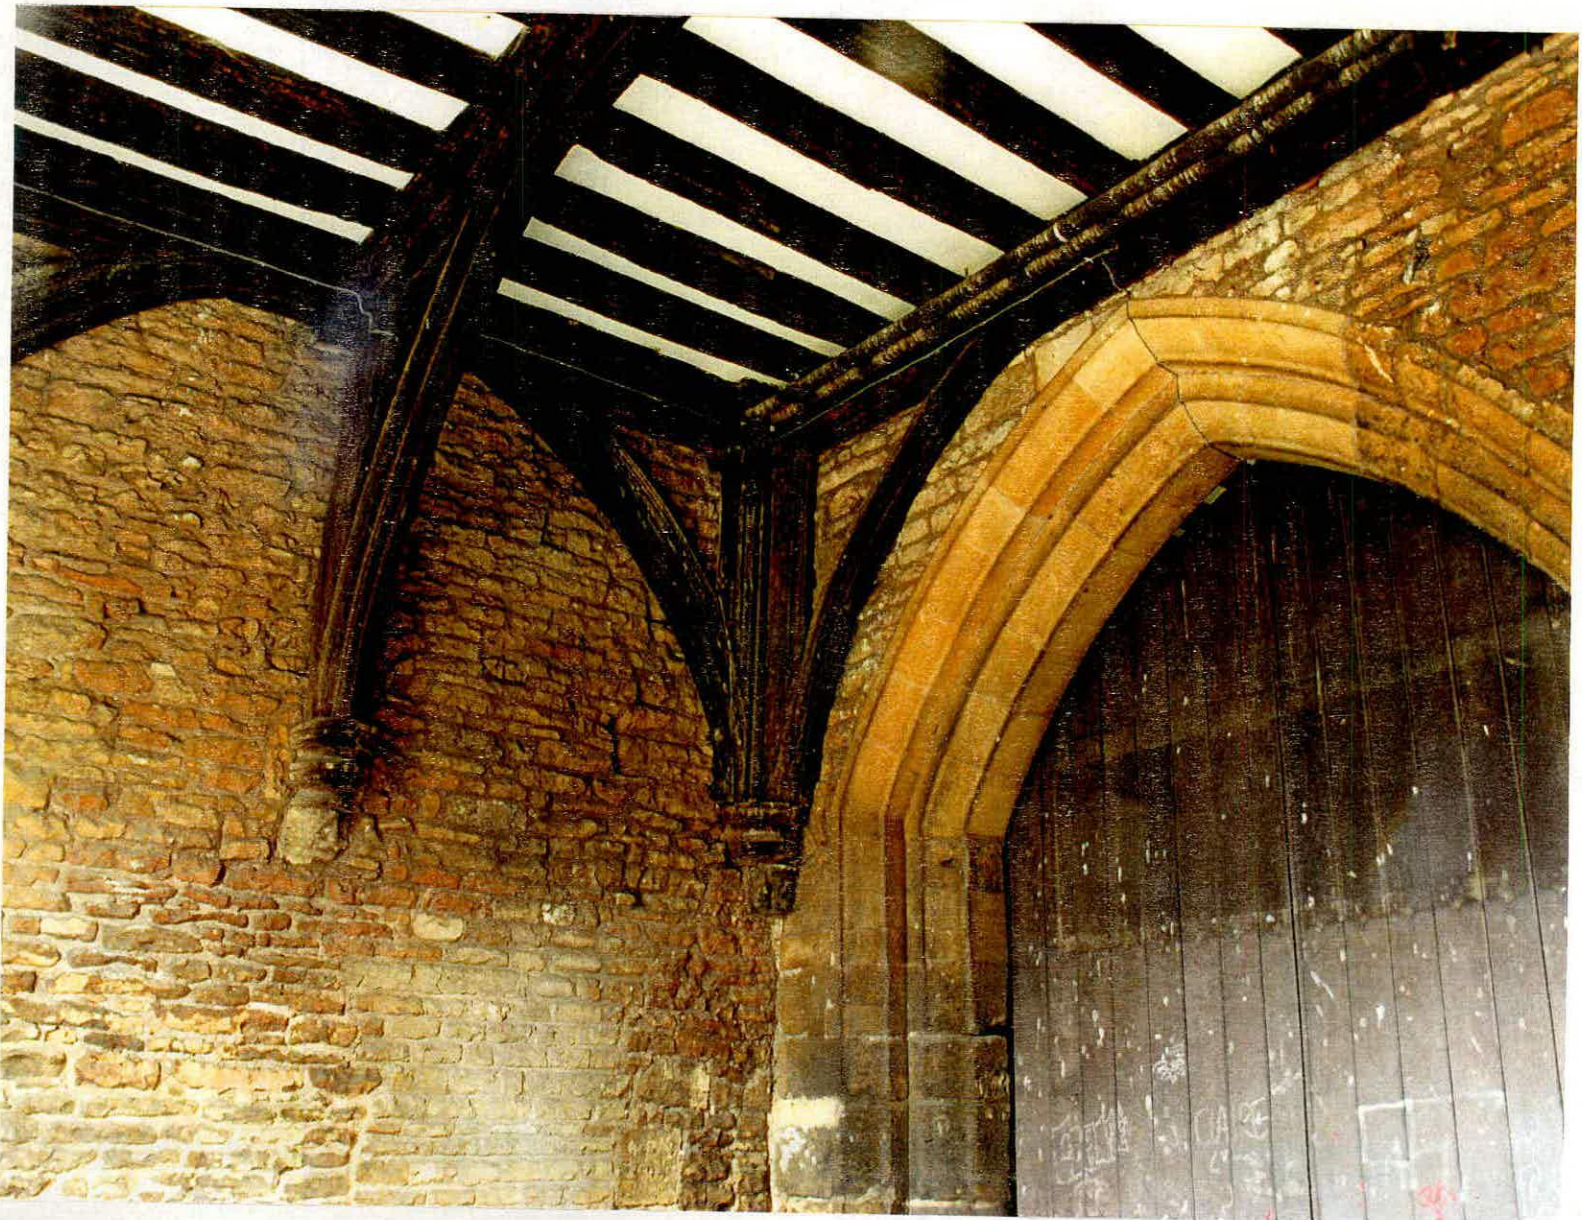
Fig. 42. Detail of the west side in the outer bay of the gate-passage. The large carriage arch into the priory precinct appears to the right.

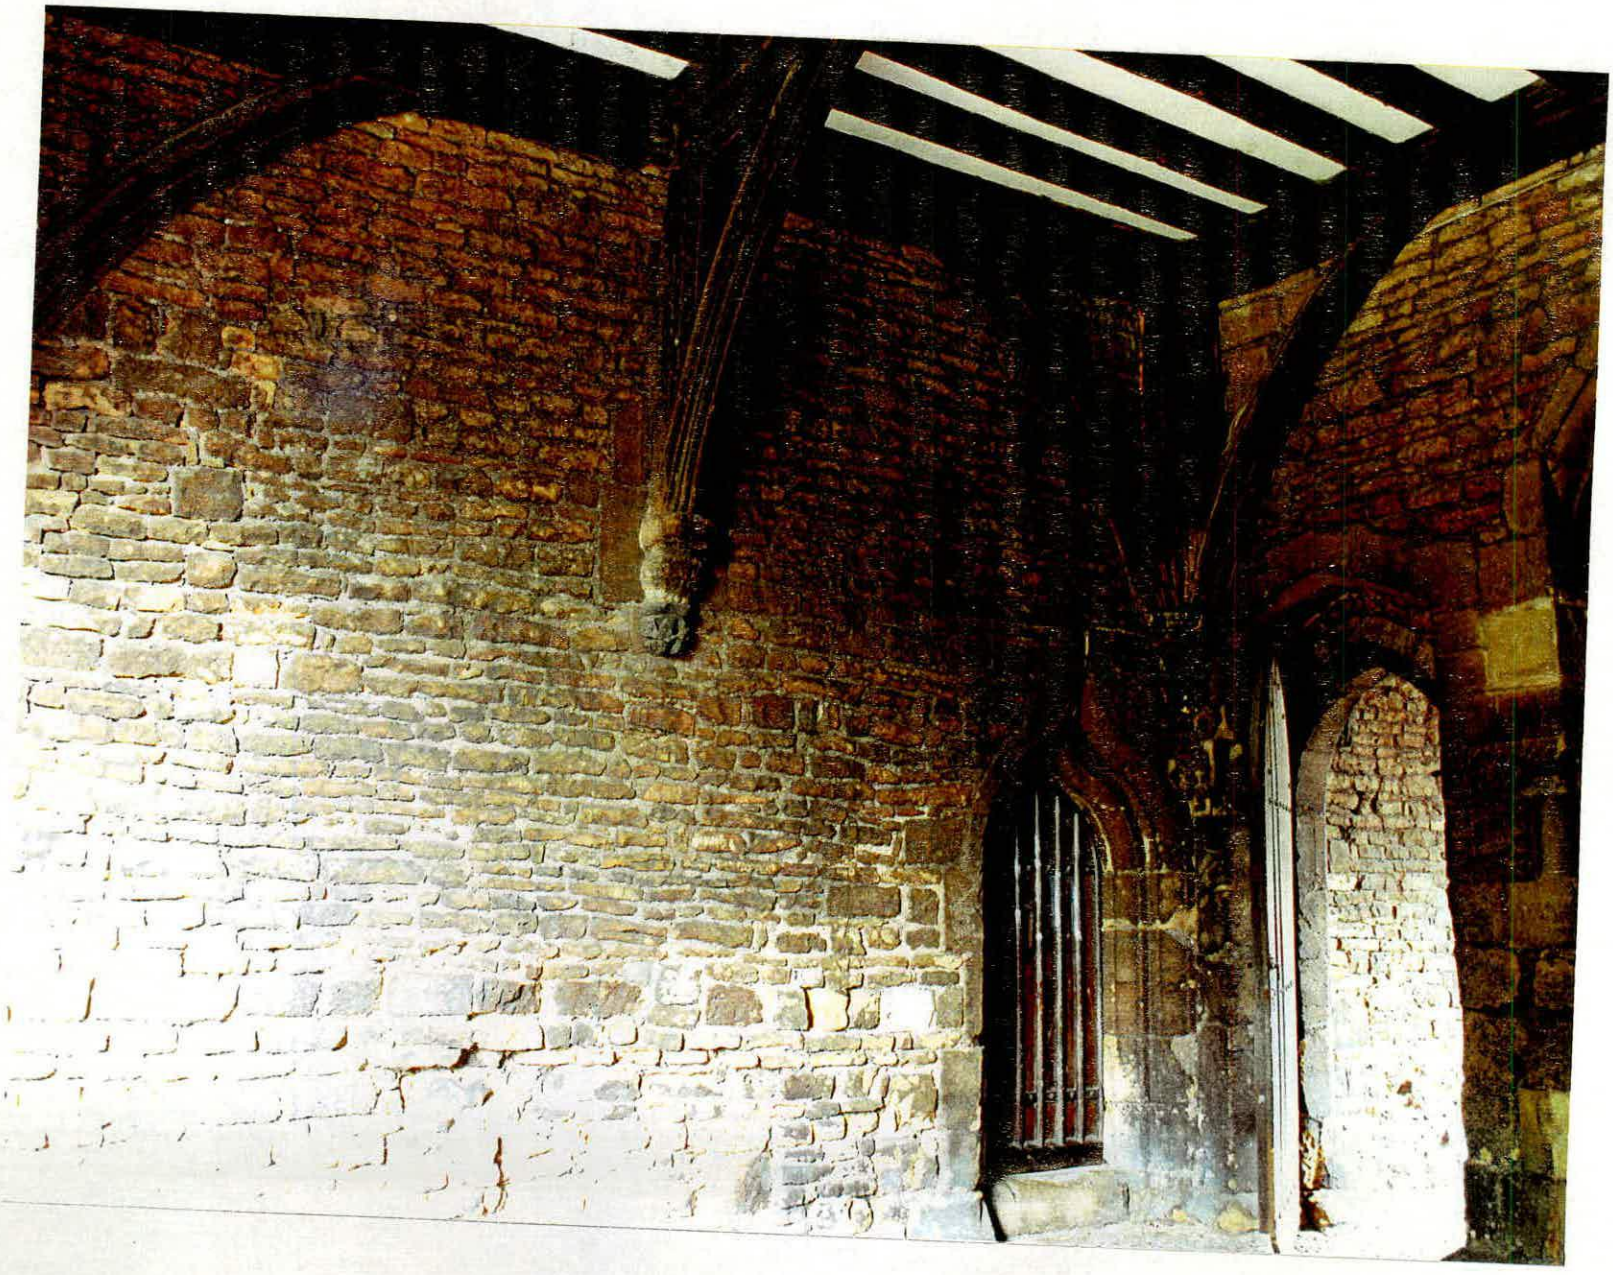
Fig. 43. Detail of the east side of the inner bay in the gate-passage. The open door to the right is the pedestrian access through the gate. The ogee-headed door leads into one of the porter's chambers.

we cannot entirely discount the possibility that this was the initial arrangement at Worksop. The use of large ashlar blocks over the stone corbels in the lateral walls of the rear bay hints at something other than that which survives today (figs. 43 and 44).

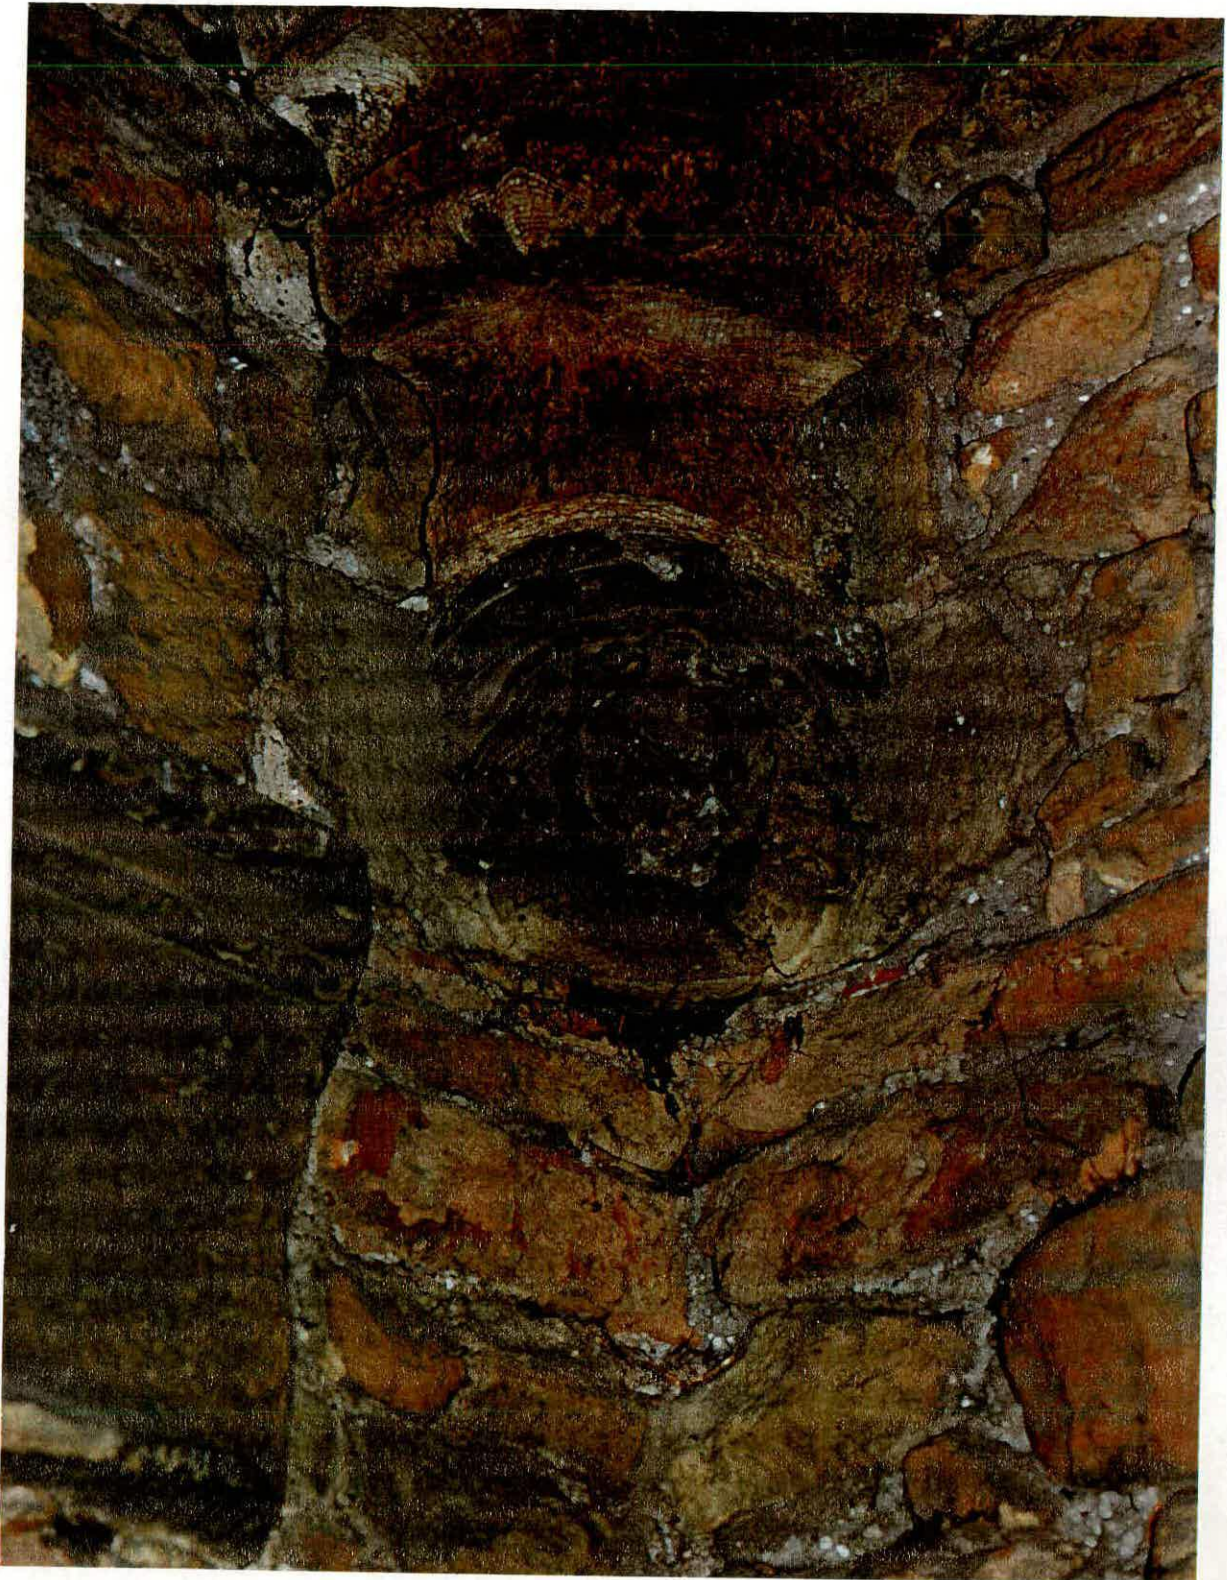
Fig. 45. An example of one of the head corbels supporting the moulded bases of the gate-passage roof structure.

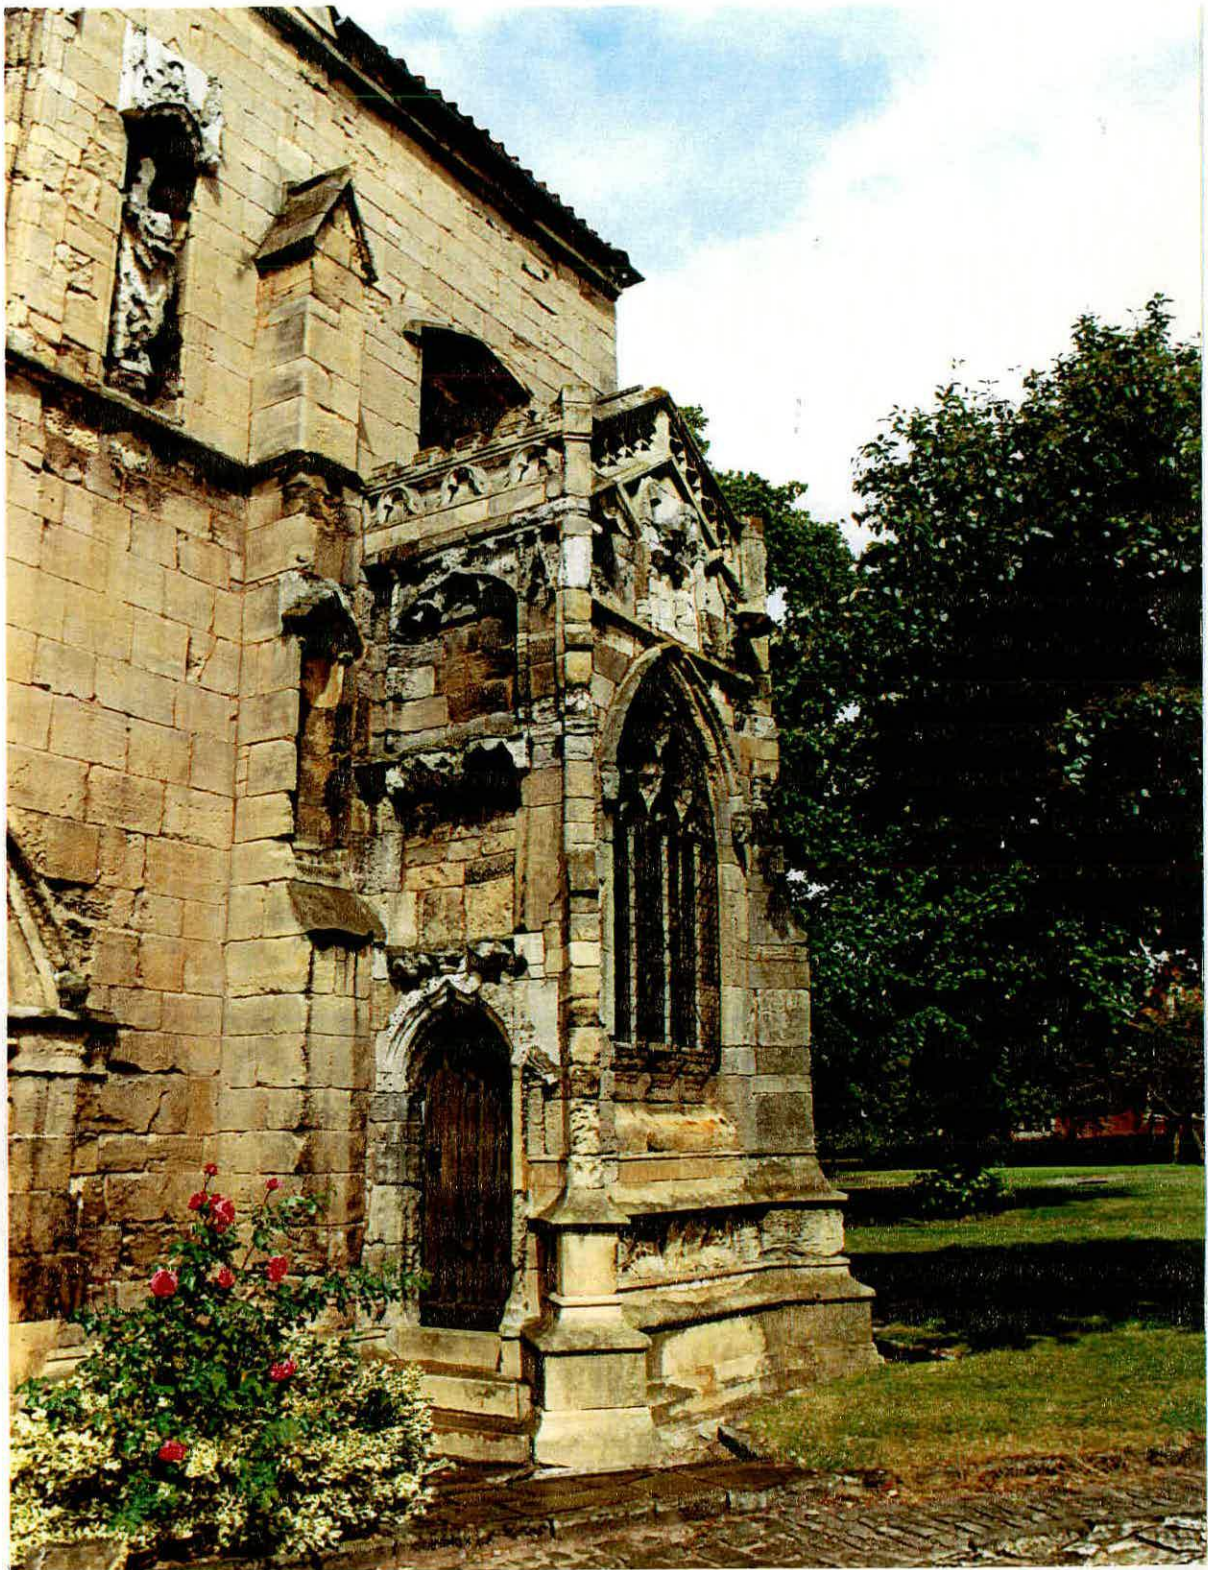
Fig. 46. A general view of the 'porch' added to the south side of the gatehouse, seen from the south-west. It is a rich example of micro-architecture of the first half of the fourteenth century. The upper stages were adorned with figure sculpture, almost certainly reflecting the contemporary importance of the cult of the Virgin.

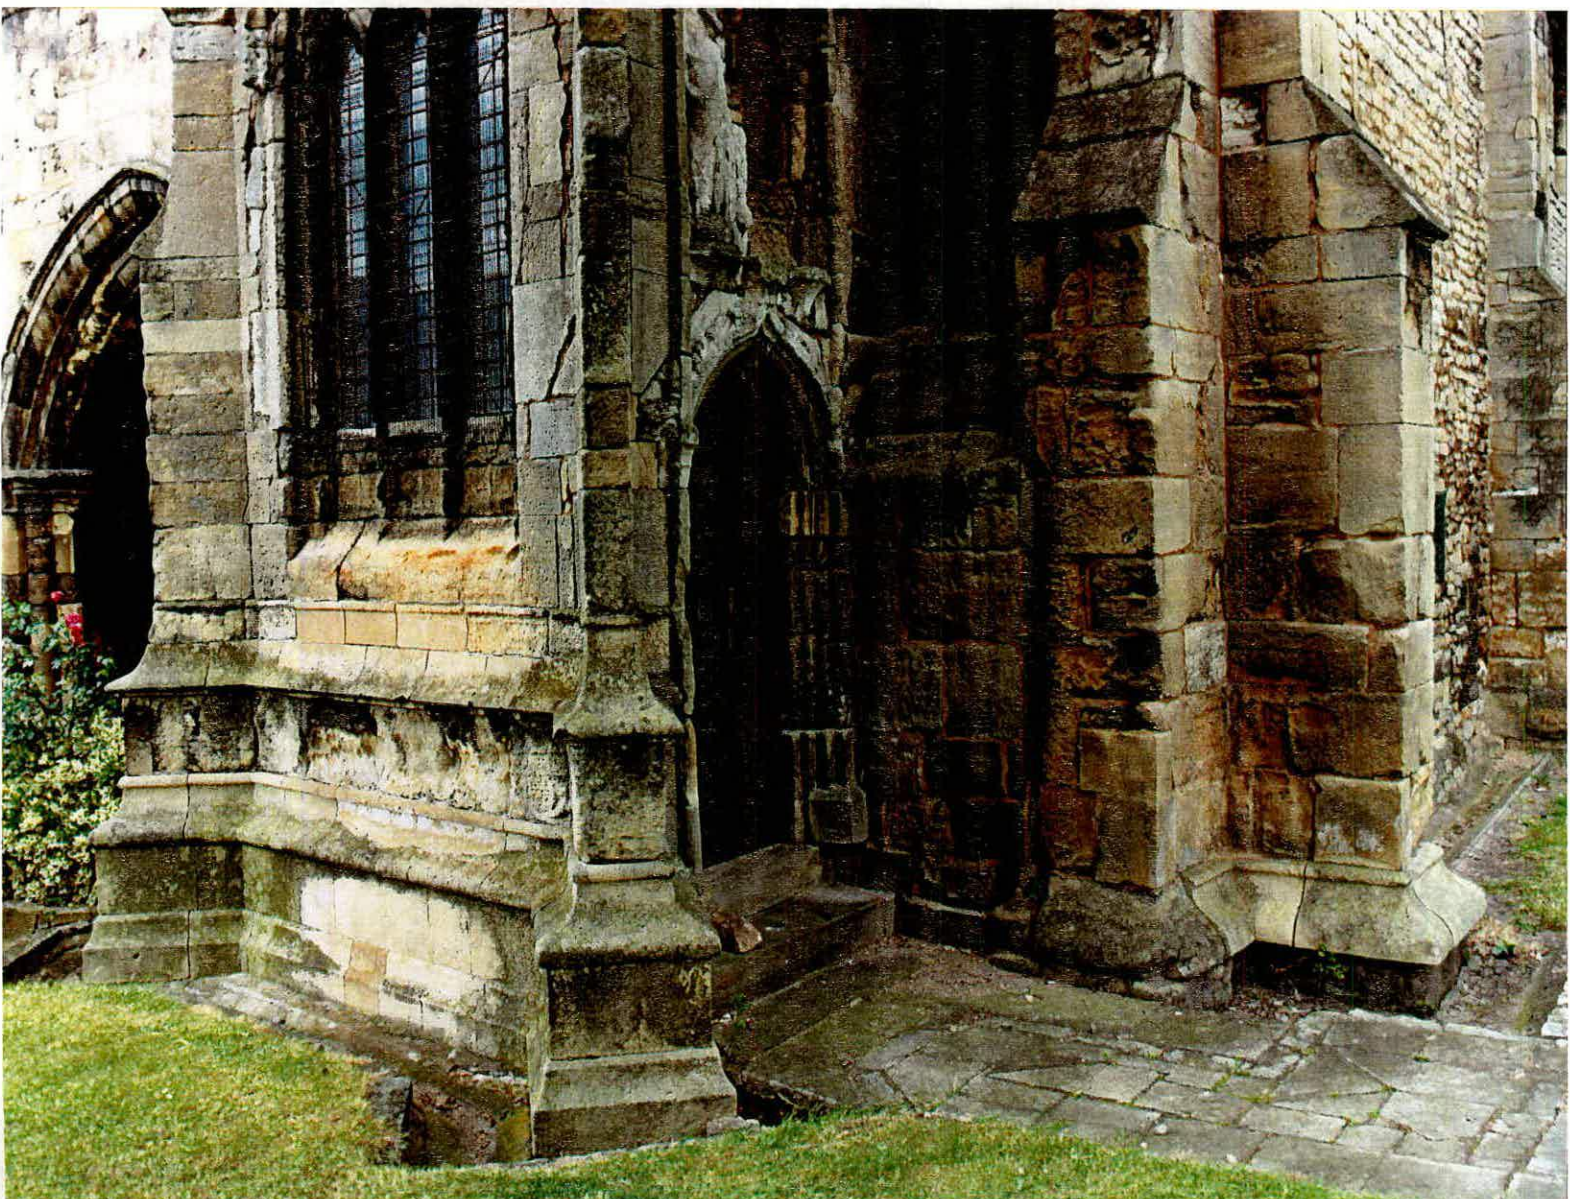
Fig. 47. Detail of the lower stage of the gatehouse 'porch' seen from the south-east.

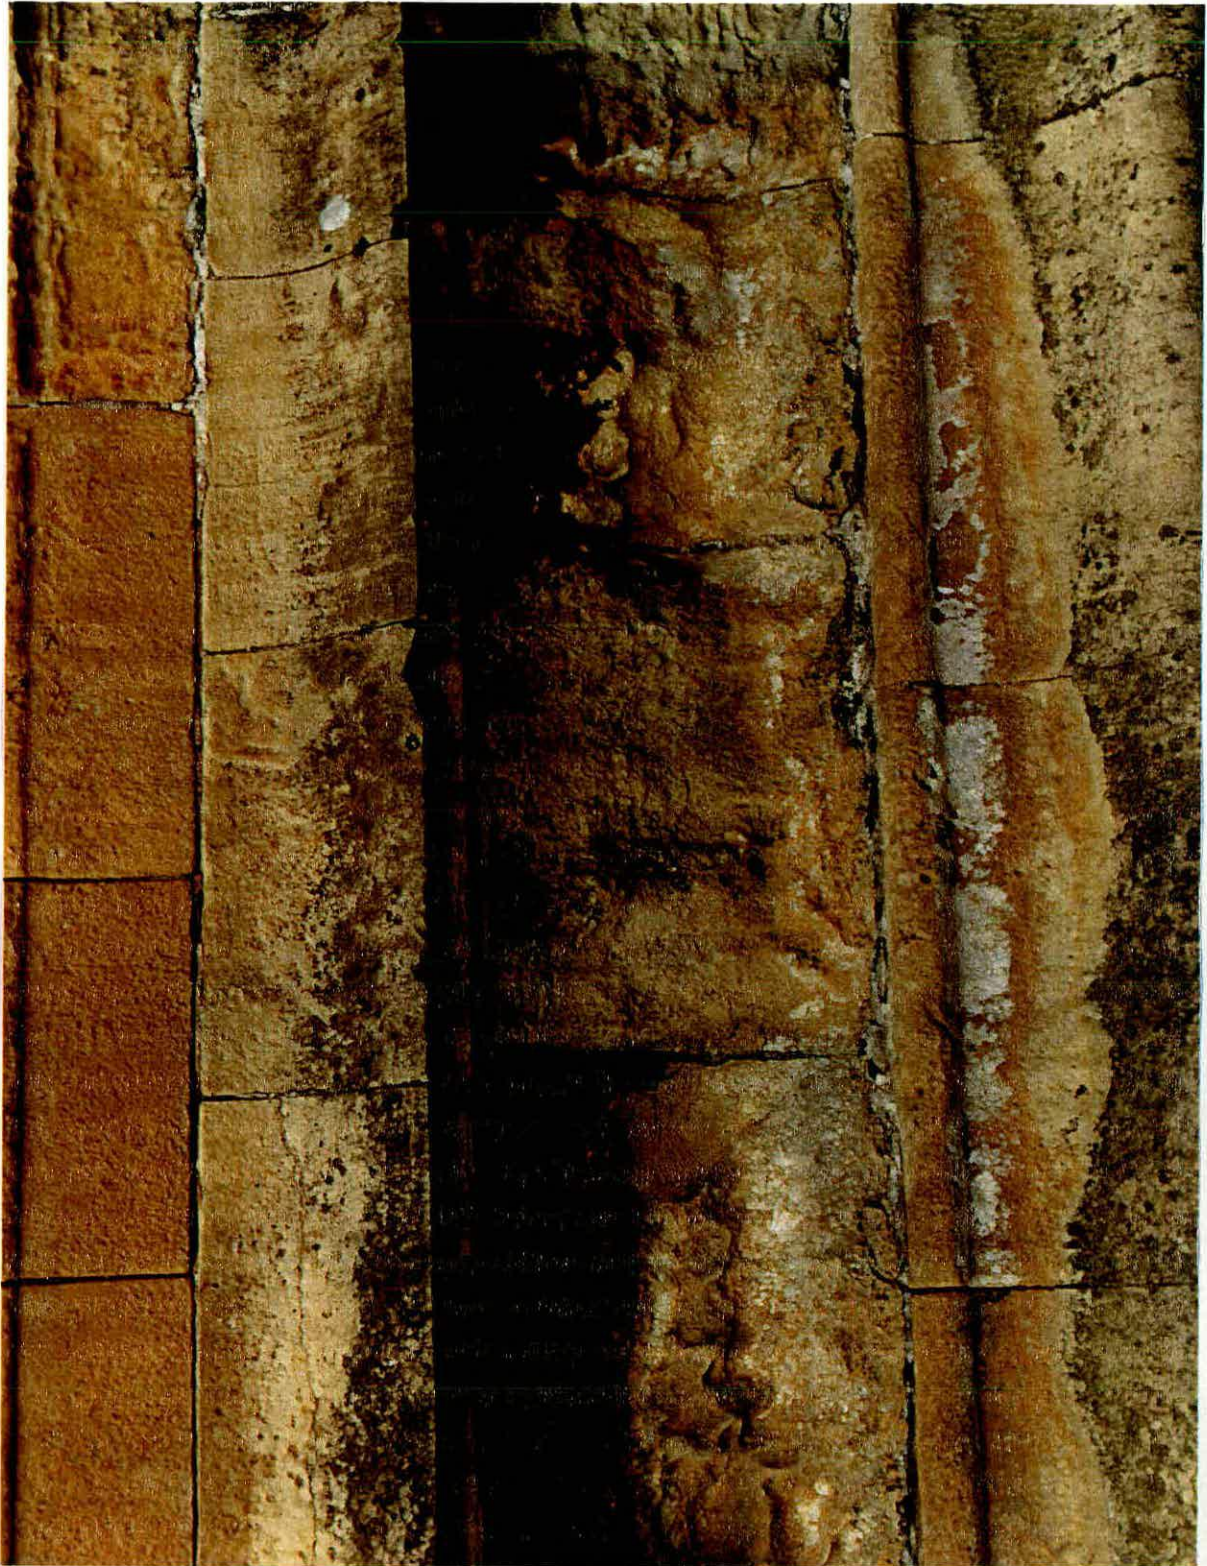
Fig. 48. Detail of the gatehouse 'porch', showing the eroded decorative band which carried blind tracery quatrefoils.

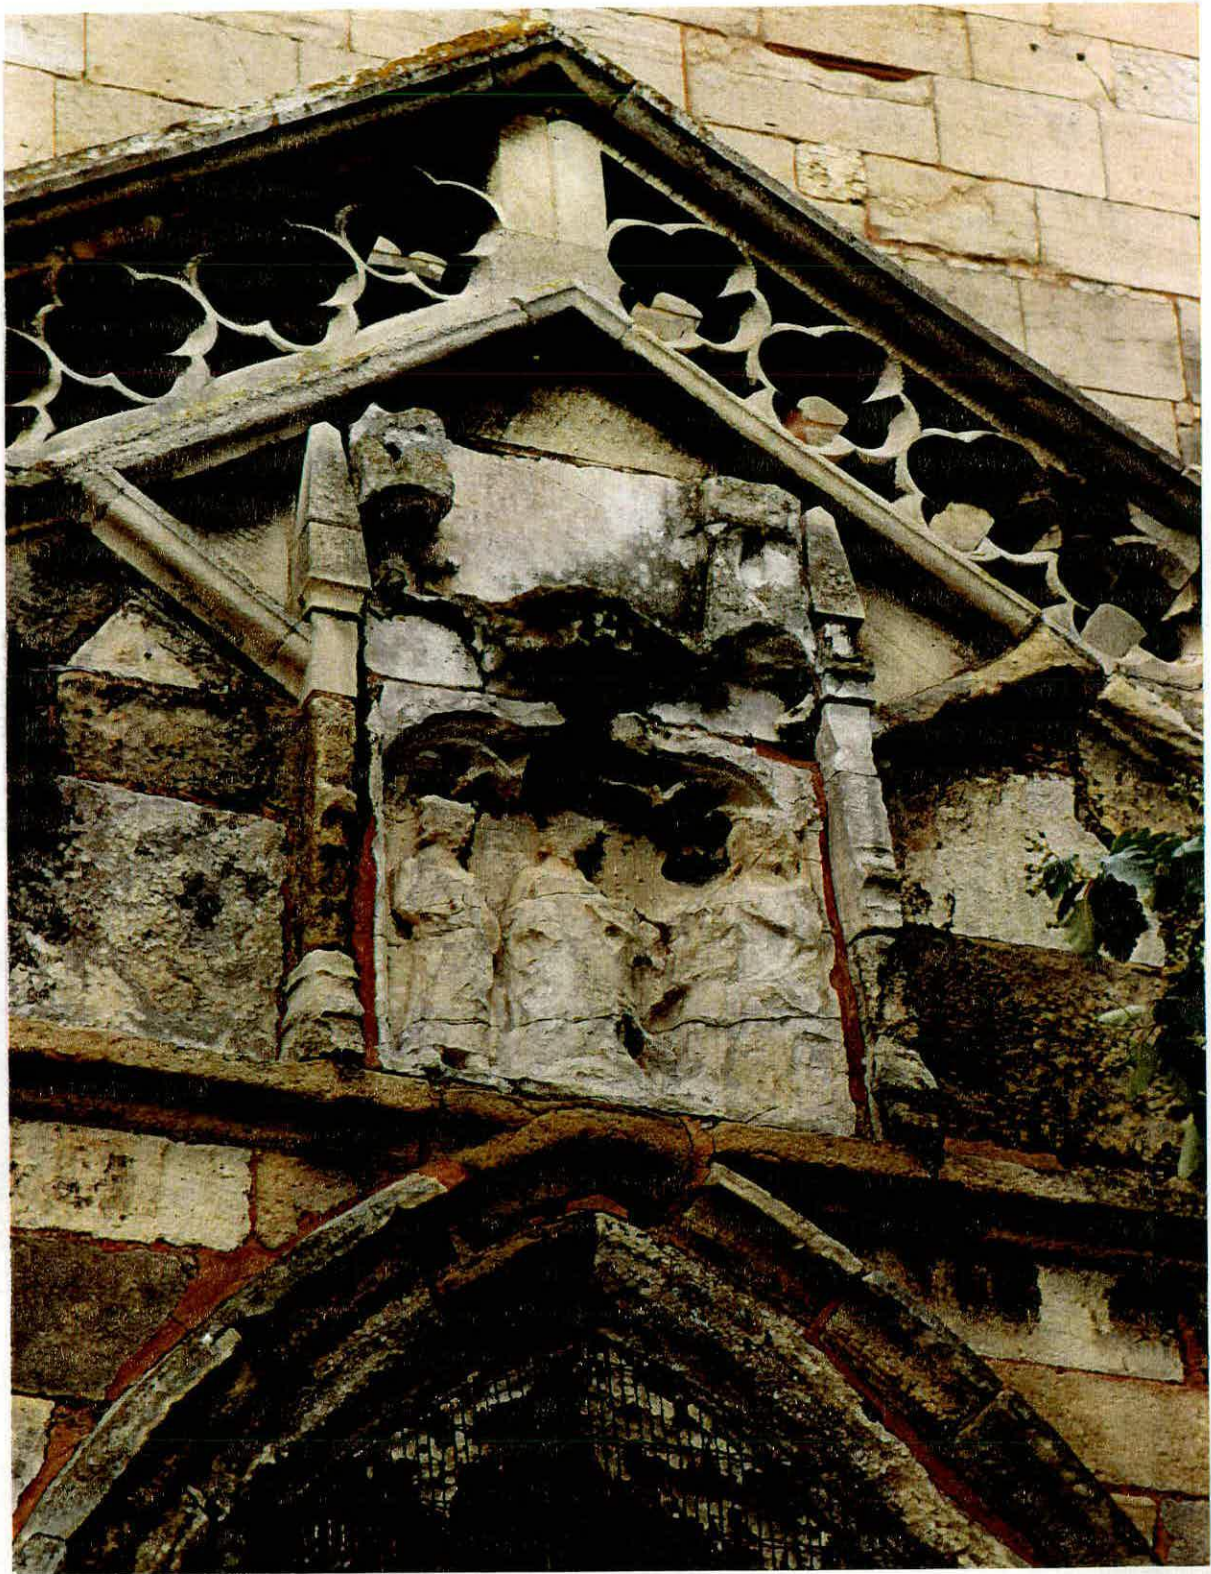
Fig. 51. Detail of the gable above the gatehouse 'porch' with sculpture panel. The panel, with its ogee cusped head, features a Magi scene.

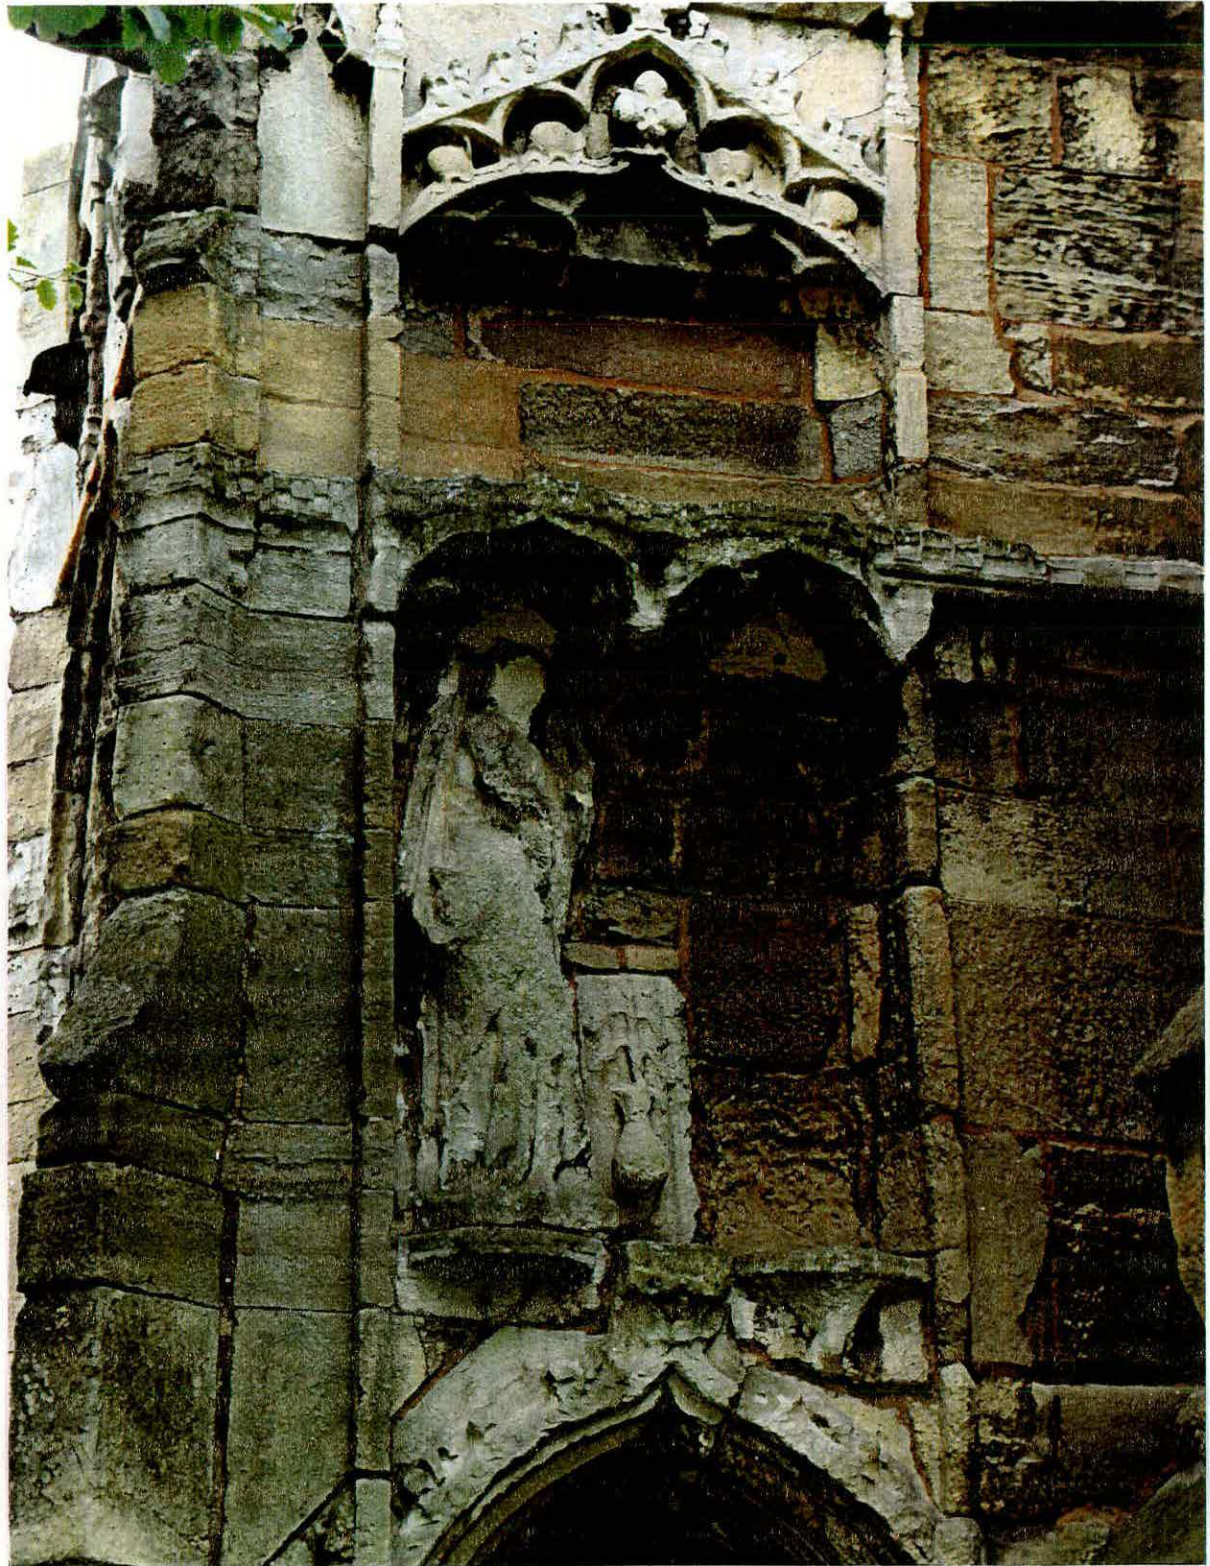
Fig. 52. Detail of sculpture niches above the east side of gatehouse 'porch'. The surviving figure represents the angel Gabriel, with a lily. The scene was the Annunciation.

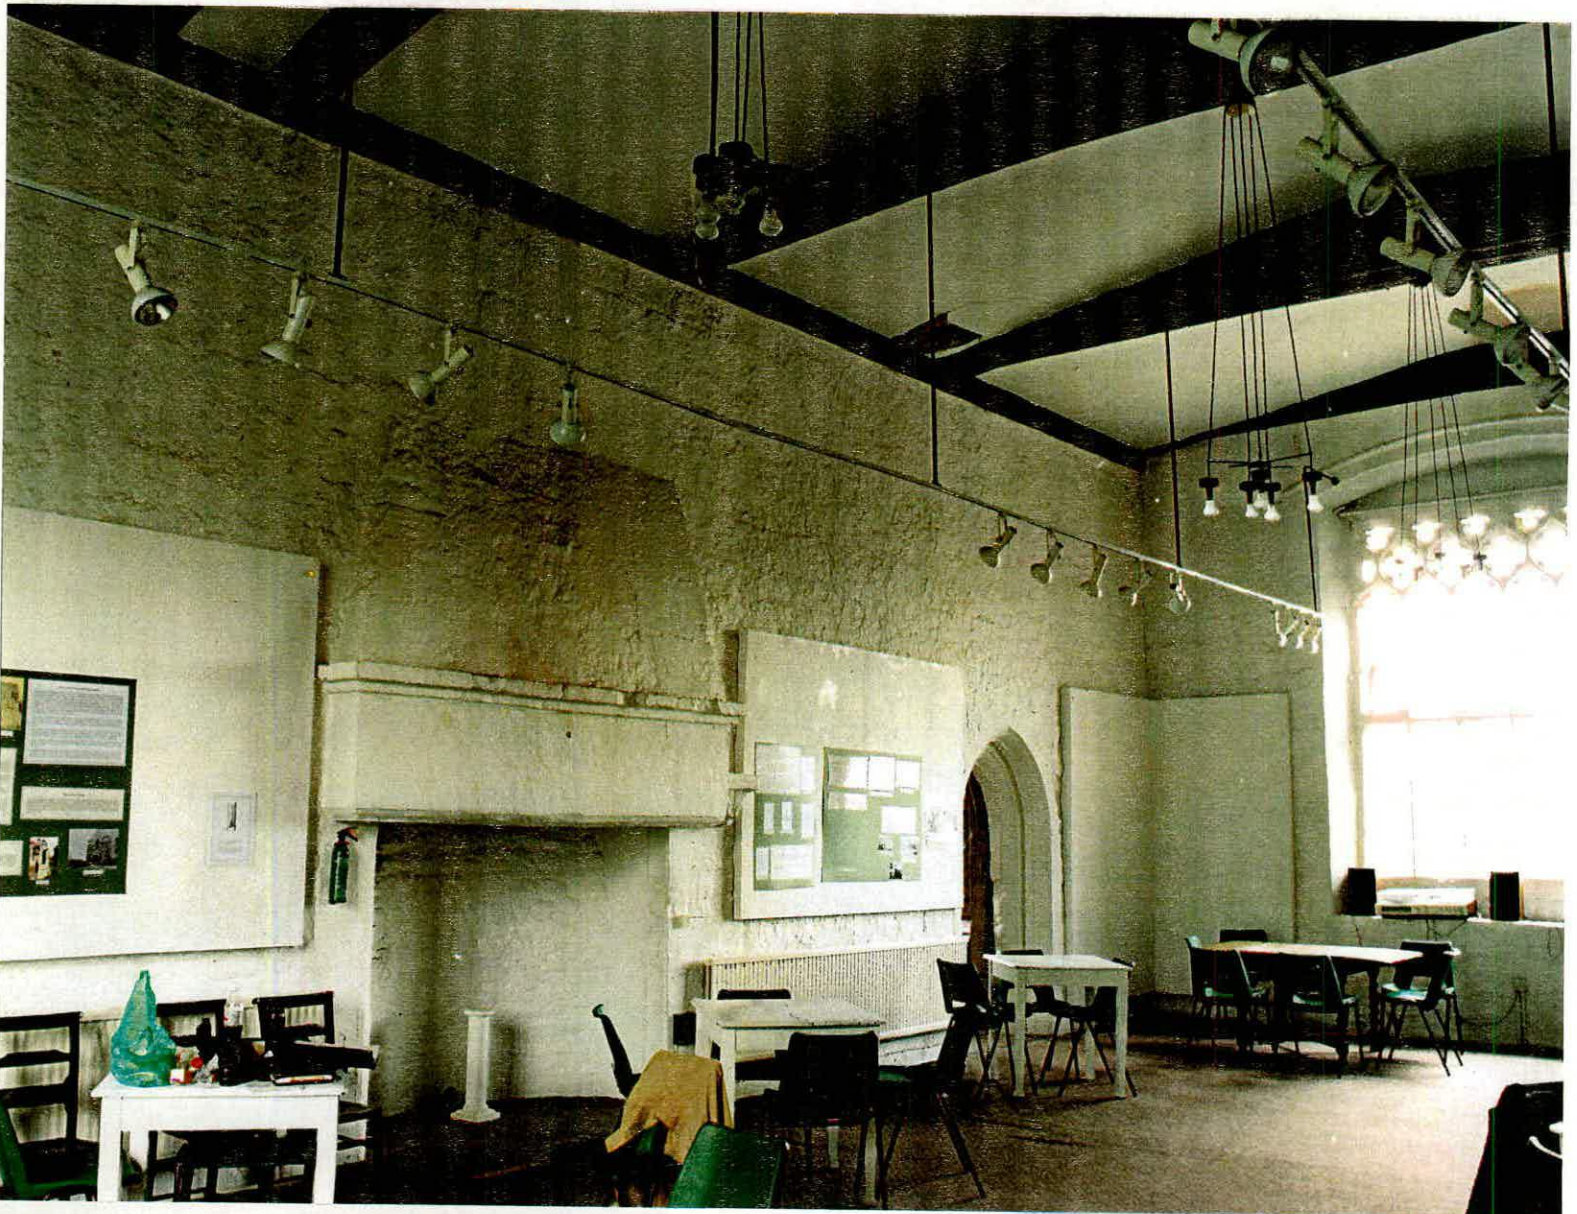
Fig. 53. A general view of the first-floor hall situated above the gate-passage, looking south-east. Notice the massive fireplace lintel and the moulded tie-beams of a late-medieval roof.

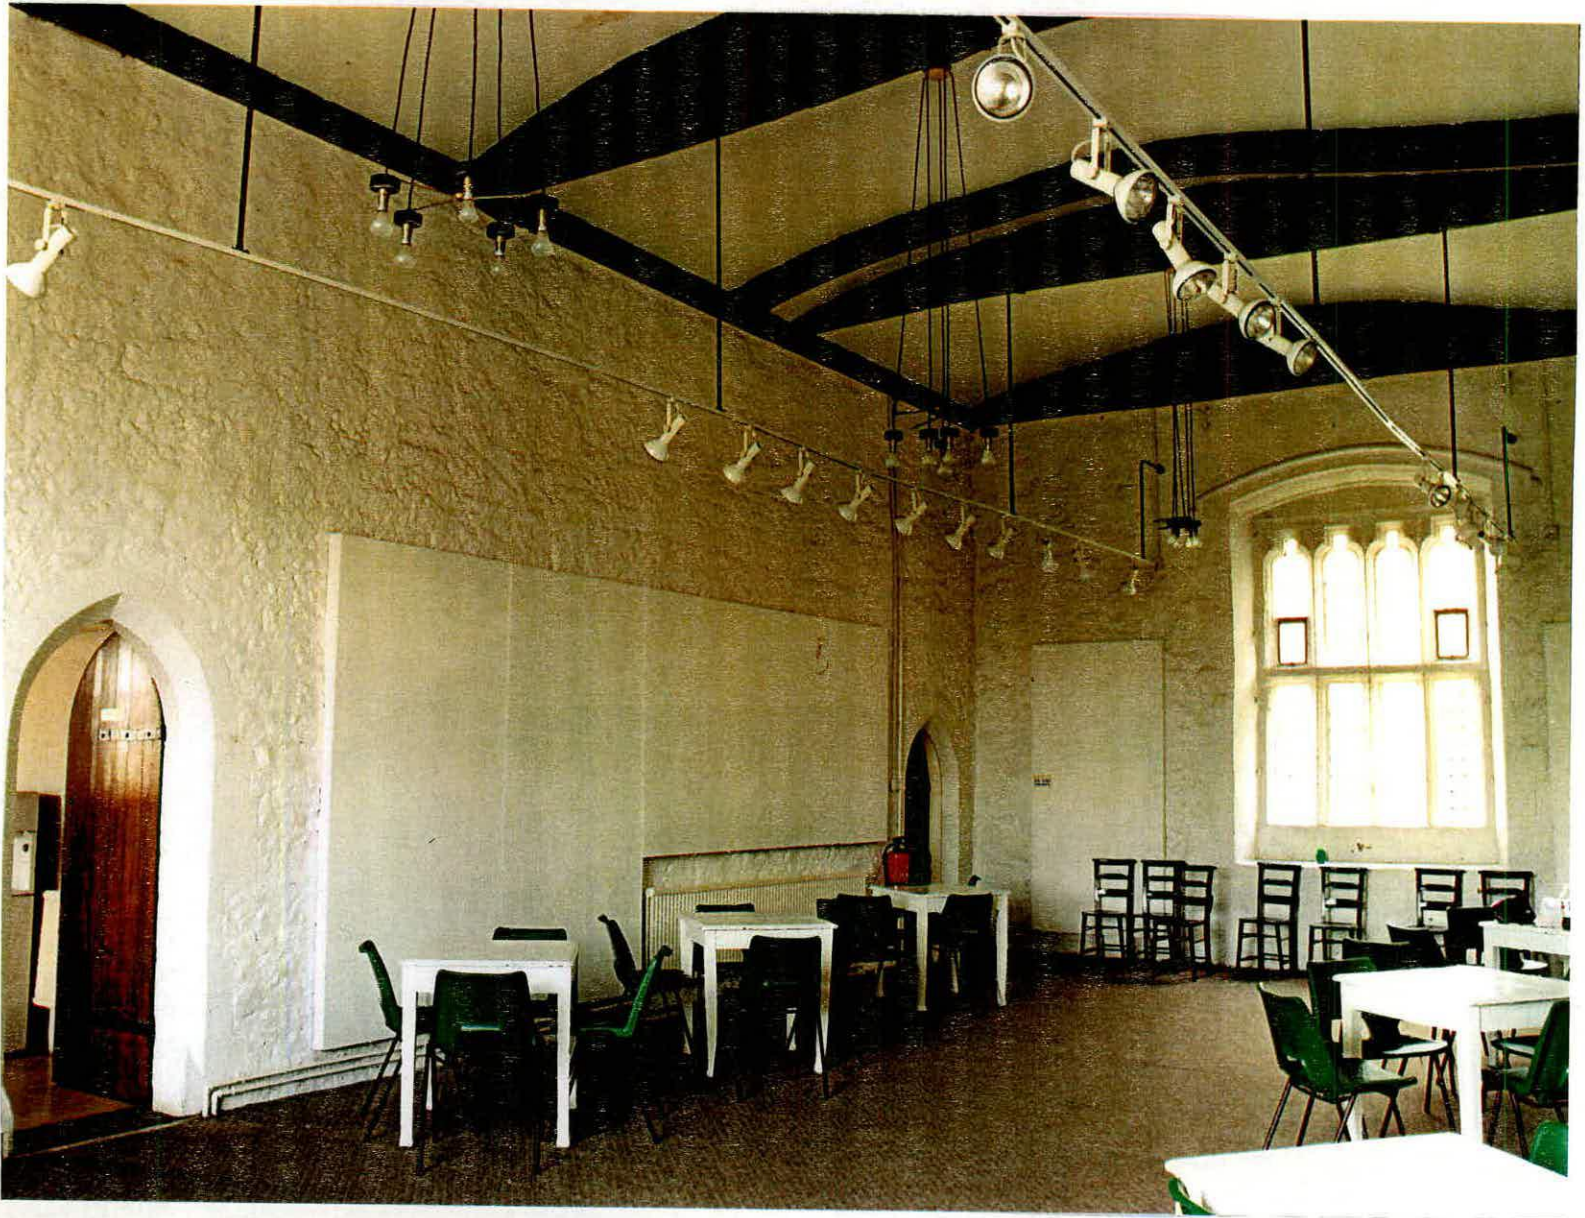
Fig. 54. A general view of the first-floor hall above the gate-passage, looking north-west.

There are two doorways in the west wall of the hall (figs. 33b and 54). These are of the same type, with two-centred pointed arches and plain chamfer dressings. The doors themselves opened into the rooms in the wing. The northern doorway now leads to and from the principal gatehouse staircase, that already observed in the north-west corner of the building. The southern doorway is slightly larger, possibly denoting a chamber of higher status at this end of the west wing.¹³³ Inside, there is a single-light window in the west wall, and a two-light window to the south. There is nothing to suggest the chamber was ever heated.

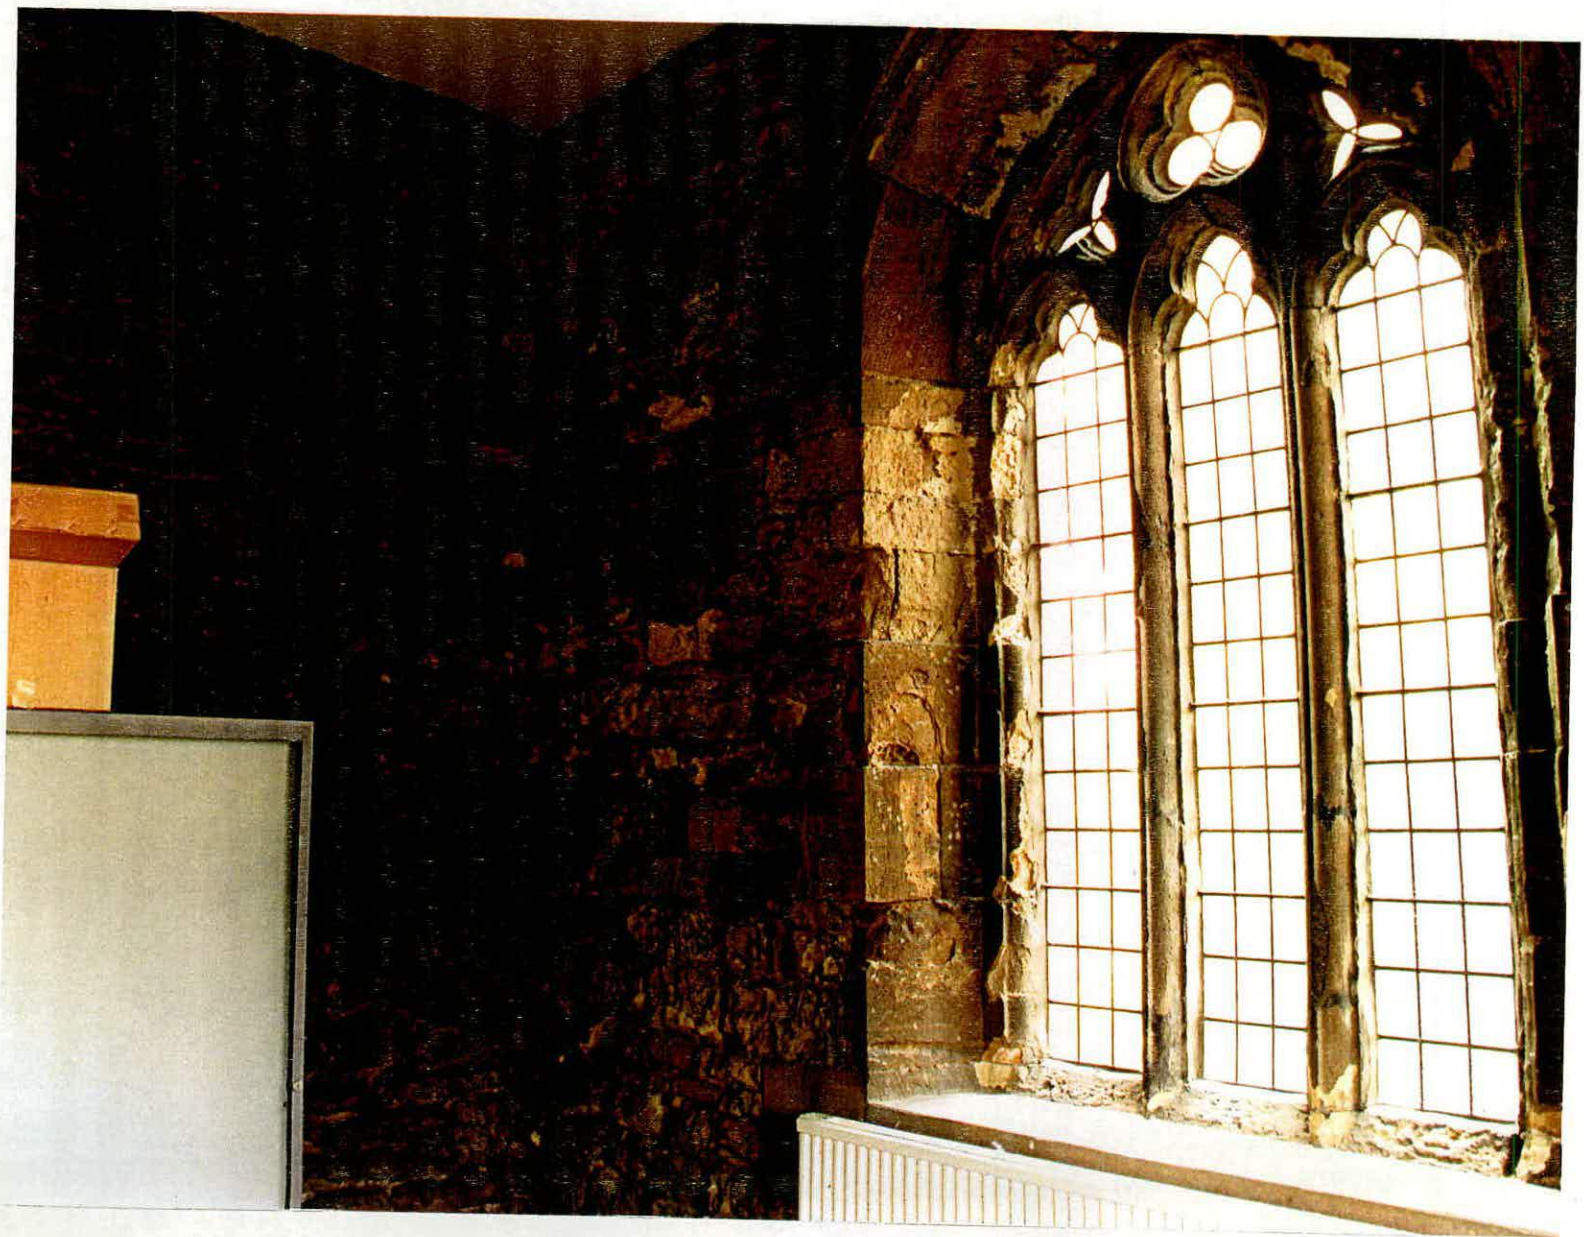
Fig. 56. Three-light window in the east wall of the first-floor chamber in the east wing.
