WORKSOP PRIORY GATEHOUSE NOTTINGHAMSHIRE

*An Architectural History
with an Account of the Significance of its Fabric*

Richard Lea and David M. Robinson

Historical Analysis & Research Team
Reports and Papers 37
2000

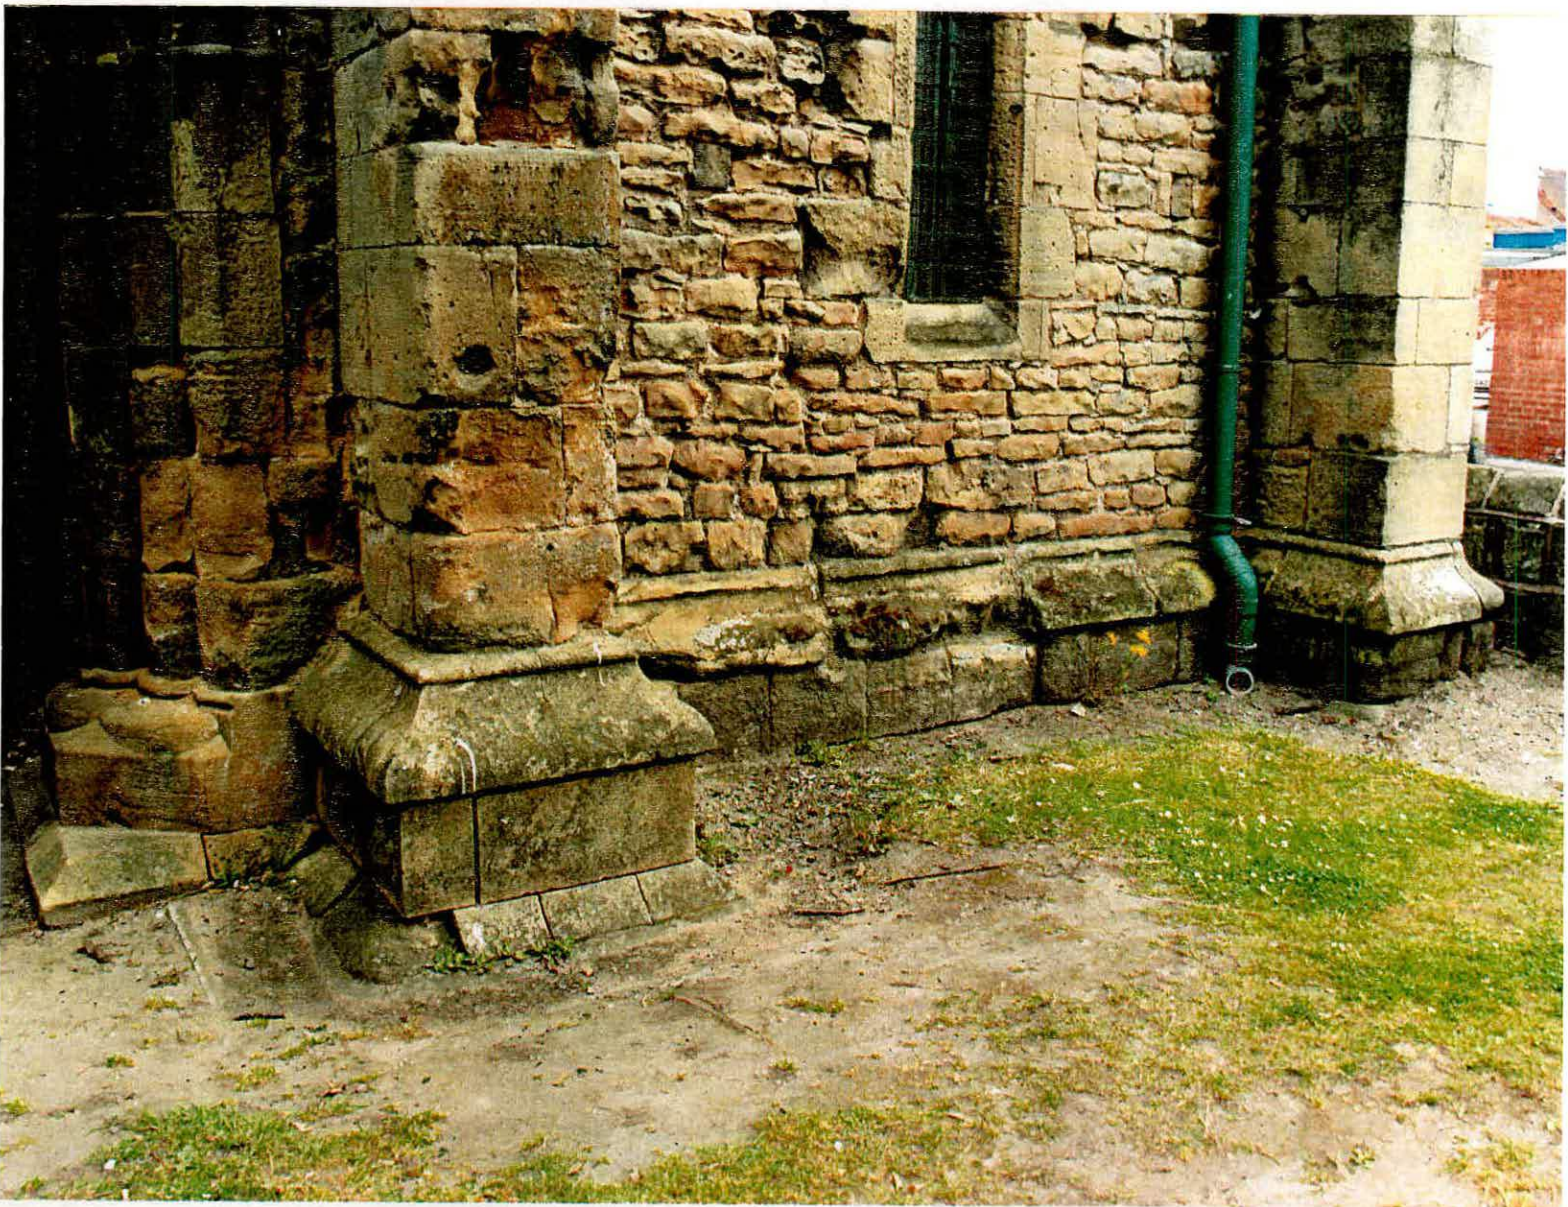
Fig. 60. Detail of the chamfered plinth which runs around the base of the gatehouse. This view is at the northern end of the west wing.

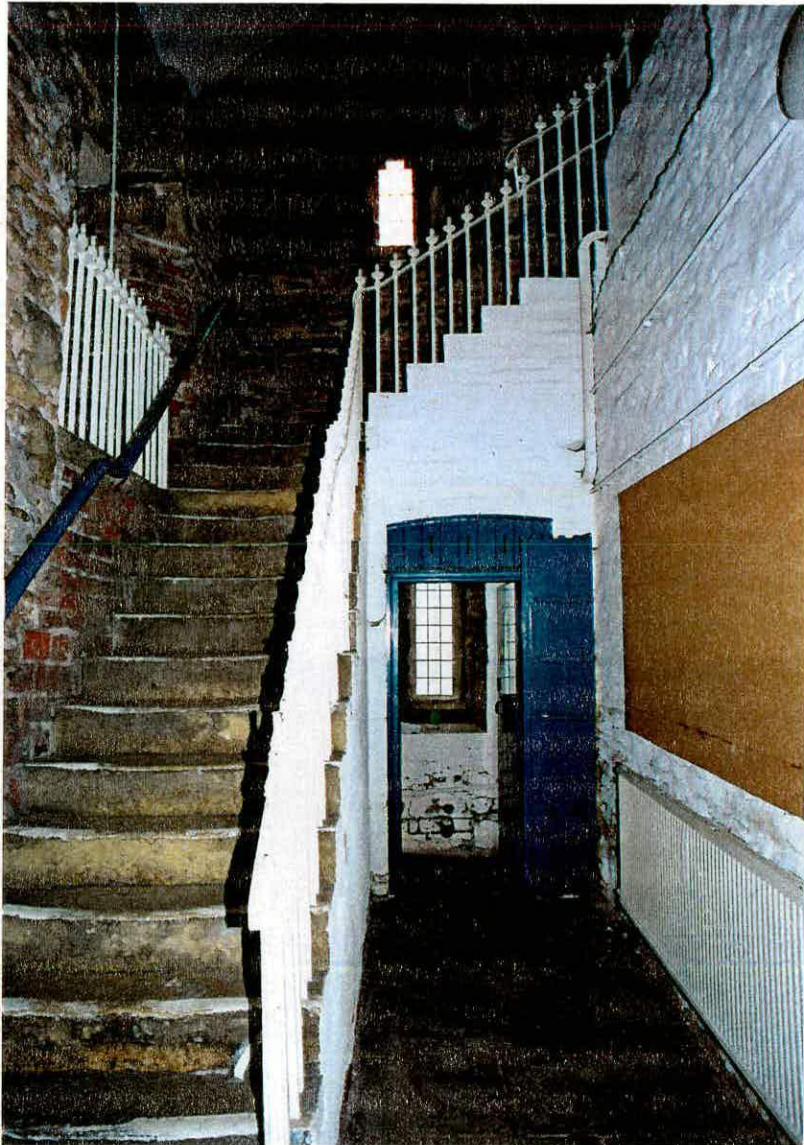
Fig. 65. The late nineteenth-century staircase in the north-west corner of the gatehouse, probably introduced in the 1890s.
