NORTH WEALD REDOUBT
Essex

A late 19th-century Mobilisation Centre

SURVEY REPORT

ARCHAEOLOGICAL INVESTIGATION SERIES

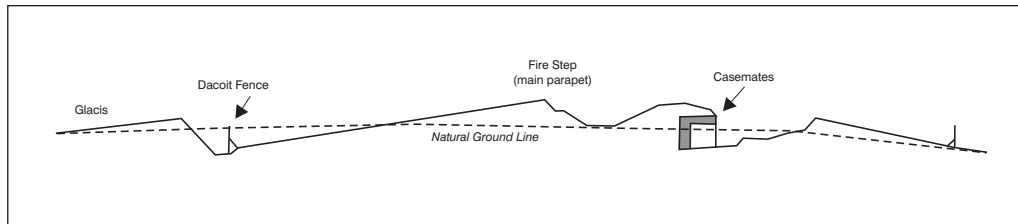
Figure 2
Twydall Profile,
idealised section
(after Thuillier,
1902)

to an unclimbable iron Dacoit fence set within a shallow ditch, that was not revetted and lacked any flank defences, cutting at an angle of about 45°. Beyond, a counterscarp glacis sloped down to meet the natural ground surface. The rear and sides of the redoubts were similarly protected. Artillery defence was provided in a self-contained sunken battery between the two redoubts.

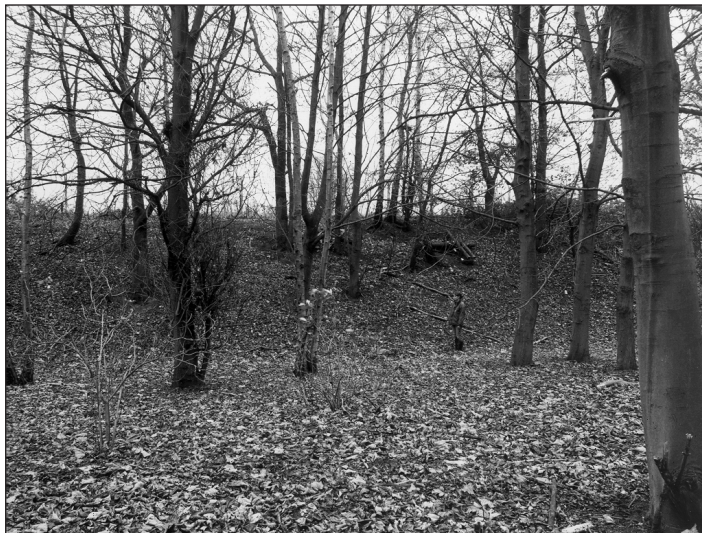
Figure 8
Section of
ditch on the
east side of
the redoubt
(AA00/1073)

The main ditch of the redoubt is unrevetted, its **counterscarp** cut at an angle of 45° to a depth of 4.6m (15ft) (Fig 8). Much of it is badly disturbed, for instance on the northern side by a pond, with the best sections situated on the east and north-west. Due to thick undergrowth it is difficult to trace the ditch on the western side but in places it would seem to have disappeared. There is evidence here of a bank, which may possibly be the result of upcast from the ditch, the whole disturbance possibly resulting from the use of the site as part of the radio station.

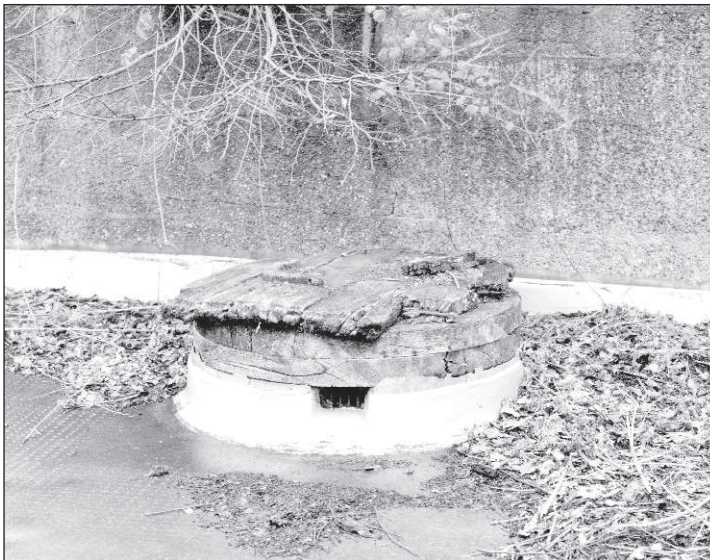
Figure 9
Ammunition
lift hatch on
the roof of the
Front
Casemates
(AA008522)

The top of the rampart is flat and lacks clear features, while the *talus* falls unbroken to the flat roof of the front casemates. The firing step is not apparent and may not have been formed as shown on the 1892 plan: the foot of the *talus* is revetted only in three short stretches, with low concrete walls adjacent to the ammunition hatches in the casemate roof. However, it is possible that alterations have removed the firing step because the *talus* retains traces of the recesses shown on the 1892 plan, which would have enabled enfilading and cross fires. The three circular hatches, through which ammunition would have been lifted from the casemates below, are intact with their original wooden hatches (Fig 9).

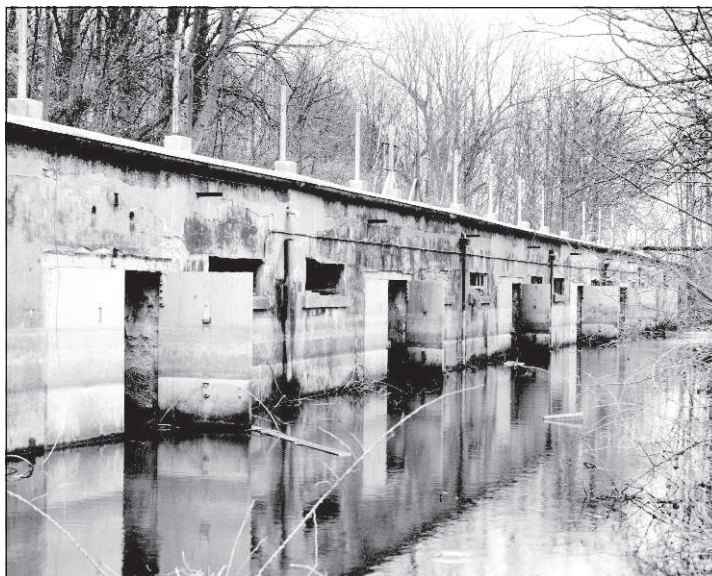
Figure 10
The gorge casemates
(AA001081)

The **gorge casemates** could only be inspected from a distance because of flooding (Fig 10). According to War Office specifications of 1893, they were built to accommodate 72 men (English Heritage, AA43268/1). Construction is in concrete throughout, including the roofs which are thickened to resist bombardment. Access could be gained from the gorge ditch

- Control and management of vegetation growth to prevent the form of the site being totally obscured and further damaged.
- Re-establishment and maintenance of drainage on the site to prevent flooding. This is a serious problem that is rapidly causing irreparable damage, particularly to the gorge casemates and *caponier*.
- Clearance and drying out of the site would enable completion of survey on the Twydall Profile, gorge casemates and *caponier*.
- The present survey brief did not include the detailed survey of buildings outside the site to the south (Caretaker's Quarters, Shell Store, Cartridge Store etc). These structures should be recorded to complete survey and analysis of the site.

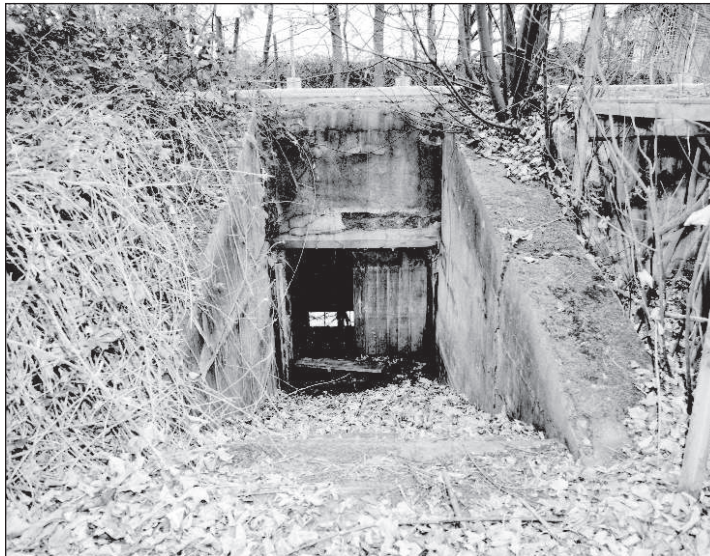
Figure 11
Eastern
entrance to the
gorge
casemates
(AA00/1071)

through several doors or down three flights of steps from the roof, as in the slightly later Fort Darland at Chatham. All three flights survive, one in the centre and two at either end of the range (Fig 11).

Each room had either an entrance or a window to the gorge ditch: there were 12 entrances, each one protected by double doors of ½-inch steel, and 28 small rectangular windows protected by vertical steel

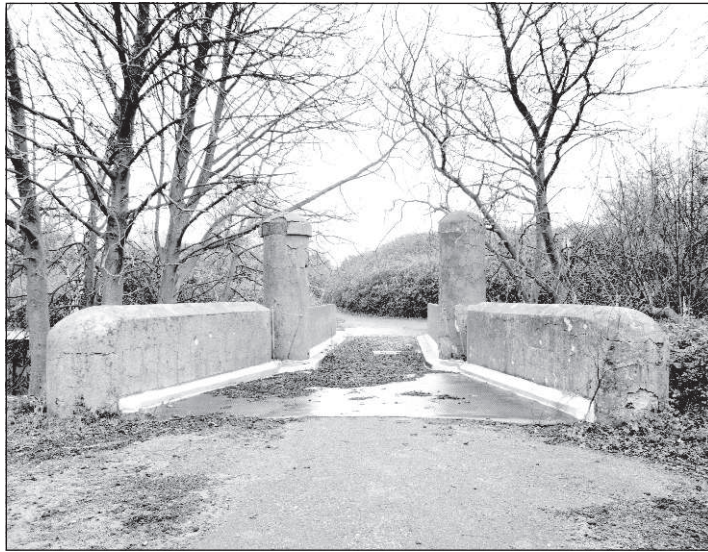
Figure 13
The bridge,
from the
exterior
(AA00/1083)

The *caponier* under the bridge is a rare example for this date, the only one constructed in any of the mobilisation centres and perhaps due to the fact that North Weald was the first to be constructed: the presence of *caponiers* in forts had been criticised several years earlier

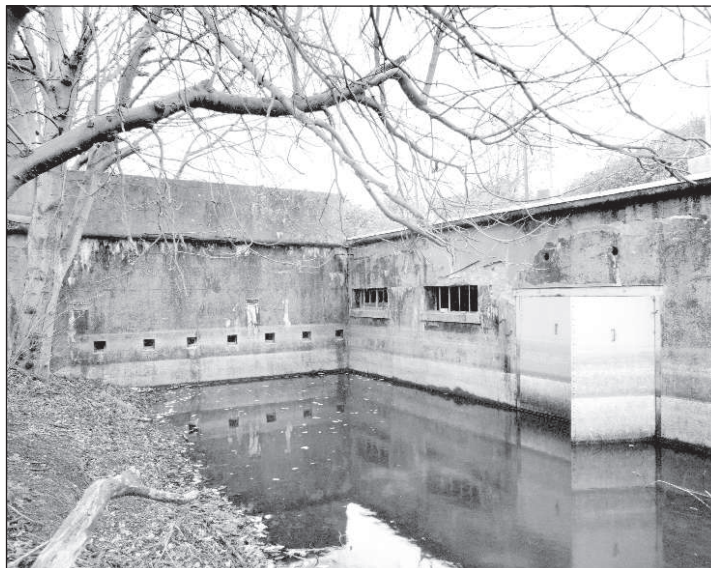
Figure 14
The caponier,
from the south
east
(AA00/1080)

because of their projecting, vulnerable positions (Smith 1985, 113). The North Weald example is a strongly built concrete passageway reached through the gorge casemates. It is pierced by eight small loopholes on each face to allow enfilade fire by rifles along the length of the gorge ditch (Figs 12 and 14). A note on a record plan of 1893 reveals that the loopholes were glazed, presumably

to prevent draughts in peacetime, and would have been broken out in the event of an attack. Ditches ran along each face of the *caponier*, spanning the width of the gorge ditch, and are referred to as *drop ditches* on the record plan; these were designed to prevent a close attack on the loopholes and deny flanking access to the bridge (PRO/WO/78/2606/4). The interior of the *caponier* could not be examined because of flooding.

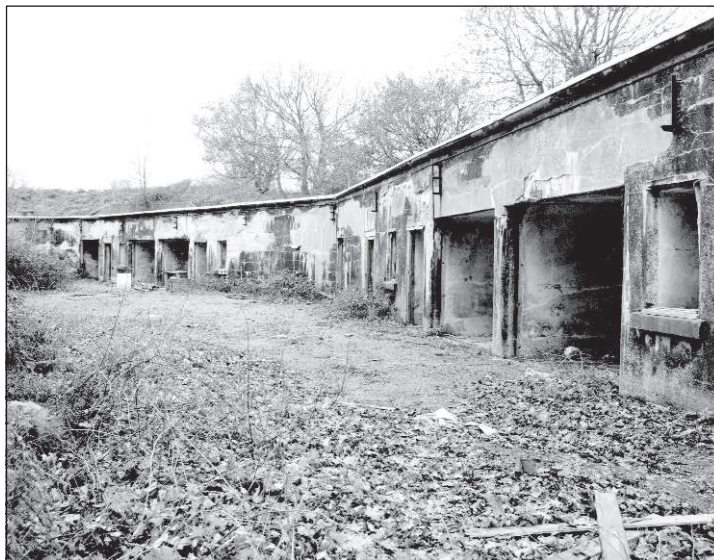
Figure 16
The front casemates and marshalling yard from the south east (AA00/8517)

These casemates rise from the northern side of the marshalling yard and functioned as magazines for the storage of artillery, ammunition and essential spares. They are of the same

thickened concrete construction to those in the gorge, with a flat roof coated with asphalt, the cartridge stores receiving the greatest protection. Internally the roofs slope slightly upward to the rear. In plan the whole range is formed from four contiguous straight sections (referred to here as sections **A**, **B C** and **D**), with changes in angle between the sections to follow the curve of the rampart (Fig 16). The end sections, **A** and **D**,

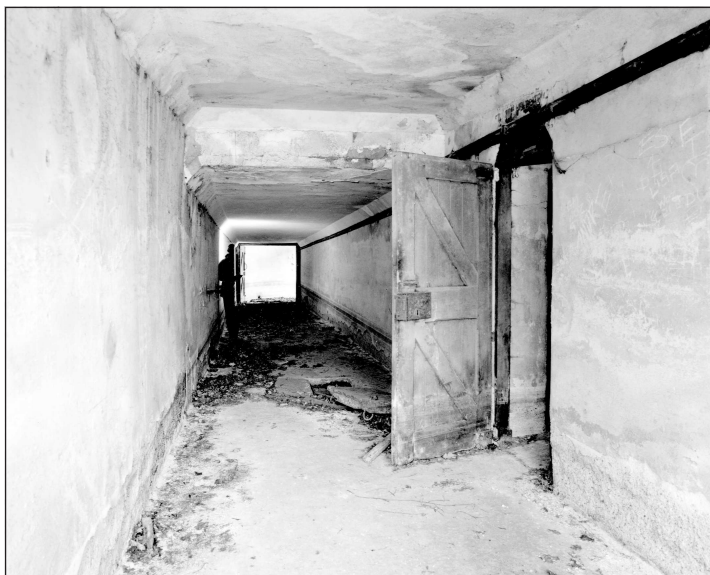
Figure 18
View along east
gallery with
entrance to shell
store (room 18) on
the right
(AA00/8520)

The **east and west galleries** are placed symmetrically in the redoubt, leading originally through strong double doors from the marshalling yard through the front casemates and under the rampart to the glacis. Both galleries also have direct access to shell stores. The galleries are 2.2m (7ft 2in) in width and run straight for some 23m (75ft 5in) to stout double wooden doors

(painted green and brown), although in each case only one door survives (Fig 18). Beyond the doors, each passage curves into the open to a short stair leading up into the infantry positions; there are drains between the doors and the stairs and the eastern passageway has a metal handrail in the middle of the stairway (Fig 19).

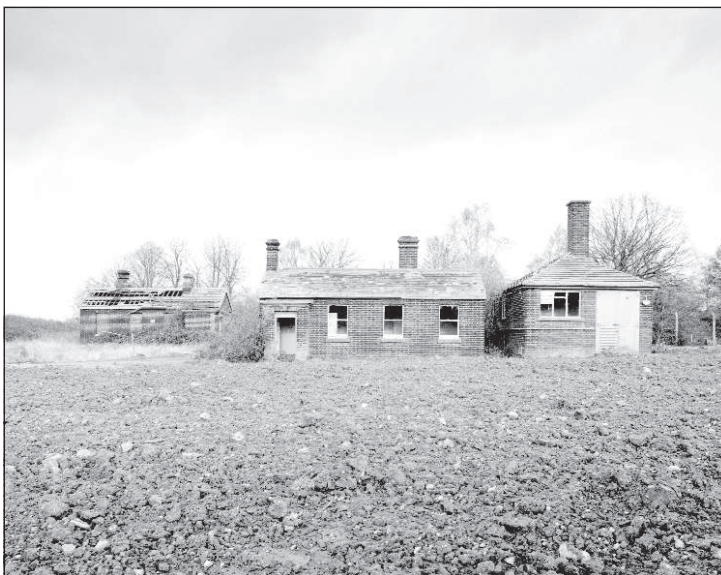
Figure 20
The Caretakers
Quarters and
structure associated
with the ? tent and
blanket store
(AA00/1093)

The mobilisation centres were not to be manned in peacetime and so were provided with caretakers, for whom small cottages were built. At North Weald, they are outside the redoubt but inside the perimeter fence, immediately south of the bridge. **Caretaker's Quarters no 2** is an

Both cottages survive, though in a very dilapidated state. The interiors have been stripped, the windows broken, partitions kicked in and the roof slates robbed or smashed. Cottage no 2 has been gutted by fire. Internal timberwork is now exposed to an increased rate of deterioration through water penetration.

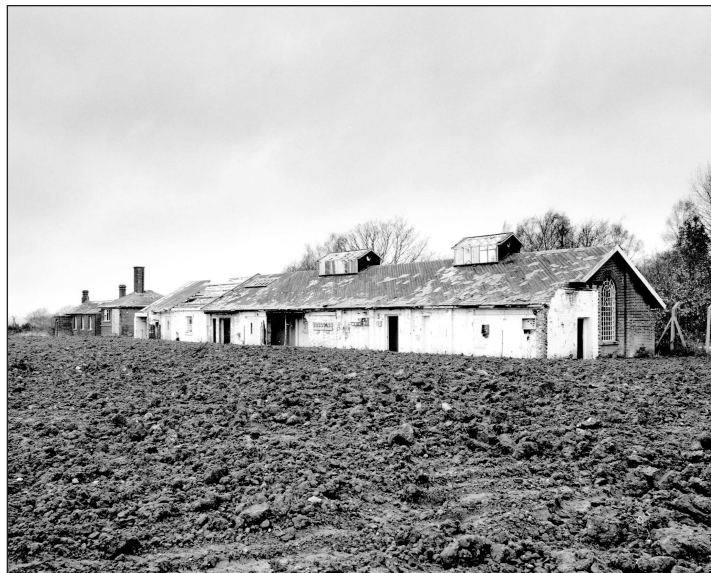
Figure 22
Exterior of the
radio station
workshop
incorporating the
1903/04 Shell and
Cartridge Stores
(note the original
large round headed
window in the
gable)
(AA00/1085)

Both of these stores were originally brick-built rectangular halls with rivetted iron trusses supporting slate roofs. They survive, amalgamated to form one building and heavily altered for the Radio Station, complete with original roof trusses and much brickwork (Figs 22 and 23). The Cartridge Store was the smaller structure, at 16.6m (54ft 4in) by 5.9m (19ft 4in), with two small rectangular windows in the south elevation, single large round-headed windows in the gables and two separate doors in the north elevation. The eastern window

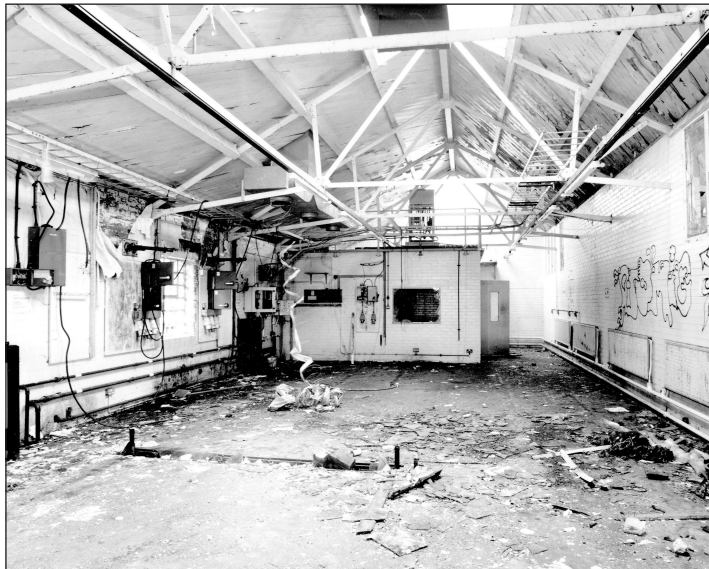
Figure 23
Interior of the
radio station
workshop
incorporating the
earlier 1903/1904
Shell and
Cartridge stores
(note the original
steel roof
structure)
(AA00/1086)

was protected on the outside by a wire screen. The Shell Store was slightly larger, at 19.9m (65ft 4in) by 5.9m (19ft 4in), of similar design but with three windows in the south elevation and an extra window between the doors in the north elevation. In both stores the ammunition was stored in boxes on the asphalt floor, in six areas with passages left for access and ventilation.

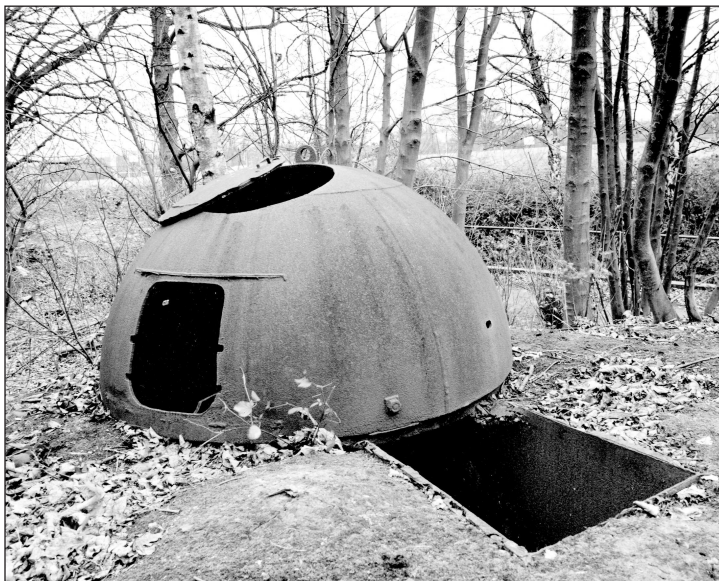
Figure 25
Allen Williams
Turret
(AA00/1070)

There are two **Allen Williams turrets**, a rare type of gun emplacement installed during the Second World War for close defence of the Radio Station, located prominently at each terminal of the main rampart. Only a small number of these turrets were produced in 1939-40 by a company specialising in pre-fabricated building components. The south-western turret is concealed in very thick vegetation but the south-eastern example is visible and consists of a rotating steel dome, 1.5m (5ft) in diameter, set over a concrete lined

pit with an entrance passage to the west (Fig 25). The dome contains space for two men, one to rotate the upper section, the other to operate the armament, which could include a Bren or Lewis LMG or a Boys anti-tank rifle. The machine guns could be mounted through the square aperture in the side of the turret or the circular opening above, allowing engagement of

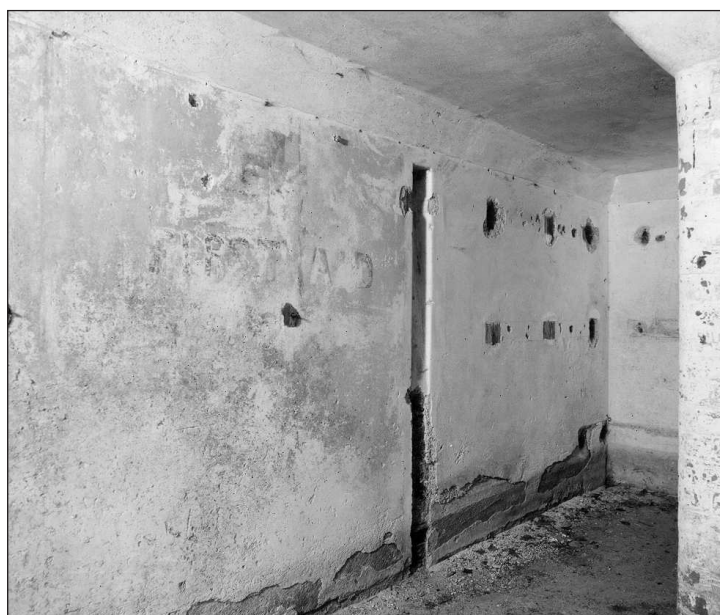
Figure 26
*Interior of shifting
lobby (room 1)
showing the barrier
rebate and first aid
sign
(AA00/8505)*

ventilator in the roof while the larger room contains holes in the wall for shelving as well as the two lamp recesses in the party wall to cartridge store (2): these are blocked with brickwork but adjacent are small square holes, each 0.13m by 0.13m, which ventilated the lamp recesses. The western wall has a painted sign for First Aid (Fig 26).

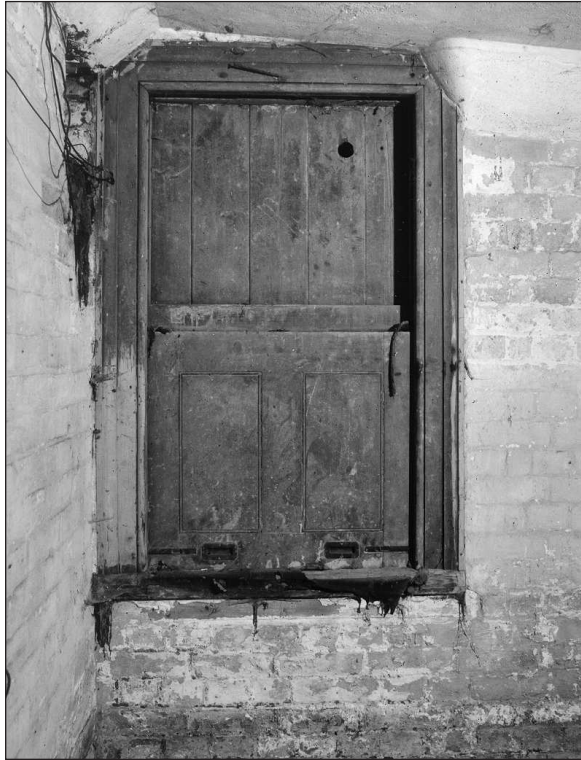
Figure 27
Issue Hatch of
Cartridge Store
(room 3)
(AA00/8514)

3) Cartridge store: entry from the adjacent cartridge store (2) was guarded by a wooden door of which only the frame survives. There is a recessed ventilation shaft in the eastern corner of the north wall. Some shelving brackets remain on the western wall, together with loose wiring. The eastern wall contains two lamp recesses, both retaining their original metal frames, the northern one also with part of the grille cover – and an issue hatch, complete with wooden frame and sliding door, to the adjacent shell store (4) (Fig 27).

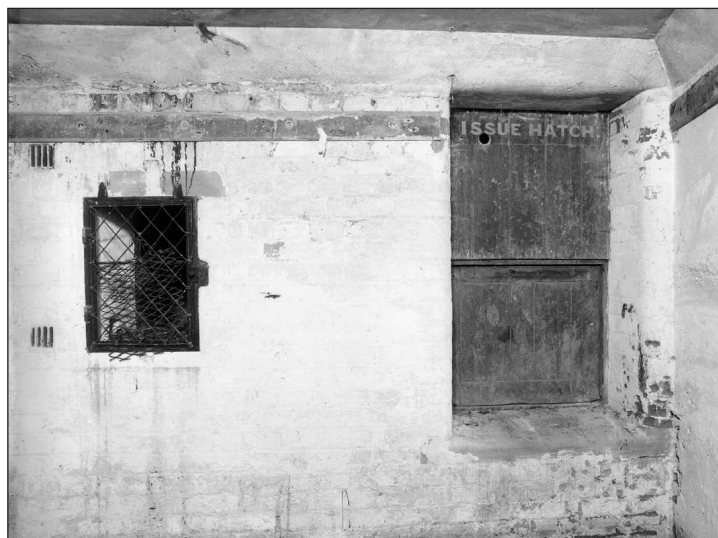
Figure 28
Grilled lamp
recess and
issue hatch of
shell store
(room 4)
(AA00/8504)

4) Shell store no 3: small triangular room reached through a door from the west passage. The dark green wooden door retains its painted sign ‘No 3 Shell Store’. The room is whitewashed and has a wooden rail just below ceiling level on all but the eastern wall. As

well as two lamp recesses to the adjacent cartridge store, a third recess is let into the eastern wall to the north of the door: it is bricked up on the passage side. The other recesses retain their metal frames and protective grilles in working condition and all three lamp recess ventilators have their original metal grilles. The issue hatch to

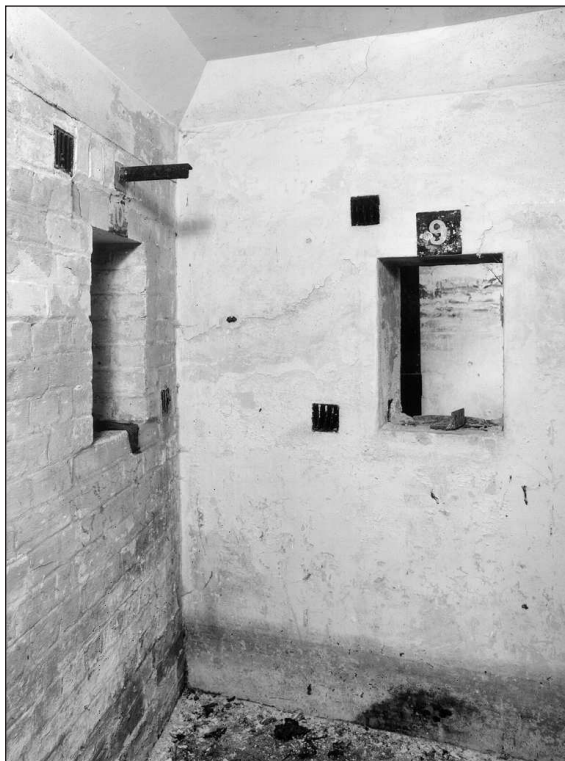
Figure 29
*Numbered lamp
recesses in lamp
room (12a)
(AA00/1100)*

12a) Lamp Room: a small room at the apex of the triangle, measuring 2.5m by 2.0m. It contains three lamp recesses, two in the west wall serving the adjacent cartridge store 10 - one of which retains its painted number, 10 – and a third in the north wall serving communicating with casemate 12b, which retains its painted number 9: all have adjacent small square ventilation holes (fig 29). There are brackets on the wall for shelves, where lamps for the front casemates were stored.

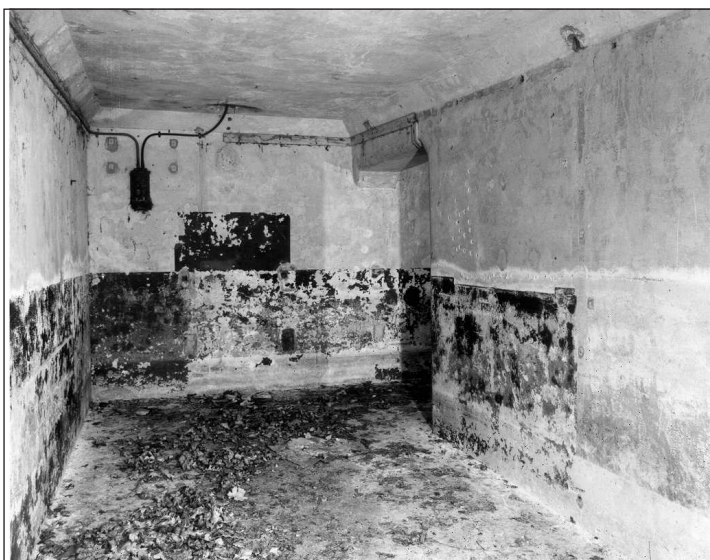
Figure 31
Surviving
paintwork in
gun casemate
(room 15)
(AA00/8509)

are from shelving; the top row in the west wall has several wooden brackets and there is a single metal bracket in the north wall. In the roof at the back of the casemate is a circular ceramic ventilator.

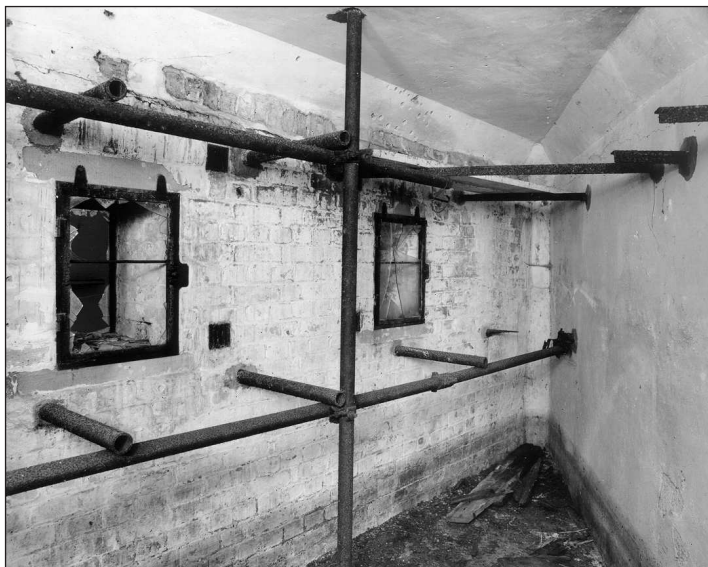
Figure 32
Lamp recesses
and
scaffolding in
shell store
(room18)
(AA00/8511)

18) Shell Store: a small triangular room reached through an intact wooden door in the east passage, it retains the painted sign “Filled Shell Store”. The east wall, in whitewashed brick, is supported by scaffolding but contains two lamp recesses and the entire wooden frame and

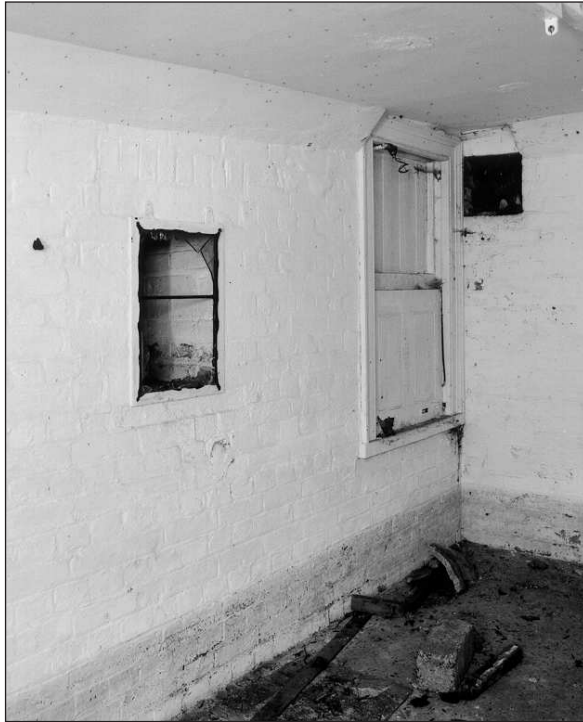
Figure 33
*Lamp recess,
issue hatch and
ventilation shaft in
cartridge store
(room 19)
(AA00/1095)*

19) Cartridge Store: this casemate is reached through nos 20 then 21, where there is a doorway to the marshalling yard. It is in a good condition, the brick walls whitewashed, and there is evidence for secondary lighting. On the west wall, there is the issue hatch to casemate 18 and the two lamp recesses, both retaining their metal frames, the southern one still its external grille. The east wall contains several rows of shelves. There is a ventilation shaft recessed into the western corner of the north wall, and is the only feature in the room

which is in a deteriorating condition. There is a red-painted wooden door between to casemate 20 (Fig 33).
