ENGLISH HERITAGE

**ROMFORD FACTORY**  
**ELVET AVENUE**  
**GIDEA PARK**  
**LONDON BOROUGH OF HAVERING**  
**GREATER LONDON**

**NBR INDEX NUMBER: 106386**

Surveyed October 2000  
Report by Joanna Smith  
Photography by Sid Barker  
Drawings by Andrew Donald

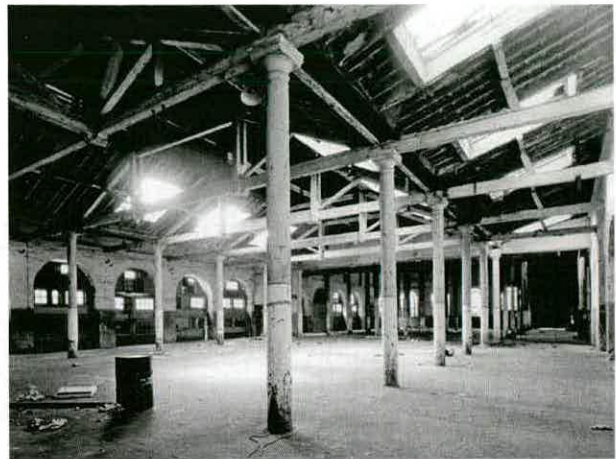
*Fig. 6 East side of the north range (English Heritage BB009388).*

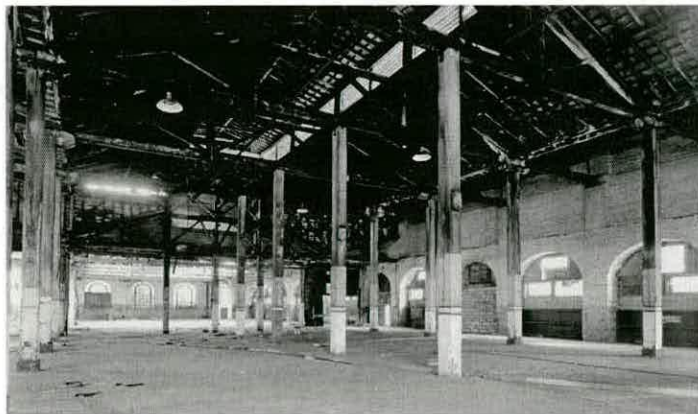
*Fig. 7 West side of the north range (English Heritage BB009394).*

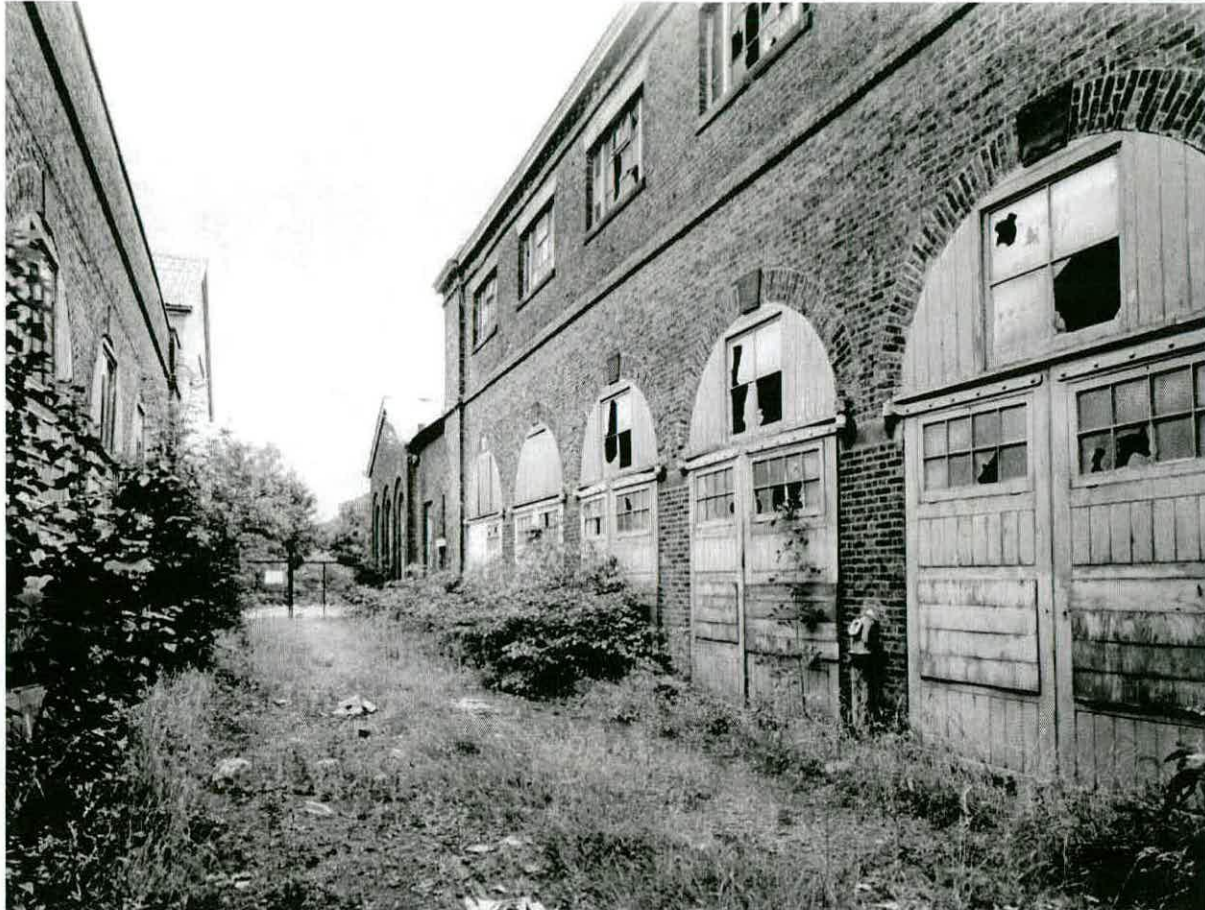
*Fig. 8 Former siding between the two ranges, looking east, and the north elevation of the south range (English Heritage BB009417).*

The building is in three parts, a dominating two-storey central section, with one-storey gabled end pavilions and one-storey linking bays. The higher middle portion is detailed in the same manner as the north elevation of the north range and a hipped, slate-covered roof in three parts with a full-length gabled lantern at the centre. The north elevation mirrors the south elevation of the north range on the ground floor, with arched openings with timber doors in each of the 13 bays (Fig.8). However, it differs in having tripartite casement windows, with flat gauged-brick heads at the upper level.

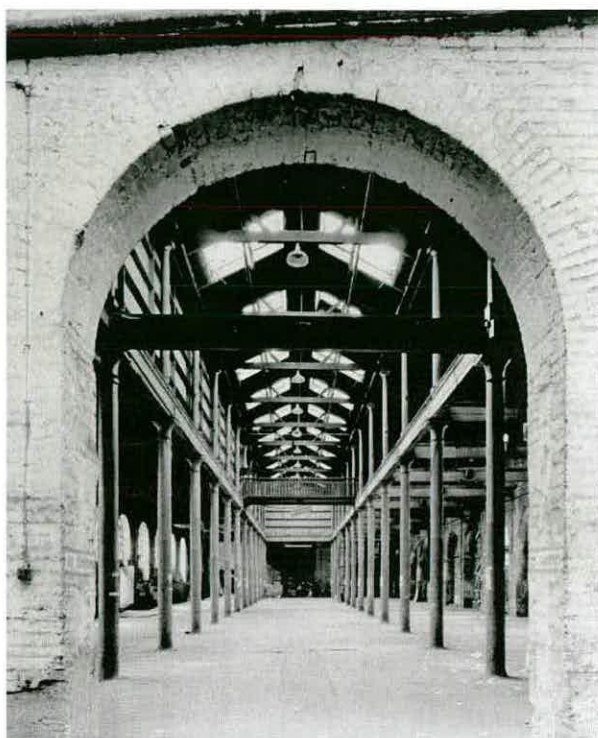
Fig. 9 Central section of the south range viewed from the east (English Heritage BB009401).
