THE BOOKCASE AND ORGAN
SCHEME OF 1766 IN THE
LIBRARY AT DANSON

AN EXAMINATION OF THE EVIDENCE
AND NOTES FOR ITS RESTORATION

Richard Lea and Chris Miele

Reports and Papers 56

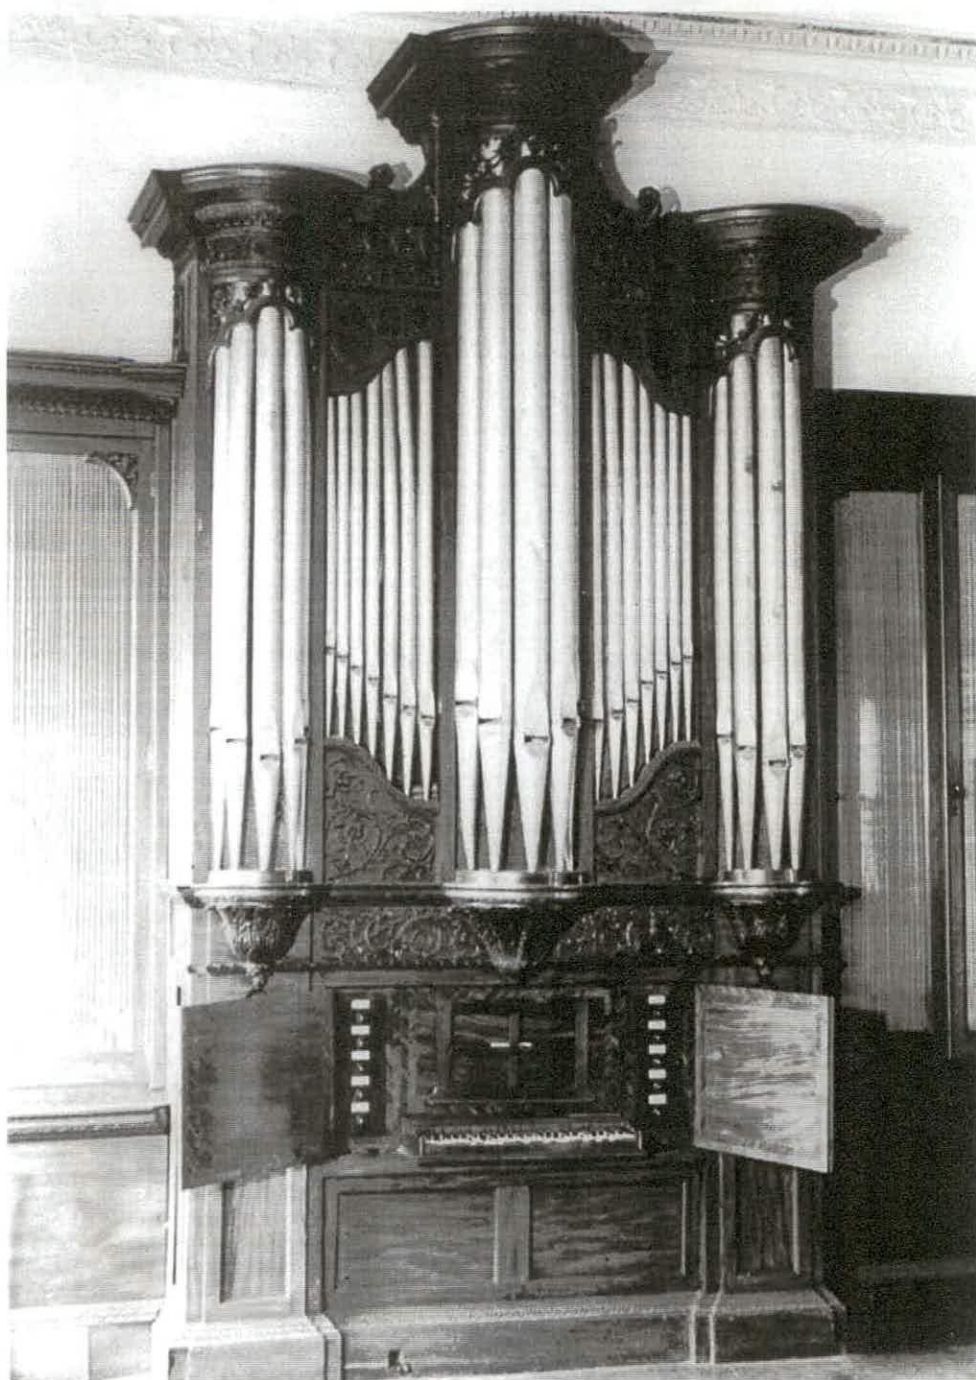
Figure 4, a photograph of the organ in 1967 after its restoration. Note the infill section of cornice beginning to fall away from between the bookcase on the left and the organ.

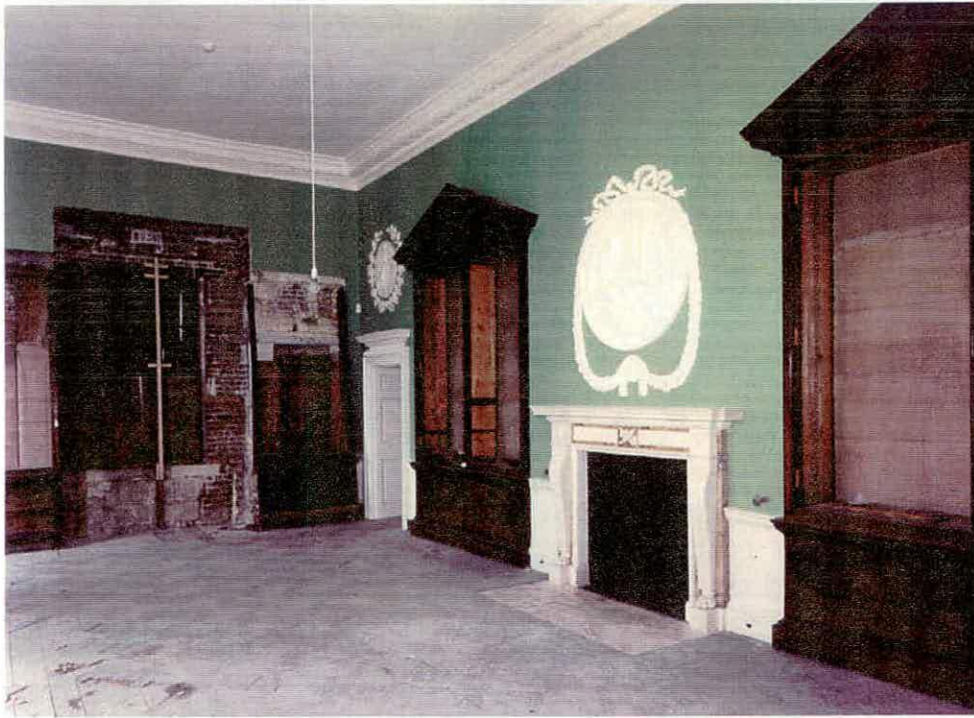
Figure 5, the Library in January 1998, after restoration of the plaster, with the two pedimented bookcases on the east wall *in-situ* and the two smaller bookcases against the north wall partially dismantled.

The plain mahogany triangular panels set within the pediments of the two bookcases on the east wall, BC1 and 2, appear to be original, Figure 5. However, it seems likely that that conjectured for the south wall, BC4, incorporated a relief carving of a bearded male head seen in profile surrounded by sheaves of corn. This fragment of carved mahogany was incorporated into the block pediment added to the top of the bookcase in the 1860s, Figure 9. The profile is of a generic type but could be read as Homer, a classical icon for learning and very appropriate to a library scheme. Assuming that the carving does derive from the original Library scheme, then its most likely original location is the pediment above the bookcase on the south wall, Figure 13.

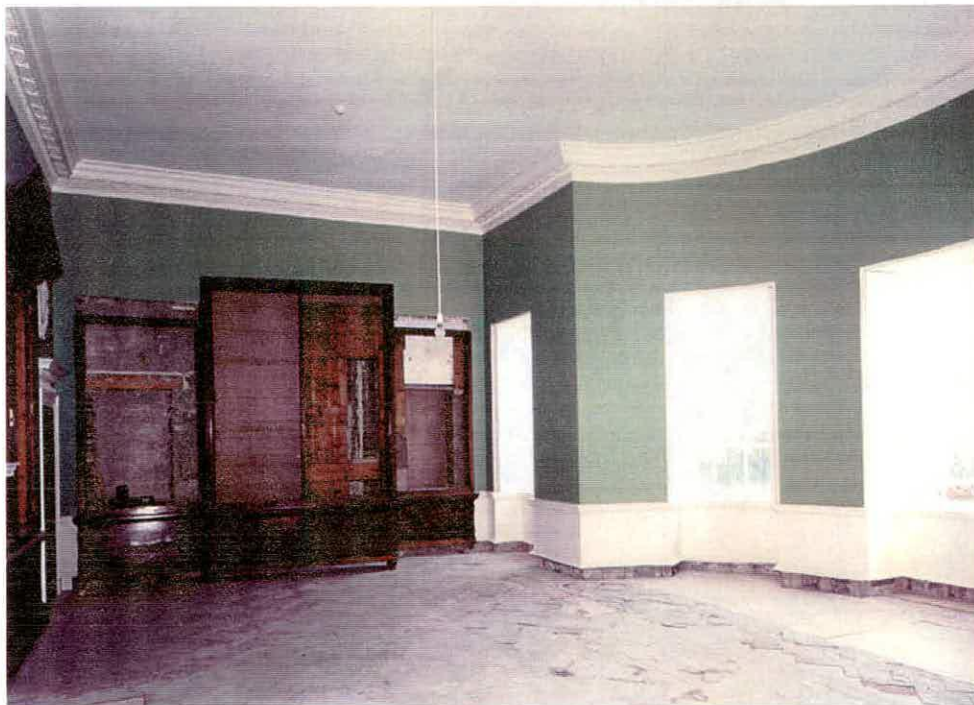
Figure 6, the Library, looking south in January 1998, after restoration of the plaster, with the three bookcases partially dismantled and only approximately placed in position.

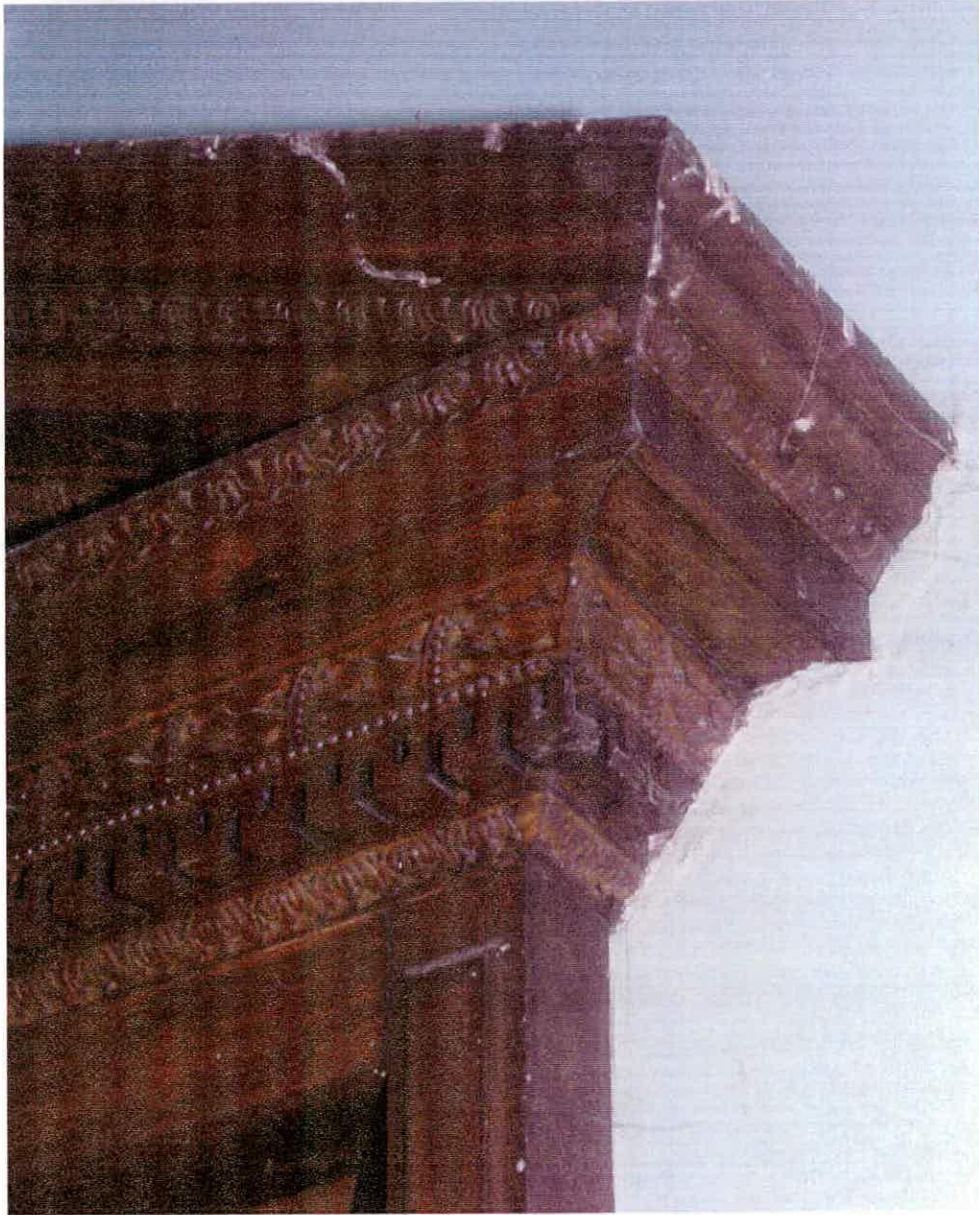
Figure 8, a detail of the cornice above one of the bookcases on the east wall

but the enrichment is bold, with the dentil course treated as a fret, Figure 8. Originally, the bookcases were built with open shelving and it is this arrangement that Sarah Johnson pictured in her watercolour of the north west corner of the Library c 1860, Figure 2.

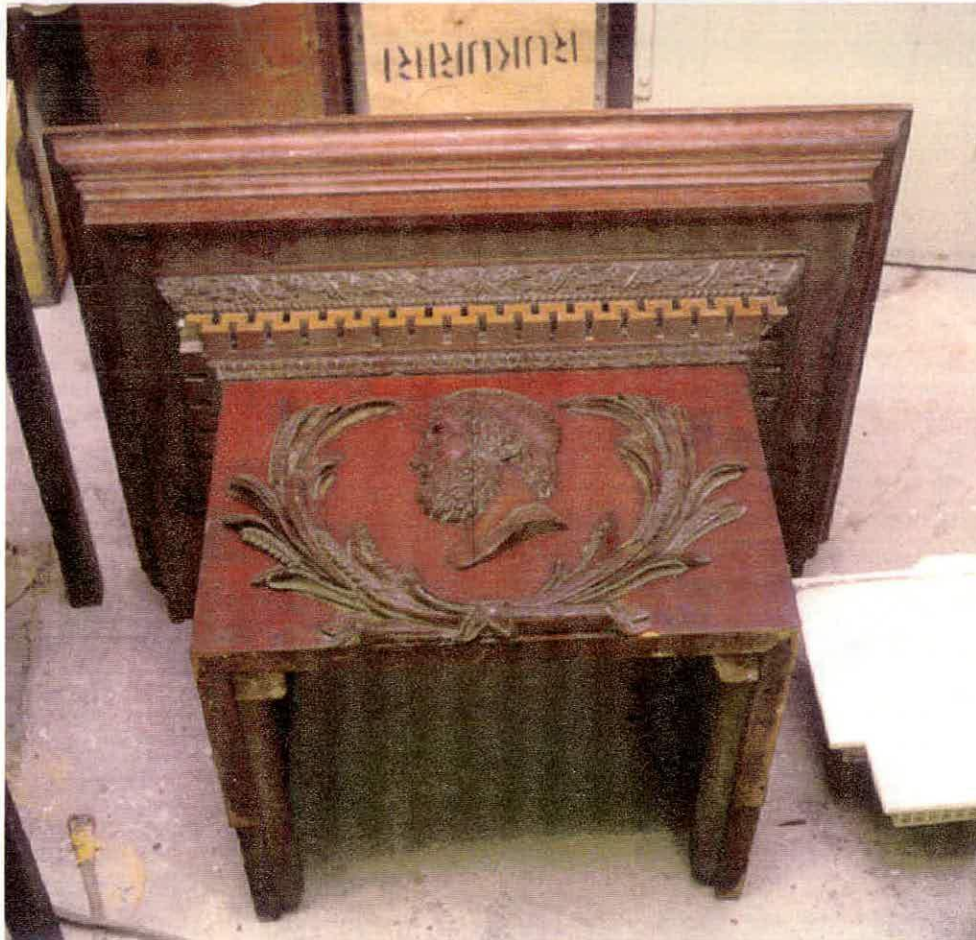
Figure 9, the block pediment fragment with the relief carving of a classical head surrounded by sheaves of corn.

Above the entablature, it seems, there was a block pediment, Figure 9. Although this fragment was found among the other items removed from the house in 1995, it does not appear in any photograph of the house that pre-dates the removal of the bookcases in about

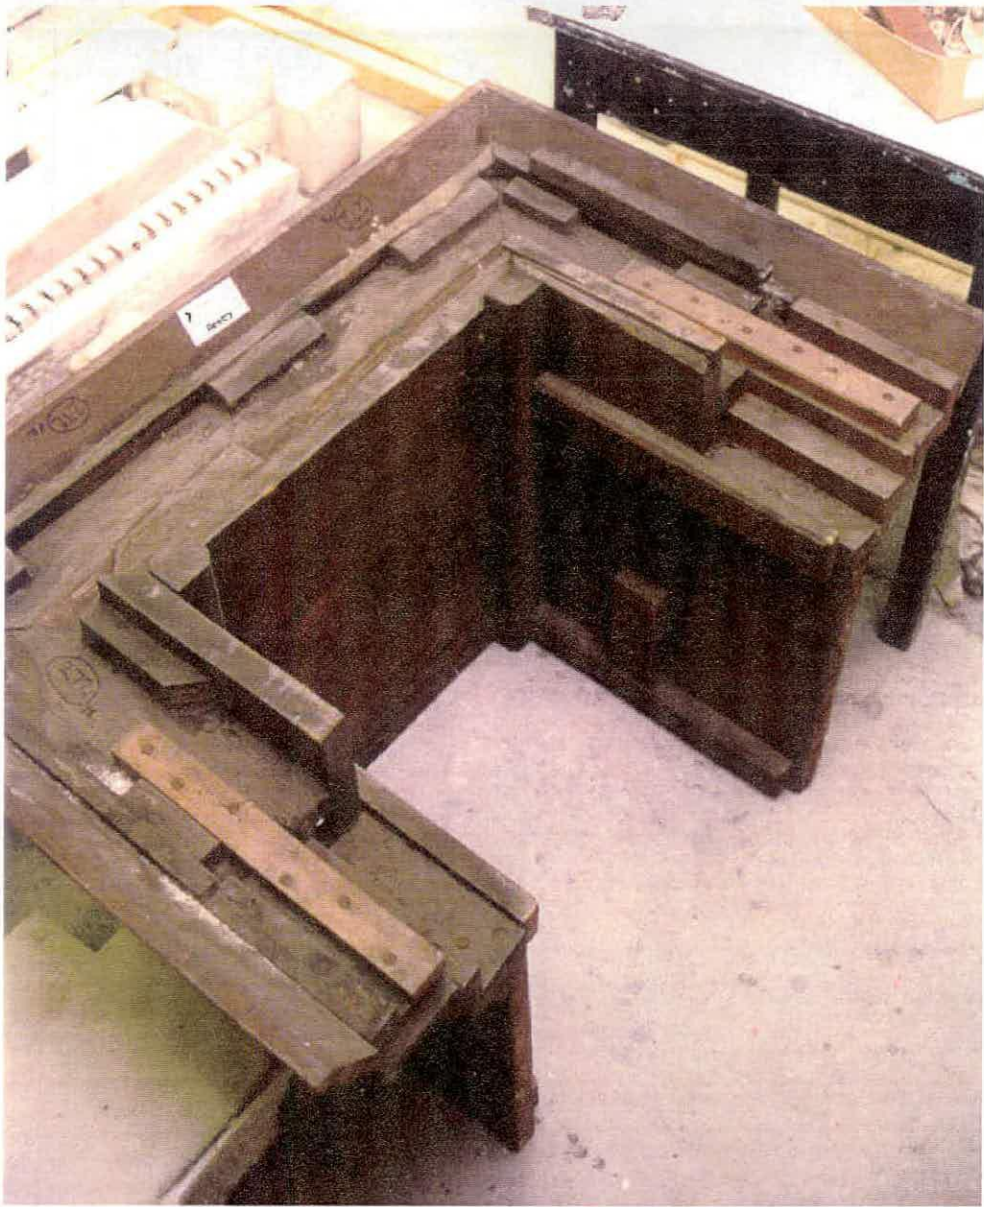
Figure 10, the back of the block pediment showing the crude Victorian method of assembly using glued battens and screws.

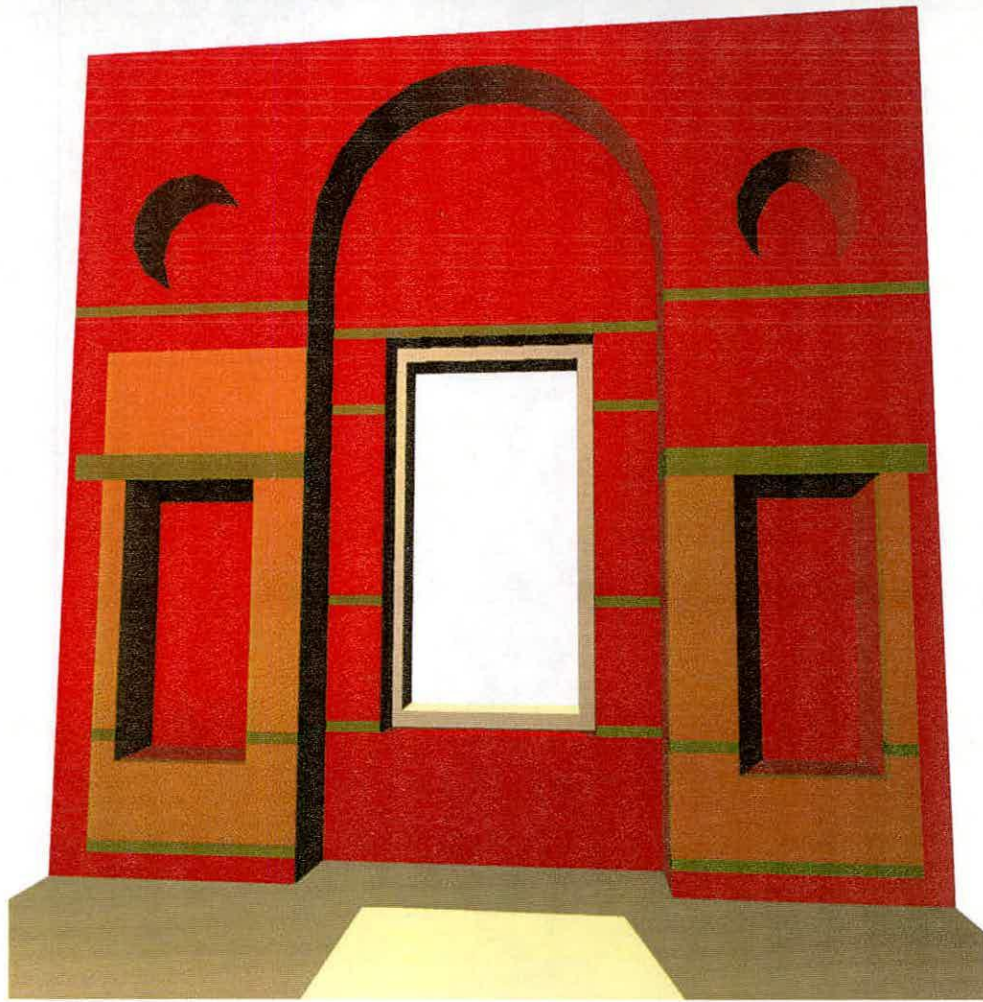
Figure 11, a reconstruction of the north wall of the Library, as it might have appeared in 1763 before fitting out in 1766. The orange coloured brick represents areas that were cut away in the 1860s.

More of the masonry and brick shell of the house was exposed in the Library during the works than in the Dining Room, Figure 7. In the Library, as in the Dining Room, Taylor used a triumphal arch motif to articulate the wall surface at each end of the room, Figure 11.

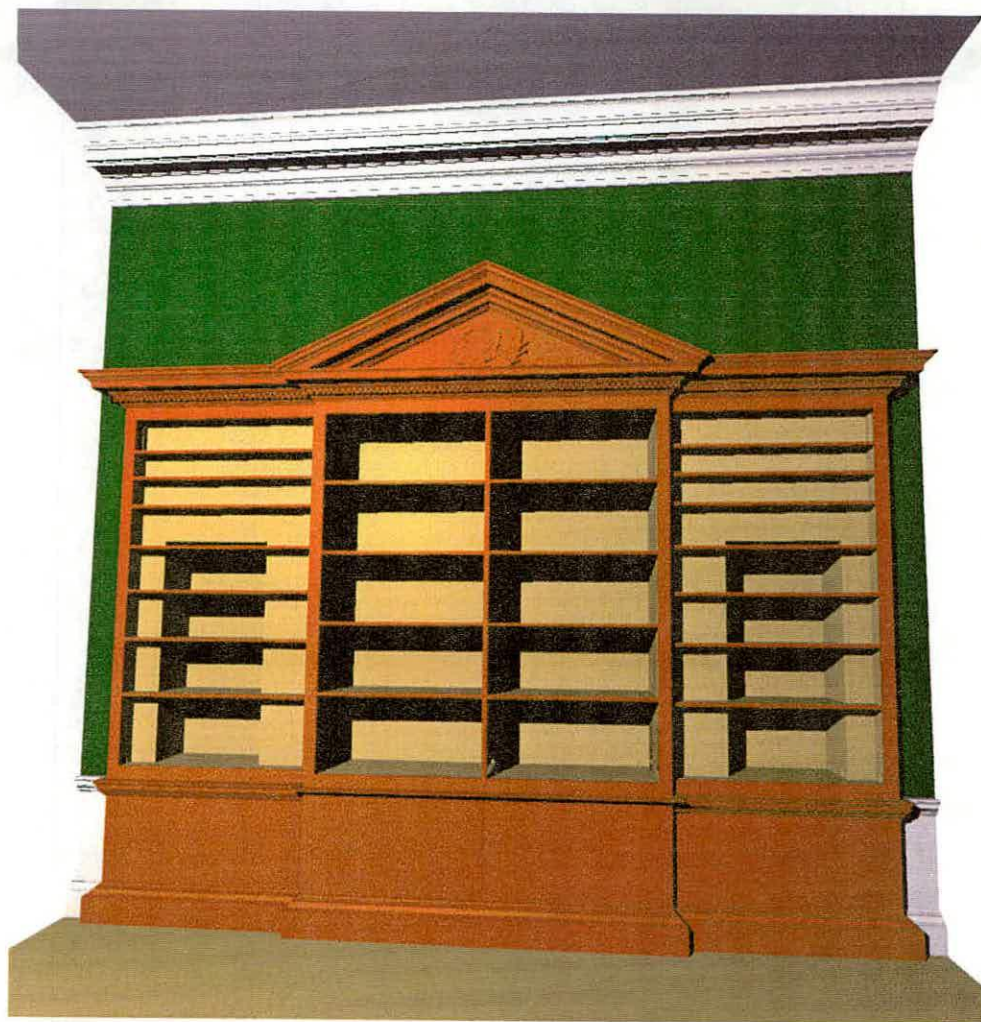
Figure 13, a reconstruction of the bookcase on the south wall, BC3, 4 and 5, as it might have appeared when first installed in 1766.

A pediment matching those on the east wall is the most likely original arrangement for the top of the centre bookcase against the south wall, BC4, Figure 13. Although, none of the surviving fragments can be associated with this conjectured pediment, it is likely that parts of the cornice mouldings were incorporated into the block cornice and frieze that replaced it in the 1860s.

The fragment of carved mahogany with a bearded male head surrounded by sheaves of corn, discussed above, is glued to the front of the box. The carving is not a complete fragment; the upper edges are broken rather than carved. It is clearly not in its original location since the upper part of the circle enclosing the head, had it survived, would have extended over the bottom edge of the cornice. It has already been suggested above that this fragment derives from the original pediment above the centre bookcase, BC4. Two mahogany brackets, now in the artefact store at the house, were probably fixed either side of the block pediment to mirror those at the top of the organ, Figure 13.

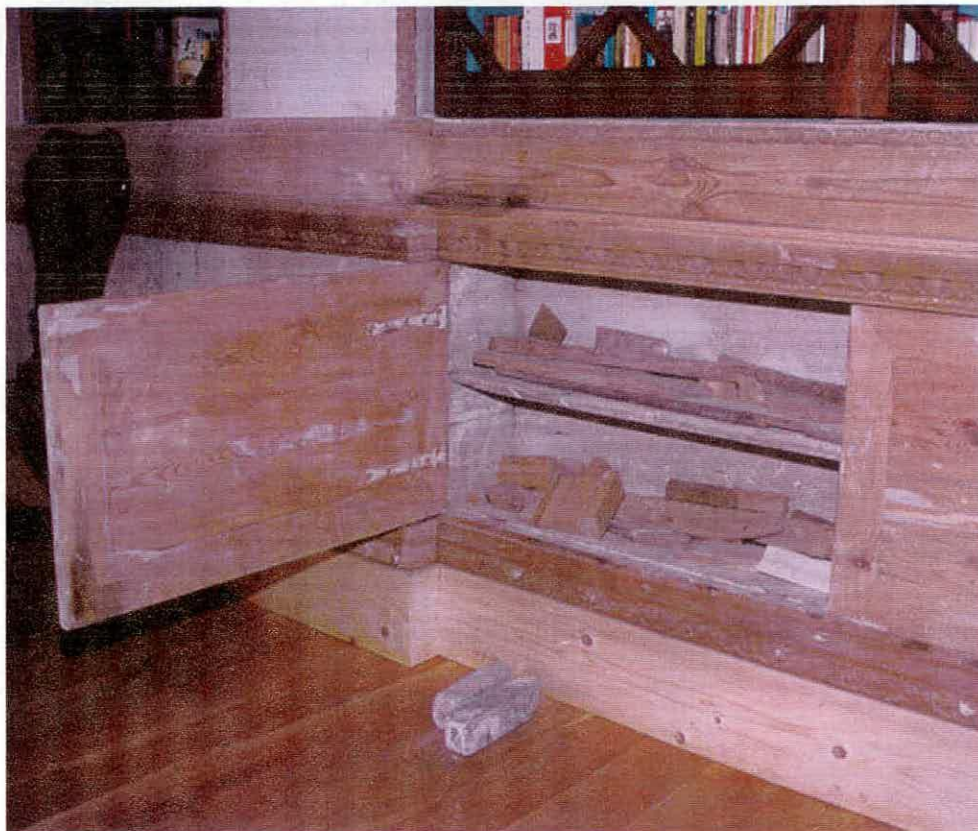
Figure 15, a cupboard door at dado level in the library at Barlaston, during restoration. Note the flush panel construction and long hinges.

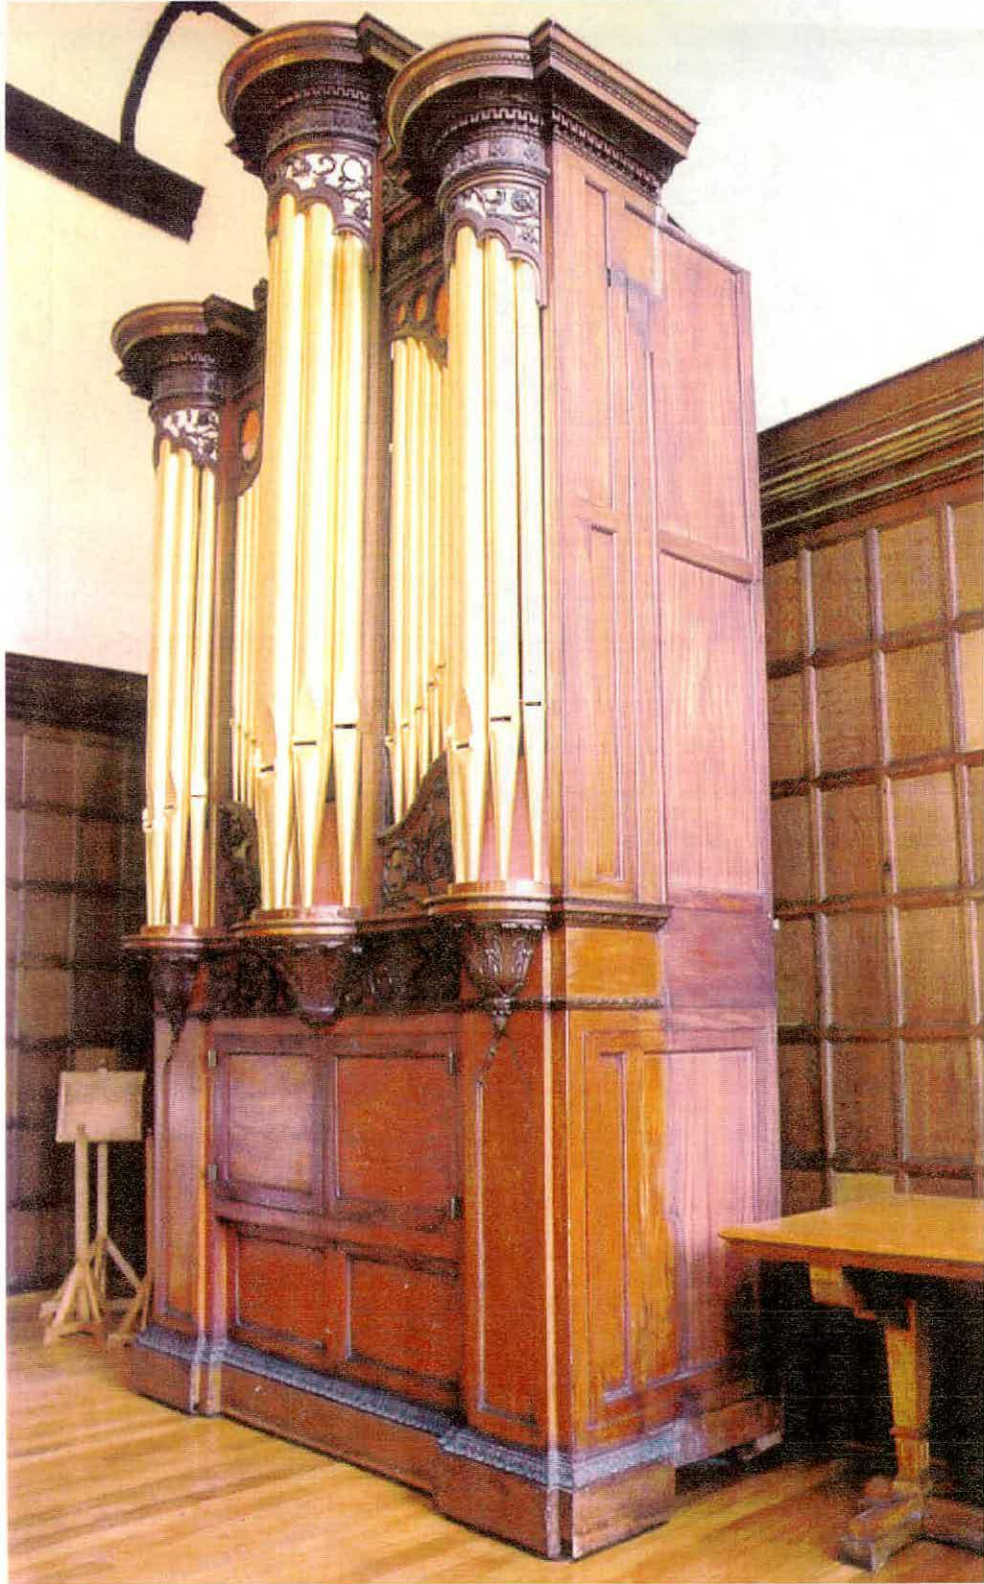
Figure 18, the Danson organ in the great hall at Hall Place, Bexley, June 2001.

Since the 1980s, the Danson organ has been kept in the great hall at Hall Place, Bexley, Figure 18. It deserves mention as an outstanding and rare example of an eighteenth-century domestic organ.¹⁴ Its significance will increase when it is returned to its original setting in the Library or Music Room at Danson. It was a conspicuous feature of the house's interior decoration but would also have figured prominently in its social life.

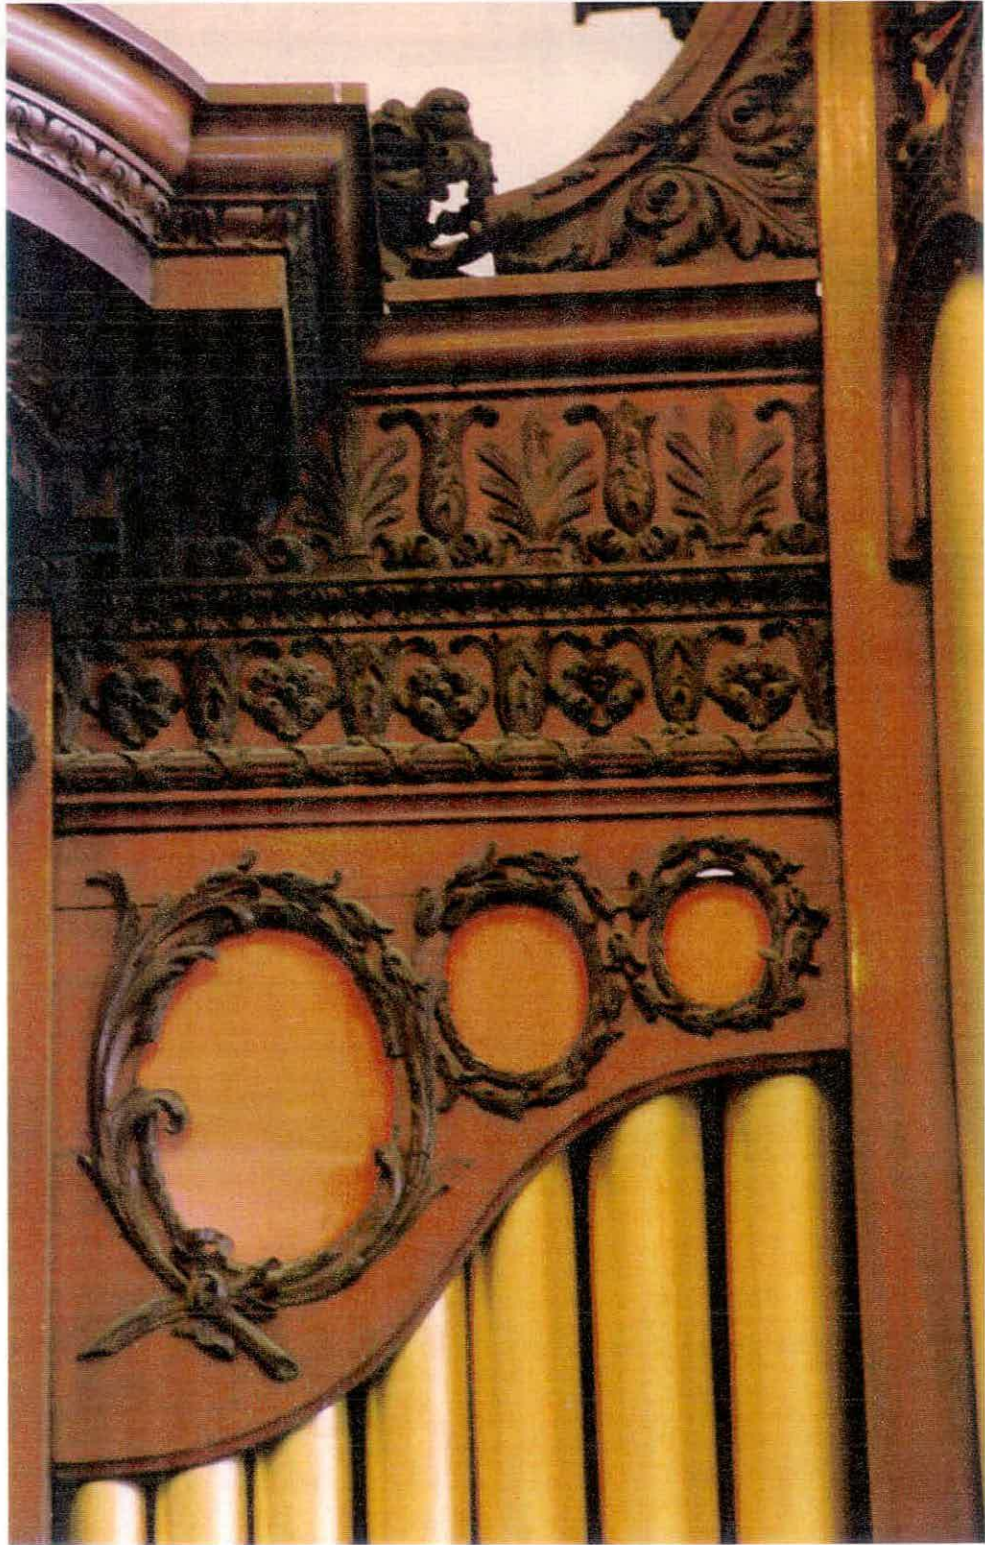
Figure 19, detail of the frieze at the top of the organ.

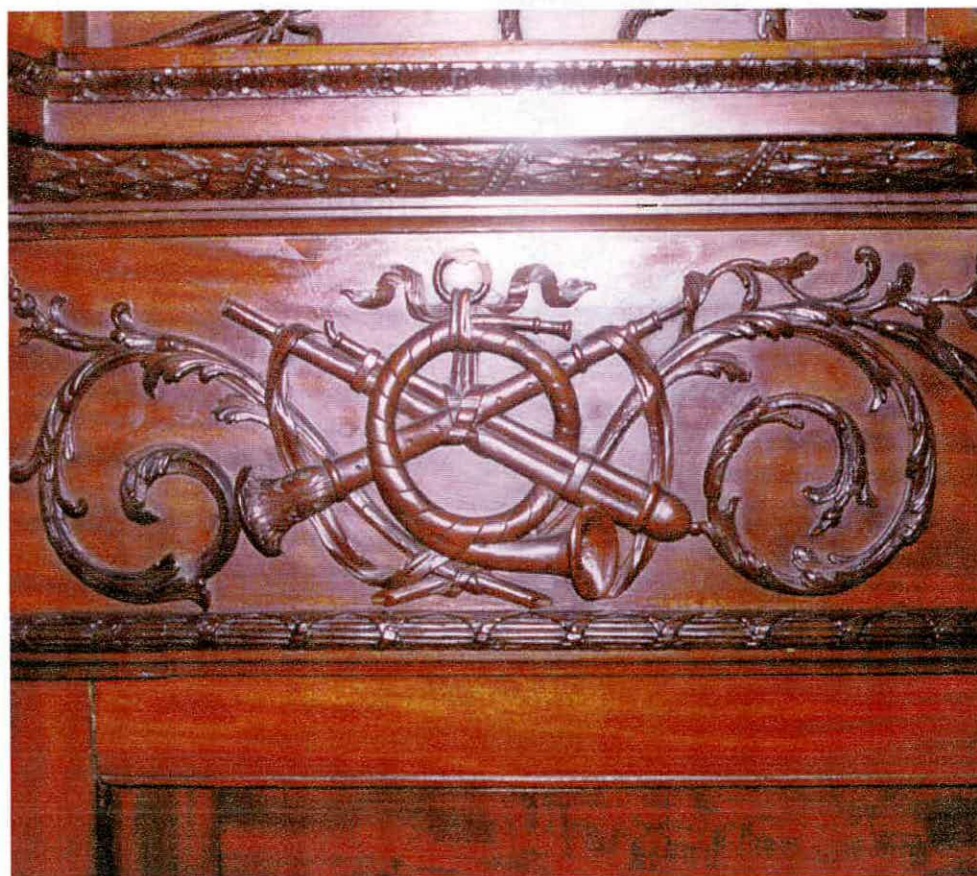
Figure 21, detail of the panoply of musical instruments to the left of the console

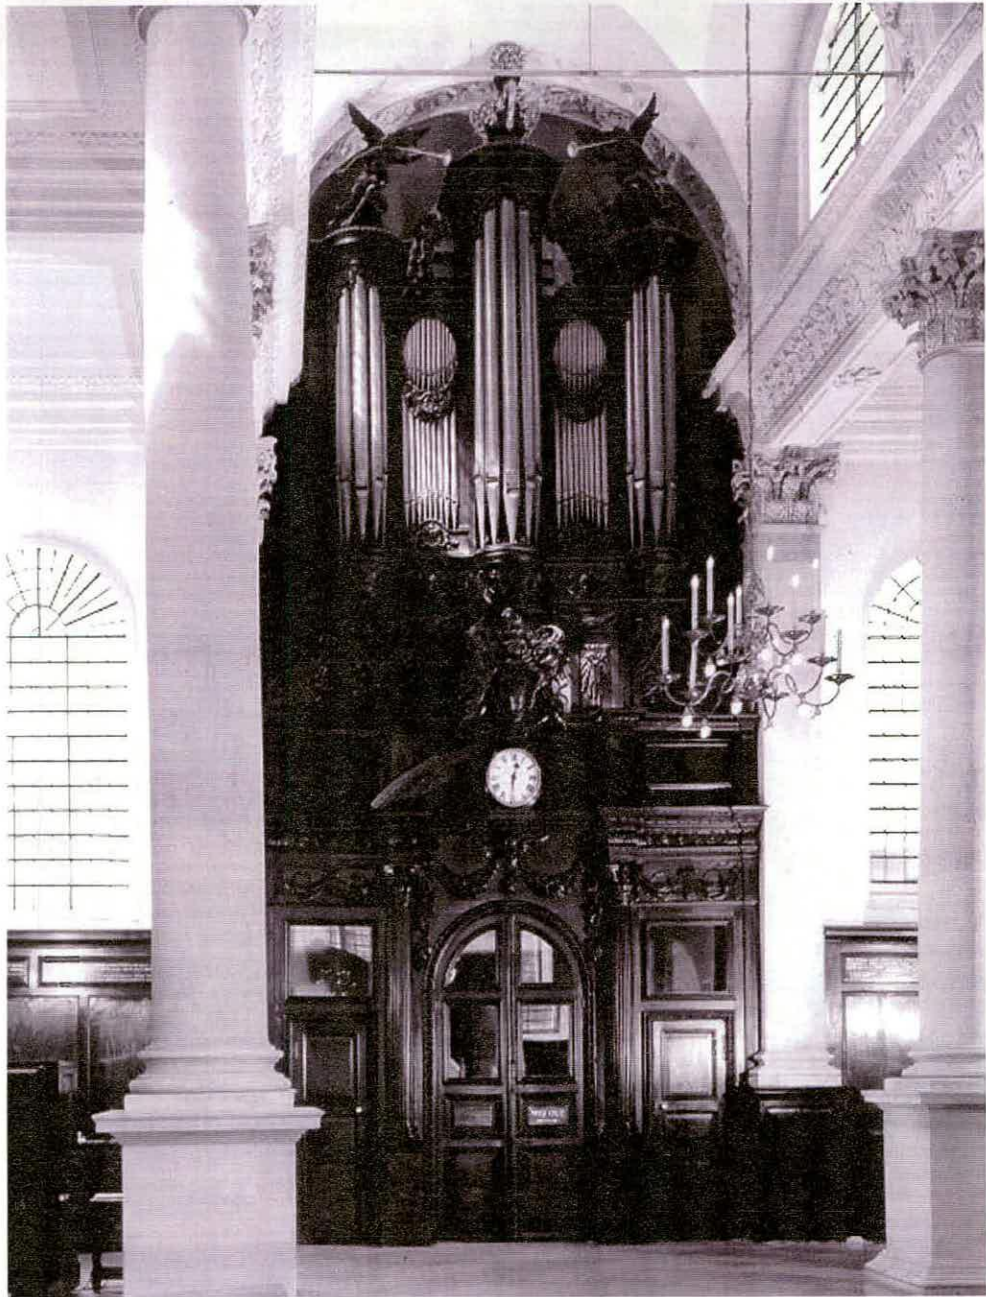
Figure 24, the organ at St Stephen, Walbrook, City of London, by George England, 1765

The towers and the 'S' shaped panels between the towers are reminiscent of the much larger organ at Christchurch Spitalfields, by Richard Bridge installed in 1735/6.²⁷ But the organ at St Stephen Walbrook by George England in 1765, Figure 24 and Figure 25, another three-tower design, has similar panoplies of musical instruments to those at Danson, Figure 20 and Figure 21.²⁸ The carving of the corbels for the towers and the oval piercing of the panels in front of the pipes decorated with foliage carving are also similar. This is perhaps not surprising as the two organs may be by the same organ maker.

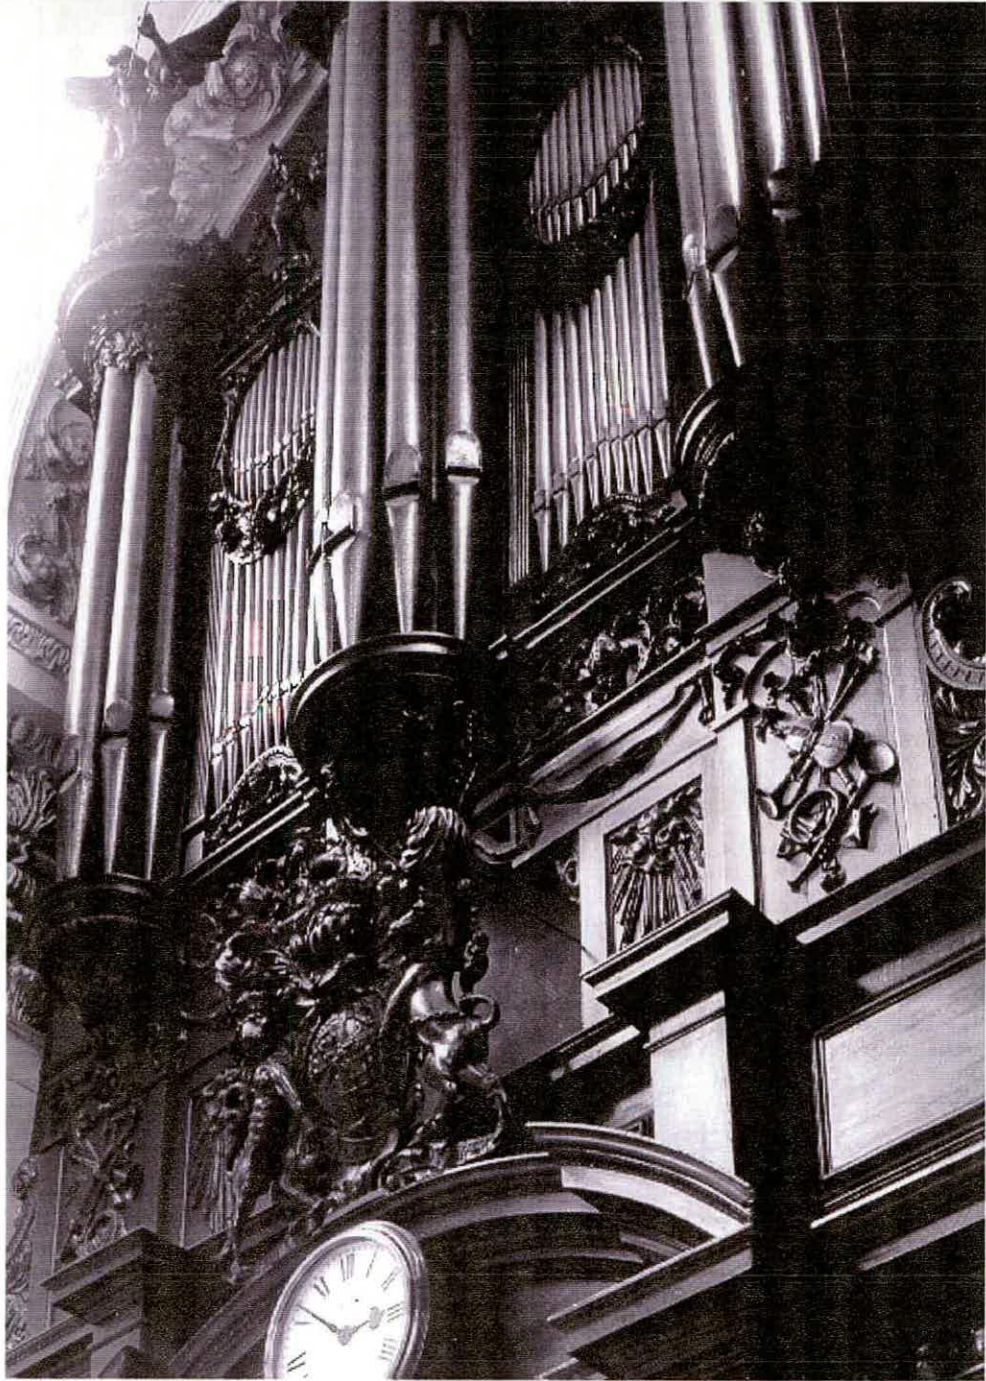
Figure 25, detail of the organ at St Stephen, Walbrook, City of London, by George England, 1765

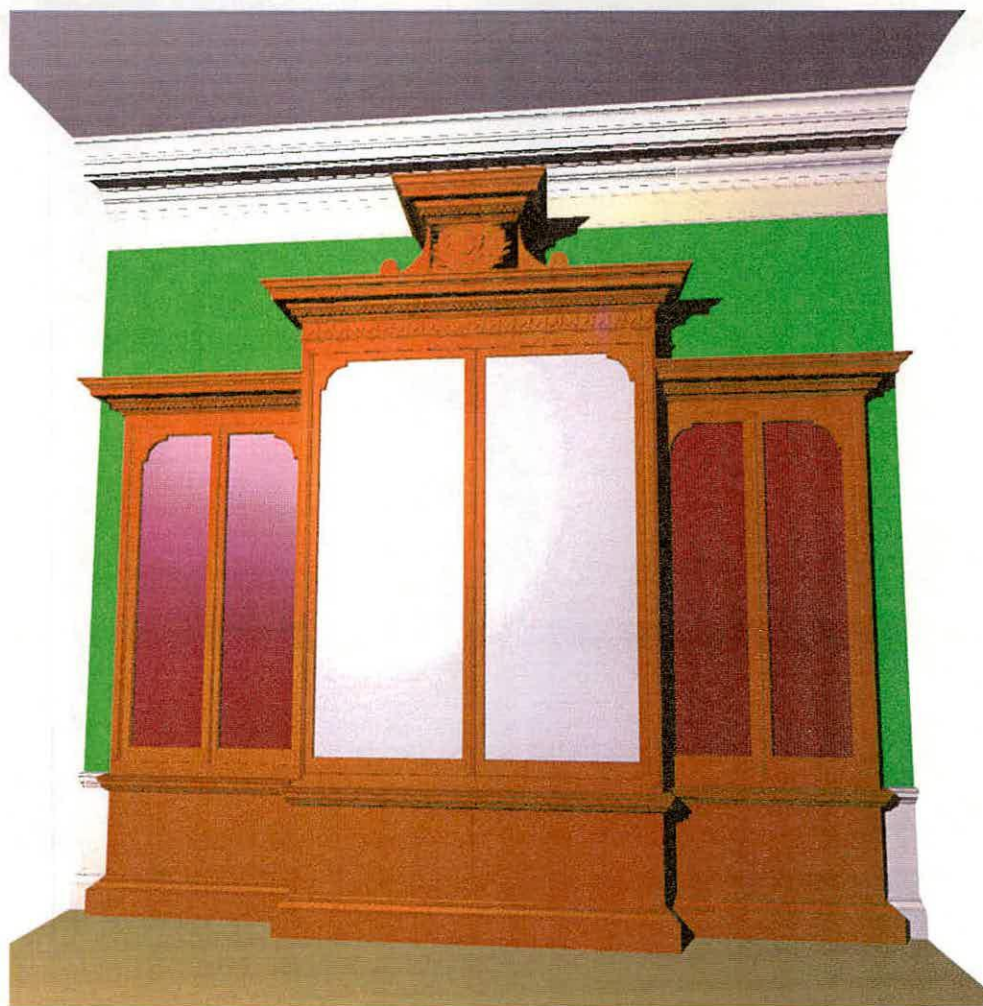
Figure 26, a reconstruction of the bookcase against the south wall, BC3, 4 and 5, as it might have appeared after alteration *c* 1863. Although this bookcase probably survived in this form until the 1990s when it was dismantled, it does not appear in any of the photographs of this room known to the authors.

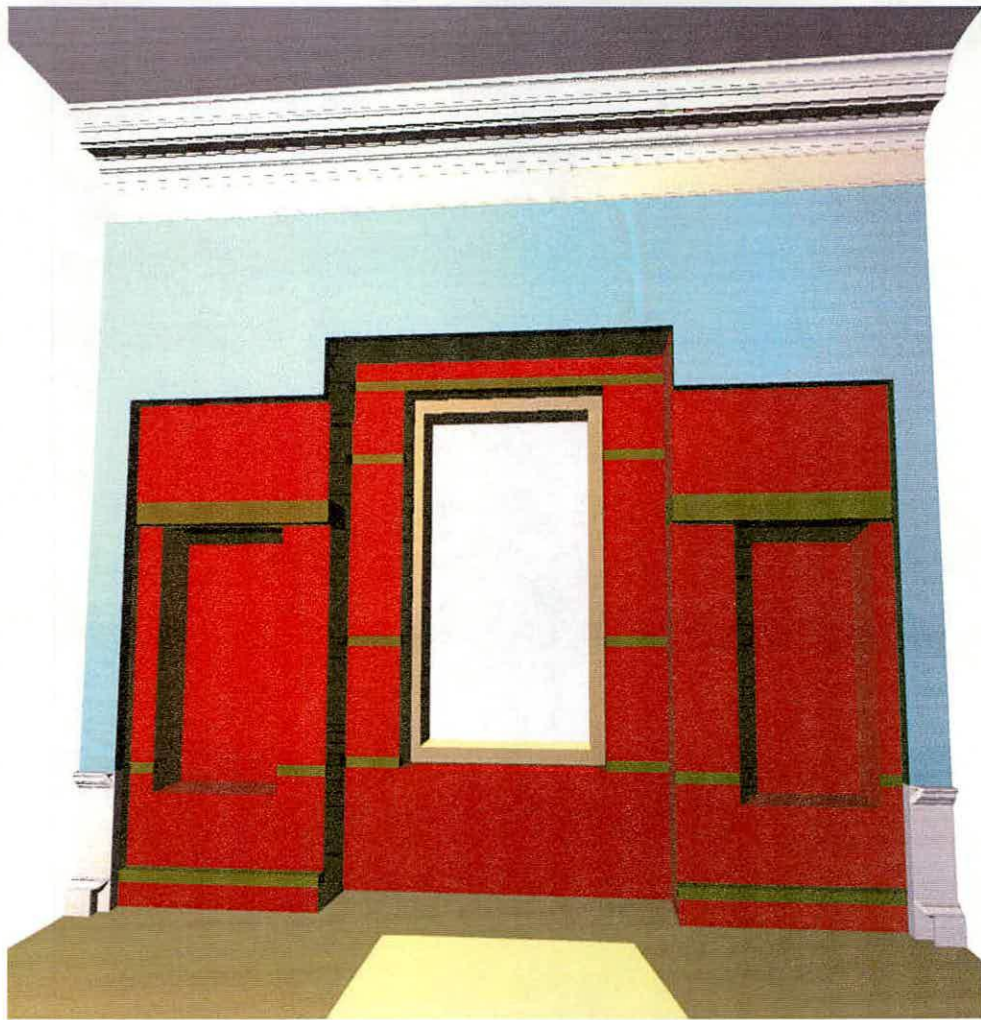
Figure 30, a reconstruction of the north wall, showing it altered by the removal of brick to receive the modified bookcases, as it might have appeared *c* 1863.

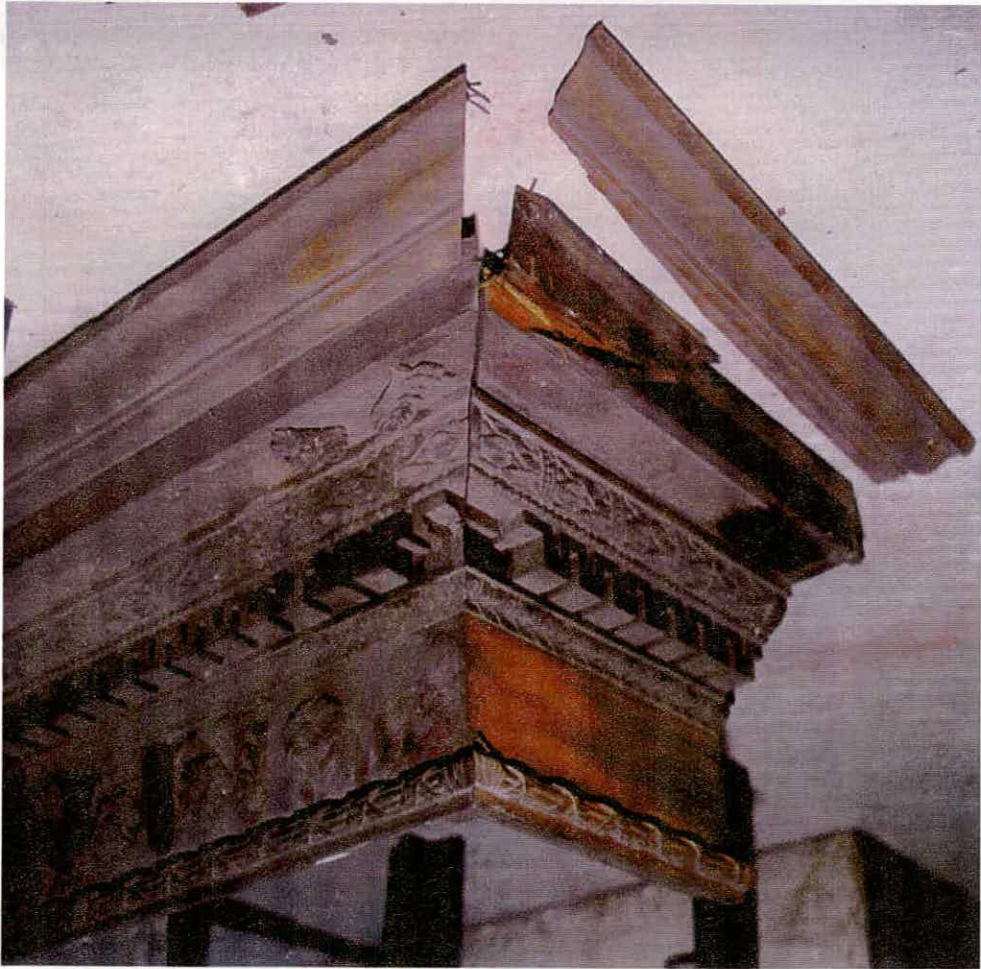
Figure 31, detail of the box cornice from the centre bookcase on the south wall, BC4.

Note, this photograph shows the box cornice on the floor of the Artefact Store, it has been inverted for clarity.

The top of the bookcase, BC4, was given an entablature consisting of a horizontal length of the original cornice set above a frieze incorporating calyces and rosettes, Figure 31. The cornice was probably made up using fragments from the original pediment. The carved mahogany calyces and rosettes in the frieze are reused. The original form of the calyces can be seen in a comparison with those in the frieze at the top of the organ. Those reused in the bookcase frieze appear to have been identical to the lower type. However, in the bookcase frieze, all of the tendril extensions have been broken or cut off and they are so closely spaced that this must have occurred before they were glued in place.

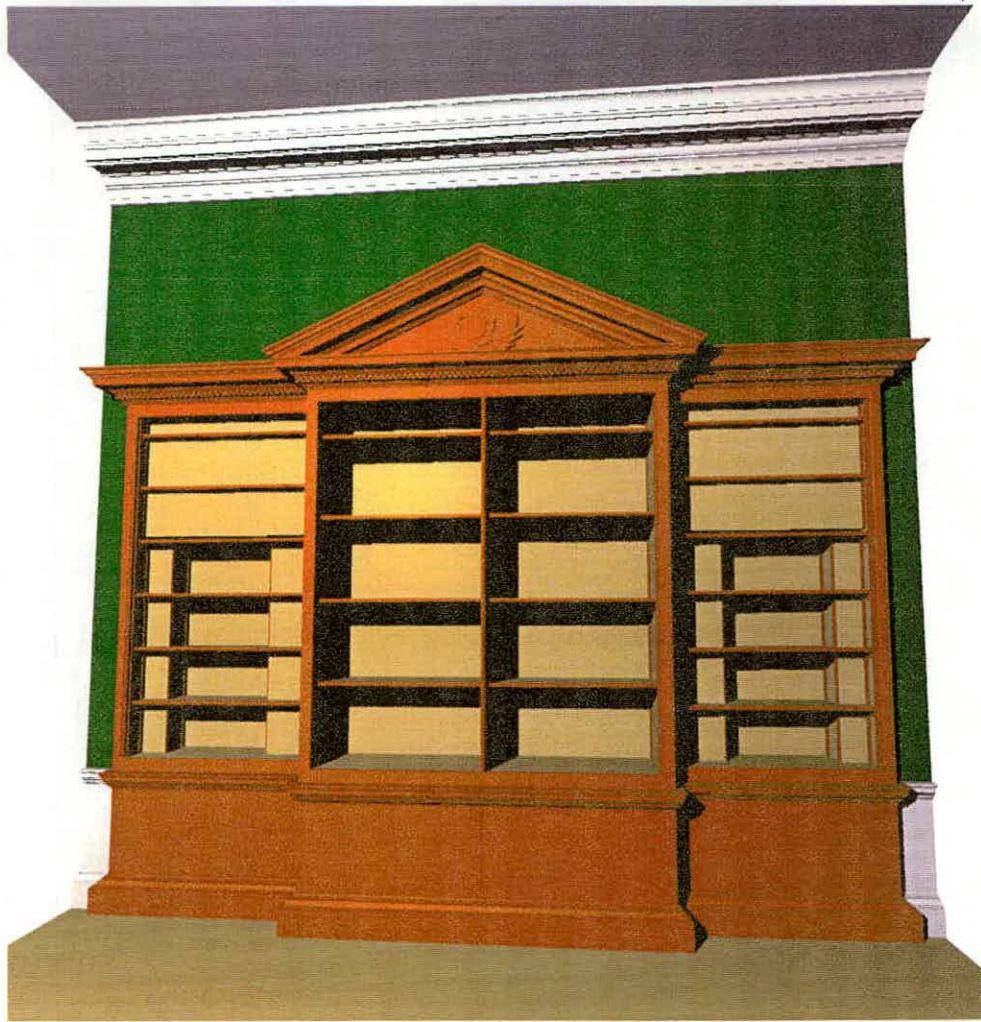
Figure 33, a perspective view showing how the bookcases on the south wall would appear if restored according to our preferred options.

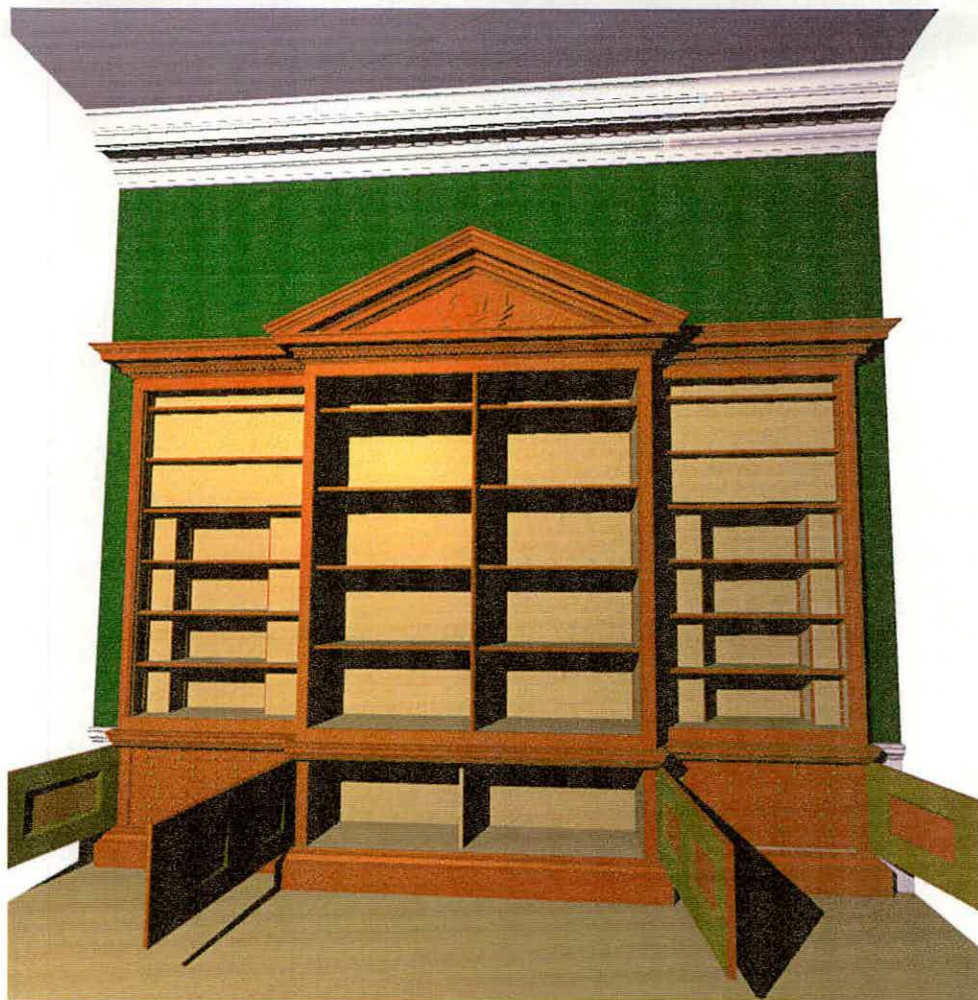
Figure 34, a perspective view showing how the bookcases on the south wall would appear with the cupboard doors open if restored according to our preferred options.
