THE BOOKCASE AND ORGAN
SCHEME OF 1766 IN THE
LIBRARY AT DANSON

AN EXAMINATION OF THE EVIDENCE
AND NOTES FOR ITS RESTORATION

Richard Lea and Chris Miele

Reports and Papers 56

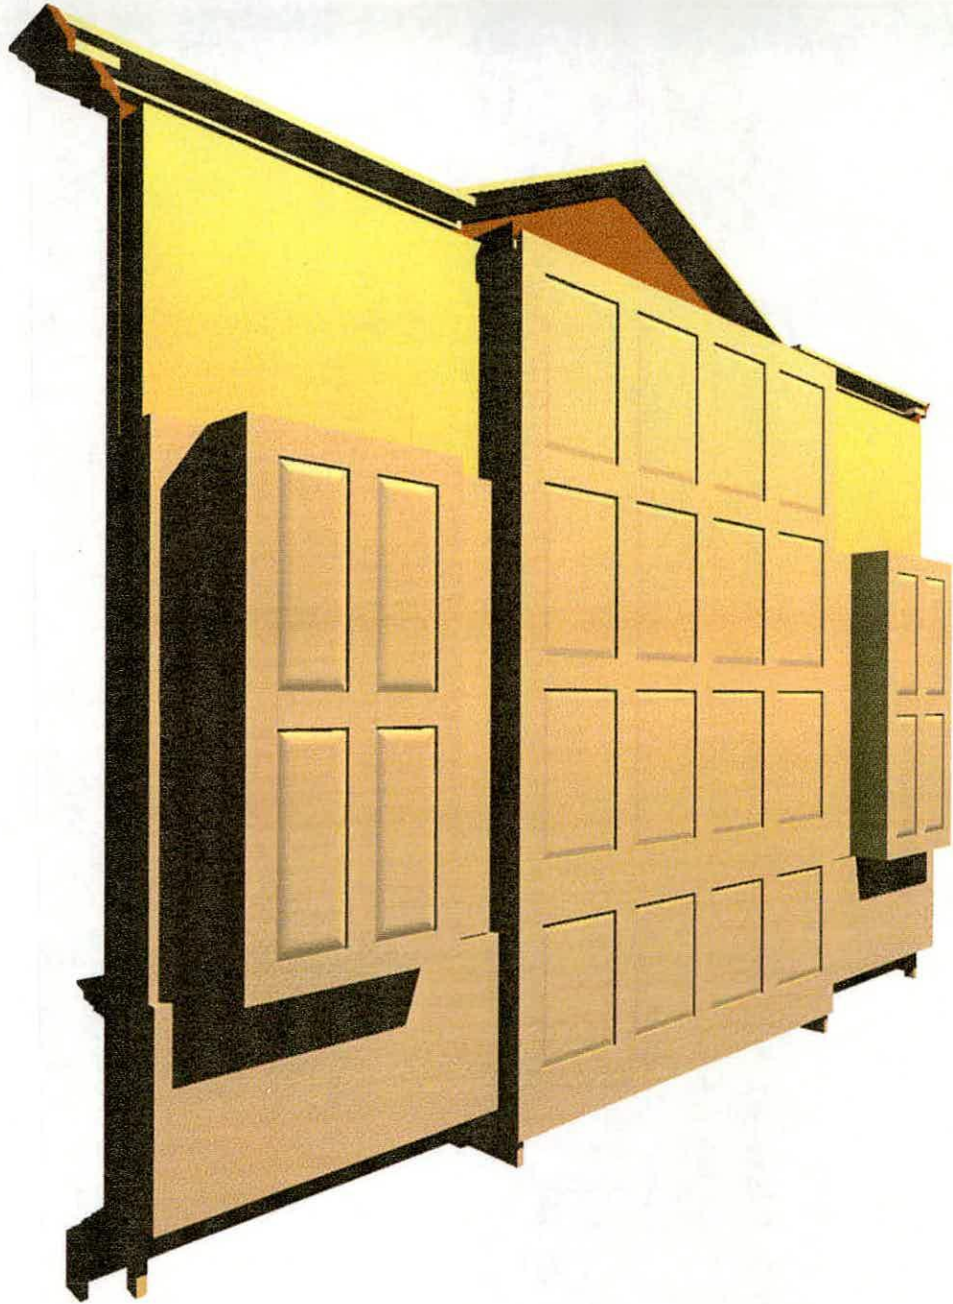
Figure 35, a perspective view showing how the back of the bookcase on the south wall would appear if restored according to our preferred options.
