WOLSEY'S COTTAGE

4 LOWER TEDDINGTON ROAD, HAMPTON WICK
RICHMOND-UPON-THAMES

Notes on the Building's Possible Historical Development

Historical Analysis & Research Team
Reports and Papers 41
2000

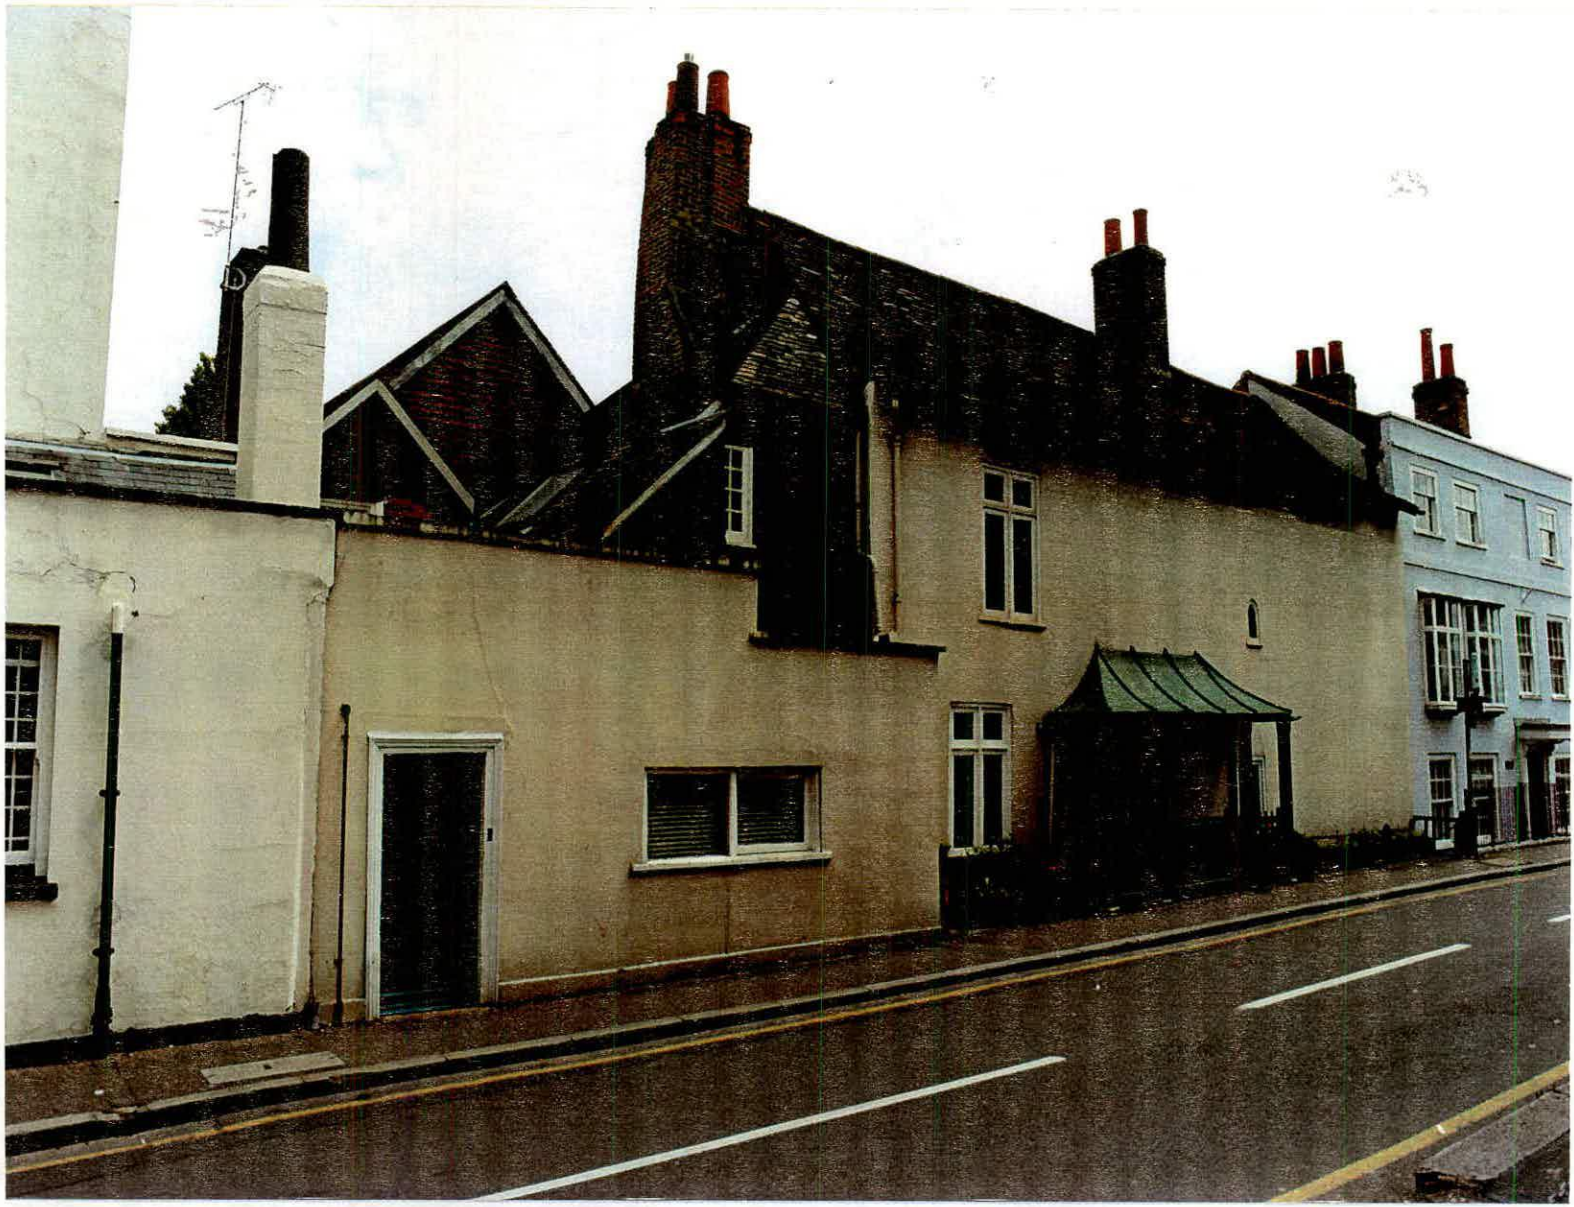
The three floor levels in the southern part of the property appear to correspond with those of the building to the south, No 2 Lower Teddington Road. This is evident from the street facade. The shared floor levels and general alignment suggest that the two properties were originally built at the same time (Figure 20).

The appearance of the five-bay three-storey house immediately south of Wolsey's Cottage suggests that it was refronted in the eighteenth century (Figure 20). The floor levels appear to line through with those in the southern half of Wolsey's Cottage but the roof is set higher. This appears to be due to the creation of a full second storey in place of an attic storey with dormers. From the extent of its facade, it is clear that the present property division between it and Wolsey's Cottage was established by that date.

Figure 20: Wolsey Cottage viewed from the north west.

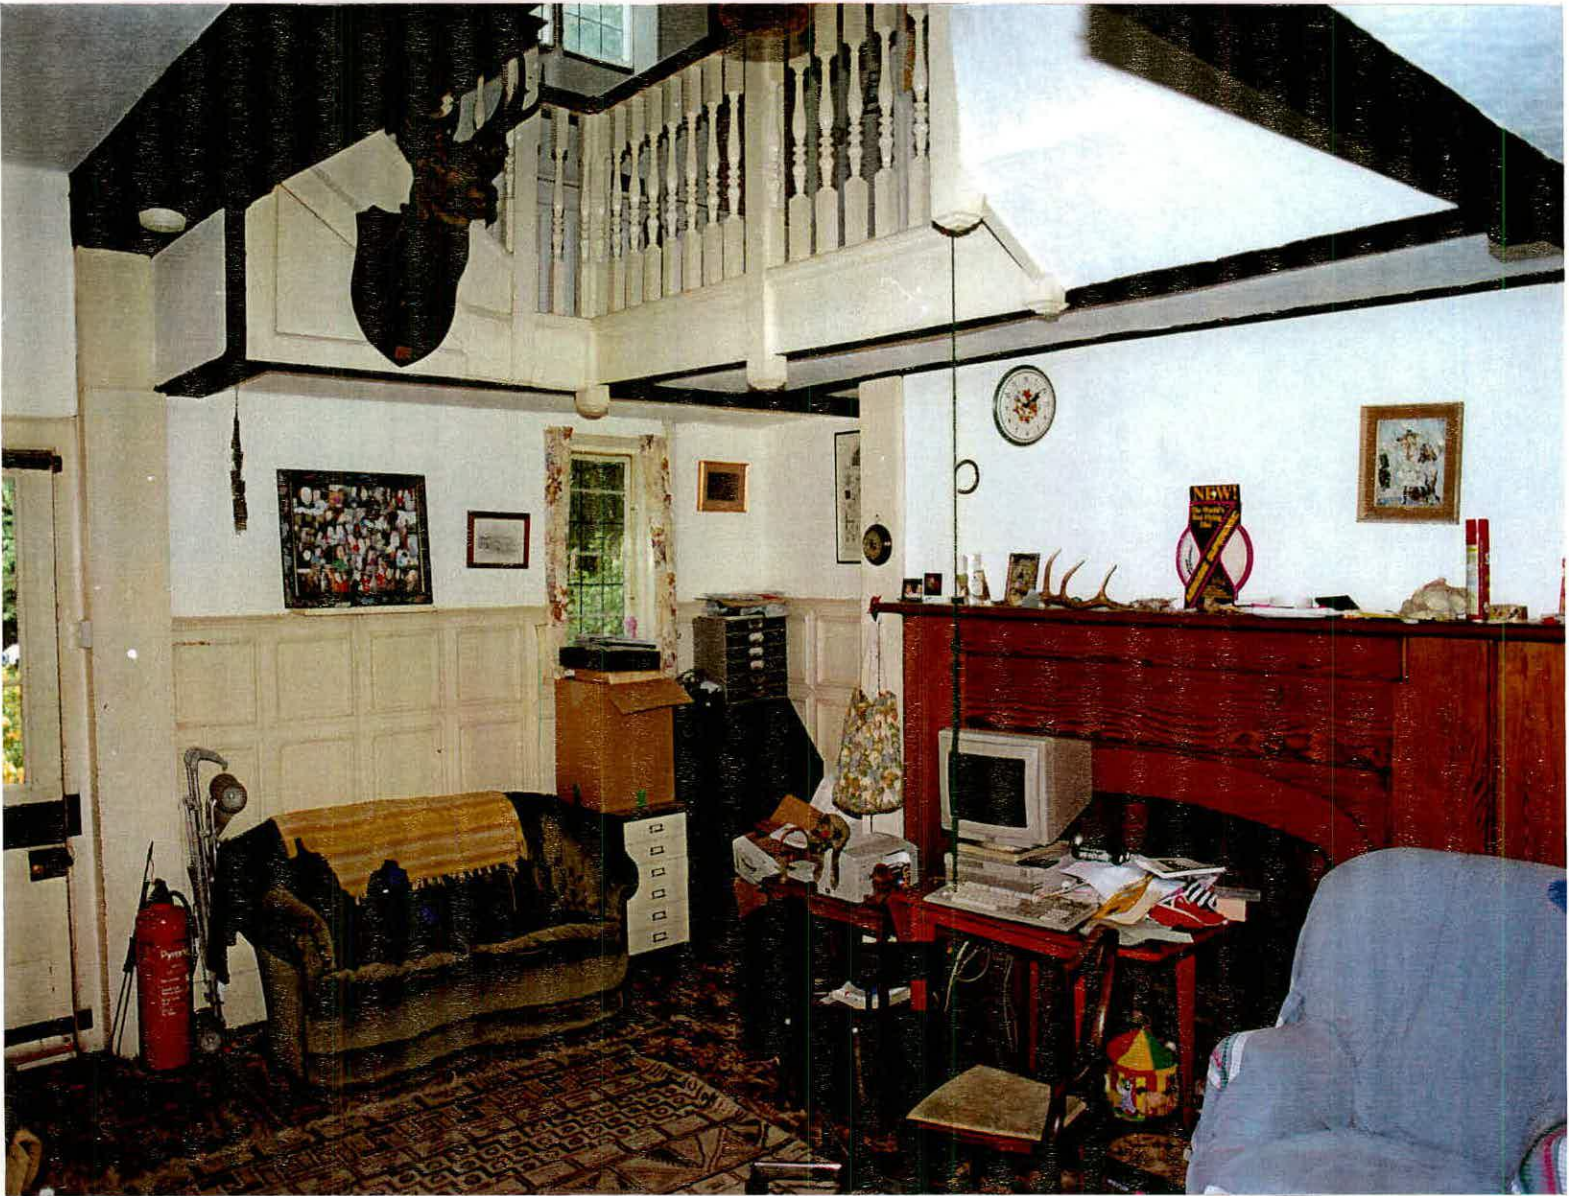
The difference in the levels of the first and second floors either side of a line adjacent to the south jamb of the front door indicates a major structural division at this point (Figure 21). There is also a significant difference in the construction of the roof trusses either side of this line. To the north and including the truss on this line, the tie beams are at second floor level. The attic occupies the space between the tie beam and the collars. In the southern half of the building, at wall plate level, there are no tie beams. The main beam for the attic floor in this area must therefore be tied to a wall post and either the principal rafters are tied to the wall posts or the principal rafters are shaped like crucks to allow greater height in the attic floor.

The staircase in the present entrance hall lost its lowest flight from ground to first floor some time after the lecture to the local society in 1884 (Figure 21). According to the later annotation on the text of the lecture, this occurred about 1890 but the detailing of the making good suggests the 1920s. The lecture text describes the staircase as having a 'carved oak balustrade' but the handrail of the surviving upper sections is clearly of pine. The balusters are painted but are probably also of pine. The lecture is therefore probably incorrect in describing the staircase in the hall as of oak: more likely, it was grained at the time.

Figure 21; the hall looking south east. The difference between two first floor levels can be seen either side of the large black beam in the left of the picture.

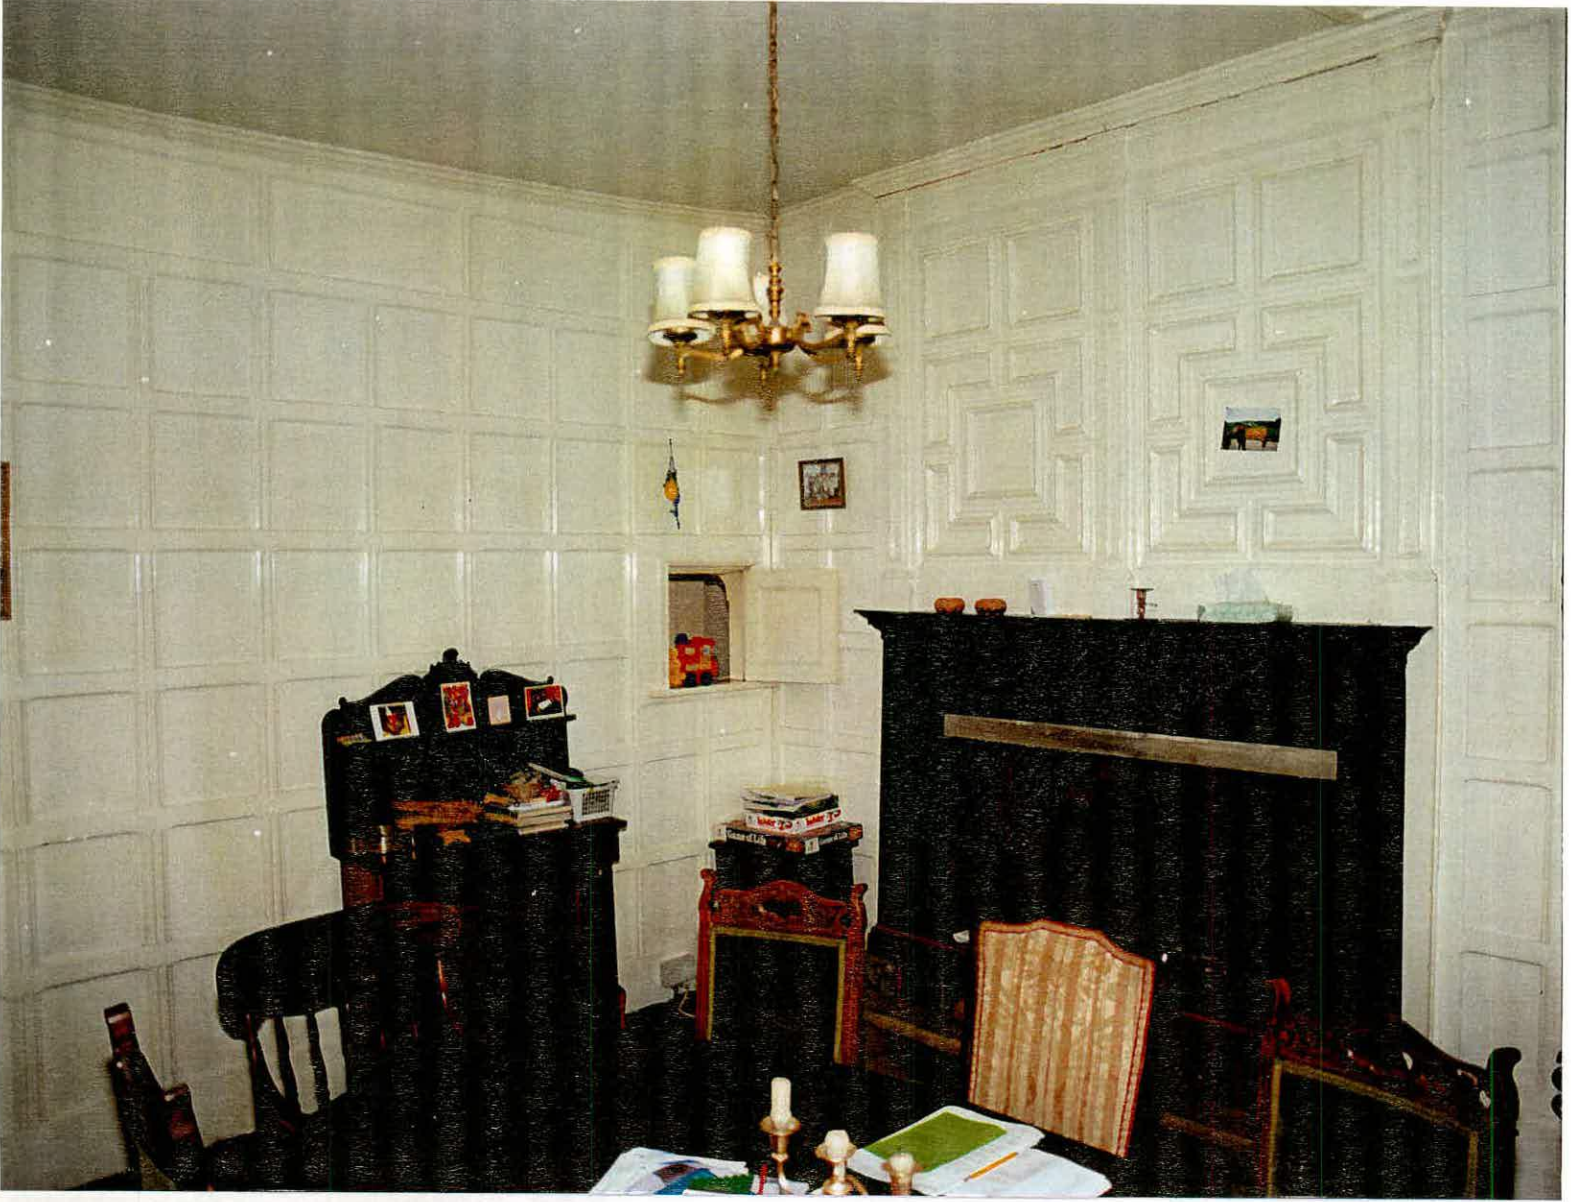
Like the first-floor room above, the dining room has been subdivided by the creation of a passage along the west wall (Figure 25). The panelling in the dining room and passage now consists of three types. The earliest panelling survives on the south, east and west walls of the original full size room. The stiles of the panelling are moulded with Grecian cymas, raised beads, and a fillet either side of a sunken panel. The overmantel is composed of two panels of bolection moulding. Each panel is in the form of a panel within a panel. The panels are separated by flat pilaster like mouldings. The overmantel may date from the seventeenth century but the fit with the twentieth-century fireplace below suggests that it might be contemporary. Elsewhere on the fireplace wall and continued on the inserted west wall of the room, the panelling is plain with simple chamfered stiles. The panelling on the west of the inserted passage wall is entirely plain. The lecture of 1884 refers to the panelling in this room as oak, but oak graining might have been more accurate.

Figure 25; the dining room, looking north west.

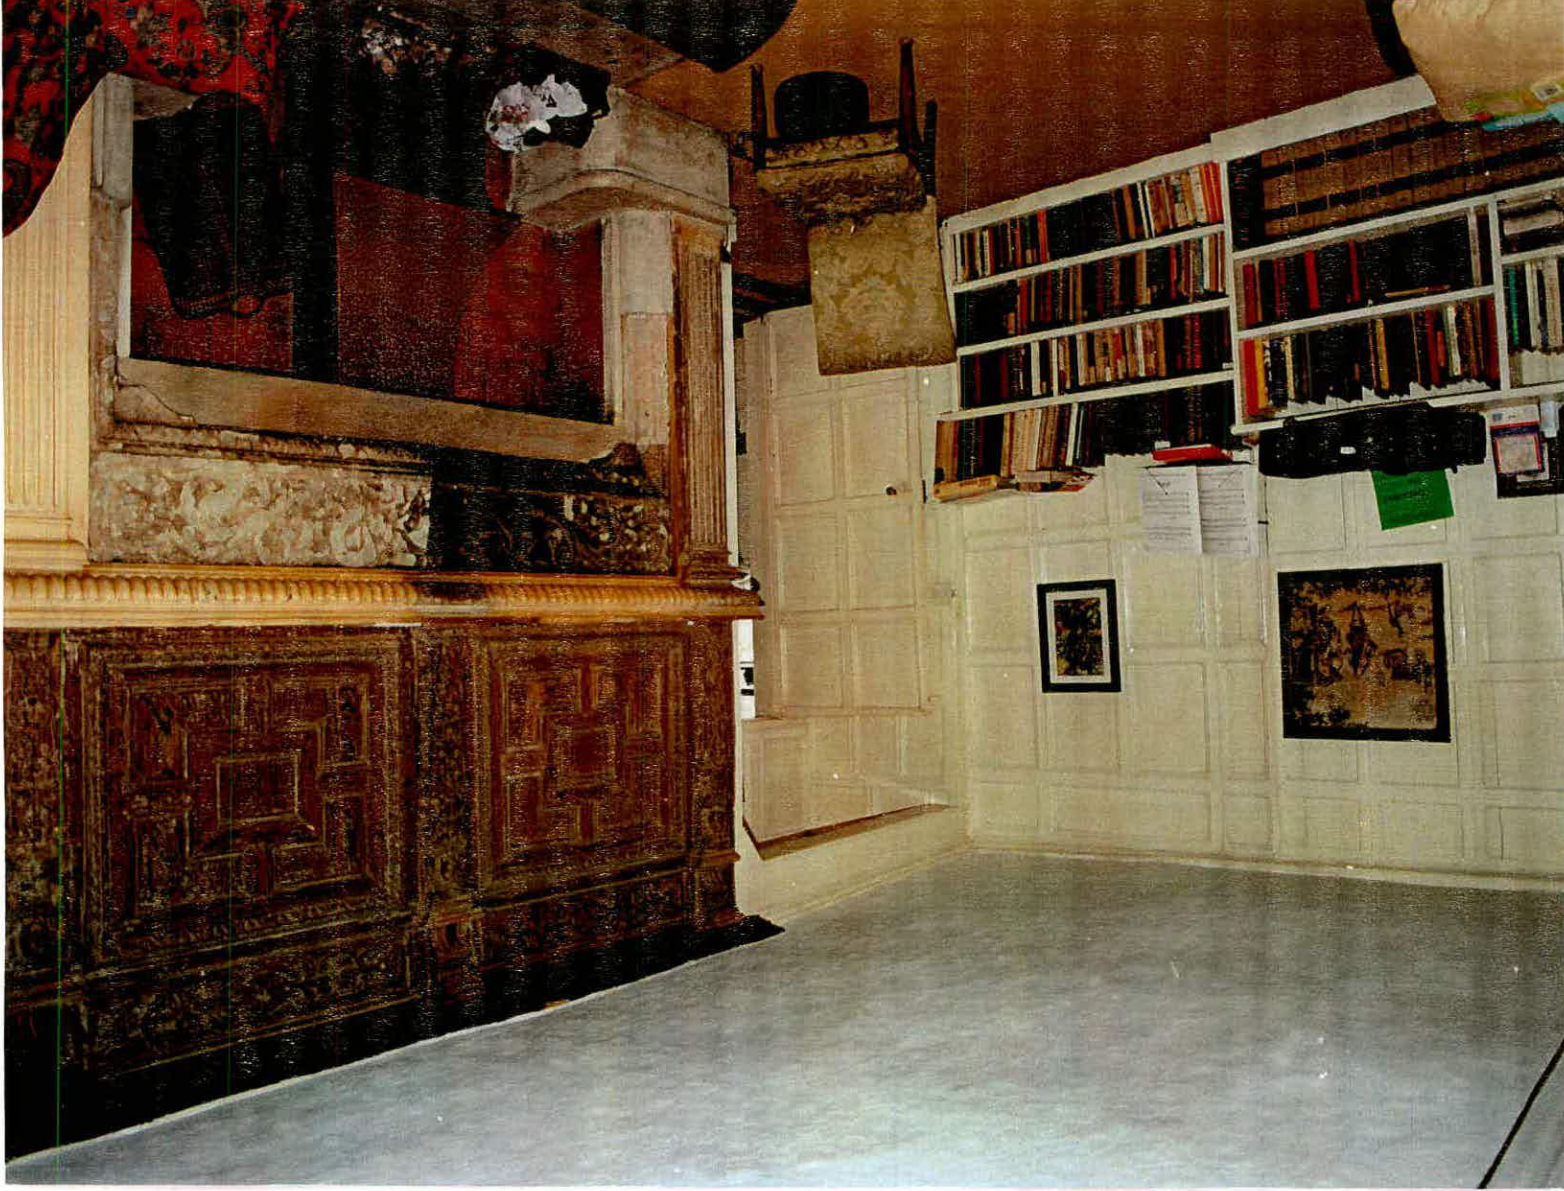
In the drawing room, the bolection panelling on the south and west walls is similar to the overmantel panelling, which appears to be contemporary and *in-situ* (Figure 26). The panelling in the two recesses in the north wall and a short section at the south end of the west wall of the drawing room is of another type and therefore appears to be secondary. This latter panelling is of the same type as that in the first-floor room above the dining room. Its appearance in the drawing room in conjunction with the bolection panelling suggests that it was relocated here, perhaps from the first floor.

Figure 26; the drawing room, looking north west.

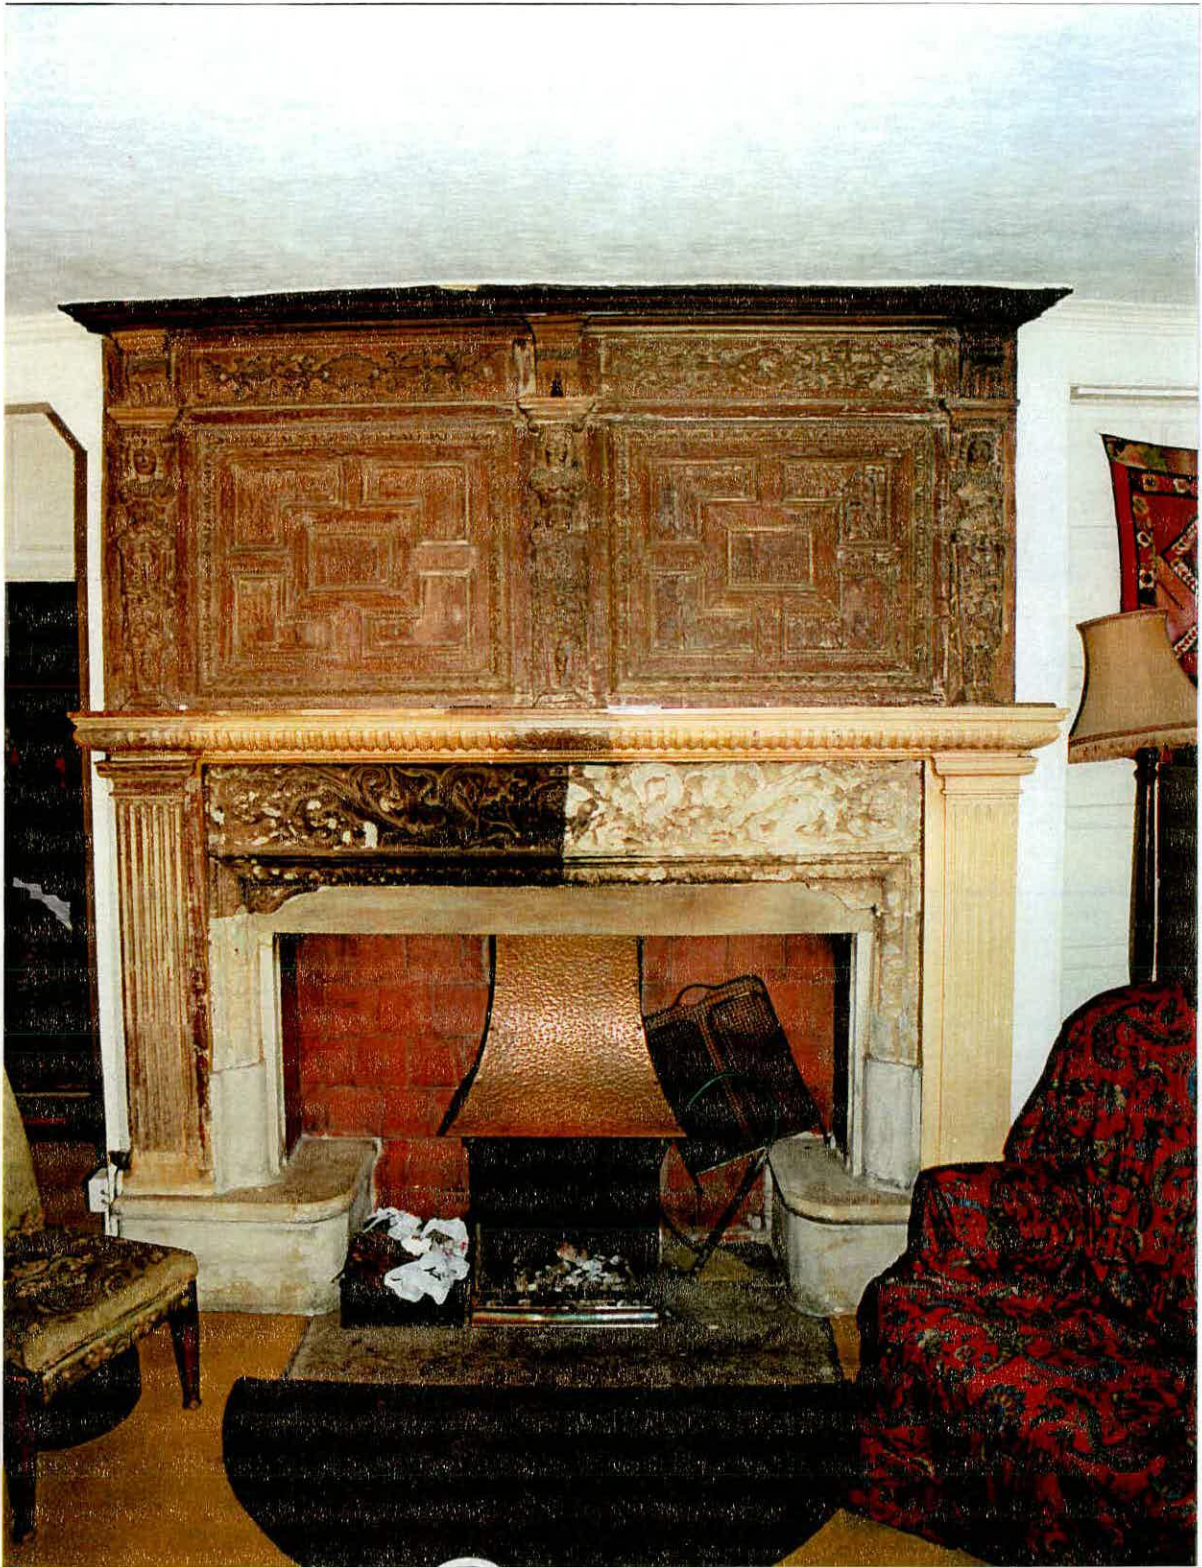
The design of the chimney-piece and overmantel suggests a late sixteenth- or seventeenth-century date (Figure 27). The device of a panel within a panel with bolection mouldings has parallels at Middle Temple Hall, in the hall screen from the 1570s,⁹ Charterhouse, Finsbury, in the west screen in the great hall, dated 1571, from the beginning of the seventeenth century¹⁰ and at Holland House, Kensington, in the fireplace in the long gallery.¹¹ The best undated parallel for the fireplace and overmantel was that in the Golden Lion, in Fulham High Street, rebuilt in 1836 (Figure 28). It had the same arrangement of two panels, with panels within, set between three caryatids, above a stone surround decorated with arabesques. The similarity with the Wolsey chimney-piece is so strong that it suggests the same hand.¹²

The carved stone fireplace, decorated with monsters, foliage and the monogrammed cartouche is clearly from a much later period than those installed in Hampton Court Palace by Cardinal Wolsey. They generally conform to the earlier four-centred or Tudor arch

Figure 27; the fireplace and overmantel in the drawing room.

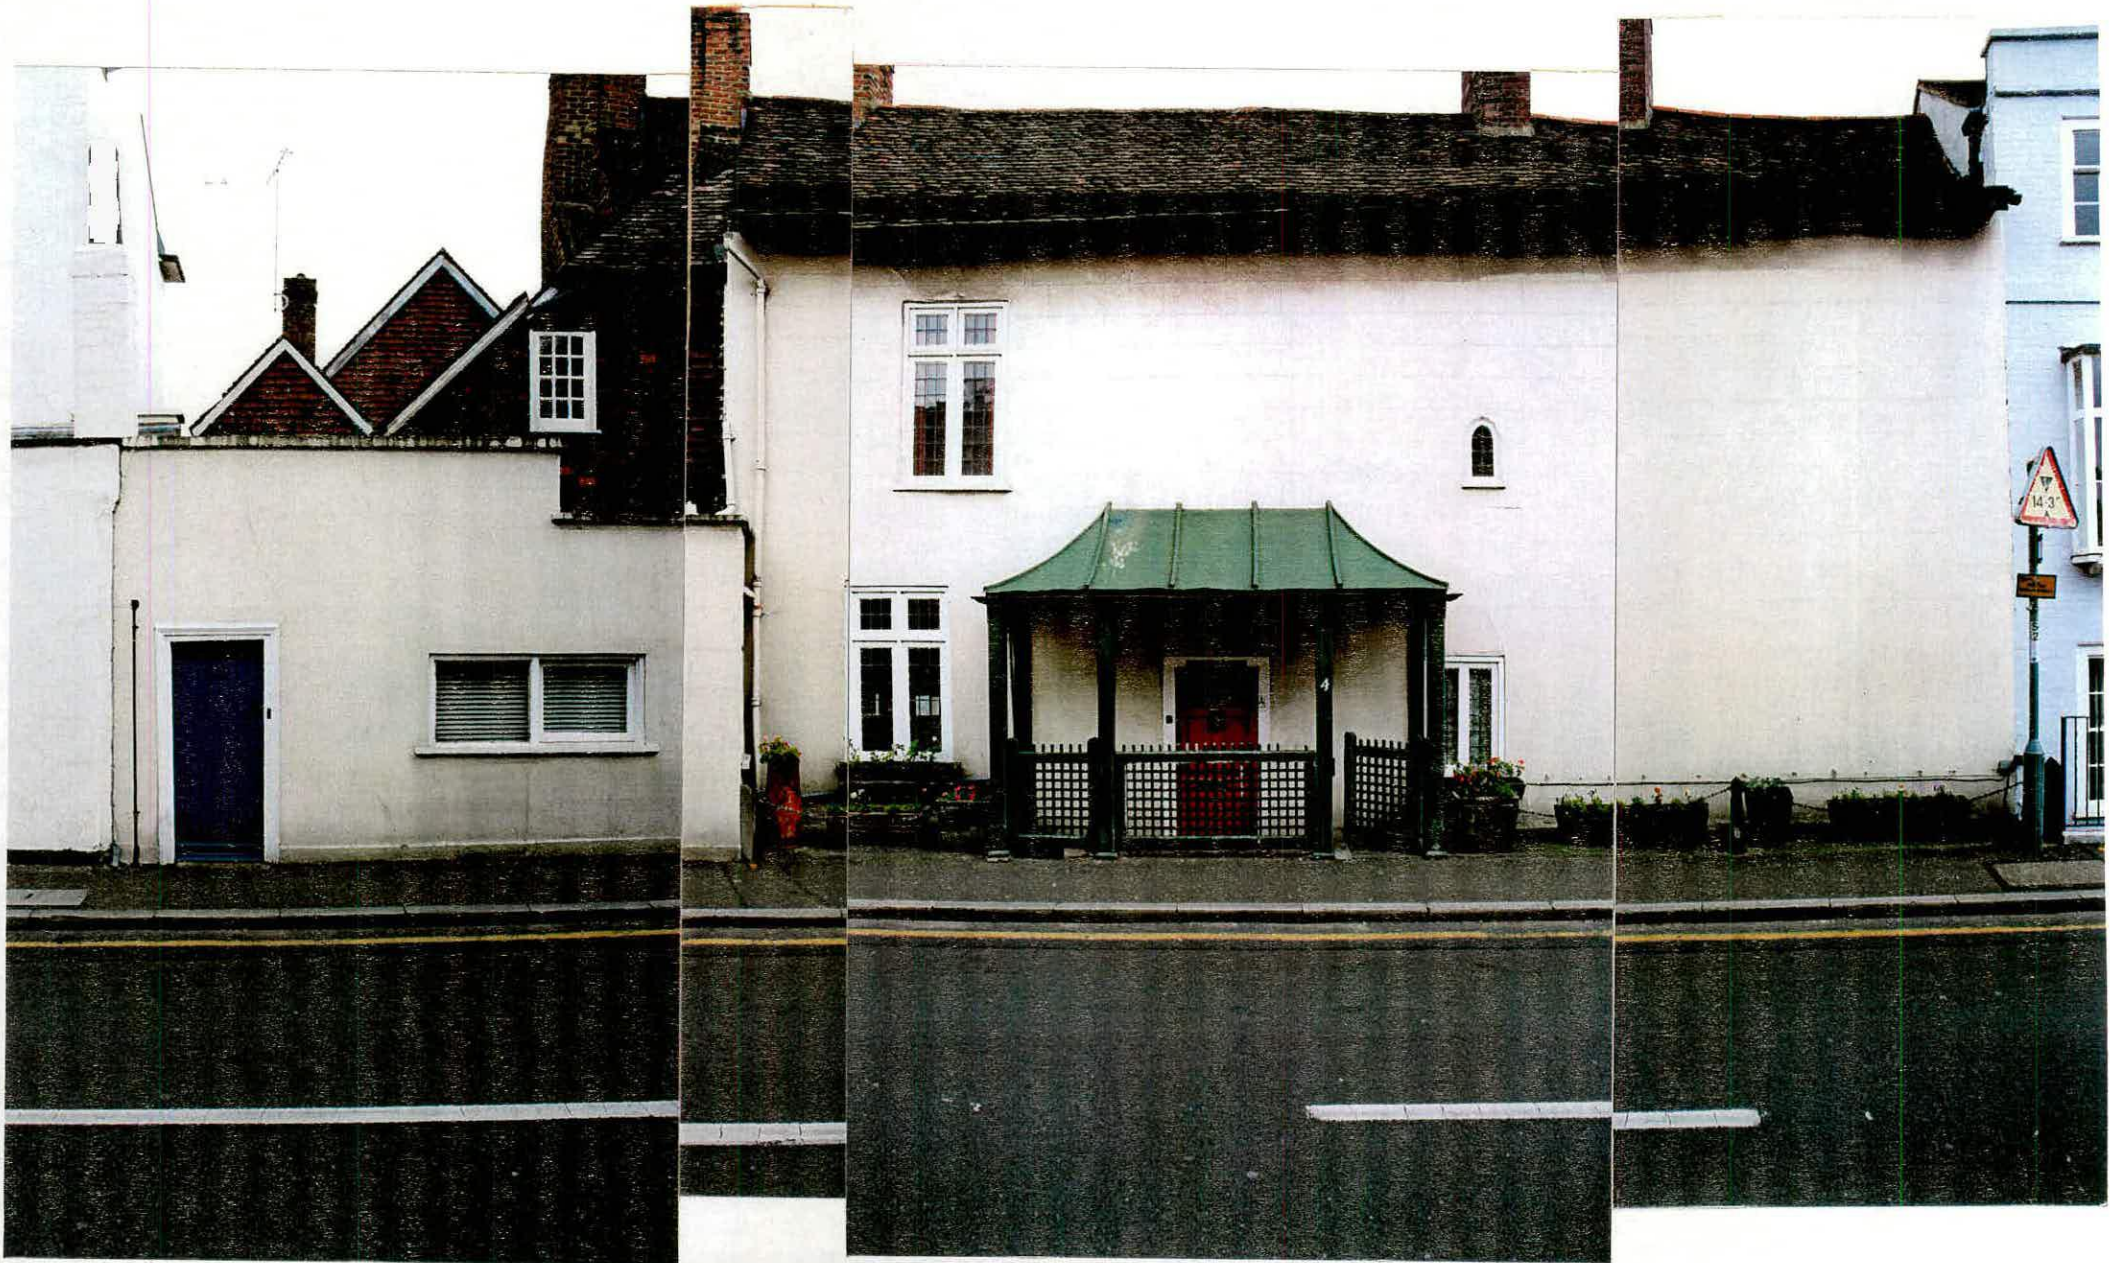
Although in the first half of the century, it was given a veneer of Regency Gothick, Wolsey's Cottage appears to have survived the nineteenth century without substantial alteration (Figure 29). The Gothick tendency can be seen in the stucco scored to resemble ashlar, traces of a four-centred arch above the front door, and the pointed window into the closet on the first floor landing. The stucco has been repaired but the greater part of it appears to date from this period.

Figure 29; a composite photograph of the west façade
