Jervaulx Abbey
North Yorkshire

SURVEY REPORT

Archaeological Investigation Report Series AI/4/1999

JERVAULX ABBEY NORTH YORKSHIRE

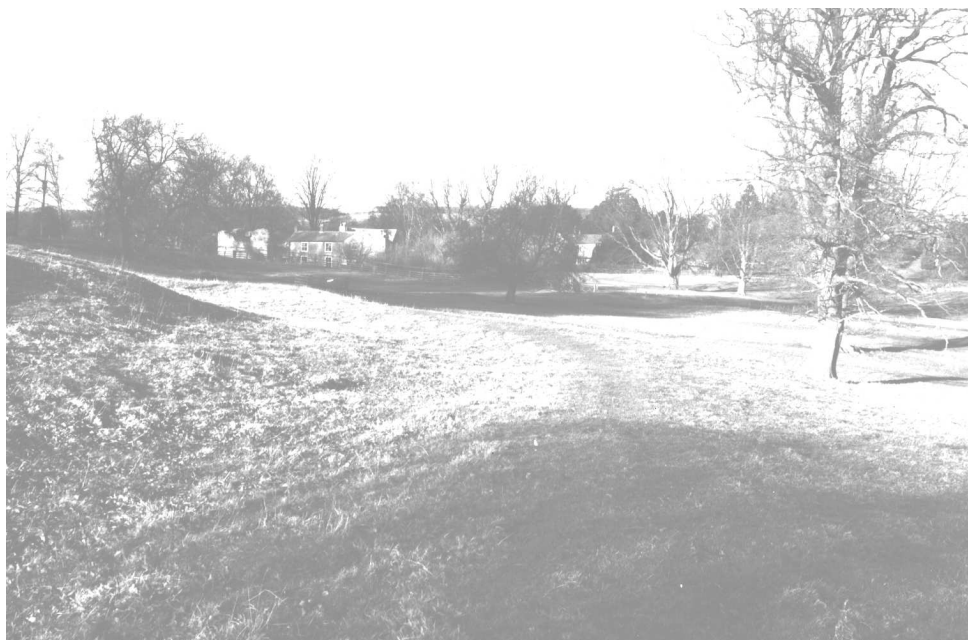
*Figure 2.
View along track
TR1/lead WF2
looking north
towards The Old
Gatehouse (NMR
AA99/03556).*

TR1 would seem to represent an earlier course of the Middleham to Masham road (the modern A6108) before it was diverted into its present angular route around the outside of Jervaulx Park. Approaching from the west, the road's initial course is no longer traceable on the surface within the survey area, although it probably entered the Park in the vicinity of the present west entrance. It would then have swung sharply south to keep to the higher ground, and it is here that the line of the old road survives (Fig. 2)

reused by the monks as the route for an aqueduct or leat bringing water to the conventual buildings from the reservoir in the south-west corner of the monastic precinct (WF2 and WF1, section 6.2.4 below). The road bed re-emerges as a slight hollow-way from beneath the leat just north of the reservoir, and swings away east in front of the reservoir dam (DM1, section 6.2.4 below) where a stretch of it seems to have been reused at a later date as local access to a complex of buildings, BC10, situated on its north side (section 6.2.2 below). The road line is truncated at this point by a late field boundary, FB5 (section 6.4.3 below), but formerly continued to the east where its original course now lies buried beneath a large negative lynchet that developed on the downhill side of a furlong of ridge-and-furrow ploughing, PF3 (section 6.4.3 below). The existence of a flat terrace at the foot of the lynchet, raises the possibility that the road was still in use when the lynchet formed and was re-routed

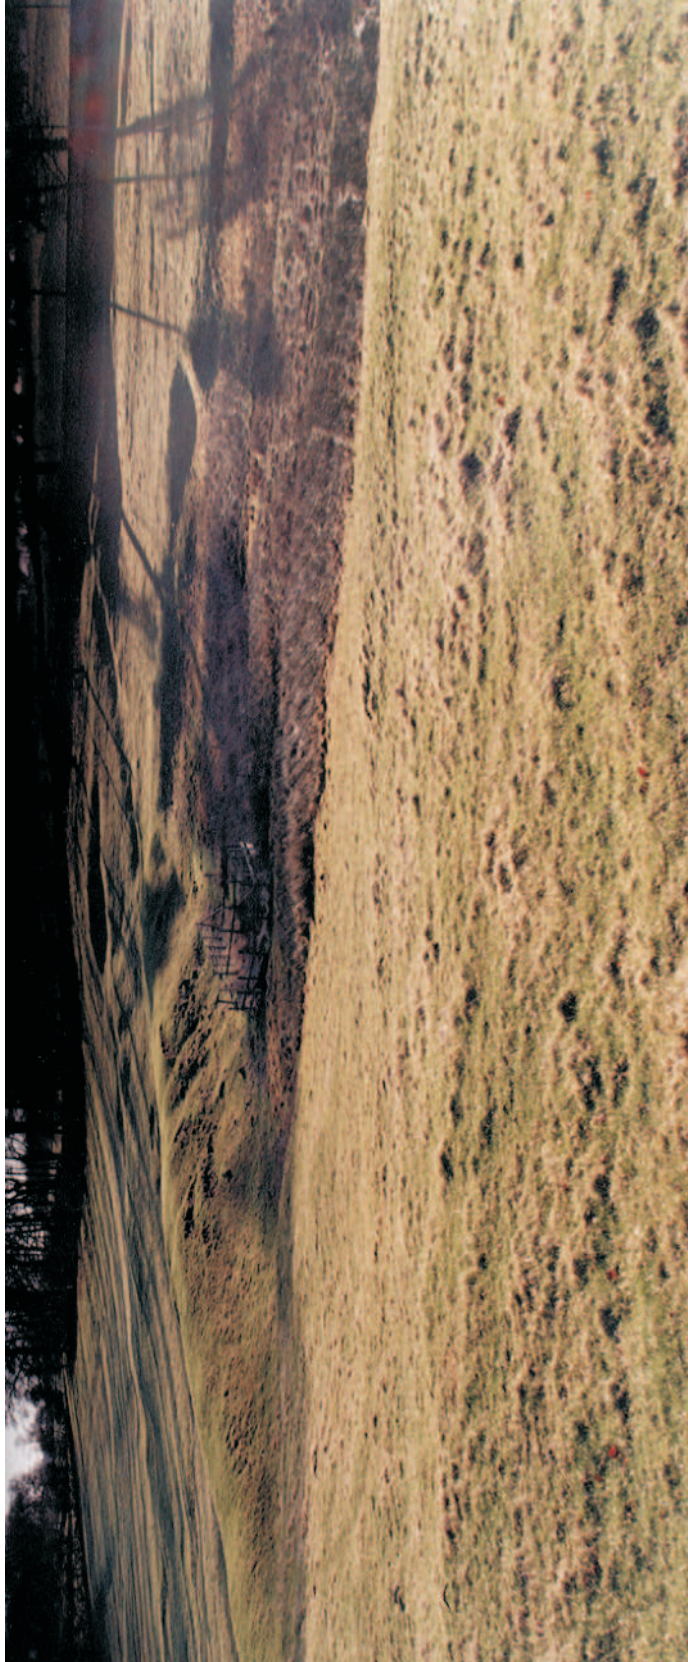
Figure 3. View across the monastic reservoir WFI, showing the dam DMI (centre left) and to its right garden feature GSI6 with building platform BC1 visible in the distance (NMR AA99/03571).

BC1 is a small platform cut into a tongue of higher land projecting out over the rising ground along the south side of the survey area (Fig. 3). It is connected to TR1 to the north, and to TR4 and the springs along the side of the small valley to the west, by a series of small interlinked hollow-ways, TR5 (section 6.1.2 above). Although the

platform could be simply a small yard, perhaps for animals, the intensity of routes leading to it, especially connecting it with the adjacent water supply, suggests it is more likely to be the site of a domestic building contemporary with the period when TR1 and TR4 were in use.

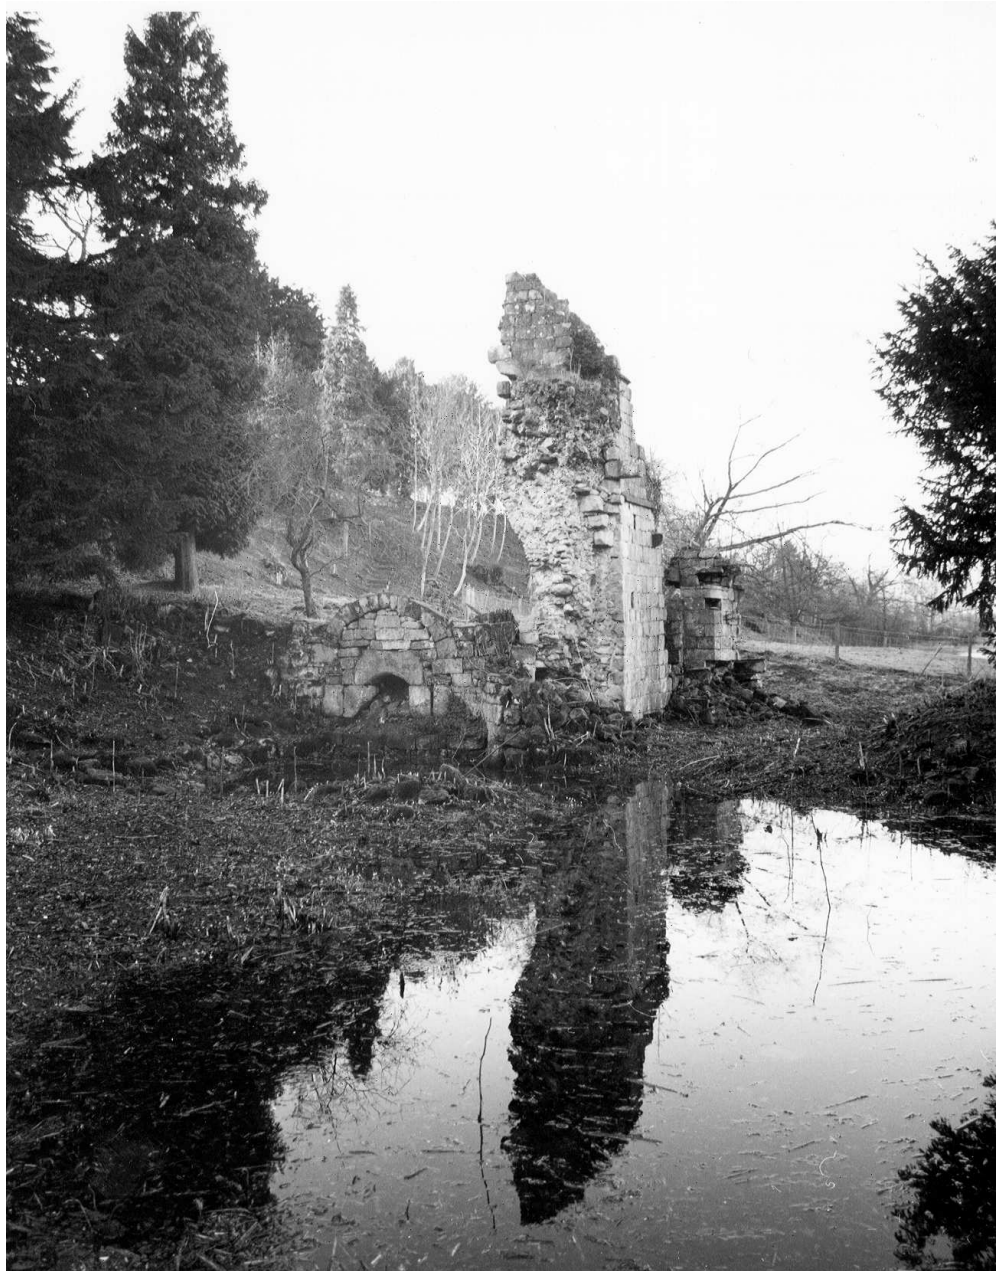
*Figure 4.
The ruins of the
alleged abbey mill
BC3 from the east
after heavy rain
(NMR AA99/03567).*

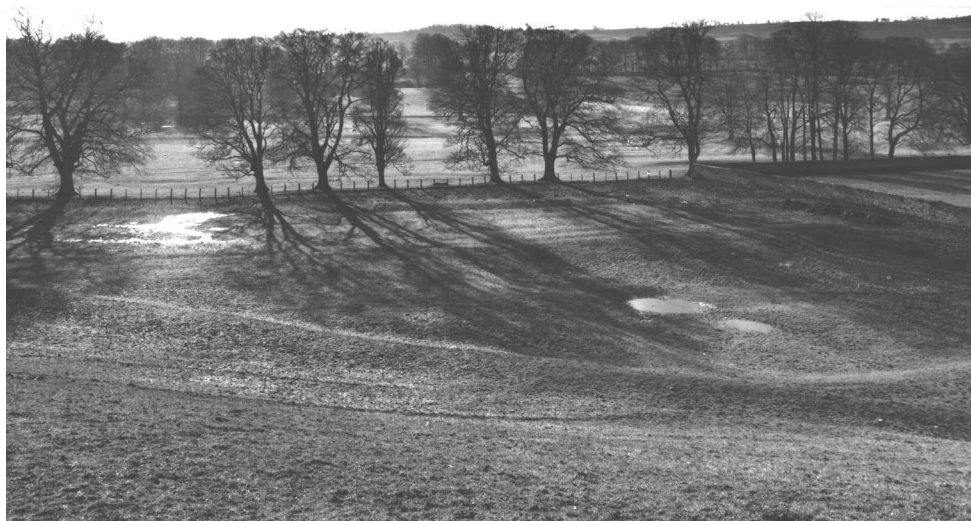
Figure 5.
Garden compartment
GC2 viewed from the
esker (NMR
AA99/03562).

The survey has identified up to fourteen separate compartments within the formal gardens, each with a number of internal features, plus a number of other structures and elements outside this core area which suggest that there may have been a fringe of less formal parkland or wilderness-type areas. The fourteen compartments are highlighted on Fig. 15, although it must be admitted that the identification of GC13 and GC14 in particular is by no means certain, and the precise location of the southern boundary to the formal area is uncertain (*cf* sections 6.3.3 and 6.4.3 below). At least three compartments - GC6, GC7 and GC9 - contain water features, and a number of other water features lie away from the formal area: these are all described in more detail in section 6.3.4 below. Individual compartments are variously delimited by terracing, watercourses, roads or paths, although the present scarp defining the northern edge of GC3, GC4 and GC5 is probably a later field boundary partly overlying these compartments (FB2, section 6.4.3 below). Whilst there is no standard size, most compartments are rectilinear, and where this is not the case as with GC2, the shape is readily explained by the constraints of the natural topography (Fig. 5). Most also have later ridge-and-furrow ploughing and/or drainage within them which has smoothed or destroyed any original internal detail and made surviving features very difficult now to survey and fully understand. Nevertheless, a certain amount of internal detail is recognisable and the relevant scarps are highlighted on Fig. 15. Whilst not a complete catalogue, the more distinctive of these features include: a platform or large terrace, GS1, in the north-west corner of compartment GC1 with possible raised walks leading south from it; a very slight but broad terrace-like feature, GS5, within compartment GC8, plus hints of a semi-circular feature, GS6, in its north-east corner; rectilinear platforms, GS10 and GS11, or sub-divisions, GS12, towards the southern ends of compartments GC10 and GC11 and between compartments GC11 and GC12; and various low mounds and suggestions of terracing, GS13, within compartment GC14.

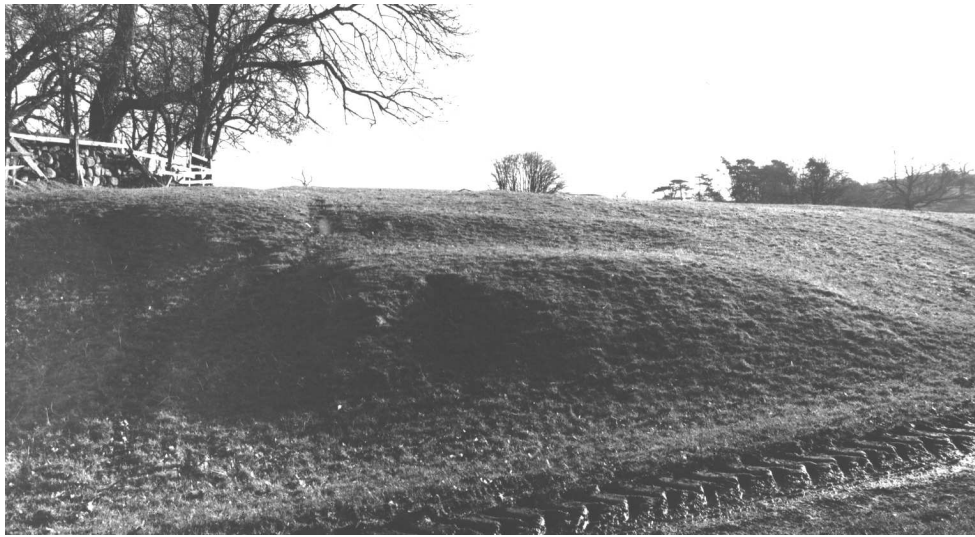
Figure 6.
Platform GS8 at the
east end of the
16th-century formal
gardens (NMR
AA99/03559).

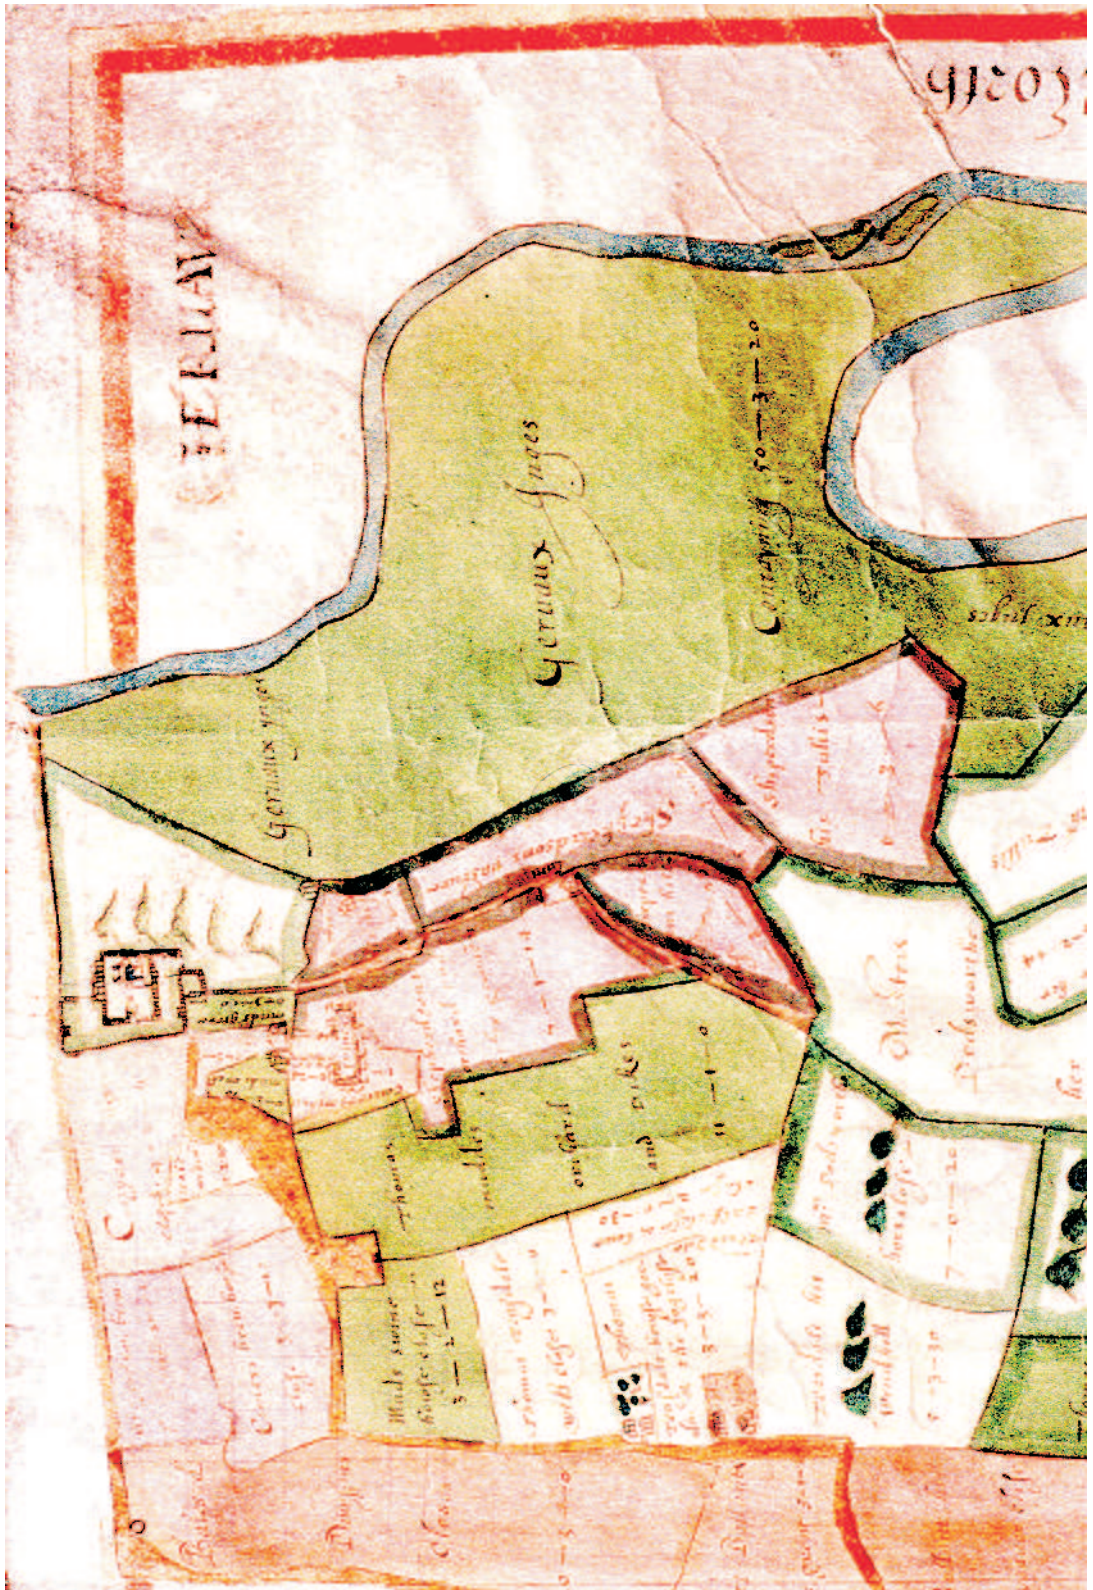
Figure 7. Extract from William Senior's estate map of 'Gervaux Abbaie' for Thomas, Lord Bruce, in 1627 (NYCRO ZJX 10/1/4, copyright reserved).

The sites of a number of buildings are clearly recognisable on William Senior's map of 1627, of which six (excluding for the time being the complex depicted in the north-west corner where Jervaulx Hall now stands) lie within the present survey area (Fig. 7). Two lie at the very northern limit of the survey at the foot of the esker north of the abbey church. Although this is the location of the alleged abbey mill, BC3 (section 6.2.2 above), it is unclear from the map whether either of the depicted buildings can be correlated with the standing ruins of that structure. Such a correspondence is unlikely anyway since it has been argued above that BC3 was already in ruins at this time and surrounded by garden features (sections 6.3.2 and 6.3.4 above). However, it is possible from the map that the westernmost of the two depicted buildings stood in the area of the small closes immediately west of BC3. This area is highlighted as BC16 on Fig. 16, although it must be emphasised that no trace of a building survives on the ground. Two other buildings are shown close together where a track (TR8, section 6.2.3 above) running east from Jervaulx Hall turns a sharp angle to pass down the south-west side of Mark Hill. Both were still standing in 1792 (NYCRO, MIC 1930 ZJX 10/10), probably comprising a small farm complex, but had disappeared by c

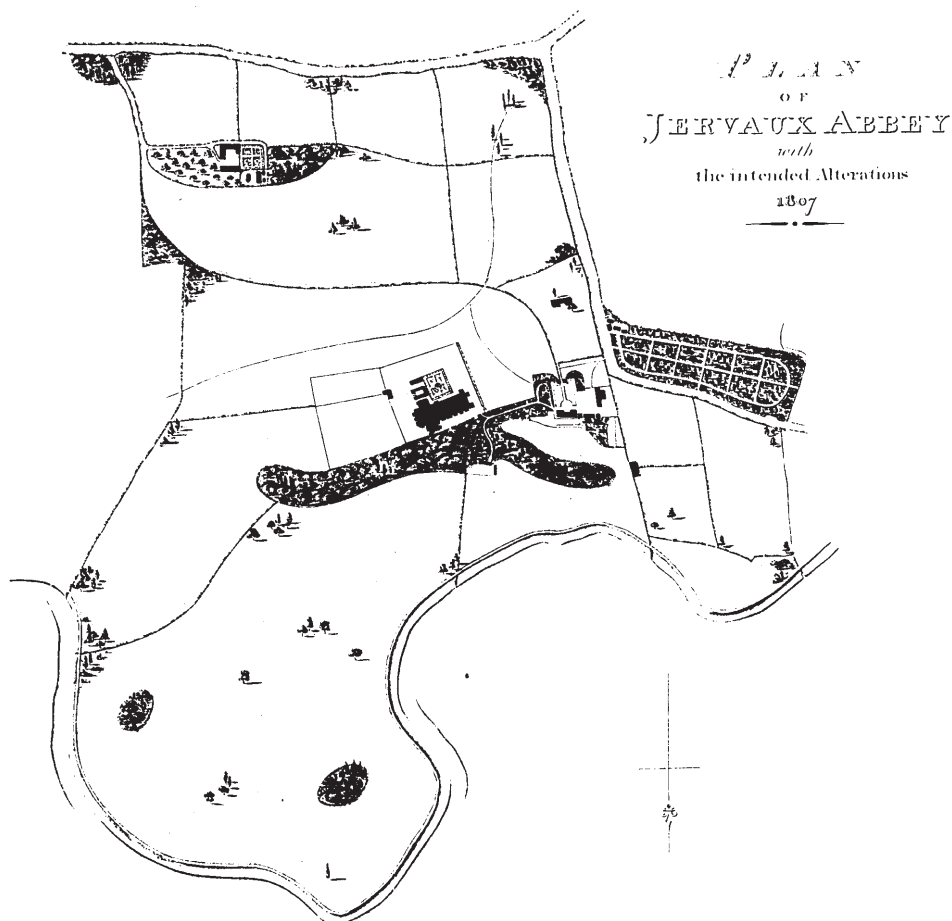
Figure 10.
Robert Menzies' design for Jervaulx Park, 1807 (NYCRO MIC 1930 ZJX 4/31, copyright reserved).
Note north is orientated towards the bottom of the page.

Menzies' plan (Fig. 10) shows the conventual ruins surrounded by a fence or wall. In the south, that boundary is on a different alignment to the southern boundary of the small walled field to the east which is still extant. This suggests that the boundary shown on that plan is not the present ha-ha, BF4, separating the ruins of the conventual buildings from the rest of Jervaulx Park, but the scarp, FB2 (section 6.4.3 above), to the south. The original proposal was thus to reuse an existing boundary, the ha-ha only being dug in 1809 to prevent visitors taking away medieval floor tiles as souvenirs (Davison 1998). The original western boundary around the ruins also re-utilised an existing field boundary ditch, the northern end of which, FB1, in this case survived when the ha-ha was dug. The identification of FB2 as the original southern boundary of the ruins is strengthened by the observation that its line is at almost exactly 90° to the western arm of the later ha-ha, whereas the southern arm of the ha-ha is at a slightly oblique angle to the latter. Although no documentary evidence has been located, the dates of the other three lengths of ha-ha - BF4 across the esker behind Jervaulx Hall, BF6 dividing the Park from Abbey Hill House to the south, and BF3 along the northern foot of the esker - presumably date to 1809 also; the

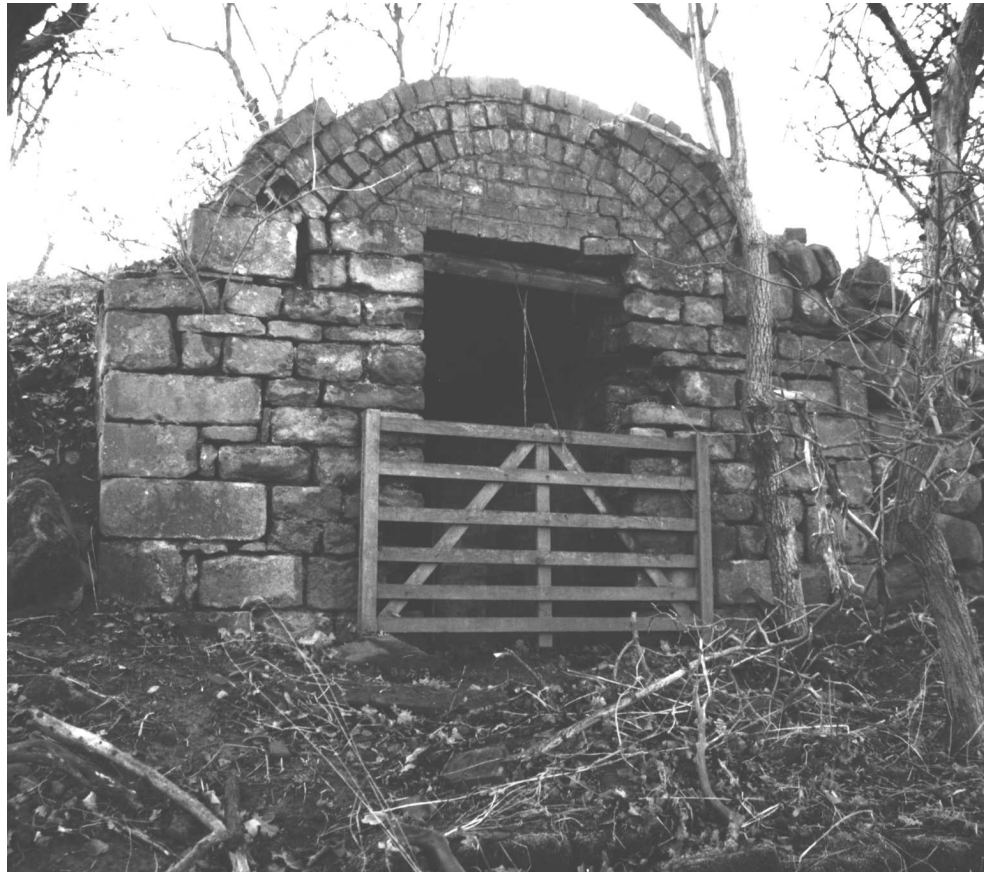
*Figure 11.
The entrance to the
19th-century icehouse
BC21 (NMR
AA99/03561).*

BC21 is an icehouse lying at the very eastern edge of the survey area. It is a Grade II listed building, accurately described in the Historic Buildings Register as of brick-lined beehive form with barrel-vaulted access, and of mid-19th-century date, the whole covered by a mound (DoE 1985, 5). The entrance faces north, approached

via a flight of stone steps (Fig. 11) leading up from a short terrace-way, TR18, which is a spur from the modern track along the top of the monastic precinct bank, BF1

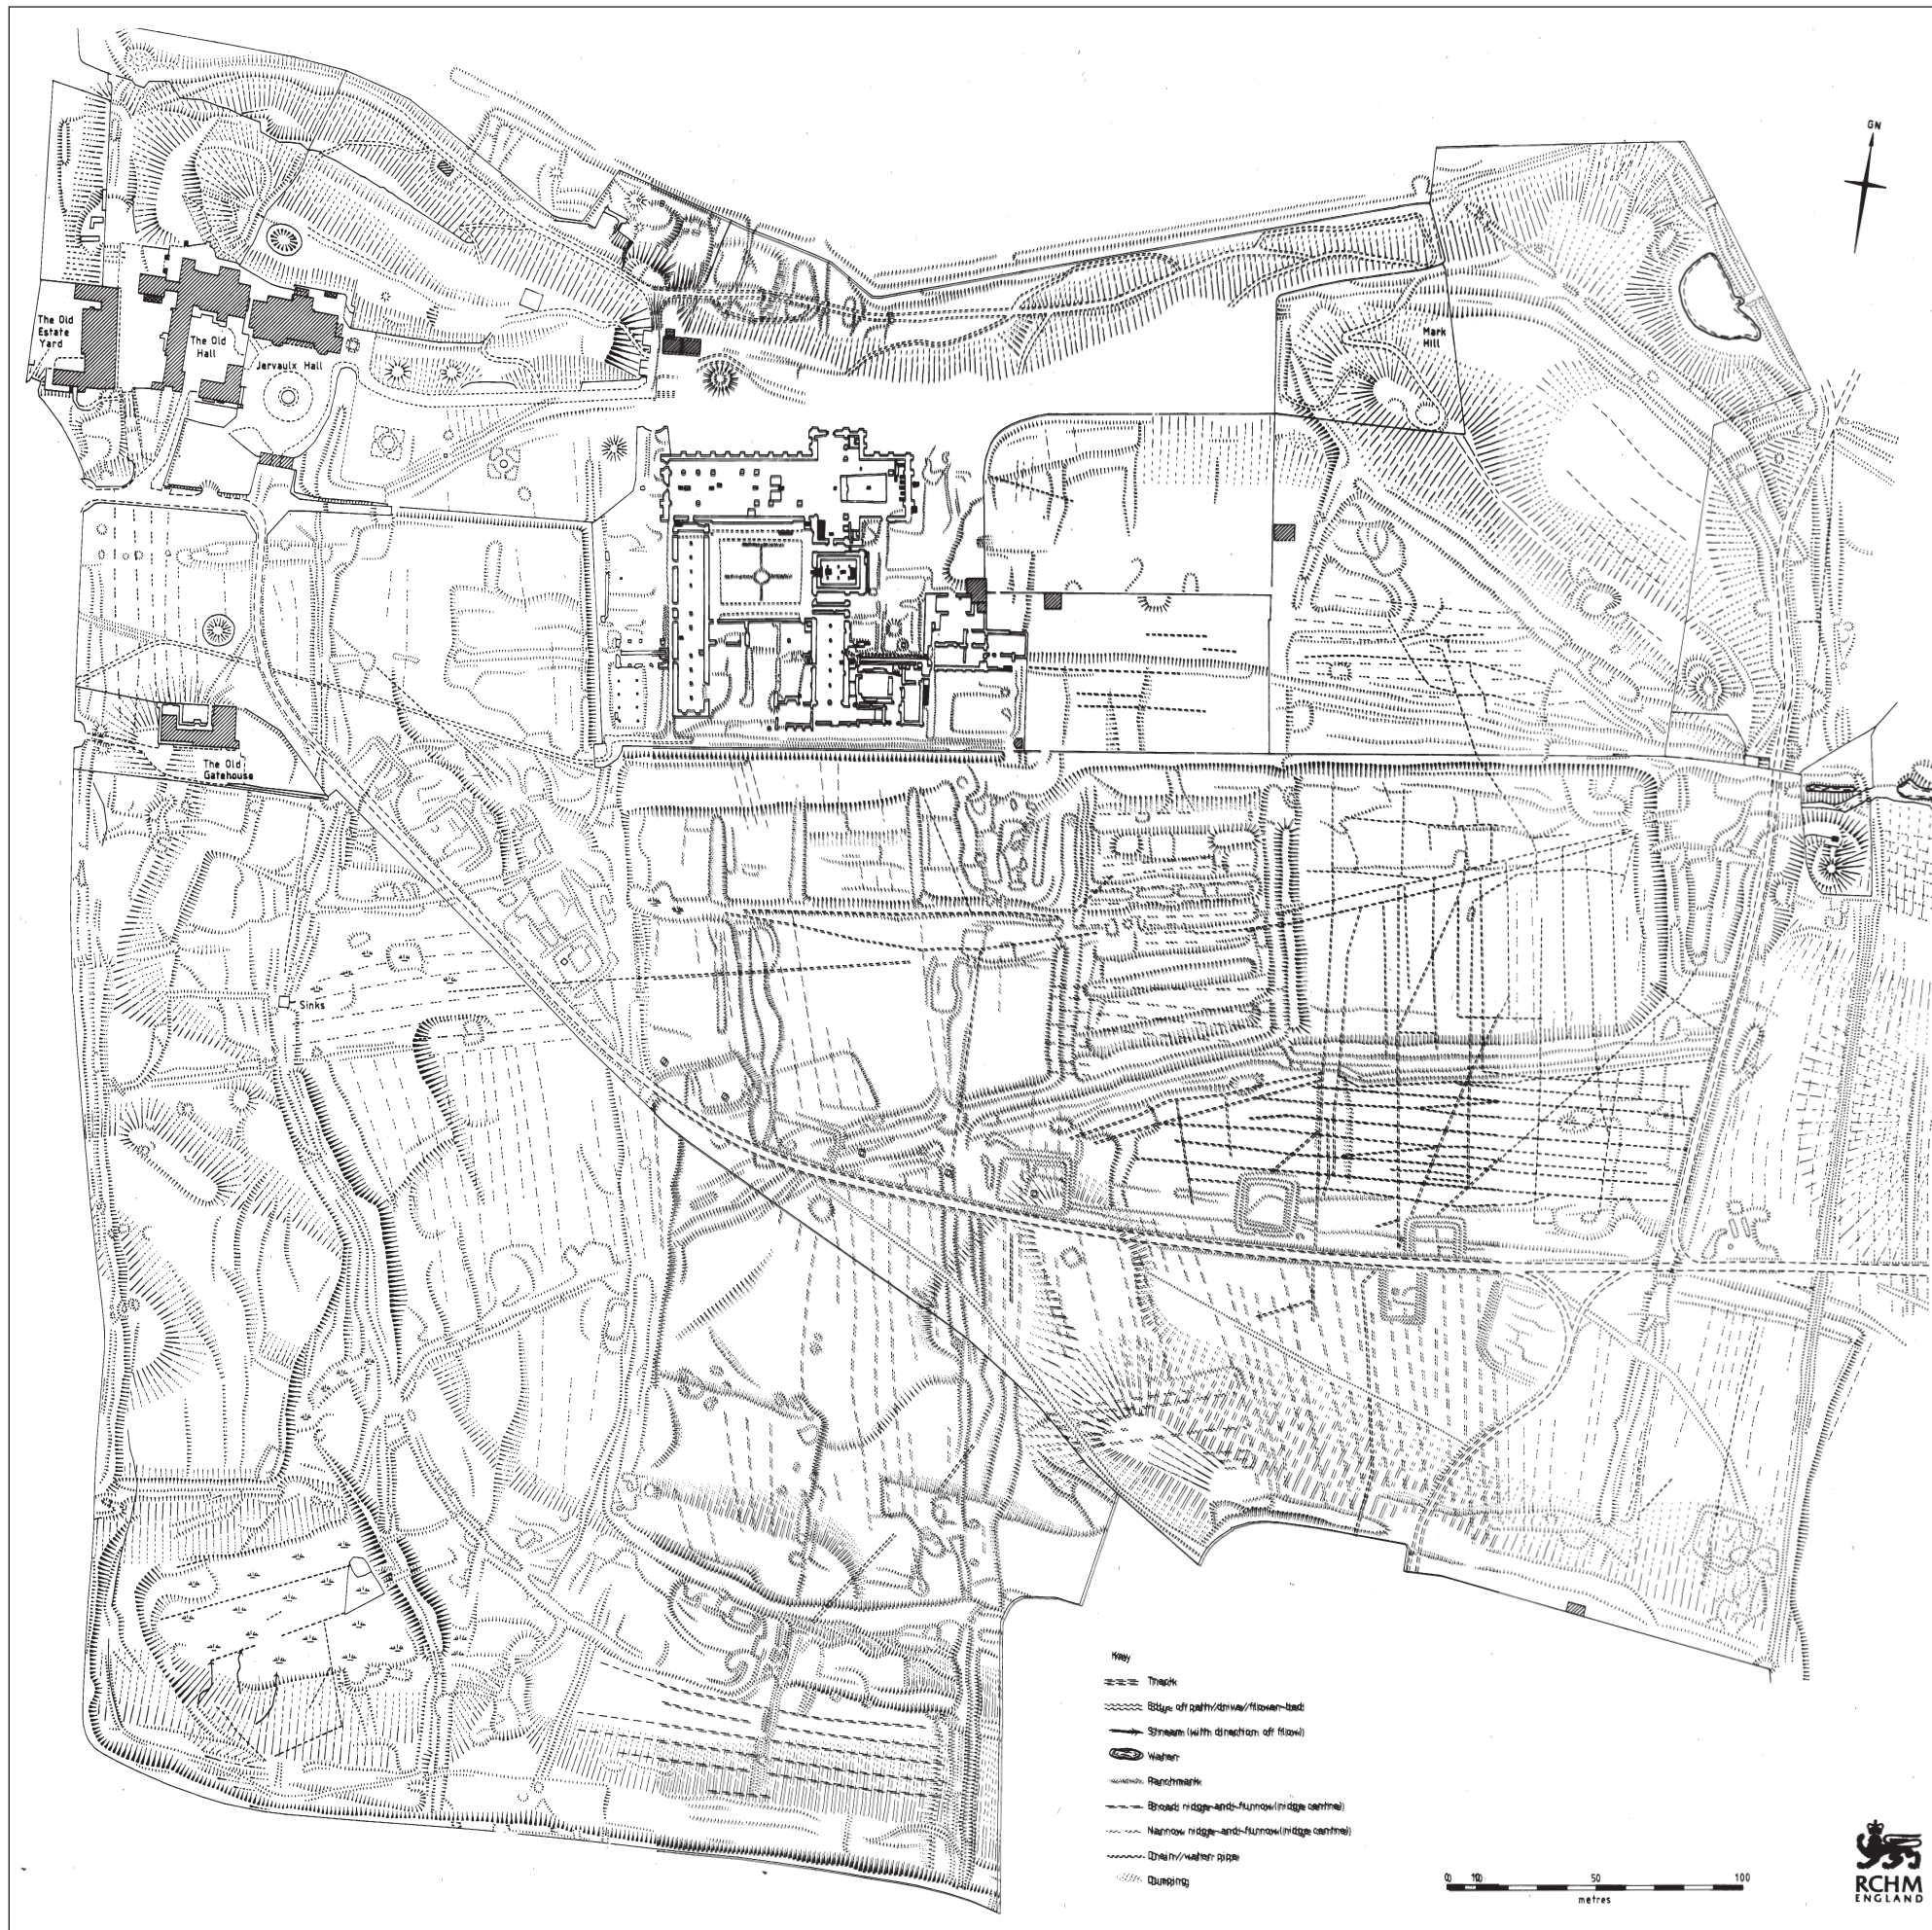
Figure 12.
 RCHME earthwork plan of the west end of
 Jervaux Park (surveyed at 1:1000 scale,
 reproduced here at 1:2500).

The plan of the earthworks and other features in the western end of Jervaulx Park as recorded by the RCHME is shown in Fig. 12. For the purposes of analysis and description, the principal archaeological elements have been given feature numbers, and assigned to one of seven general periods. A catalogue of these features is given below, arranged in approximate chronological order starting with the earliest. Features assigned to each period are numbered and highlighted on the relevant phase diagram (Figs. 13 to 19), while features of an earlier or later period mentioned in passing are cross-referenced in both the text and figures.
