THE 200 FOOT SOUND MIRROR

Denge, District of Shepway, Kent

Roger Bowdler

Historical Analysis & Research Team
Reports and Papers 19
1999

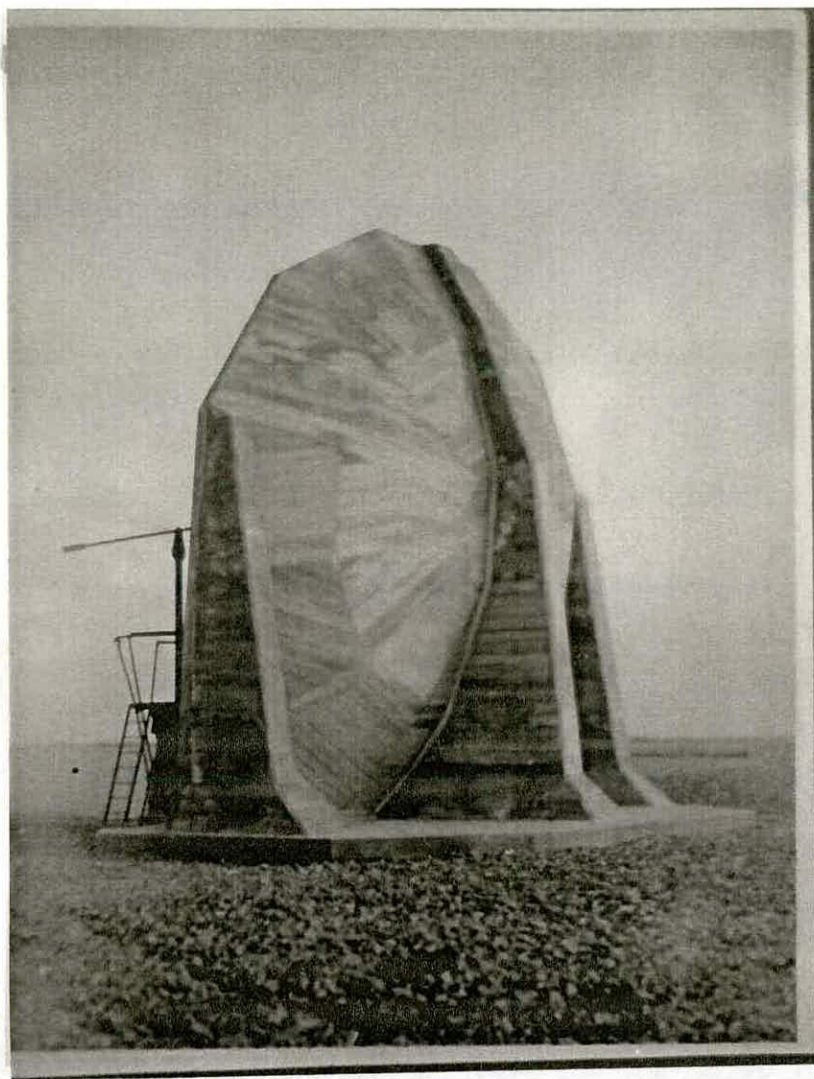
Denge: 20 ft mirror from south showing microphone stand, 1928 (via RJCT)
