RC H M E S U R V E Y R E P O R T

FORMER LOOMSHOP

Tonedale Mills
Wellington
Somerset

Former Loomshop (building 83)

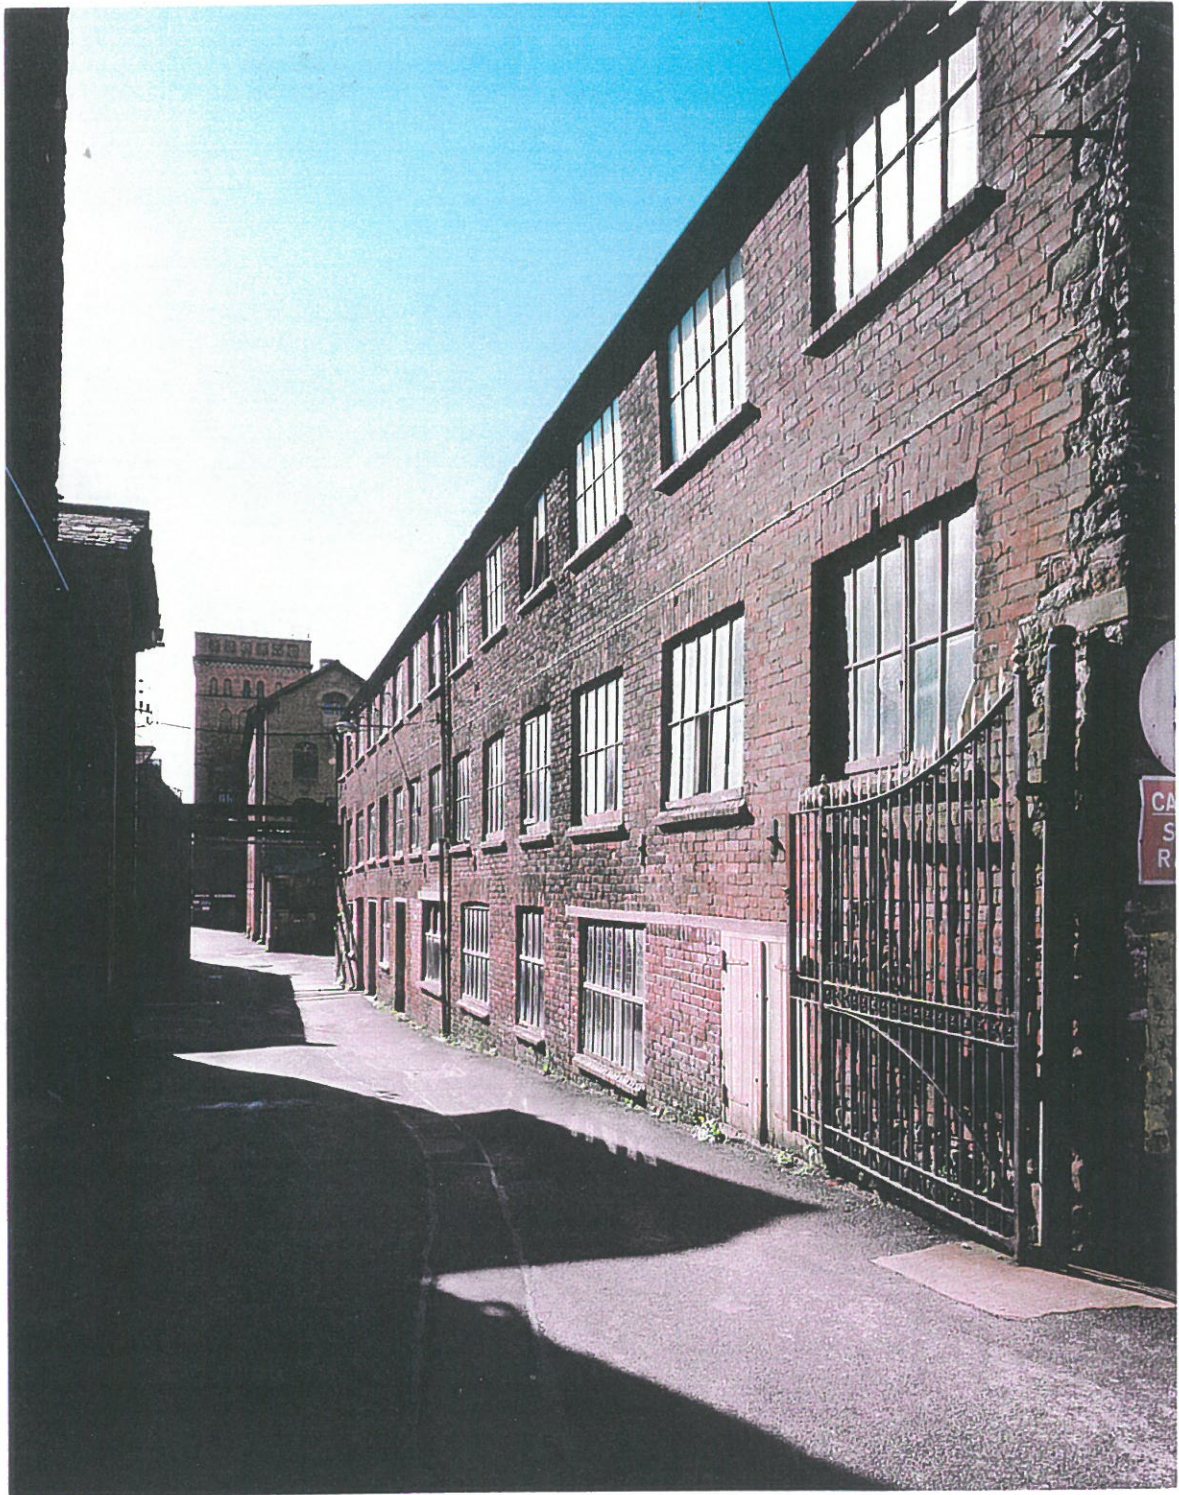
SOUTH ELEVATION, FACING WEST

The general arrangement of the original fenestration has been retained, but the window sills of the south elevation have all been replaced in moulded red brick, probably of late 19th century date. "Closer" bricks in the jambs do not extend down to the present level of the sills, suggesting that the window sills may also have been lowered.

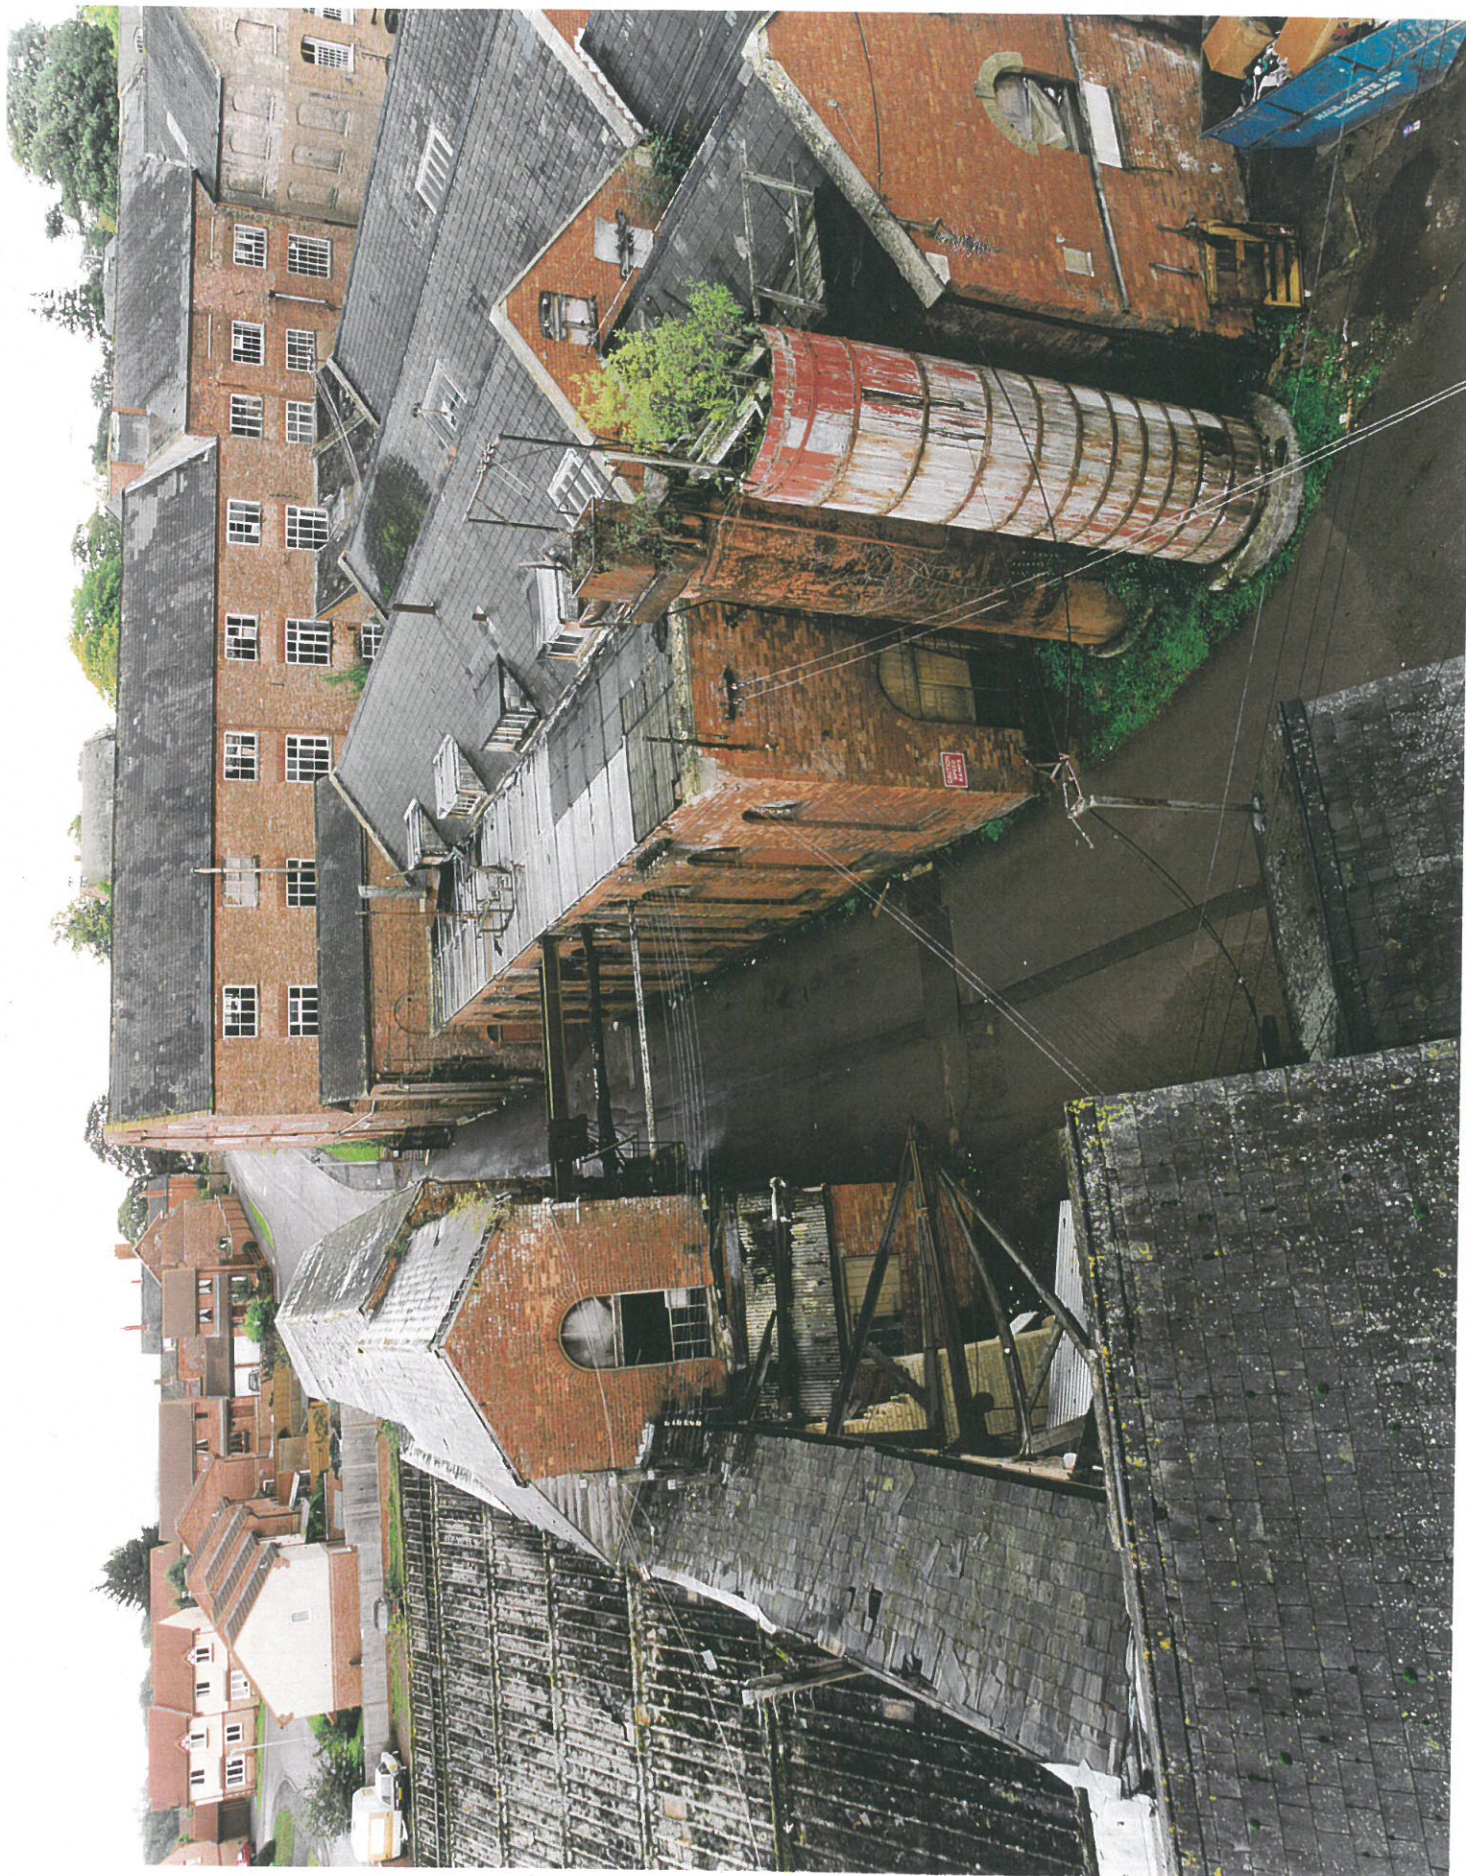
BEAM-ENGINE HOUSE WITH LOOMSHOP TO REAR, FACING EAST

The engine house attached to the west end of the loomshop is of typical size and proportions for a mid-19th century single-cylinder beam engine. It was probably built to power the weaving sheds to the north, but may have been adapted at an early date to also power the large spinning mill in the western part of the site. Documentary sources in the Fox archives indicate that the beam engine was replaced by a horizontal tandem engine in 1886⁸. The engine house is lit by narrow arched windows in the west end and north side; other former windows may have been blocked. It is constructed of slightly larger red brick than the loomshop and the side walls retain large ashlar blocks indicating the former

position of the entablature beam. At ground level, the north side also has ashlar blocks for the main flywheel shaft and a large blocked cast-iron shaft box indicating where the main drive shaft entered the weaving shed. This box also has cut-off brackets for a main horizontal drive shaft running east-west along the south end of the shed; to the east of the engine house this shaft must have been attached to the north side of the loomshop. Inside the engine house there is no evidence of the engine itself. The entablature beam, beam floor and engine beds do not survive. The engine house is still open to the original gabled roof, the tie-beams of which retain lifting rings used in the installation of the engine. An unusual feature is a heavy cast-iron beam which spans the window jambs in the west end. The beam is of I-section with a wider bottom flange. The flange includes a bolting face for the bearing of a horizontal shaft which probably extended beyond the west end of the engine house. This shaft may have been related to the adaptation of the beam engine to power the large spinning mill to the west, which was built in-line with the engine house in 1863⁹ (69 on Block Plan). At a later date additional shaft boxes were inserted into the side walls for a high-level drive shaft which spanned the road to the south. It is not known whether this shaft was powered from the north or south end.

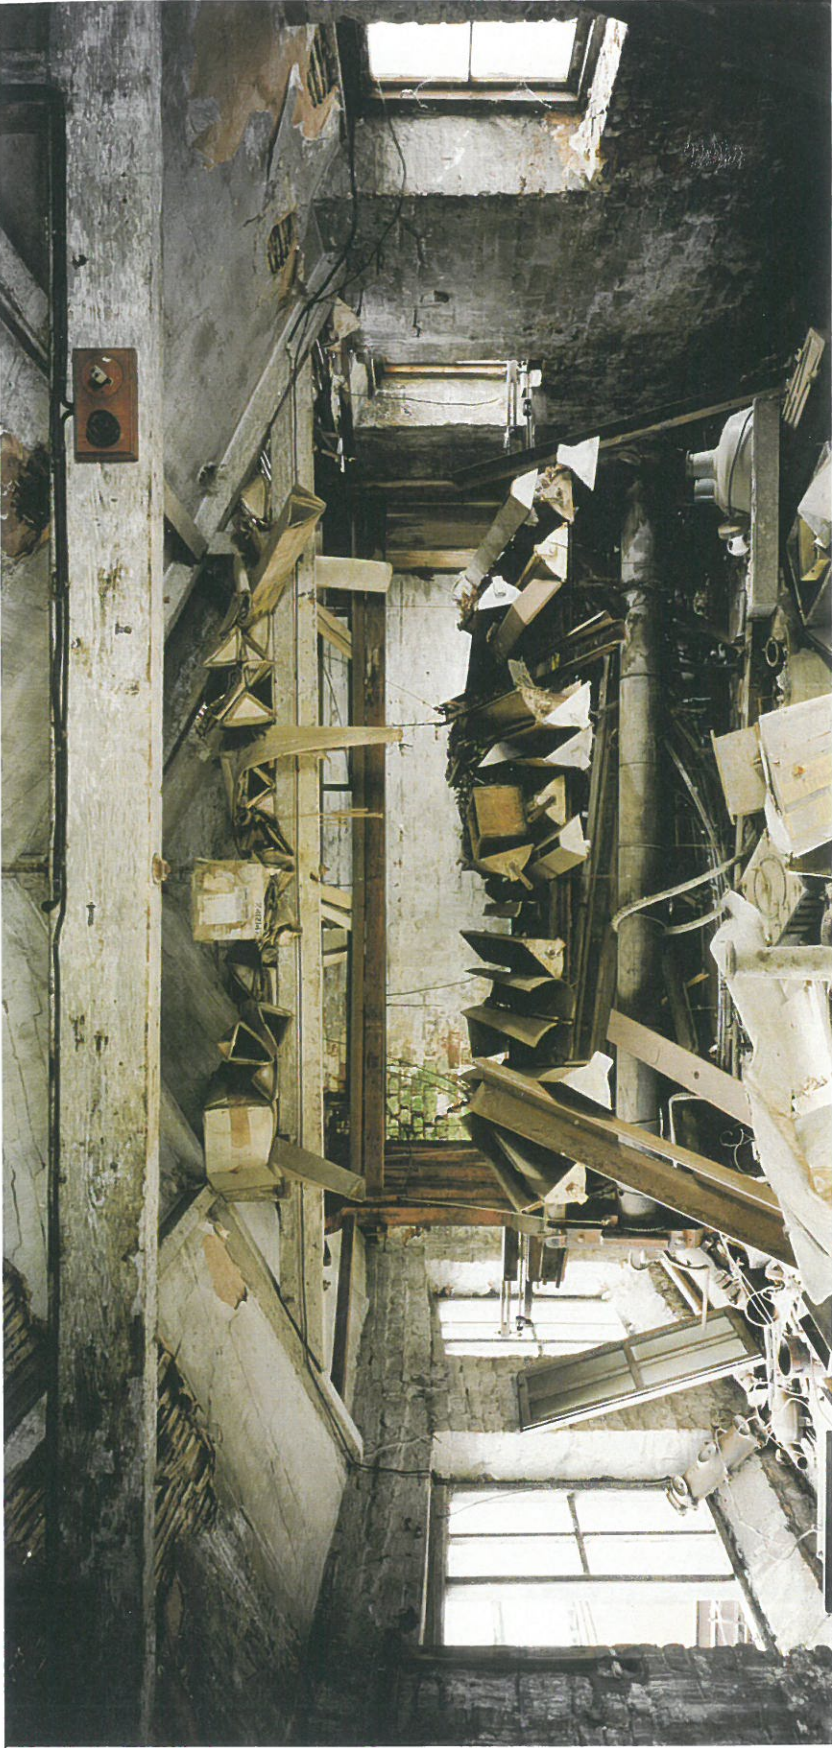
TOP STOREY, BROAD HAND PATTERN LOOM, FACING WEST

The handloom which survives in the west end bay of the top storey appears to have been installed for use in the building sometime after the replacement of the floors and is therefore not original. It is probably the Broad Hand Pattern Loom mentioned in the 1916 valuation. It is of pegged timber construction and may be of mid-19th century date. It is not a typical handloom, however, and may have been used for the production of a specialised fabric; in particular it is unusually wide, occupying most of the width of the building.

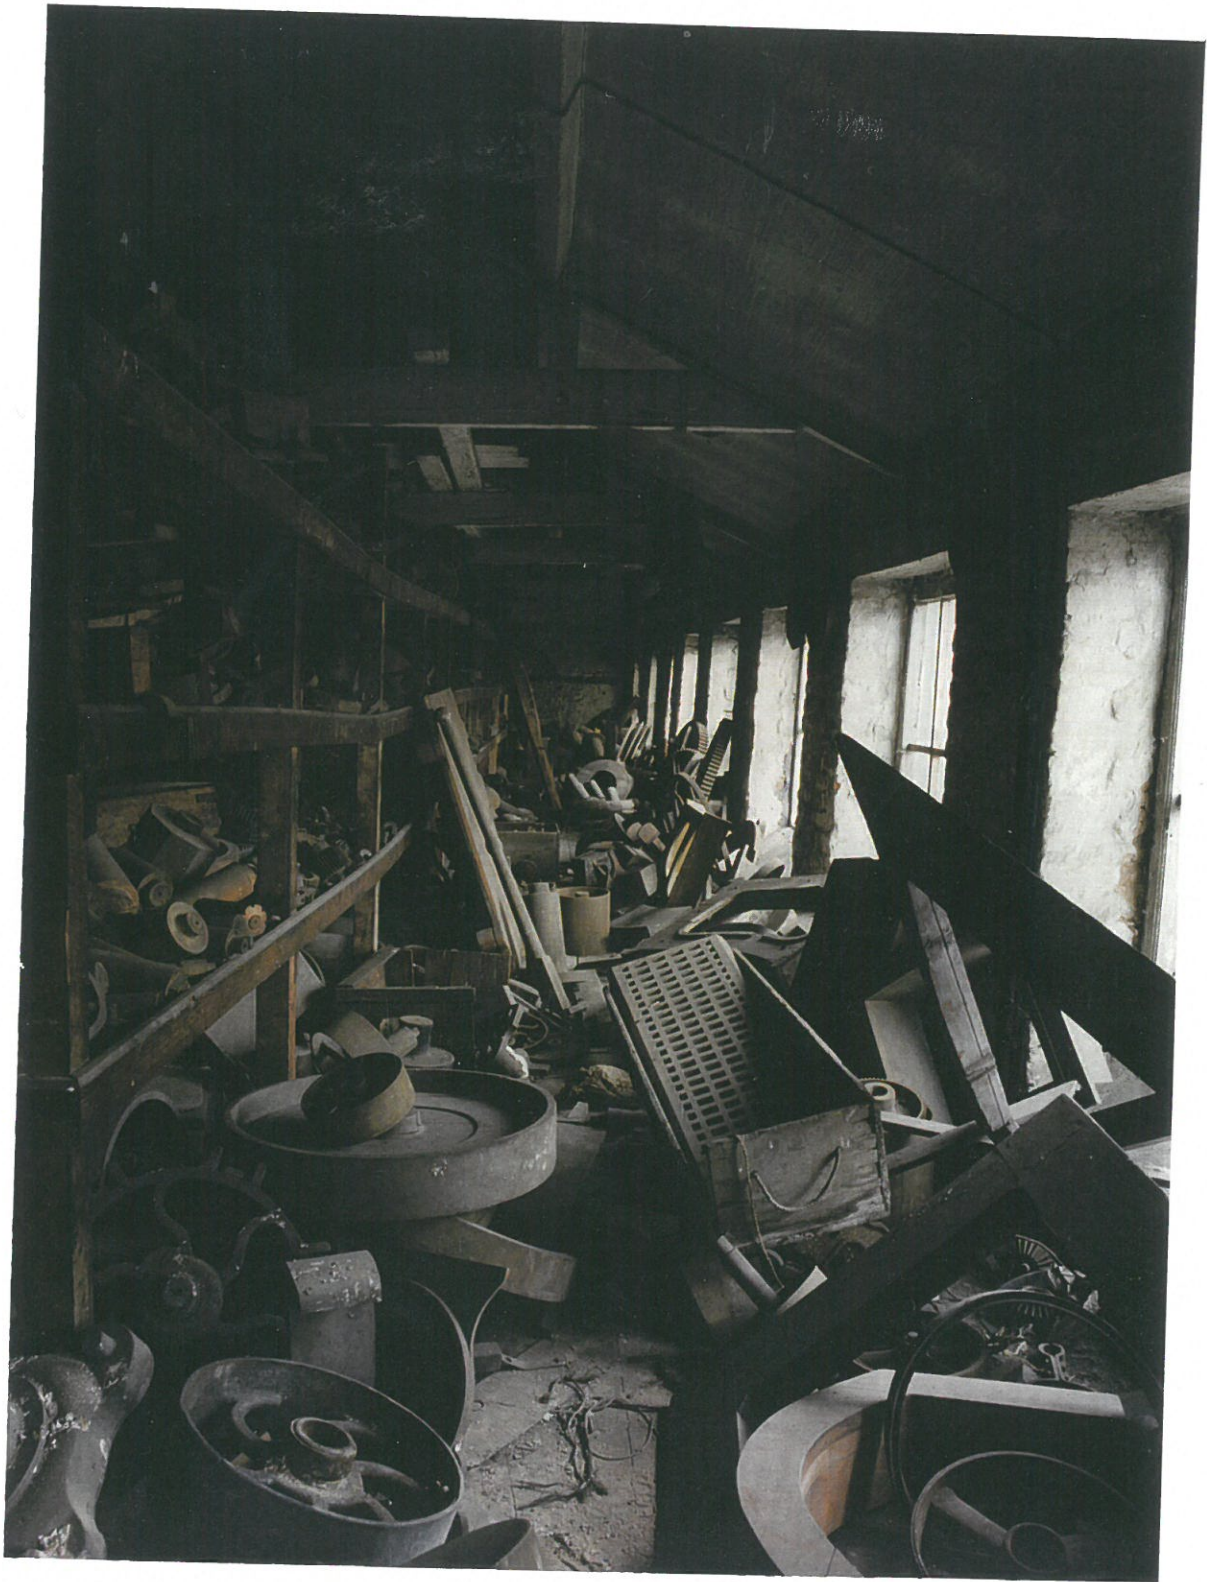
TOP STOREY PATTERN STORE, FACING EAST

From the early 20th century the loomshop has been principally used as a store. A valuation of the site date 1916 describes two rooms in each of the three storeys⁷. The top floor contained the Pattern room and "Store for pickers, including Broad Hand Pattern Loom". The middle storey contained a storeroom and a drying room, and the bottom storey a "Store room for electric fittings". At the time of survey the east half of building contained engineering stores in the bottom two storeys. The top storey includes the handloom and the exceptional survival of an extensive store of wooden casting patterns for plant and machinery which was formerly used at the site.
