THE HISTORICAL DEVELOPMENT OF COURT COTTAGE

Preston Wynne, Hereford and Worcester

Historical Analysis & Research Team
Reports and Papers (First Series, 45)
1998

The historical development of Court Cottage, Preston Wynne, Hereford and Worcester

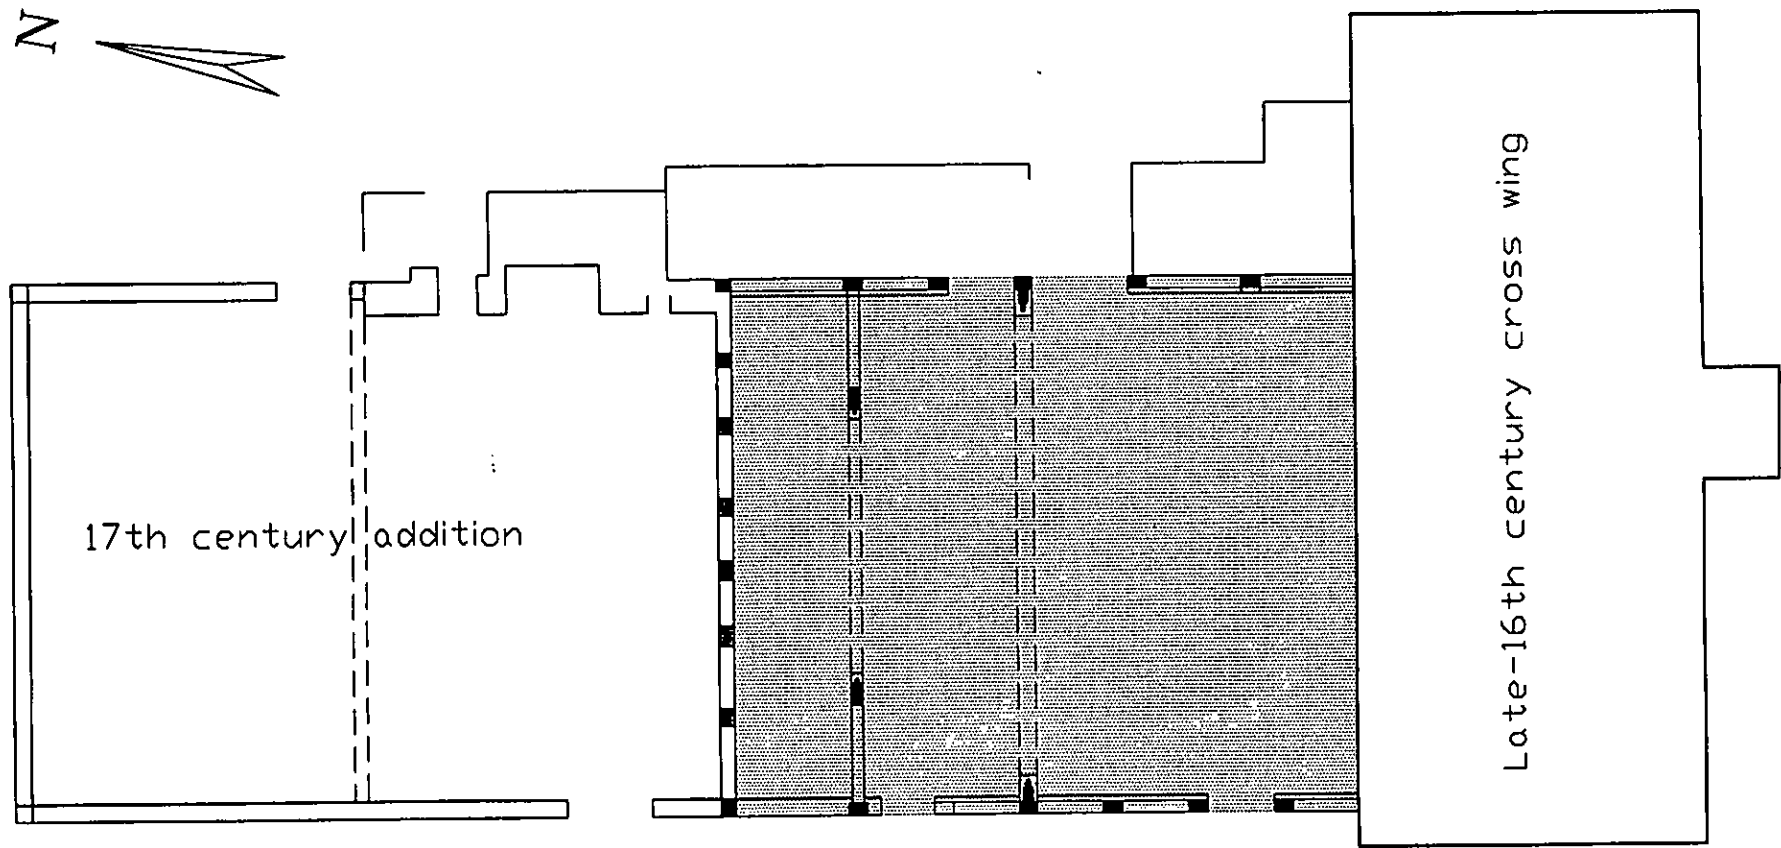
Figure 3 Plan of house as existing

Hatched area indicates extent of medieval open hall

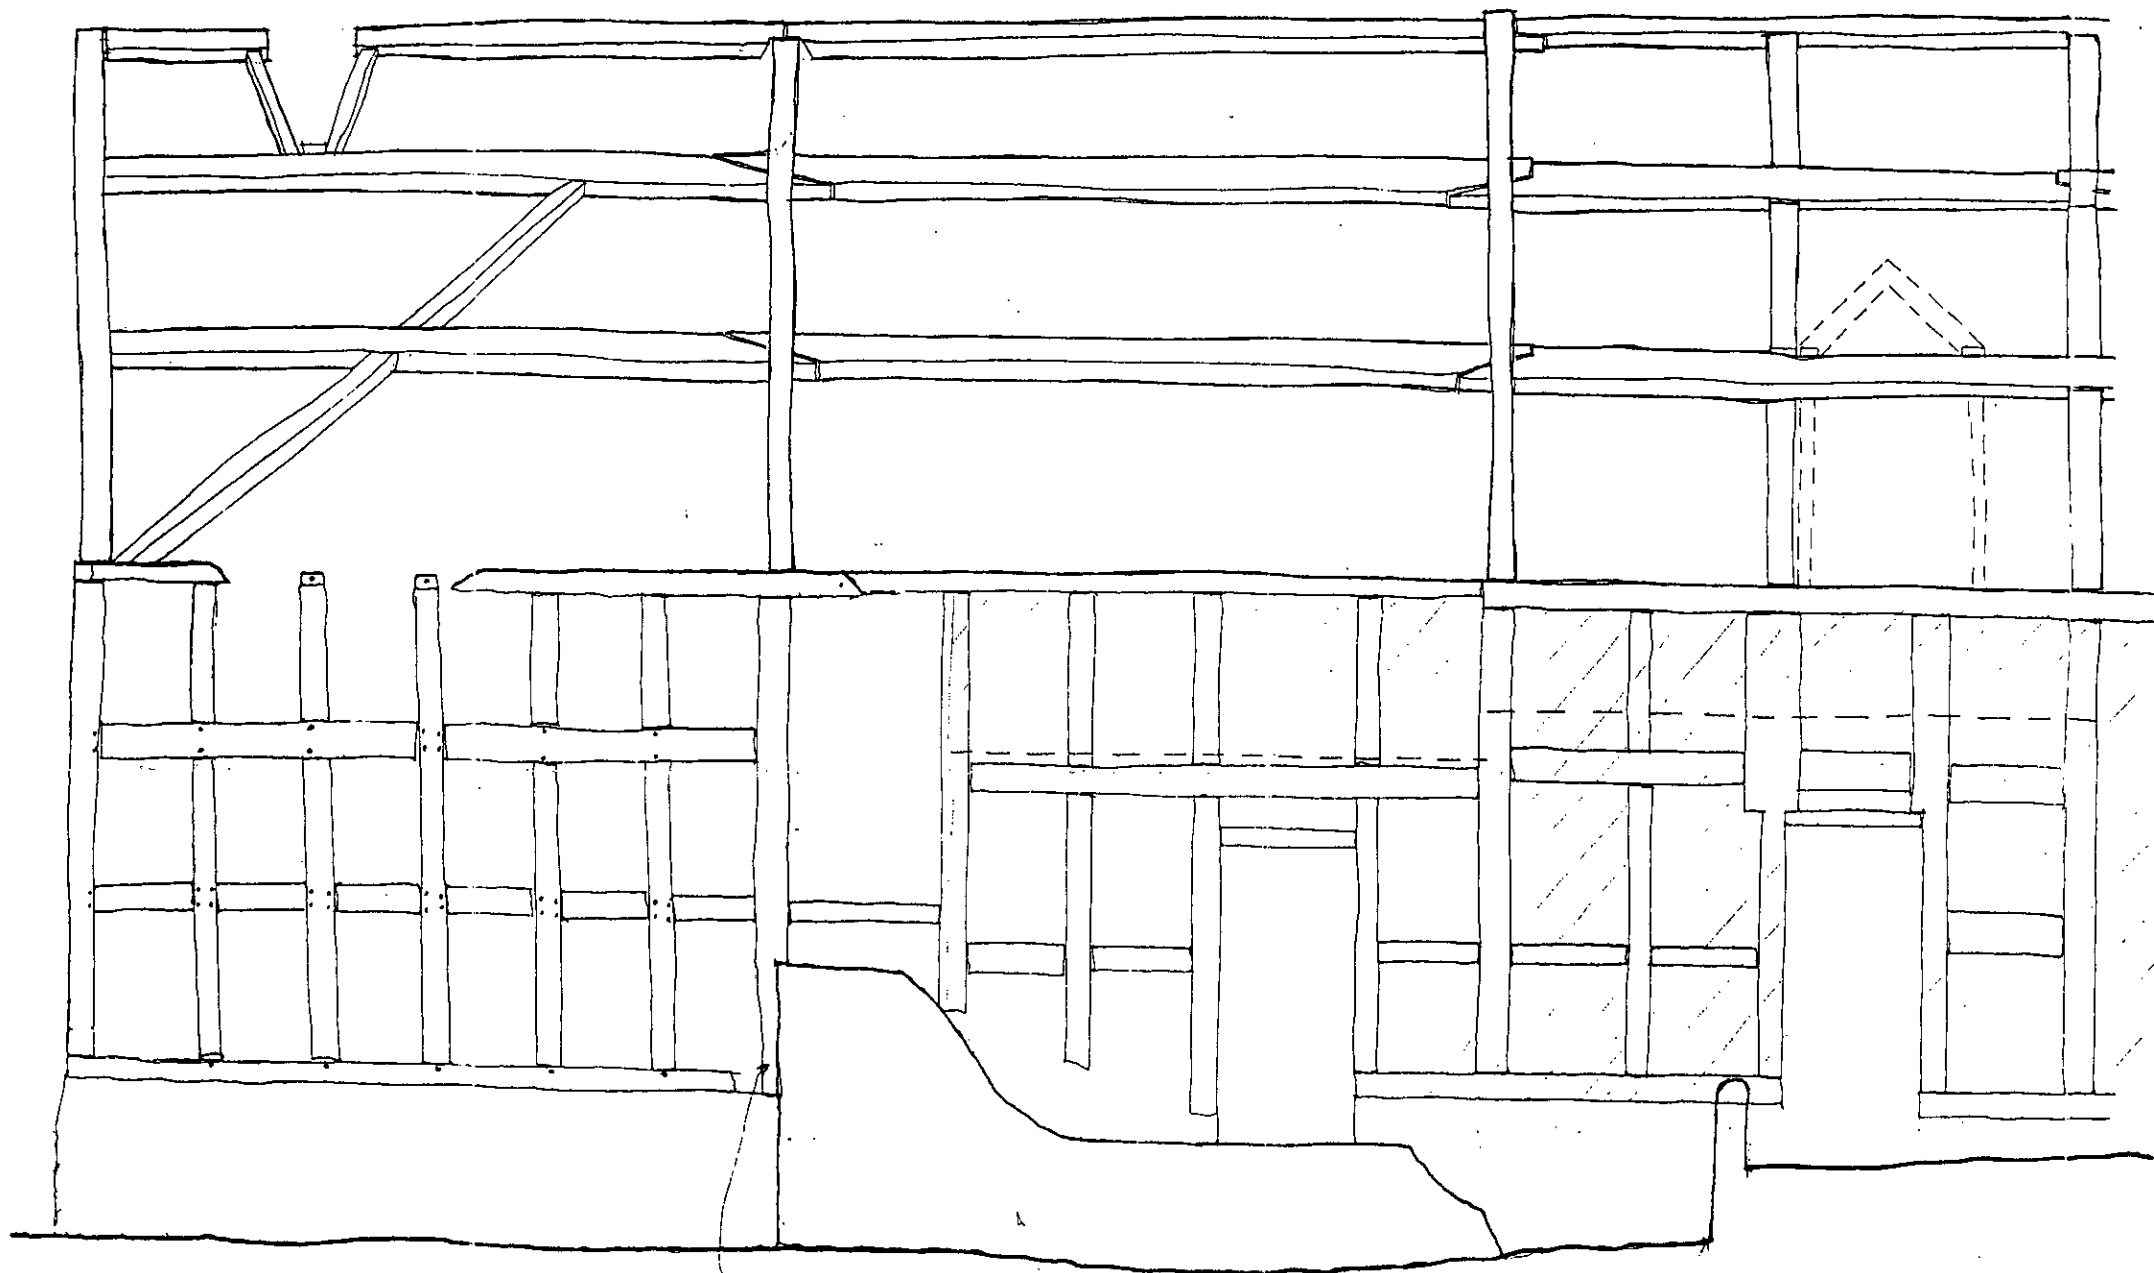
Figure 8 West elevation of rear range as existing

Sole plate here completely lost and post has settled disturbing adjacent framework and roof

Stone base to steps to first floor door. Steps themselves all lost.

Over hatched area framework is concealed by render externally.

- 4.2 Following the rebuilding of the north end of the rear range the earlier south end underwent a series of changes. The original doorway leading into the cross passage on the west side of the hall was blocked, and a new door opening (existing) constructed further to the south (*fig 8*). A new partition wall was built along the west side of the building running southwards from the west spere post. This created a narrow enclosed passageway leading from the new entrance door into the new rear extension (*fig 4*).
