An Earthwork Survey at Kingshurst Hall - Solihull, West Midlands

An Earthwork Survey at Kingshurst Hall, West Midlands

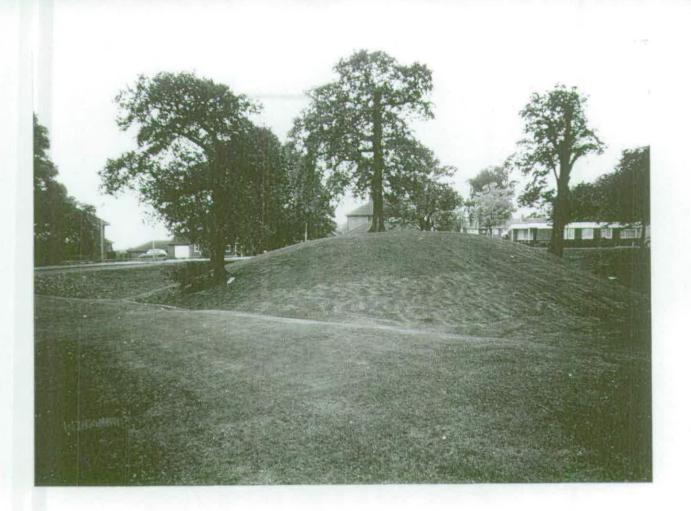
Fig. 1. The motte at Kingshurst Hall looking west.

The mound is a relatively steep-sided sub-circular feature measuring up to 32m diameter at the base and diminishing to 9m at the top; it stands to a height of 3m above the ditch (fig. 1). Surrounding the mound is a ditch which is up to 2m wide and uniformly 1m deep. On the north side of the mound, by the residential flats, is an elongated low mound measuring $8 \times 1.5m$ and about 0.2m high. This mound is probably a recent feature, possibly the result of dumping. On the northern side of the mound, towards the bottom, wooden planking is exposed at a point where there is a break in the slope which was presumably used in the consolidation of the mounder.

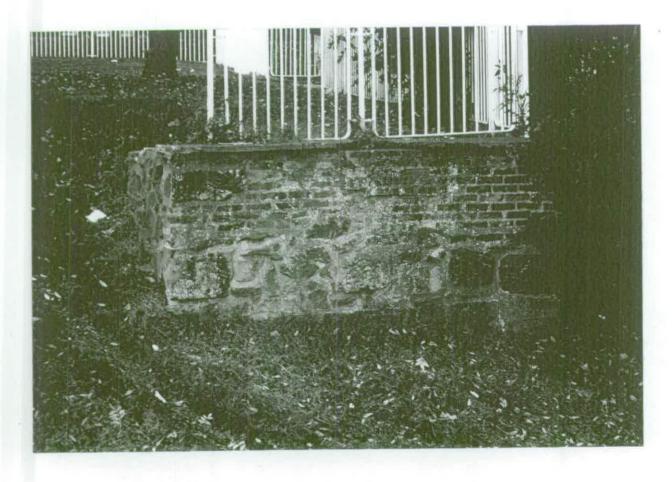
Fig. 2. Stone and brick walling on the eastern corner of the platform at Kingshurst Hall

On the north-east side of the mound is a flat trapezoidal platform surrounded by a ditch. The platform measures 25×27 m and stands 1.5m above a surrounding ditch. The platform is revetted by a brick wall on the north-east and north-west sides. In the eastern corner the wall has stone footings (fig. 2). The ditch measures 3m wide and a slight berm, measuring up to 1m wide, separates the wall and ditch. On the southwestern side the construction of housing has masked the form of the ditch. On the southern side of the moat there is a slight trench, probably a modern pipe-line trench, that leads from a car parking area to the moat.

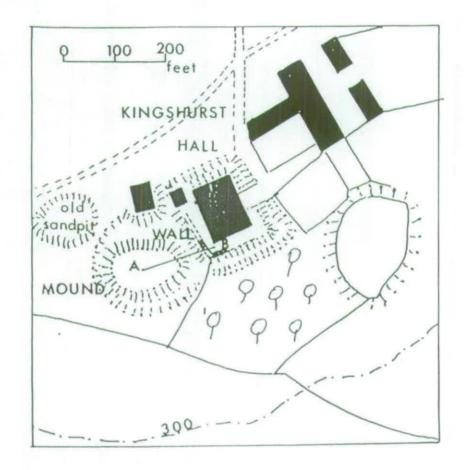
Fig. 3. A plan showing the line of the 1961 excavation trench

In 1961 F.C. Johnson cut an archaeological trench across the mound and moat of the house (Anon 1962). He discovered that the mound was of two phases. In the first phase the mound was less substantial with no trace of a structure; there was, however, a slight revetted ditch and sand floor. In the second phase the mound was heightened and the width of the ditch increased; there was also evidence of an inner palisade and traces of large post-holes in the interior which were interpreted as a possible tower. Pottery from this second phase would suggest a date in the second half of the 13th century. The section was continued across the moat of the house and disclosed an enclosing stone wall of probable 14th century date.

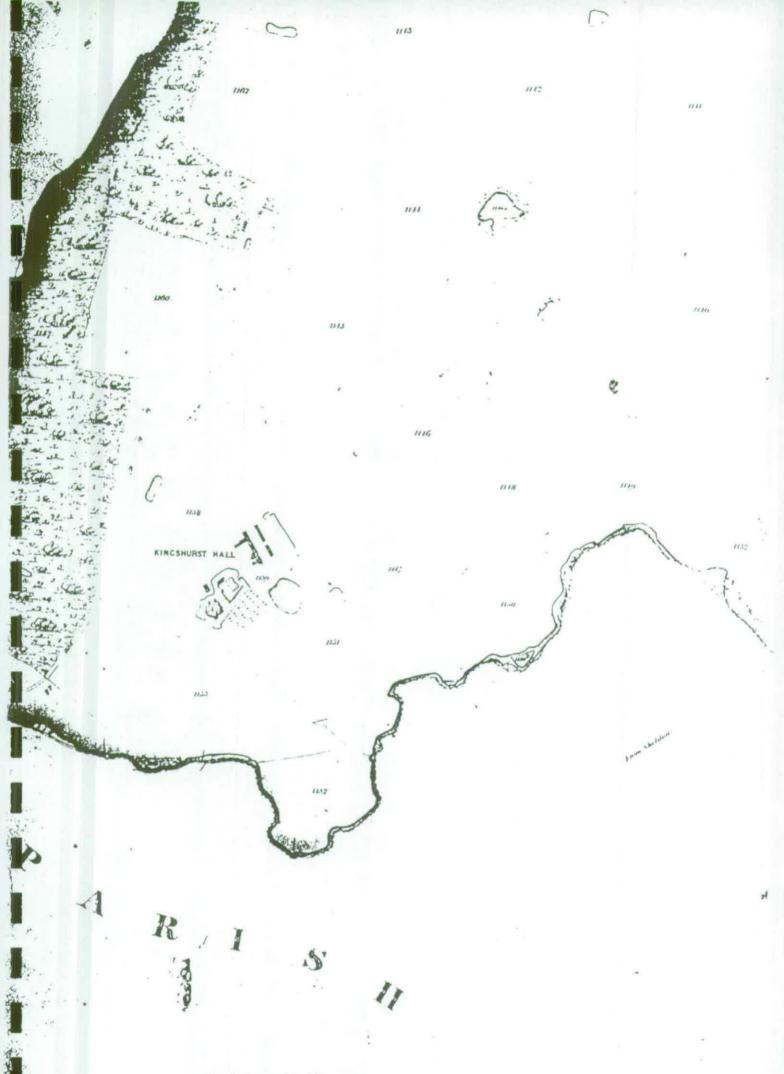
Fig. 4. A copy of the 1844 Tithe award map for Kingshurst Hall

Whether the ditch separating the bailey from the motte is an original feature is unknown; nevertheless, it is clear that both the motte and bailey have undergone substantial alteration. Evidence of recent changes can be seen by examination of early maps. For instance, in the mid-19th century (Tithe Award map) the moat on the west side is more irregular and much wider (fig. 4); this shape persisted until at least 1937 (OS map, Warwicks XV.1, 1937) after which it was appreciably narrowed. On the east side the moat is straight, suggesting that this has also been modified. The motte itself has also clearly been re-modelled since the mid-19th century. The rather smooth profile of the monument, and lack of evidence of the excavation trench, would also suggest that it has been re-modelled since 1961.
