# DOWN HOUSE BROMLEY, KENT

*Notes on the Trellis Attached to the Walls of Down  
House Shown in Photographs and Watercolours Dating  
from Charles Darwin's Residency*

Richard Lea

Historical Analysis & Research Team  
*Reports and Papers (First Series, 37)*  
(1997)

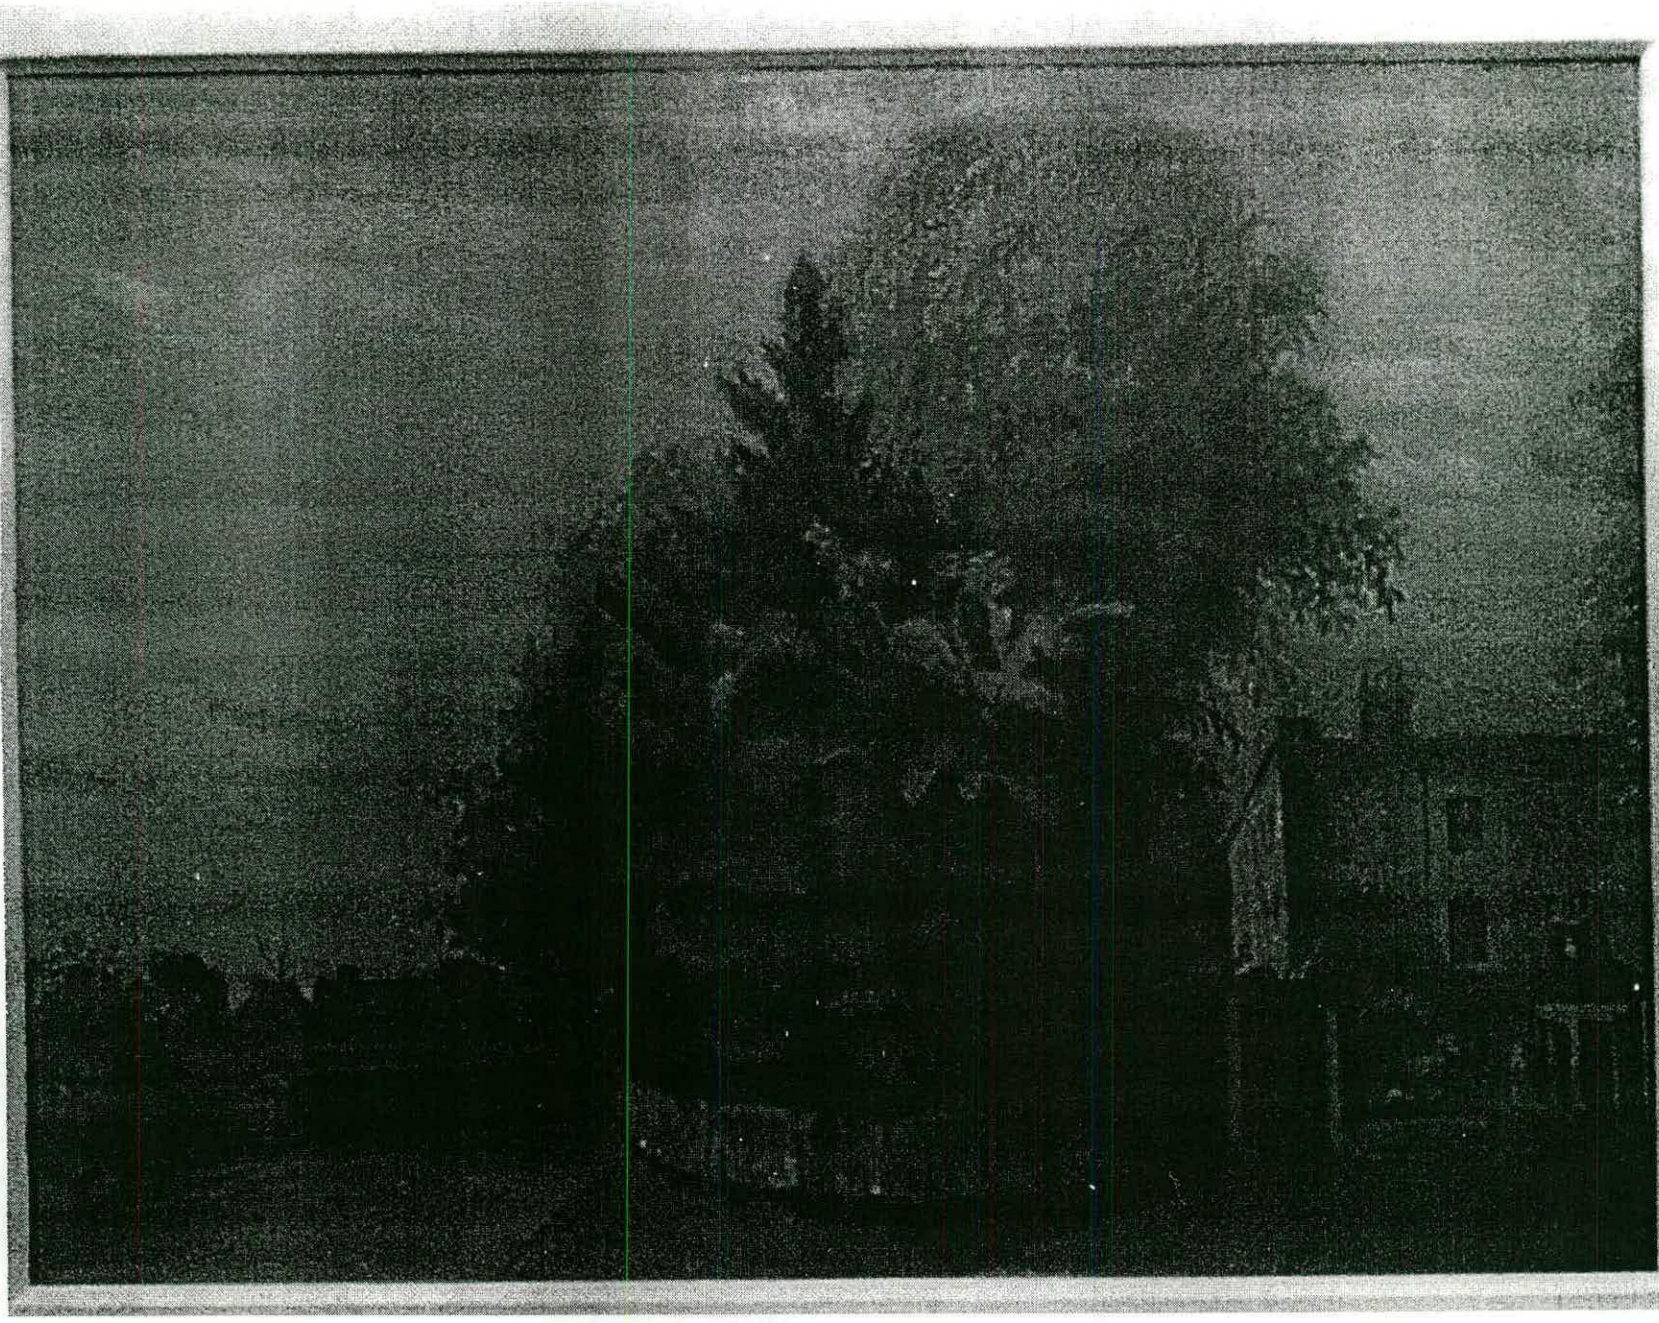
**Figure 3** A watercolour of the house viewed from the east c 1830 probably by Johnson, very similar to Figure 1 (Down House Museum Collection)

Two pencil drawings of the house (Figure 1 and Figure 2) and a watercolour (Figure 3) probably by Lieut. Colonel John Johnson, who owned the house from 1819 to 1835, show the house before alterations to the main roof by the local architect Cresy c 1835. The house appears to have been free from ivy on the east and north walls at least.

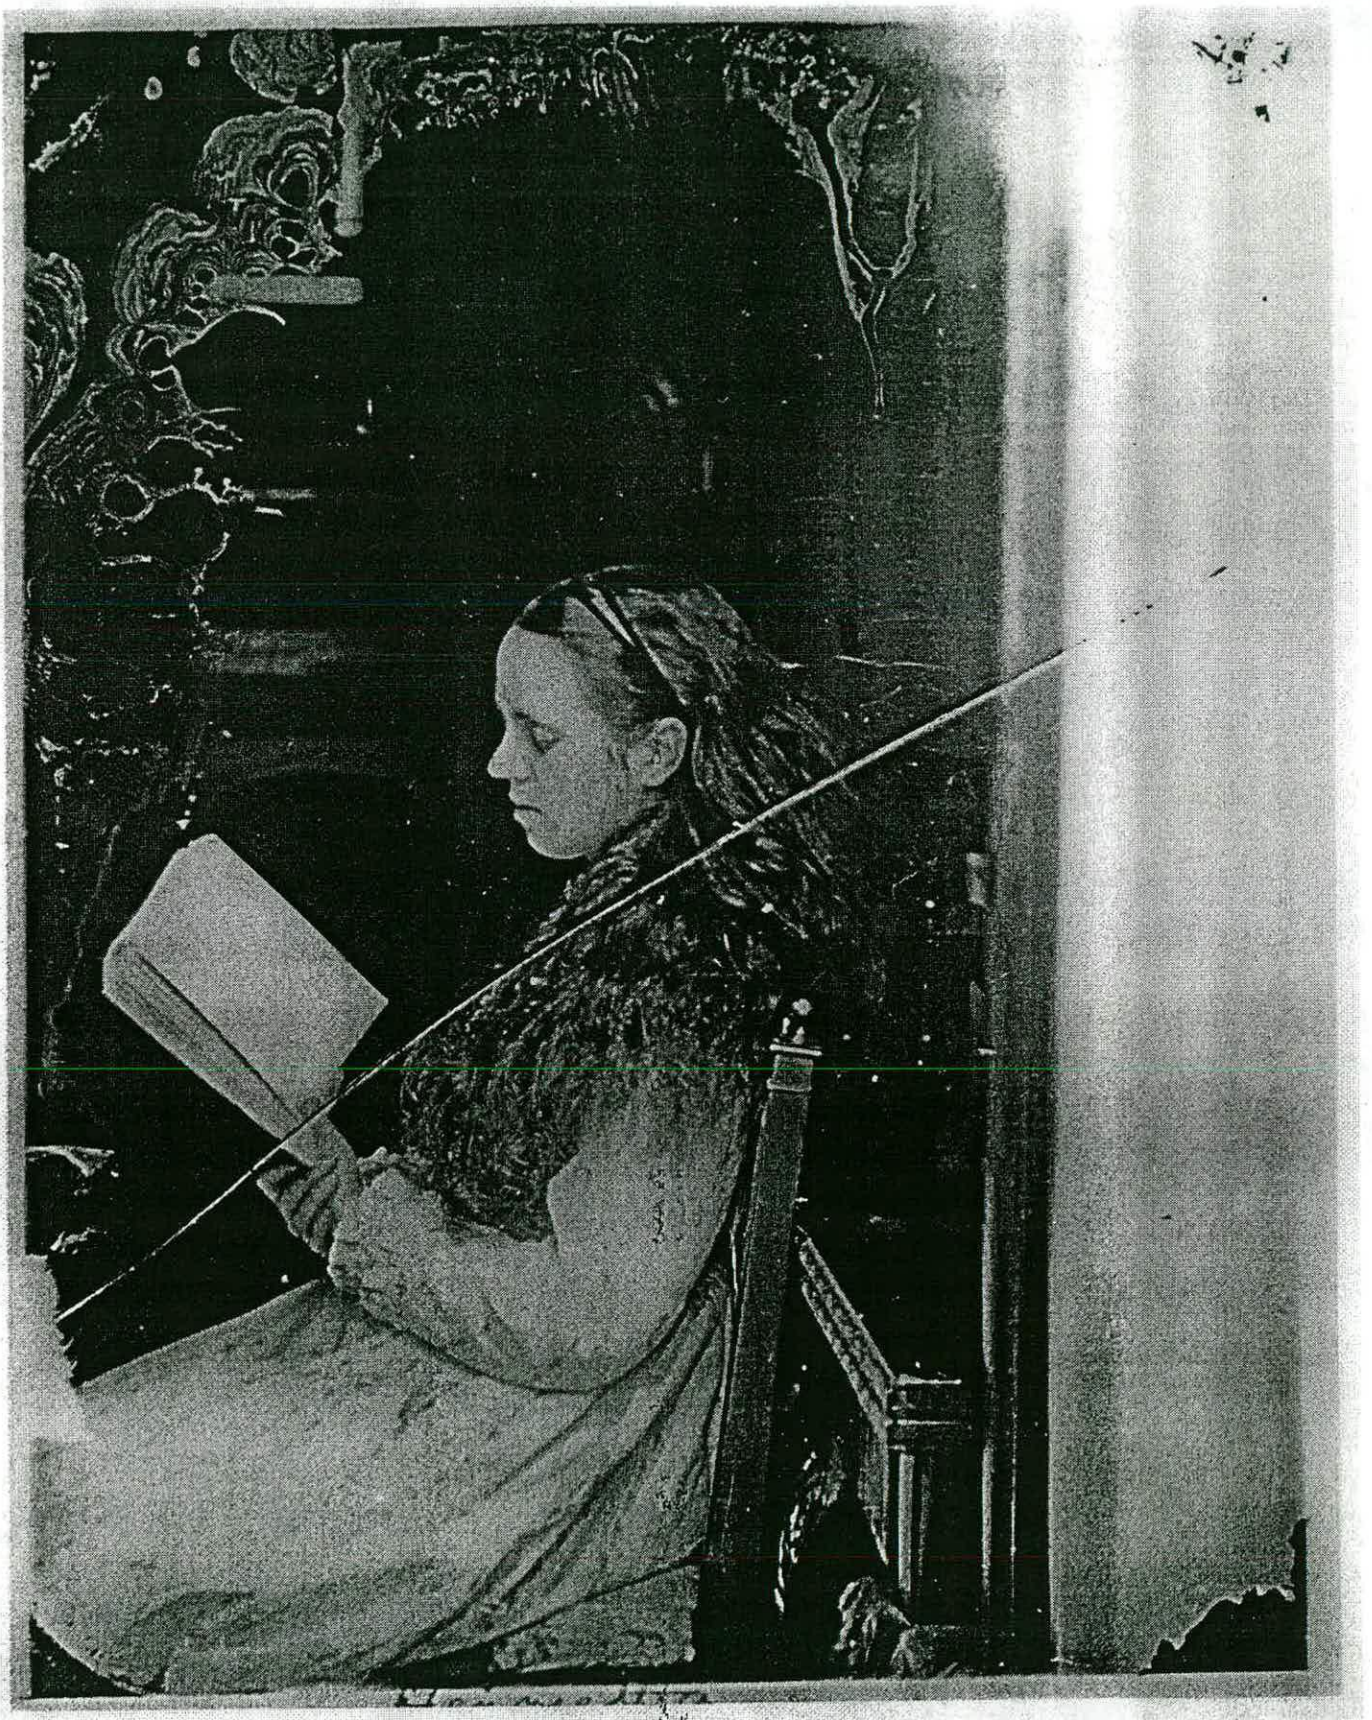
**Figure 4** Darwin's daughter Henrietta sitting in the centre bay window of the drawing room, c 1860 (CUL DAR 219.12.10)

A photograph inscribed 'Henrietta' (Figure 4) shows Darwin's daughter, born in 1843, reading in the centre window of the new drawing room, with the fireplace in the gloom behind her. The drawing room was built in 1858. From Henrietta's appearance, it seems the photograph was probably taken soon after that date. The photograph shows neither trellis or any sign of a sunblind visible in the next photograph (Figure 7) suggesting it is the earliest in the sequence.

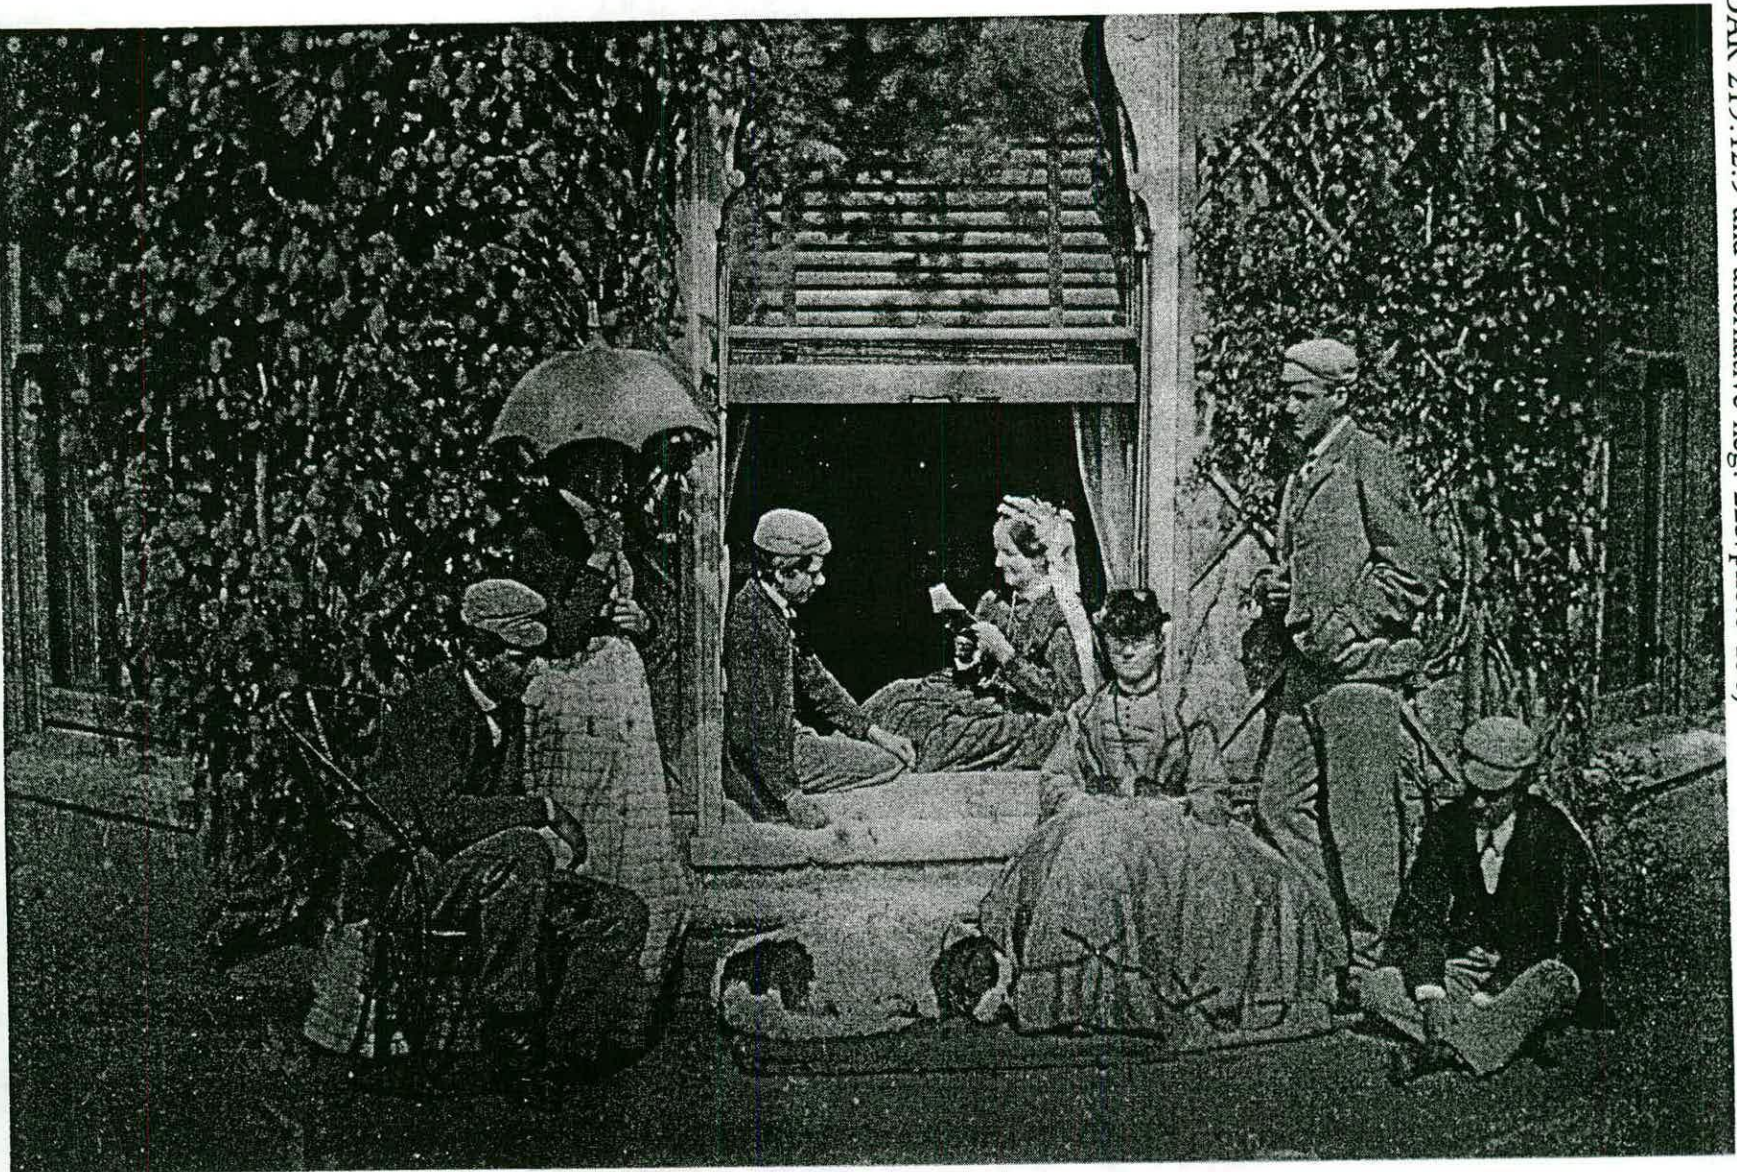
Figure 7 Darwin's family around the centre window in the Dining Room c 1865 (CUL DAR 219.12:9 and alternative neg. 225/photo 156)

The photograph of the family sitting around the centre window in the dining room (Figure 7) on the basis of the apparent ages of the various members, dates from about 1865. On the left hand side of the window is a well established ivy with large leaves. On the right hand side is a smaller leafed climber. The trellis is the same as that in the earlier photograph (Figure 5). It appears to have been constructed using framing battens 2" wide, with 1" wide laths spaced at diagonal intervals of *c* 12". By this date, it appears to have deteriorated, with the loss of some sections of the latticework. A reconstruction of the lattice pattern is shown in Figure 27.

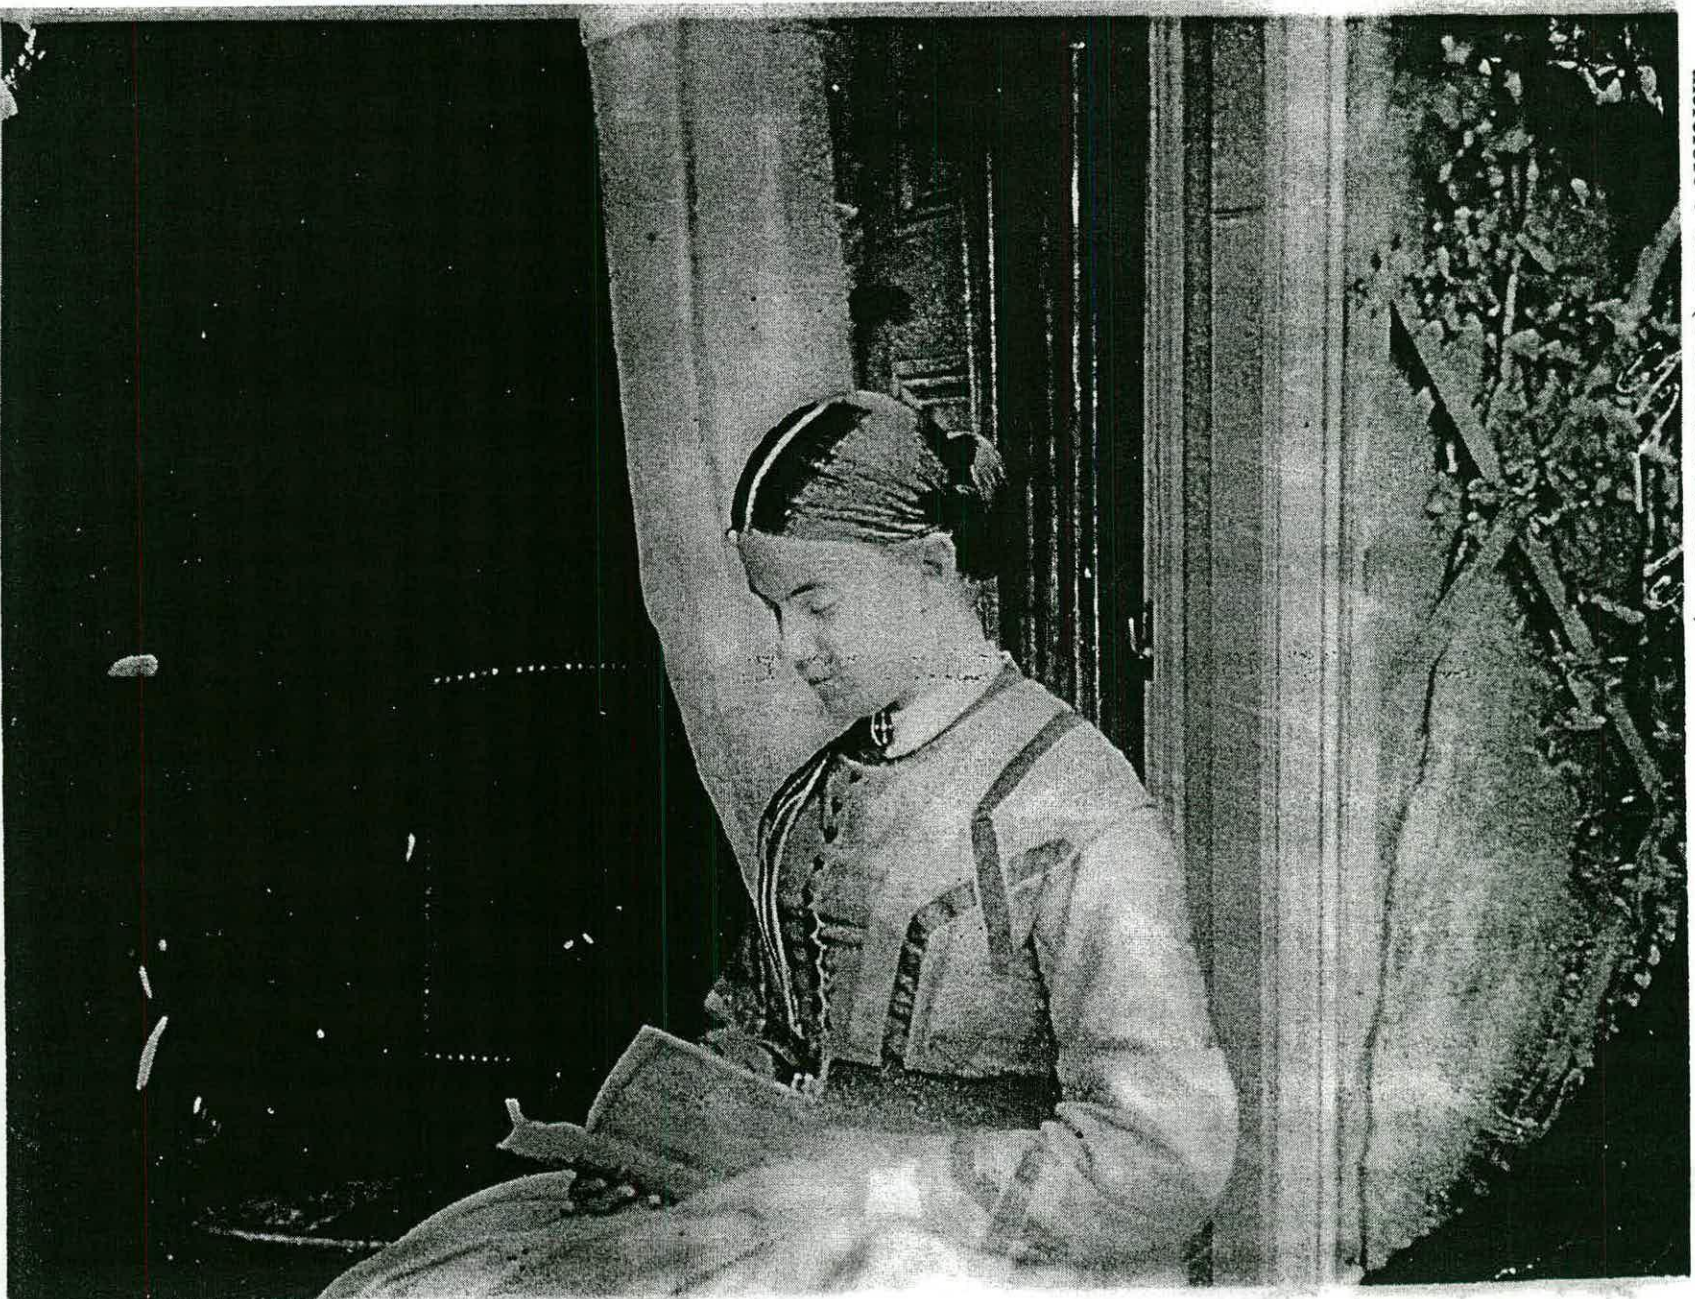
Figure 8 A photograph inscribed 'Bessy Taken by LD' showing Darwin's daughter Elizabeth in the centre window of the dining room, contemporary with Figure 7, therefore c 1865 (CUL DAR 219.12:11)

The photograph inscribed 'Bessy Taken by LD' (Figure 8) of Darwin's daughter Elizabeth, born in 1847, reading in the centre window in the dining room, shows similar sprigs of ivy or creeper on the right hand side of the window as in the previous photograph and she is wearing the same dress. The two photographs are therefore probably contemporary. The laths, in this photograph, clearly stand proud of the wall face, probably at a distance of *c* 3/4".

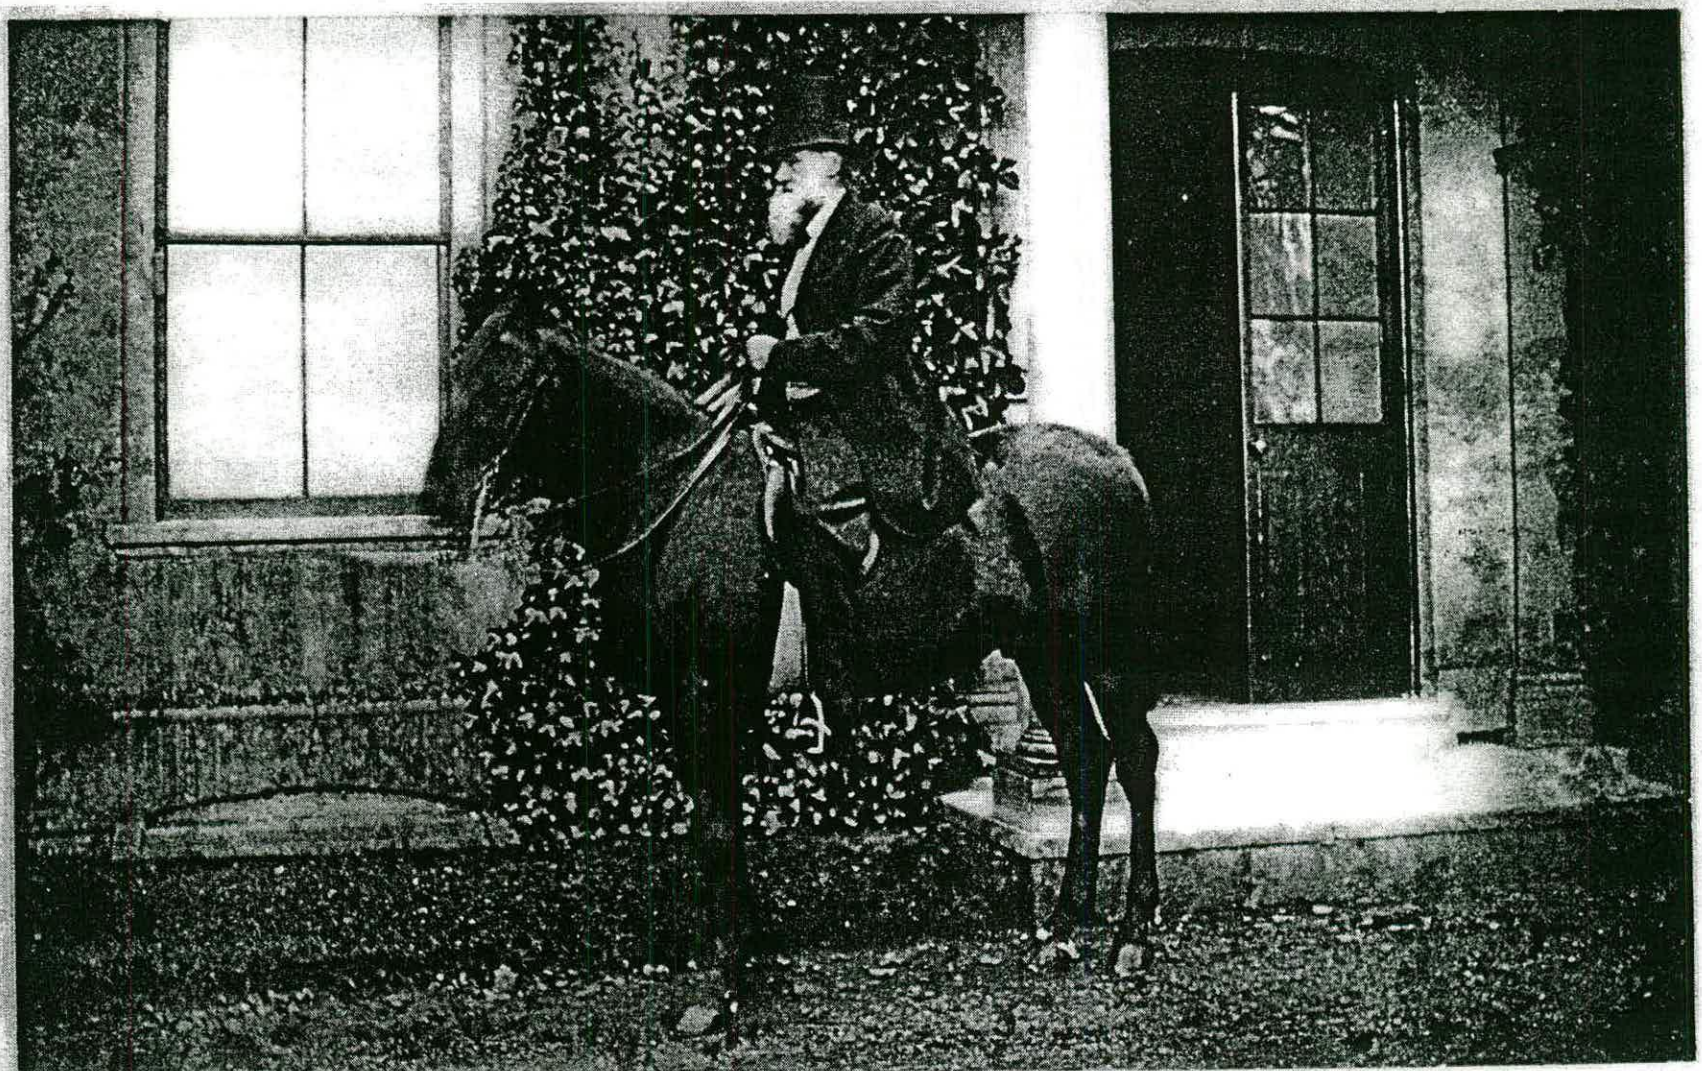
Figure 10 Charles Darwin on his horse Tommy, probably taken c 1868 (CUL DAR 225/photo 116)

The photograph of Darwin on his horse Tommy (Figure 10) shows the area around the front door. Darwin fell from his horse in 1869 and reputedly never rode again. The door is not the one which survives today and the columns were not mounted on pedestals. The present arrangement first appears in 1909 (see Figure 20) and probably dates from alterations made by the Down House School from 1906. Ivy is shown growing against the wall on both sides of the door but there are no signs of a timber trellis. Either the ivy was supported by wire or it clung to the walls directly.

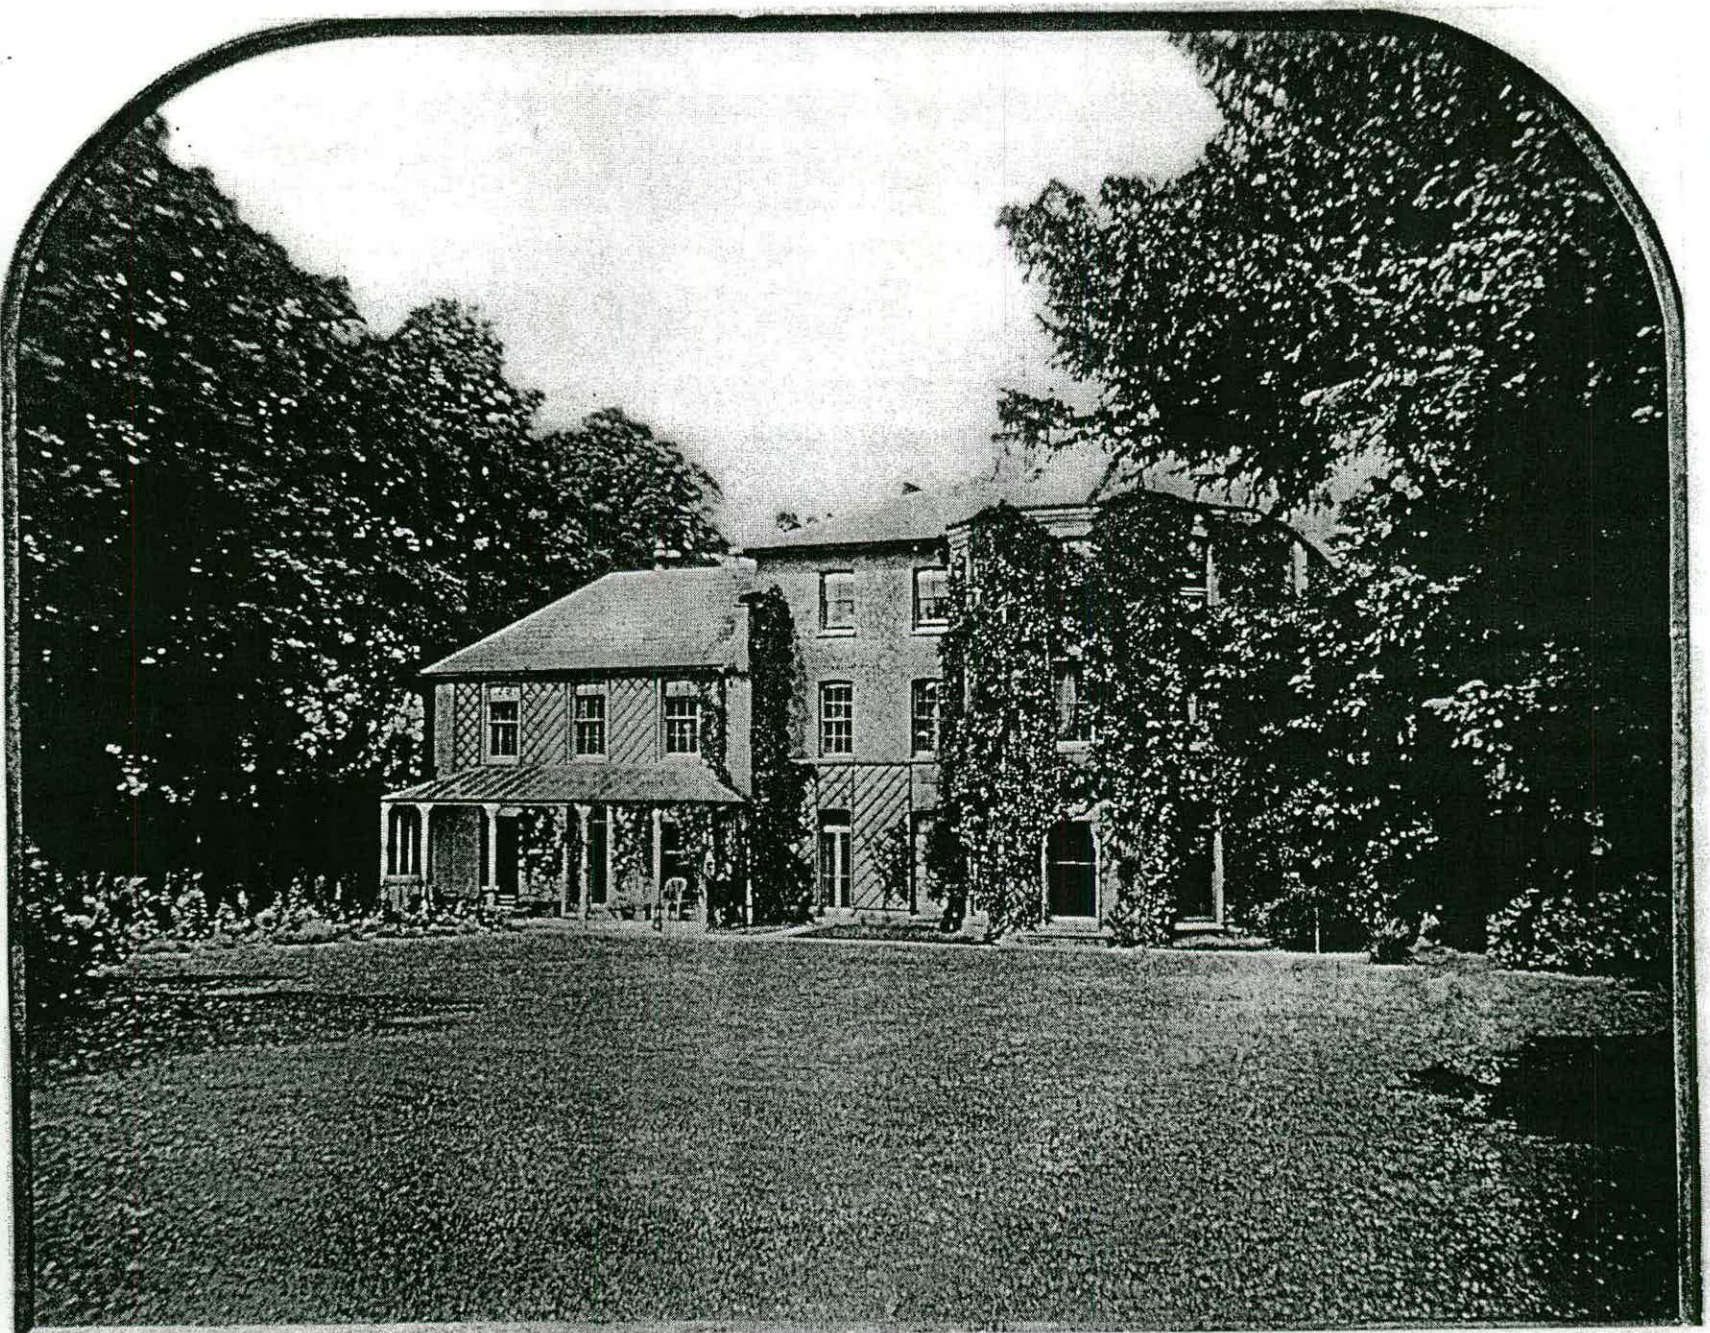
Figure 11 A photograph of the house and garden with some growth of climbers above and inside the verandah, therefore c 1873 (CUL DAR 219.12:172 or 173)

The photograph of the house from the garden looking north-east (Figure 11) shows the house probably soon after the addition of the verandah in 1872. There is some established growth of ivy or creeper under the verandah and on the wall above, which suggests that at least a year had elapsed since the verandah had been built. Above the verandah, the trellis had been altered from its appearance in the earlier photograph (Figure 5). In this photograph, the diagonal grid appears to be smaller, with a diagonal spacing of c 11". The sunblind is still in position in the centre window of the dining room and the growth around the bay is well established and very luxuriant.

The growth in the return between the drawing room and the hall is also well established. The west wall of the hall is now clearly shown with timber trellis attached to it. The spacing of the diagonal laths appears to be consistent with that on the wall above the verandah. The trellis on this wall also features curving battens above the window heads. Although it is not clear from this photograph, similar battens are shown in later photographs above the bay windows and on the main east facade. This slightly unusual feature suggests contemporaneity.

The window into the hall is shown converted to a double door, although the window, to the closet on the right, remains as a full length sash, glazed nine over nine. Also, the second floor windows above the hall are clearly glazed two over two, although the other upper floor windows are still six over six.

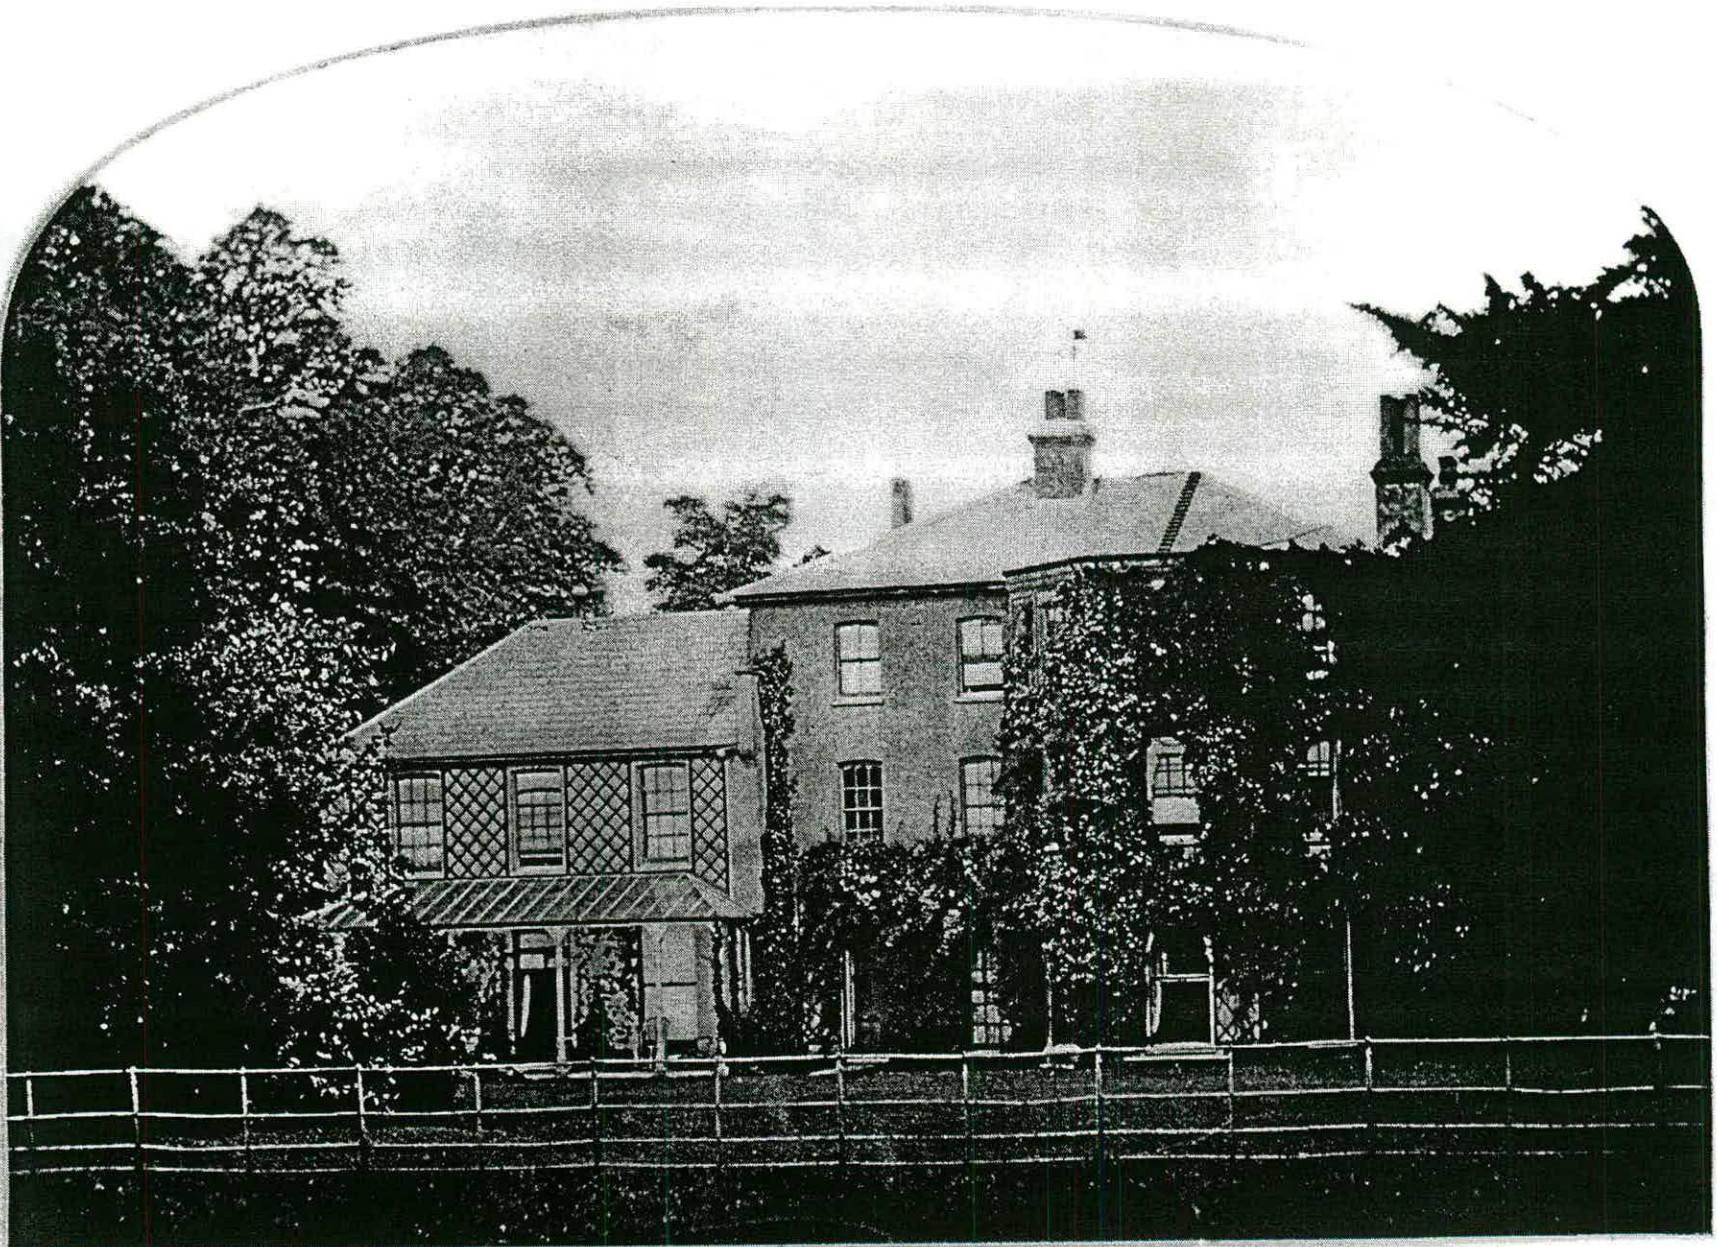
Figure 12 A photograph of the house from the garden probably c 1875, since it shows more developed growth around the bay than in Figure 11 (CUL DAR 225/photo 27)

A photograph of the house from the west (Figure 12) shows the growth across the bay and hall very well established but less around the verandah than in the previous photograph. It clearly dates from after the addition of the verandah. It shows the sunblind in the dining room centre window seen in the previous photograph (Figure 11) but now there is a similar sunblind in the first floor window above, Darwin's bedroom. On the basis of the extra growth, a date of c 1875 is suggested for this photograph.

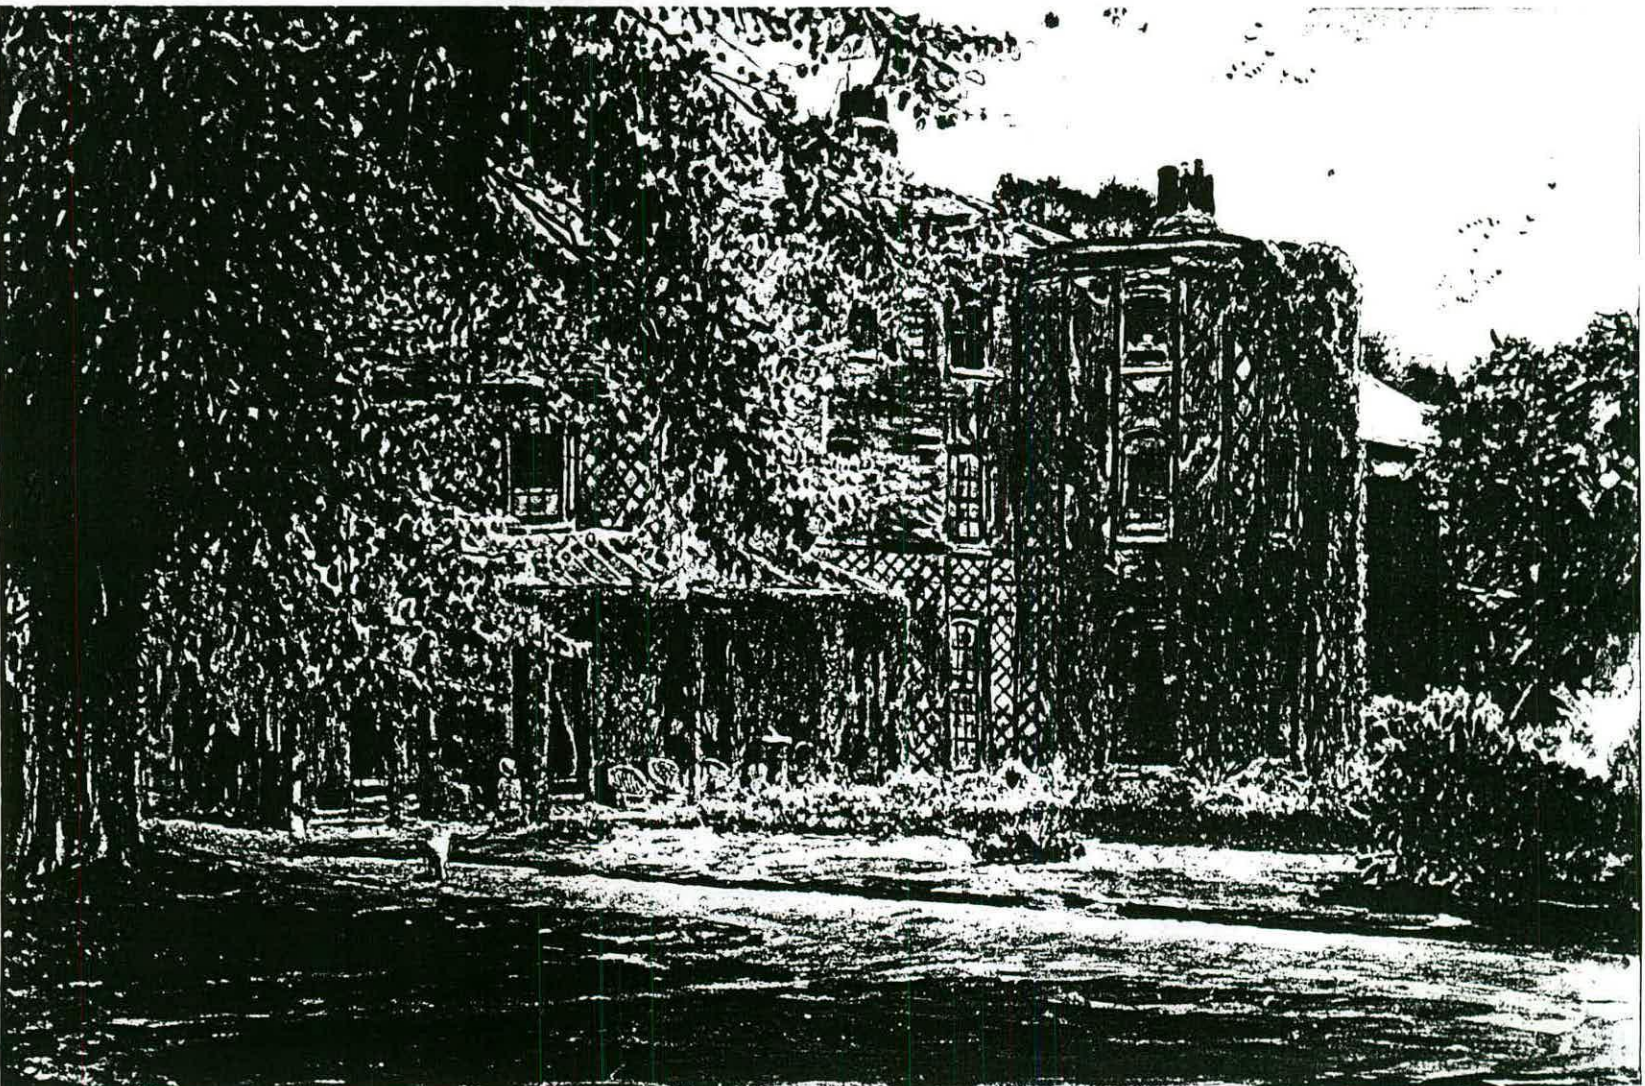
Figure 13 A watercolour of the house viewed from the north-west by Goodwin dated 1880 (Down Museum Collection 88202056)

Two watercolours by Albert Goodwin, show the house two years before Darwin died. The view from the north-west is dated '80' (Figure 13) and shows some reduction in the growth around the bay and on the hall wall. There is growth on the verandah along the eaves, but little on the wall above it. The older trellis, which predated the construction of the verandah, shown surviving on the bay with the larger 18" grid, was apparently painted blue. The trellis with the smaller grid, post dating the construction of the verandah, is shown dark brown or black. It might or might not have been painted. The painting of trellis is not at all unusual in the Victorian period, contemporary watercolours of gardens often show green, blue, black and brown trellis. The use of two paint colours is consistent with the two major phases of trellis identified so far.

The 11" grid trellis appears darker in the photographs than the earlier, apparently blue, trellis on the bay. This distinction is confirmed in the Goodwin watercolour of 1880 (Figure 13). The newer trellis was therefore probably painted black or brown. This was possibly intended to match the use of a dark paint, most probably brown or wood graining on the windows to the drawing room. Later, by 1880, from the Goodwin watercolours (Figure 13 and Figure 14) and the Wedgwood watercolour (Figure 19) it seems all the window sashes were painted brown or woodgrained.

Darwin probably started growing the ivy and creepers around the house in the 1840s or 1850s. By 1880, when Albert Goodwin painted his watercolour views (Figure 13 and Figure 14) the growth had peaked. Two years later, Darwin had died and the foliage around the bay was cut down.

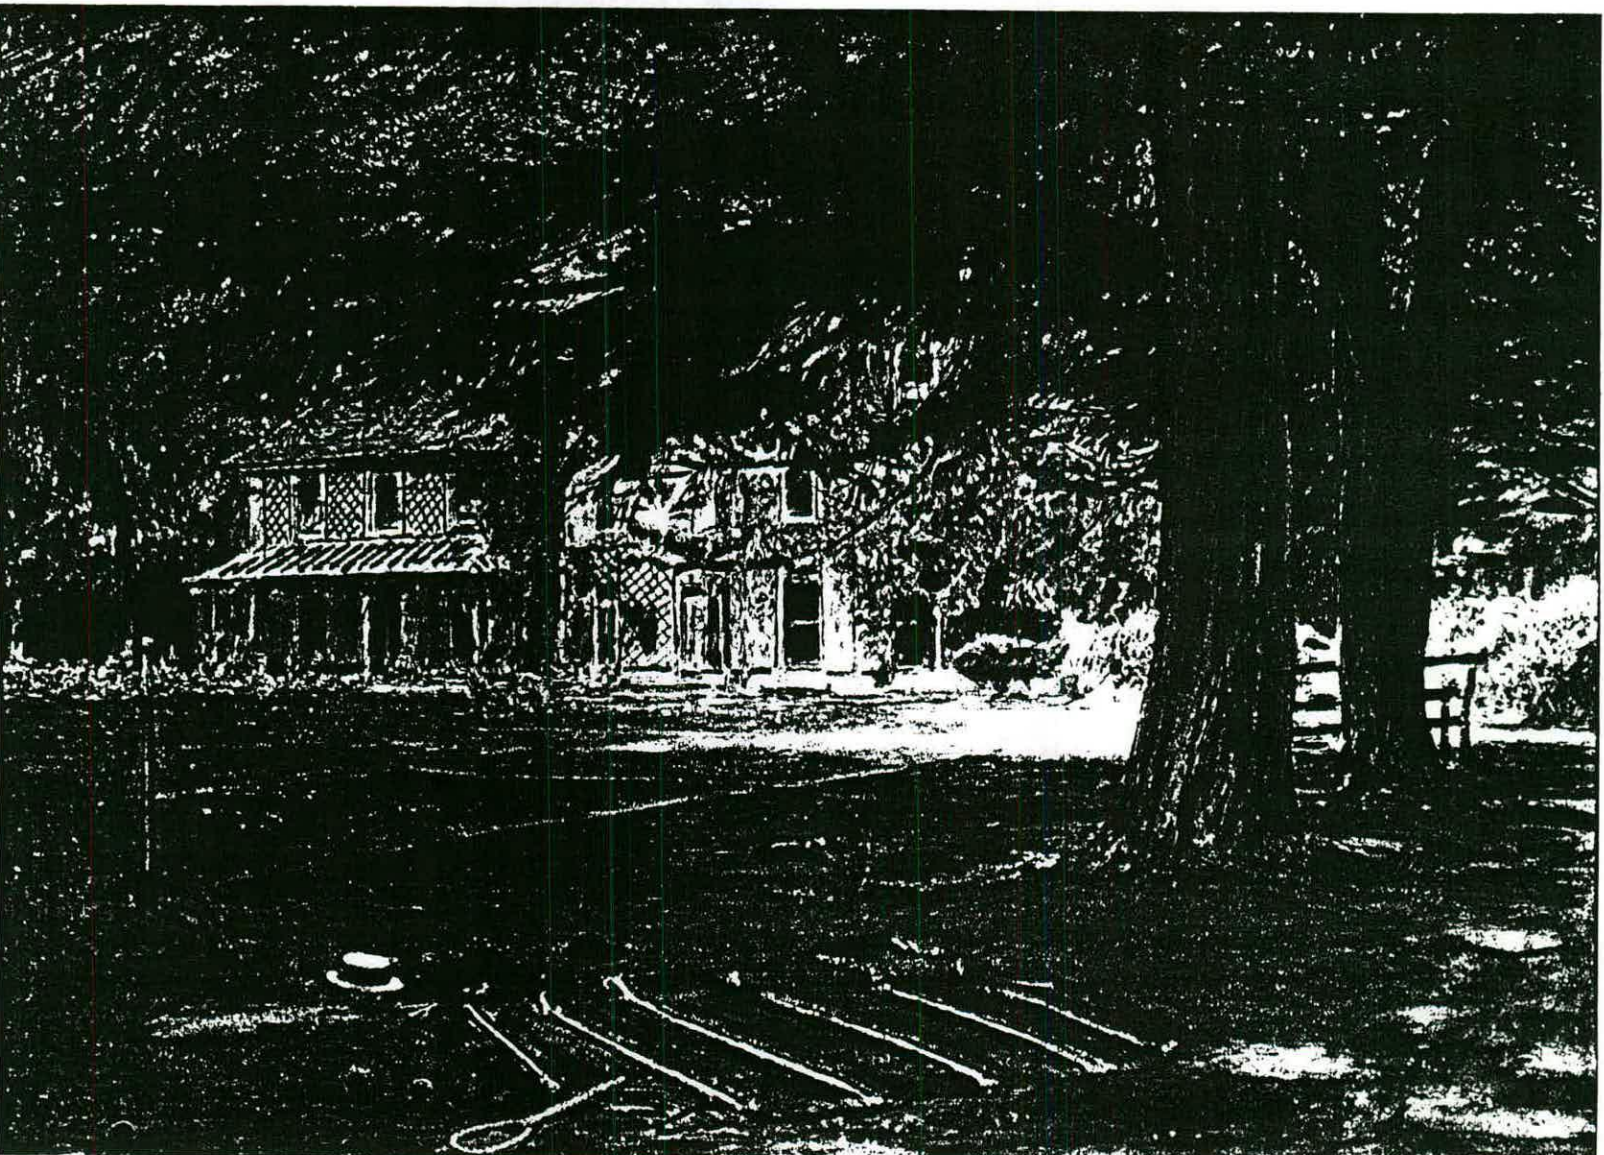
**Figure 14** A watercolour of the garden front viewed from the south-west by A Goodwin not dated but apparently a companion to Figure 13, therefore probably 1880 (Down Museum Collection 88202055)

The view from the south-west (Figure 14) again shows the trellis at the north end of the garden front in strong contrast with the wall surface, suggesting it was painted dark brown or black. Blue is not used to pick out the trellis on the bay, but much of this part of the picture is obscured by the overhanging tree in the foreground.
