# DOWN HOUSE BROMLEY, KENT

*Notes on the Trellis Attached to the Walls of Down  
House Shown in Photographs and Watercolours Dating  
from Charles Darwin's Residency*

Richard Lea

Historical Analysis & Research Team  
*Reports and Papers (First Series, 37)*  
(1997)

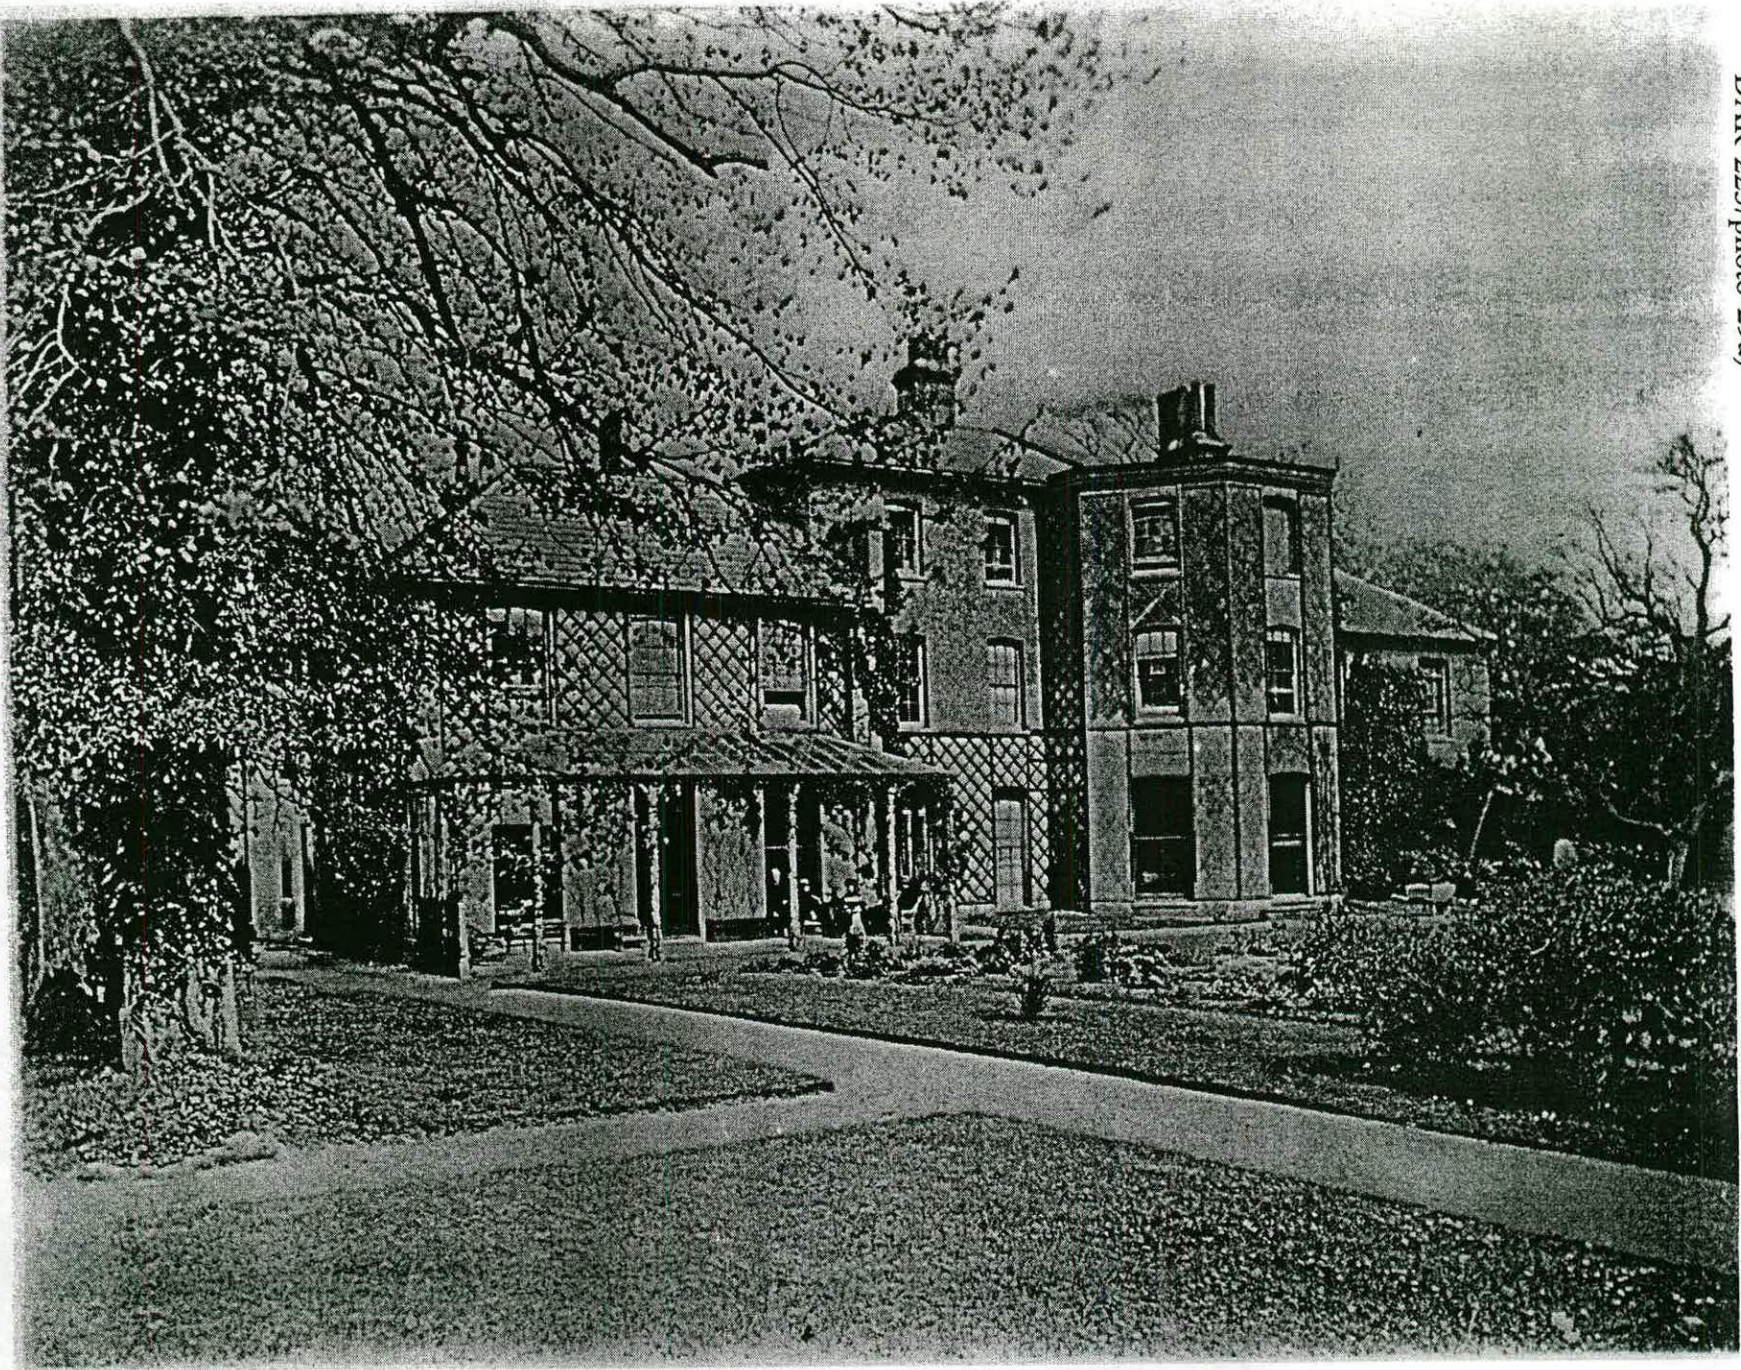
Figure 17 A photograph of the garden front viewed from the north-west, c 1882 (CUL DAR 225/photo 29a)

This is confirmed in a photograph (Figure 17) which must date from the same year, although clearly not mid-summer. Members of the family appear sitting in the verandah viewed from the north-west. The detail of the trellis corresponds closely with that shown in the Parsons view (Figure 16). This photograph also clearly shows well established growth on the north wall of the drawing room and on the kitchen wall. In neither area was the ivy necessarily supported by trellis.

The view of the bay by Alfred Parsons from August 1882 (Figure 16) and the apparently contemporary photographs (Figure 17 and Figure 18) clearly show the bulk of the growth around the bay had been cut down. The framing battens around the bay were left *in-situ* but the lattice had been removed.

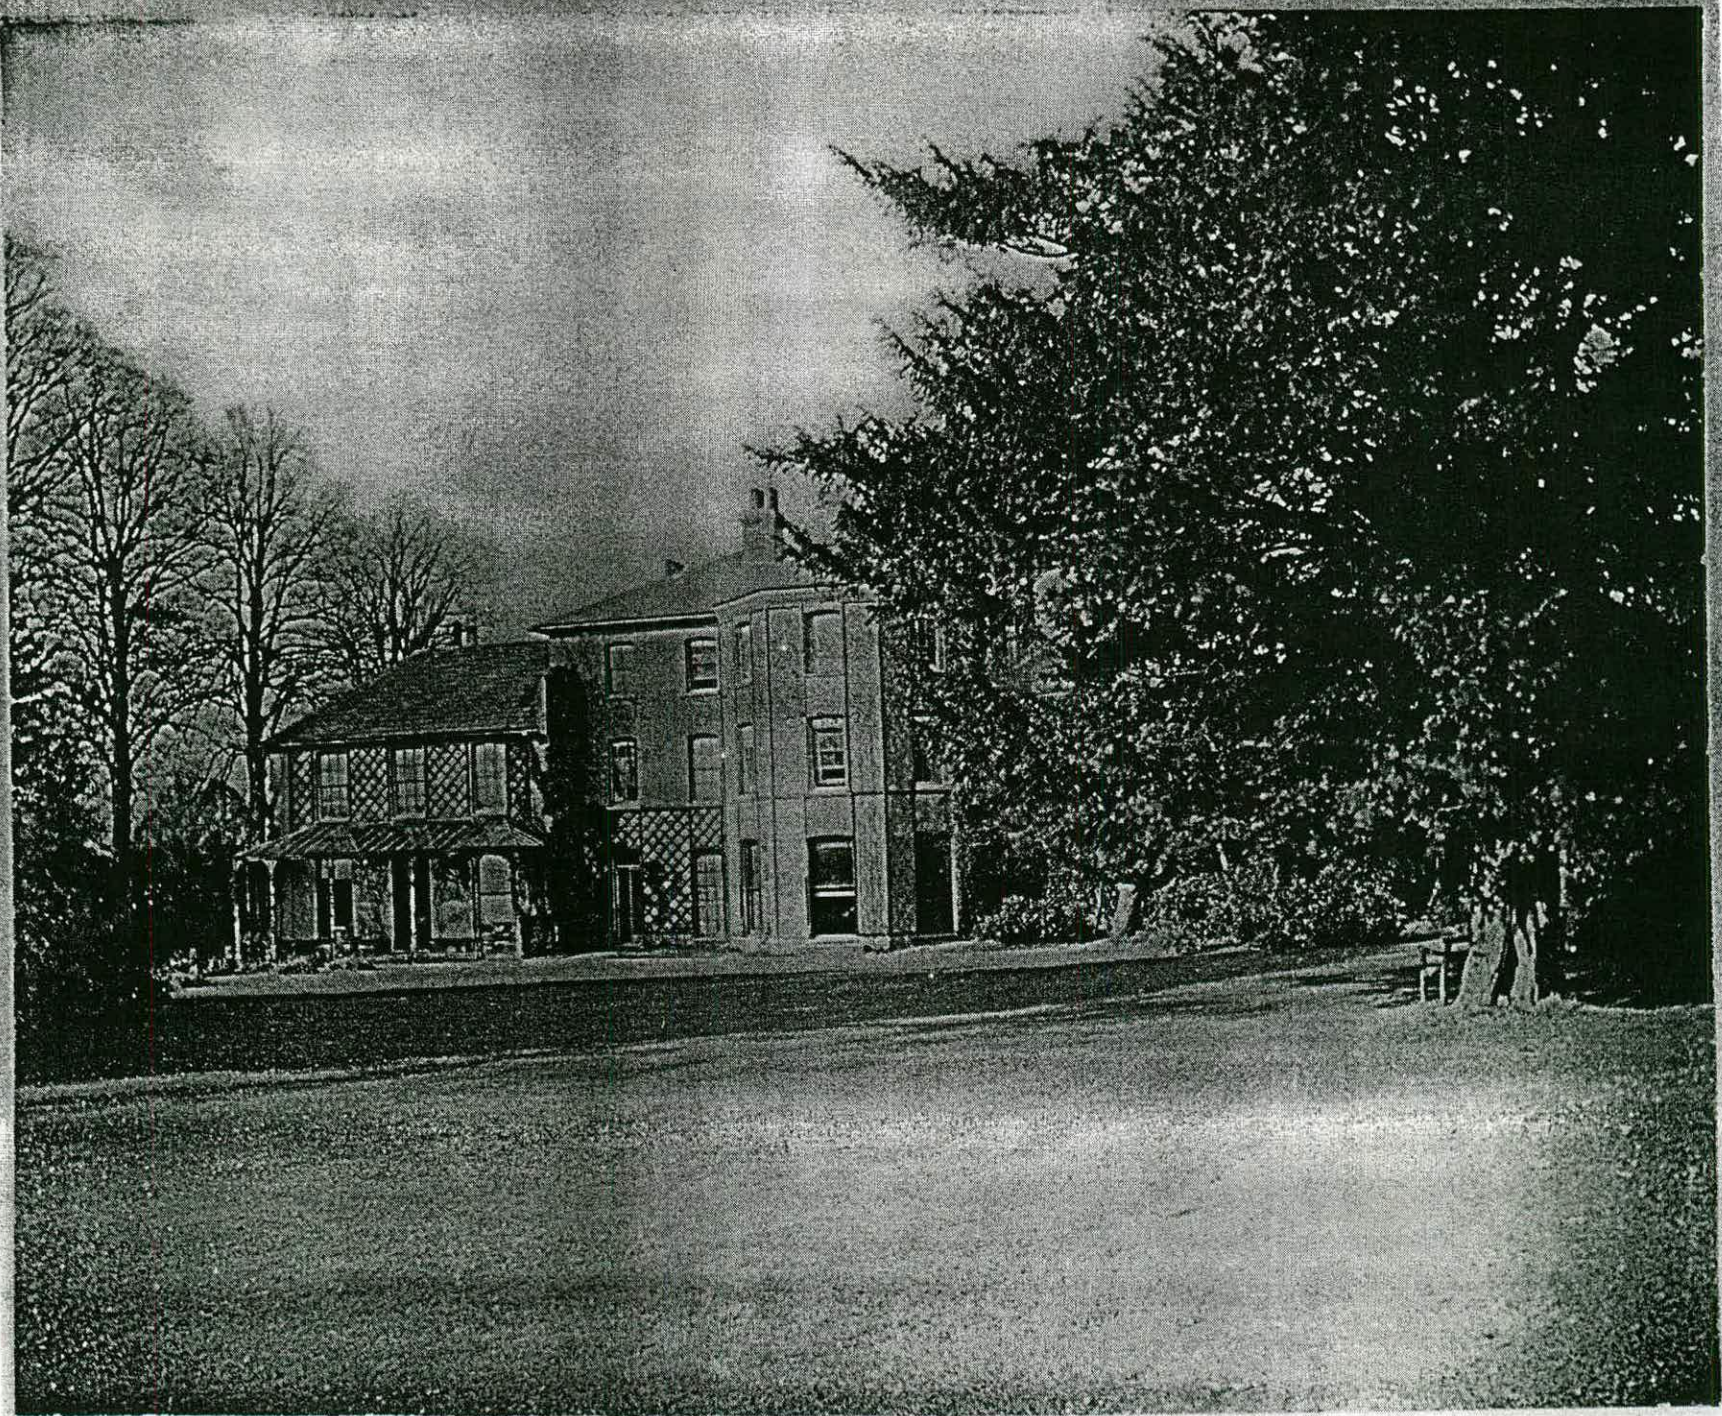
Figure 18 A photograph of the garden front viewed from the south-west, c 1882  
(Down House Museum Collection)

A second photograph (Figure 18) showing the house from the south-west is clearly contemporary. It has the same configuration of the trellis stripped of laths and growth around the bay.

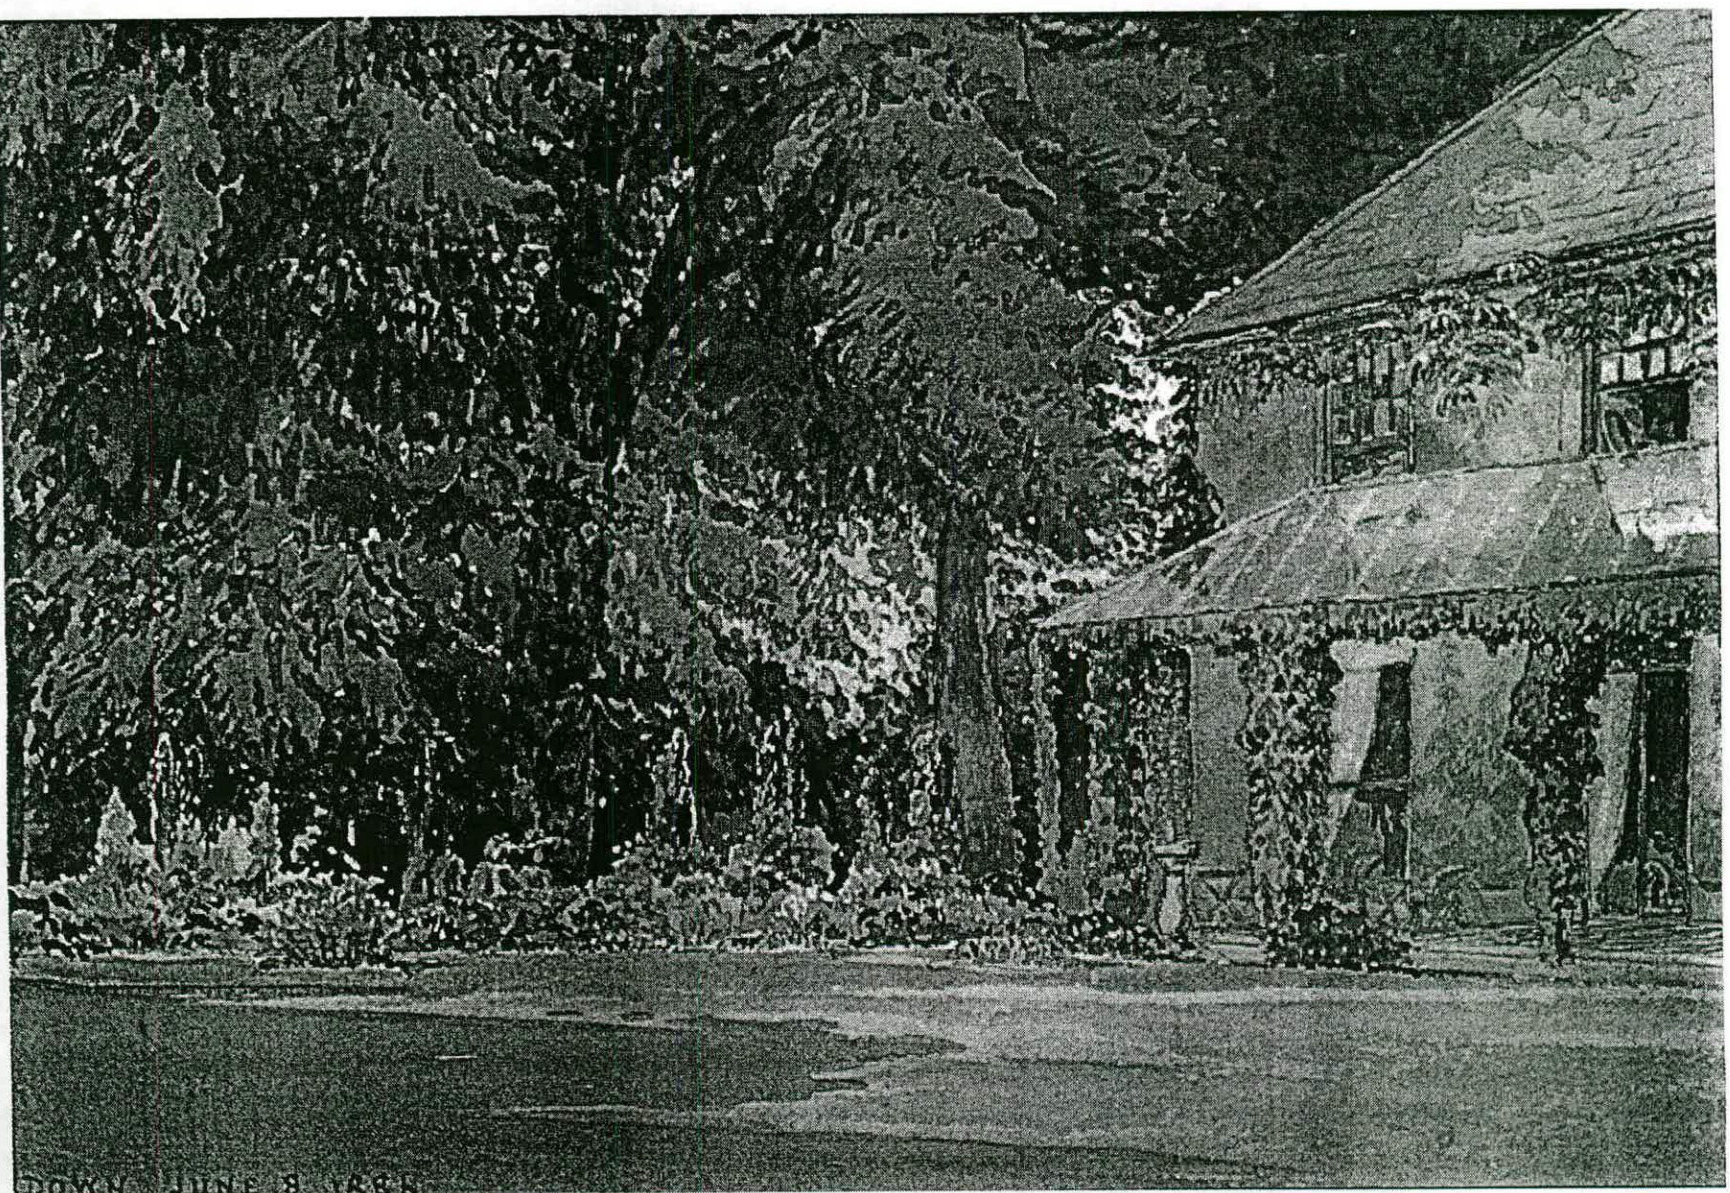
Figure 19 A watercolour by J Wedgwood inscribed 'Down June 8 1886' (Down House Museum Collection)

A watercolour by Julia Wedgwood (Figure 19) inscribed 'DOWN JUNE 8 1886' shows the north end of the house and verandah viewed from the south-west.

There is little growth on the actual trellis above the verandah, it appears to concentrate on the eaves.

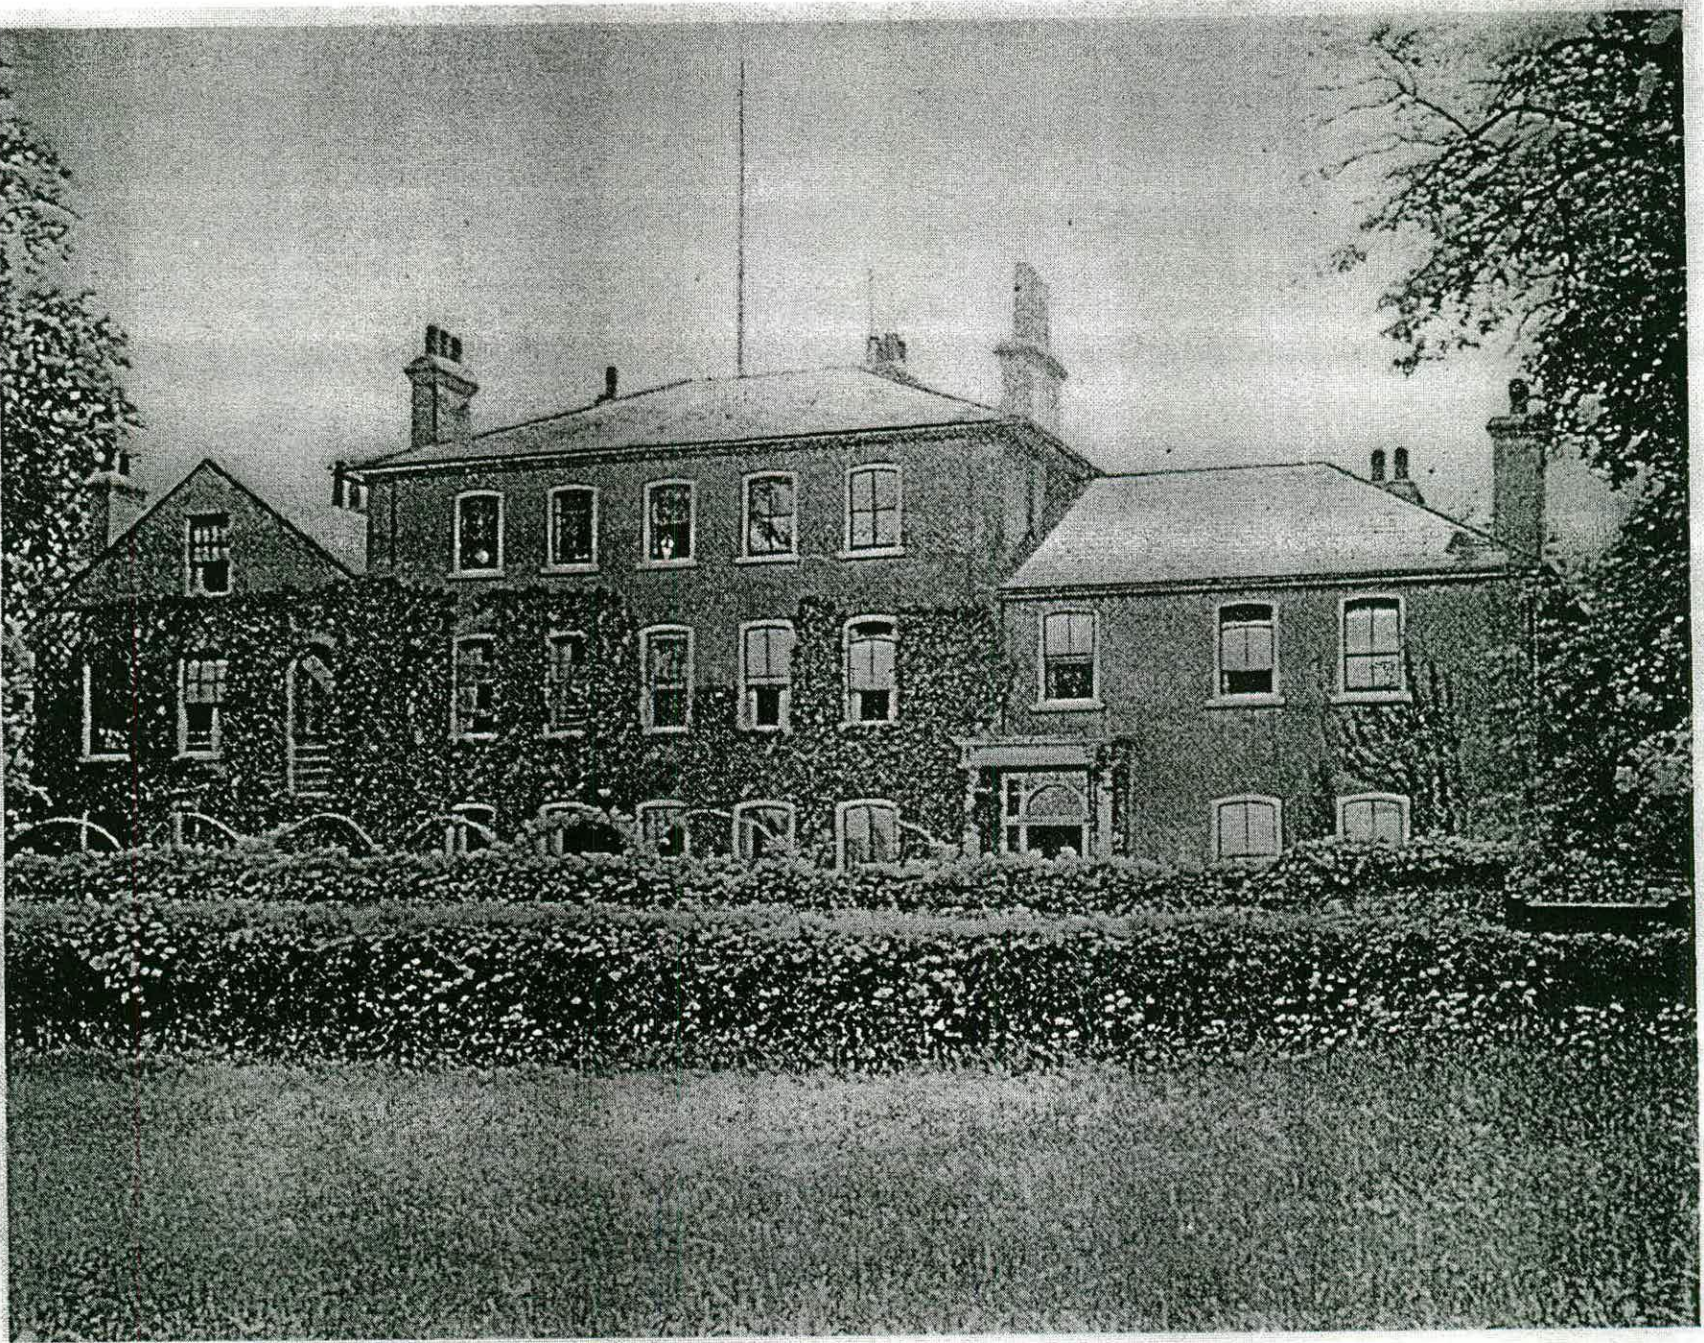
Figure 20 A photograph of the east front of the house reproduced in *Darwin*, The Bookman, February 1909 (CUL DAR 233.1:7)

A photograph of the house after its conversion to a school (Figure 20) and published in 1909, shows the east front of the house with growth in much the same areas as in the view of 1882 (Figure 15). However, the top of the gable wall at the south end has been cleared. At the north end, a climber is beginning to cover the wall of the New Study.

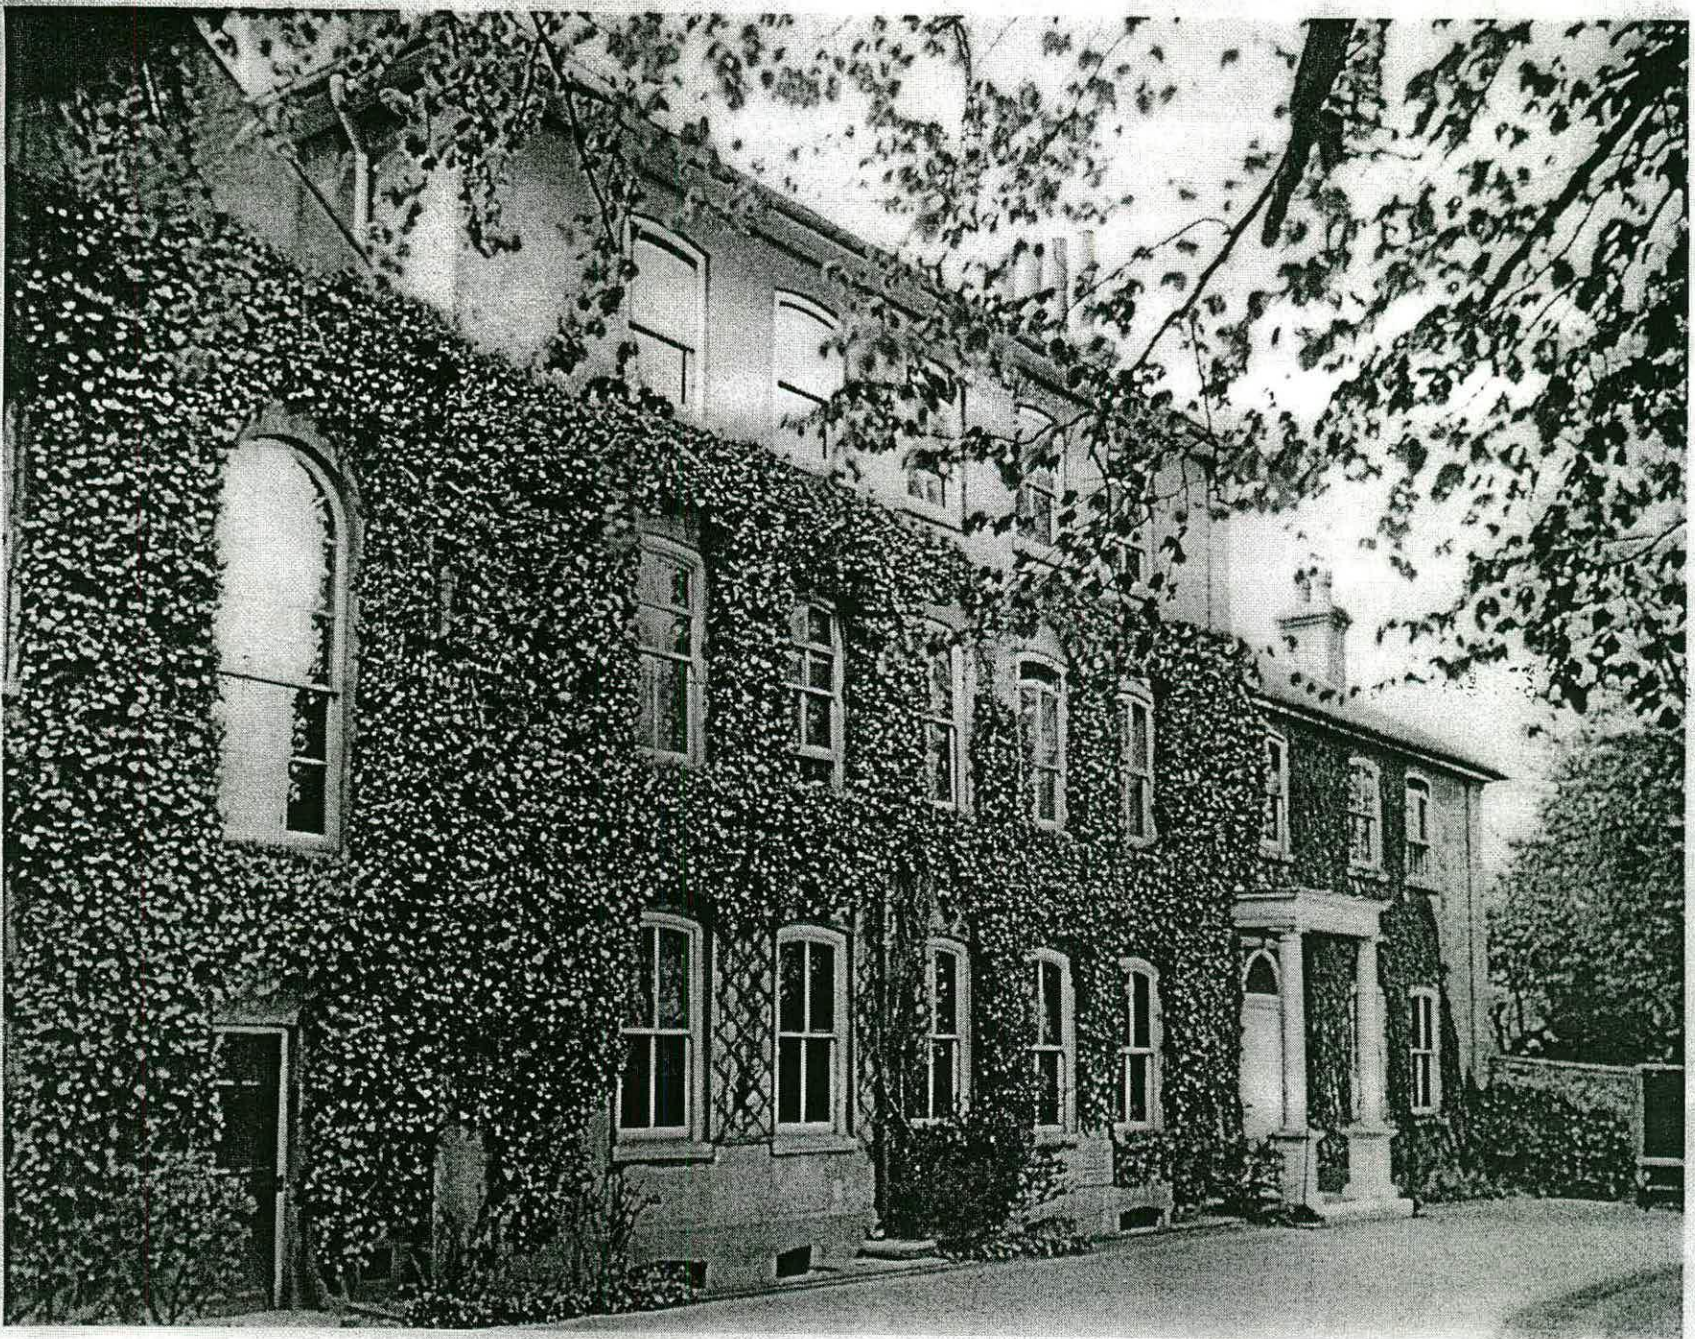
Figure 21 A photograph of the east front of the house after its conversion to a museum, c 1930 (CUL DAR 233.1:6)

A photograph taken after the conversion of the house to the Down House Museum (Figure 21), shows that the east front had changed very little since the school photograph of 1909 (Figure 20). The New Study wall had by now become almost covered with creeper. It also shows some trellis between the southern three ground floor windows of the main facade and above the window heads. The detailing of the trellis, especially the curved battens above the window heads suggests that it is contemporary with the trellis introduced on the garden front of the house after the construction of the verandah.

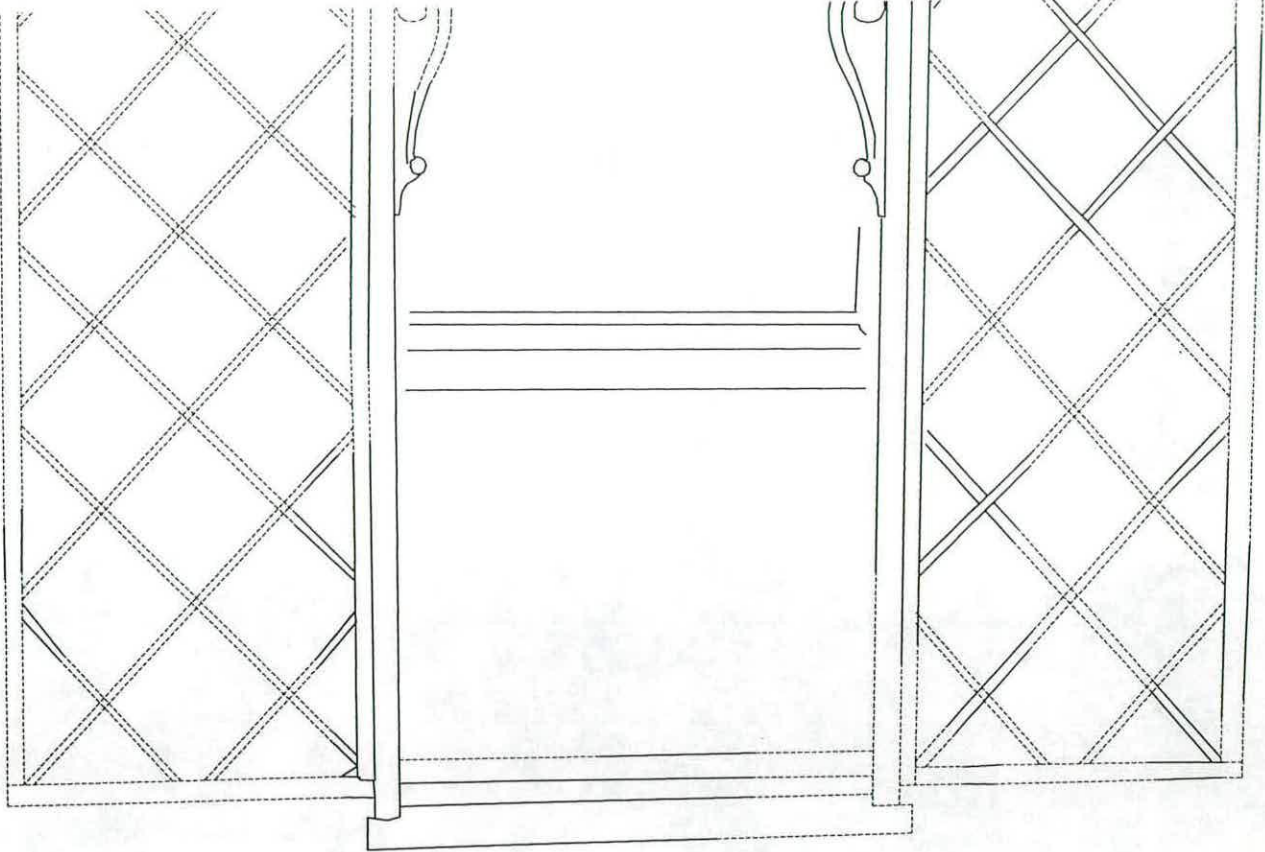
Figure 27 A reconstruction of the lattice shown in the family photograph, Figure 7.

The photograph of the family sitting around the centre window in the dining room (Figure 7) on the basis of the apparent ages of the various members, dates from about 1865. On the left hand side of the window is a well established ivy with large leaves. On the right hand side is a smaller leafed climber. The trellis is the same as that in the earlier photograph (Figure 5). It appears to have been constructed using framing battens 2" wide, with 1" wide laths spaced at diagonal intervals of *c* 12". By this date, it appears to have deteriorated, with the loss of some sections of the latticework. A reconstruction of the lattice pattern is shown in Figure 27.
