HISTORIC BUILDING REPORT

**No. 7
Old Palace Yard
WESTMINSTER
London W1**

September 1994

No. 7 Old Palace Yard

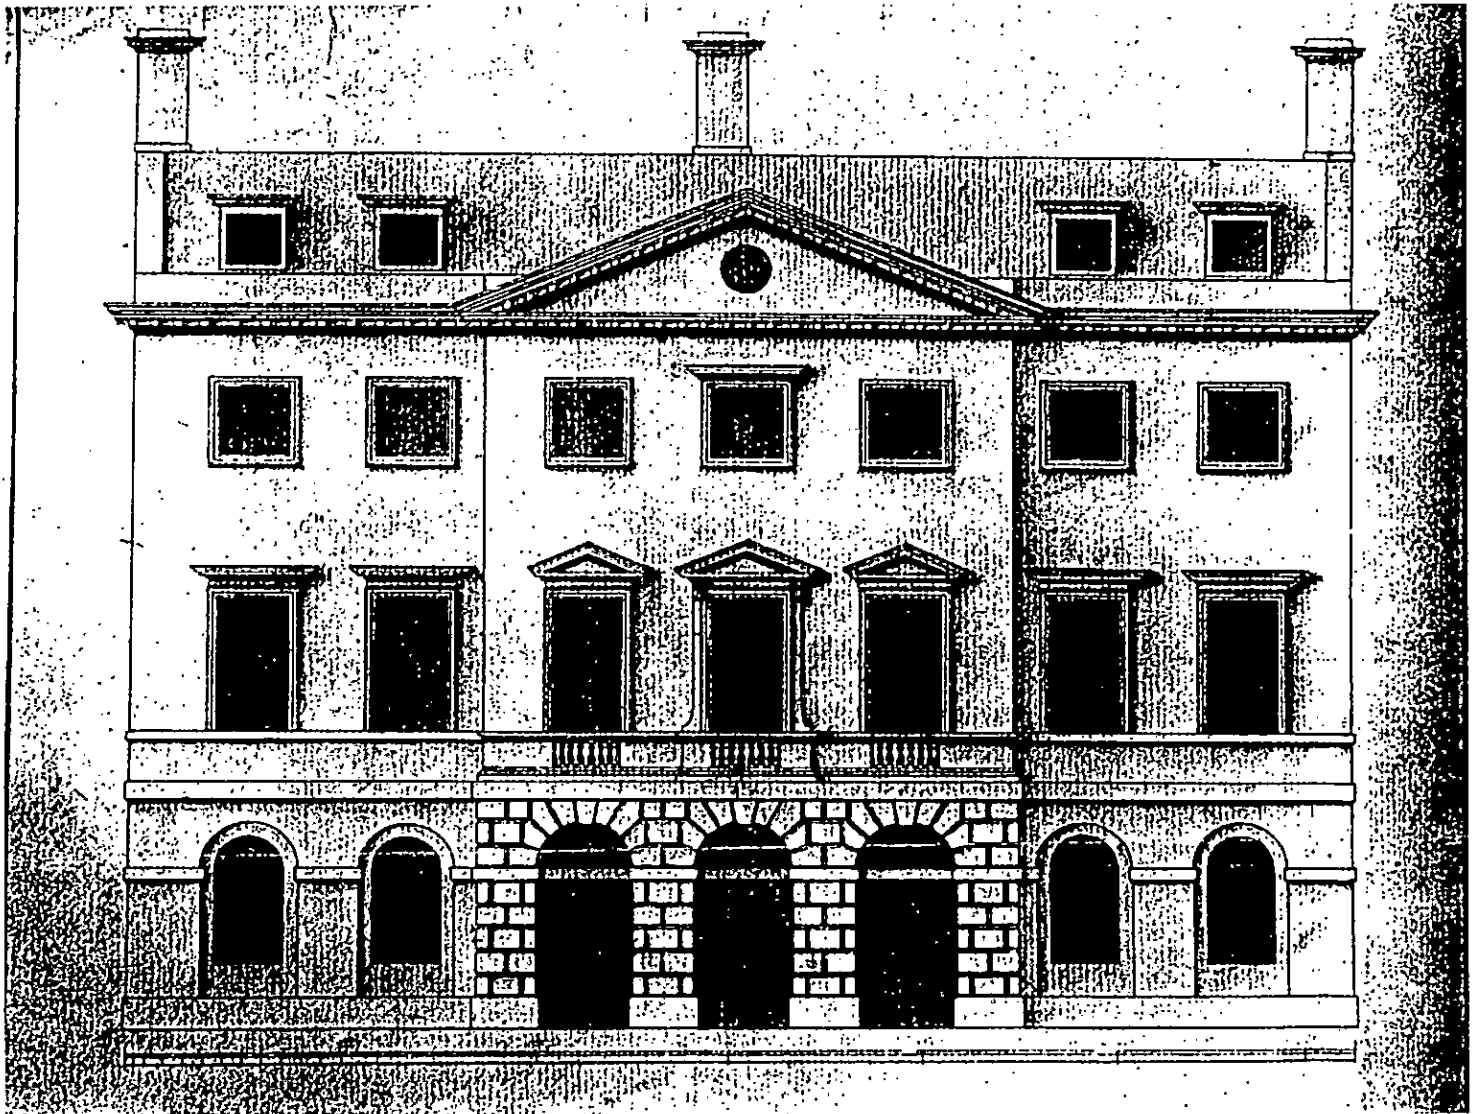
FIG. 1 Drawing of the elevation of Nos. 6-7 Old Palace (described in the text as Nos. 6-7 Abingdon Street) attributed by J. Harris to Isaac Ware. (Avery Architectural library, Columbia University).

The identity of the architect of Nos. 6-7 Old Palace Yard has not been conclusively established. A drawing of the principal elevation exists in an American collection (fig.1) been attributed to Isaac Ware²⁶, the Secretary to the Board of Works, but this attribution has been questioned²⁷. It seems likely that some responsibility for the design would have been taken by the Clerk of Works for the Palace of Westminster. This office was held until June 1754, just prior to the authorisation of the new building, by John Vardy. However, it is not Vardy but Kenton Couse who is mentioned in the surviving works accounts²⁸. However, Couse did not become Clerk of Works for Westminster until 1766. Vardy's successor was William Robinson, and it is possible that he may also have had some role in the construction. The choice of a Palladian style for the building is not surprising, indeed, J. Mordaunt Crook has described the Office of Works as 'in many ways the centre of Palladianism in England' at this time²⁹. There is also a contemporary parallel with William Kent's and John Vardy's grand Horse Guards building on Whitehall, under construction from 1748-1756. Both Robinson and Couse also worked on this building.

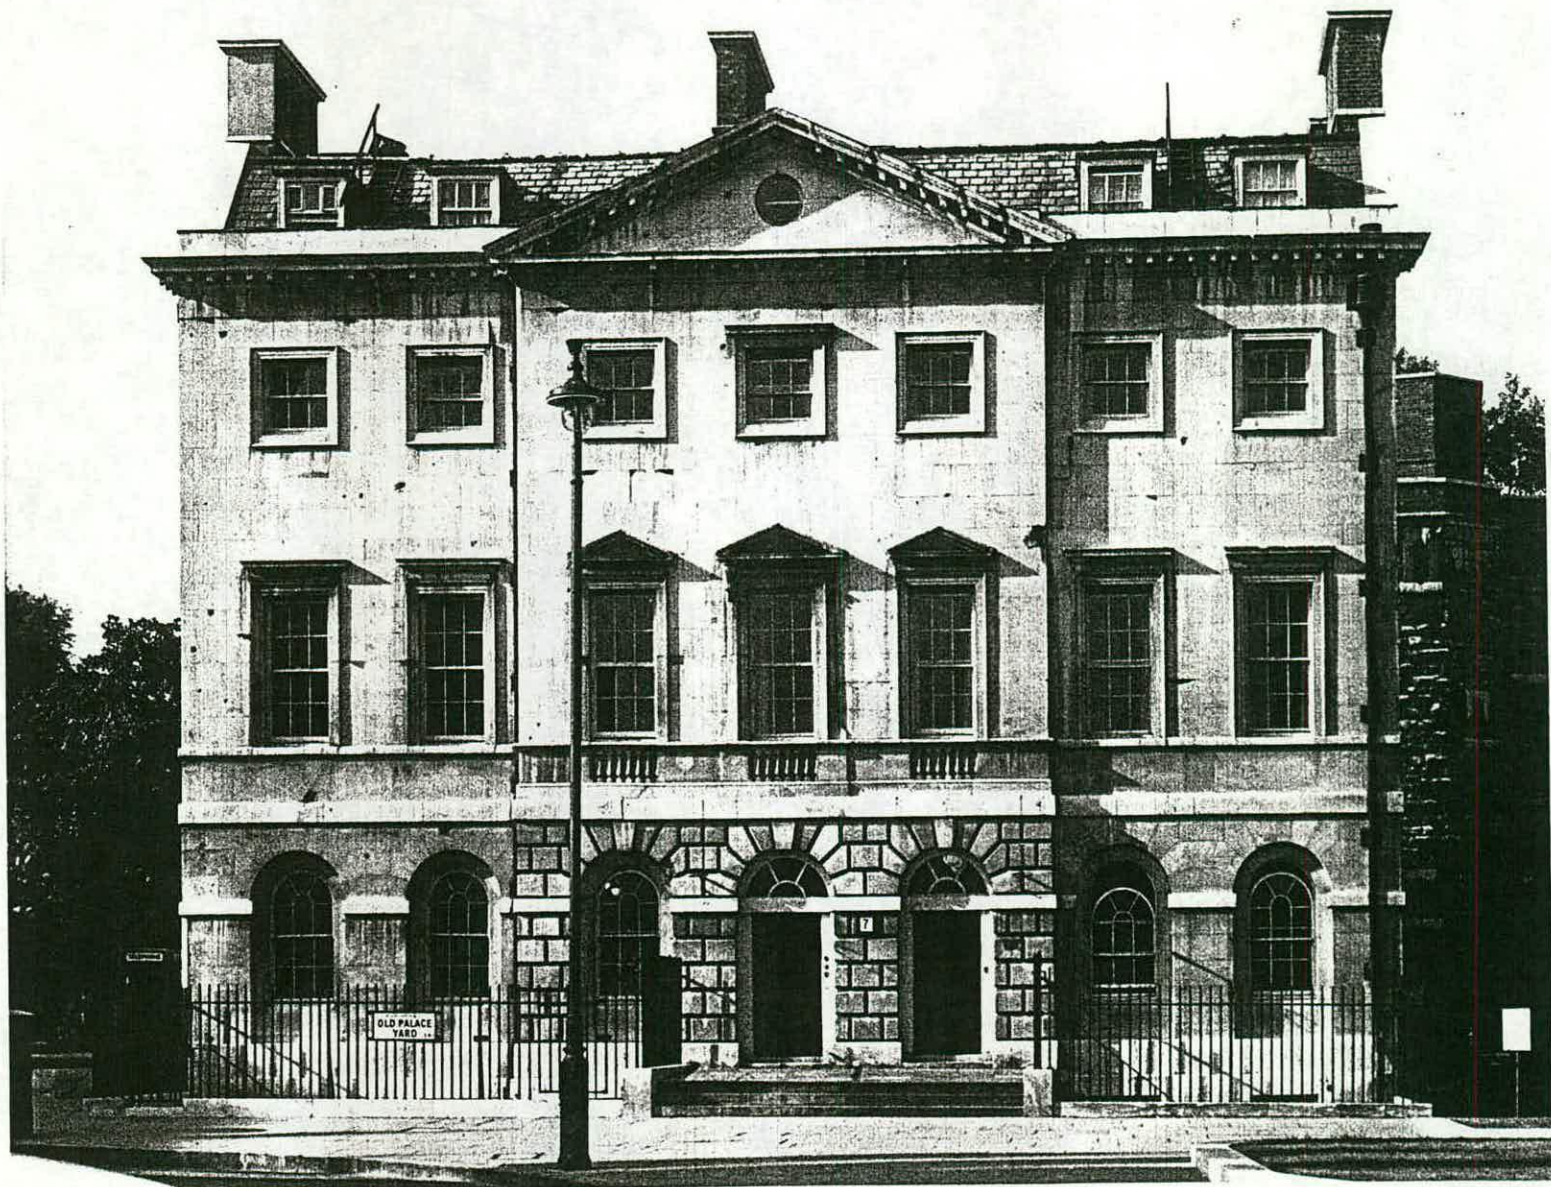
FIG. 2 The north elevation taken 1969, negative number BB69/3347. (RCHME)

At the time of investigation the exterior of the building was scaffolded and could not be fully inspected. The building has three storeys with basements and attics. The principal elevation, an astylar Palladian design, is to the north side and is treated as a unified composition (fig.2). The seven bay Portland stone facade has a three bay pedimented centre break, rusticated to the ground floor with pediments and blind balusters to the first floor windows and an oculus to the pediment. All the openings to the ground floor are set in arched recesses with an impost band. The slate roof has dormer windows with an off centre chimneystack and paired stacks to both gable ends. The basement areas have wrought iron railings, with a forecourt to the paired central doorways. The elevation is not obviously altered. However, a drawing of the elevation possibly of mid 18th century date (fig.1) shows all three bays of the centre break with door openings. Evidence that this may indeed have been the original arrangement exists in the patching of the stonework to the east side of the east-of-centre window opening, probably indicating where the railings would originally have been

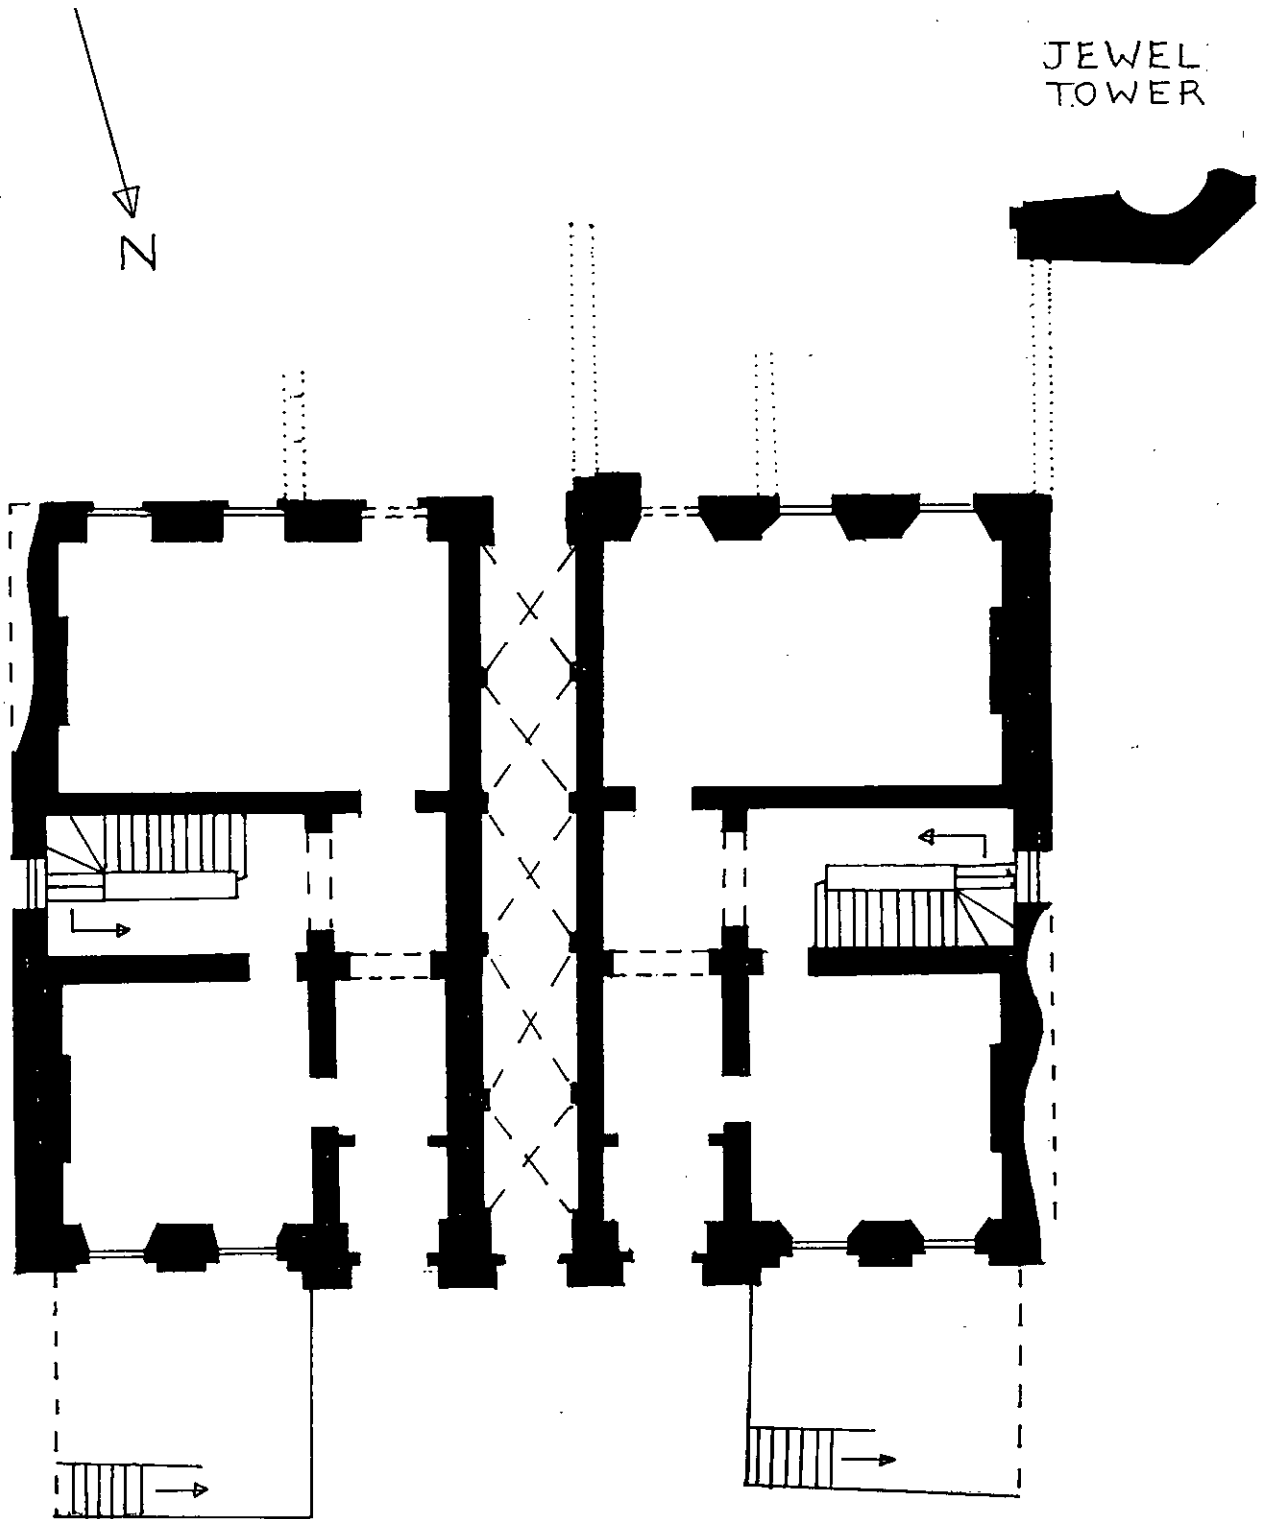
FIG. 4 Conjectural reconstruction of the ground floor plan in 1756. Not to scale.
(RCHME)

The planning of Nos. 6 and 7 Old Palace Yard, excluding the demolished southern range, would appear to have been symmetrically arranged to the ground floor (fig.4) and interlocking to the basement (fig.6) and upper floors. This would seem to indicate that no distinction was made between the Clerk and his Assistant

The planning of the ground floor of the Clerk Assistant's house has had only piecemeal alterations. In the entrance hall the main doorway has been blocked off and a opening made in the east wall in recent years, but the space otherwise appears to be largely as built (fig.4). An 18th century fanlight arch separates the entrance hall from what was probably a vestibule or waiting area. An original six-panel door to the room to the north remains. The fittings of this room also appear to be of mid 18th century. The modest ovolo moulded panelling, box cornice and simple wooden chimneypiece contribute to an air of functionalism that, along with the smallness of the room, suggest that its use has always been as an office. The south room has been refurbished. The decoration scheme of reeded window surrounds, incised cornice and a marble neo-classical chimneypiece is reminiscent of Soane's style and may date from the early 19th century. The stair hall retains its original stair arch which presumably functioned as the boundary between the official and the

The planning of the ground floor of the Clerk's house has been substantially altered (fig.5). As built it was probably identical in layout to the Clerk Assistant's house (fig.4). The phasing of the works to the bay that is now the vaulted entrance hall are particularly complex. However, from the evidence of the original purple stock brickwork, partially revealed during refurbishment, it appears that in the 1750s this bay formed an open-ended vaulted passageway. The existence of struck pointing to the walls, with a band of red brick at the impost level, and rubbed red brick angle arrises to the cross vaults springing from dressed stone impost blocks, suggest that the passage was probably unplastered. It seems likely that the passage, whose purpose would have been to give access to the Parliament Office in the Jewel Tower, was unconnected to either house. Examples of similar vaulted footways are also to be found in the Horse Guards building³¹. The present appearance of the entrance hall, more completely preserved to the northern bays, would appear to date from the 1790s, although the plaster cyma moulded panels at impost level may be an earlier alteration. The 1790s reworking appears to have included the plastering of the vaults, with the addition of plain panelling to the walls and piers and the addition of the paired plaster lion head corbels (originally 16 in total of which 12 survive³³) and the plaster patera. It is probable that Soane himself may have been responsible for the design of the decoration³⁴. The siting of the patera, which depicts the head of Medusa set round with leaves,

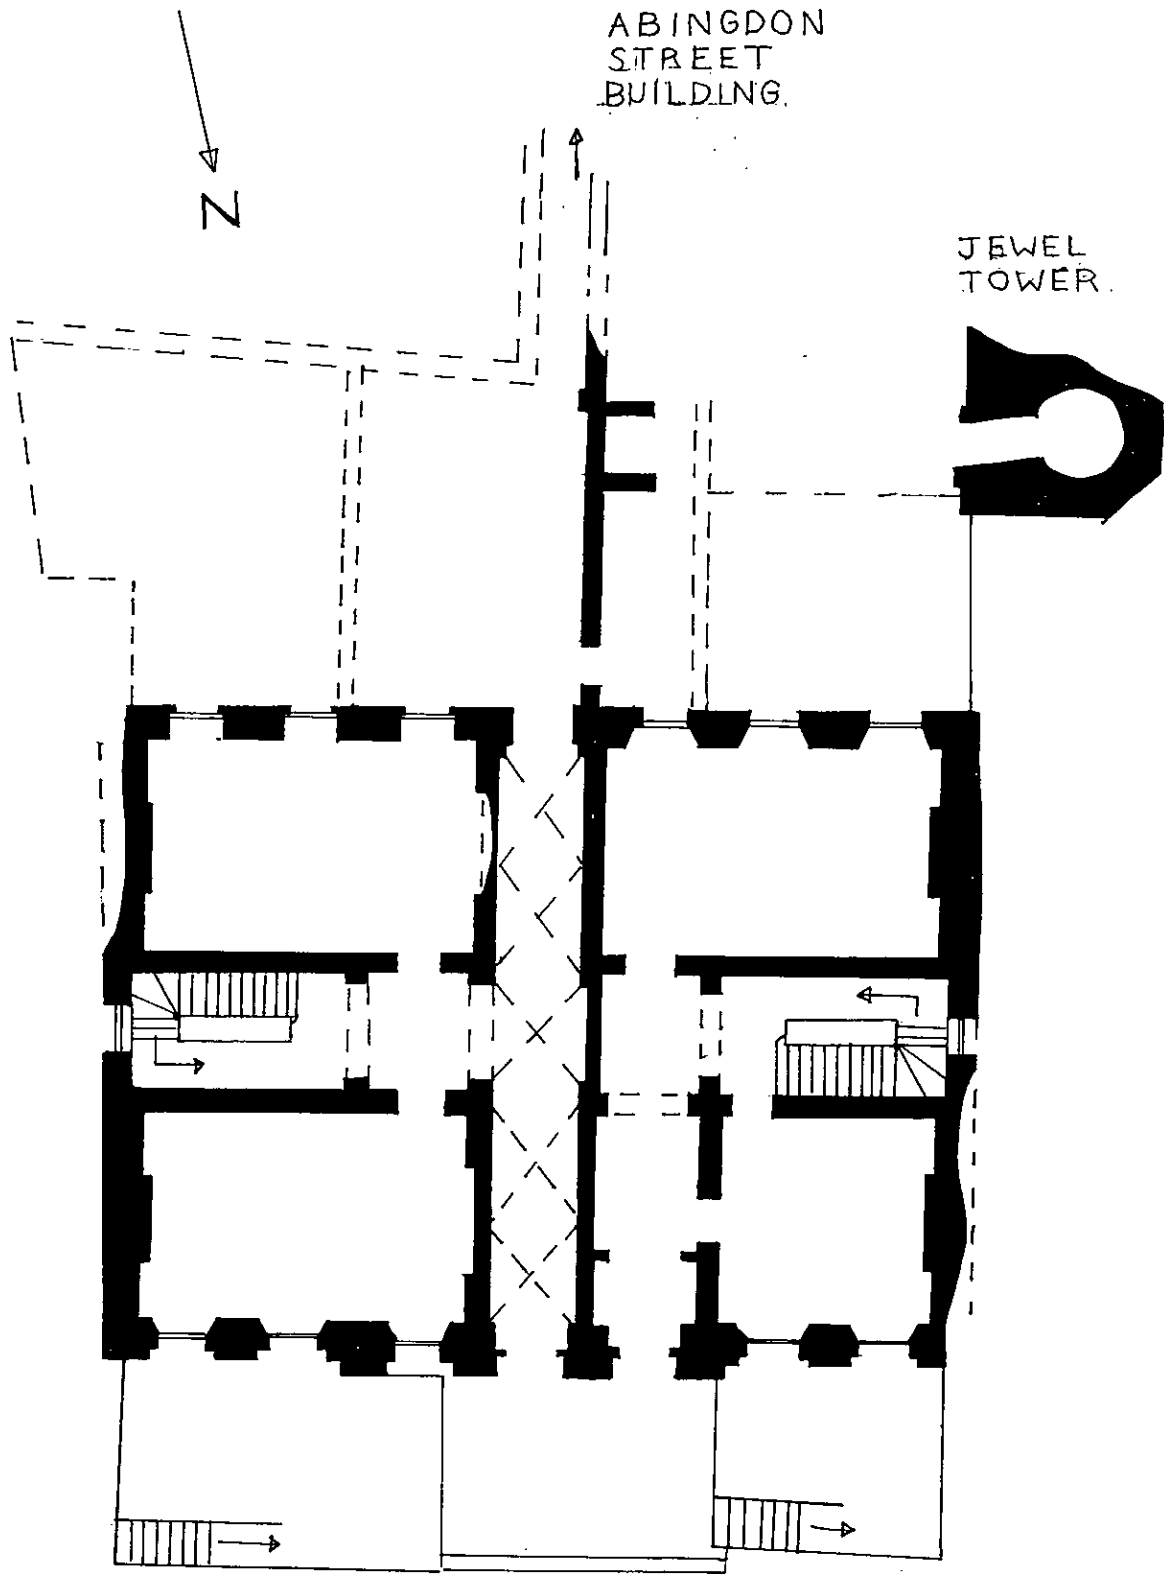
FIG.5-Conjectural reconstruction of the ground floor plan in 1793. Not to scale (RCHME)

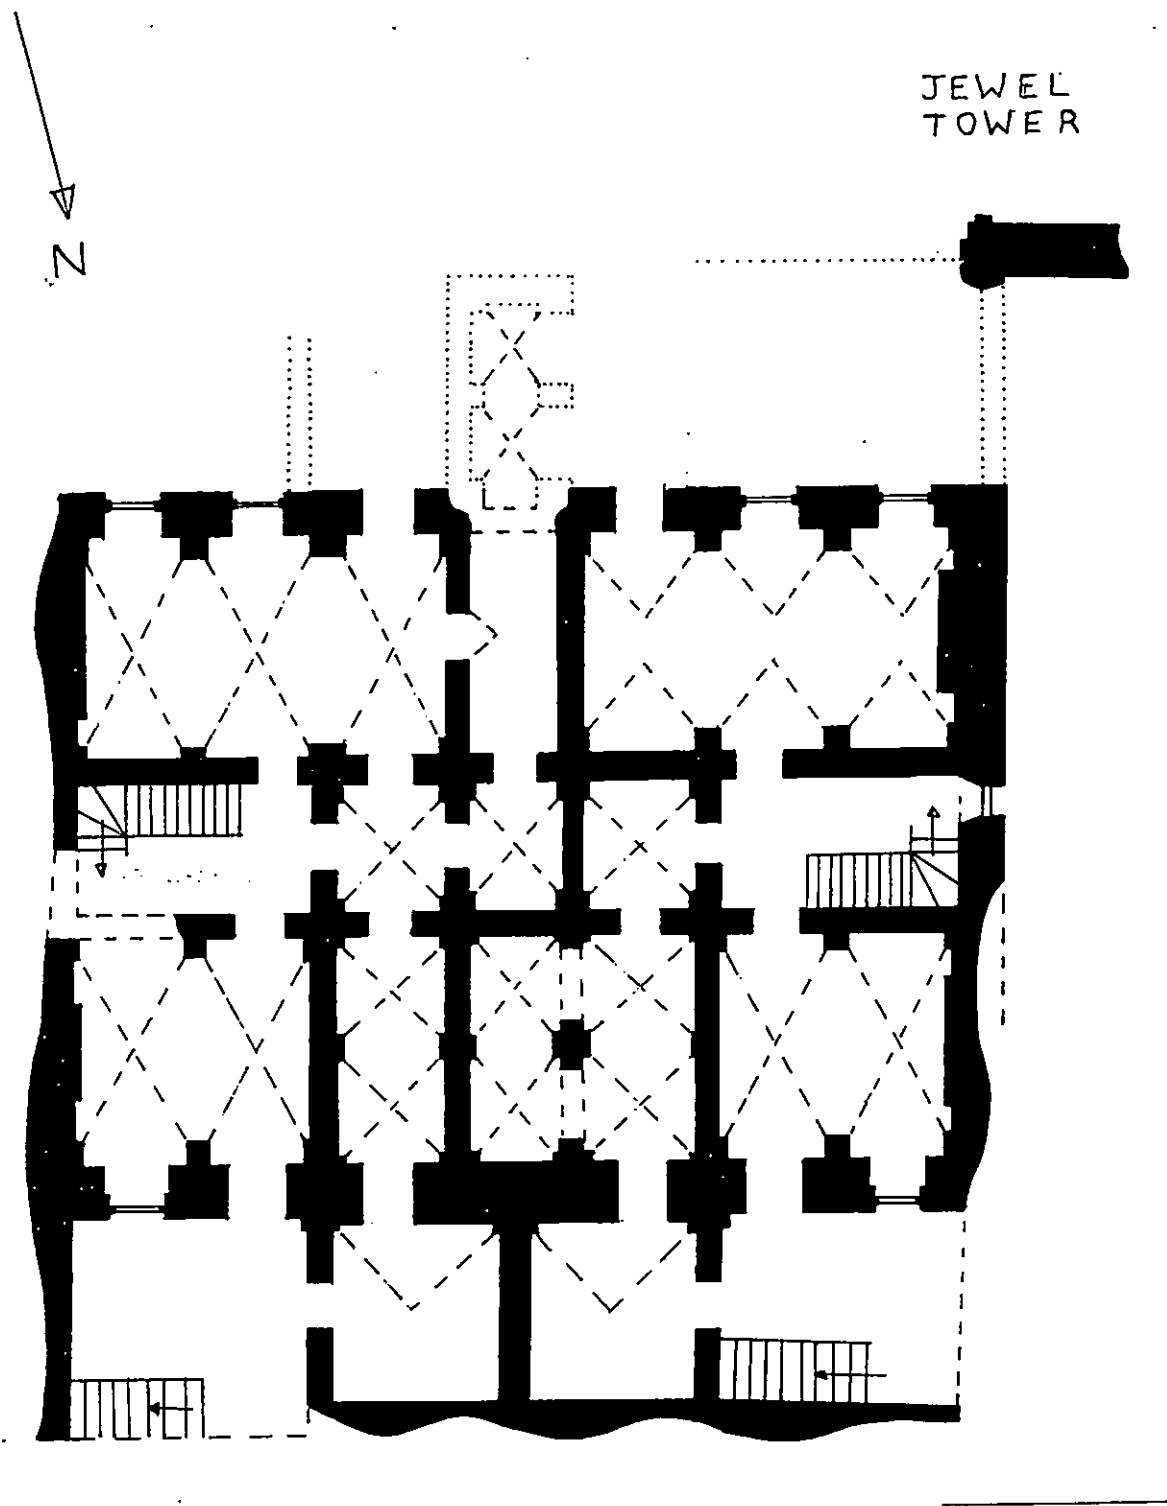
FIG. 6 Conjectural reconstruction of the basement plan in 1756. Not to scale. (RCHME)

in the division of space. This is perhaps a consequence of the strict application of Palladian principles by the architect, at least in the main part of the building and it is possible that additional accommodation for the Clerk was provided in the southern range. Unfortunately, because of the alterations to the basement, ground and first floors of the Clerks house it is impossible to tell if any distinction was made in the fittings and decoration of the two houses. However, one consequence of Soane's alterations to the Clerks house was the introduction of a hierarchical distinction (fig.6).

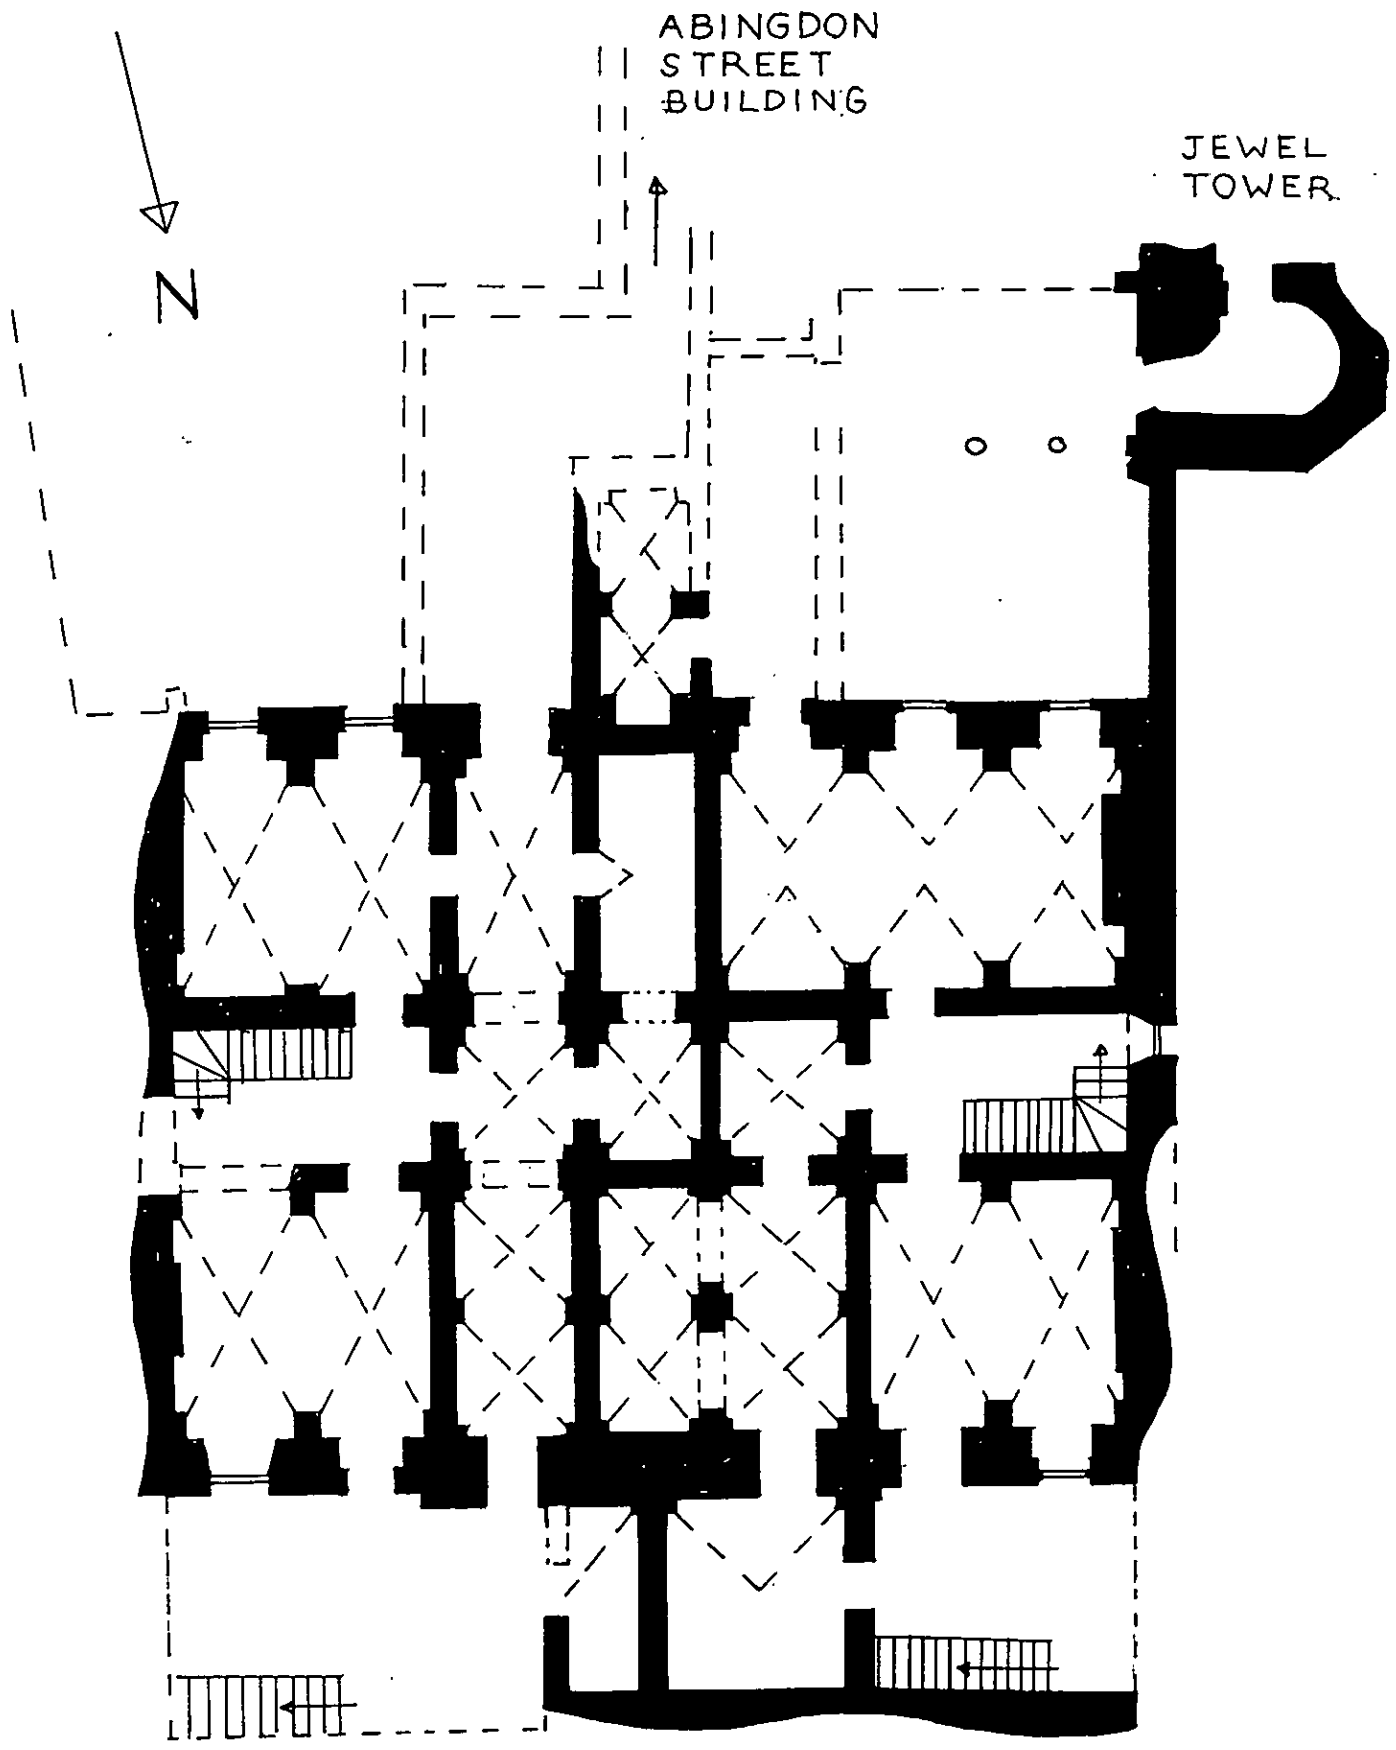
FIG. 7 Conjectural reconstruction of the Basement in 1793. Not to scale. (RCHME)
