Broadbottom, Broadbottom Lane, Hebden Royd, West Yorkshire An Historical and Architectural Survey

Research Report Series 029-2018

**BROADBOTTOM
BROADBOTTOM LANE,
HEBDEN ROYD, WEST YORKSHIRE**

AN HISTORICAL AND ARCHITECTURAL SURVEY

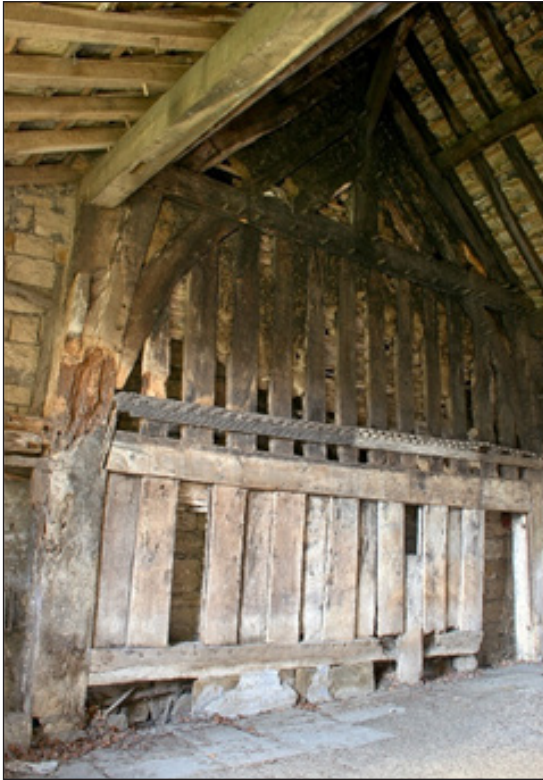
Fig 3 (left): the housebody, view to north west showing truss IIII with plank and muntin screen (© Diane Charlton)

That the outer walls of the housebody were timber-framed is demonstrated by the unhappy way in which the present stone walls relate to the aisle ties of truss IIII. The stone wall at the rear of the house is of c.1800 and its construction may have caused

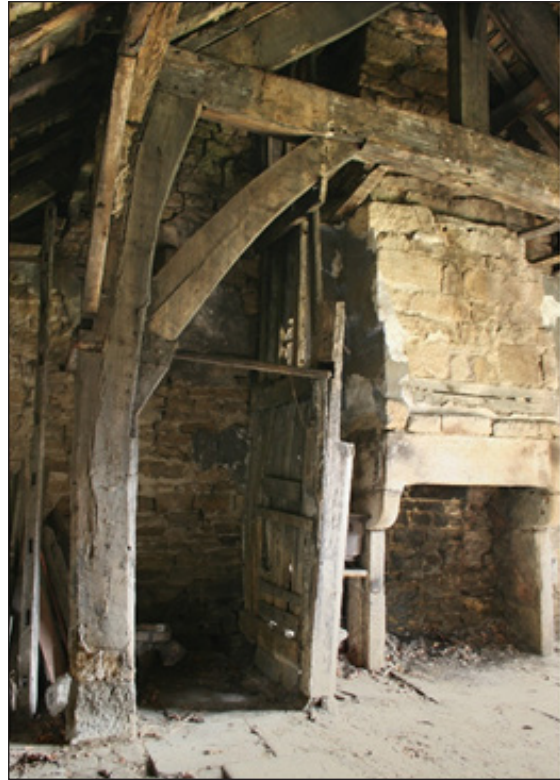
Fig 4 (right): the housebody, view to south east showing open truss III over fire area (© Diane Charlton)

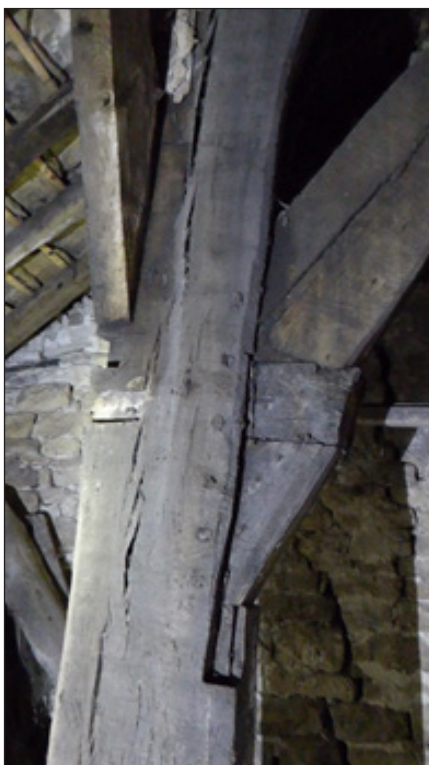
Fig 6: post f, west face, showing pegged joint for brace to tie beam and door lintel (©Historic England. Colum Giles)

The northern arcade post in the open truss (Stell f) has, in its southern face, a long, six-pegged mortice, partly occupied as is conventional by the tenon of a curved brace up to the tie beam. The lower, notched, part of the mortice may have taken the end of a bressumer spanning between the arcade posts (Stell e-f) and forming the support for a timber and plaster firehood over the hearth (Fig 6).³⁵ There is, however, some doubt about this. As a timber of great scantling, a bressumer demanded a strong joint where it was fixed at the ends, and this entailed the use of a long, multi-pegged mortice and tenon joint in the supporting posts. Some local houses show such an arrangement. The six-pegged mortice in the arcade post at Broadbottom (Stell f) was probably largely occupied by the tenon for the brace up to the tie beam: elsewhere in the building, similar braces have four or five pegs securing this joint. If this was the case in post f, there was little room for the tenon of a firehood bressumer of heavy scantling. It might also be noted that the mid rail of truss IIII (analogous, it may be suggested, to a bressumer) is triple-pegged into the post: a bressumer would have demanded the same type of joint. The arrangement suggested by Stell, and still partly in place, is perhaps correct: he proposed that the lower part of the mortice in post f took the tenon of a door lintel fixed at the other end to a short post, the latter providing support for the bressumer to its south. The short post, marked f¹ on the Historic England plan (see Drawing 1), survives and displays in its southern face a long mortice appropriate for the tenon of a bressumer (see Fig 28).³⁶ Although this could represent the original arrangement, it is clear that in its present configuration it results from later alterations, for the short post shows evidence of redundant mortices and, while stop-chamfered at its upper end where it met the bressumer, lacks stop chamfers at its foot. Presumably, the south end of any bressumer would have been supported by the southern arcade post (Stell post e), but this has been removed and the evidence therefore has been lost.

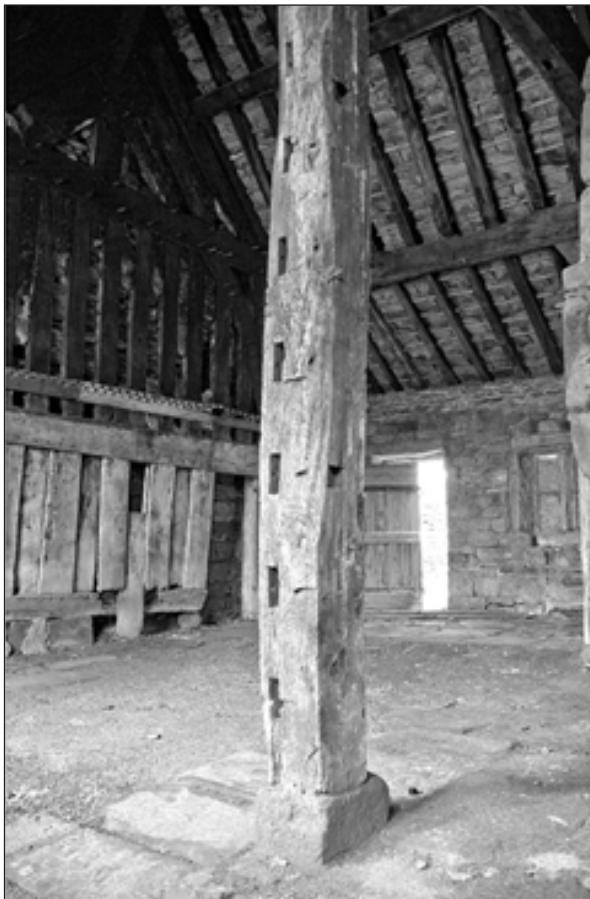
Fig 7 (left): bressumer re-used as support for tie-beam, replacing post e: mortices in upper face for stud wall above and in east face for bearer beams for firehood (© Diane Charlton)

A substantial bressumer has been re-used in the vertical plane to replace the south arcade post (Stell e) of the open truss (Figs 7, 8). The bressumer has shallow rounded mouldings along the upper and lower edges of its good face, a rare example of decoratively worked timber. It has a simple chamfer on its lower outer edge and a very broad chamfer on its inner edge, the conventional form of chamfering for a bressumer. Both chamfers have simple triangular stops at the visible upper end. The original length of this bressumer, and therefore its fit within the aisled structure, cannot be determined, for it was cut to its present size (3.58m) to act as a supporting post and has therefore lost part of its span. It was not subjected to successful dendrochronological testing, which might have provided an indication of whether it might belong to the same phase as the rest of the aisled structure. The presence in the upper face of the bressumer of a series of closely-spaced pegged mortices, clearly for a stud wall rising from the timber, casts doubt on the possibility that the timber could belong to the first phase of the standing building, for there is no evidence in the tie beam of the open truss over the fire area for corresponding mortices to take the upper ends of studs. The tie beam displays, centrally in its soffit, only a single-pegged mortice designed to take a vertical post down to a bressumer (Fig 9).³⁷

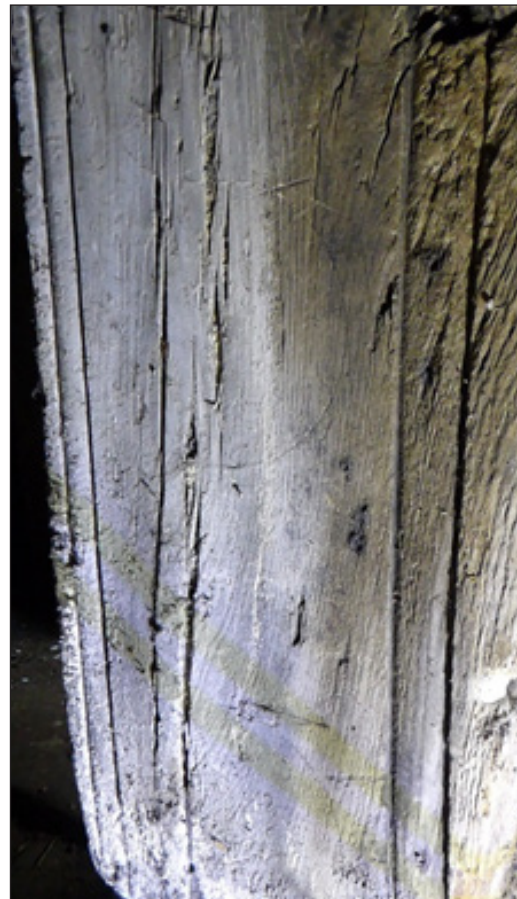
Fig 8 (right): re-used bressumer, west face, showing roll mouldings on upper and lower edges (©Historic England. Colum Giles)

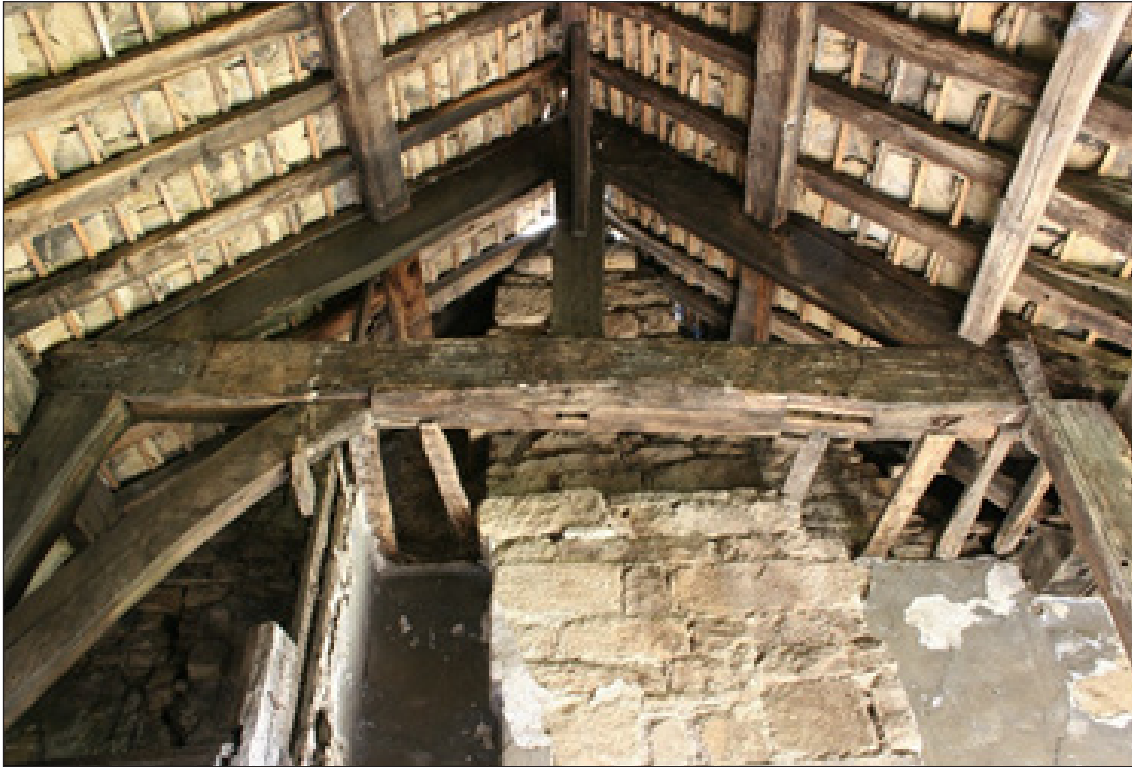
Fig 9: truss III, showing brace from post f, king-post truss and tie beam with mortices in soffit for brace to right and, centrally, for strut formerly down to bressumer (© Diane Charlton)

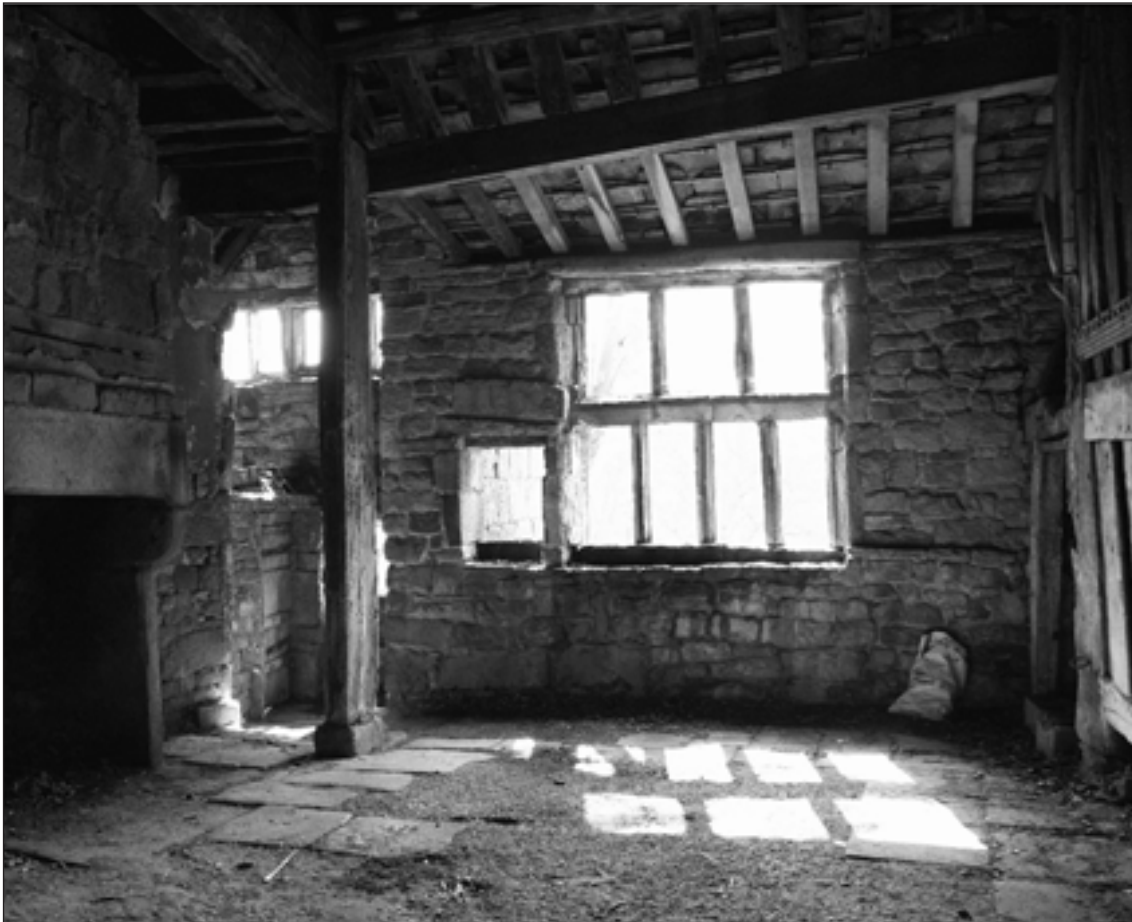
Fig 10: the housebody, view to south into south aisle (© Diane Charlton)

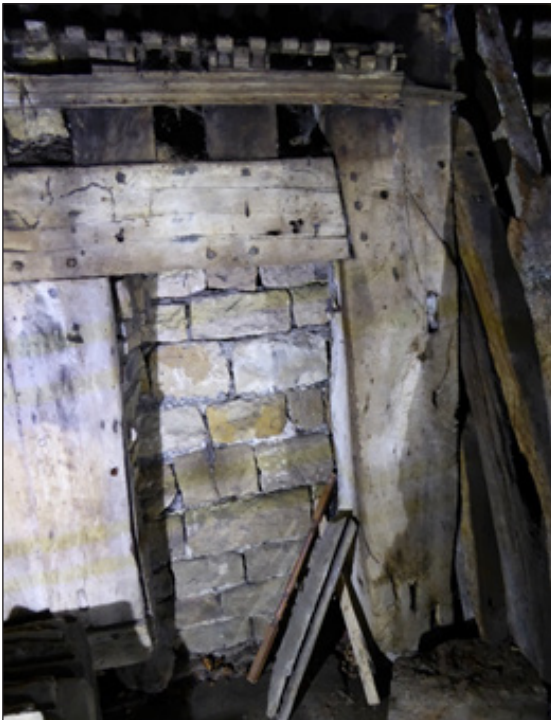
Fig 11: Truss III, post h, showing upper and lower mortices for screen at end of dais (©Historic England. Colum Giles)

First, the lower wall of the closed truss at this end of the room was made up not of close-studding, used above the mid rail and doubtless considered the ordinary method of walling, but, beneath the mid rail, of a plank and muntin screen, a richer and more elaborate form of walling. The planks of the screen are extraordinarily heavy: as noted above, they are each approximately 11³/₄" by 3¹/₂", massively over-specifying what was required and probably intended as a display feature. The sill securing the lower end of the plank and muntin screen is morticed into the arcade post (Stell g) at its southern end but was not morticed into the arcade post (Stell h) at its northern end (*see* Fig 11: Stell's section drawing shows the sill pegged to the post, but clearly this was not the case.). Although unusual, this arrangement must be accepted as original. It is likely that a dais bench was set against this wall, but there are no visible signs of the method of fixing it. There is, however, evidence for a screen at the north end of the seating area, for the arcade post (Stell h) has, in its east face, two unpegged mortices securing the top and bottom of a timber end to the dais area (Fig 11).

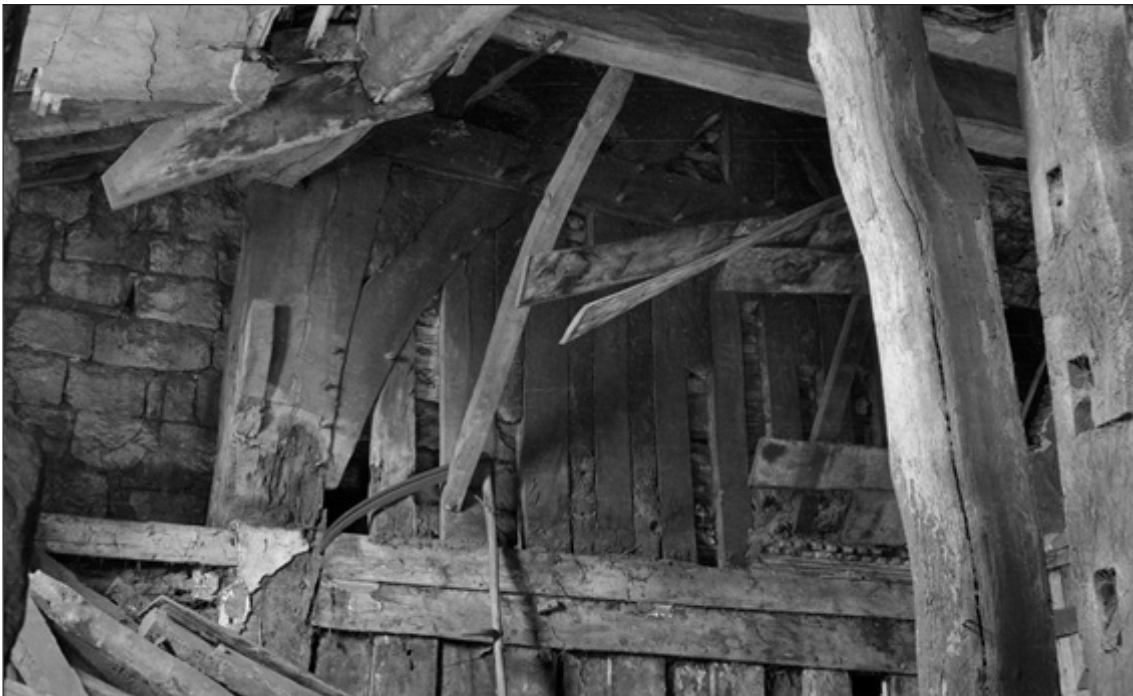
Fig 12: remains of the dais canopy, c.1956-7, photographed by Christopher Stell. Much of the plank boarding had been removed, but the head beam and some ribs remained, the latter pegged to the studs of truss IIII (©John Stell: Historic England Archive, STE01/01/005/04 (RB Card: 6672/35))

The evidence for the canopy at Broadbottom lies not only in Stell's photographic record but also in two features in the surviving building. First, the seating for the canopy head beam is evident in the presence of a lap dovetail joint in the upper face of the northern arcade plate, approximately 5 feet (1.5m) from truss IIII. A beam spanning the housebody in this position could have had no other function than to support the upper end of the canopy. Second, there remain fixed to truss IIII above the mid rail two lengths of timber ornamented with mouldings and brattishing (a sort of dentillation) (Figs 13, 14). Highly unusual, if not unique in West Yorkshire, one at least of these timbers appears to have acted as the support for the ribs of the canopy, or at least to mark its lower end. Stell's section drawing records the position of the longer of the two timbers, that fixed to the northern part of the truss, and his photographic record shows the ribs rising from above the brattished rail, with pegs securing the lower end of the ribs to the stud wall. Horizontal boarding below the brattished rail provided a neat finish to the canopy above the truss's mid rail.

Also of interest in revealing an earlier phase of restoration is the renewal of the arcade structure in the south aisle. Stell's c.1956-7 photograph (Fig 12) shows that the raising of the roof line of the south aisle in c.1600 had led over time to structural failure of the principal timbers: a poorly finished arcade post had replaced the original post (Stell post e), and an arcade plate, again poorly finished, had been inserted to replace the original timber. The arcade plate was not supported by a brace from the post (Stell post g), the stub of the brace being visible in the photograph. The date of this phase of repair is not known, but the rough nature of the timbers suggest that it was carried out when the house had been tenemented. The existing structure shows a desire to replicate the original form of the arcade in much better finished timbers. In this phase of repair, the crudely-finished substitute for post e was removed, and a new arcade plate, of square sawn timber, was inserted, complete with mortices to take braces up from the arcade posts. This restoration was never completed, no new post e having been inserted and no braces added to support the arcade plate. This phase of work post-dates Stell's record of the building, and must therefore belong to an unidentified period in the second half of the 20th century.

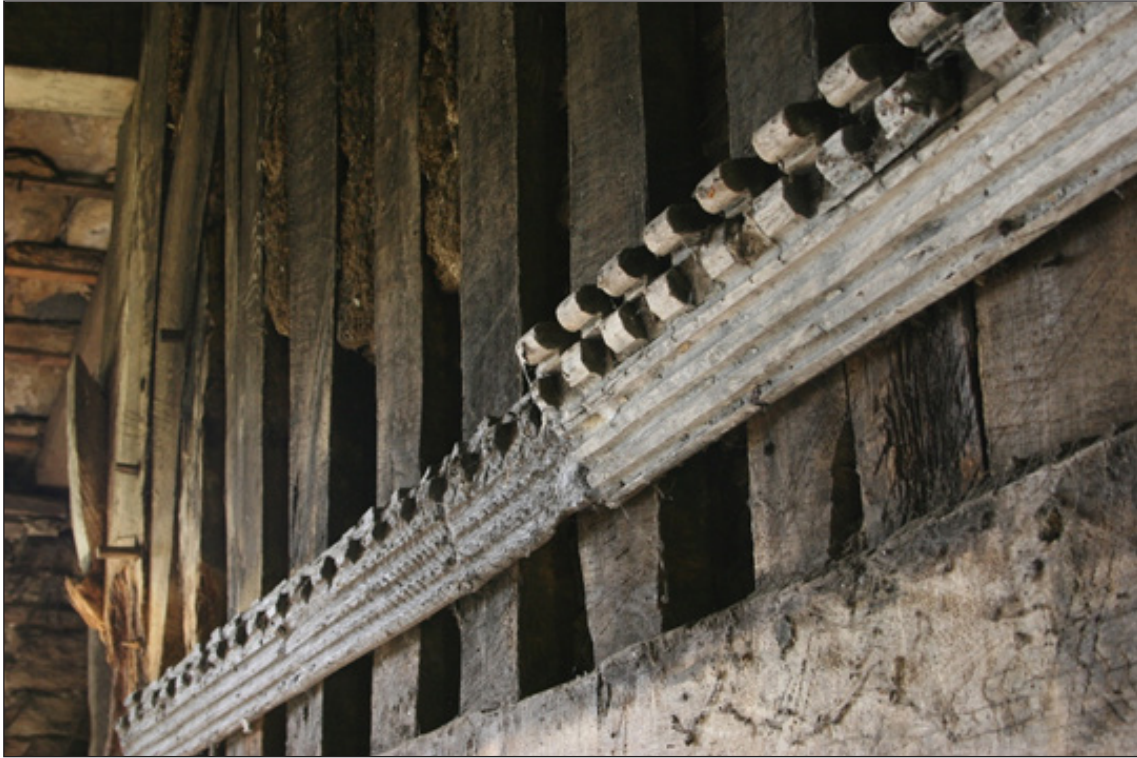
Fig 13: brattished rail fixed to truss IIII above mid rail (© Diane Charlton)

It is not certain that the brattished rail recorded by Stell, and still in place, is in its original position, for its northern end is not finished neatly, terminating in a crude cut. However, this may simply be the result of a brutal alteration to the canopy area, some cutting away being necessary for some unknown purpose. Oral evidence attests that some decades ago the shorter timber (that on the southern part of the truss) was discovered acting as a fence post and subsequently removed and fixed in its present position. It should be noted that the two brattished rails are today very different in character, but this might be the result of the shorter timber's prolonged exposure to the elements and secondary use as a fence post. The three hollow-round mouldings on the two parts of the brattished rail are similar or identical in profile, and the lack of matching dentillation could result, in the southern timber, from erosion, decay or trimming for a new purpose.

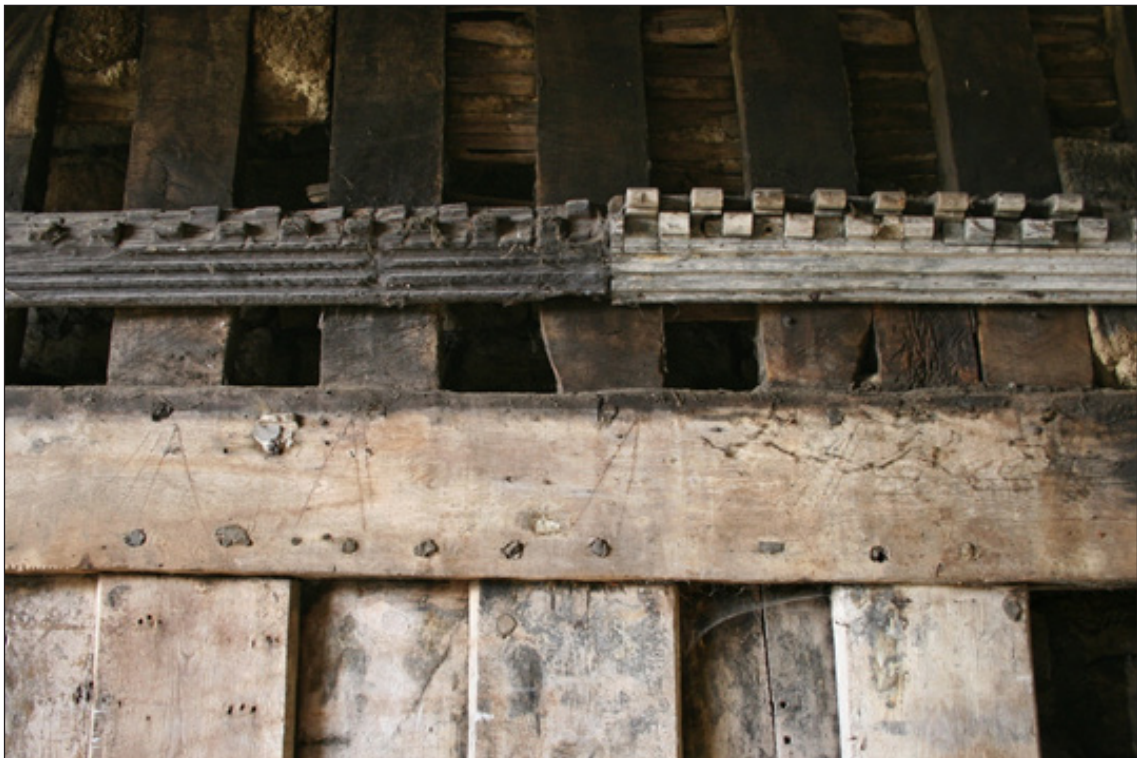
Fig 14: brattished rail, junction of timber: note the carpenters' numbering of the joints (© Diane Charlton)

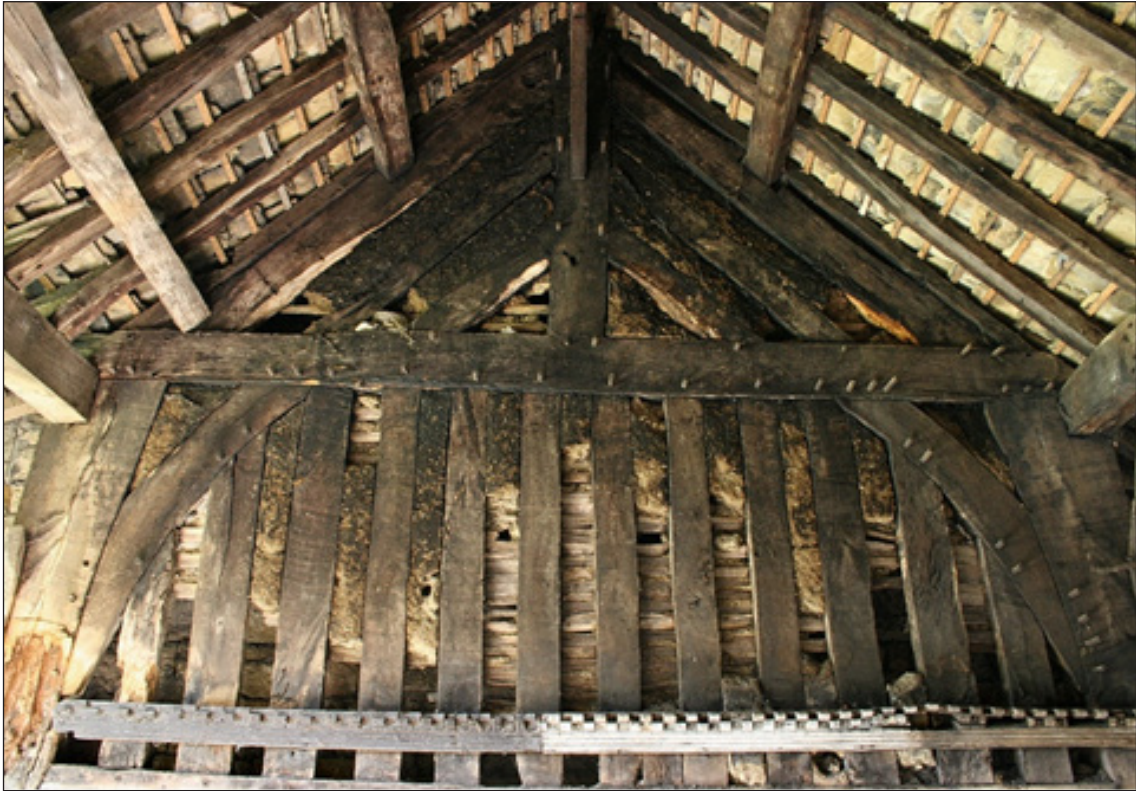
Fig 15: truss IIII, upper walling showing projecting pegs (© Diane Charlton)

The existence of a dais canopy at Broadbottom is demonstrated by two further features, both found in the truss IIII. First, the timbers and infill of the upper walling, above, that is, the plank and muntin screen and mid rail, are very dirty, more so than timbers elsewhere. This is likely to have been the result of having been inaccessible for centuries, lying behind the canopy where dust and dirt could accumulate. Furthermore, there is a clear difference in the treatment of the pegged joints in the upper part of the truss. While elsewhere in the building pegs were mostly trimmed off flush with the surface of the timbers, here the pegs are left projecting very markedly, some as much as 12 centimetres (Fig 15). This again is explained by the fact that this walling would not have been visible, for it was obscured by the canopy. A decision was clearly taken not to finish the carpentry in this area to the same standard as in more visible parts of the timber structure.

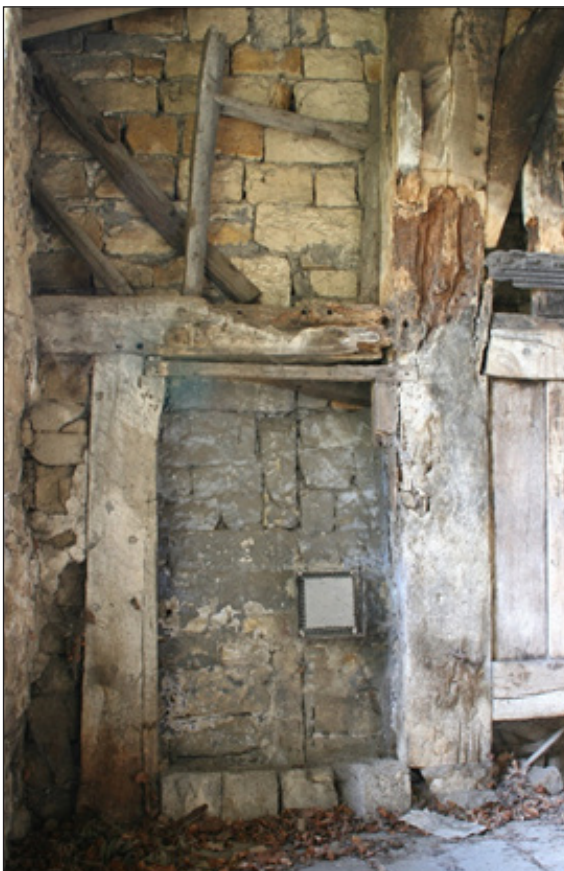
Fig 16: truss IIII, south aisle, showing aisle tie and doorpost for door to west: above the aisle tie are parts of the timber window recorded by Stell (© Diane Charlton)

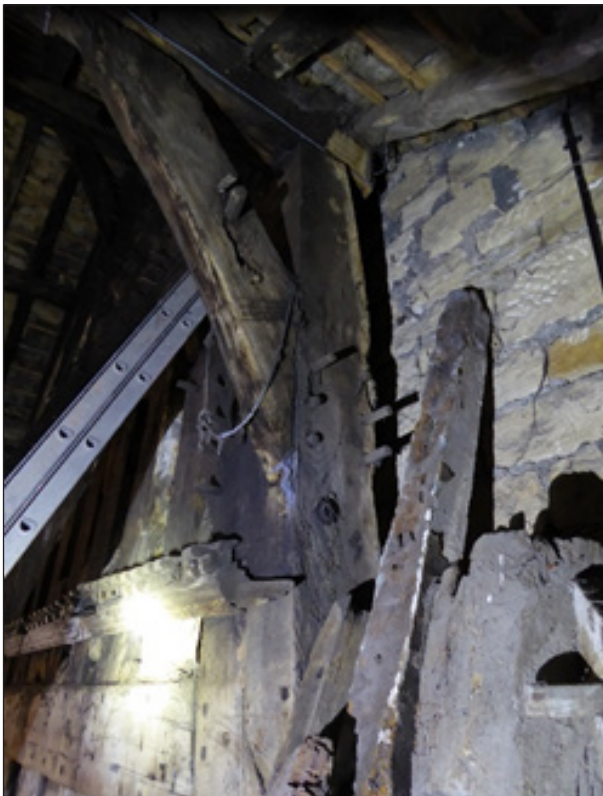
Fig 17: truss IIII, post h from north, showing brace up to arcade plate to east and pegged joint for similar brace (no longer in place) to west (©Historic England. Colum Giles)

It is certain that the 1464 building continued in some form to the west beyond the housebody, in the area now occupied by the 1844 dwelling. The evidence of connecting doorways has already been noted, and it is clear that truss IIII was an internal truss, the best face of the timbers being presented to the housebody rather than to the west. The precise form of any structure to the west is, however, unclear. It is likely that it was aisled on the north side, for the arcade post of truss IIII (Stell h) shows a long pegged mortice for a brace up to a western continuation of the arcade plate (Fig 17).

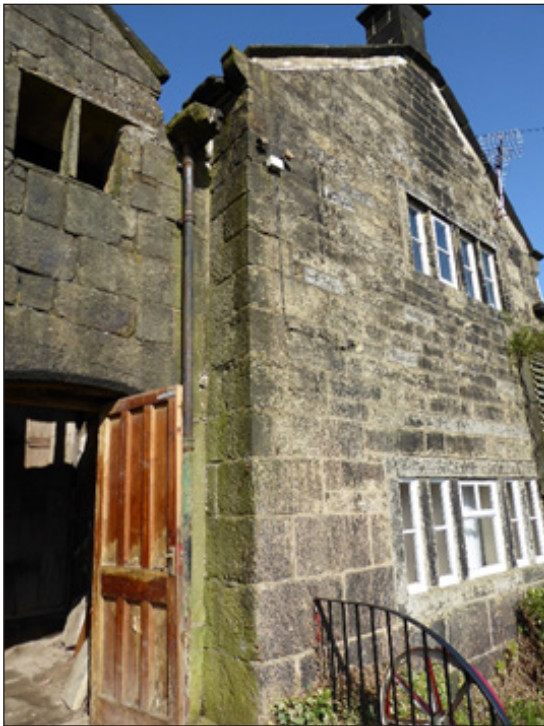
Fig 18 (left): east wing at junction with porch, showing first phase of deep-coursed masonry (©Historic England. Colum Giles)

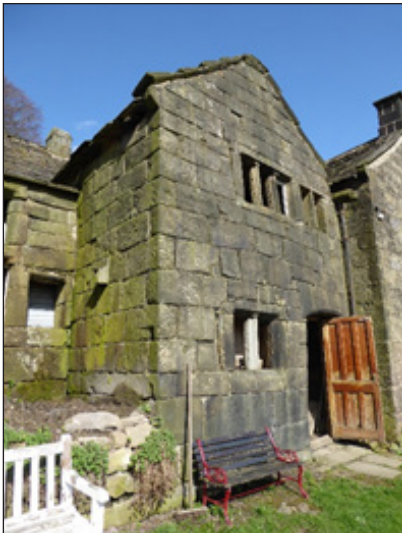
Fig 21 (left): porch, with deep-coursed masonry (©Historic England. Colum Giles)

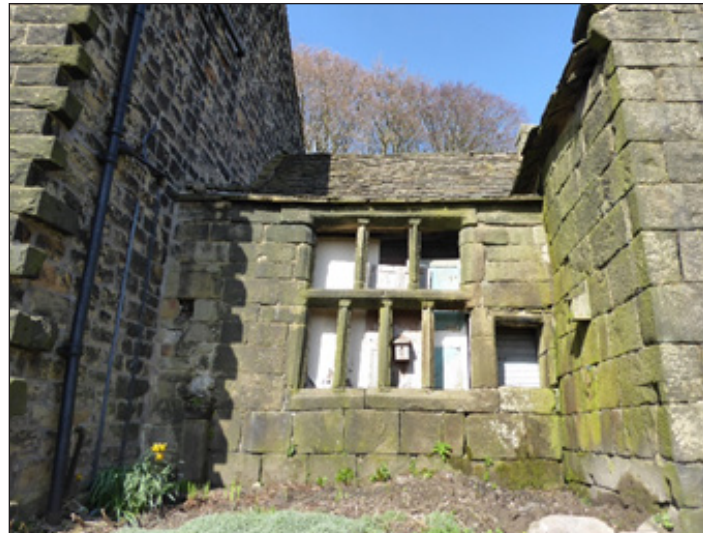
Fig 22 (right): housebody south wall, with mullioned and transomed window of three over four lights (©Historic England. Colum Giles)

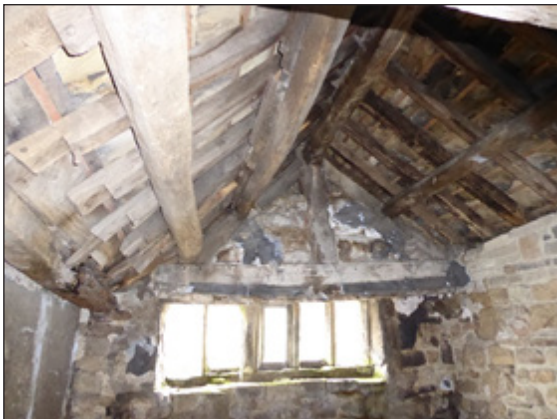
Fig 23 (left): porch first floor, view to south showing king-post truss in south wall: note tie beam shorter than width of porch (©Historic England. Colum Giles)

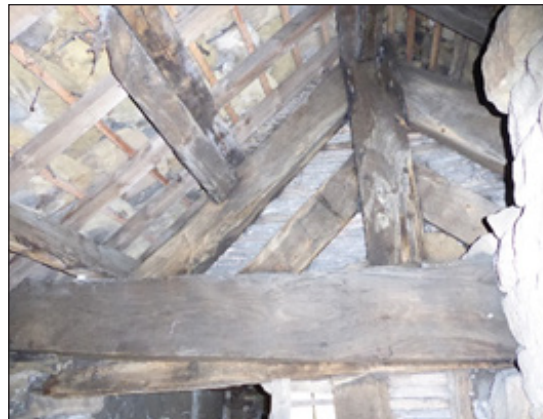
Fig 24 (right): porch first floor, king-post truss on line of southern arcade plate (©Historic England. Colum Giles)

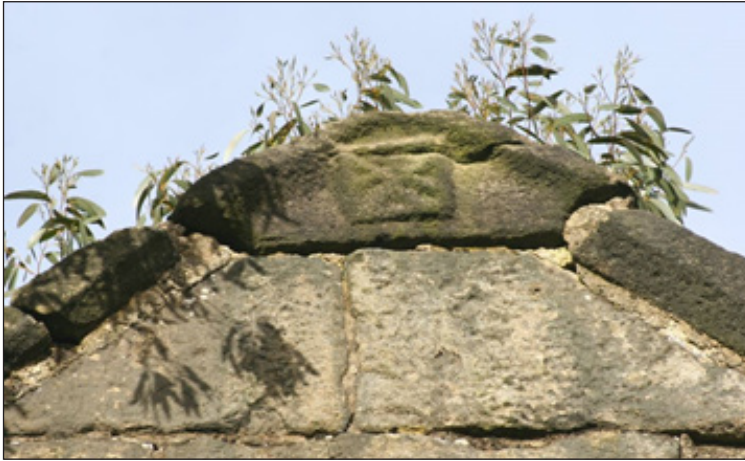
Fig 25 (left): decorative coping stone in porch gable (© Diane Charlton)

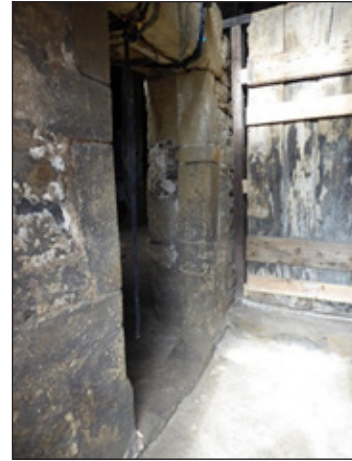
Fig 26 (right): lobby, view to north showing doorway to housebody (©Historic England. Colum Giles)

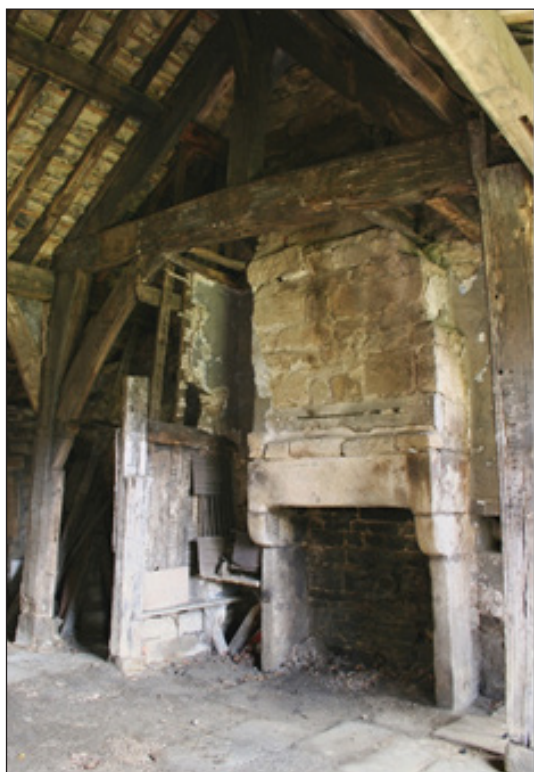
Fig 27 (left): housebody fire area, showing short post f¹, heck screen and bench and fireplace (© Diane Charlton)

For reasons that are not clear, changes were made to the heating arrangements in the housebody (Fig 27). These later arrangements are represented by the short post at f¹ on plan and by the attached heck screen (Fig 28). The lack of stop chamfers at the foot of the post, and the presence of a redundant pegged mortice towards its top, together demonstrate that the post is re-used in its present position and for its purpose. It may, however, belong to the late-medieval building, adapted for a later configuration, perhaps in the 17th century. It rises to a height of over 2.5m, but is crudely terminated at this height. It is stop-chamfered on its southern edges against a notch, at head height, for a long mortice, formerly, it can be suggested, housing the tenon of a very heavy bressumer running south from the post and defining the fire area, possibly, but not certainly, the bressumer re-used as a prop to replace post e.⁴⁵

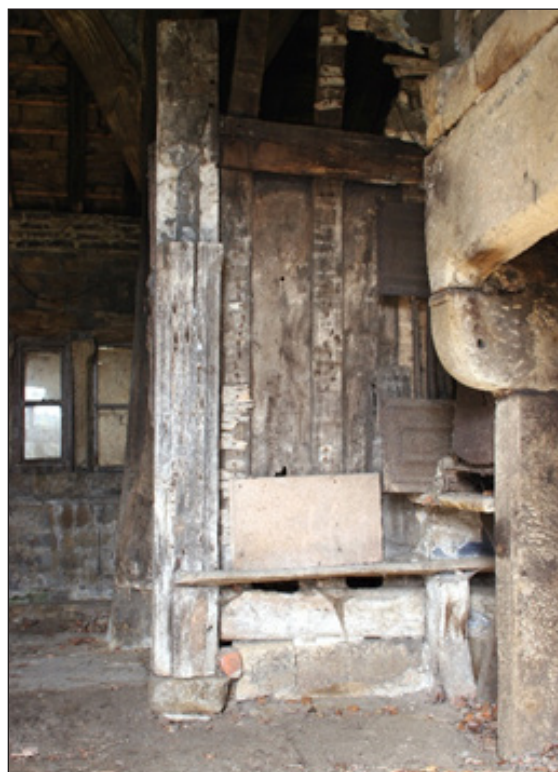
Fig 28 (right): housebody fire area; short post f¹ and heck screen and bench: the long mortice for the end of a bressumer is just discernible in the upper part of post f¹ (© Diane Charlton)

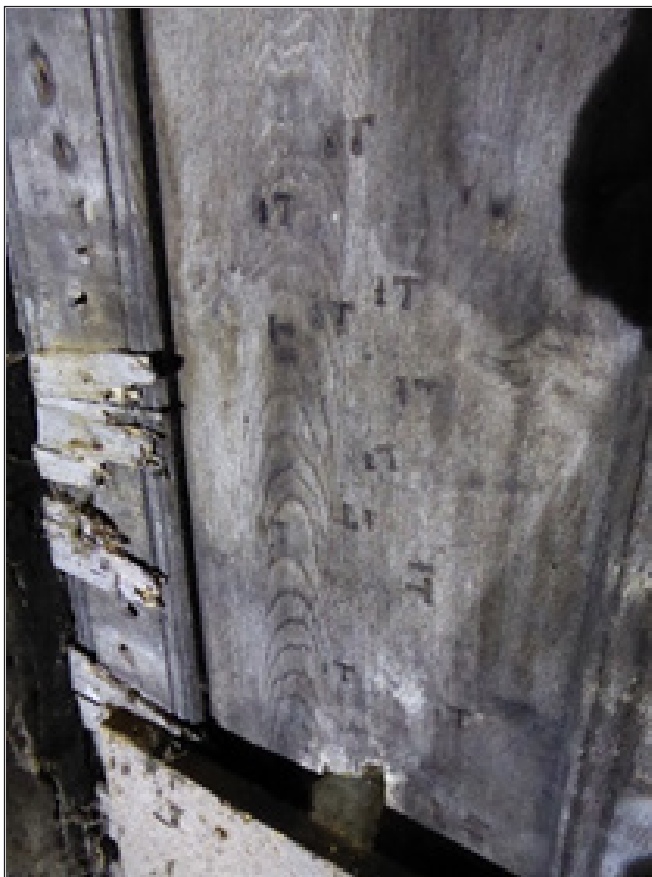
Fig 29: carved initials 'IT' on plank of heck screen, with shallow roll mouldings to studs (©Historic England. Colum Giles)

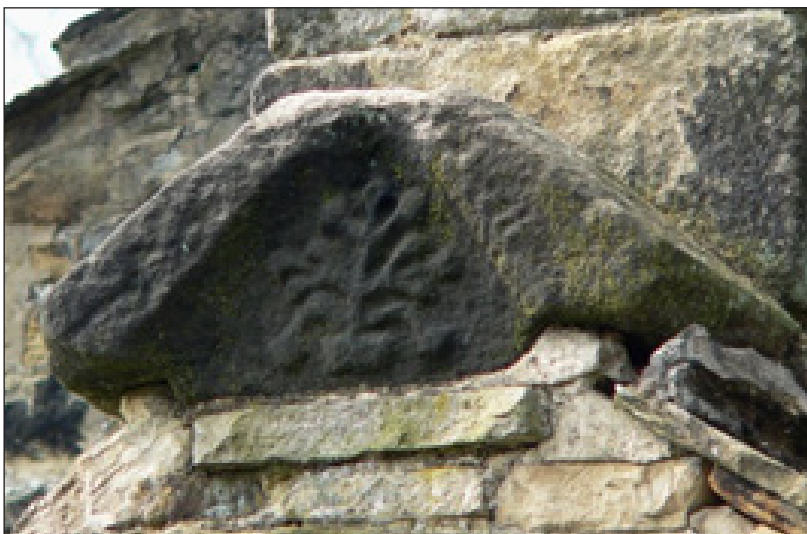
Fig 30: decorative floral carved coping stone (© Diane Charlton)

The east end of the roof over the housebody has, visible from the rear, a coping stone at the gable apex, immediately adjacent to and associated with the housebody chimney stack. The stone is carved with a decorative motif, perhaps floral (Fig 30). This matches the similar treatment of the coping at the apex of the porch on the south front (see Fig 25). Both are unusual features. Stell's 1956-7 photograph of the rear of the house shows, however, that the external part of the housebody chimney stack did not exist at that date. Neither does the photography show the associated decorative carved stone: although of some antiquity, this must have been put in place in the second half of the 20th century, perhaps brought from another house.

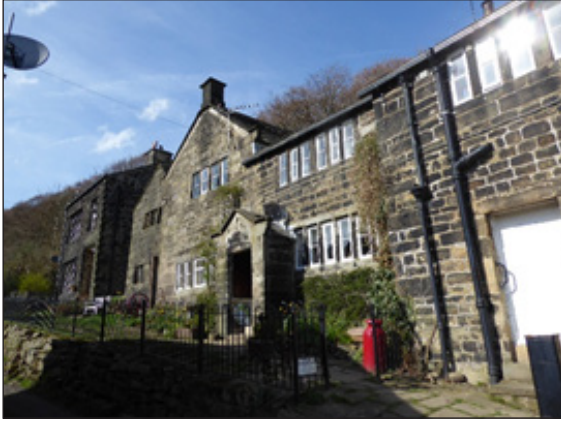
Fig 31 (left): east wing and extension, from south east (©Historic England. Colum Giles)

The east end of the medieval house, first remodelled in the late-16th or early-17th century, was largely taken down and rebuilt c.1800 (Figs 31, 32). On the south wall the lower courses of the earlier (c.1600) wing were retained but new walling was provided above. The wing has its own independent entrance, within a small porch on the south wall. The features of the building on the south front appear to date from the early-19th century: the masonry is watershot, and the windows have square mullions flush with the wall face on ground and first floors, although the eastern window on the ground floor has chamfered flush mullions. At the rear of the cottage, the wing evidenced by the mid-20th century photograph cited above (*see* Fig 20) was altered to provide new windows and a doorway. To the east of this now removed wing, the rear wall of the building is less well finished in the quality of its masonry. Its alignment demonstrates that by c.1800, if not before, the rear aisle of the lower end of the medieval house had been removed.

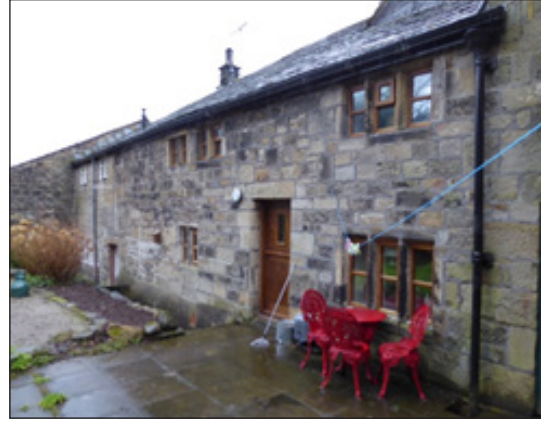
Fig 32 (right): east wing and extension, from north west (©Historic England. Colum Giles)

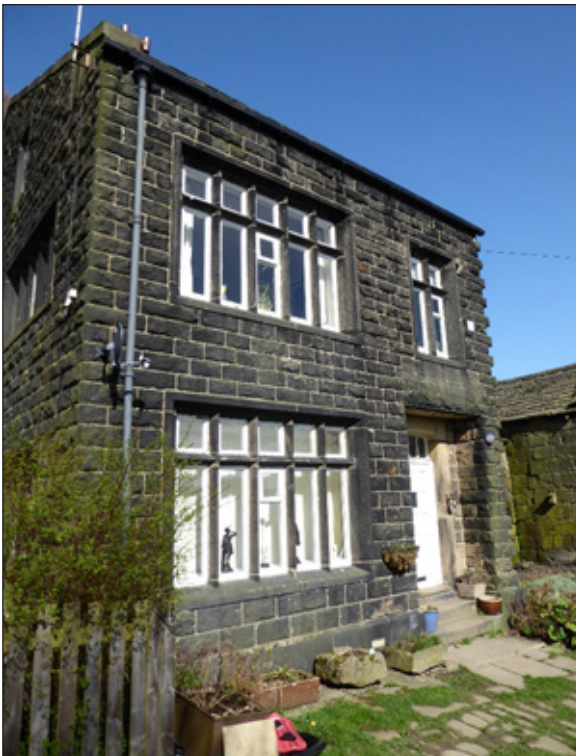
Fig 33: the 1844 house to west of housebody (©Historic England. Colum Giles)

The west end of the medieval house, to the west of the housebody, was replaced in 1844 by a substantial independent dwelling of two tall storeys, dated by a stone on the west gable (Fig 33). It is constructed in rock-faced masonry and has large mullioned and transomed windows. The dwelling clearly formed part of a larger scheme intended to replace the medieval house to its east, for at both south-east and north-east corners the masonry is toothed in preparation for bonding in to a subsequent construction campaign, which never happened. Blocked or blind openings in the gable wall of the 1844 build, above the roof of the medieval housebody, demonstrate the intended connection between the new block and its proposed extension.

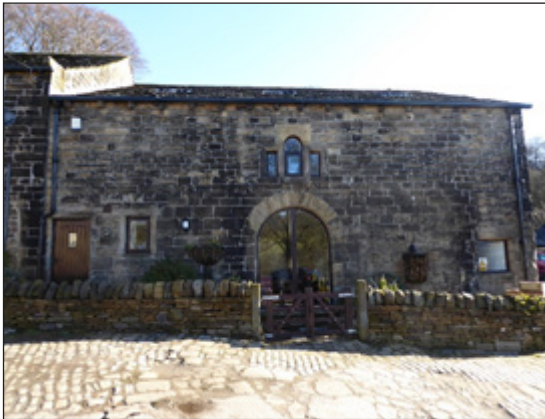
Fig 34 (left): the eastern laithe, rebuilt 1897 (©Historic England. Colum Giles)

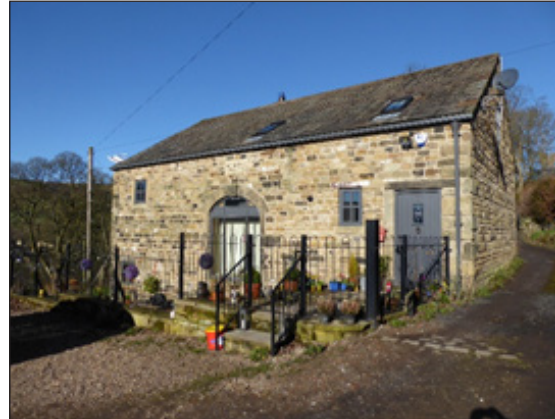
Fig 35 (right): the detached laithe, rebuilt 1788 (©Historic England. Colum Giles)

Detached to the south of the main range is a second laithe, bearing a datestone reading 'Rebuilt 1788 Again 2008' (Fig 35). Although re-using some earlier features, rebuilding here was more thoroughgoing than in the case of the 1897 laithe, although again the plan appears to have provided a central cart entrance and mistals at the ends of the building.
