DERWENTCOTE, CO DURHAM
ARCHAEOLOGICAL SURVEY REPORT

NZ 131 565
(centred)

DERWENTCOTE
DERWENTSIDE DISTRICT

CONSETT PARISH
CO DURHAM

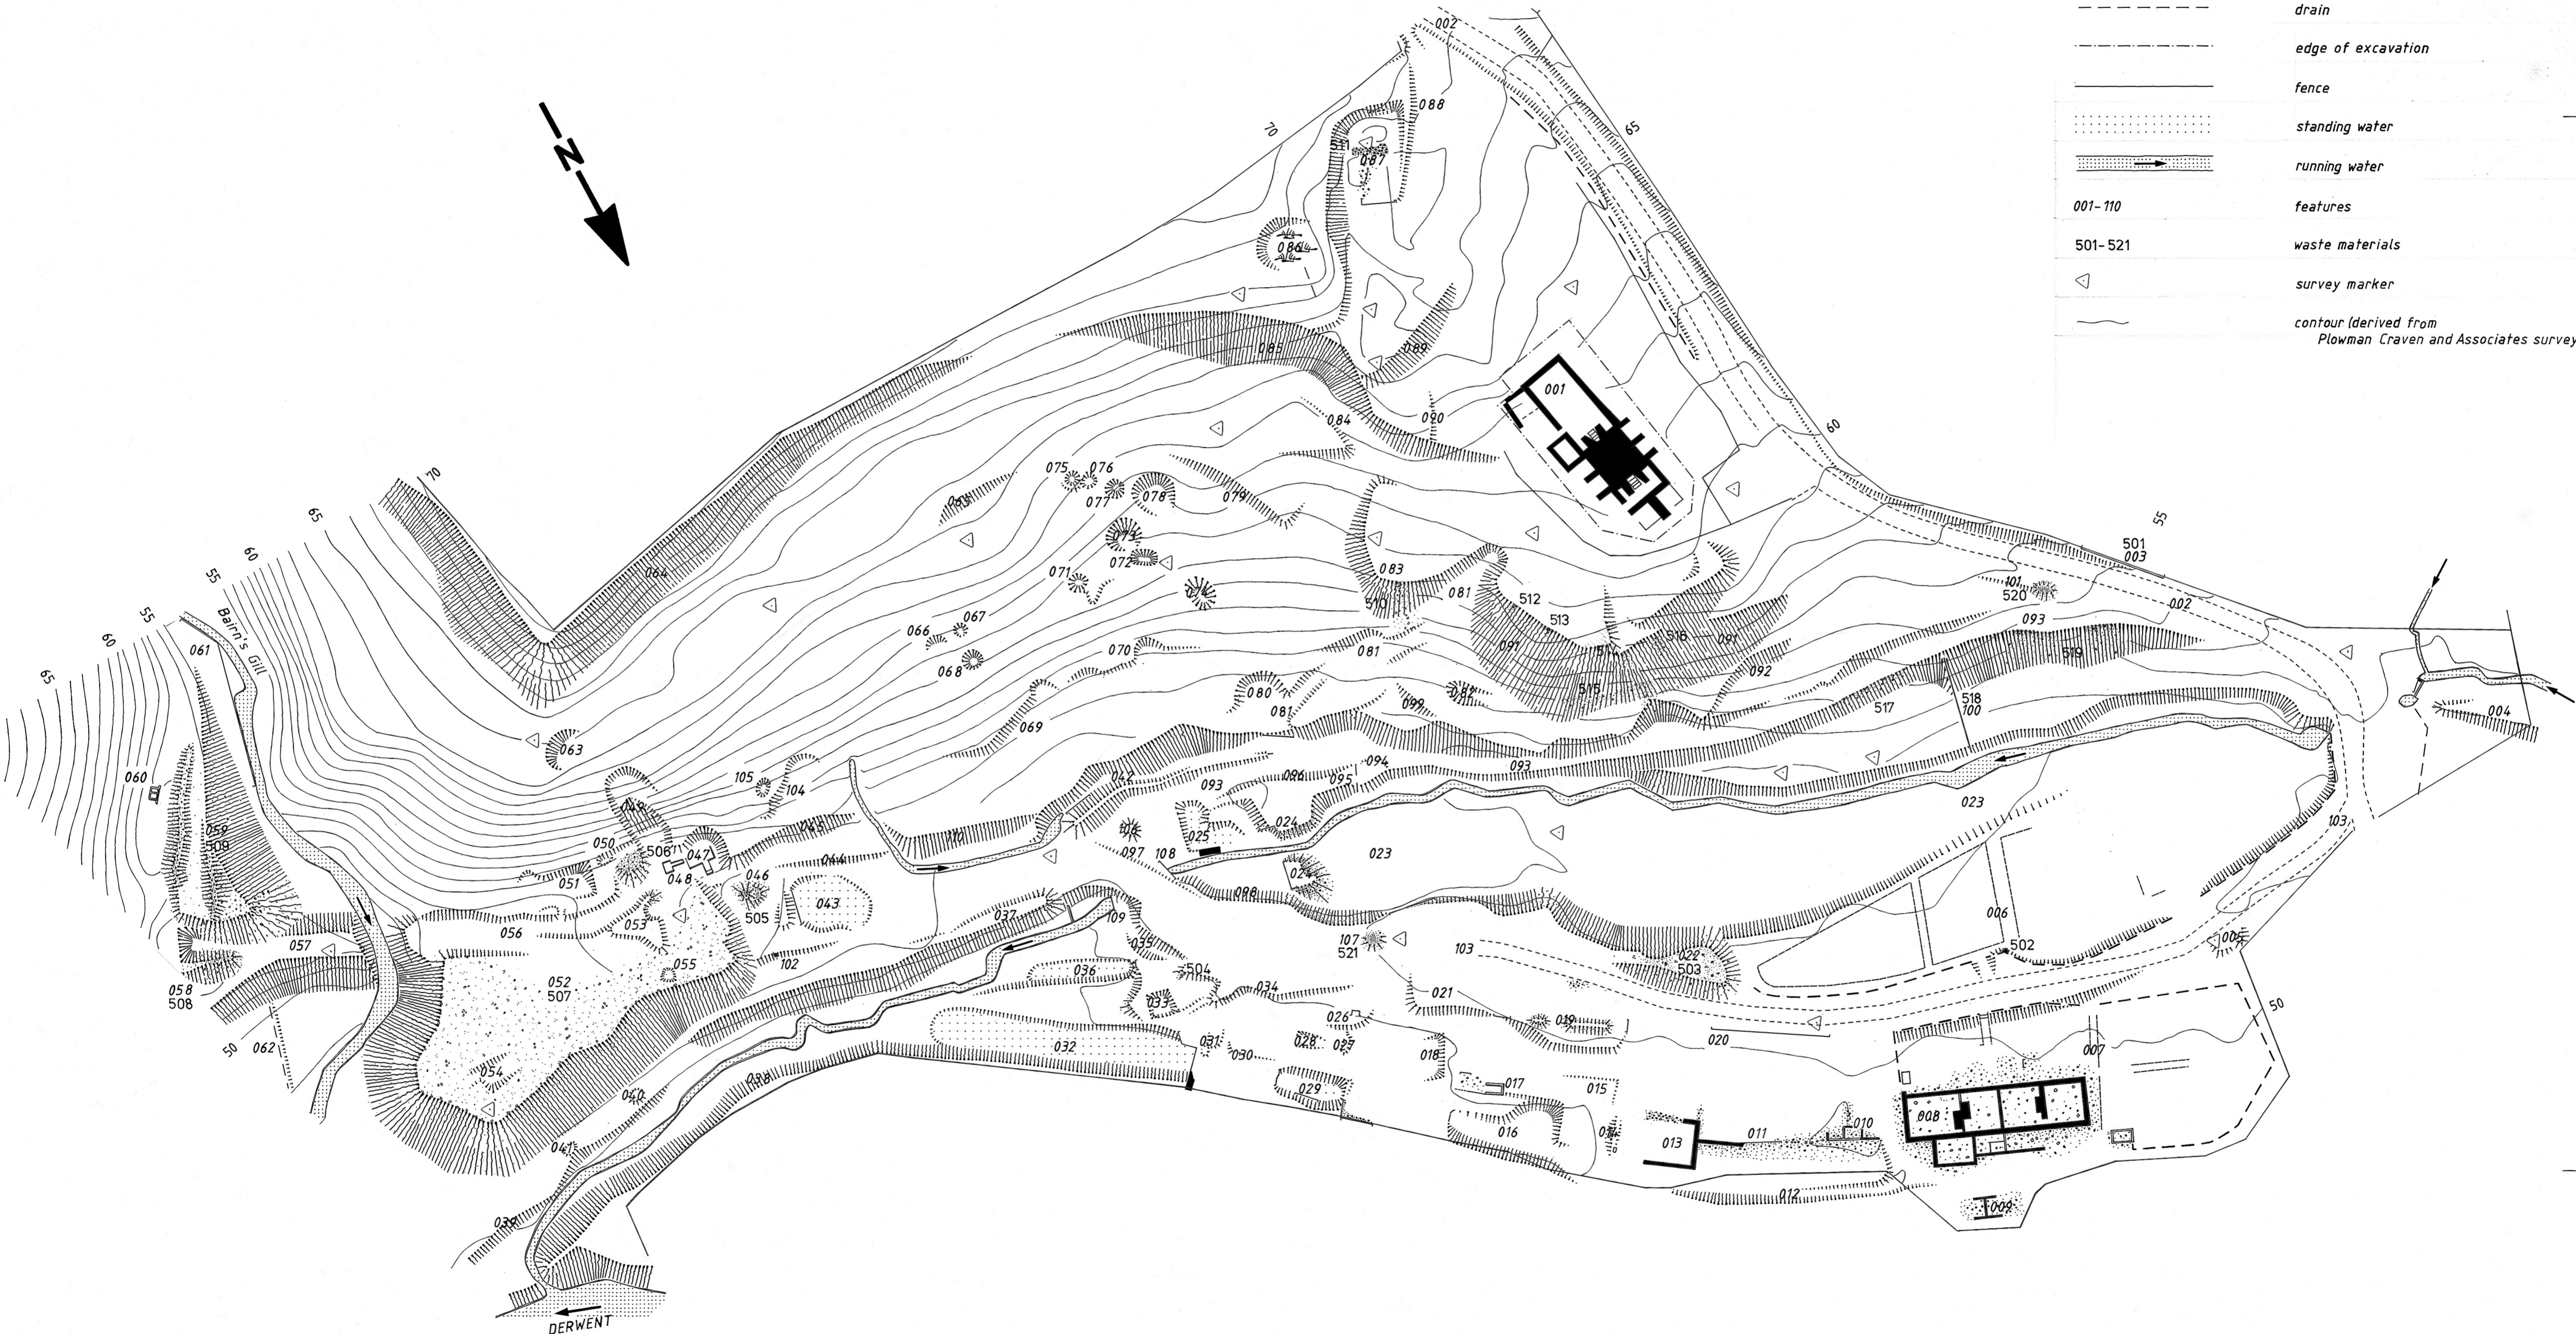
The results of this survey are presented as a conventional hachured plan, at a scale of 1:500. An overlay sheet shows the location of waste materials visible at the time of the survey. The overlay sheet is also labelled with the numbers by which upstanding remains, archaeological features and waste materials are identified in this report. Numbers in the sequence 001-110 refer to archaeological features, numbers in the sequence 501-521 refer to waste materials.

track
	stone edging
	old hedgeline
	standing masonry
	exposed wall face
	drain
	edge of excavation
	fence
	standing water
	running water
001-110	features
501-521	waste materials
	survey marker
	contour (derived from Plowman Craven and Associates survey)

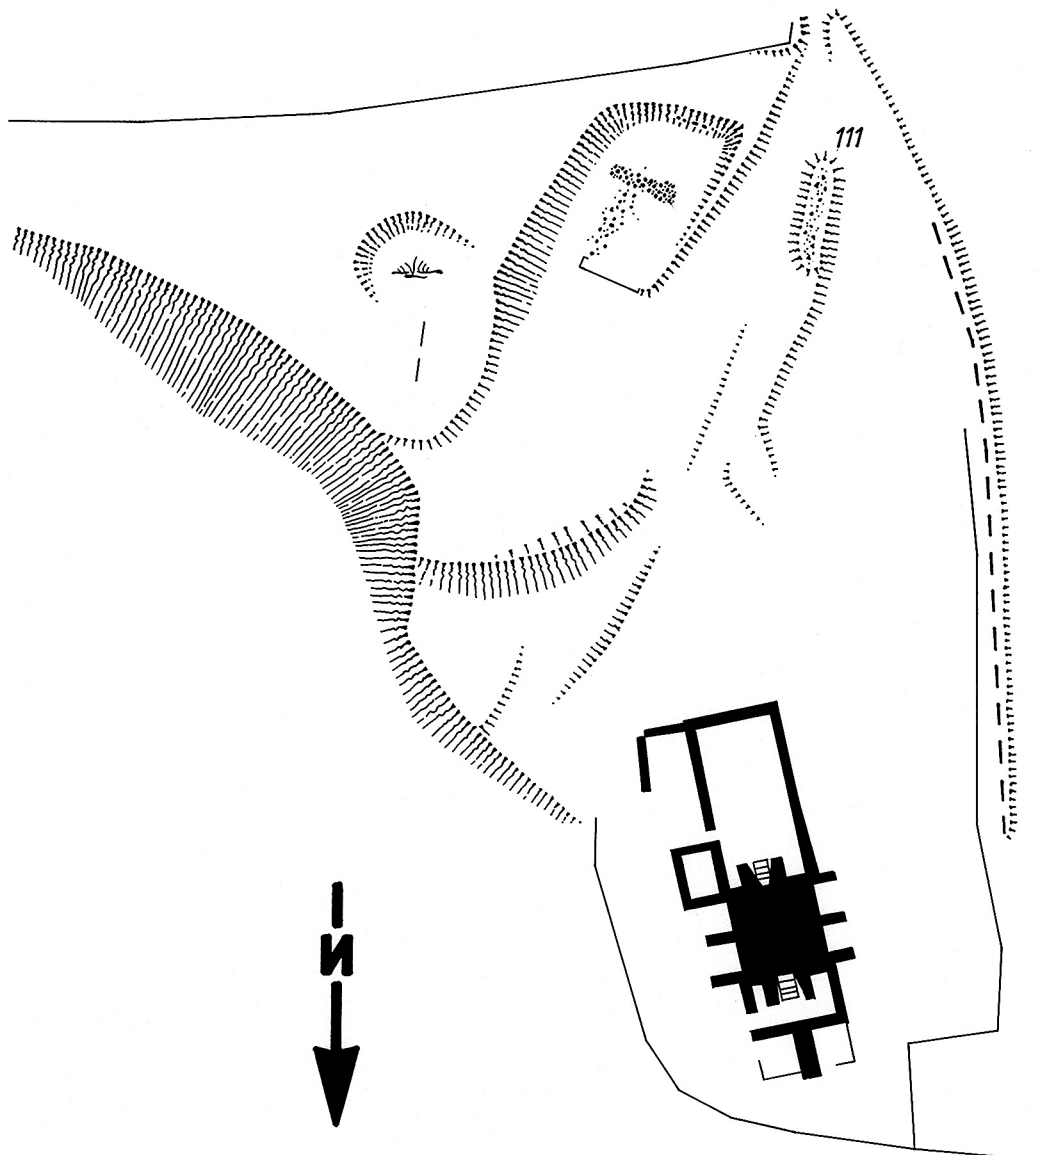
Appendix

In January 1991 undergrowth was cleared from an area to the S of the steel cementation furnace at Derwentcote. This clearance revealed features not recorded in the RCHME survey of January-March 1990. These features consist of scarps, up to 0.2m high, forming a length of the hollow way shown as a track on OS maps of 1856 and 1895 and other parts of which are depicted on the previous RCHME survey (081-088).

In addition a stony mound (111), 0.4m high, lies on the W side of the hollow way. It probably represents a structural feature but certain identification is not possible without further investigation.

It is also possible that another building stood on the flat area to the N of building (087).
