OBSERVATIONS AT THE
ARCHBISHOP'S PALACE,
CROYDON,
1987 TO 1996

Research and Analysis
Reports and Papers **B/009/2004**

March 2004

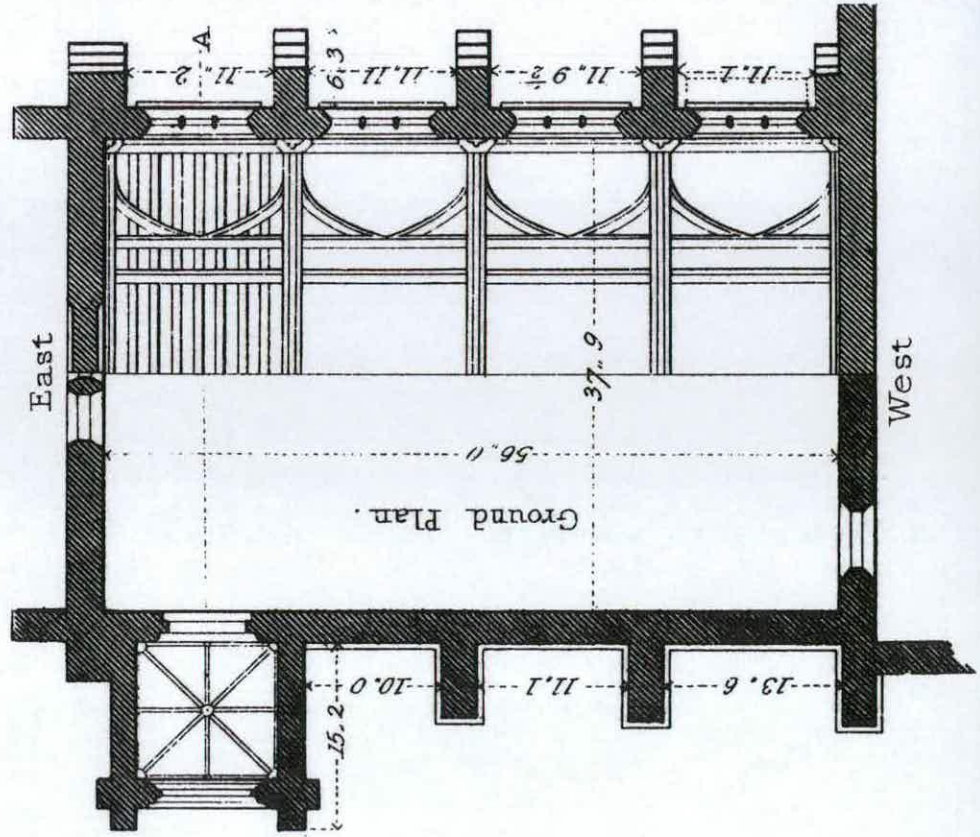
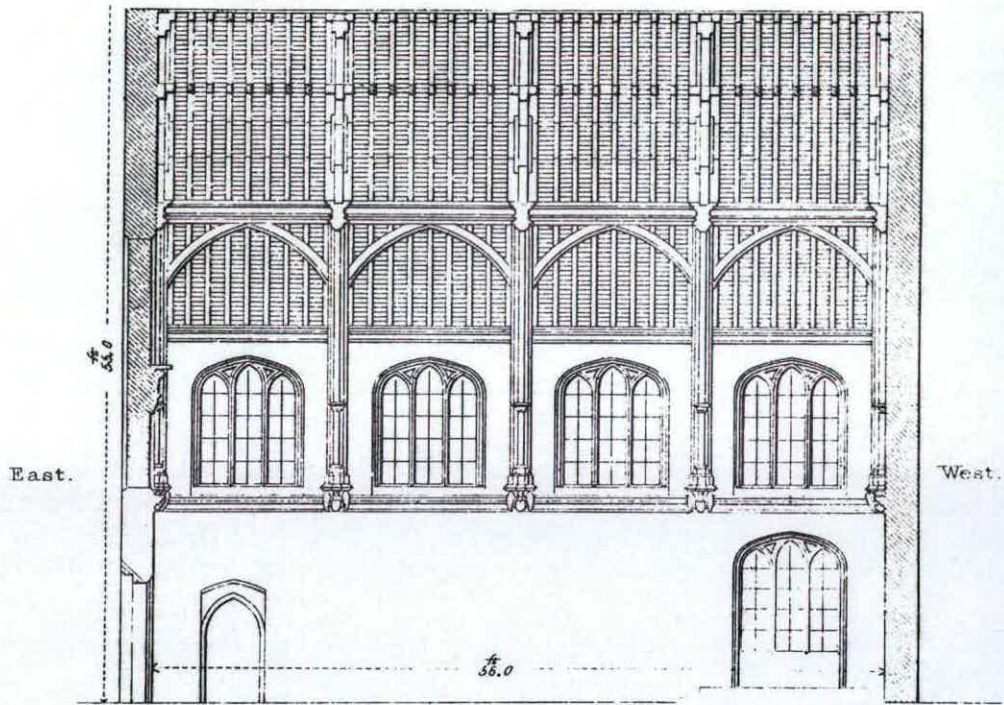
Fig. 5, plan and section through the Great Hall at Croydon Palace from *Examples of Gothic Architecture*, by A and A W Pugin, 1838-40.

Augustus Pugin and his son Augustus Welby Northmore Pugin published drawings of the hall in 1838 that show the hall in plan and longitudinal section. The correspondence between the present survey and that of the Pugins' is good. The present survey supplements the older survey with details of mouldings. Although the Pugin drawings were published after the collapse of 1830, they were probably surveyed before that date since they show a door with a window above in the east wall. It is not clear from the plan whether the window was two- or three-light. It must be noted however, that these drawings are interpretative to a degree since they omit the tie-beams inserted in 1748.

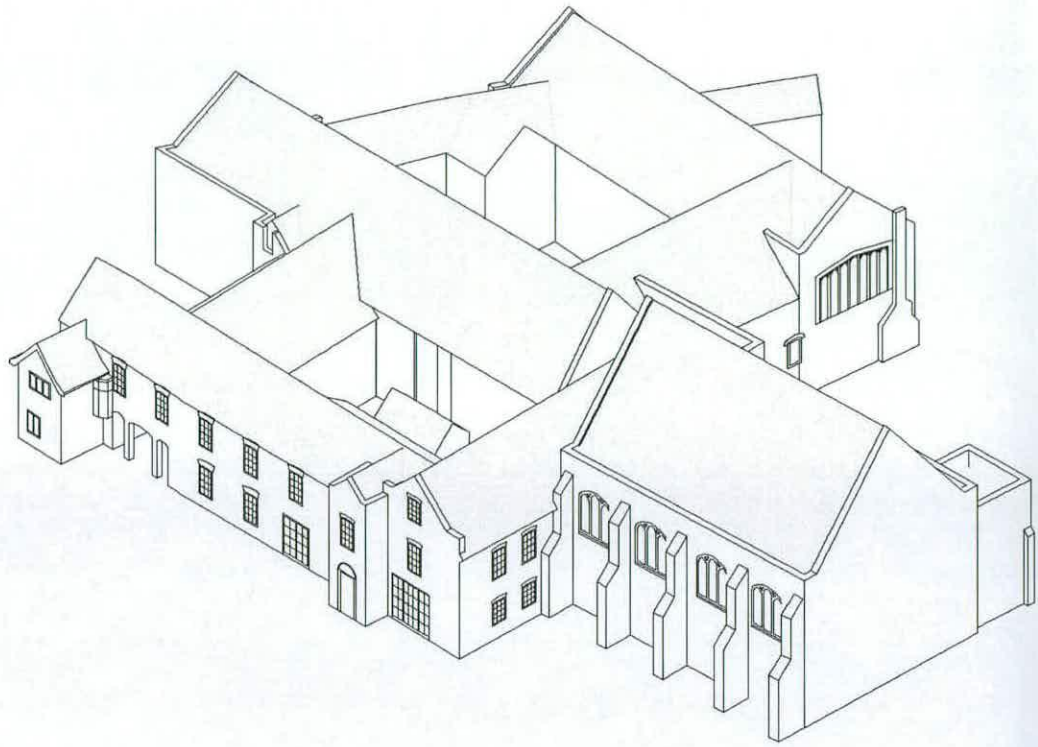
Fig. 8, an isometric of the main complex, looking north-west, drawing number 0007

Croydon Palace is a complex of late-medieval buildings, Fig. 8. Some parts of the complex have acquired particular names, such as the Guard Room, through historical association. However, in this report, the complex is described as a set of ranges disposed around two courtyards. The ranges are therefore referred to in the following way: the central range is the two storey range dividing the north and south courtyards containing at first floor level the Guard Room and presently used by the school as a Library. The north-east range is a three storey building east of the north courtyard extending between the central range and the Chapel. In building works, the attic space was converted for use as a rest room. The south-east range is a three-storey building on the east side of the south courtyard, containing, on the first floor, the Queen Elizabeth Room in its southern half and the Panelled Classroom in its northern half. During the 1980s, the attic space was converted for use as a classroom and a staircase was inserted at the north end of the building to connect the ground floor to the attic floor.

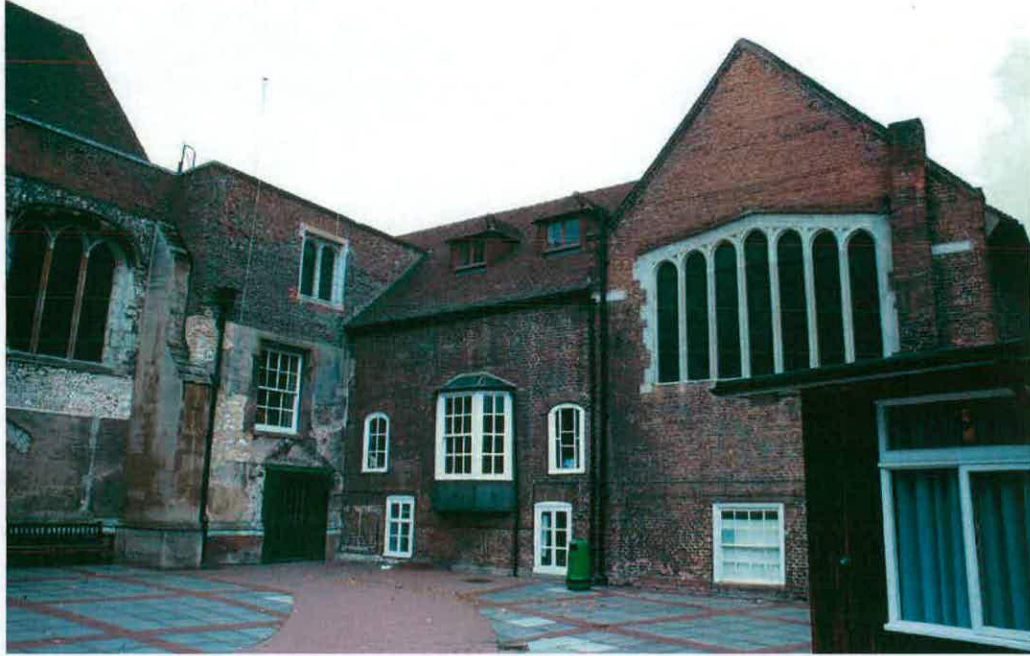
Fig. 9, the junction between the north-east and south-east ranges, viewed from the north-east. Photograph: August 1991

The investigations took place during alteration to the school's staff room facilities in November 1987, Fig. 9 to Fig. 11. The brickwork was removed to create a doorway at attic level through the north wall of the east range of the south courtyard. The purpose of the door was to give access at attic level to the east range of the north courtyard where the staff rooms are located.

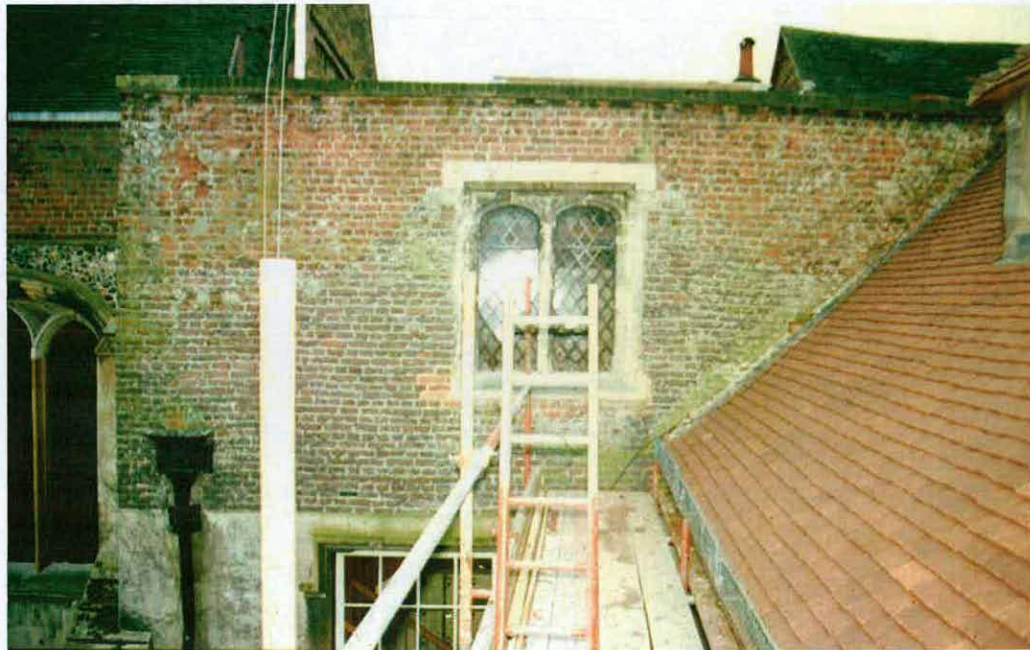
Fig. 10, the north wall of the south-east range. Photograph: November 1987.

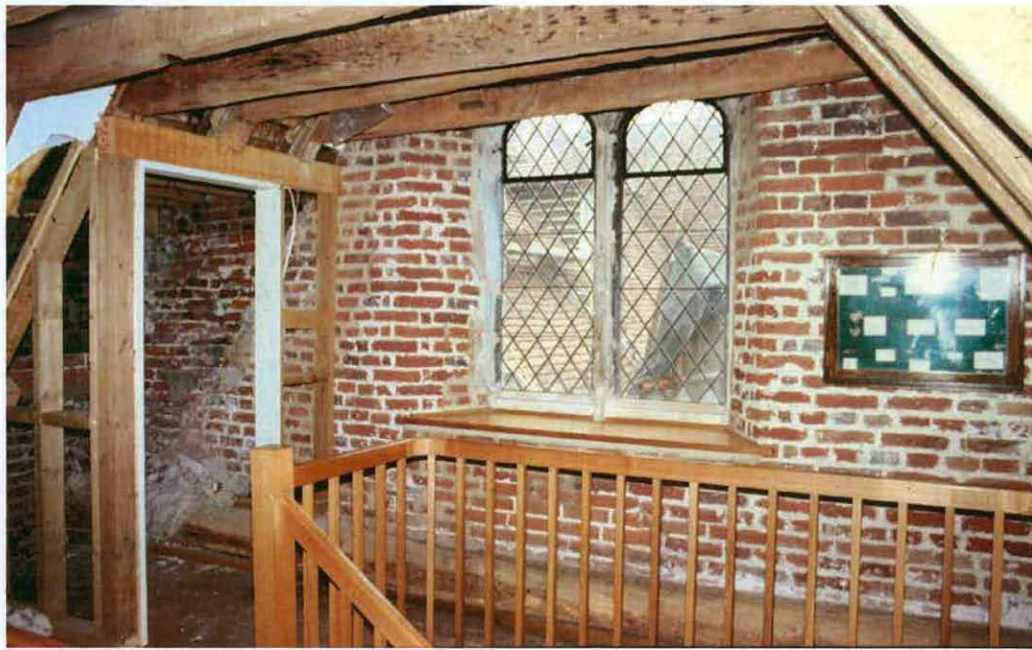
Fig. 11, the top of the staircase at the north end of the south-east range. Photograph : November 1987

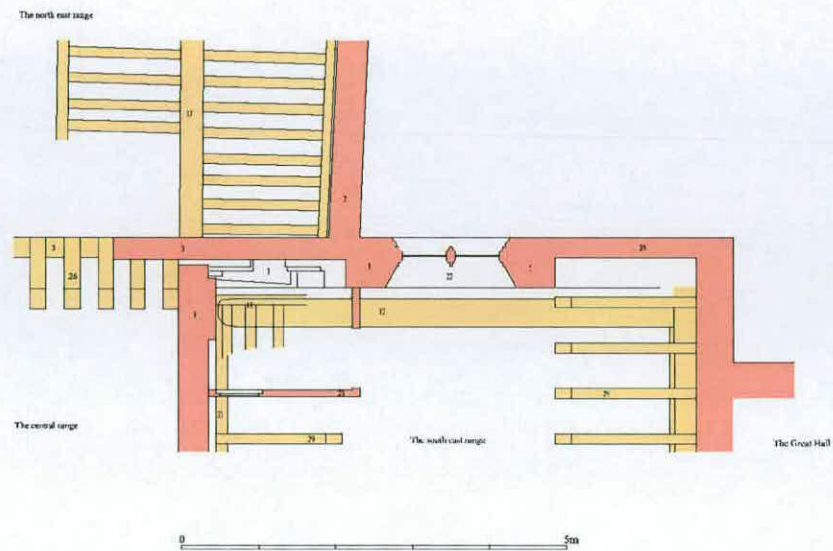
Fig. 12, a plan of the attic floor of the south-east range at its junction with the north-east range and the central range, drawing number 0001

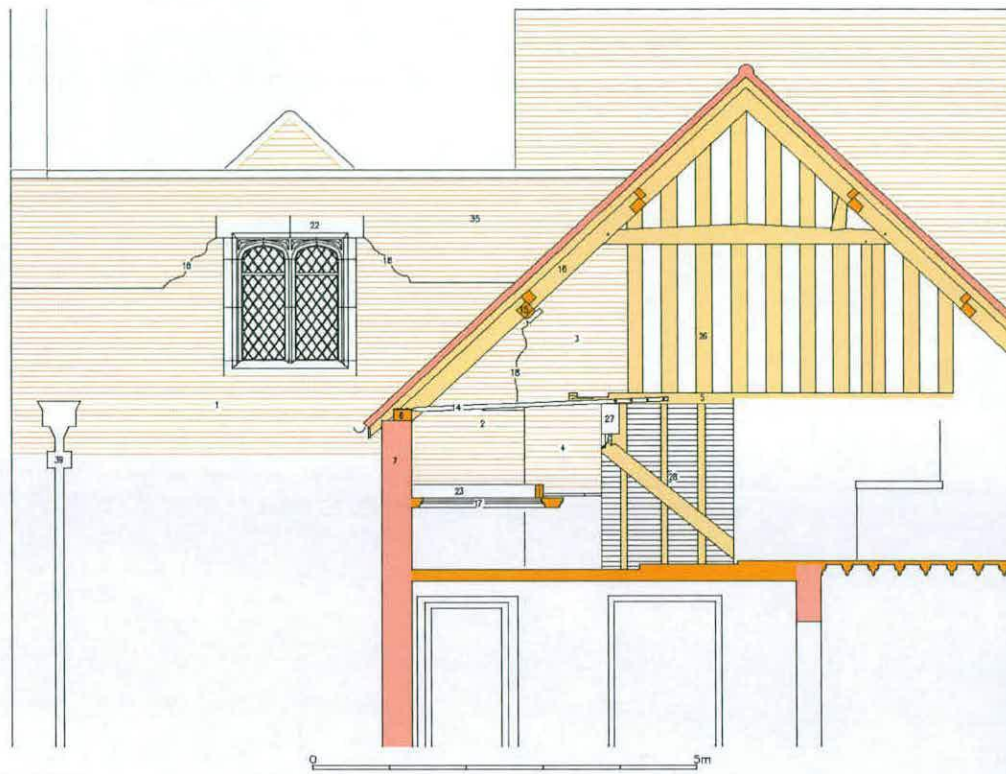
Fig. 13, an elevation of the north face of the north wall of the south-east range at attic floor level, drawing number 0002

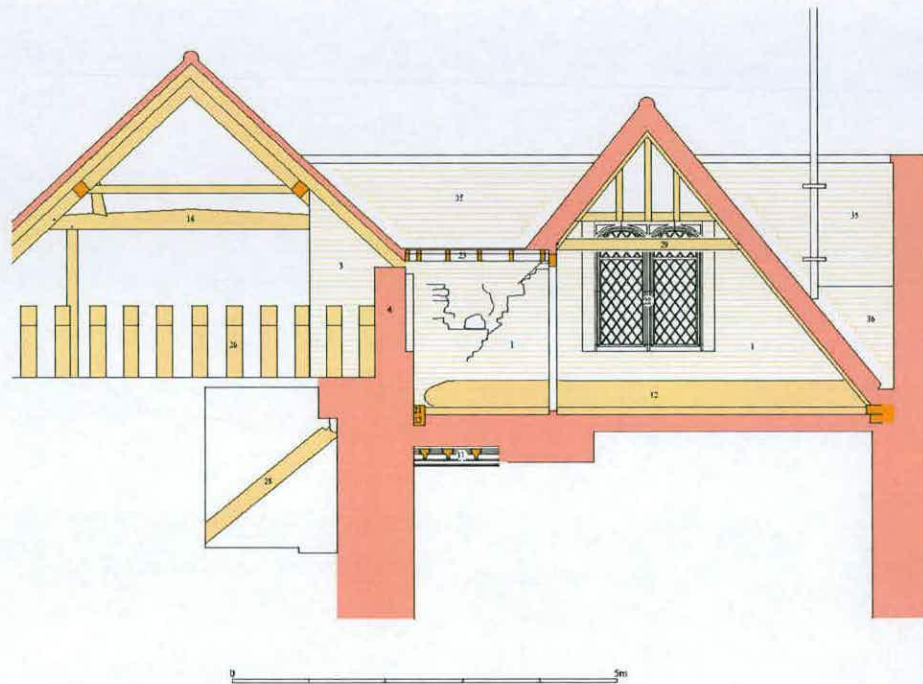
Fig. 14, an elevation of the south face of the north wall of the south-east range at attic floor level, drawing number 0003

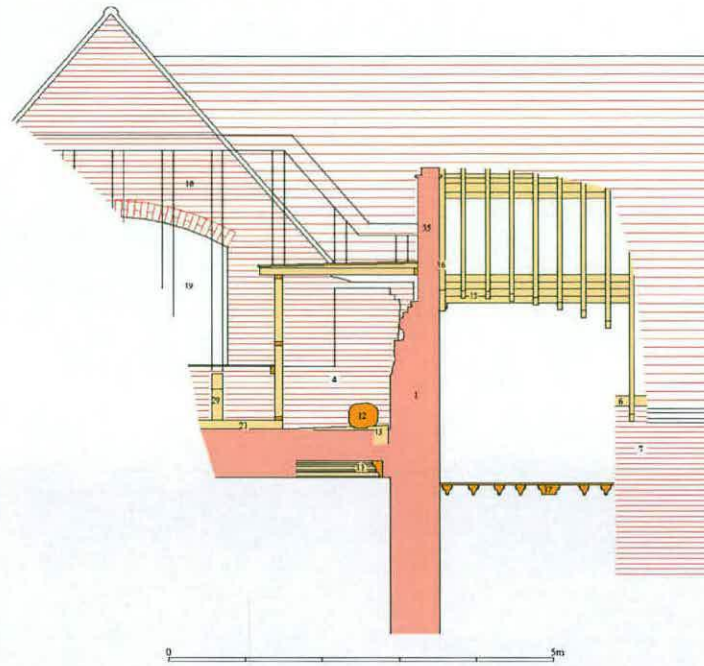
Fig. 15, a south-north section through the south-east range showing the gable wall at the east end of the central range at attic floor level, drawing number 0004
a

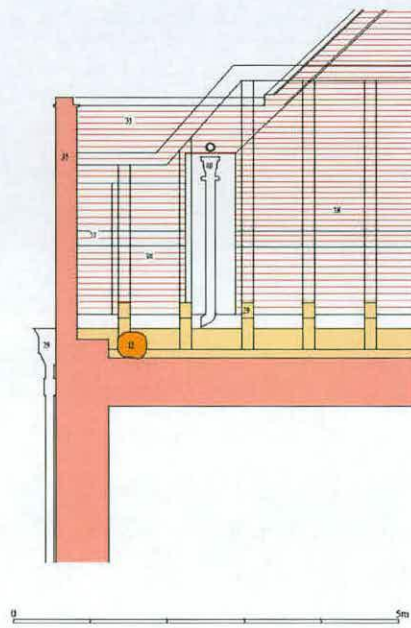
Fig. 16, an elevation of the west face of the east wall of the south-east range at attic floor level, drawing number 0005

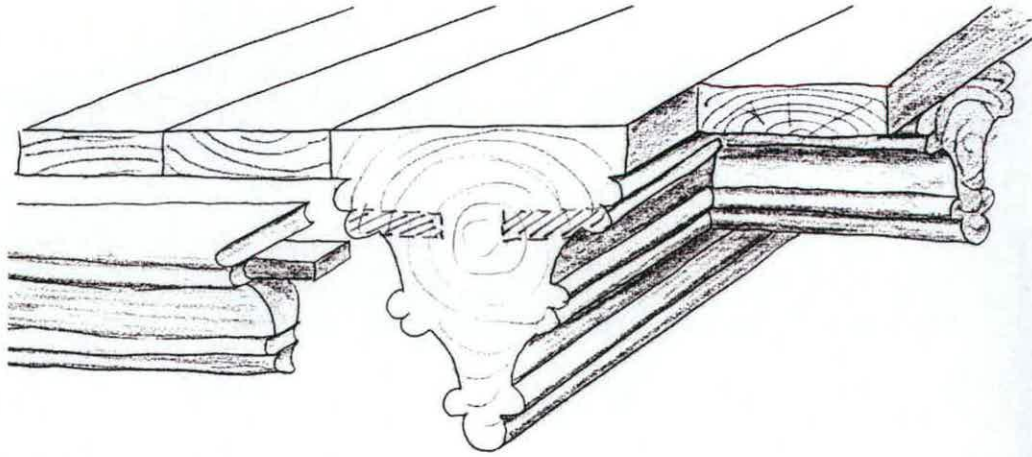
Fig. 17, a sketch illustrating the roll moulded oak floor, 17, in the north-east range.

A strictly archaeological relationship between the moulded joists, 17, and the brickwork, 7, forming the east wall of the north east range was not observed. However the floor clearly conforms to the alignments of the wall, 7, and the east-west wall, 1, to the south. Elsewhere in the Palace especially in the north-west range the moulded joists are associated with diaper brickwork and are thought to be the work of Archbishop Morton, 1486-1500. Although this group is associated with the previous group, the butt joint at the south end of the east wall clearly puts it second in the sequence. Similarly, the same east wall abuts the end wall of the Chapel to the north which is also thought to be the work of Archbishop Bourchier, 1454-1486.

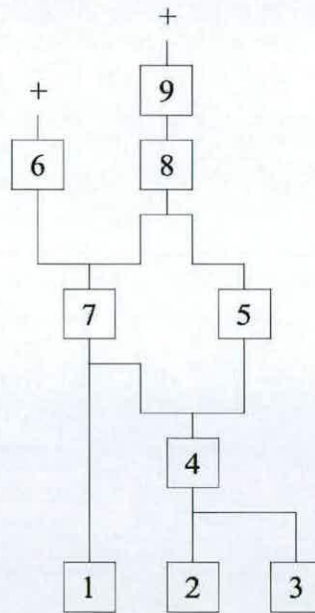
Fig. 18, the group matrix illustrating the phasing of the features identified at the junction of the north-east south-east and central ranges, drawing number 0008

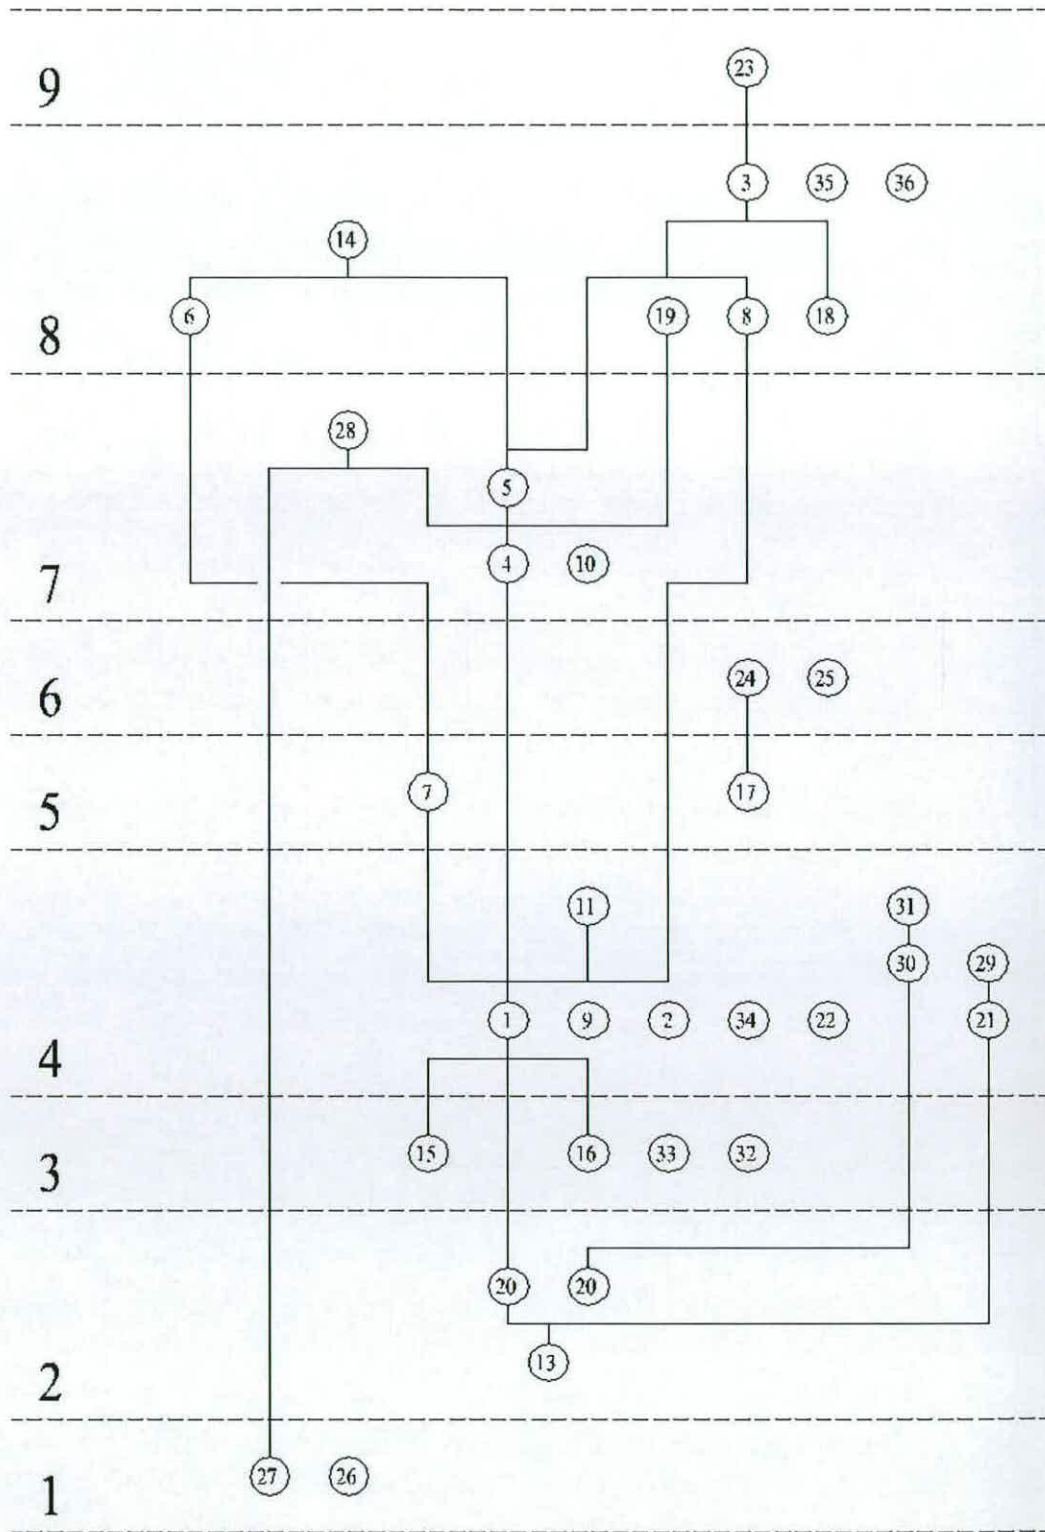
Fig. 19, site matrix, drawing number 0009

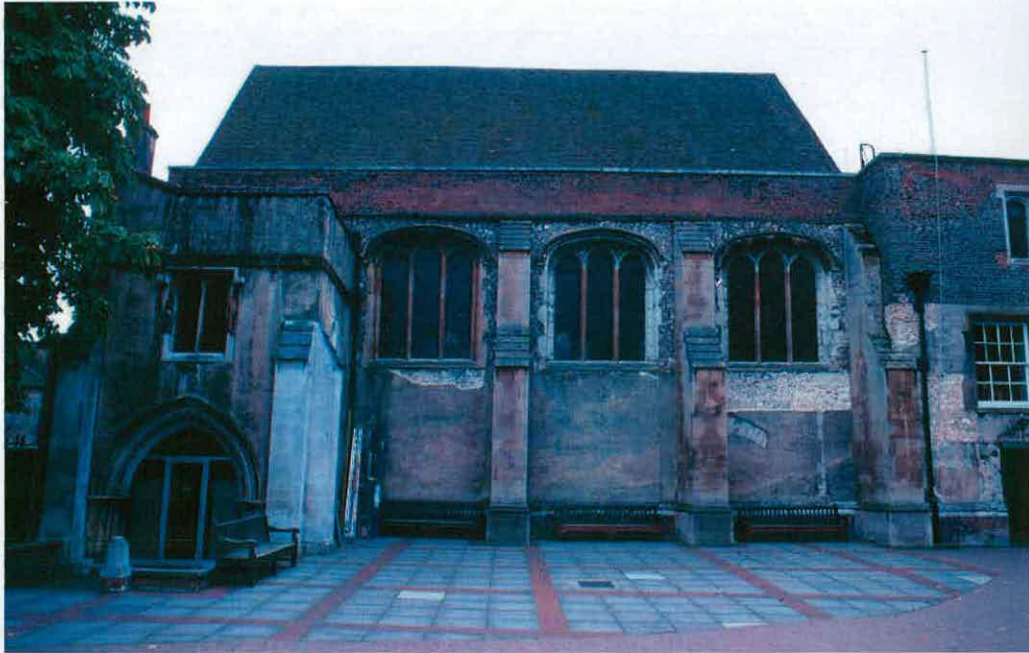
Fig. 20, the north wall of the Great Hall. Photograph: August 1991.

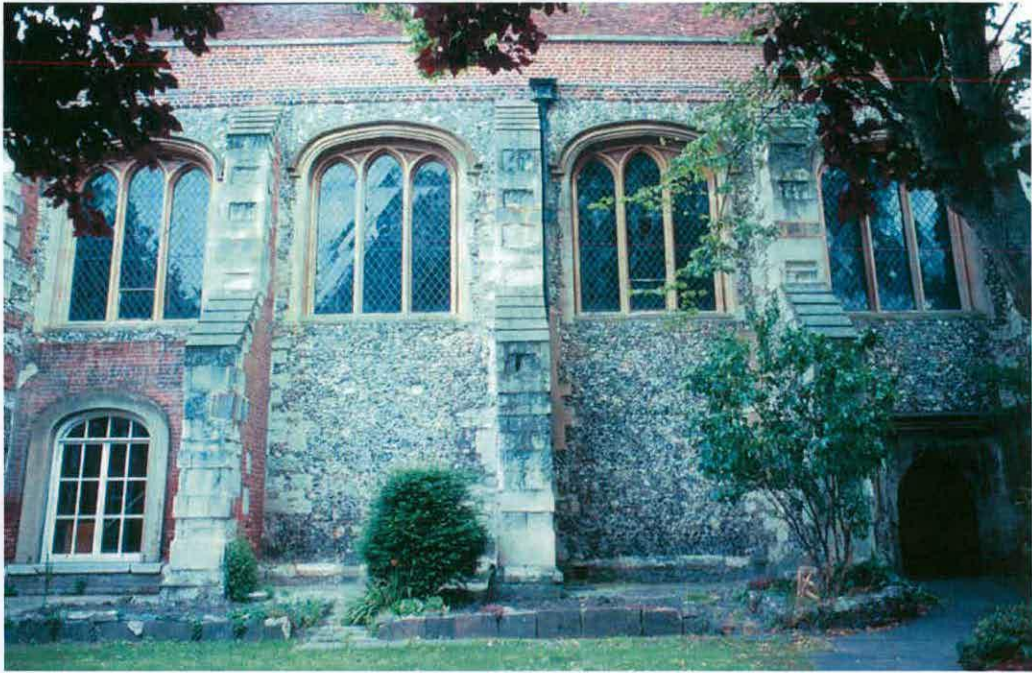
Fig. 21, the south wall of the Great Hall. Photograph: August 1993.

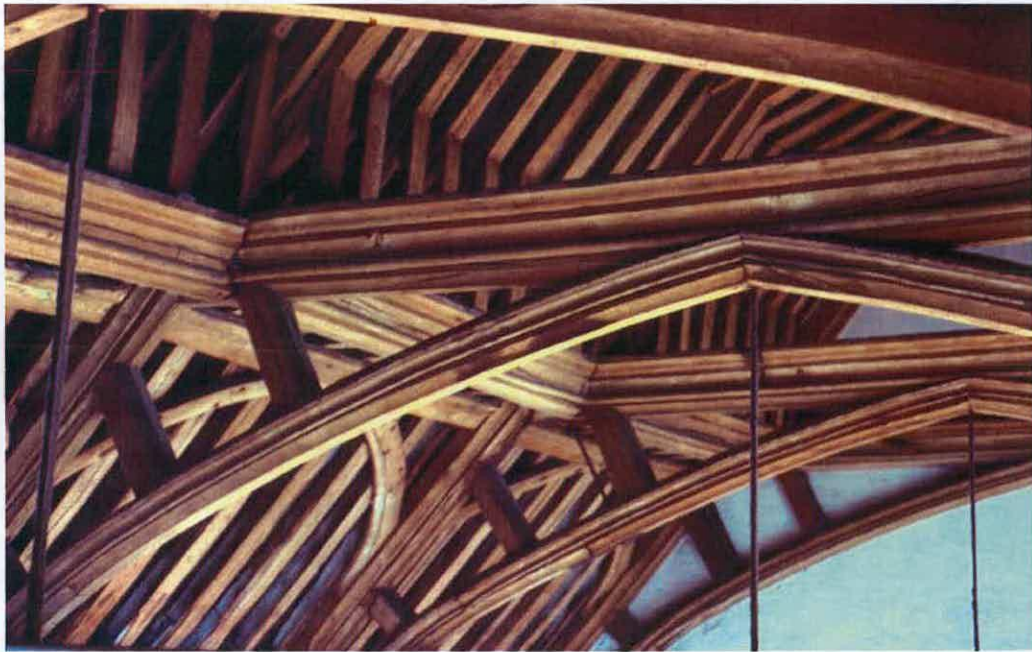
Fig. 22, a general view of the roof above the Great Hall from scaffolding erected against the west wall. Photograph: March 1990.

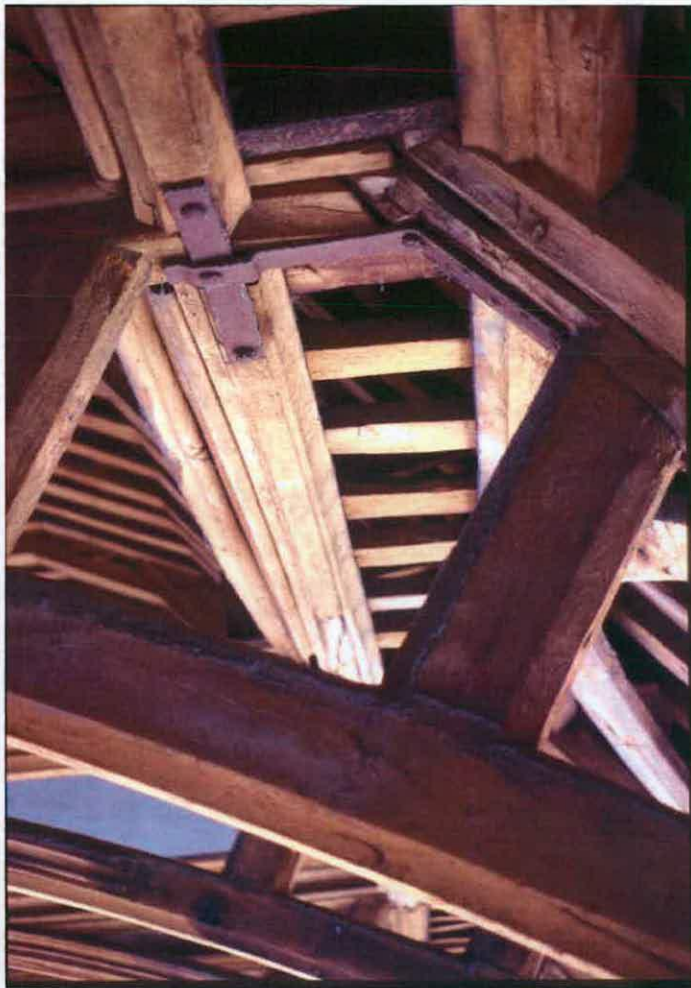
Fig. 23, a detail of the truss between the first and second bays at the west end of the Great Hall, viewed from the west. The iron strap repair may be contemporary with the insertion of the tie-beams in 1748. Photograph: March 1990.

The pine tie-beams spanning each truss appear to have been installed in the time of Archbishop Herring. The western tie-beam is painted with the date and his initials, 'T 1748 H'. The beams are tied to the wall plates with iron straps. They may be contemporary with other similar iron repairs to the roof, Fig. 23.

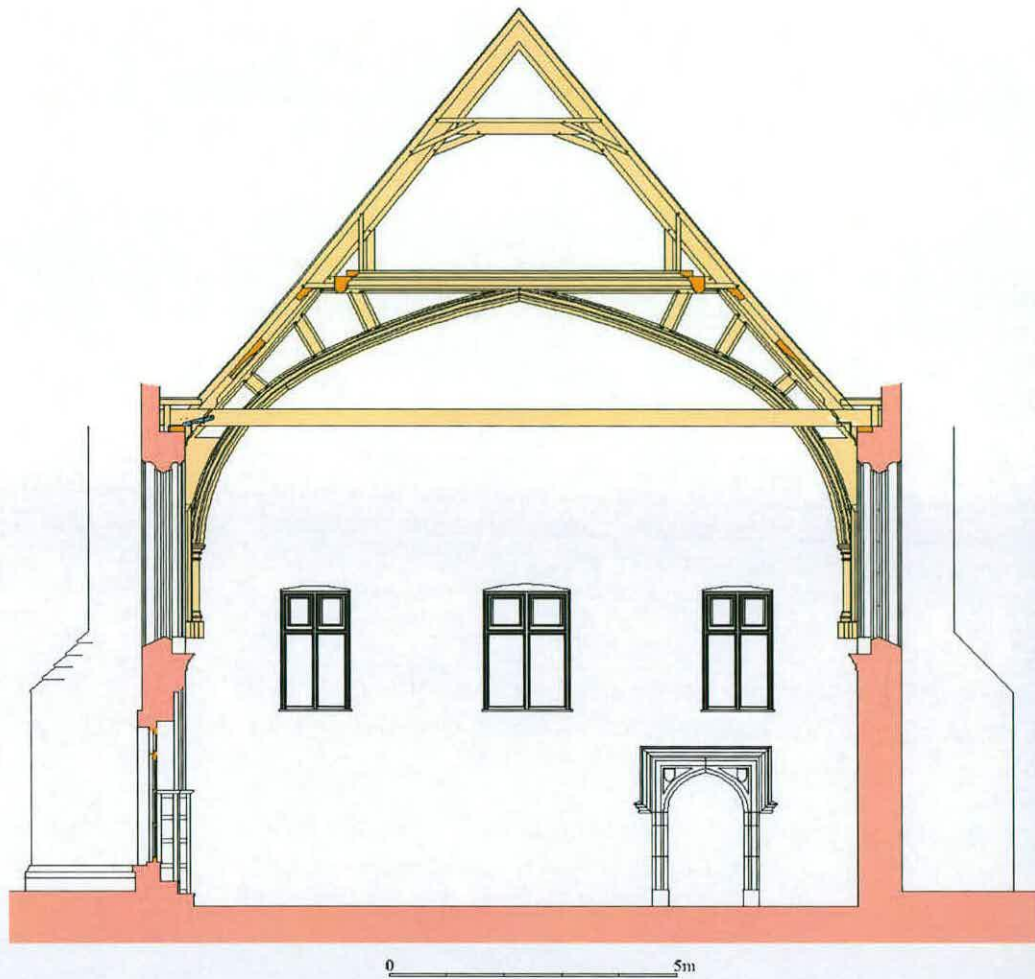
Fig. 25, an elevation of the roof truss at the west end of the Great Hall, drawing number 0010

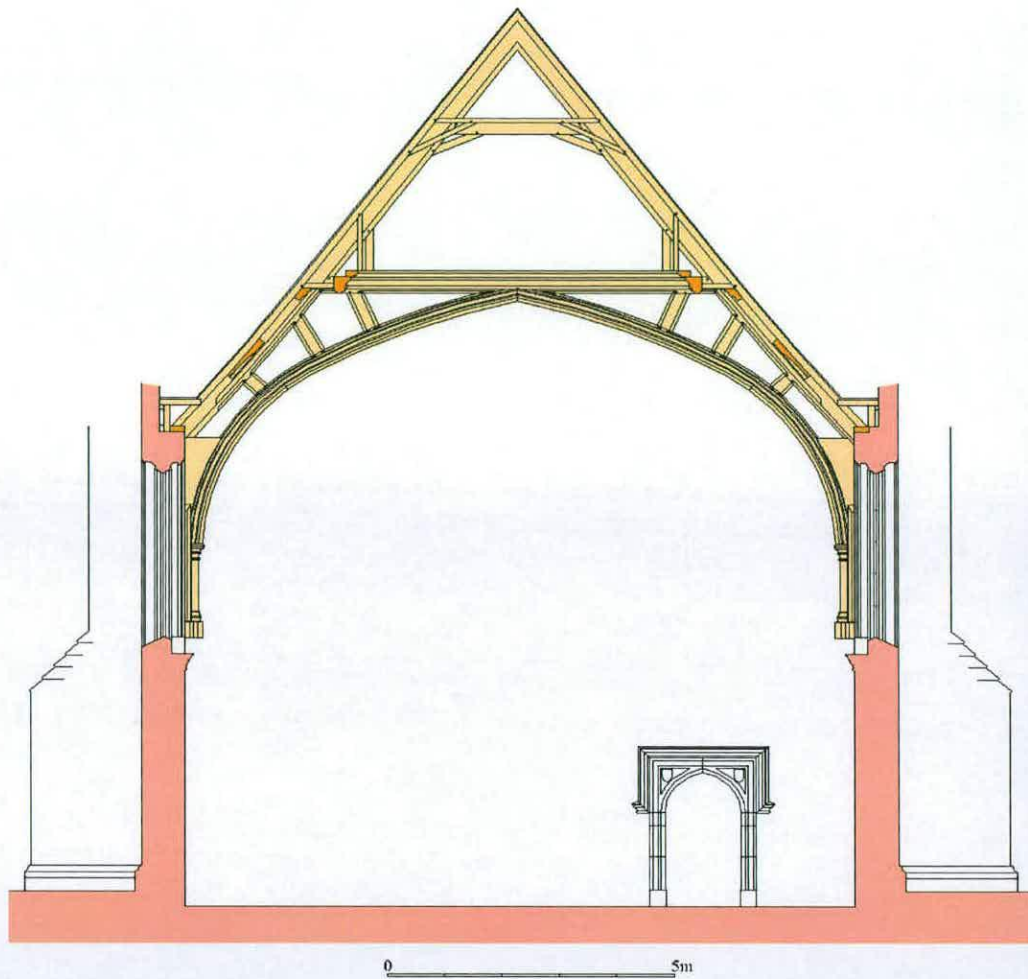
Fig. 26, an elevation of the roof truss at the west end of the Great Hall, shown without the later tie-beam, drawing number 0011

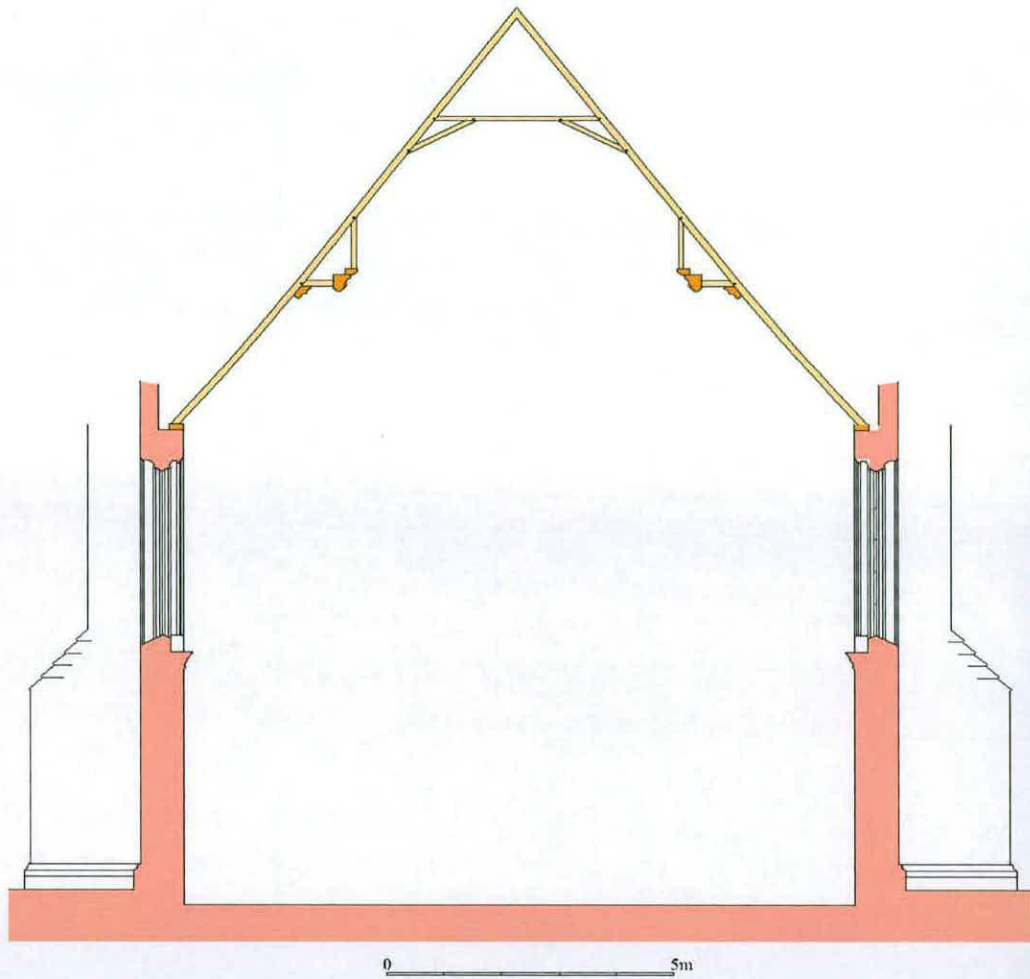
Fig. 27, an elevation of a common rafter pair in the west bay of the hall, drawing number 0012

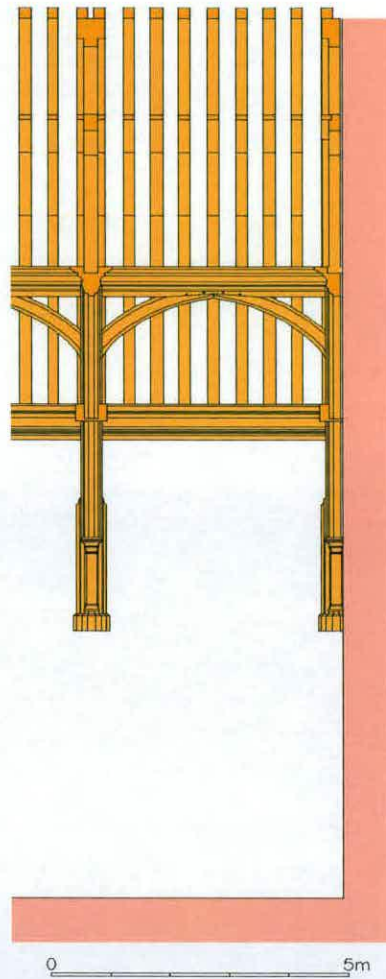
Fig. 28, a section through the west bay of the Great Hall looking south, drawing number 0013

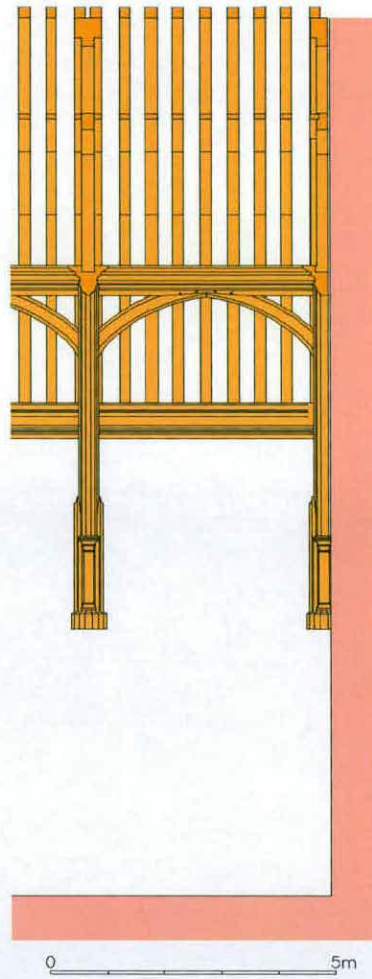
Fig. 29, a section through the west bay of the Great Hall looking south, without the later tie-beam, 0014

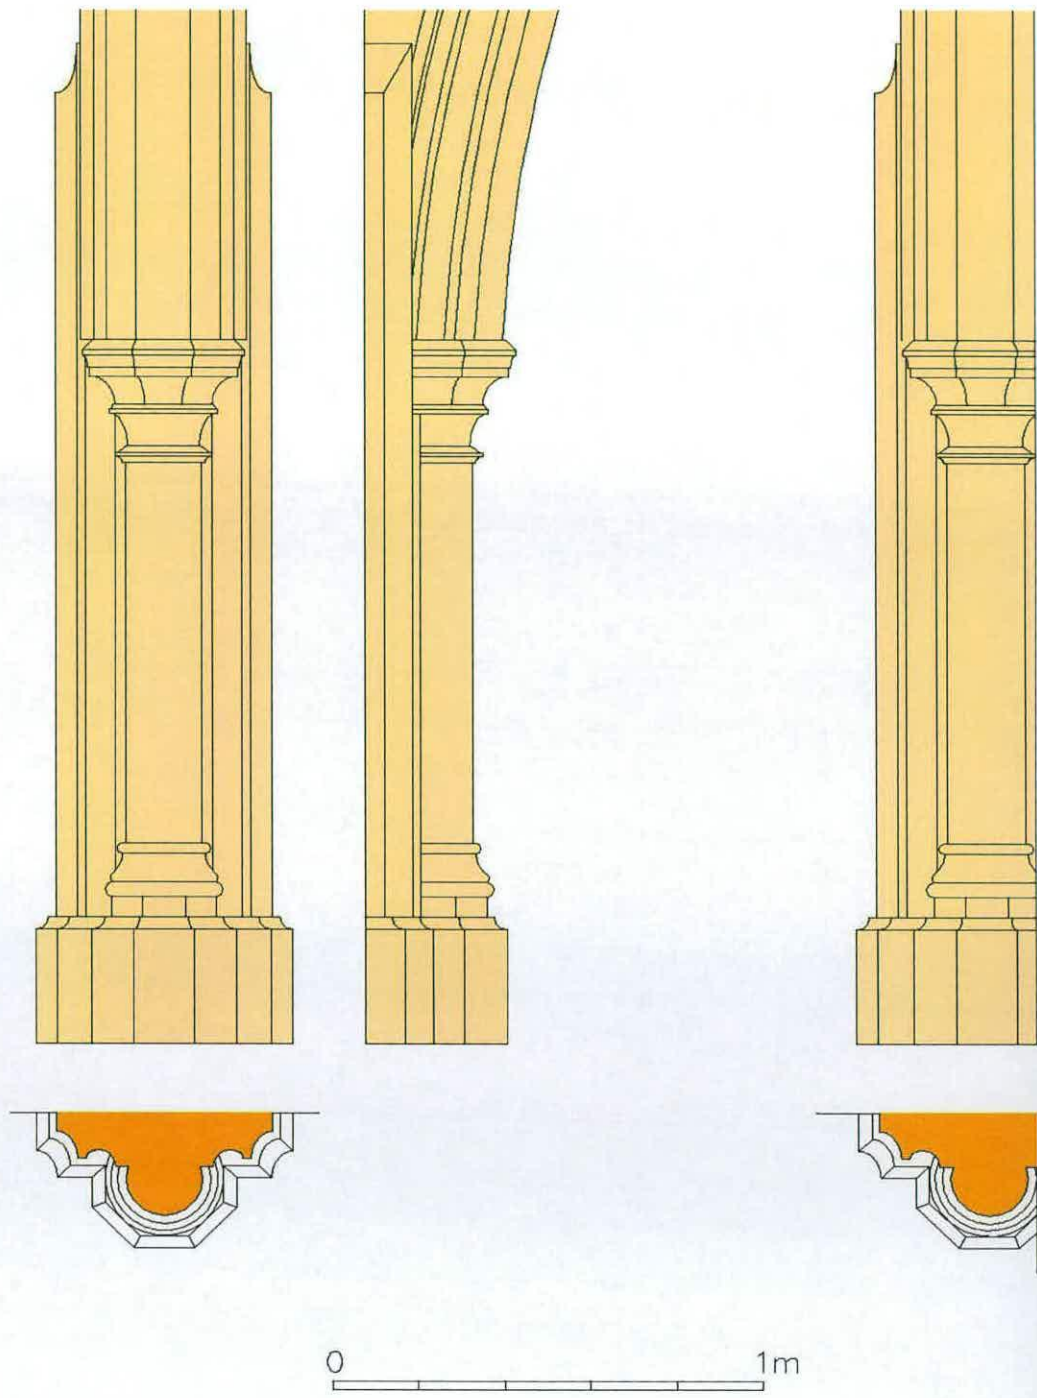
Fig. 31, Timber responds supporting the roof of the hall, 0016

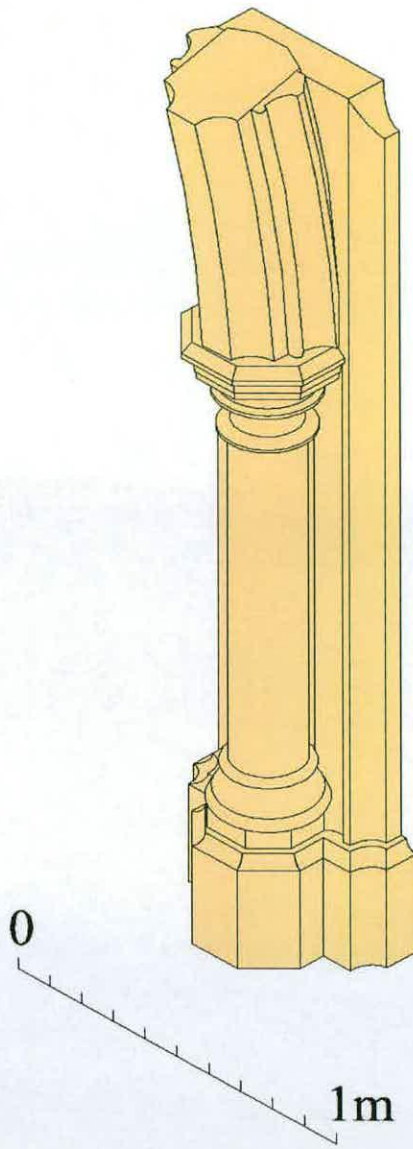
Fig. 32, an isometric of a timber respond supporting the roof of the Great Hall, drawing number 0017

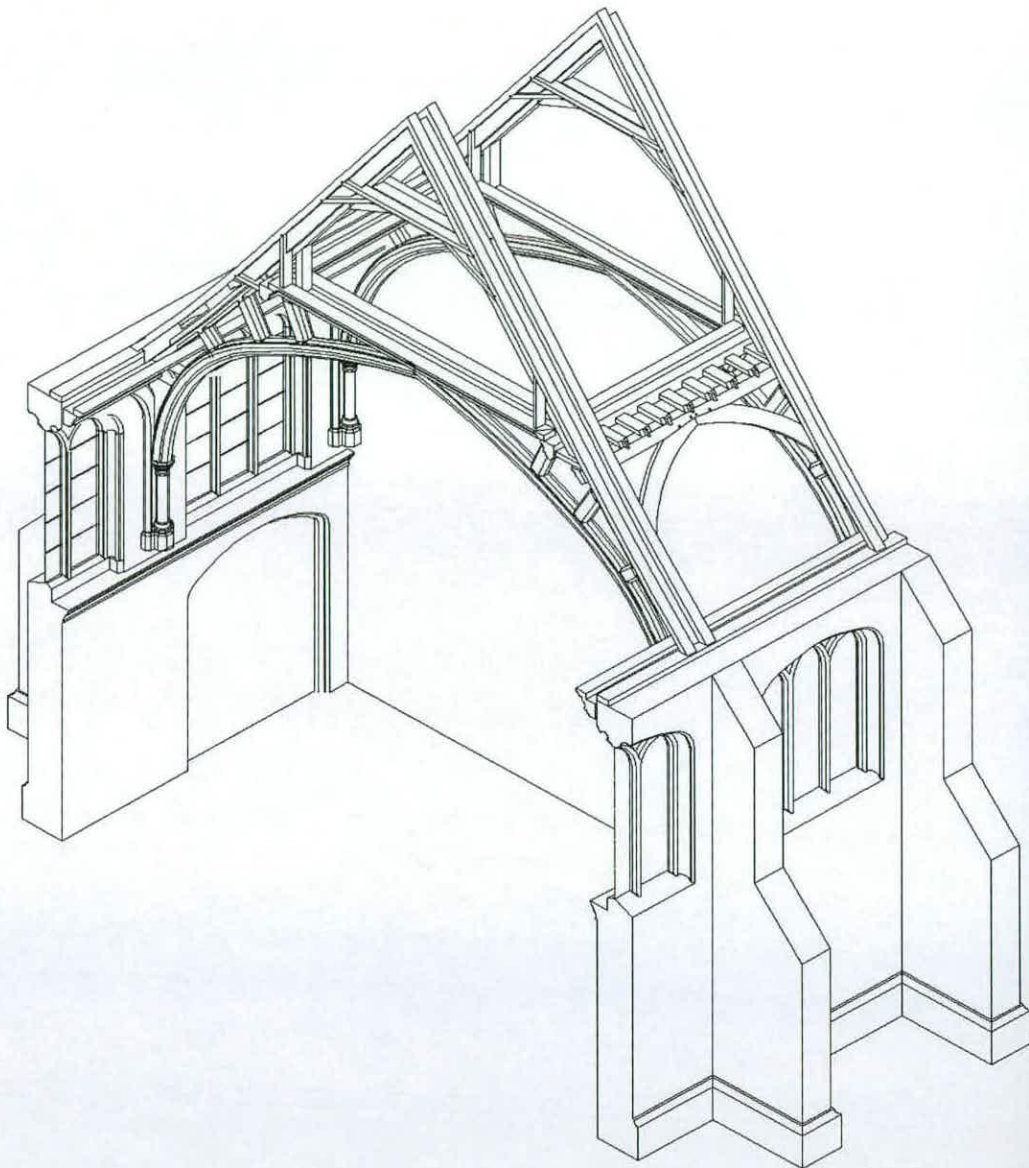
Fig. 33, an isometric projection of the west bay of the roof above the Great Hall, drawing number 0018

There is a consistent pattern of nail holes and broken off nails in the soffits of the rafters above the pine box cornice. This pattern suggests that once there were ashlar pieces at this level and that they were removed in 1748. The nails and the nail holes are consistent with those used in the ashlar pieces above the collar cornice. The missing ashlar pieces would therefore appear to have been original. This in turn suggests that at wall plate level, there was another set of cornice mouldings to match those at collar level. The parts of the responds where these timbers would have met are now concealed by boards that probably date from 1748, except for the hollow chamfer moulding adjacent to the wall that in all cases is crudely terminated at the top. We can therefore suggest that there were wall arches above the window consisting of arched timber braces and probably moulded to match the wind braces higher in the roof. Above these, there would probably have been a timber cornice moulded to match that at collar beam level. This arrangement is shown in the isometric reconstruction, Fig. 33.

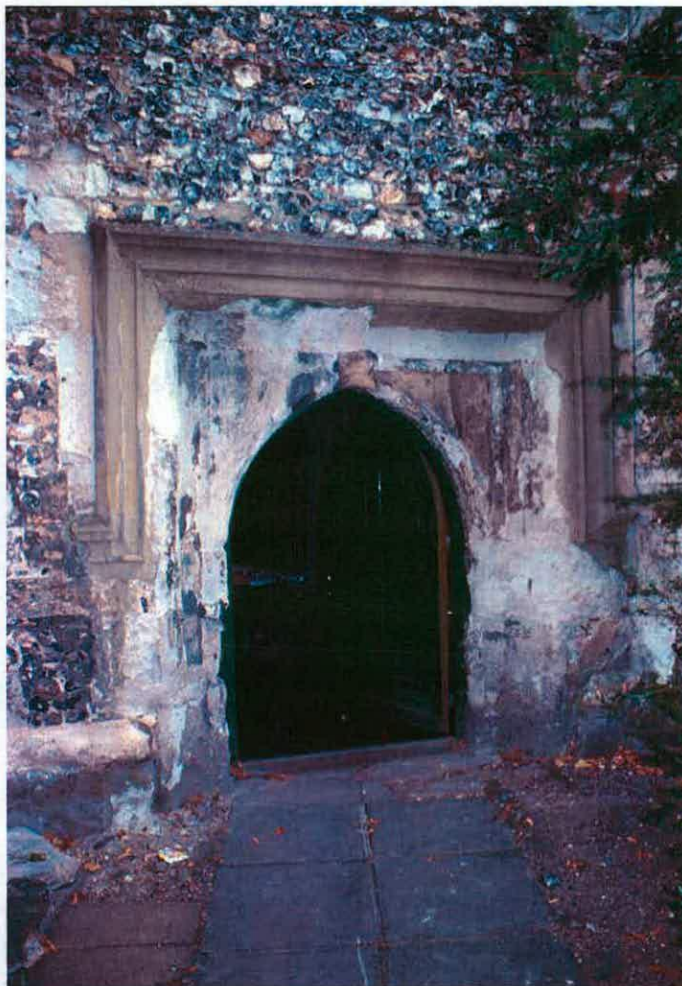
In 1993, the exterior stone work of the south door to the Great Hall was deteriorating and the architect, Mr Gardner, suggested that some repairs were envisaged. Most of the arrises had already disappeared and the hood mould appeared to be entirely composed of modern cement render although it is possible that some of the original stone survived underneath. There were no signs of the original bases and, judging from the proportions of the door, they were probably submerged beneath the present ground surface.

Fig. 34, the door at the east end of the south wall of the Great Hall. Photograph: August 1993.

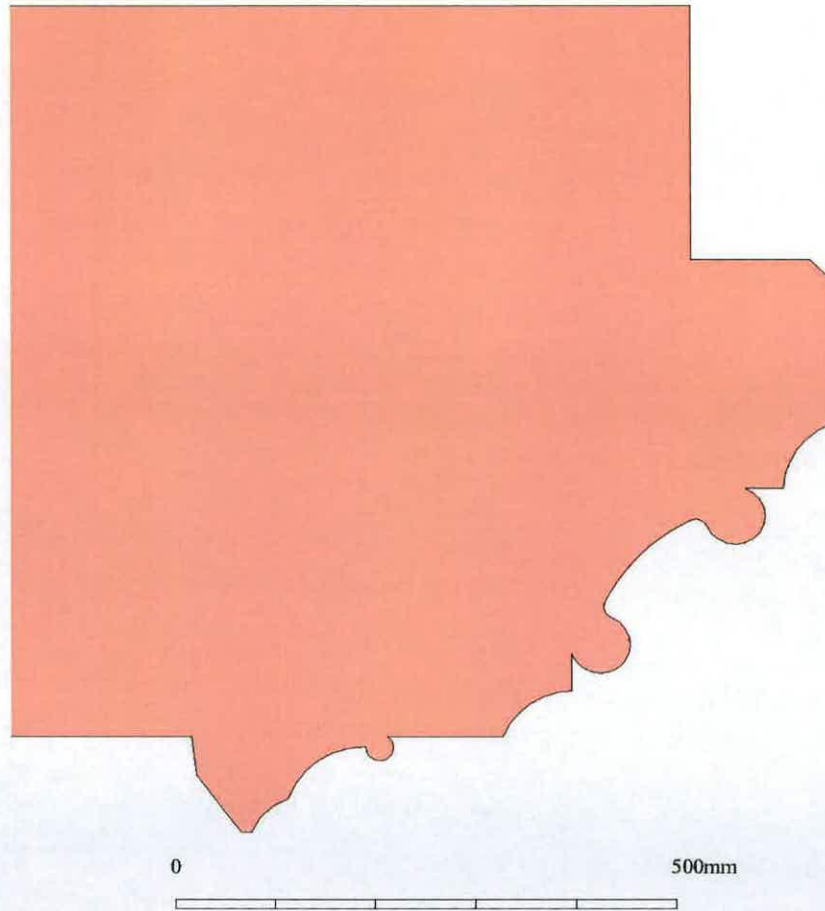
The reconstruction drawings are based on dimensioned pencil sketch notes and are an interpretation of the surviving fabric. The moulding profile was drawn at 1:5. The door is reconstructed on the basis of a fully reconstructed moulding profile. The chamfer stop base is typical of the period.

Fig. 35, a composite section through the jamb of the east door in the south wall of the Great Hall, showing the maximum survival of the rolls and arrises.
