OBSERVATIONS AT THE
ARCHBISHOP'S PALACE,
CROYDON,
1987 TO 1996

Research and Analysis
Reports and Papers **B/009/2004**

March 2004

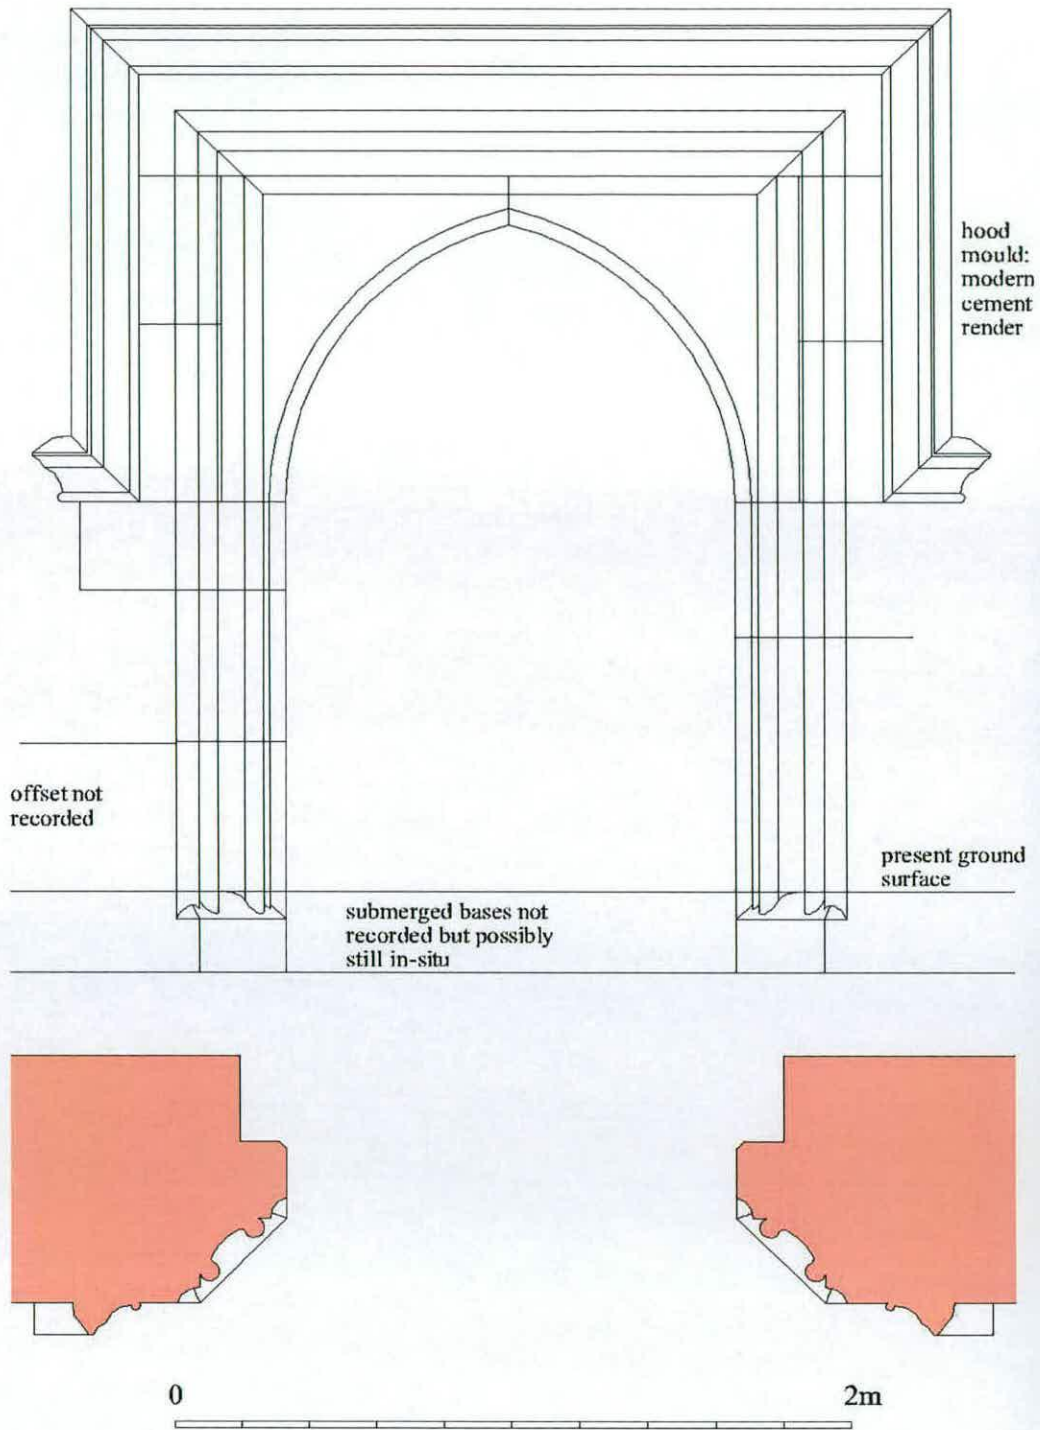
Fig. 36, a reconstructed elevation and plan of the door at the east end of the south wall of the Great Hall. The hood mould profile is that of the present cement render hood, which may or may not be historic. The bases were not observed. Drawing number 0020.

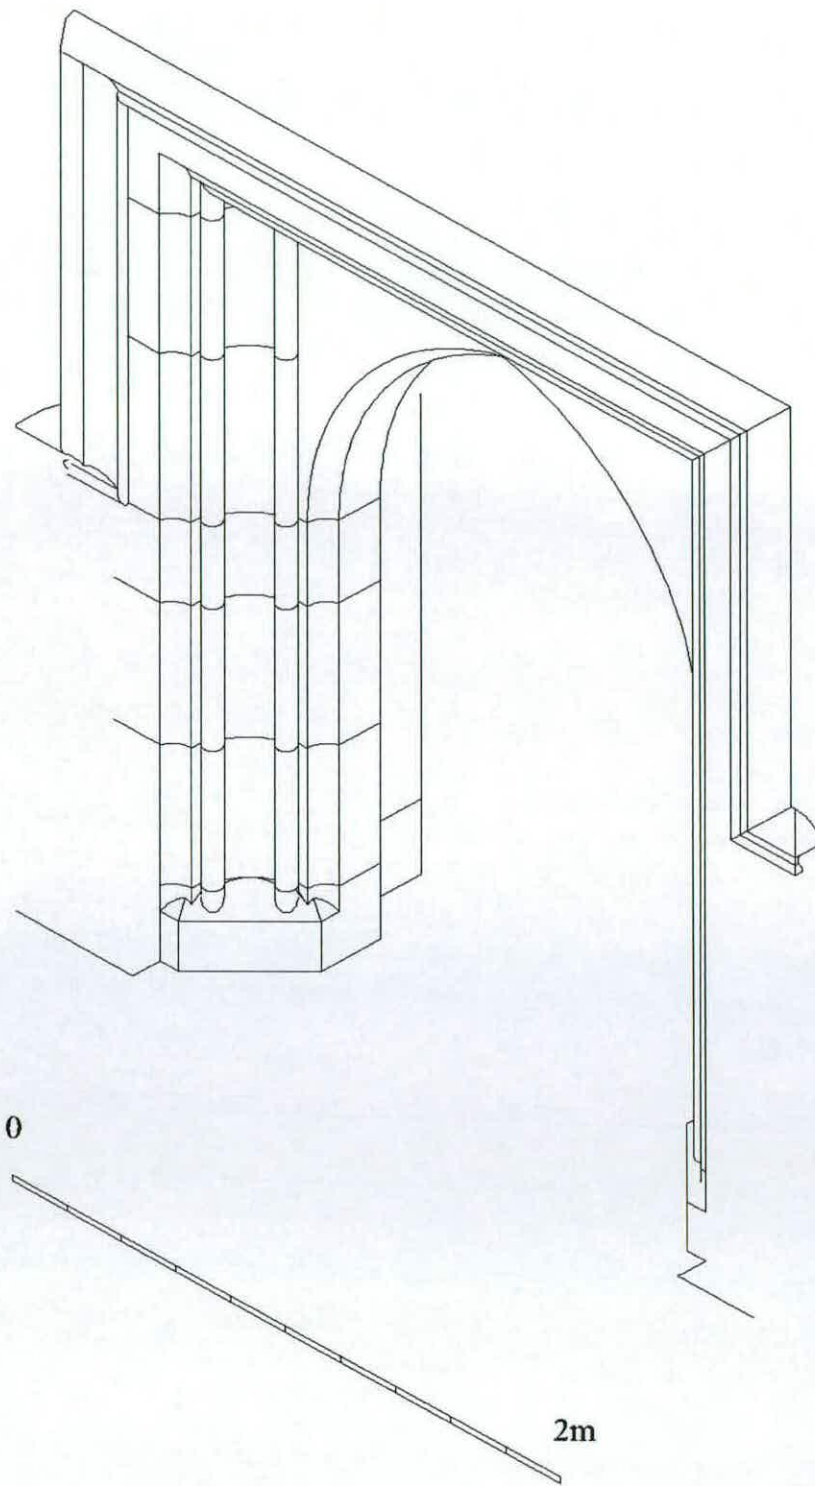
Fig. 37, an isometric reconstruction, of the east door in the south wall of the Great Hall viewed from the south, drawing number 0021.

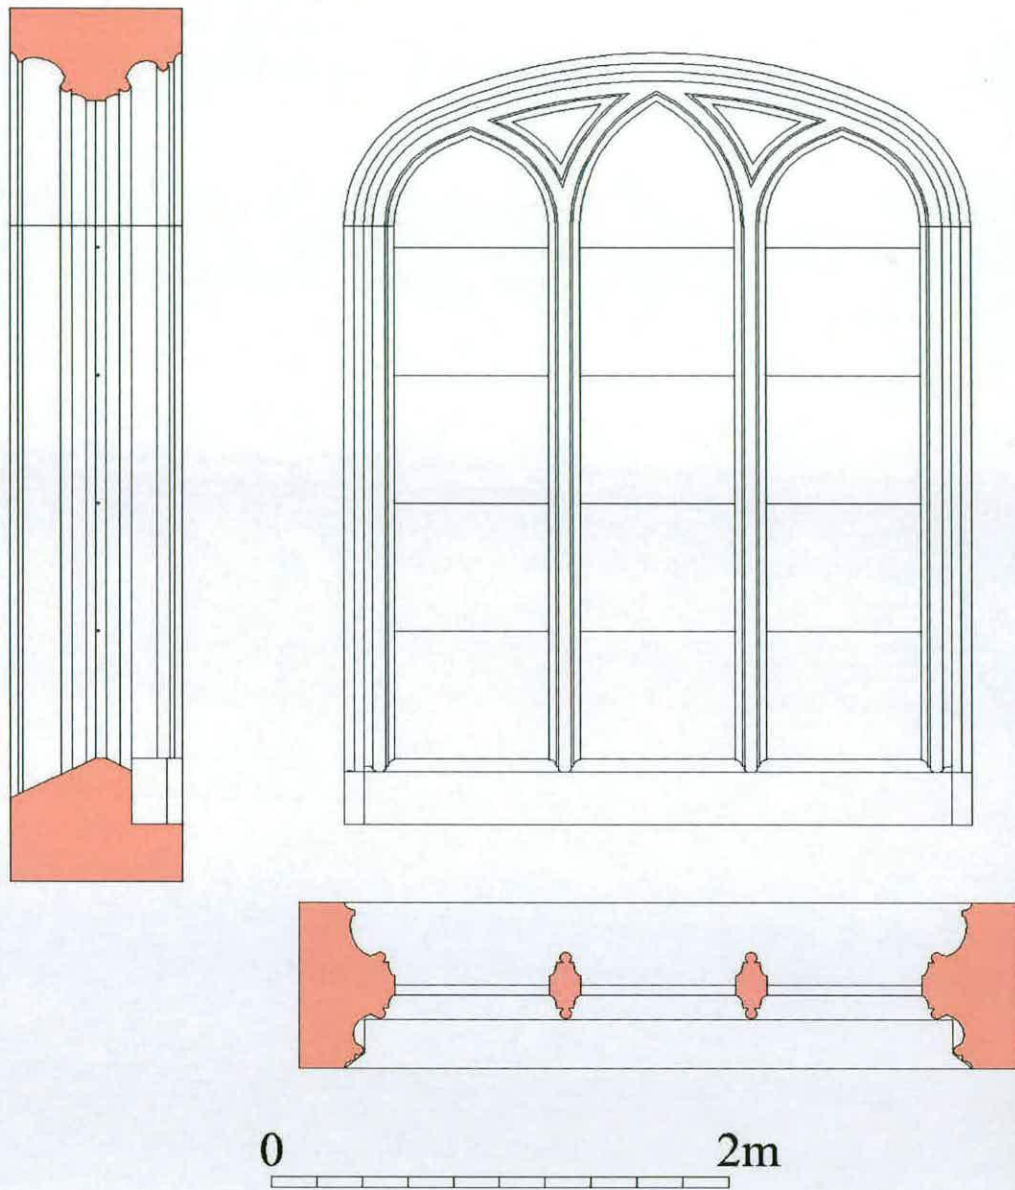
Fig. 38, plan, section, and elevation of one of the windows in the Great Hall, drawing number 0022

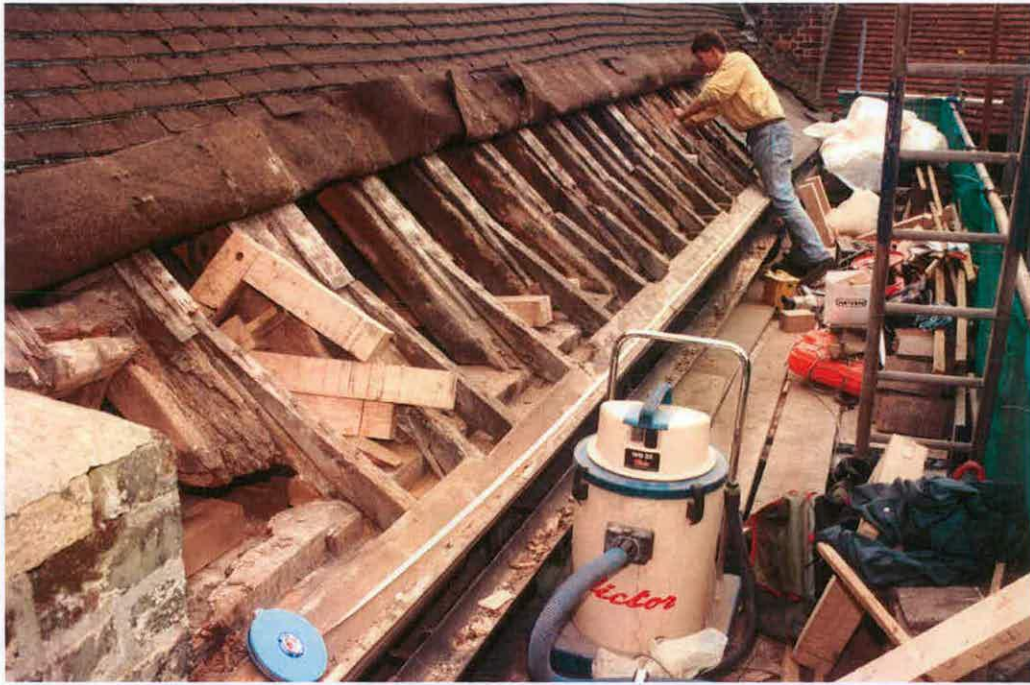
Fig. 39, the rafter ends above the north wall of the Guard Room. Photograph: October 1995

The tiles were removed from the affected area and access was provided by external scaffolding at eaves level, Fig. 39. The repairs involved the installation of timber frames designed to triangulate the rafters with the two wall plates, Fig. 40. The original rafter ends and housings were exposed and it was possible to draw the timbers and their sections, Fig. 41 to Fig. 42.

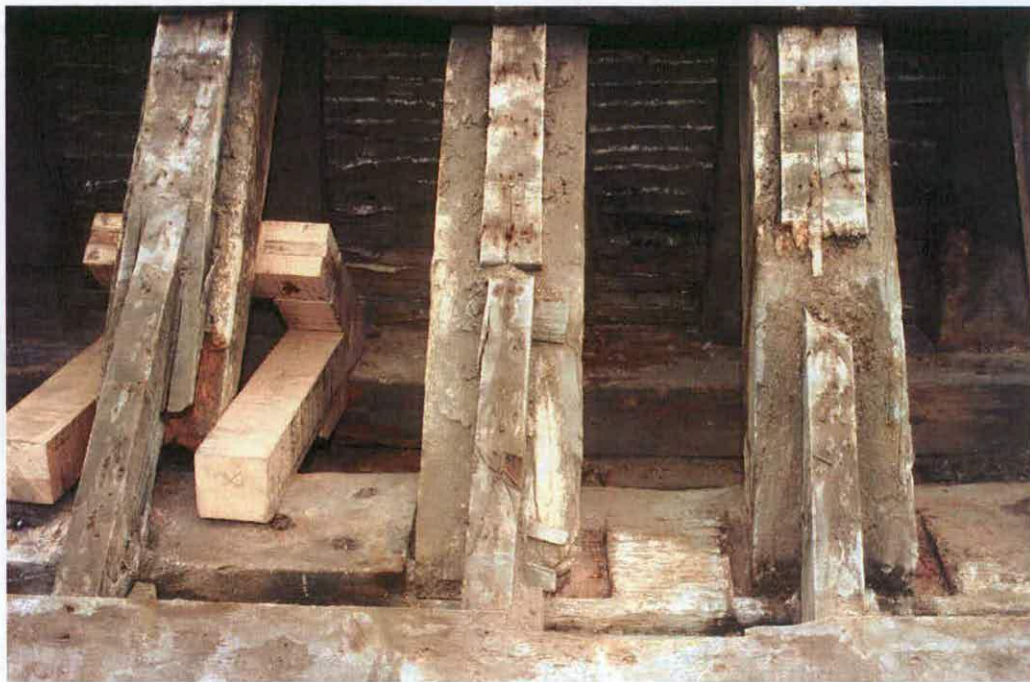
Fig. 40, rafter ends above the north wall of the Guard Room with one of the timber frames installed in 1995 to triangulate the rafters with the wall plates. Photograph: October 1995

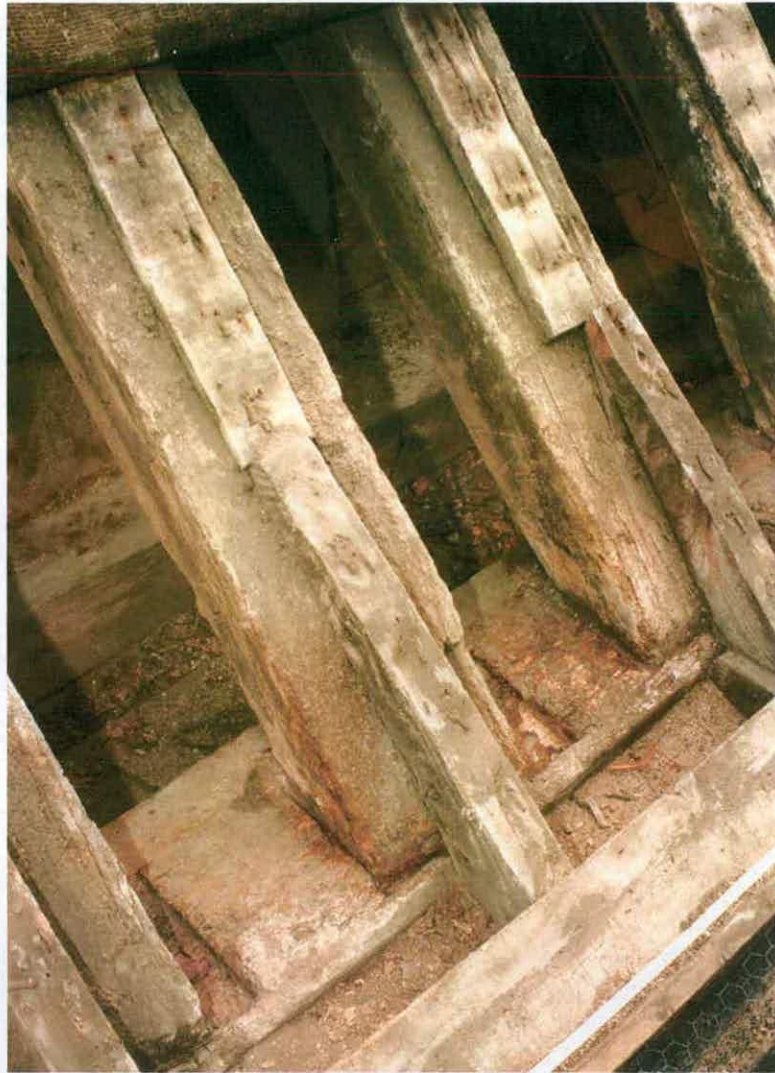
The rafters sit on the outer wall plate. For each of the rafters, curved timbers forming arch braces or ashlar pieces rise from an inner wall plate that is moulded on its inner face. Short timbers tie the two wall plates together. The roof appears to have had no longitudinal bracing. This raises the question of the function and significance of the moulded principal trusses. What purpose did they serve? They do not offer significantly more resistance to the roof spreading. Perhaps, it was intended that the roof be lined with boards to create a tunnel vault, articulated into bays by the moulded principals. Such boarding would have provided a significant degree of resistance to racking.

Fig. 41, the rafter ends above the north wall of the Guard Room, set in their housings in the outer wall plate. Photograph: October 1995.

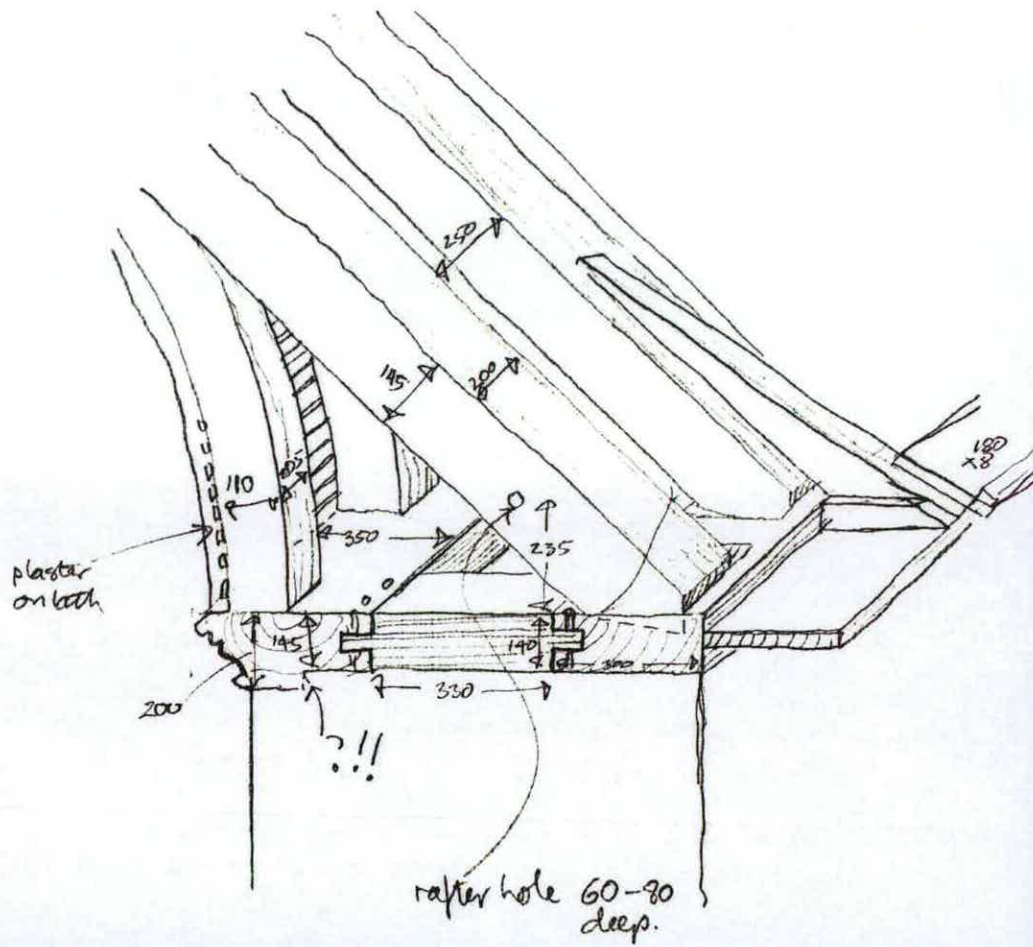
Fig. 42, a sketch showing some of the details of the Guard Room roof at eaves level.
