Wiltshire

Archaeological Investigation Report Series AT/31/2004

SURVEY REPORT

**OLDBURY CASTLE HILLFORT,
WILTSHIRE**

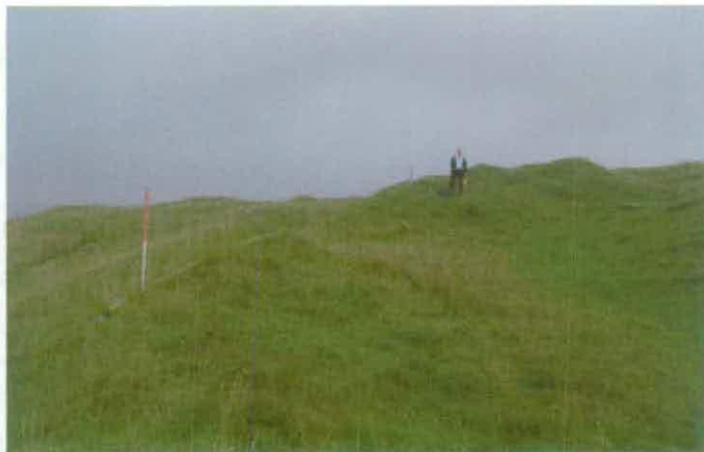
Fig 1. Inner ditch and outer rampart at the west end of the fort; the flat sarsen block can be seen in the ditch bottom, to the right of the figure

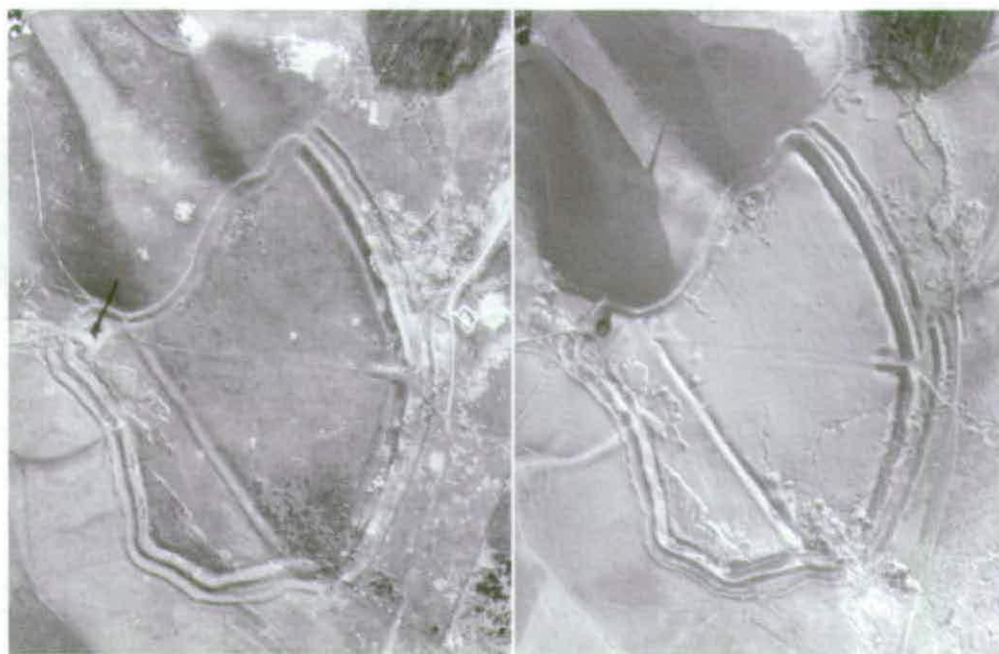
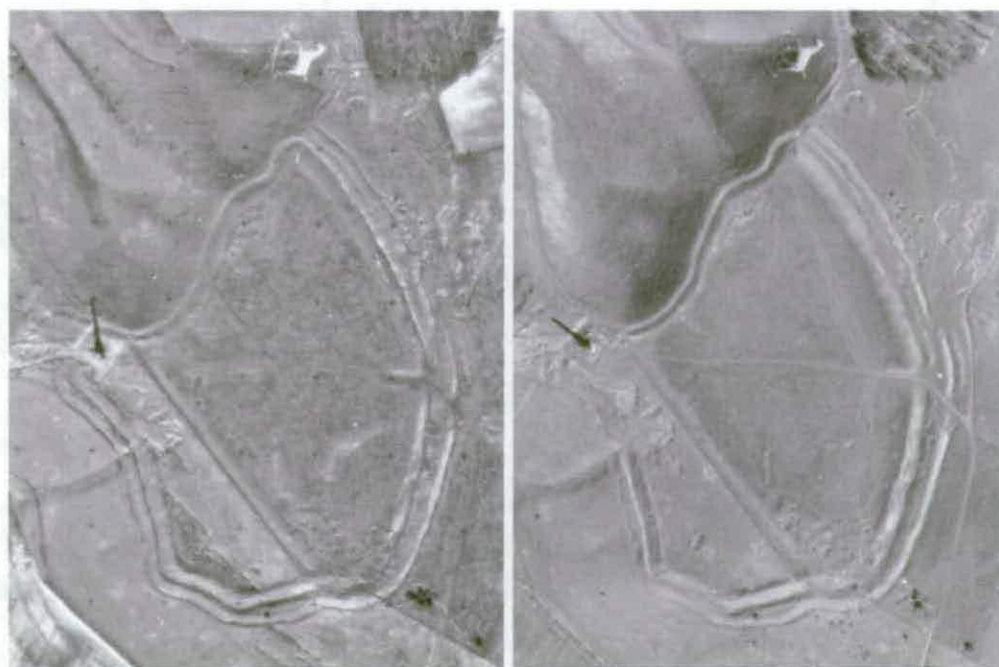
Fig 3. Vertical aerial photographs of Oldbury; a, 14 Apr 1946 (RAF 106G/UK/1415/4069); b, 1 Dec 1952 (RAF 540/958/4147); c, 10 Apr 1973 (OS 73070/118); d, 28 Apr 1989 (OS 89094/149)

There are two breaches (n & p) through the outer rampart on the south-west side of the hillfort but neither of them is an original entrance nor, indeed, a major entrance at all. However, one of them (p), which occurs at a point where there is a major change in levels in the ramparts, was in use as a vehicular access route in 1946 (RAF106G/UK/1415/4069-4070 – see Fig 3a).

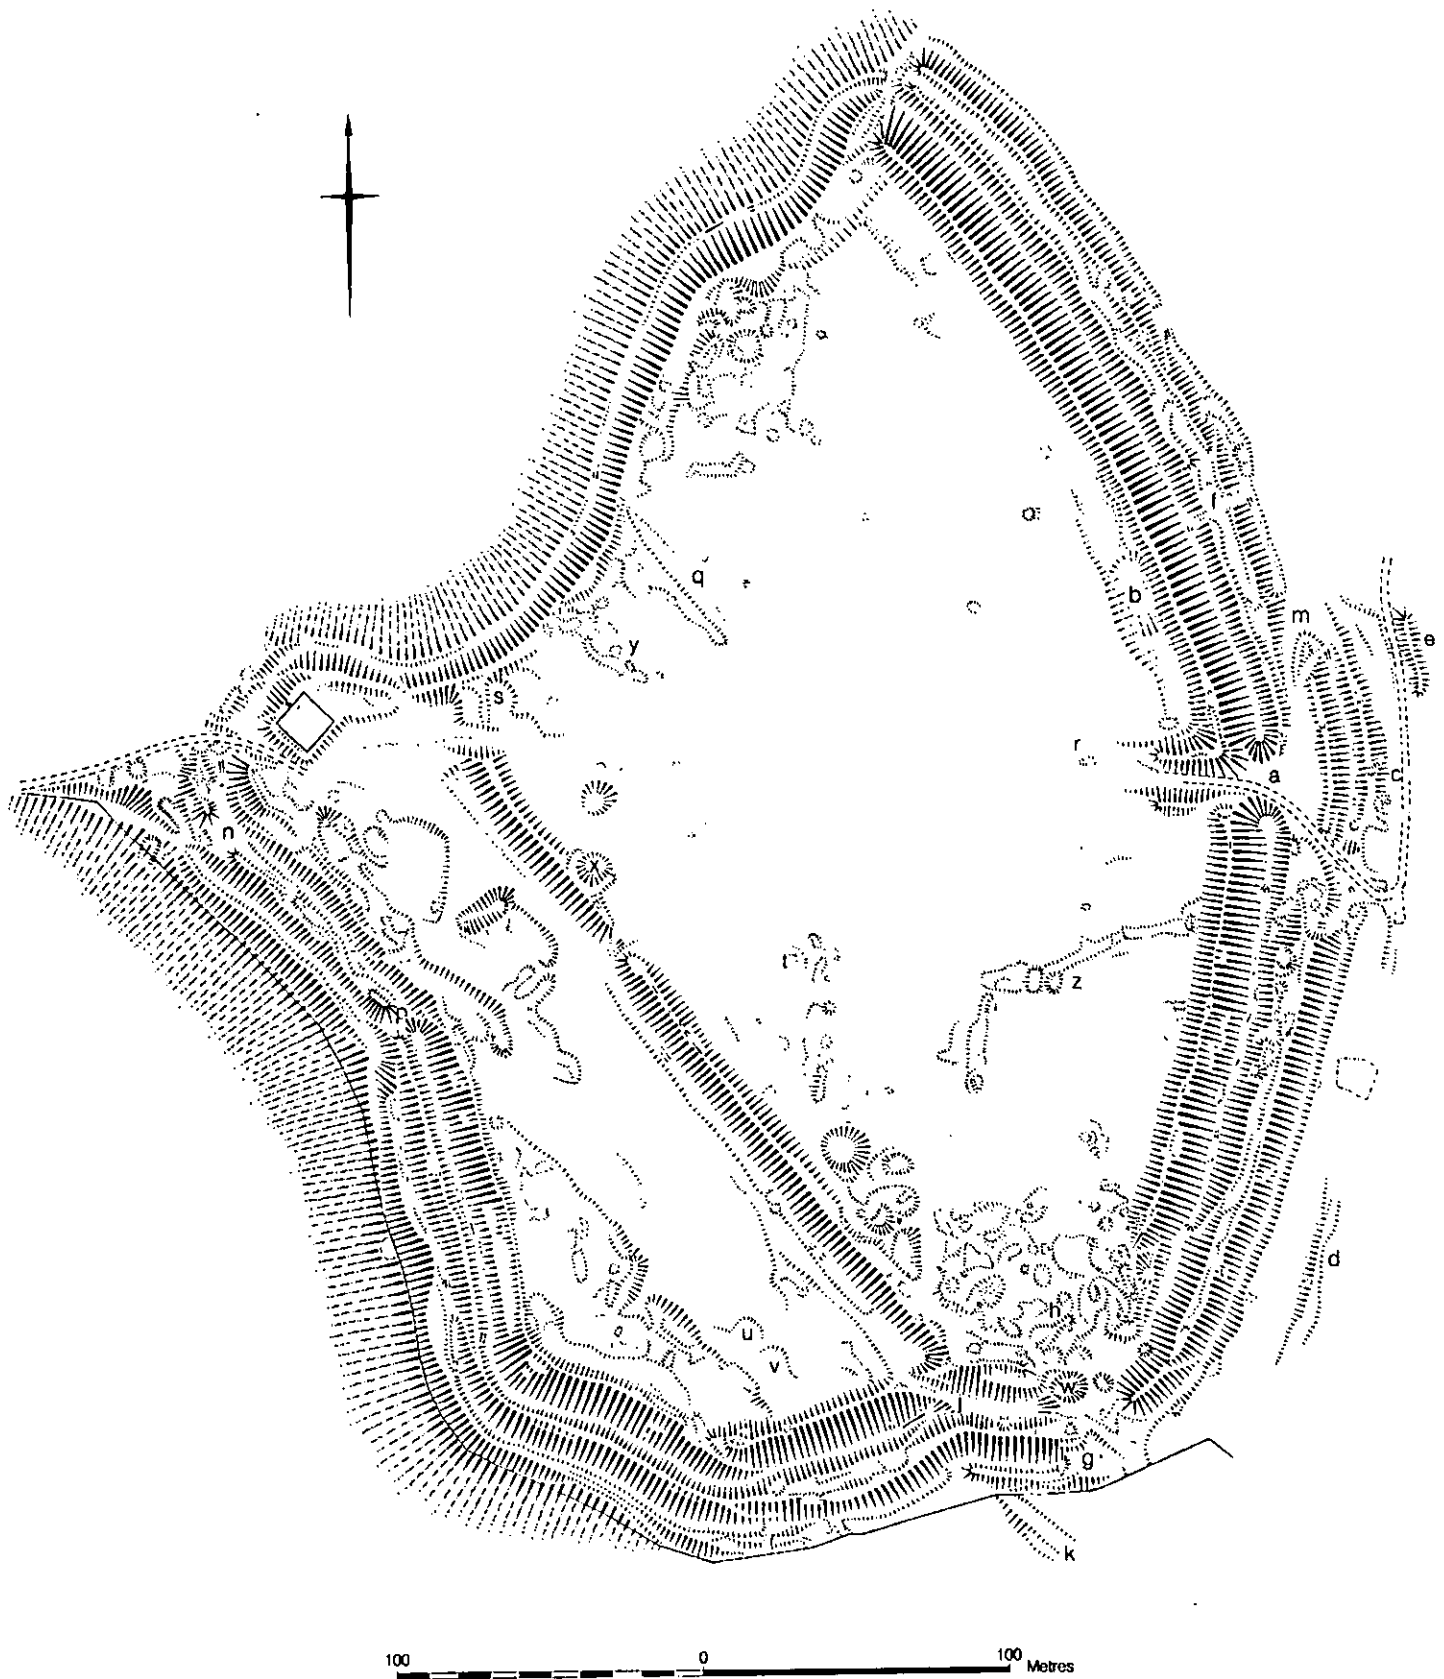
Fig 4. Earthwork survey plan, reduced from original at 1:1000

For such a large and prominent hillfort, Oldbury has received surprisingly little attention from archaeologists. Richard Colt Hoare surveyed and described the earthworks (1821, 97, pl VIII). The activities of flint diggers rather than antiquaries in the 18th and 19th centuries recovered some interesting finds, though there were also some cursory excavations (Cunnington 1887; 1894). The finds recovered span an era from the Neolithic to the Post-medieval, with almost all periods represented. Aside from an excavation in 1930 (VCH 1957, 53), no further intrusive researches are recorded. The site was surveyed for the 1st edition OS 25-inch map in 1885, and re-surveyed and recorded for the OS Archaeology Division by J Palmer in 1968 (NMR no SU 06 NW 27). Aerial photographic transcription of the area as part of the Avebury World Heritage Site Project was undertaken in 1996 (Helen Winton pers comm; Small 1999) and geophysical survey of a large part of the interior of the fort took place in the same year (Payne forthcoming). The survey reported here is the first detailed investigation of the earthworks (Fig 4).

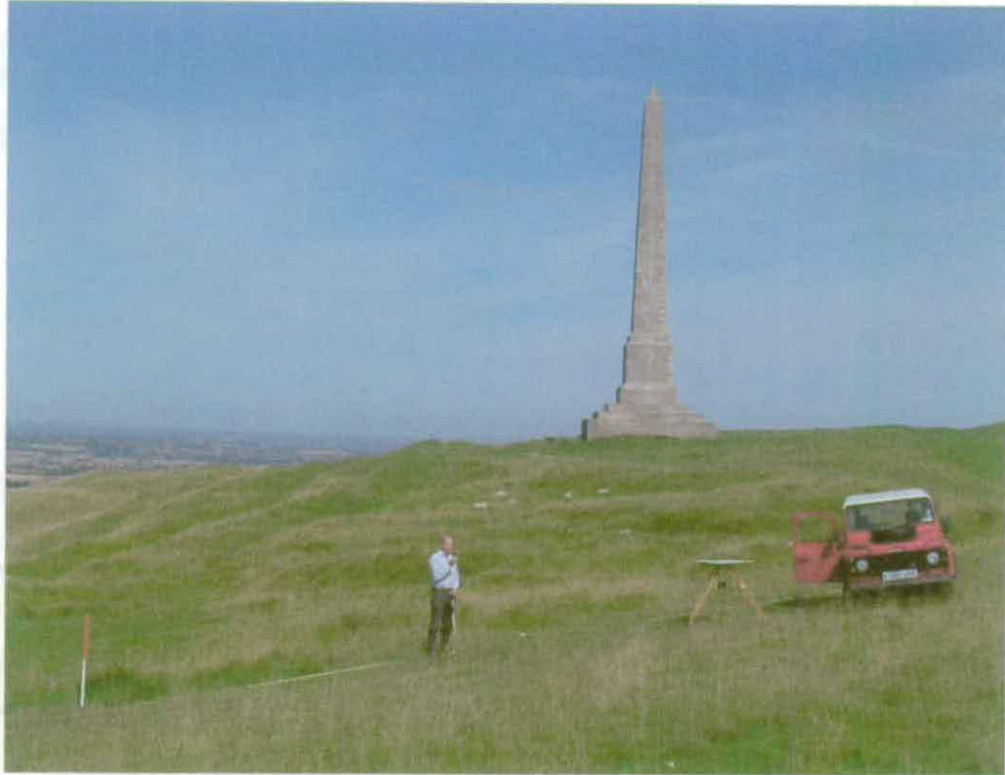
Fig 5. Quarries in the south-western part of the fort

The quarrying (Fig 5) lies in bands more or less along the contours and is presumably following seams of flint. The apparently haphazard digging of deep cone-shaped hollows is probably explained by the deposits of Tertiary material containing flint, lying in solution hollows in the chalk (Cunnington 1887, 221). However, flint was not the only material being extracted. Chalk was also taken and an 'Old Sand Pit' is marked on the 1st edition OS 1:2500 map (1886) (w). This map also indicates the extent of quarrying in the mid-nineteenth century, especially in the southern corner of the hillfort where a small rectangular 'Chalk Pit' is marked in an area that has been extensively quarried out; whether the more extensive quarrying is later or whether the mapped 'Chalk Pit' represents the final phase of this activity is uncertain, but earthwork and aerial photographic evidence (see Fig 3d) supports the latter interpretation. Pastoral activity is also represented in the earthworks – cut partly into the back of the cross-rampart is a small dew pond (x). This is smaller than the usual Wiltshire dew ponds and is not shown on Colt Hoare's plan, so might be relatively late.

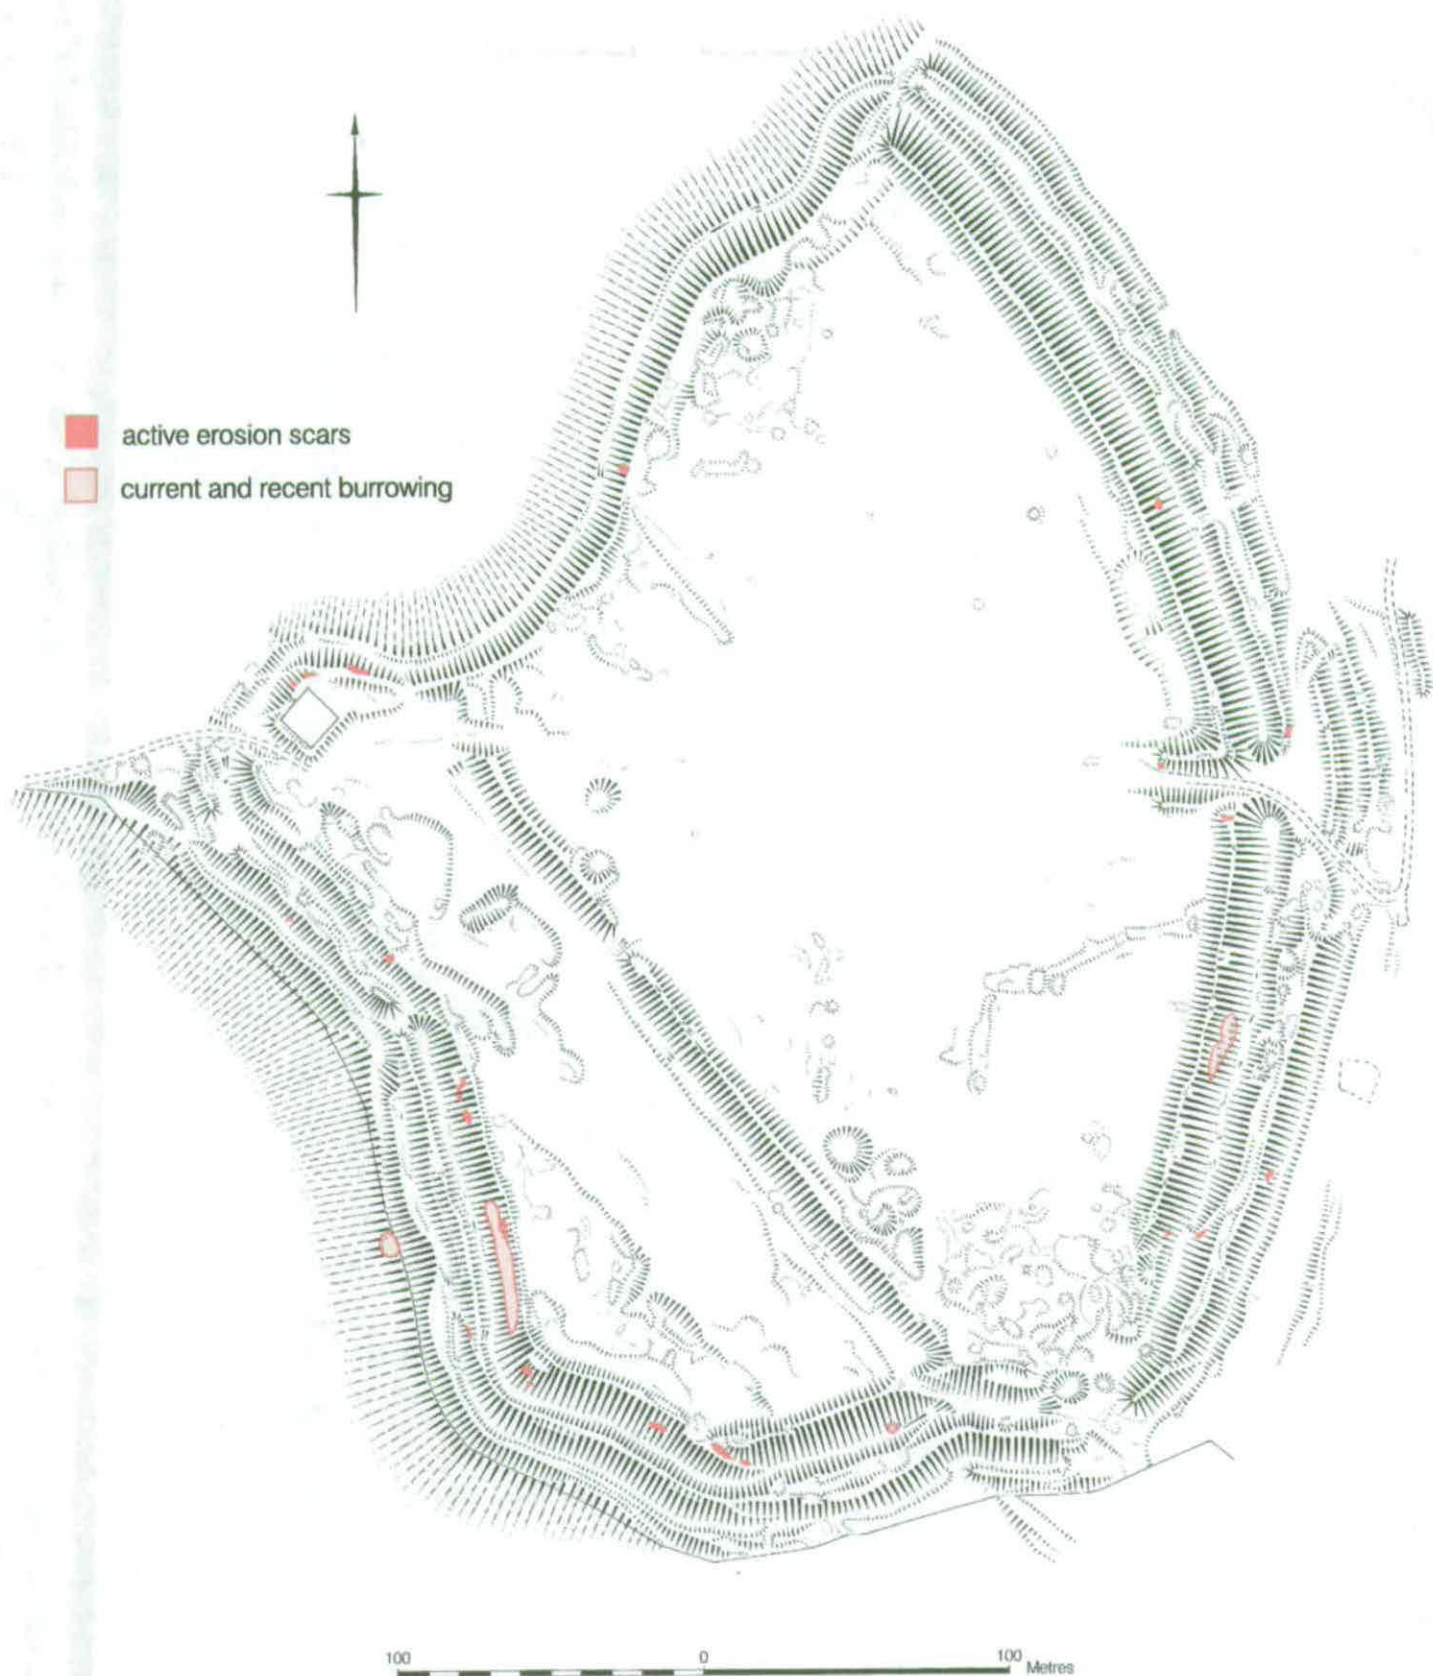
The erosion scars that gave rise to this survey are not numerous, though some individual examples are deep and clearly damaging the monument (Fig 7). More worrying is the evidence of continued burrowing and the illicit use of the earthworks for off-road vehicles (Fig 8). Unless checked, these may lead to serious damage.

Fig 7. Current erosion scars (over 1m long) and main areas of animal burrowing

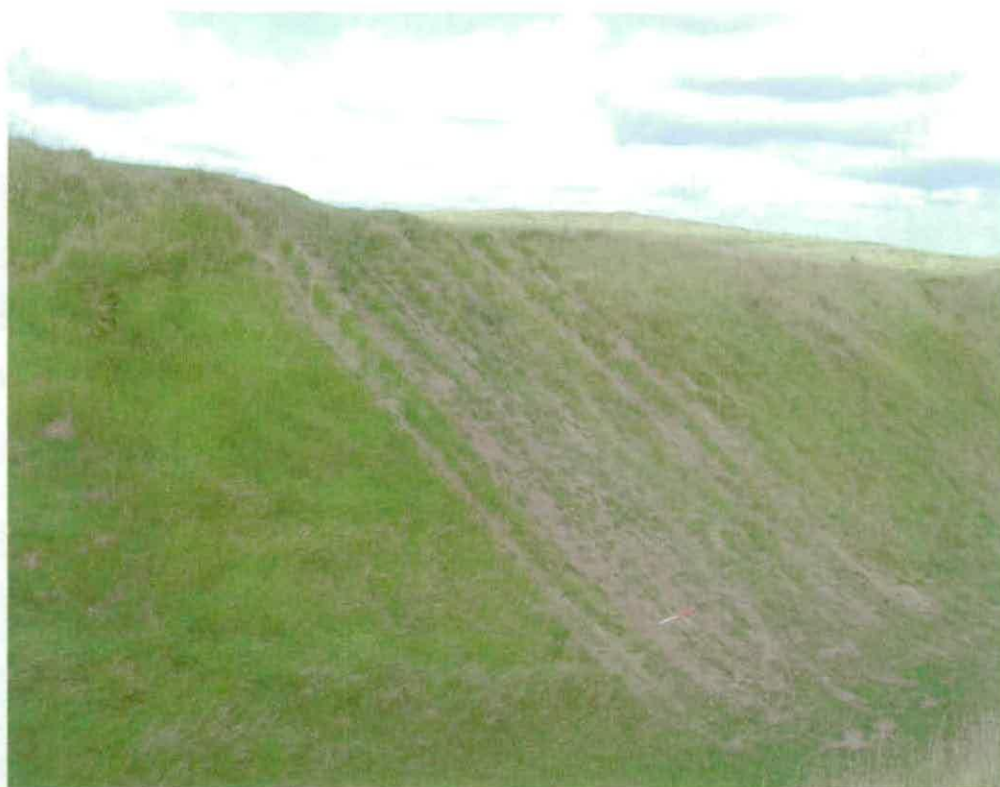
Fig 8. Damage by off-road vehicles; inner rampart, north of the east entrance
