SURVEY REPORT

Archaeological Investigation Report Series

**THE PINKERY CANAL,
EXMOOR, SOMERSET**

Archaeological Investigation Report Series AI/07/2004

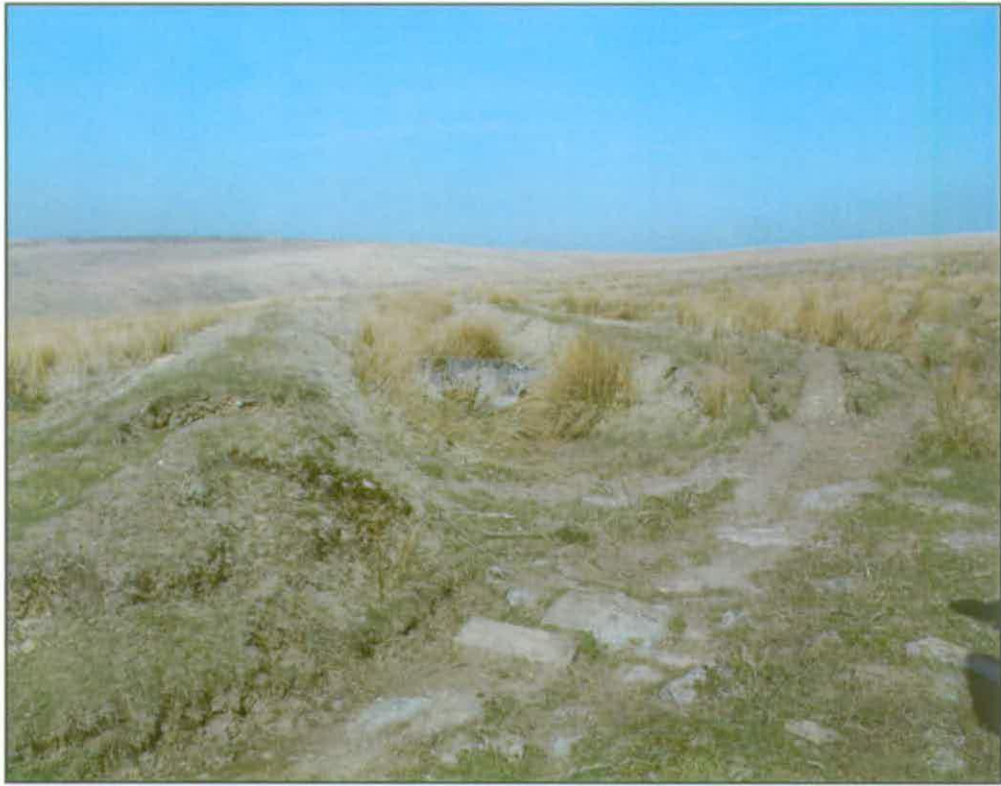
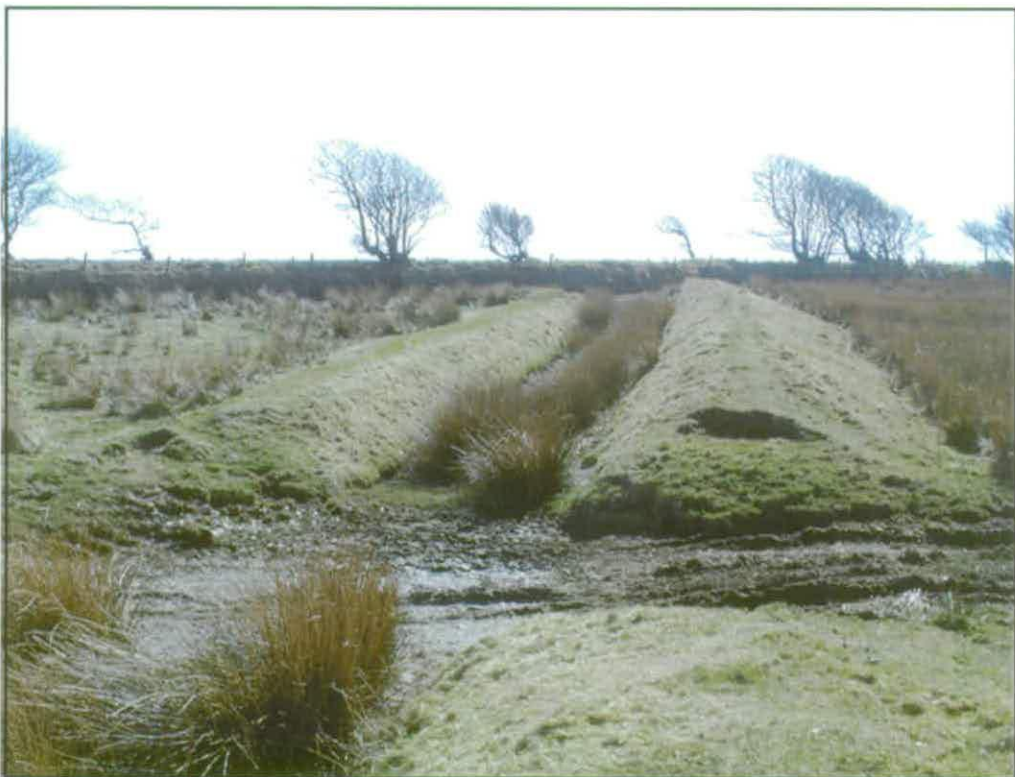
THE CANAL AT PINKERY: Looking west (above); looking east (below)

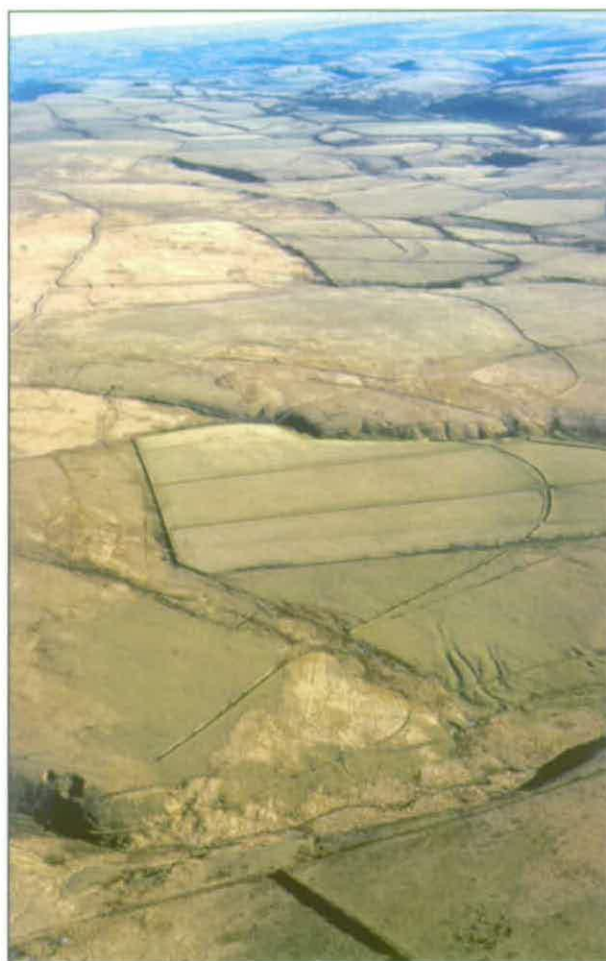
Figure 2
Aerial view
looking West
along the Canal
(© Crown
copyright NMR:
15606/16)

The Pinkery Canal is situated on the south-facing slope of the central ridge which runs east-west across Exmoor [Fig 2]. It runs from below Pinkworthy Pond at NGR SS 721 419, along the 435m contour above Simonsbath to NGR SS 793 402 opposite Warren Farm. The land above is the moorland plateau with blanket bog, known as The Chains, with a height of 460 to 487m (Maltby 1995, 33). The River Barle rises there and is soon dammed by Pinkworthy Pond. The River Exe also rises above the canal further east at Exe Head. Several streams have cut small valleys (known as combes) into the slope.

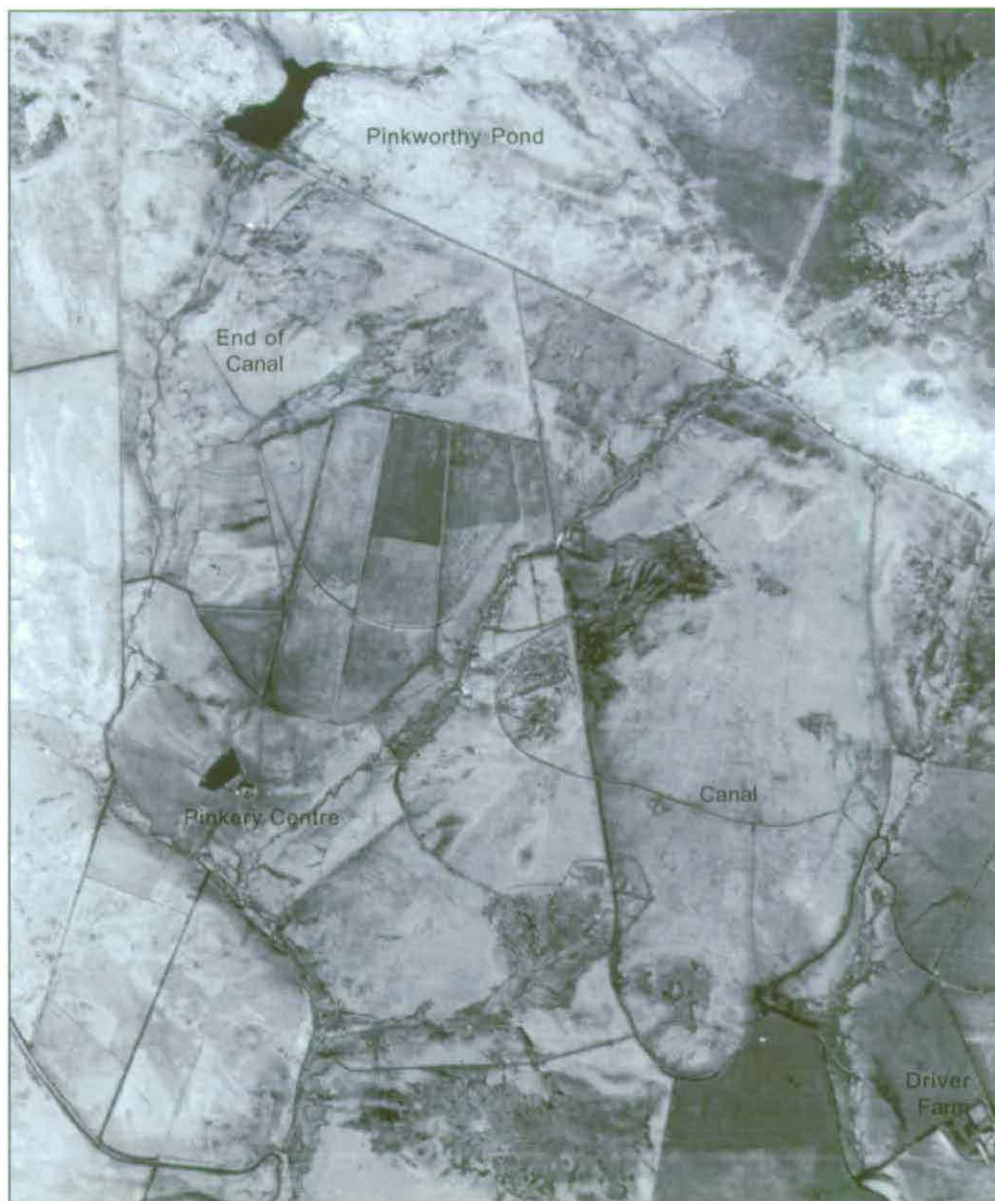
Figure 3
Aerial photograph
of Pinkworthy
Pond and the
Canal (© Crown
copyright NMR:
3149, 11/4/47)

The aerial photograph of The Chains [Fig 3] shows not only the canal's location and relation to Pinkworthy Pond, but two other features of the high moors: extensive efforts at surface drainage and peat-cutting. Both these factors will have affected the land below, though the miles of drains do not appear to have been able to cope (Orwin 1997, 58). Exmoor has a damp climate with high average rainfall (2000mm +).

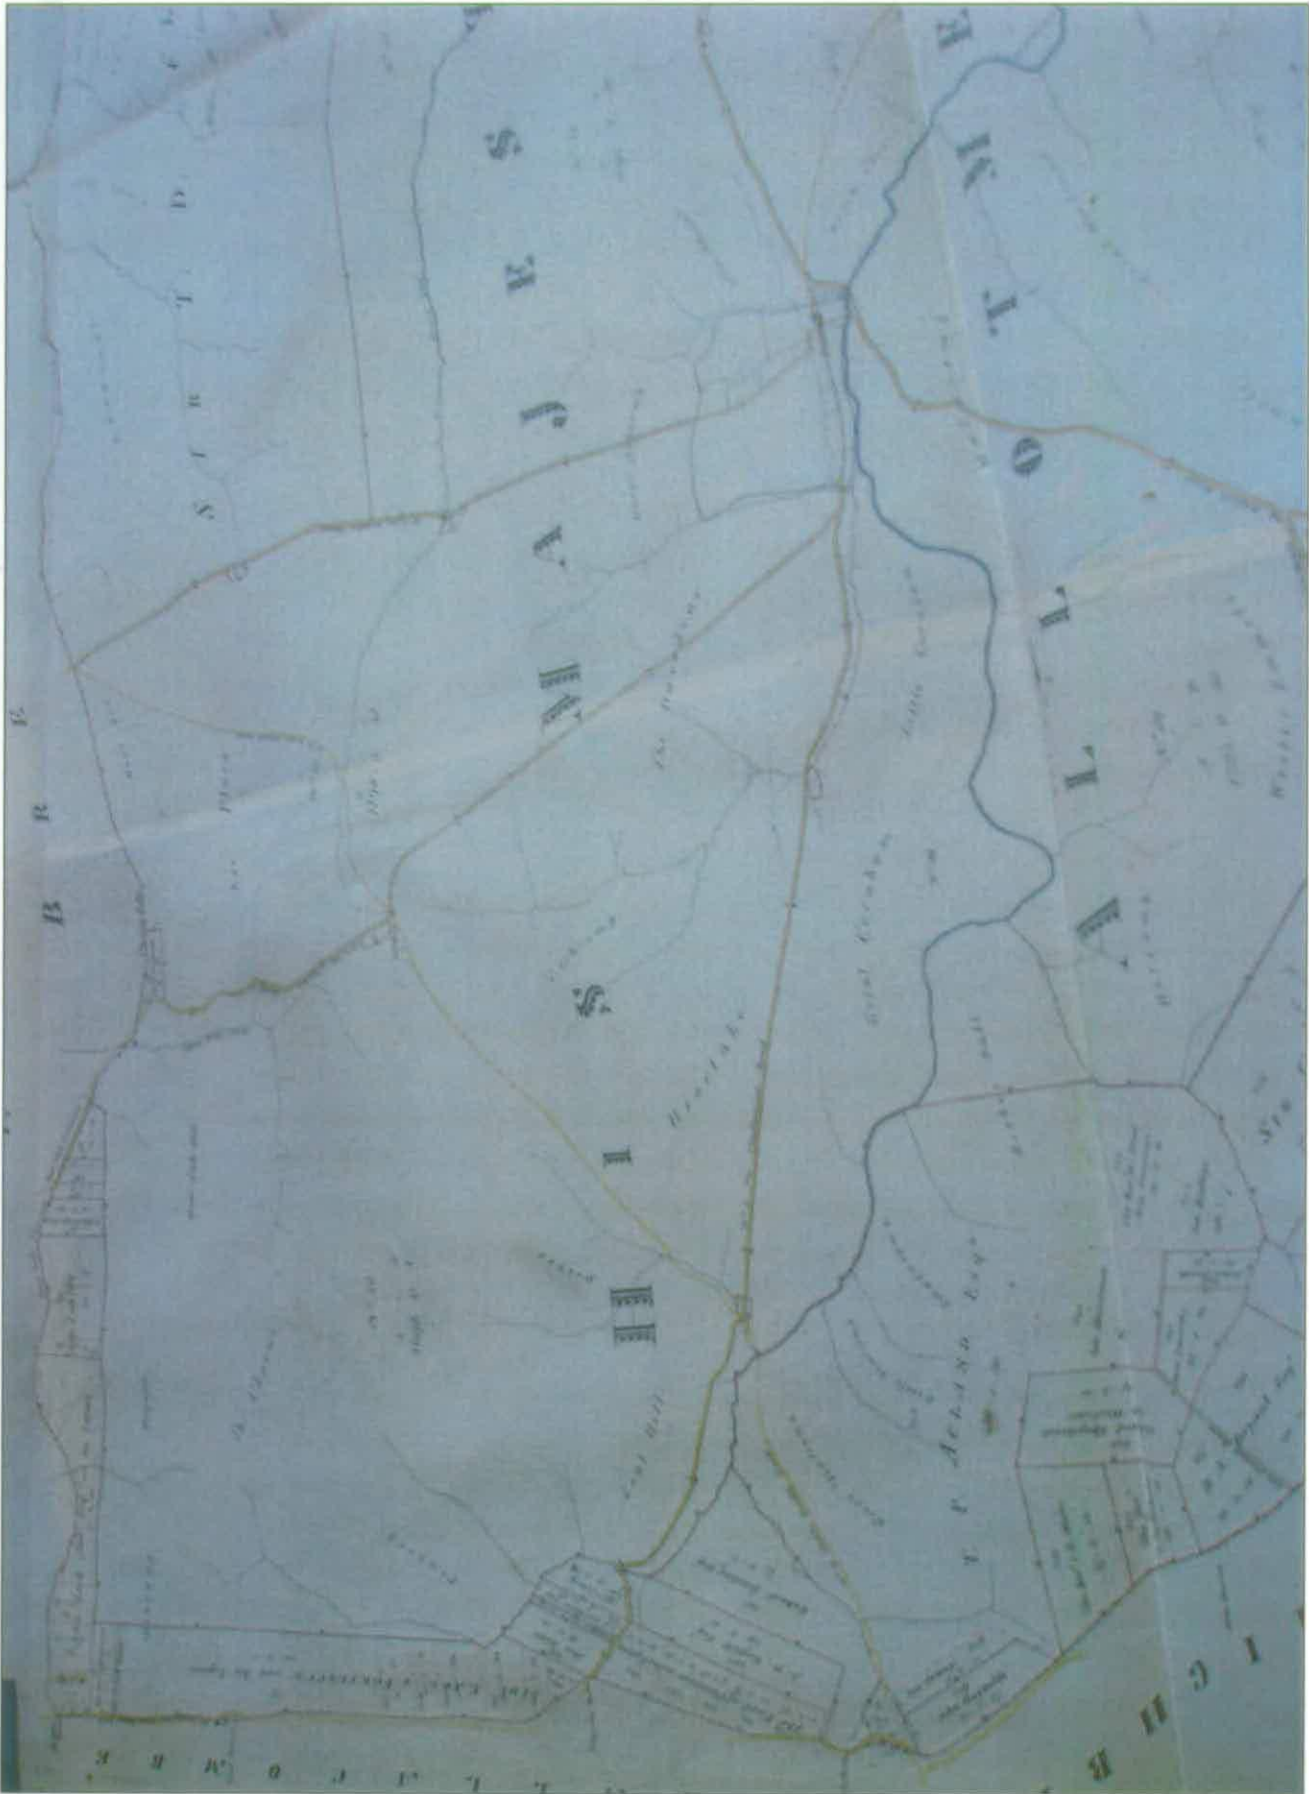
Figure 4 1819 Exmoor Inclosure Map (SCRO Q/Rde/140), reproduced with permission of the Somerset Archive and Record Service

The 1818 and 1819 maps by the Inclosure Commissioners (referred to above and in Fig 4) show the area of the Royal Allotment to be enclosed, just prior to John Knight's purchase. The only apparent extant features are the roads and the Simonsbath enclosure, and the pond or canal are not shown. It is not possible to see the Duredon road or the No 11 bridleway and these were probably cut by the canal construction as they had gone or were going out of use. (No.11 bridleway can still be seen across Driver land as earthworks forming a hollow-way in Oxen Park Field). However the road known as the Lynton road was already in existence when the canal was built and its relationship with the canal at Prayway is uncertain. The road was described as a forty foot wide public carriage road. This would probably have been no more than a track prior to the Knights amelioration, used for the movement of animals. The construction of the pound at Simonsbath suggests the continued use for this purpose as well as other traffic. This poses an unanswerable problem regarding the relationship of the canal and the road: did the canal cut across this road? Was it to be bridged by the road? The construction of the beech hedge-banks have removed any physical relationship between the features.

- 9 – DD/BR/YL- Miscellaneous 1836-1890.
- Fig 4- Q\Rde/140- 'A map of Exmoor Forest', Inclosure Awards, 1819.
- Fig 18 DD/X/YL/1 - 'Exmoor Ironstone Deposit', undated map, c.1850-55, showing proposed railway and tramway to pits or workings. (An attempt was made to contact the depositor without success regarding reproduction.)

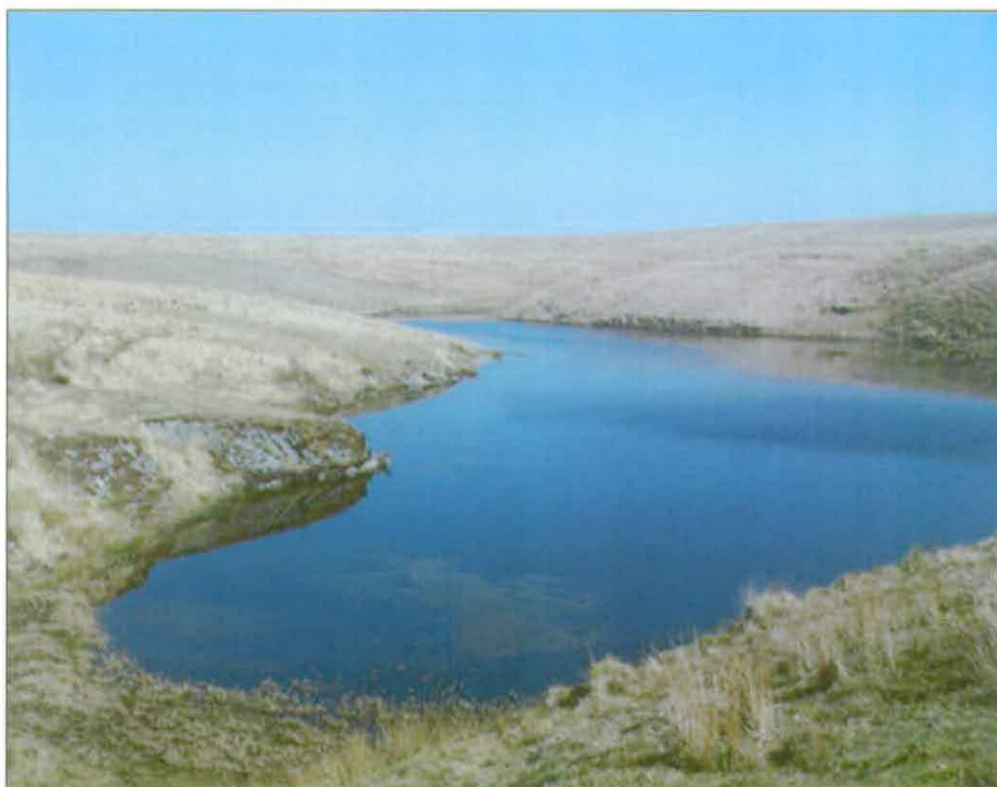
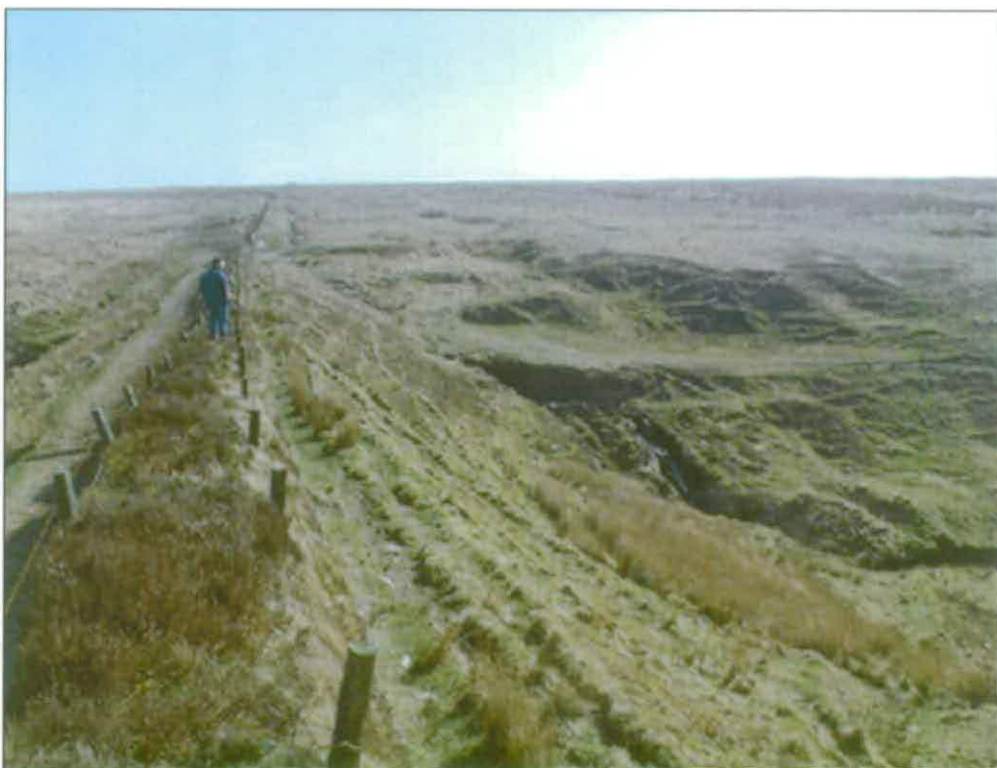
Figure 8 Pinkworthy Pond (top) and Dam (below)

Heights were taken across the top of the dam, showing it to run fairly level at 445m. An additional feature was surveyed, which appears to be an overflow for the pond at 445.217m, NGR SS 722 422. It is a ditch cut into the valley side with a bank on the downslope, eastern, side [Fig 7]. It runs a short distance southwards, down the valley, from the top of the dam. This provides a run-off at some distance from the dam, thereby preventing the danger of excess water undermining the construction. Several paths are cut into the valley sides and a leat runs off near the valley bottom towards Pinkery Farm (now the Outdoor Centre).

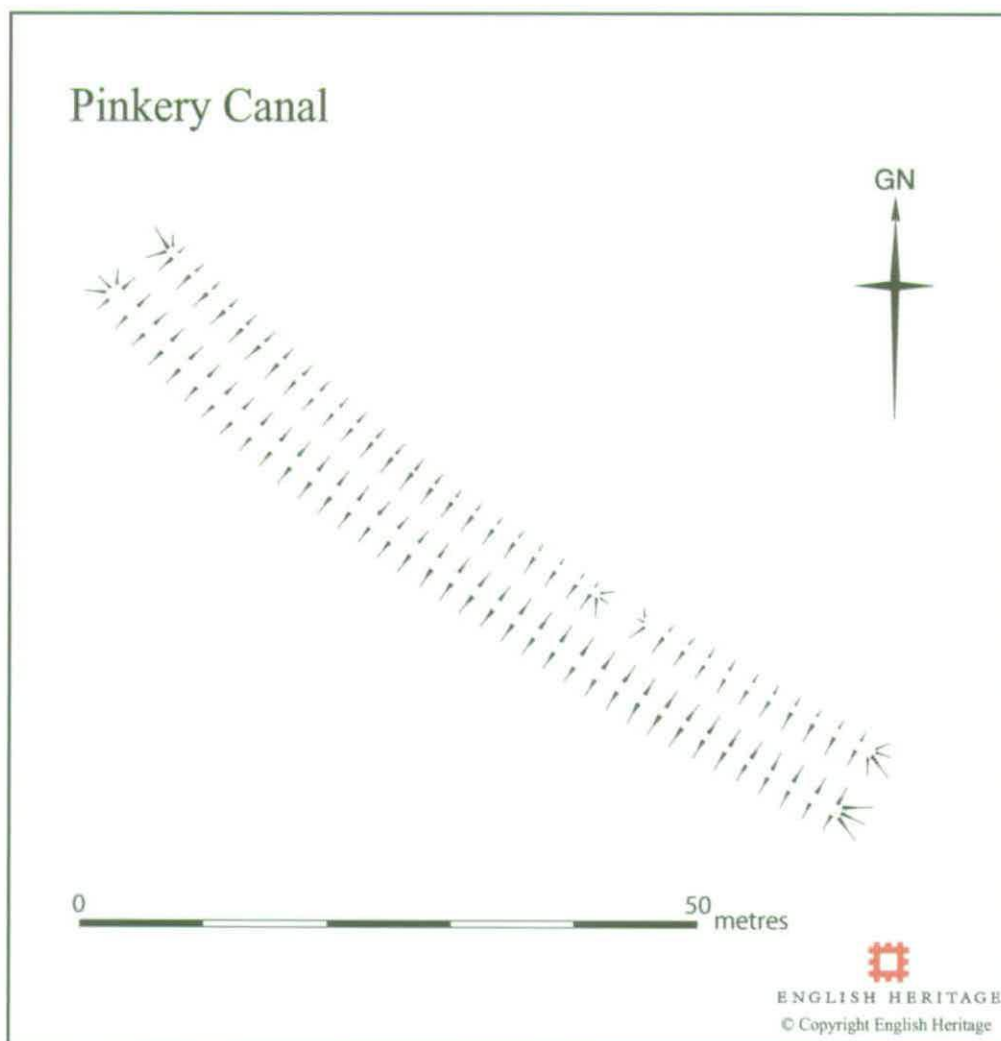
Figure 10
Earthwork plan
of a truncated
section of the
Canal, 1:500

The next section at NGR SS 724 415 was surveyed fully in order to produce an earthwork plan at 1:500 [Figure 10]. The canal is cut by more walls and several farm tracks before reaching the first combe. Its condition is generally stable along this stretch as the ground is not so damp [Fig 7, Profile 4]. Where a wall cuts the actual line of the canal, a hole is left in the construction of it near the base to allow any water still being channelled to flow through (NGR SS 725 414).

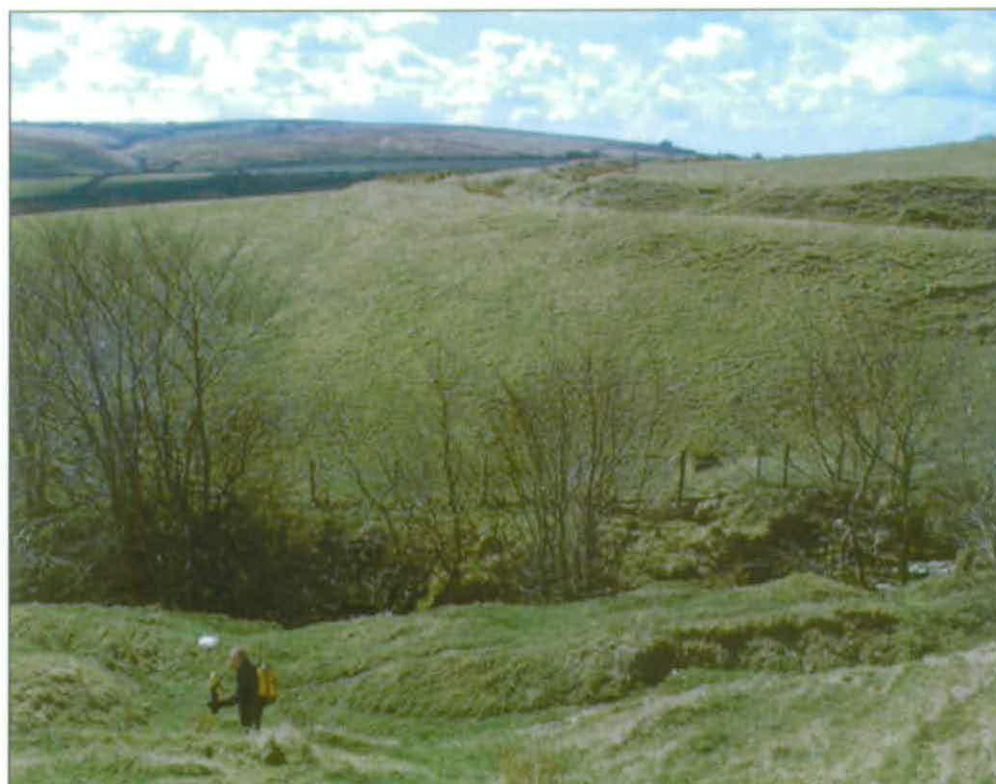
Figure 11
The canal at the border of the Astrop Estate: good survival on Driver land; a quarry in the coombe side being surveyed in the foreground

The border with Astrop Estate land is marked by another gully and quarry (NGR SS 740 410). The levels are 434.613m on the west side and 434.519m on the east. Up to this point the canal is easily recognisable as a feature (Fig 11). From this point however, the upper bank has been re-used as a hedge-bank. The ditch is quite wide and marshy; the south bank is low and wide and occasionally missing – washed away in another boggy area and cut by streams. A ditch appears deliberately cut, heading southwest, to drain this excess water. The canal is cut by a bridleway and another bank.

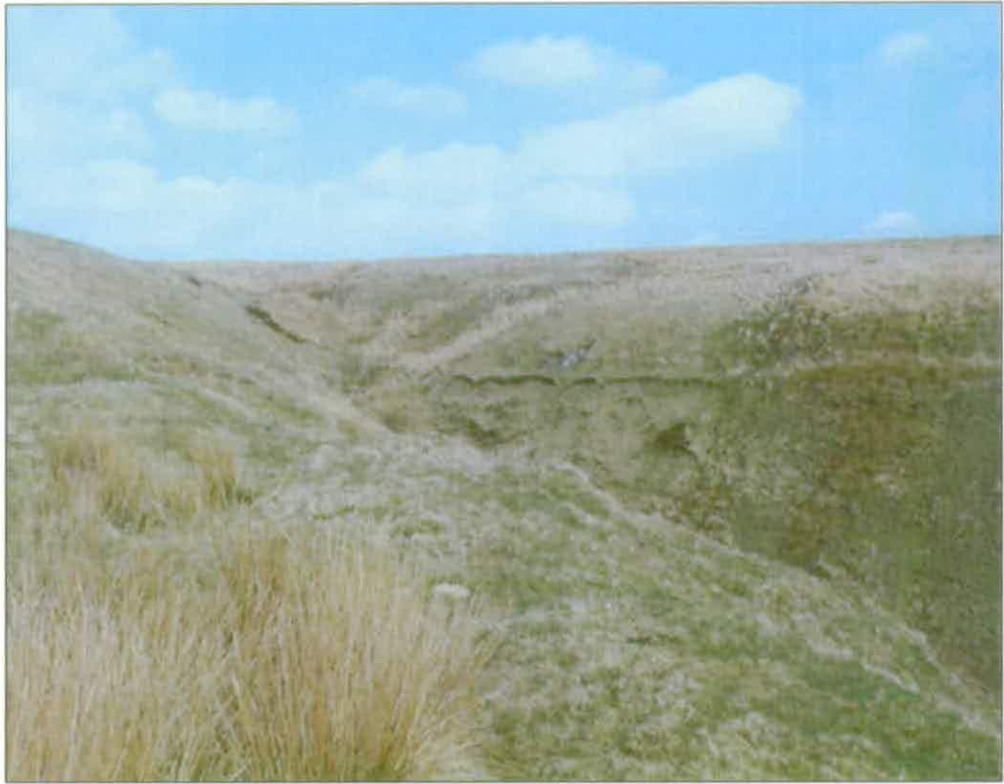
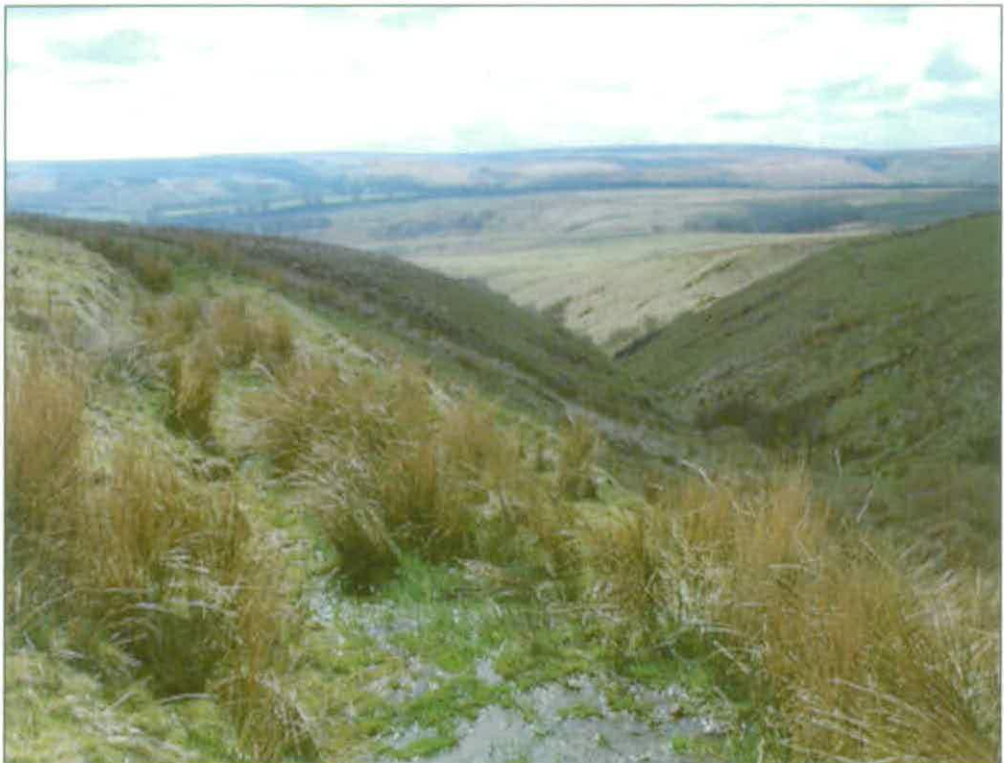
Figure 12 The Canal at Tang's Bottom: a) looking in, b) looking out

Tang's Bottom is much wider, deeper and steeper than the other combes so to remain level the canal has to go much further back into the head of the combe [Figs 6 and 12]. As the canal narrows it is cut into the rock and becomes much narrower [Fig 7, Profile 12], with a short outer bank which falls steeply down the combe edge. The combe sides are very boggy and so is the head of the combe (NGR SS 751 412). A leat runs parallel with the canal for a short section [Figs 6 and 7], visible on aerial photographs for a longer distance (NMR 3151, 11/4/47). The level on the west side of the combe is 434.906m and 434.835m on the east. The next section has again been washed away and silted up: the remains of banks can be followed along the route. In some places there is quite good survival, in others many breaches by either water or farm tracks. Then the bank sides appear quite eroded and the ditch quite wide with a deep water and marsh fill [Fig 7, Profile 13].

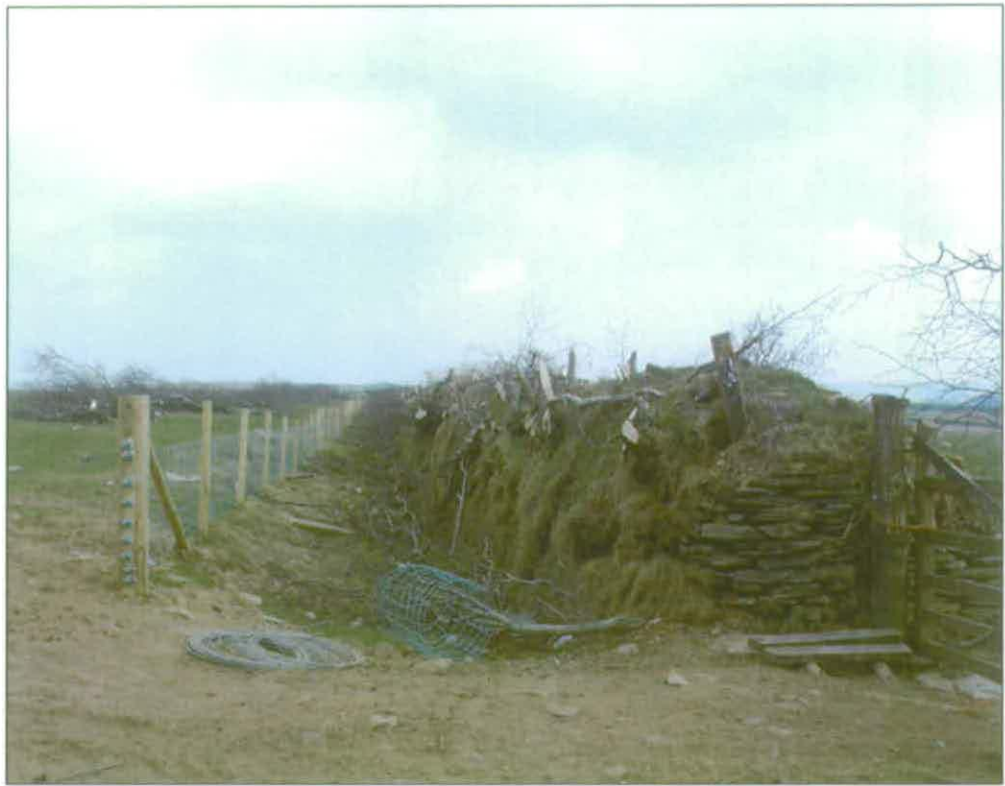
Figure 13 The canal at Prayway: virtually unrecognisable

sheep dip above Limecombe (NGR 763 408). The next section to the road is virtually unrecognisable (NGR 764 408 to 769 407) [Fig 13]. Aerial photographs confirm that this was a section of the canal. On aerial photograph NMR 3077, taken 13/5/46, it survives well up to its interruption by the sheep dip.

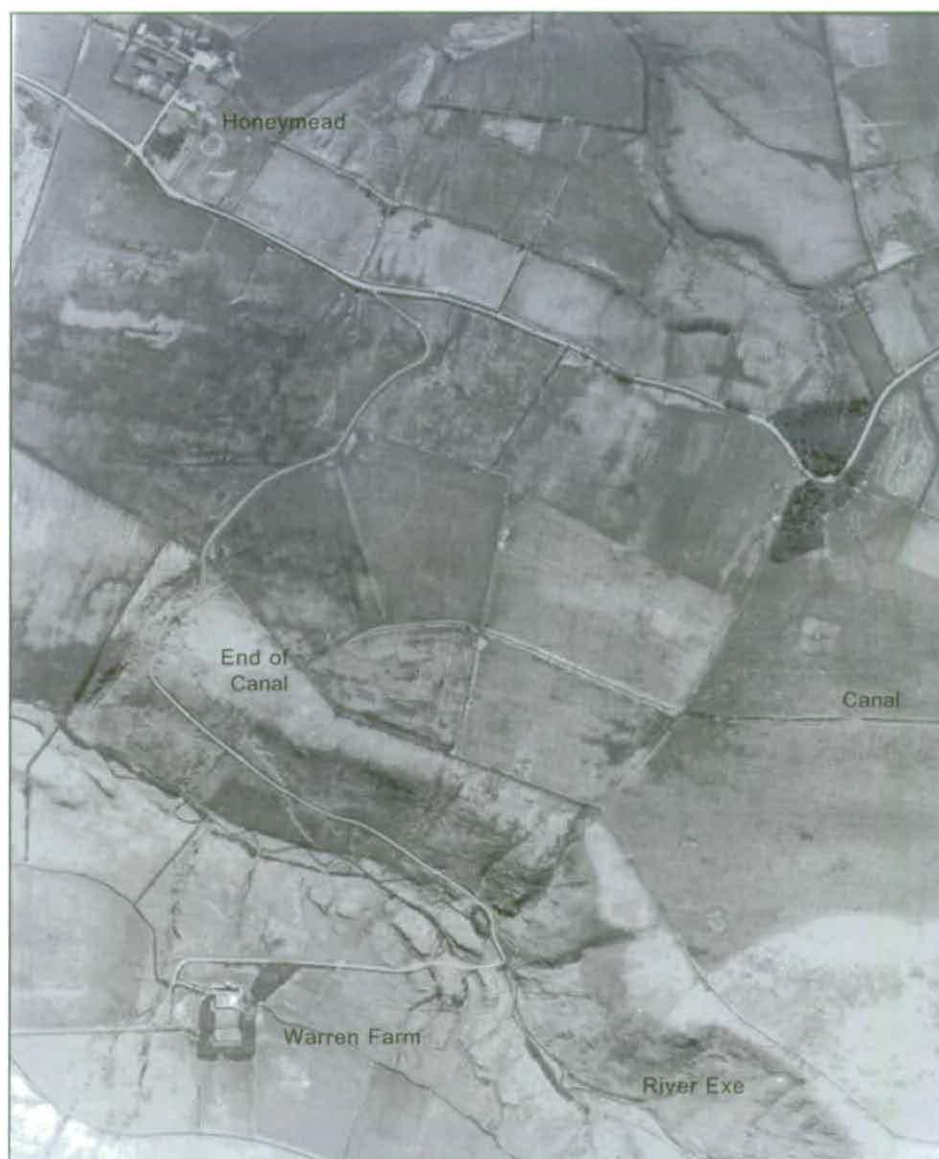
Figure 15
Aerial
photograph of
the Canal
opposite
Warren Farm
(© NMR 4156,
11/4/47)

There is a wide gap cut by the B3223 at Prayway Head. Across the road the condition is slightly better, the south bank is still the hedge bank and the north bank is often flattened. The ditch has rushes growing in it and there is more of a bank. The course continues across Ashcombe, cut by farm tracks, a bridleway and footpath; the level here is 434.457m. There is a distinctive kink in the field boundary at NGR SS 776 786: at this point the hedge bank is no longer imposed on the feature but carries straight on [Figs 6 and 14]. The course of the canal is hard to spot; a level was taken at 435.197m where it is filled with ploughsoil. As it heads across the field it is almost totally ploughed out, though occasional remnants of banks and a slight hollow are discernible (NGR SS 775 405) [Fig 7, Profile 15]. In an aerial photograph taken 13/5/46 (NMR 3075), it is clearly defined to the kink in the bank. The ploughed out section was visible after heavy snow on 7/3/79 (NMR SS 7740/6/157).

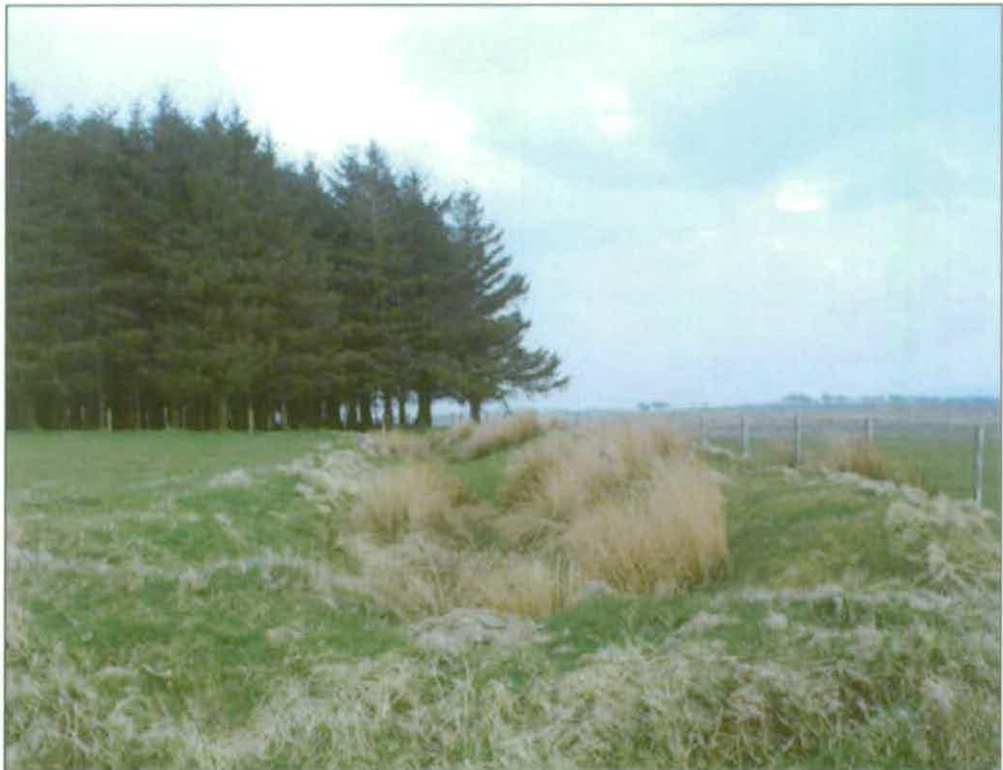
Figure 16a
*The Canal at
Three Combe
Hill: fairly good
survival*

A final section survives in fairly good condition (NGR SS 792 402 to SS 793 402) and its form is returns to that of the Pinkery end although the banks are slightly more eroded; the level at the base is 434.510m [Fig 7, Profile 16 and Fig 16a]. The canal then continues into the plantation on Three Combe Hill, where it survives right through, cut by fences and pipes carrying cables to masts within the plantation [Fig 16b]. This plantation has appeared by the aerial sortie of 27/6/53 (NMR CAP 8120/56). The canal finally terminates in this field at NGR SS 793 402; the level is 434.870m. The bank ends appear to have been ploughed over- they are not so well defined as at the western end. On a photograph of 13/5/46 (NMR 3073), the canal can be seen before the trees were planted and it terminates at the same point. A slight mark caused by water run-off is visible. Aerial photographs of the area to the east of this point (NMR 3128-9, 8/11/52; 67/76/158, 4/8/76; 3072,13/5/46) confirm that the canal goes no further.

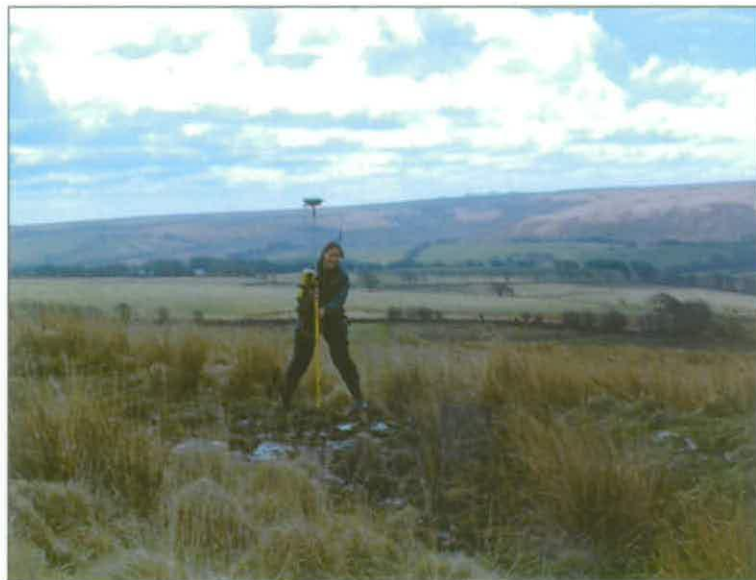
Figure 17
Difficulties in surveying on boggy ground

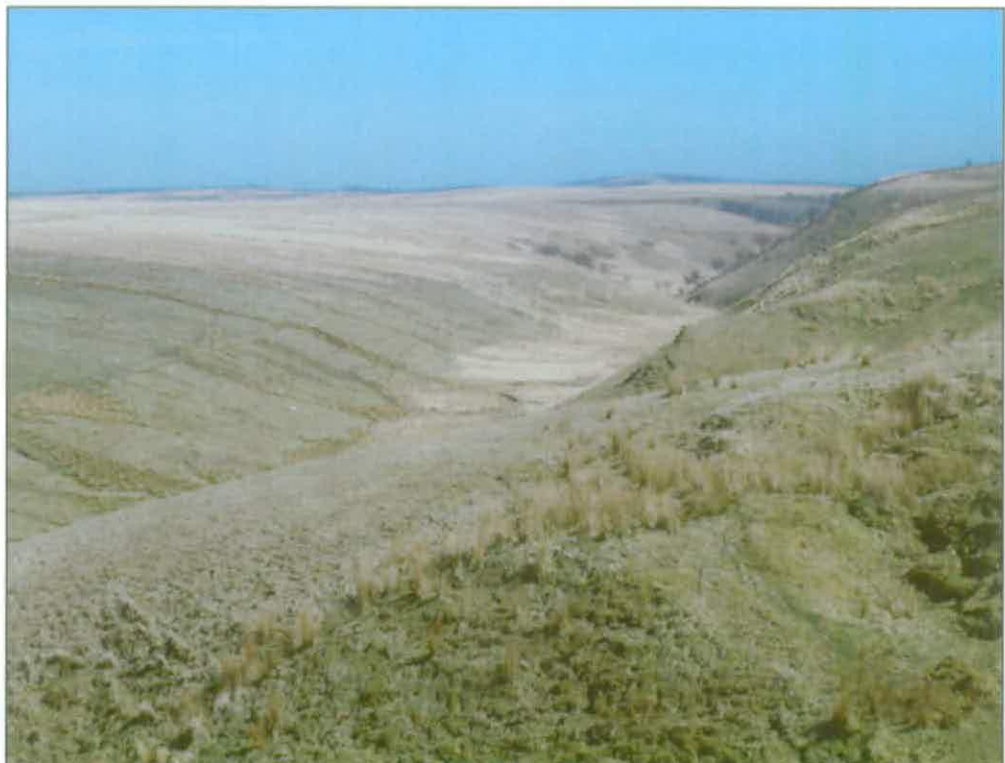
Figure 19
*View east along
the Exe valley,
from Blackpits to
Warren Farm*

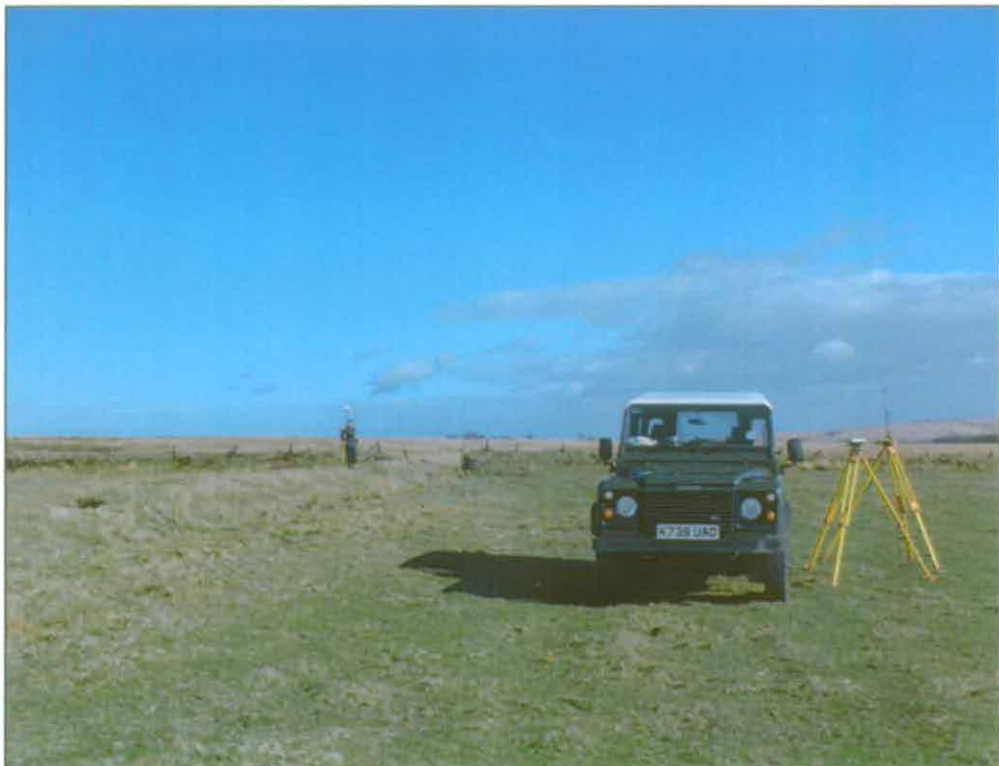
Figure 20
GPS survey in
progress

The GPS base-stations' co-ordinates were calculated in Trimble Geomatic Office (TGO) software using five Ordnance Survey (OS) active stations. The survey was located to the OS National Grid using TGO's OSTN02 transformation. The controllers were set to the following parameters: horizontal 10mm, vertical 15mm. The survey was plotted using ACAD 2000.
