Archaeological Investigation Report Series AI/13/2003

The Mansion at Columbjohn, Broadclyst, Devon

An archaeological survey by English Heritage

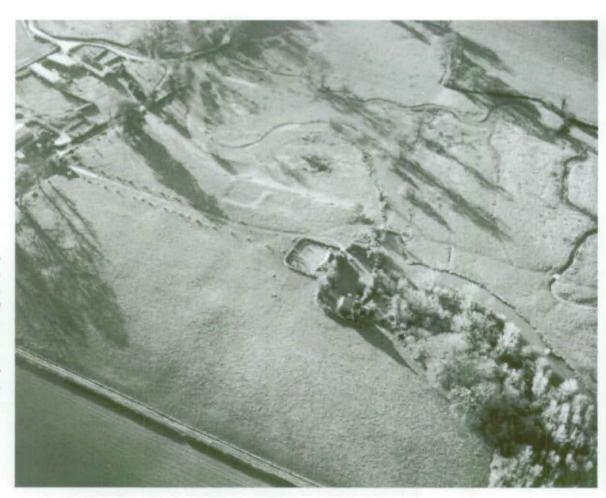
Figure 3. An oblique air photograph of the survey area - the traditional site of the mansionis indicated by the square, whitish e a r t h w o r k s. (NMR SX959994. SX959998. 11.December 1986 DAP 5524/12. Copyright Frances Griffith. Reproduced with permission.

APs taken in December 1986 show a very fine oblique view to of the survey area. The square stance built against the linear river scarp is clearly visible. Many of the ploughed down earthworks in the eastern area are also evident - mostly as smoothed scarps under grassland. A number of the mature trees, which stood within the survey area, had been cut down. A new avenue of trees has been planted on an alignment between the chapel and the gateway and a new access track created between this avenue as an access track to Pidgeon Cottage from the farm road.

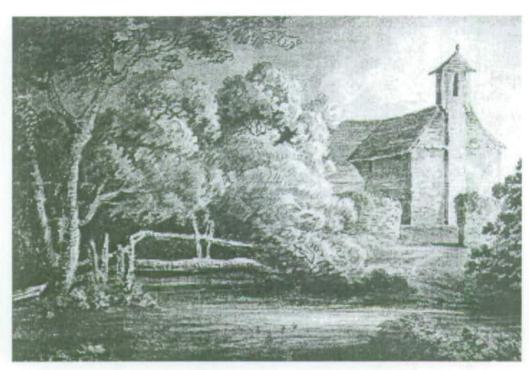
Fig. 4. Swetes' drawing of Columbjohn Chapel (Devon Record Office S64M/F17/175, Reproduced with permission)

(Risdon, 352). The will of Sir John Acland dated 1619 states that 'Mass is said in Culmjohn Chapel and that a sermon is to be preached there. The preaching minister is to have a convenient chamber and lodging for himself in Culmiohn Mansion'. When the mansion was abandoned in favour of Killerton, the chapel continued to be used by the family. They made the journey every Sunday along a drive that came to be known as the processional way which led directly across the fields from Killerton. The family chaplain, who took the Sunday services, robed in an upstairs room in the adjacent Pidgeon Cottage. The room is reached by the external stairs which can be seen from the chapel-ground. Eventually, the Sunday journey to Columb John Chapel became too inconvenient and in 1842 Sir Thomas Acland, 10th Baronet, built Killerton Chapel as a replacement. Swete made a drawing of Columbjohn Chapel during his visit in June 1800 (Fig. 4). Subsequently it was either restored or perhaps even rebuilt by Arthur Acland in about 1844/45. The 'Old Chapel', as it became known was used mainly for funerals - the burial-ground was consecrated in 1851 for the use of the Aclands and those closely connected with them. For funeral services, altar ornaments were brought from Killerton Chapel, and the coffins were carried along the processional way. On the last occasion in 1919, enormous amounts of stone chippings were required to make the journey possible. Pevsner (1989, 279) notes that the Chapel of St John is "on the site of the chapel to the house that preceded the one of c 1590." He describes the chapel as a miniature church, prettily Romanesque with a pantile roof, dated 1851 and built largely through the exertions of Arthur Acland.

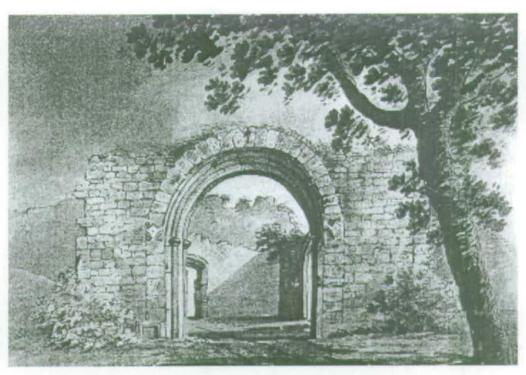
Fig. 5. Swete's drawing of the Gatehouse (Devon Record Office F64M/ F17/171, reproduced with permission)

Swete made a drawing of the remains of a roofless gatehouse in June 1800 (Fig. 5) and he described the remains thus: 'The Gate-way, having an arch of a semicircular cast, which by the remains of a building connected with it appears to have been a lodge ... to the mansion. This little edifice which originally consisted of a room or two with three arches all differing from one another in their curve'.

John Gendall made a pencil sketch of 'The gate at Columb John' in about 1834 (Acland 1981, Pl. 5). The drawing, which is somewhat indistinct shows a rather ragged and overgrown structure constructed of coursed slabs and blocks with a mounting block on one side. The arch is more or less as it is today. The present structure, an ornate gateway is described in the HHR listing as: Ruins of gatehouse to Columbjohn Mansion (now destroyed). 16th century. Random rubble volcanic trap with dressed stone quoins and moulded wall plinth. The inner arch and wall, along with parts

of the side walls of the building, survive. Arch with moulding. To the north (exterior) is a hood mould with unusual stops in the shape of a diamond with three attendant bosses.

The gateway at Columbjohn incorporates the principal elements of the elevation drawn by Swete - except that the fine carved foundation plinth on which it stands is not clearly evident on his drawing. Both Swete and Gendall depict the fabric of the gateway as random coursed slabs and blocks which bears no resemblance to the actual volcanic rubble fabric - this is presumably artistic licence. In both drawings the wall does not extend above the archway as it does today. Swete depicts ragged unfinished edges to the walls (fig 5) but Gendall shows fine quoins in 1834.. The low thick walls which now form the west and east sides of the structure appear to function as partial buttresses to support the Gateway; they are doubtfully original given that in the west wall Swete depicts an arch. On the southern elevation of the present gateway, adjacent to the arch, is a curious buttress-type pillar constructed of carved stone blocks (now partially robbed) with a large foundation stone and also a protruding cap stone. Its origin and function are obscure but it could simply have been an added decoration -perhaps to utilize a 'spare' carved stone course. These observations about the subtle differences in the form of the gateway as depicted in 1800, 1840 and its appearance today prompts the question whether or not the present structure is original or whether it is a reconstruction using existing materials. Perhaps the present gateway is a pastiche of the original structure, erected on or near the site of the original gatehouse, possibly as a lasting memorial of the mansion. Interestingly there is no surface evidence of any sort of metalled track predating the modern track from the gateway into the interior of the site.

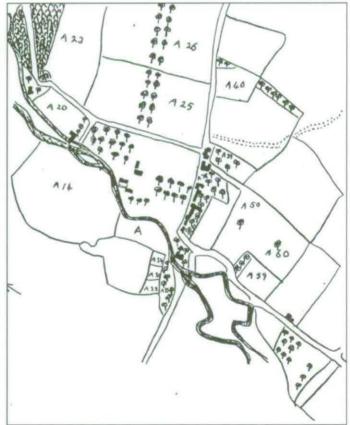
Fig. 6. A sketch of part of the 1756 Killerton Estate map.

The small scale Killerton Estate map of the Barton of Culm John dated 1756 gives some important information. A sketch of this map (Fig. 6) shows two avenues of trees. One avenue leads from the gateway towards the chapel and the second, which extends from the chapel towards Killerton House, marks the processional way. At or near their junction, four unnamed buildings are shown, one with an attached plot. The function and purpose of these buildings are unclear although one must be the chapel. Two of the buildings probably lie to the west of the chapel. The northern part of the site is occupied by a plantation. A water mill, located on the mill leat adjacent to the river in the north-west, forms part of a large L- shaped group of buildings.

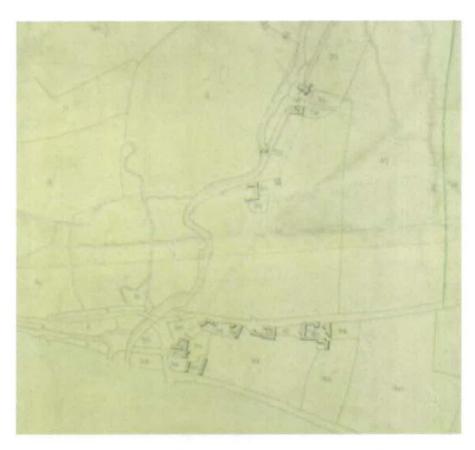
Fig. 7. Part of the Broadclyst tithe map dated 1842 (Devon Record Office).

The Broadclyst tithe map dated 1842 (Fig. 7) depicts a large E-shaped and sub-divided building with a plot on one side and, to the rear, a second plot which extends to a small square structure that is probably part of the present Pidgeon Cottage. The tithe apportionment describes the southern part of this building as 'chapel' and the northern part as 'barn and buildings'. It also names the eastern field within the survey area 'Warren'. The tithe map shows Culmjohn Farm and the gateway. Additionally a series of buildings at Culmjohn Mill are depicted along with the access route to the mill which comprises a track that crosses the survey area diagonally from a gate near the present Columbjohn Bridge to the head of a sunken track leading down to the mill complex.

The tithe map depicts a track which diagonally crosses the site from a stile in the south-west corner, near Columbjohn Bridgeay, to the north-east corner to link up with the hollow way to the mill. It cuts through the processional way and it is a well used, if circuitous, route to the water mill It probably dates from the 19th century and its course - taking a long way round - suggests that it deliberately avoids the area around the chapel.

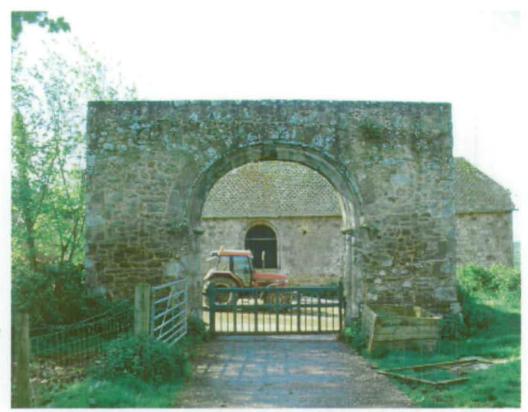
Fig. 9. The gateway at Columbjohn in 2003.

The arched gateway at SX9594997 is an impressive feature in the landscape (Fig. 9). It is most probably part of the structure listed as a Gate Chamber in the 1646 Inventory; its position is depicted, usually indistinctly, on all known maps dating back to 1756. Swete's drawing and description of the 'Gateway at Columb John' of c 1800 is perhaps the only record of the gatehouse and gate arch before much, if not all of it was taken down. His drawing, of what appears to be the northern elevation, shows a very fine moulded round-headed arch resting on columns with a relieving arch constructed of dressed blocks. At each end of this arch is a stop in relief consisting of three bosses around an embossed shield. The origin of this design is not known. Visible through the arch in Swetes drawing are the roofless remains of a square building. Two arched doorways are shown - one, a two-centred round-headed arch with a fine moulding and the other, apparently a four-centred arch; both are set in rendered, apparently windowless walls. Swete noted that the three arches 'differ from one another in their curve'. The pencil sketch by Gendall of about 1840 (Acland 1981) is also apparently of the northern elevation. He depicts the gated arch and the ruined wall however it is not clear from his sketch whether the gatehouse still survives behind the wall.

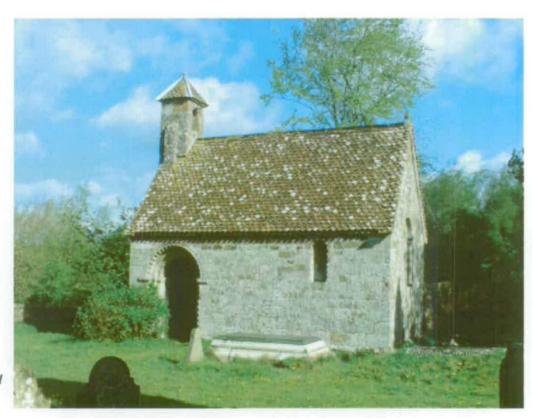
Fig. 10. The Chapel in 2003.

The original chapel was a small rectangular building recorded as 'new'in 1619 but in exisistence in 1616 (National Trust SMR No.107344). The old chapel was overgrown and neglected in 1831. The present chapel (Fig. 10) is listed grade II and is described as a *circa* 1844 building of ashlar volcanic trap with a roof of red clay fish scale plain tiles and with a bellcote. The graveyard wall of random rubble volcanic trap is also listed.

The present chapel may not occupy the precise position of its predecessor given that it could have been completely rebuilt rather than being refashioned in 1844 when it could have been repositioned. The 1842 tithe map shows a large E-shaped building here which is sub-divided - the old chapel formed the southern end with a small plot on its south side. The larger part of the building is described in the apportionment as 'barn and buildings'. There is a linked plot on the east with, in its corner, a building that might now be part of Pidgeon Cottage. Swete made no mention of this large building or the cottage when he visited the site only forty years before. It is possible that the footings of the cottage may have been derived from the foundations of the mansion or more likely one of its outbuildings rather than simply being the footings of a dovecote as suggested in the HHR listing - although if this were so then Swete would surely have noted the foundations.

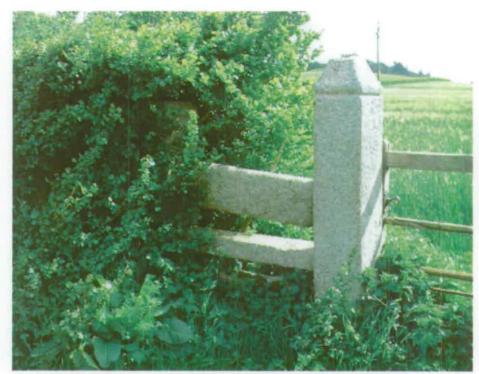
Fig. 11. The granite stile and on of the gateposts.

An impressive three-slab granite stile and two granite gateposts (Fig. 11), which mark the alignment

of this processional route, are located in the hedgerow on the eastern side of the survey area. It is described in the National Trust SMR (No.107351) which notes that it was constructed in the 19th century out of fragments of the 16th-century Columbjohn mansion. This observation is perhaps debatable given that the components of this structure are clean cut and not in any way weatherworn. The upper part of each gatepost, which possibly comprised a round ball, has been destroyed.

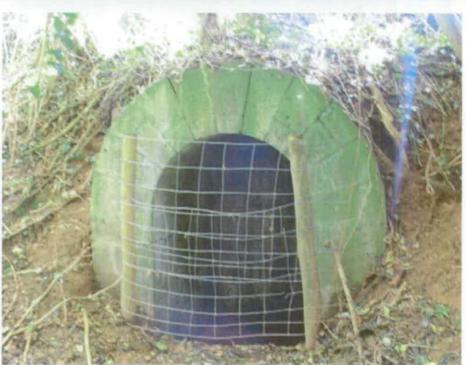
Figure 12. The well house.

During the 2003 survey a very fine well house was recorded to the north of Pidgeon Cottage (Fig.12). Built into the side of a steep earthen slope it comprises a round headed arch which fronts a chamber containing a 0.9m diameter well and stone seat. The arch has an 0.5 m wide plain façade of dressed and tooled stone and is 2m wide and up to 1.6m high - although the lower part is now silted. The entrance is blocked by a fence. The well chamber is 1.5m by 1.4m and about 1.8m high. The arch facade which dates from around 1842 may have been superimposed onto an exisiting well house (Richardson pers.com). It is not mentioned or described in documentary sources.

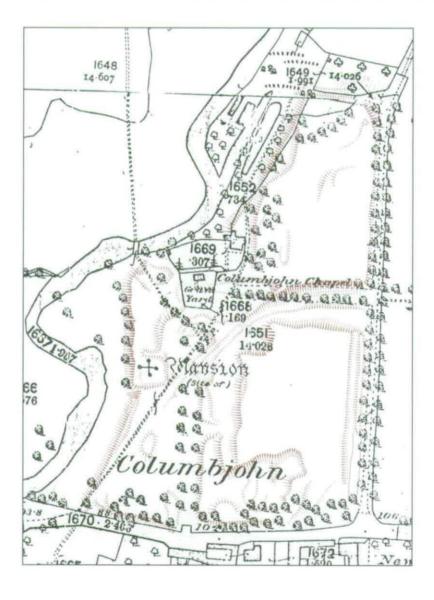
The location of the mansion is depicted on all early large scale Ordnance Survey map editions dating from 1889 as a siting symbol centred at SX 95929986 (Fig.13); this siting is most probably derived from the 1756 estate map. Columbjohn Chapel with its graveyard is depicted and described at SX95969974. The gateway is depicted at SX95949973, but not described on Ordnance Survey maps.

Fig. 13. The new English Heritage survey imposed on the 1st edition Ordnance Survey 1:2500 scale plan. Reproduced from the 1889 Ordnance Survey map.

The embanked stance located at SX 95929986 is the generally accepted site of the mansion chiefly because the early large scale Ordnance Survey maps show an 'antiquity' siting symbol here although the earthworks are not depicted. This siting was almost certainly derived from the depiction of four buildings in this area on the small scale estate map dated 1765. The proximity of the chapel which has an early 17th-century origin - lends weight to this location. However the general impression gained by most observers is that this low-lying site located on the edge of a floodplain is somewhat restricted to be the position of a mansion of such apparent pretension. The new survey clearly shows that the steep linear slope of the terrace which defines the western part of the area, does not accord with the 'natural' scarps visible both to the south and the north. This

observation suggests that this pronounced earthern slope has been artificially created from the natural floodplain terrace slopes either by being cut back, straightened, extended - or through a combination of all three. The original or natural edge of the floodplain cannot now be identified on the ground. There is unambiguous evidence however that the south-west corner of the stance has been extended beyond the general line of the natural slopes to the south. This artifically created linear scarp is on average 1.4m high; there are fragments of stonework visible but no obvious revetment. There is no indication in the archaeological record of foundations or finds which might add support to the presence of a mansion in the immediate area of the siting. Equally there is no evidence from air photographs of parch marks or crop marks within the stance. The NMRC air photographic coverage (Appendix 1) represents a fairly comprehensive indicator of the activity on this site over a period of nearly sixty years.

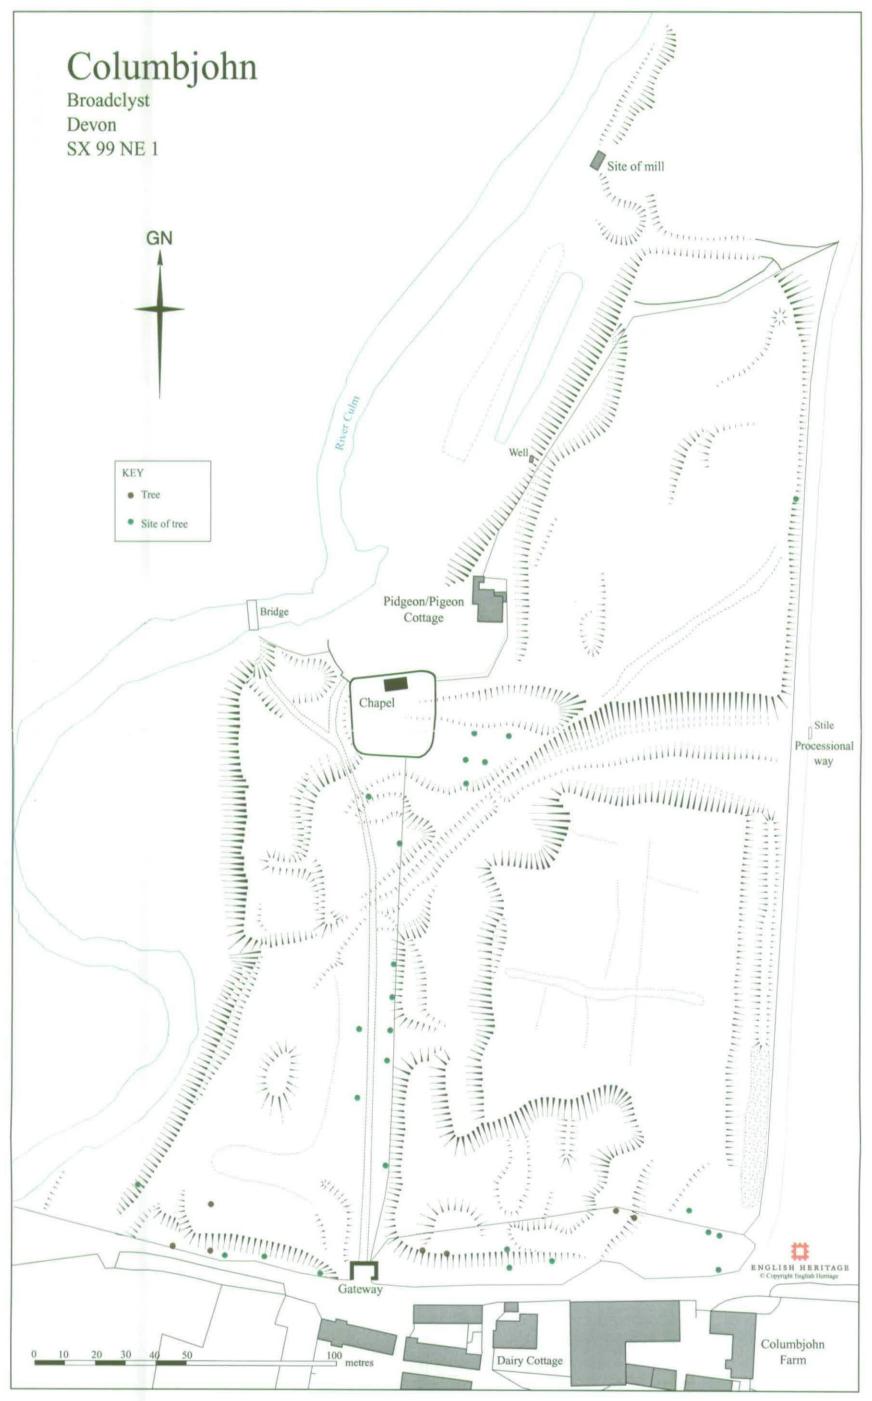
The surveyed area (Fig. 2) is now split into two fields by a post and wire fence and a partially metalled 20th-century track, which extends from the arched stone gateway to Pidgeon Cottage (named after a tenant called Pidgeon). These fields, both under permanent pasture, have not been ploughed intensively since at least World War II - although the upper field has been lightly ploughed for re-seeding as recently as 1978.

Fig. 2. Columbjohn: English Heritage 1:1000 scale survey (reduced). This map is reproduced from the Ordnance Survey map by English Heritage with the permission of Ordnance Survey on behalf of The Controller of Her Majesty's Stationery Office © Crown copyright. All rights reserved. Unauthorised reproduction infringes Crown copyright and may lead to prosecution or civil proceedings. English Heritage 100019088 2003.

The traditional site of the mansion, situated in the lower field at Columbjohn, comprises an embanked stance located on a narrow terrace above the broad floodplain of the River Culm. This stance measures internally a maximum of 23m by 18m and it is levelled about 0.5m into the natural slope. It is bounded on the east and north by a wide, earthen bank averaging 0.6m high and to the south a scarp a maximum 0.5m high. The front is formed from the steep floodplain scarp; here there are some stones evident, perhaps part of a slight, crude wall. The interior is fairly level with numerous molehills revealing good quality soil; no stone is visible. To the north is a narrow stance some 14m in width which opens out to the north; it has a back scarp up to 0.9m high. The only trace of sub-surface stone, perhaps some metalling, was noted when the survey instrument was set up to the east of the stance.

Prominent earthen slopes a maximum 1.1m high, define the extensive level 'platform', which occupies the south-eastern part of the site. This area has been ploughed in the past such that the slopes have become rounded and somewhat denuded. The southern part of the platform has been cut into by an irregular pit which resembles a shallow, but fairly extensive area of amorphous surface quarrying. The eastern part of the platform is delineated by a linear earthen mound, now some 128m long, 9m wide and up to 0.6 m high - although the southern part has been partially dug away. It has a broad shallow 7m wide ditch on the western side; the track on its eastern side may overlie a ditch on this side. The flat surface of the 'platform', which has in the past been ploughed has vague traces of very slight linear earthen banks which were identified during the survey but their function is unclear
