The Langstone Moor
 Stone Circle, Peter Tavy,
 Devon and its Prehistoric
 Environs

SURVEY REPORT

Archaeological Investigation Report Series AI/25/2003

County: Devon
District: West Devon
Parish: Peter Tavy
NGR: SX 555 780
NMR No: Various. See appendix 5
SAM/ RSM No: Various.
Date of survey: Sept -Oct 2003
Surveyed by: Phil Newman, Simon Probert
Report author: Phil Newman
Illustrations by: Elaine Jameson, Phil Newman
Photography by: Phil Newman

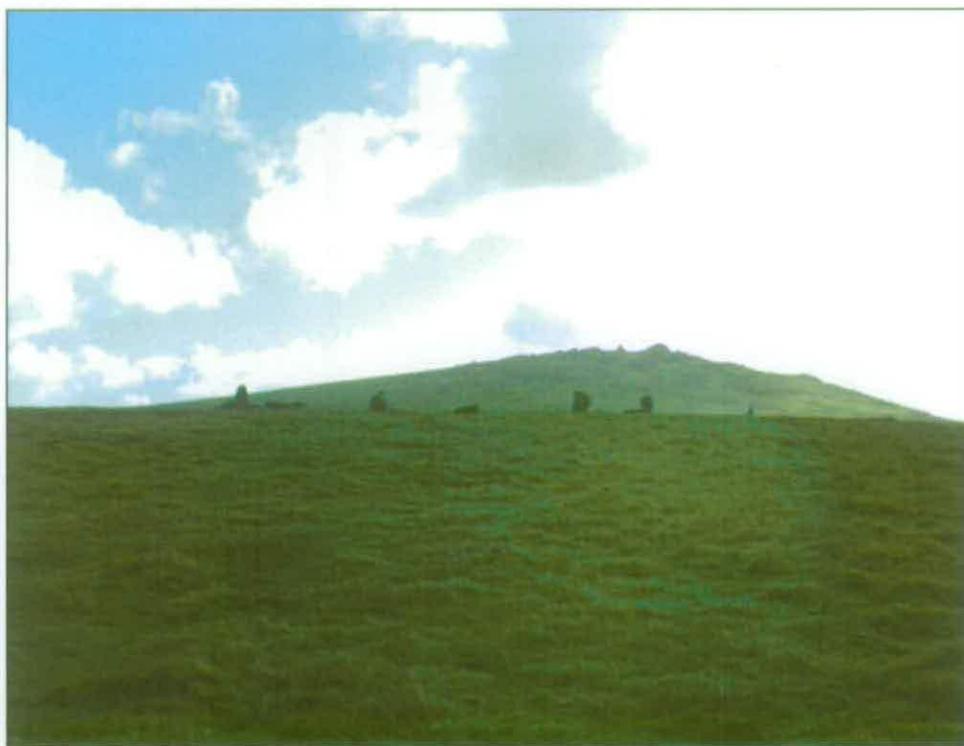
The Langstone Moor Stone Circle looking south to Mistor. This is a similar view to that taken by Robert Burnard in 1894, shortly after re-erection but before the damage caused in in the 1940s.

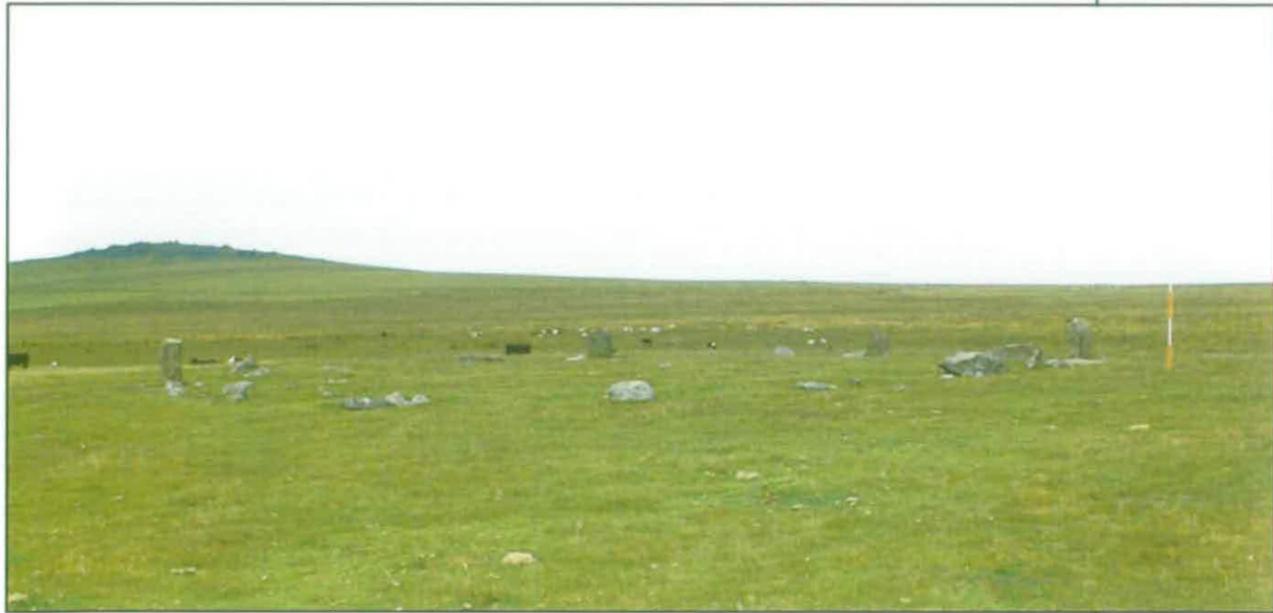
The Langstone Moor stone circle looking north-west

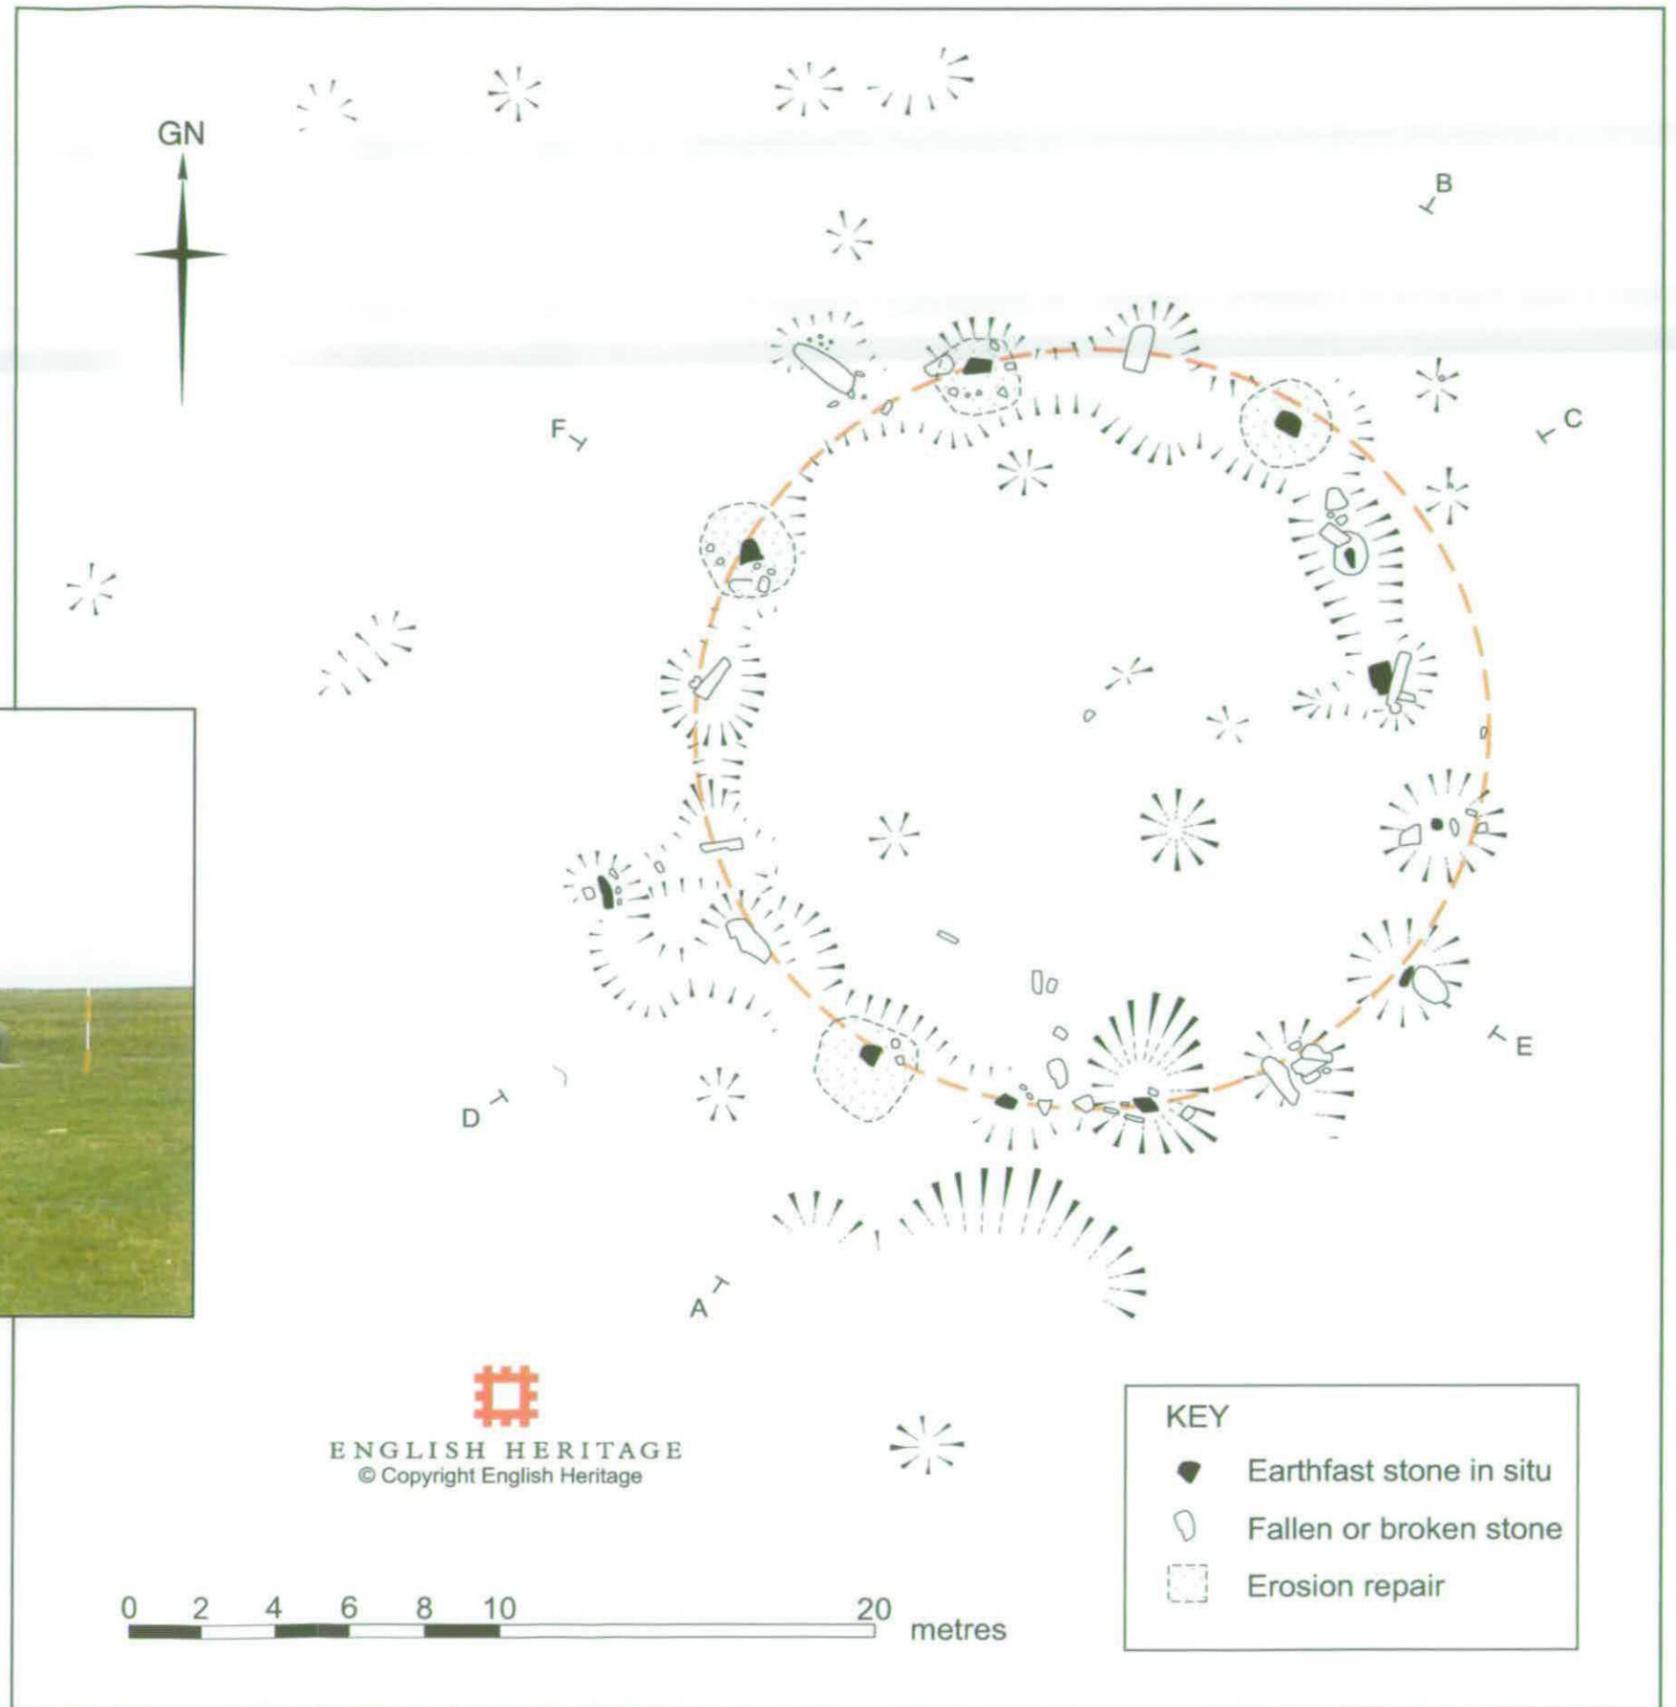
Figure 4 The Langstone Moor stone circle 1:200 scale survey.

Of the 16 stones of the restored circle only 10 now remain *in-situ*, though several of these are much shorter than they appear in Burnard's 1894 photograph, including five which can only be described as stumps (see frontispiece for an up to date similar view). The tallest stone today stands only 1.1m in height though Burnard recorded stones of between 5 and 6 feet (1.5 - 1.8m). Fragments of the broken stones lie scattered on the ground around the erect stones. There are also six stones that are completely toppled (see appendix i, iia, iib for details of all stones). Of the two stones said by the DEC (1895) to be outside the main circle, only one remains on the west side and stands to 0.7m in height. Some remedial work was recently carried out by the DNPA, during which erosion hollows around four of the stones were filled. Small hollows outside the circle may be ordnance impact craters.

The new survey revealed that the stones form a far from perfect circle. Although it is possible that in its original form the monument was an imperfect circle, this seems unlikely and it is perhaps more credible that the DEC re-erected the stones incorrectly. The lack of a detailed plan before the DEC work took place means that it is difficult to argue this point either way.

As to the possibility of an outer circle, this seems to be based on the existence of one surviving (currently loose) stone on the west side. The idea that the remainder of the stones have been robbed is implausible because the site is too far from any likely destination where the stones could be reused. The enclosed area around Wedlake for example, which is the closest to the circle, had ample sources of quality stone much closer to home at Whittor and Roos Tor.

1. Standing intact, 1m high. Erosion hollow recently restored.
2. Stump 0.5m high on rebuilt concrete base. Top section lying on ground in 3 pieces.
3. Stump 0.45m high. Top section lies alongside. Original height c. 1.8m.
4. Stump 0.2m high. Three small fragments on ground beside.
5. Ground level stump. Top section on ground beside, 1.2m long.
6. Fallen slab 1.6m long plus fragments.
7. Stump 0.3m high plus shattered pieces.
8. Stump 0.4m high plus shattered pieces.
9. Standing intact, 1.1m high. Erosion hollow recently restored.
10. Fallen slab 1.5m long.
11. Edge-set slab, 0.7m high. Loose.
12. Fallen slab 1.25m long.
13. Fallen slab 1.35m long.
14. Standing, 0.9m high. Erosion hollow recently repaired.
15. Fallen slab 1.85m long plus shattered pieces.
16. Standing, 0.9m high. Splintered top section. Erosion hollow recently repaired.
17. Fallen 1.25m long.

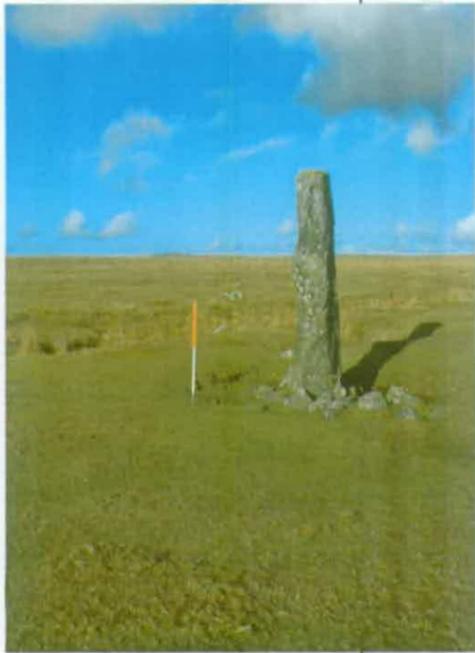
The stone was re-erected in what was described as its 'original' socket hole, in 1893 (Worth 1953, 270; DEC 1995, 83). It stands to 2.75m and has an erosion hollow around the base. This stone sustained damage in the war years and has impressions formed by ordnance impacts visible on the west face.

The Langstone Moor standing stone or 'Longstone' looking south.

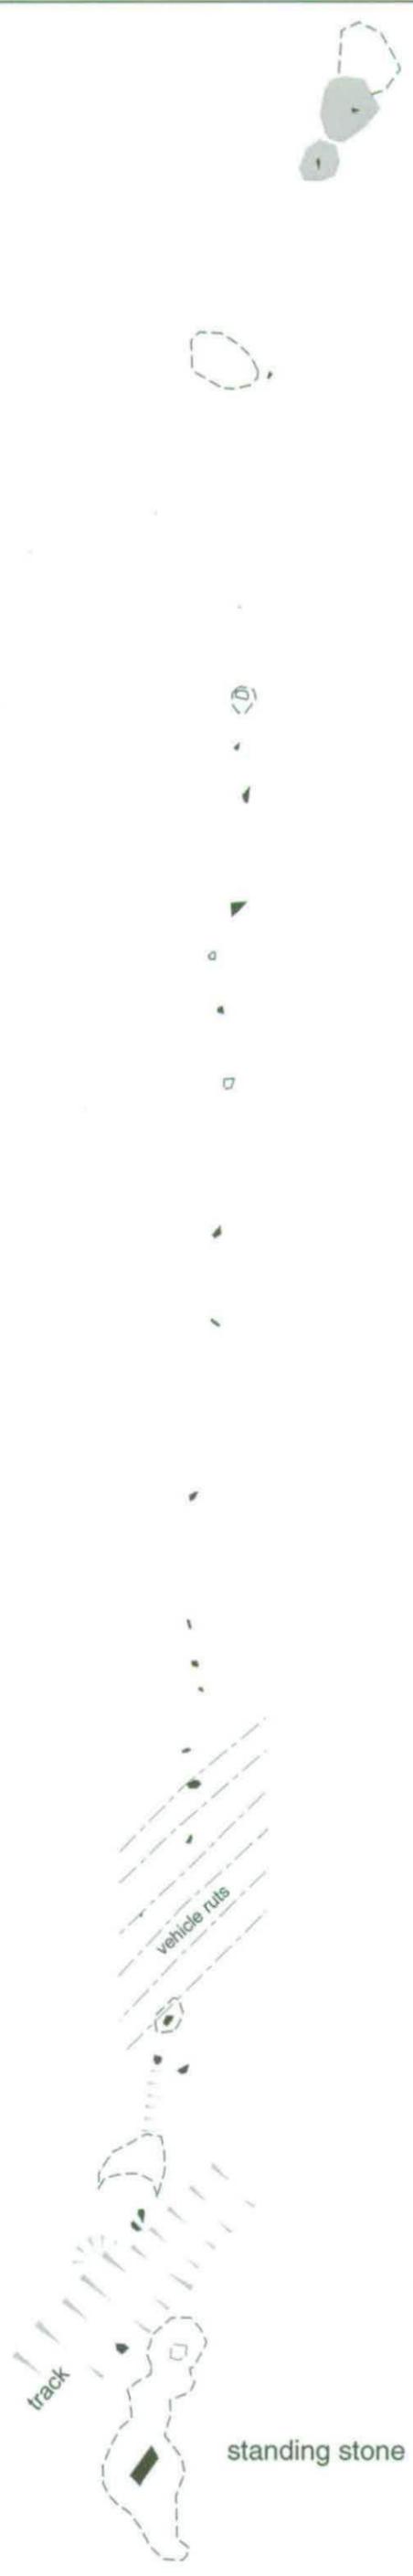
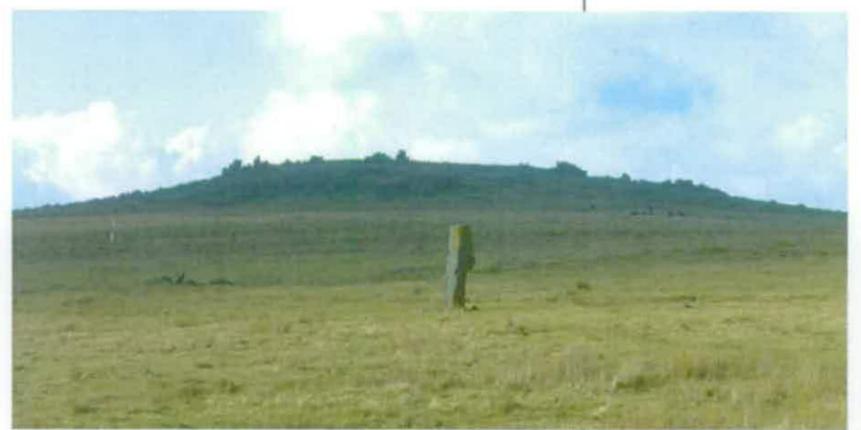
Figure 6 The Langstone Moor stone row and the standing stone

The Longstone forms the southern terminal of a single stone row which is oriented just 5° east of north. Twenty-seven stones are currently visible, arranged in a somewhat erratic alignment with several large gaps. Twenty-two of the stones are set in the ground, though of these, some are loose. All the stones are low, the tallest is only 0.3m high though most are flush with the ground and of generally small proportions. In 1895 the DEC reported that 'spade investigation' revealed the stones did not penetrate the ground to any great depth. Two stones at the northern end of the row appear to be out of alignment with the main body, and are surrounded by small mounds. This, it is believed by Butler, is the site of a former cairn (Butler 1991, 77) which was destroyed when a large, egg-shaped shallow seasonal pond of 632m² was dug here. Although a plausible idea, the evidence is insufficient to be certain of the existence of this cairn.

Damage in the recent past has been caused by a sunken trackway being cut through the alignment just north of the standing stone. This in turn has become disused and current vehicle traffic is using a route 10m to the north causing further damage to the monument.

1. In small turf mound 0.2m high
2. In small turf mound 0.2m high
3. 0.1m high
4. Flush with ground
5. Fallen
6. Loose, 0.2m high
7. Fallen
8. Fallen and loose
9. Fallen and loose
10. 0.2m high
11. Fallen
12. 0.25m high
13. small, completely loose
14. 0.1m high
15. Flush with ground
16. Completely loose
17. Flush with ground
18. Flush with ground
19. Flush with ground
20. Flush with ground
21. Flush with ground, slightly offset
22. Fallen
23. 0.3m high
24. Loose 0.15m high
25. Fallen 0.25m high
26. 0.2m high
27. 0.2m high, disturbed in trackway

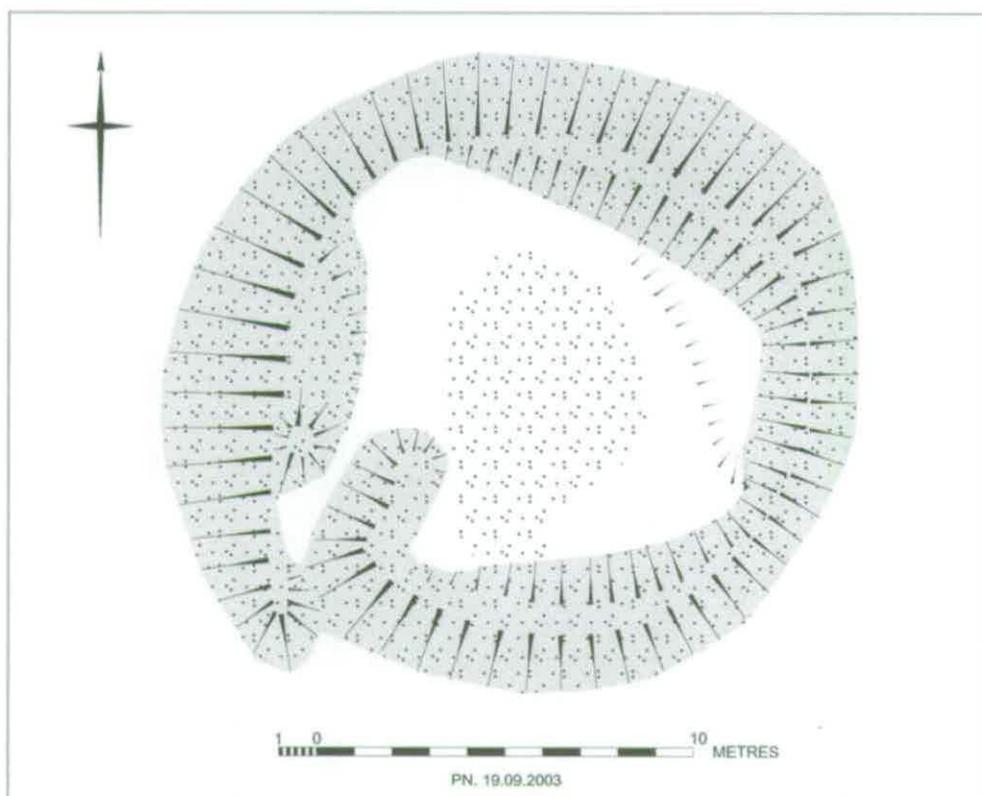
Figure 7
*Ring cairn near
Wedlake*

A very fine ring cairn (14) is located on the western side of Langstone Moor overlooking the Colly Brook and Whittor to the north. It consists of an 18m diameter ring of small stones, now turf covered, enclosing a mainly flat area strewn with loose stone. The bank, which has been disturbed on the south-west quadrant stands to approximately 0.5m high.

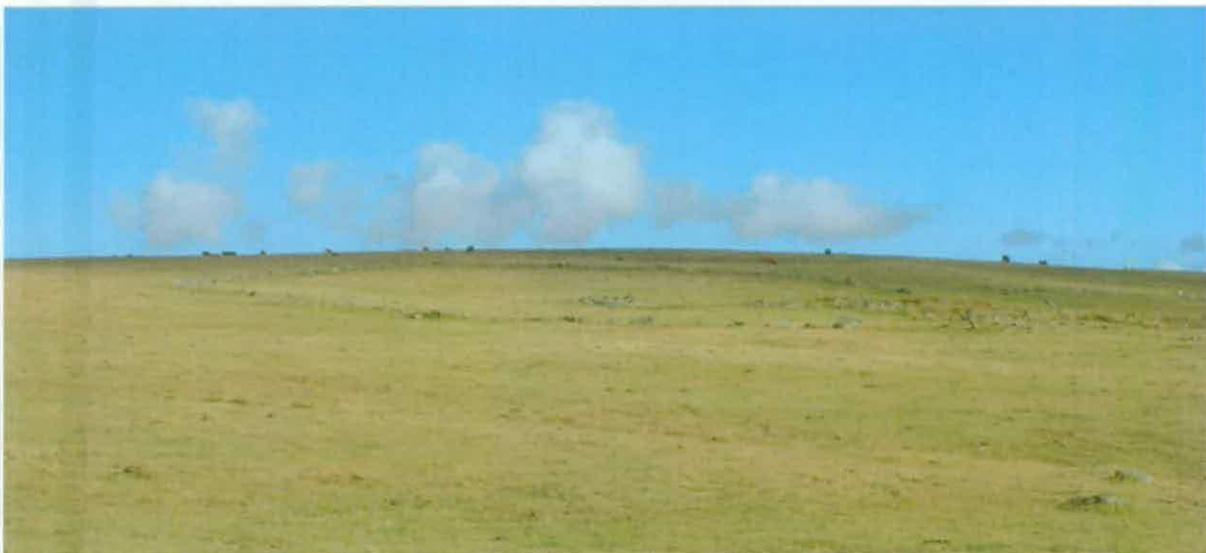
Figure 8
View of the enclosed settlement from the south-west

South-west of the stone circle, on the moderate south-facing slopes of the Walkham valley, at an altitude of 410m above OD is a complex hut settlement, comprising at least 35 hut circles, many of which are contained within small enclosures, and covering a total area of 4.7ha.

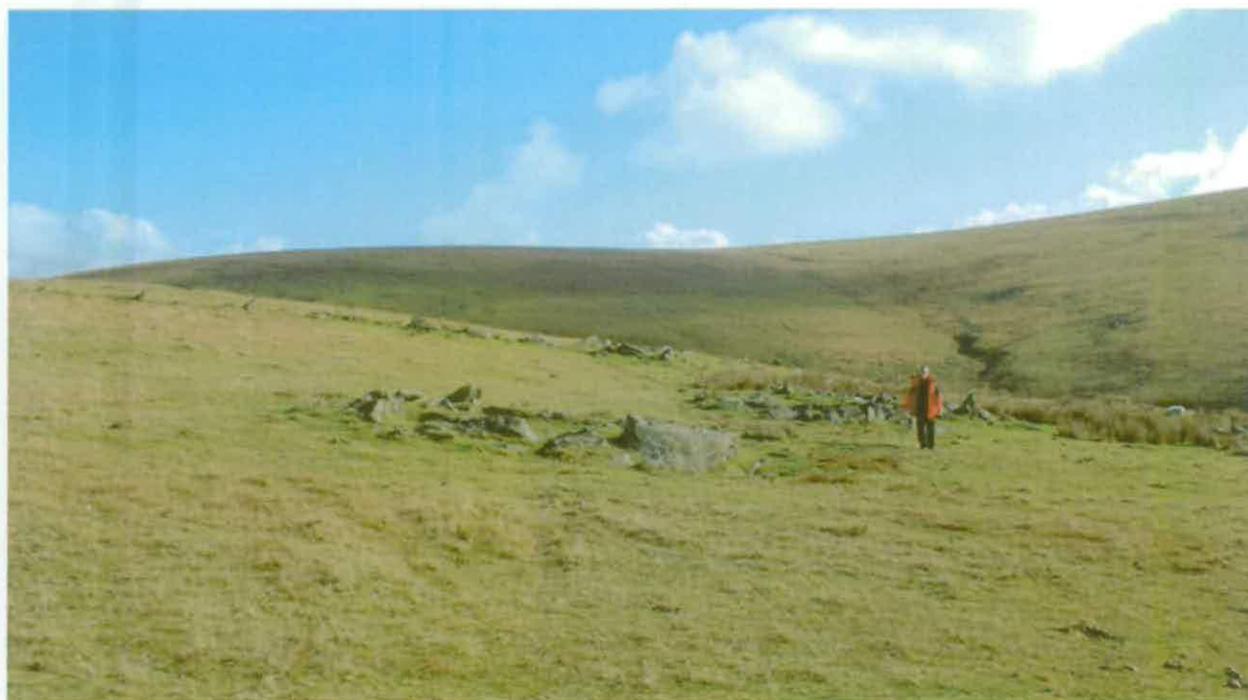
Figure 10
Huts 16 and 17
within enclosure A

Many of the huts are associated with lengths of enclosure walls. The walls are in places very fragmentary but there is a minimum of five enclosures (A-E), some of which may once have been conjoined. Enclosure A is notable for surviving in a much better condition than the others; its walls are thicker at the base and they stand to an average height of 0.8m. However, a portion of the south-east corner appears to be missing. Slightly less well-preserved though still having an intact circuit is enclosure B, just a few metres south-east of A. The walls are of lesser proportions consisting only of a single line of boulders, mostly fallen or tilted.

Of the certain huts a total of six (16-20; 34) are fully enclosed, five in enclosure A alone, and a further ten (12-15, 22, 23, 27, 28, 32, 35) are built into enclosure walls or onto their exteriors. Hut 33, the largest hut in the entire group was probably enclosed though much of the enclosure is missing. Twelve huts (1-6, 13, 24-26, 29-31, 39) have no apparent association with the enclosures, though among the five huts south of enclosure A (7-11) fragments of walling in the locality may suggest otherwise.

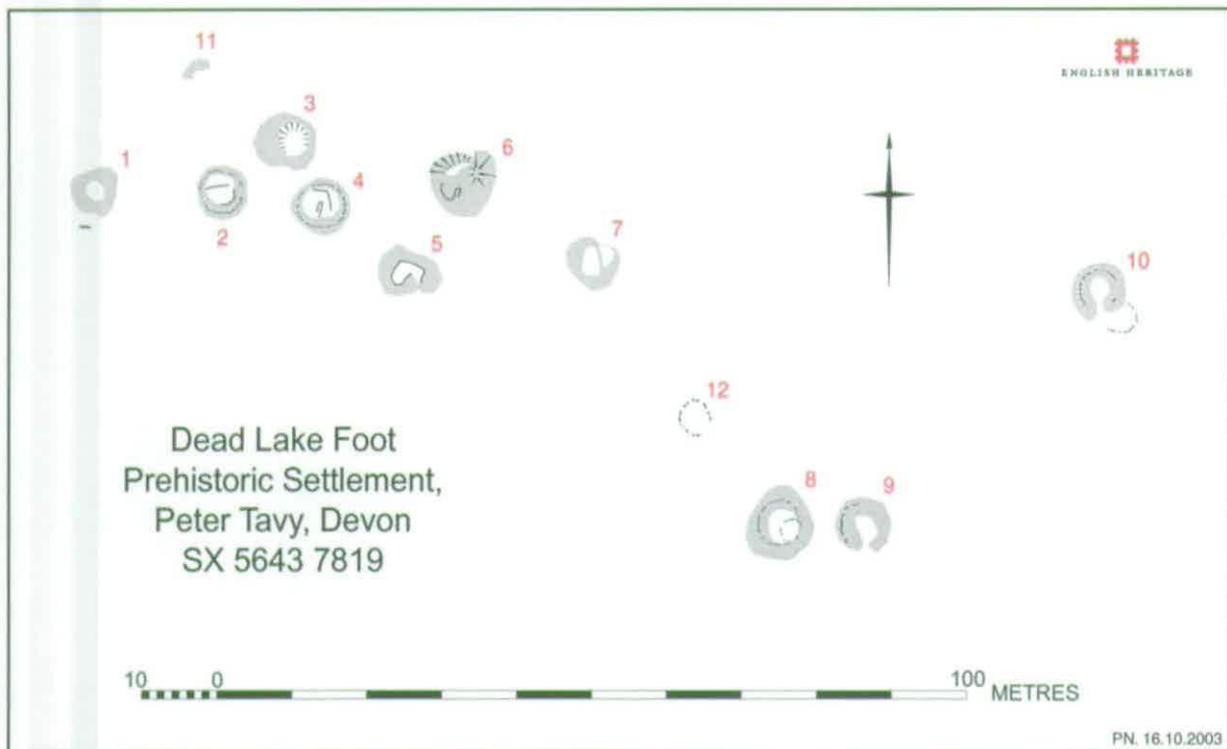
Figure 11
Hut Settlement
at Dead Lake Foot

There is a total of ten huts (1-10) plus a small circular stone feature (12) that is unlikely to have been a dwelling but could have been a building of some description. A short curved fragment of wall (11) is unlikely to be remains of a hut. The interiors of the huts are generally smaller than those at the main Langstone settlement and the walls are crudely built apparently lacking the inner and outer rock facings. Hut 8 is an exception: this is the largest hut in the group, though much disturbed with an internal diameter of 5.2m. A second, smaller hut with a diameter of 2.5m has been constructed within the interior of the larger hut.

Most of the huts appear to have been disturbed since abandonment, in particular huts 5, 6 and 7 have been remodelled, probably fairly recently. Huts 1, 2, 4 and 5 are of particularly slight construction and may have been robbed or disturbed. Hut 10 has had an additional semicircular external wall, of slight construction added to the south-east exterior.

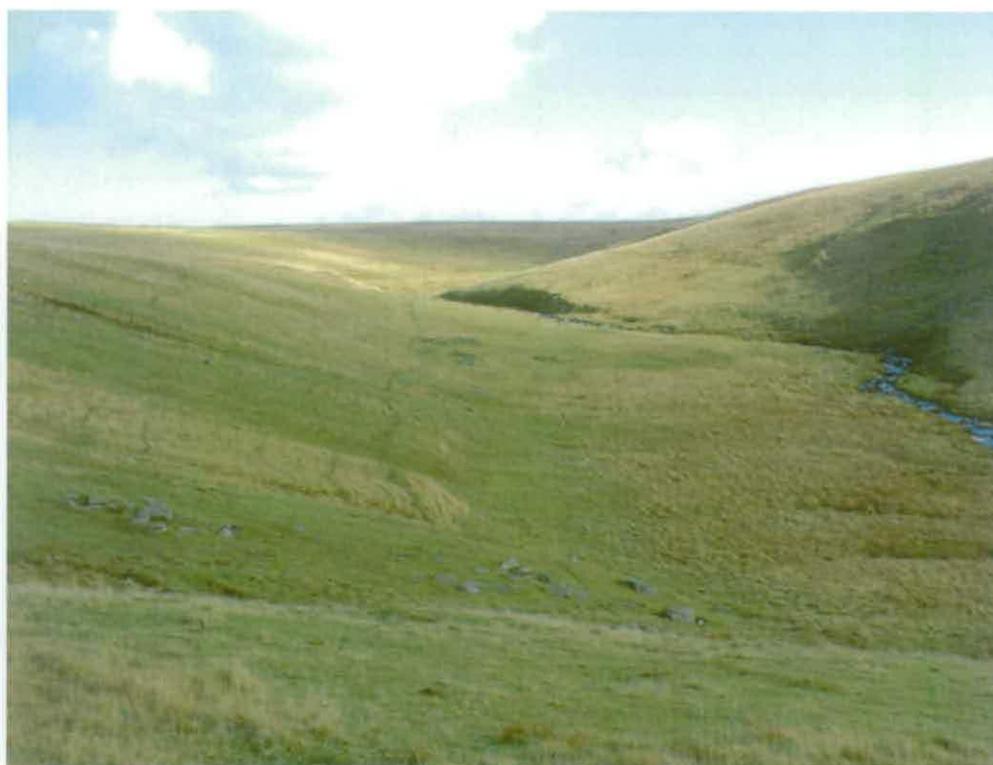
Figure 12
The Walkham valley
looking north
showing location of
the Dead Lake
settlement

Due west of Dead Lake Foot, at 420m above OD, is a small hut settlement located on the west bank of the River Walkham within and at the edge of the alluvium at the foot of the deep valley slope.

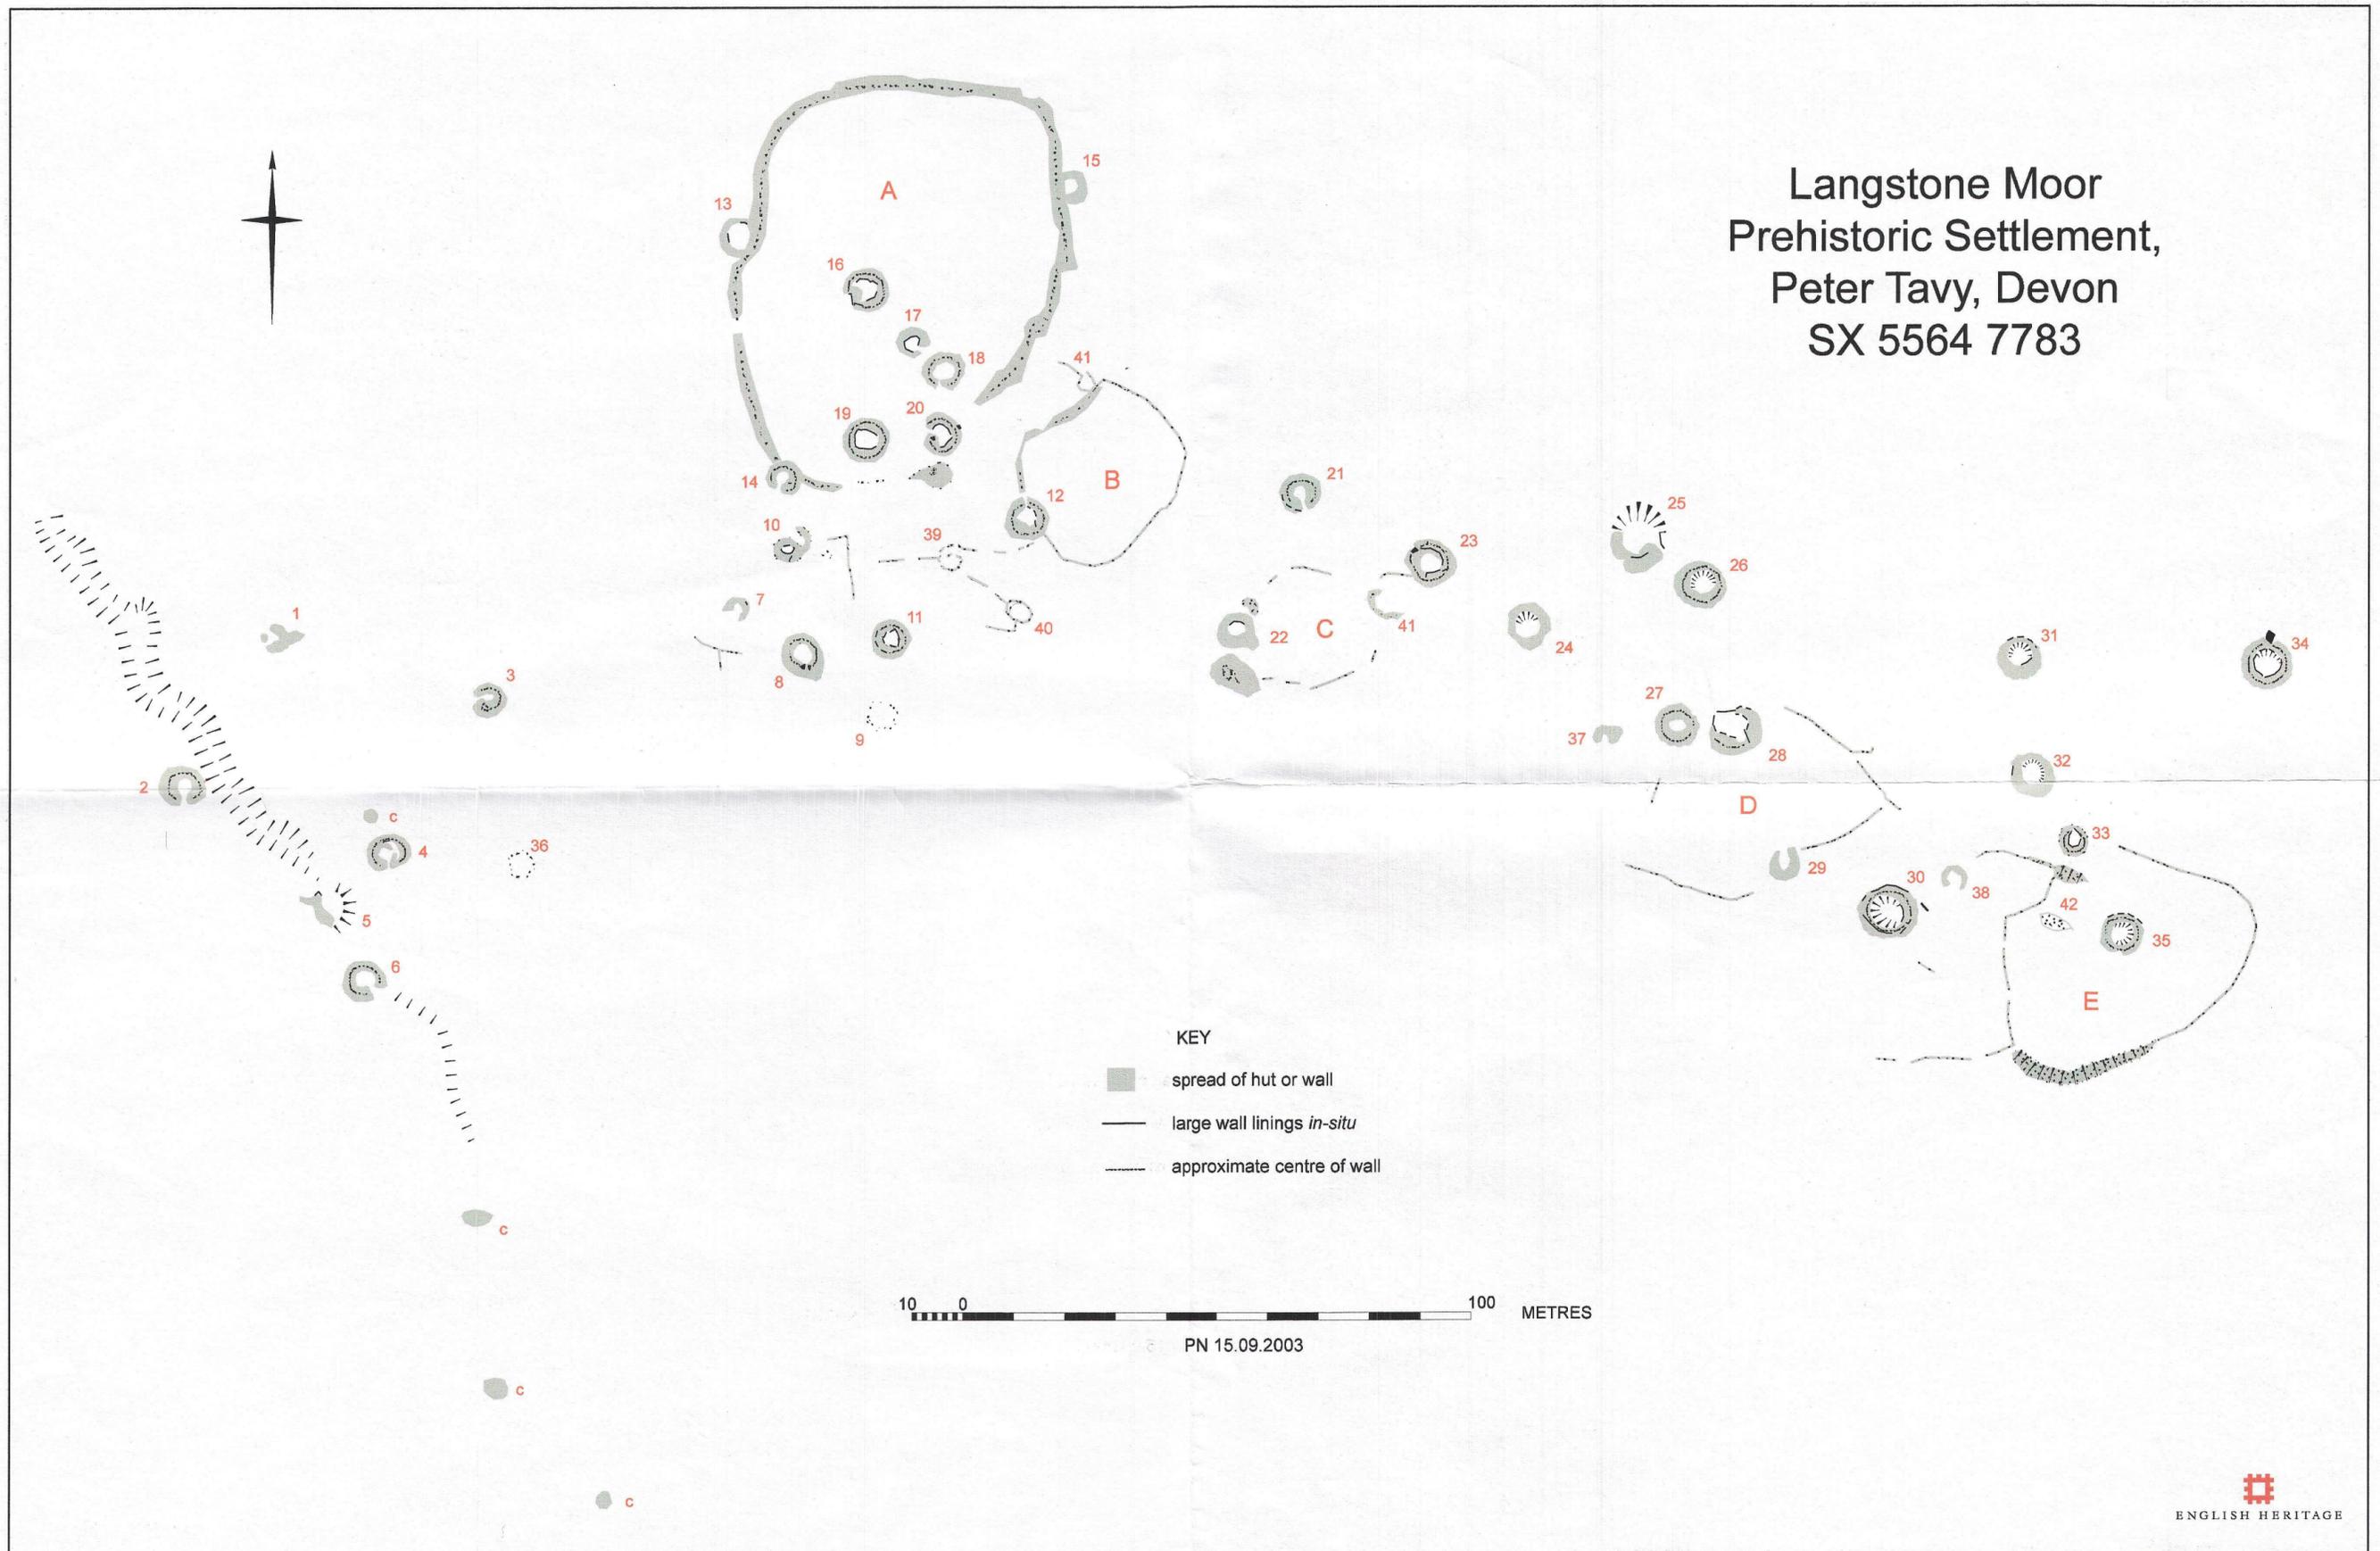
Figure 9 Langstone Moor hut settlement 1:1000 survey.

Although there is a significant difference between the internal diameter of the smallest (2.4m) and the largest hut (6.3m) in the settlement the approximate average is between 3.5m and 3.8m (see appendix iv). The majority of the huts were constructed in a robust fashion using an inner and an outer slab wall which is still visible on some huts though many of the stones are displaced. Some huts are of slighter construction however, including a group of seven (1-6, 36) at the far west of the settlement which apparently contain less stone within the walls. Some of these also appear to have been robbed as have several huts or possible huts in the main group (7, 10, 32, 35, 36, 38). Possible huts 36-8 for example are incomplete circles.

Entrance openings are visible in several of the huts, including huts 8, 18, 26 and 30 which still have upright door jambs in place, standing to an average height of 1.1m.

Judging by the present day appearance of the huts it is possible to suggest which 11 of the certain 35 huts were excavated by the DEC. These are 8, 11, 18, 19, 25, 26, 27, 30, 31, 33, 34. This suggestion is based on the sharply defined nature of the inner walls at these huts, the lack of tumble on the floors, or, in the case of hut 25, the large spoil heap on the southern exterior of the wall and the removal of the northern half of the circle. It should be noted that this list differs slightly from that of Butler (1991, 68).
