# ANGLESEY ABBEY, CAMBRIDGESHIRE

**ANGLESEY ABBEY**  
**LODE**  
**CAMBRIDGESHIRE**

Earthwork Survey

**NMR INDEX No: TL 56 SW 4**

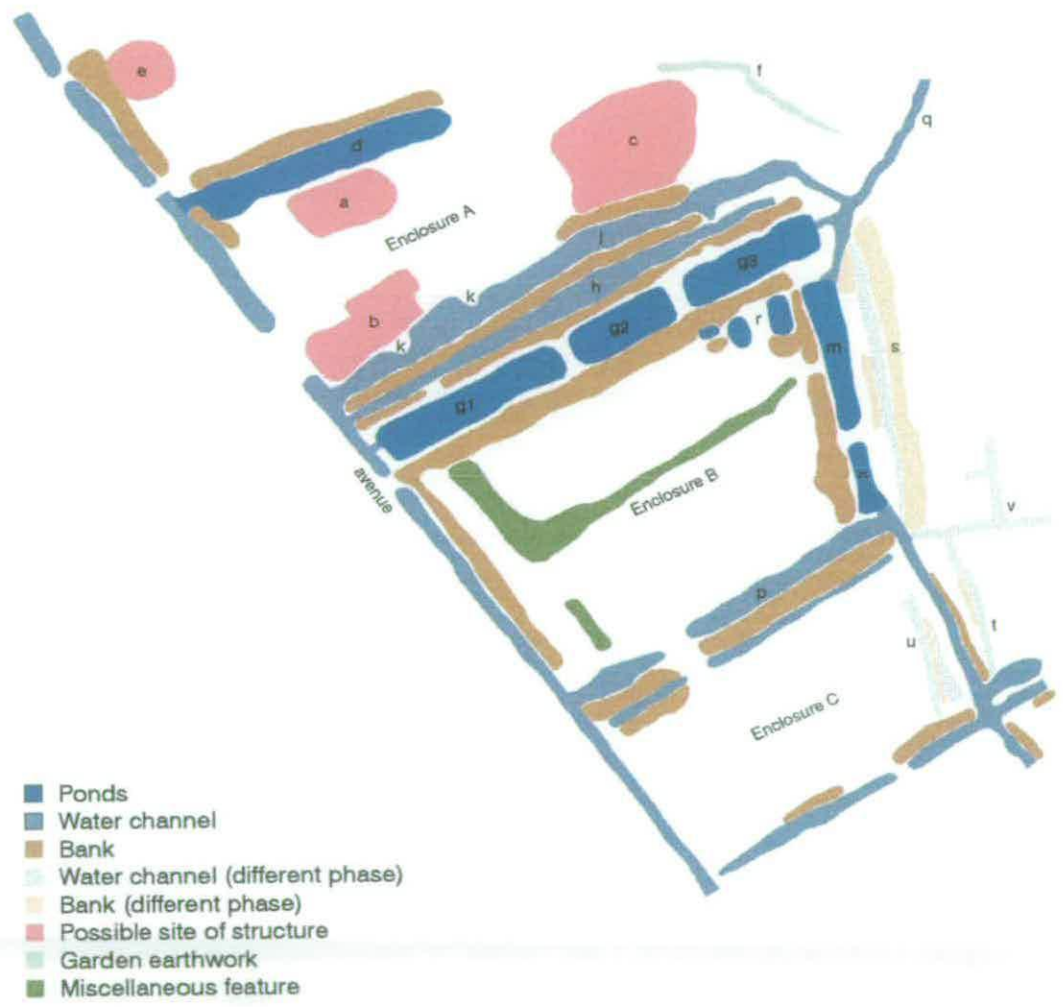
Figure 4  
RCHME  
interpretation plan  
of the earthworks  
at Anglesey Abbey

For text shown in bold see Figure 3, while an interpretation of the earthworks appears in Figure 4.

- Ponds
- Water channel
- Bank
- Water channel (different phase)
- Bank (different phase)
- Possible site of structure
- Garden earthwork
- Miscellaneous feature

On present evidence, the safe bet is to accept that the majority of the earthworks identified are monastic, concerned with the control, use and distribution of water, probably largely for keeping fish in the south-western part of the abbey precinct. The water features also served to drain and divide the land, creating areas for general agriculture. The areas so defined could have been fields and other enclosures designated to varying agricultural functions.

However, the survey has shown that enclosure A probably contained a group of buildings: the undulating and disturbed nature of the ground is certainly consistent with underlying robbed-out structures. However, historic maps, no matter how sketchily, suggest that the main cluster of abbey buildings stood to the north and west of the present house. So what were these buildings? It is possible that they were agricultural and placed away from the main claustral core - buildings which were demolished very soon after the Dissolution, perhaps because they were in prospect of the present secular house created from some of the other abbey buildings.

However, could it be that the undulations themselves cover the site of post-Dissolution secular house? This would allow for a much more comfortable relationship of such a house with enclosures B and C: it could have faced onto the enclosures, themselves re-used and adapted as a formal garden, whereas the alignment of the present house is totally at odds with the majority of the earthworks. This might further explain the fine state of preservation of the ponds and channels themselves.
