ORFORD CASTLE  
Orford, Suffolk

SURVEY REPORT

**ORFORD CASTLE,  
ORFORD, SUFFOLK**

Archaeological Investigation Report Series AI/22/2004

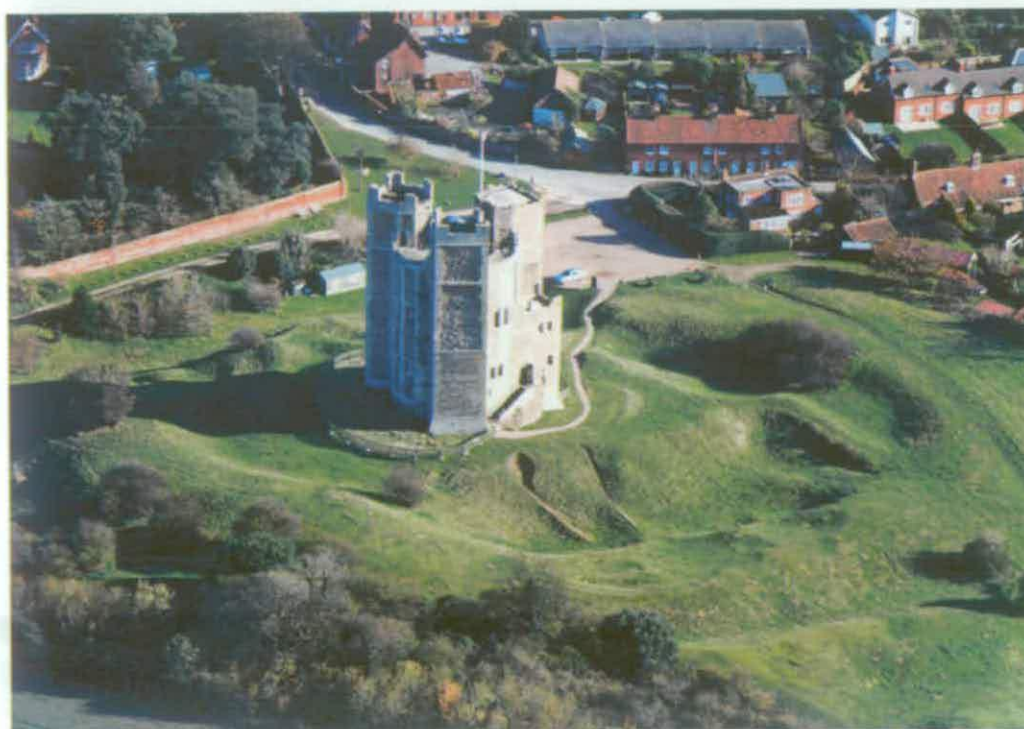
**Figure 2**  
Orford Castle keep  
and surrounding  
earthworks  
(© English Heritage.  
NMR TM4249/19)

A grade 1 listed building, the keep is the only standing structure to survive and has therefore been the main focus for study (Fig 2). This has left significant gaps in our understanding of the rest of the castle, particularly the nature and position of the other castle defences. This

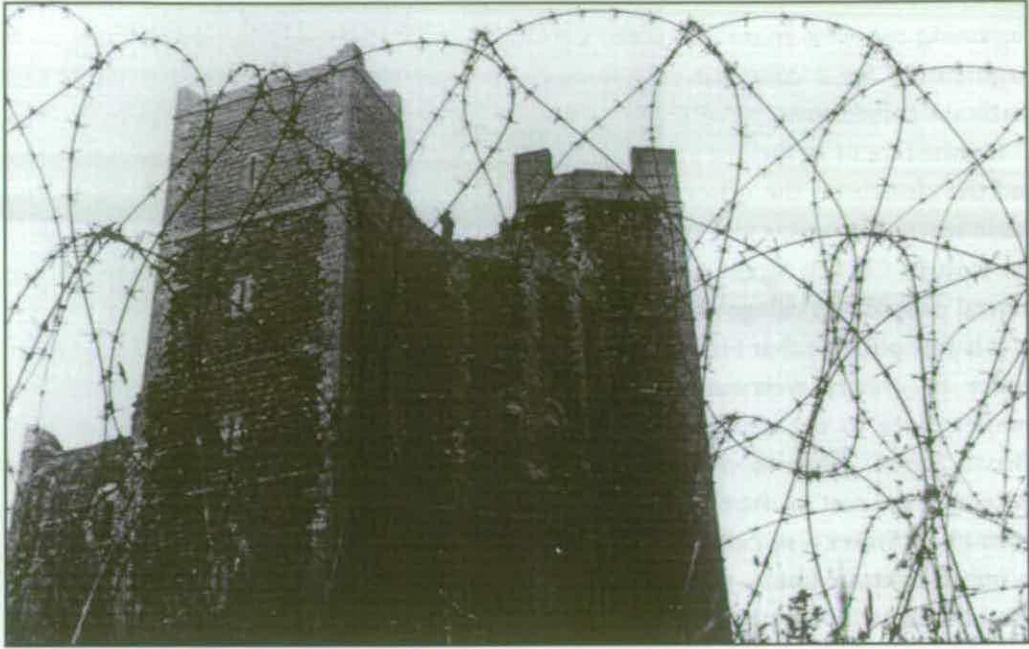
**Figure 12**  
Orford Castle c1941.  
Photograph from a  
series 'Invasion Village'  
Ministry of Information  
(© Stockwave/COI)

During the Second World War the castle was requisitioned and a reinforced concrete roof was constructed in the south turret (Fig 12). This was initially intended to hold an anti-aircraft gun but instead housed a radar observation post. Radar had been developed by Robert Watson-Watt and his team working at the 'Ionospheric Research Station' on Orford Ness during 1935-36 (Foyne 1994, 117). Aerial photographs of 1945 also show two huts within the castle grounds, one just to the north of the present car park and the other in the quarry ditch south of the keep (NMR: RAF/106G/UK/832 4174). The castle escaped damage, although within the town some 13 people were reported killed by a single bomb dropped in the market square during October 1942 (Foyne 1994, 258).

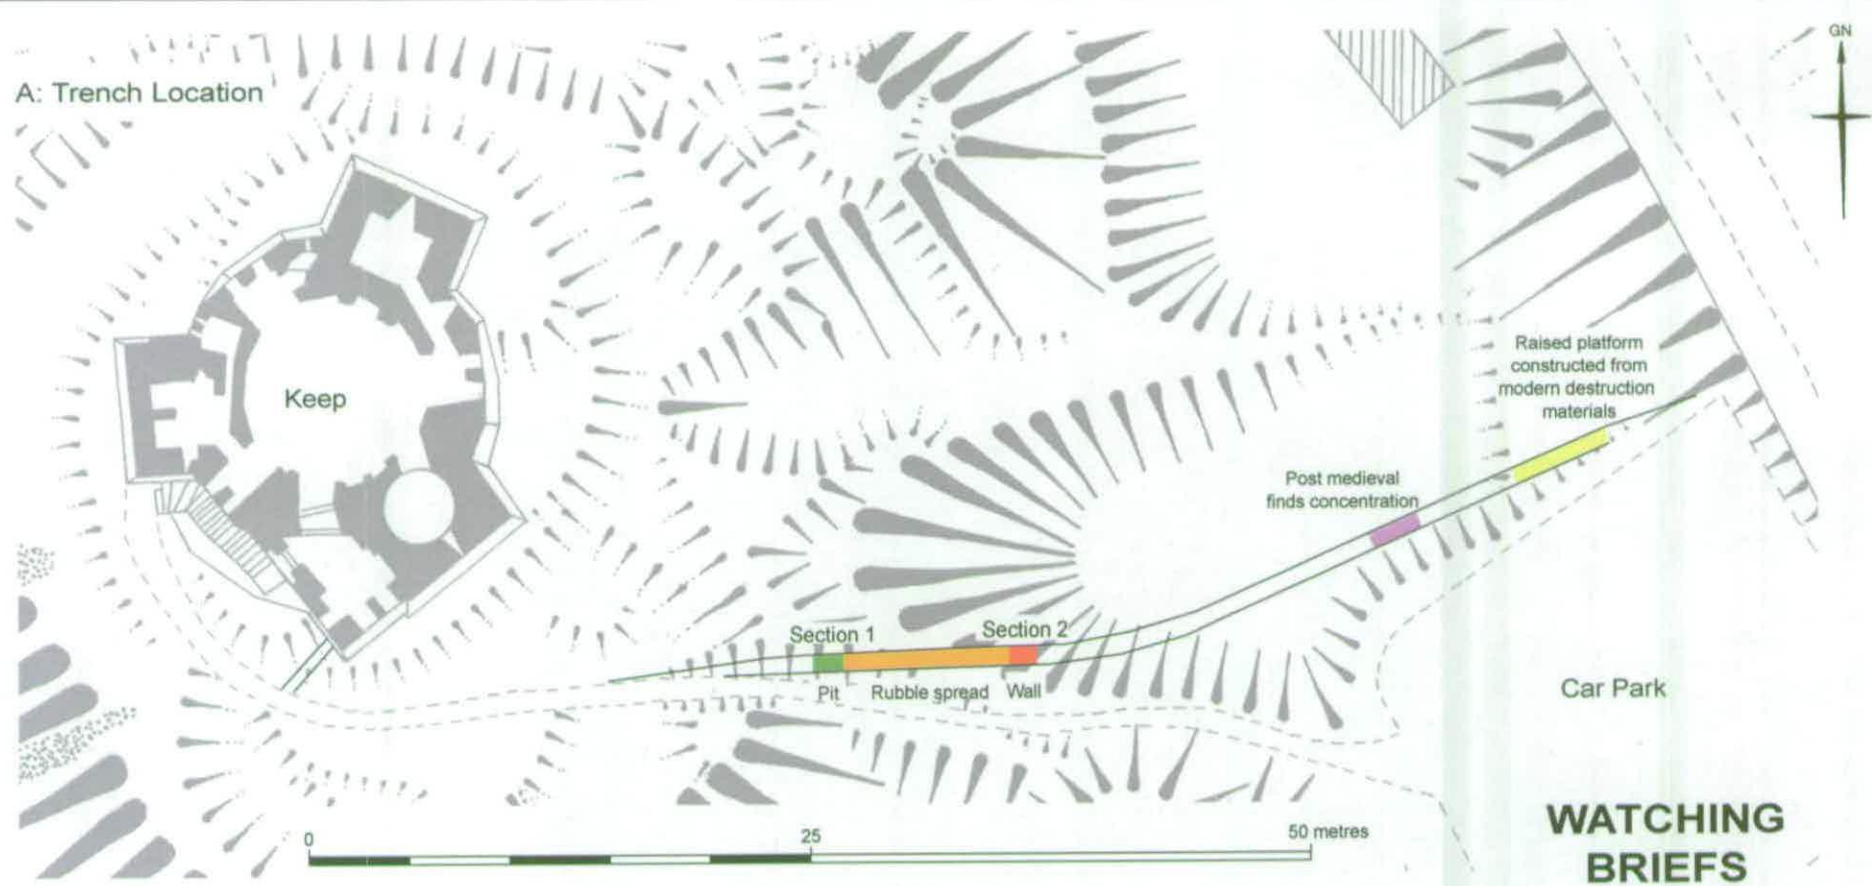
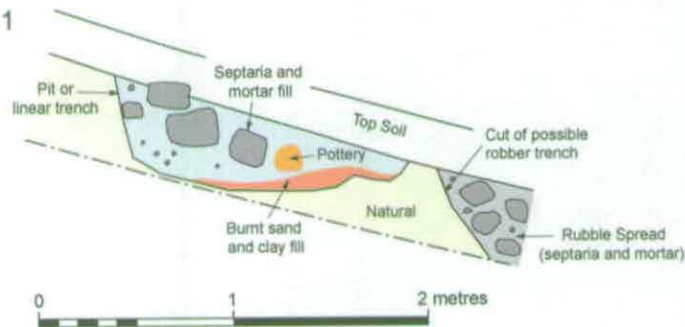
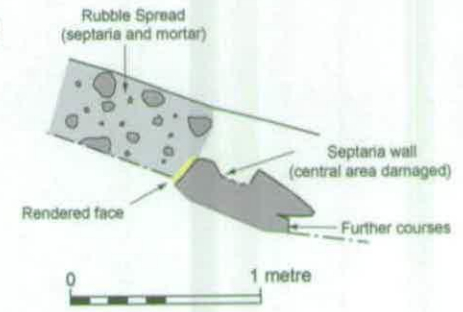
**Figure 14**  
Features uncovered during monitoring in 1993 and 1995 (after SCCAS 1995)

To the north of this wall was a rectangular pit, some 0.4m deep, with a primary fill comprising a layer of burnt red sand and clay. The pit was backfilled with septaria blocks in a loose matrix and contained some nineteen sherds of 13<sup>th</sup>/14<sup>th</sup>-century pottery (Fig 14; SCCAS 1995, Nenck *et al* 1996, 284).

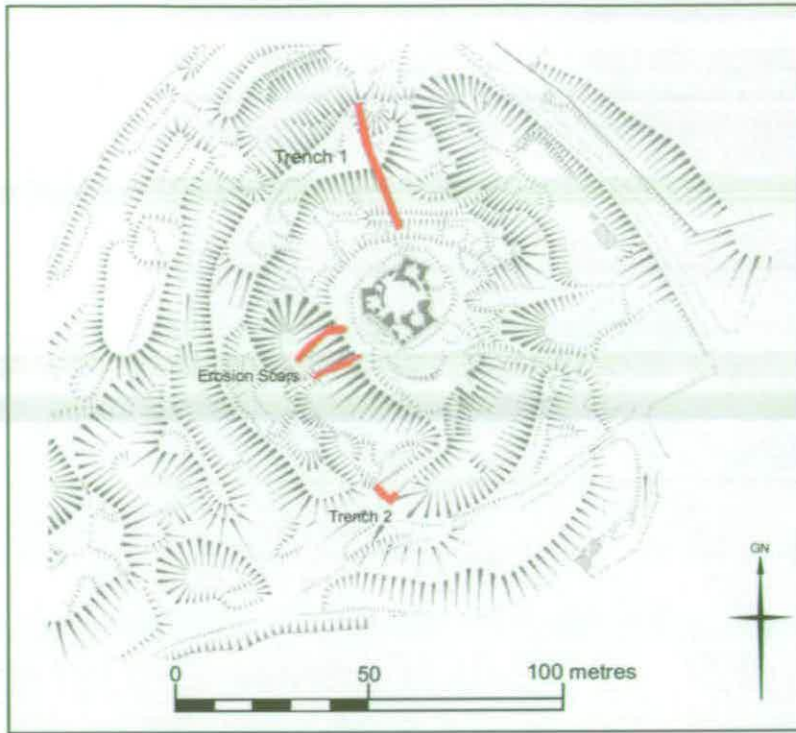
**Figure 15**  
Location of trenches

Two trial trench excavations, together with the cleaning of erosion scars, were undertaken by Suffolk County Council's Archaeological Service as part of the 2002-2003 investigation (Fig 15). Trench 1 was located in an area where the curtain wall was thought most likely to survive, some 5m north of the keep, measuring 35m in length by 1.6m wide. Remains of the robbed-out wall foundation were located some 7m north of the keep, beyond which lay a large shallow-sided ditch of at least 13<sup>th</sup>-century origin. The large outer bank centred 35m

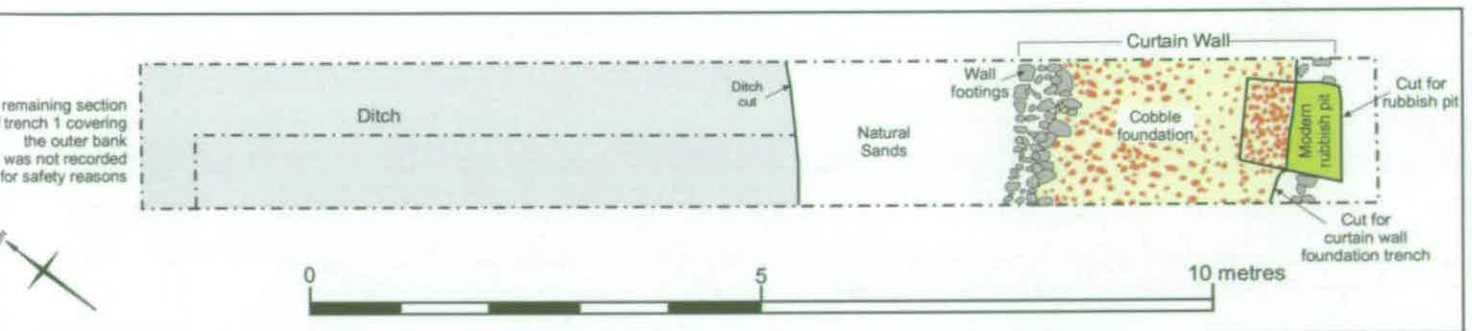
**Figure 16**  
Cross-section of the southern half of trench 1 (after SCCAS 2003, figure 2)

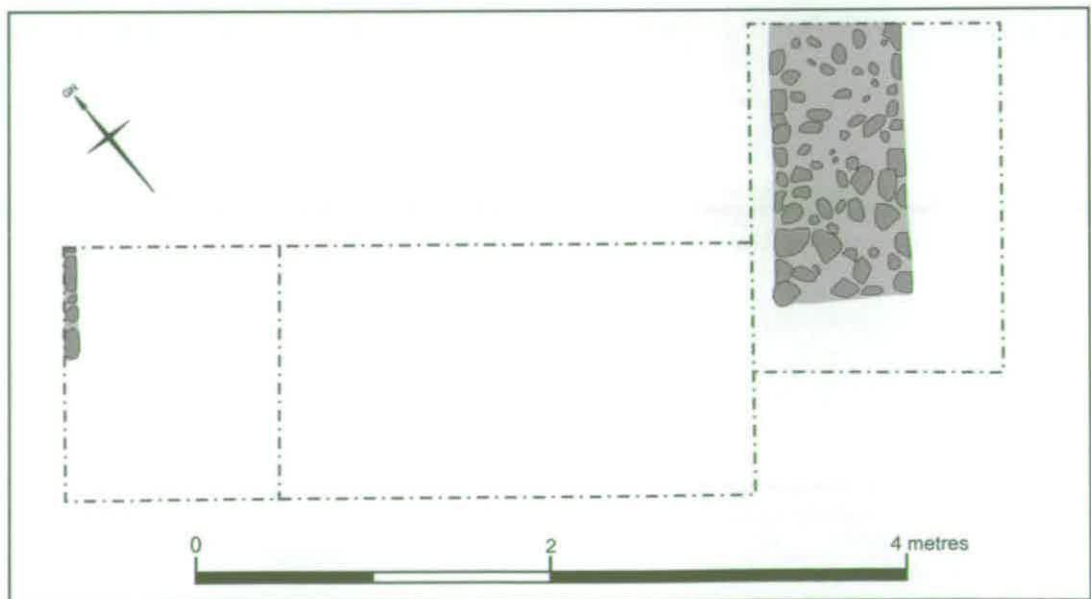
**Figure 17**  
Plan of trench 2 showing the two passageway walls which formed the barbican of the castle (after SCCAS 2003, figure 3)

Trench 2 was located at the south-western end of the causeway, where masonry remains are visible. The trench identified two well-preserved buried walls both faced and rendered, constructed of septaria and flint (Fig 17). The evidence suggests that both walls were designed to be upstanding structures, forming an entrance passage leading to the gatehouse in the southern corner of the curtain wall, as shown on Norden's plan of 1600-02 (Fig 18). No evidence of a causeway surface was encountered at depths of up to 1.7m below the existing ground level and it was assumed that any surviving surface lay beyond the depth of excavation (SCCAS 2003, 6-8 and 13-14).

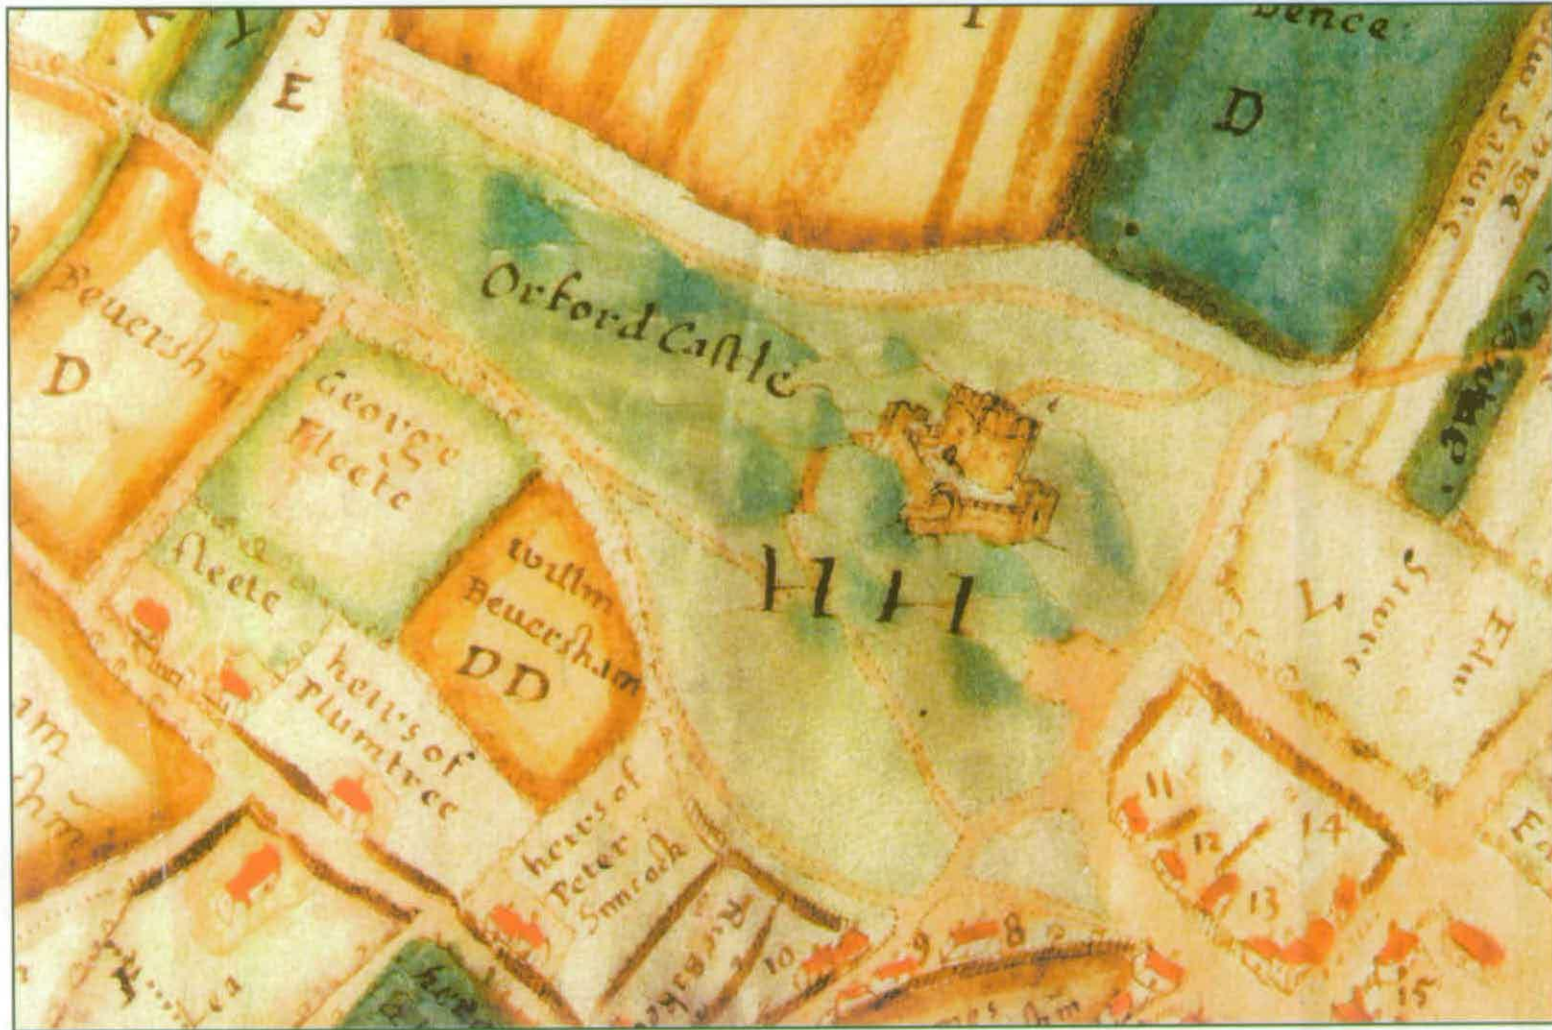
**Figure 18**

Extract from John Norden's 1600-02 survey of the Sudbourn Estate showing Castle Green. Note the passageway (barbican) running up to the castle entrance, this was revealed during the 2003 excavation  
(© The New Orford Town Trust)

The most likely position of a bridge for the postern gate would be at **g**, which corresponds with a pathway shown on Norden's plan running up to the curtain wall from the northern corner of Castle Green (Fig 18). Here the main section of ditch **a** ends, and a causeway 13m wide is defined. Counterscarp bank **e** also has a terminal here, although earthworks at **h** suggest the original continuation of both the ditch and bank across this area, implying that this may not have been an original feature of the castle.

Whilst Norden's 1600-1602 plan of Castle Green shows an undulating ground surface, no quarries are indicated. Furthermore some of the pathways he shows crossing the Green are situated in the area now encompassed by quarry a (Fig 18). This, combined with the condition of the exposures within the quarry indicates it is unlikely to have been opened in the 12<sup>th</sup> century to provide building material for the castle. Perhaps some of the large deep pits uncovered during an evaluation and excavation of land at Castle Hill during 2000-2001 or the 'gravel pit' shown on Castle Hill at the junction with Broad Street on a 1770 plan of the town are more likely candidates (Gainster and Bradley 2001, 326; SRO: EE5/11/2).

A series of paths are shown crossing Castle Green on several illustrations. Some of these are visible as slight earthworks on the 2002 survey. Norden's plan (Fig 18) shows one path following the northern boundary of the Green, part of which now survives at **a**, whilst the path which follows the southern boundary can be traced in the earthworks at **b**. This ran to and from Castle Green via two lanes **c** and **d**, still used today. A path down the eastern boundary of the site corresponds to the current track at **e**, where a hard standing is also shown by Norden at **f**. A small section of the path, otherwise removed by quarrying, can be traced at **g**, as can the route running to the south of the castle at **h**, which subsequently divided and ran north along the base of the castle ditch to join path **a**, possibly following an earlier approach to a postern gate as noted earlier. In addition to the path into the sand pit shown on the first edition 25-inch Ordnance Survey at **i**, additional routes are shown running to the cottage at **j**, as well as from the track on the east boundary to the northern boundary at **k** (Ordnance Survey, 1882).

In the northern corner of Castle Green there is a pond-like depression 30m long by 13m wide and 1.5m deep (Fig 45). This appears as a pathway on Norden's plan (Fig 18) but by 1880, it is depicted as a depression, and by 1902 had been fenced off from the rest of the Green (Ordnance Survey 1882 and 1904). The line of this fence may be represented by the scarp at a. By 1924 it had been removed and the area planted with trees (Ordnance Survey 1927).

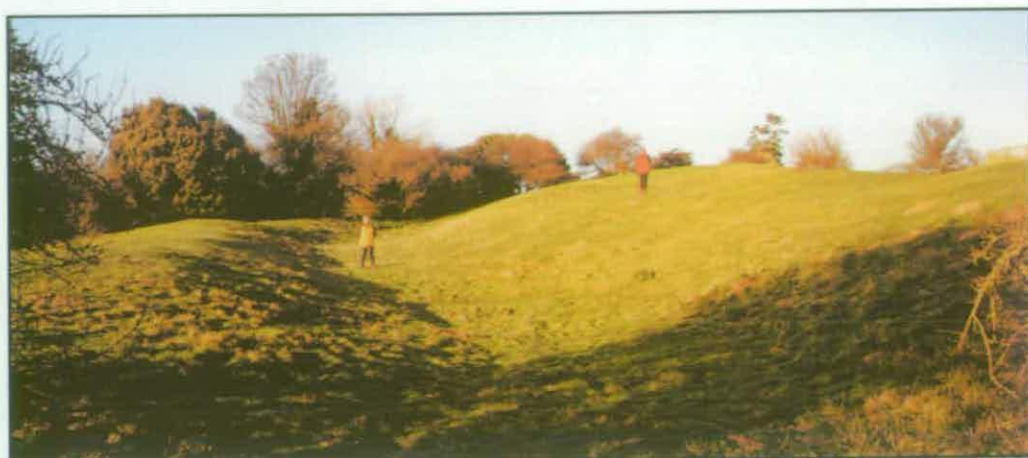
**Figure 24**

Section of ditch and counterscarp bank to the west of the keep. The figure in yellow stands in the base of the ditch with the counterscarp bank to the left  
(© English Heritage. NMRAA044145)

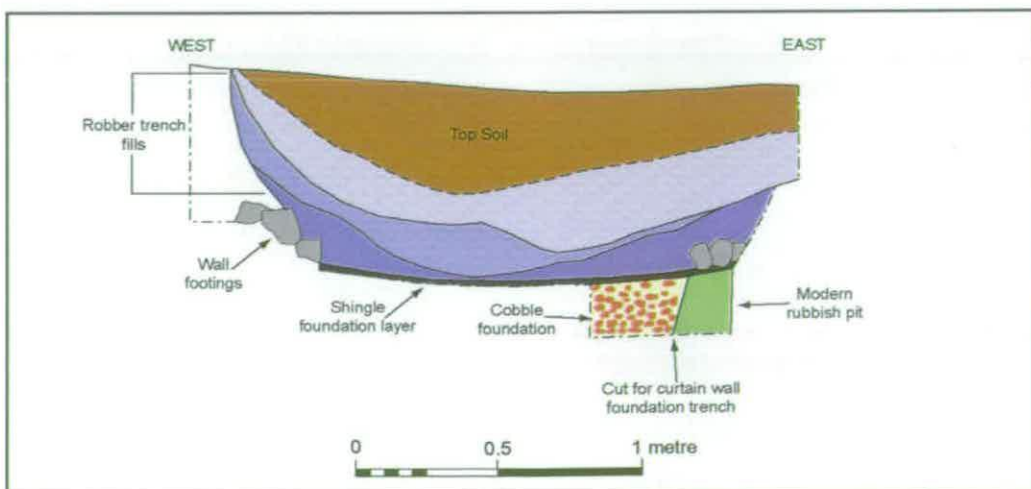
**Figure 26**  
South facing section of trench 1, showing the curtain wall foundation and footings together with the robber trench (after SCCAS 2003, fig 2)

depth. A thin layer of shingle was then spread over the cobbles on top of which lay the surviving remnants of more solid footings, principally flint rubble with occasional septaria, again packed with sand (Fig 26). There was no evidence of mortar having been used although it is possible that the free-draining and acidic nature of the soil has removed traces. At first sight this would not seem to provide a particularly solid base for such a substantial structure, however, techniques of medieval foundation building indicate that solid foundations are rare. The most common approach was to fill a foundation trench with alternating layers of crushed mortar or chalk together with more elastic clayey deposits containing pebble or cobble inclusions, thus providing a flexible foundation with high load-bearing properties that enables some degree of gradual lateral movement. The example seen at Orford demonstrates a similar approach and would likely have had similar properties, albeit achieved using very different locally available materials (SCCAS 2003, 12).

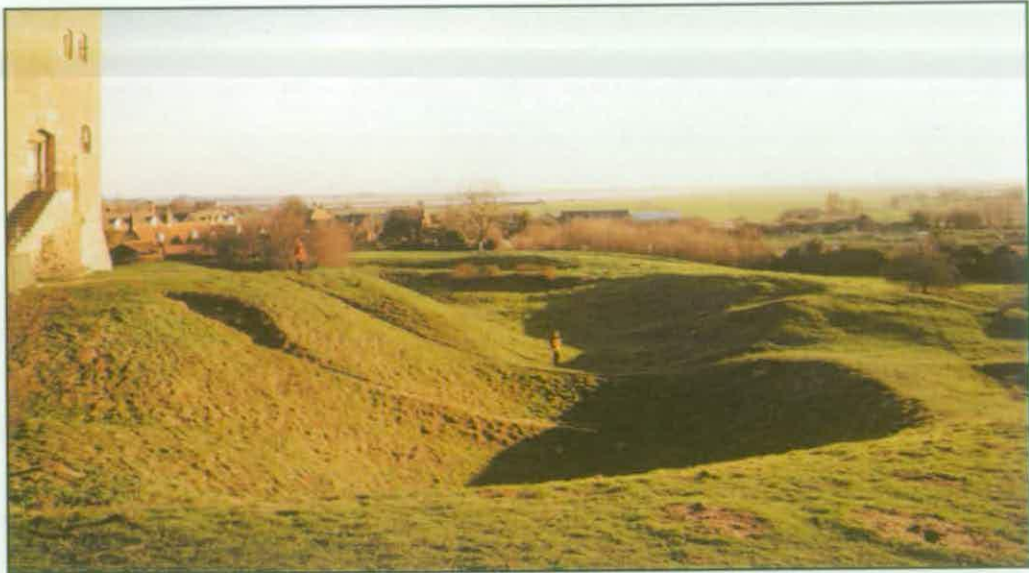
**Figure 27**  
View looking south  
along quarry **c**.  
(© English Heritage.  
NMRAA044143)

To the east, south and west of the keep a series of substantial quarries less accurately mark the line of the curtain wall. Quarries **c** and **d** are separated by the **causeway**, and are a maximum 23m wide and some 4.5m deep (Fig 27). Quarry **e** is a more substantial feature encompassing a much larger area of the castle defences. Here the curtain wall is thought to have run along the western edge of the quarry face and would cross at or near to **f**, the stonework and demolition rubble encountered during the 1993 and 1995 watching briefs (Fig 14; section 3.2).

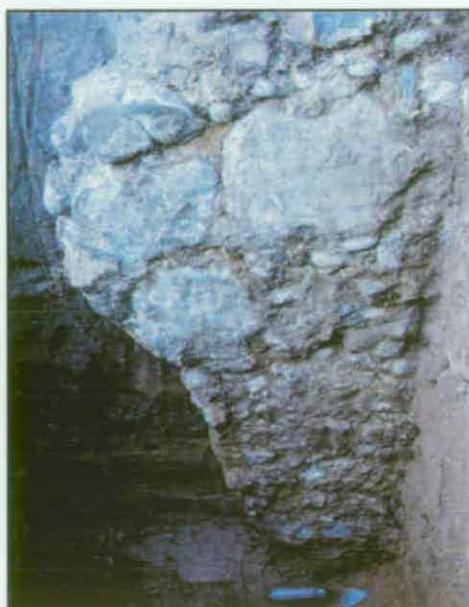
**Figures 31-32**

Photograph and section showing the inside face of the north barbican wall (after SCCAS 2003, plate 2 and fig 3)

sections of wall 4m apart. The northern section formed a continuation of the masonry remains visible in the side of the causeway at a and was excavated to a limited depth of 1.7m below the existing ground level, where neither the base of the wall nor any construction trench was encountered. Three different building phases were noted, the earliest consisting of a 1m-high rendered section, which was followed by a 0.4m-high faced but unrendered section of large septaria blocks with occasional smaller roughly hewn flints and finally a 0.3m-high section of roughly hewn flints and occasional smaller fragments of ceramic building material which appeared to represent a later 14<sup>th</sup>-15<sup>th</sup> century repair or capping (Figs 31 and 32; SCCAS 2003, 6-7).

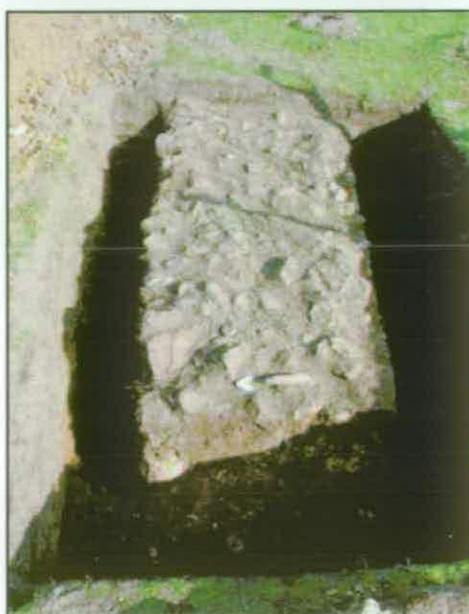
**Figure 33**

Photograph showing the south barbican wall (after SCCAS 2003, plate 3)

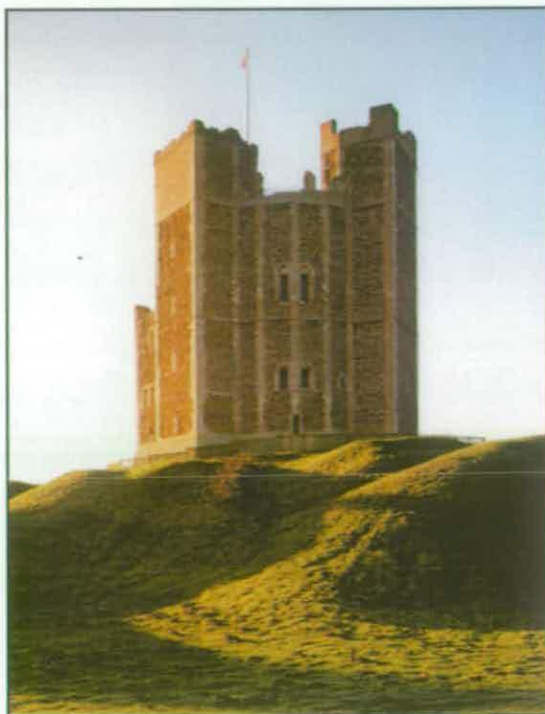
**Figure 35**  
Quarrying to the east of the keep. (© English Heritage. NMR.AA046862)

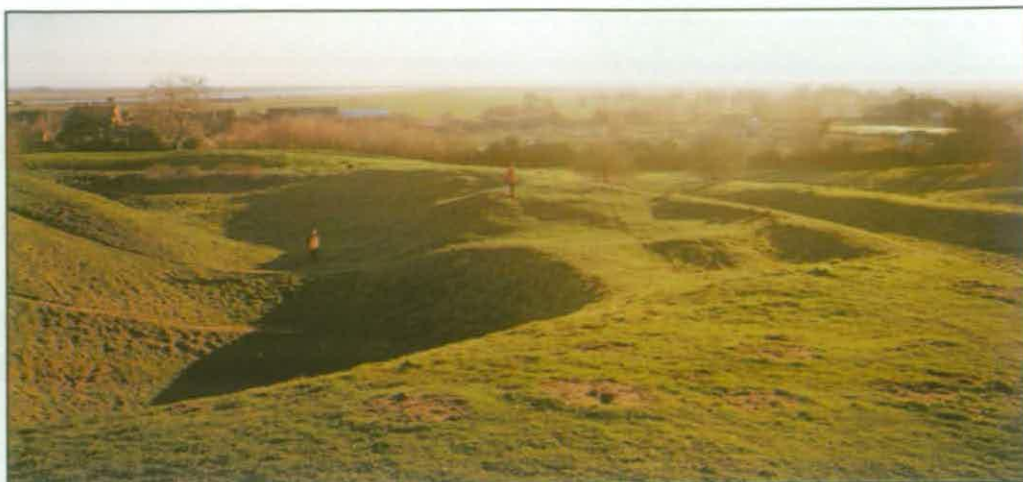
**Figure 36**

Earthworks in the berm to the west of the keep which lie between a quarry on the left hand side of photograph and the castle ditch on the right hand side

A 12m-wide section of berm escaped quarrying to the west of the keep and here are a series of earthworks at **c**, forming sub rectangular depressions up to 0.4m deep (Fig 36). Resistivity survey over this area encountered high readings indicative of large quantities of dumped material, which suggests that the original ground level of the berm may lie beneath this, possibly level with the section of berm surviving at **d** to the south of the keep (Fig 13; ECCFAU 2003, 2).

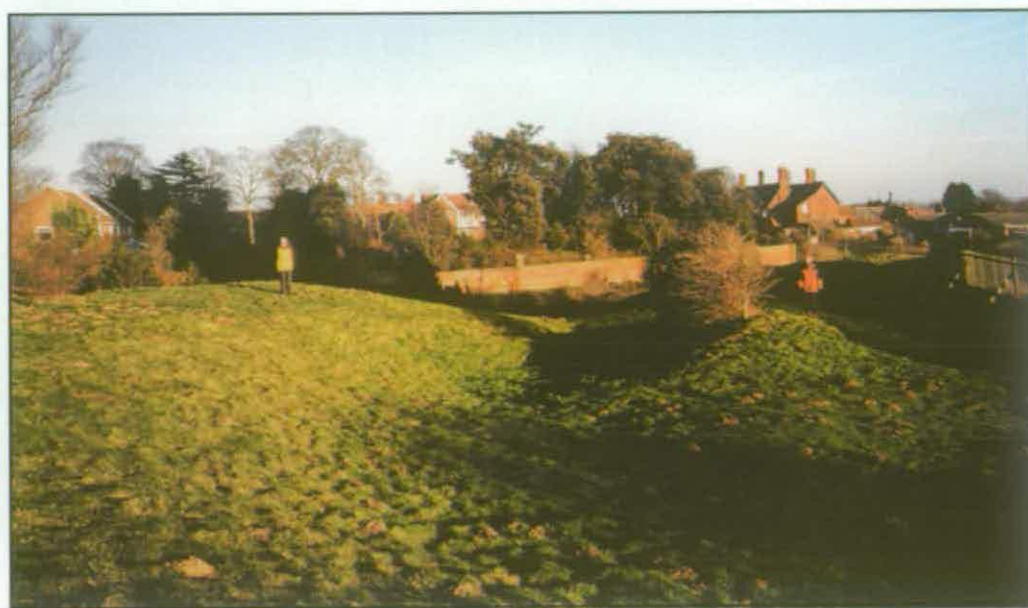
**Figure 37**

Earthworks on the berm to the north of the keep. The figure in yellow stands on the modern bank whilst the figure in red stands on the bank resulting from the robbing of the curtain wall which originally stood to the right of this feature

The section of berm to the north of the keep has escaped quarrying and contains an 18m wide by 2.1m high **bank** together with several slight earthworks at **e**, which correspond to the position of a trough shown on the 1<sup>st</sup> edition Ordnance Survey (Fig 10). The recent excavation indicates that the bank results from late 19<sup>th</sup>/early 20<sup>th</sup> century landscaping activity and is made up of 1.9m of friable mottled yellowish brown sand with occasional silty patches, under which lies the earlier ground surface (Fig 37). South of this, excavation revealed the southern edge of a smooth shallow-sided ditch lying some 2.3m north of the curtain wall which was excavated to a limited depth of 1.2m and which contained pottery of 13<sup>th</sup>/14<sup>th</sup> century date (Fig 38; SCCAS 2003, 5-6). Without more extensive excavation interpretation of this feature is difficult and whilst it would appear to be contemporary with

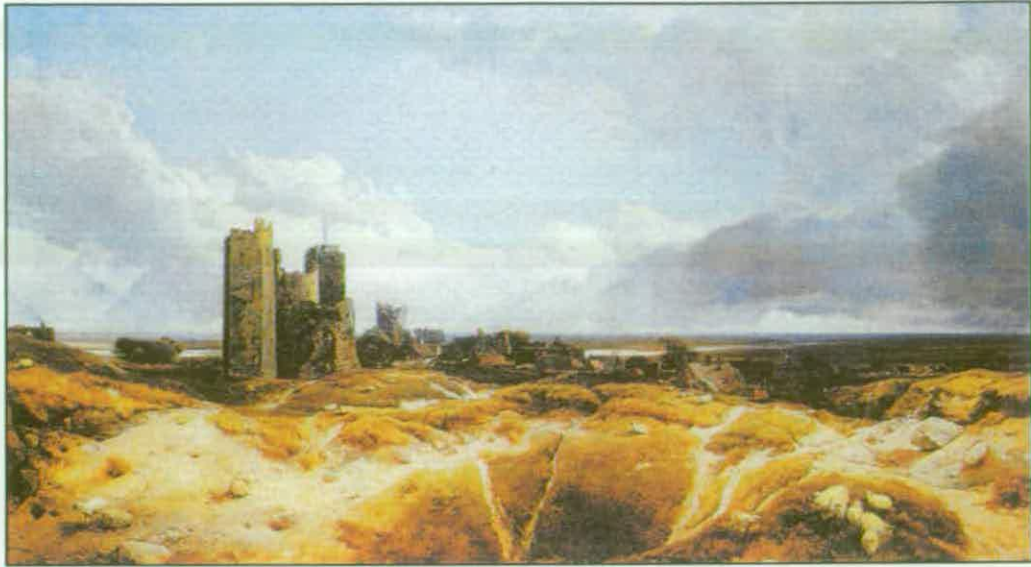
**Figure 41**

Orford Castle and village, painted by Henry Bright in 1856 showing the extensive quarrying on Castle Green  
(© Norwich Castle Museum and Art Gallery)

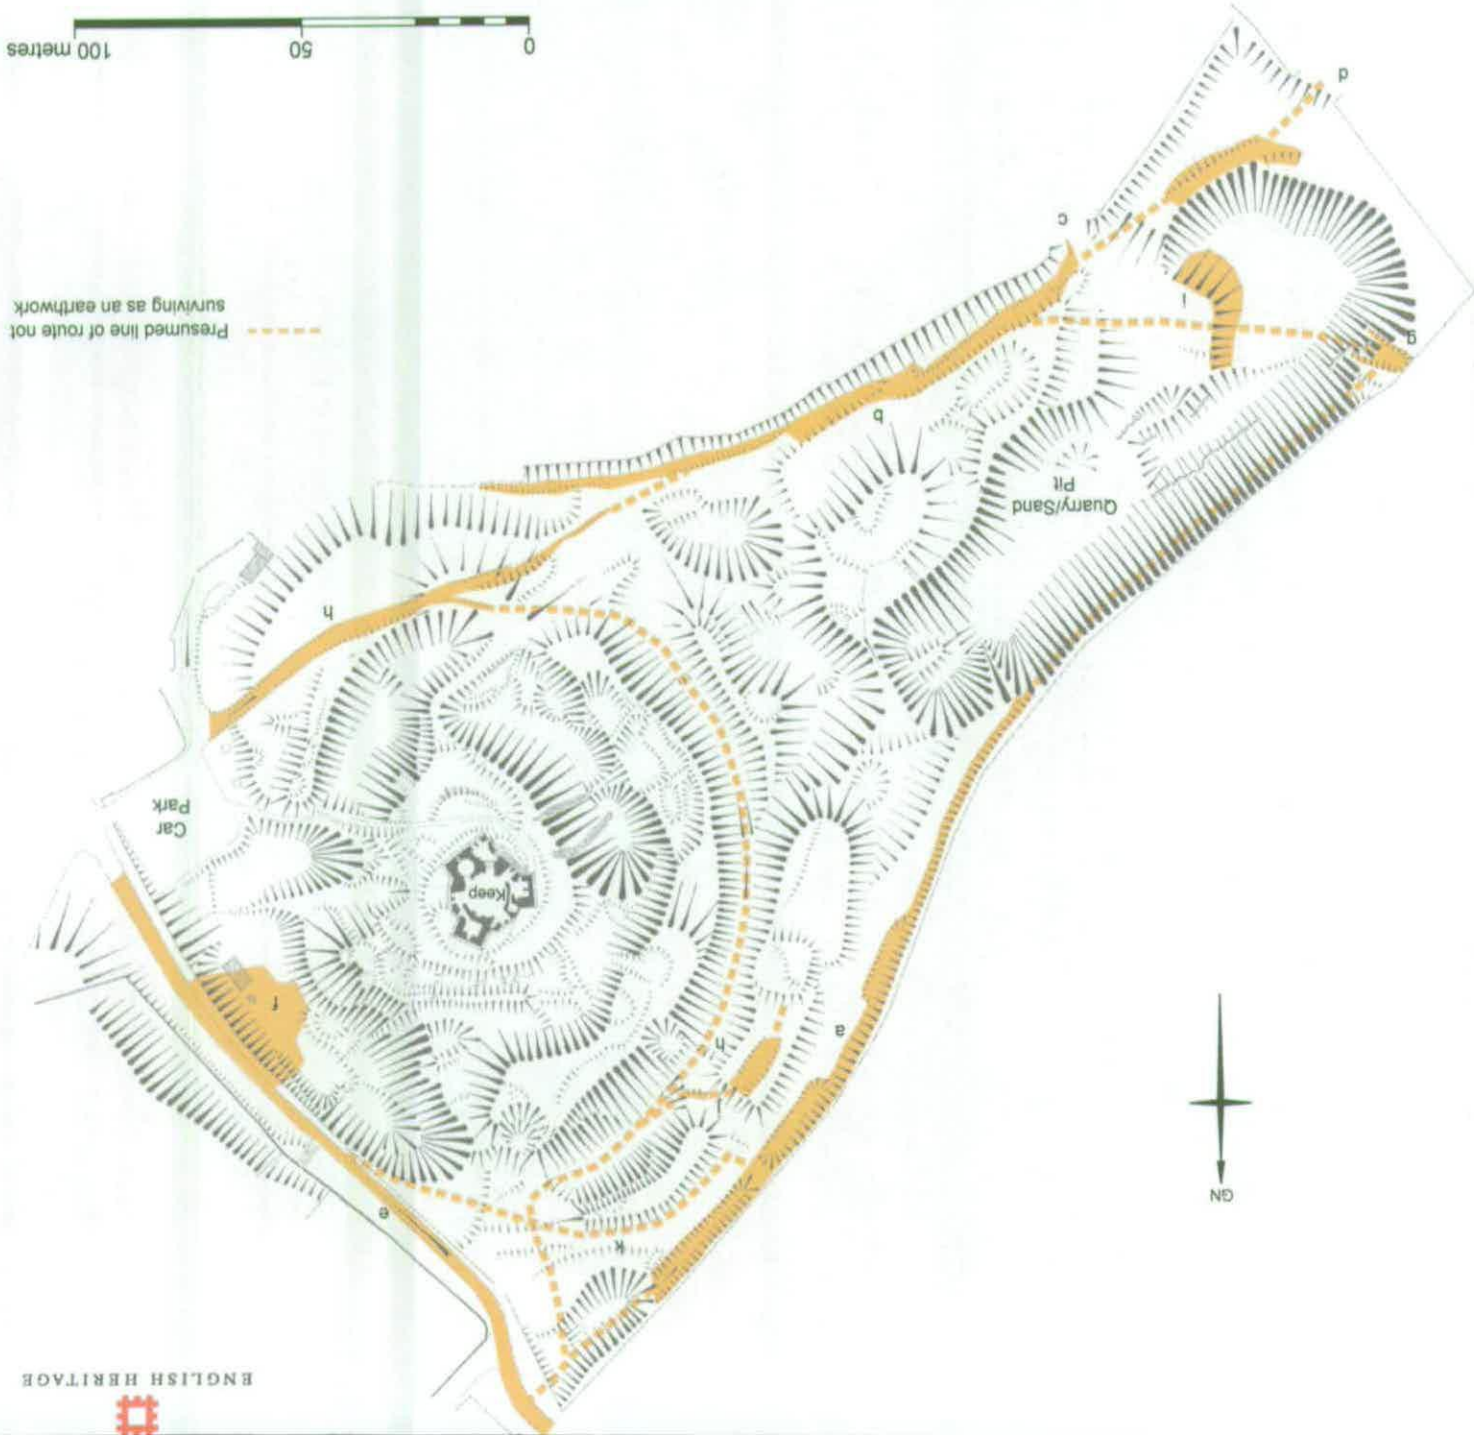
Figure 42  
Interpretation plan showing the  
position of routes across  
Castle Green

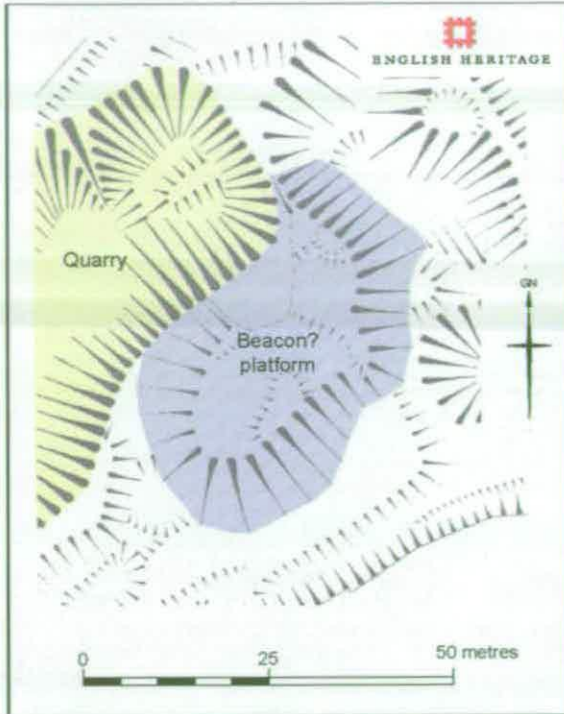
**Figure 43**  
Interpretation plan showing the possible beacon platform on Castle Green

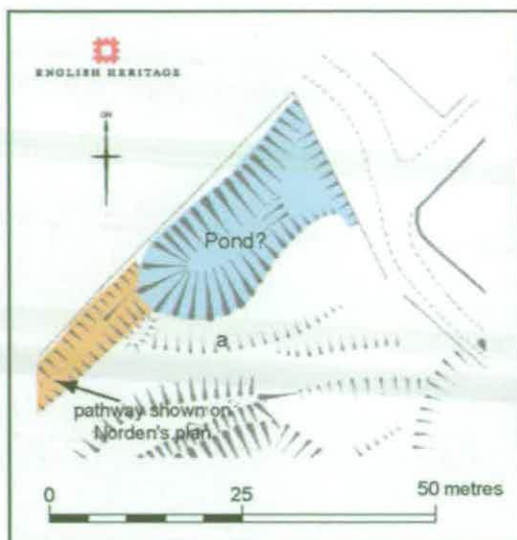
**Figure 45**  
Interpretation plan  
showing the pond - like  
depression in the  
northern corner of  
Castle Green

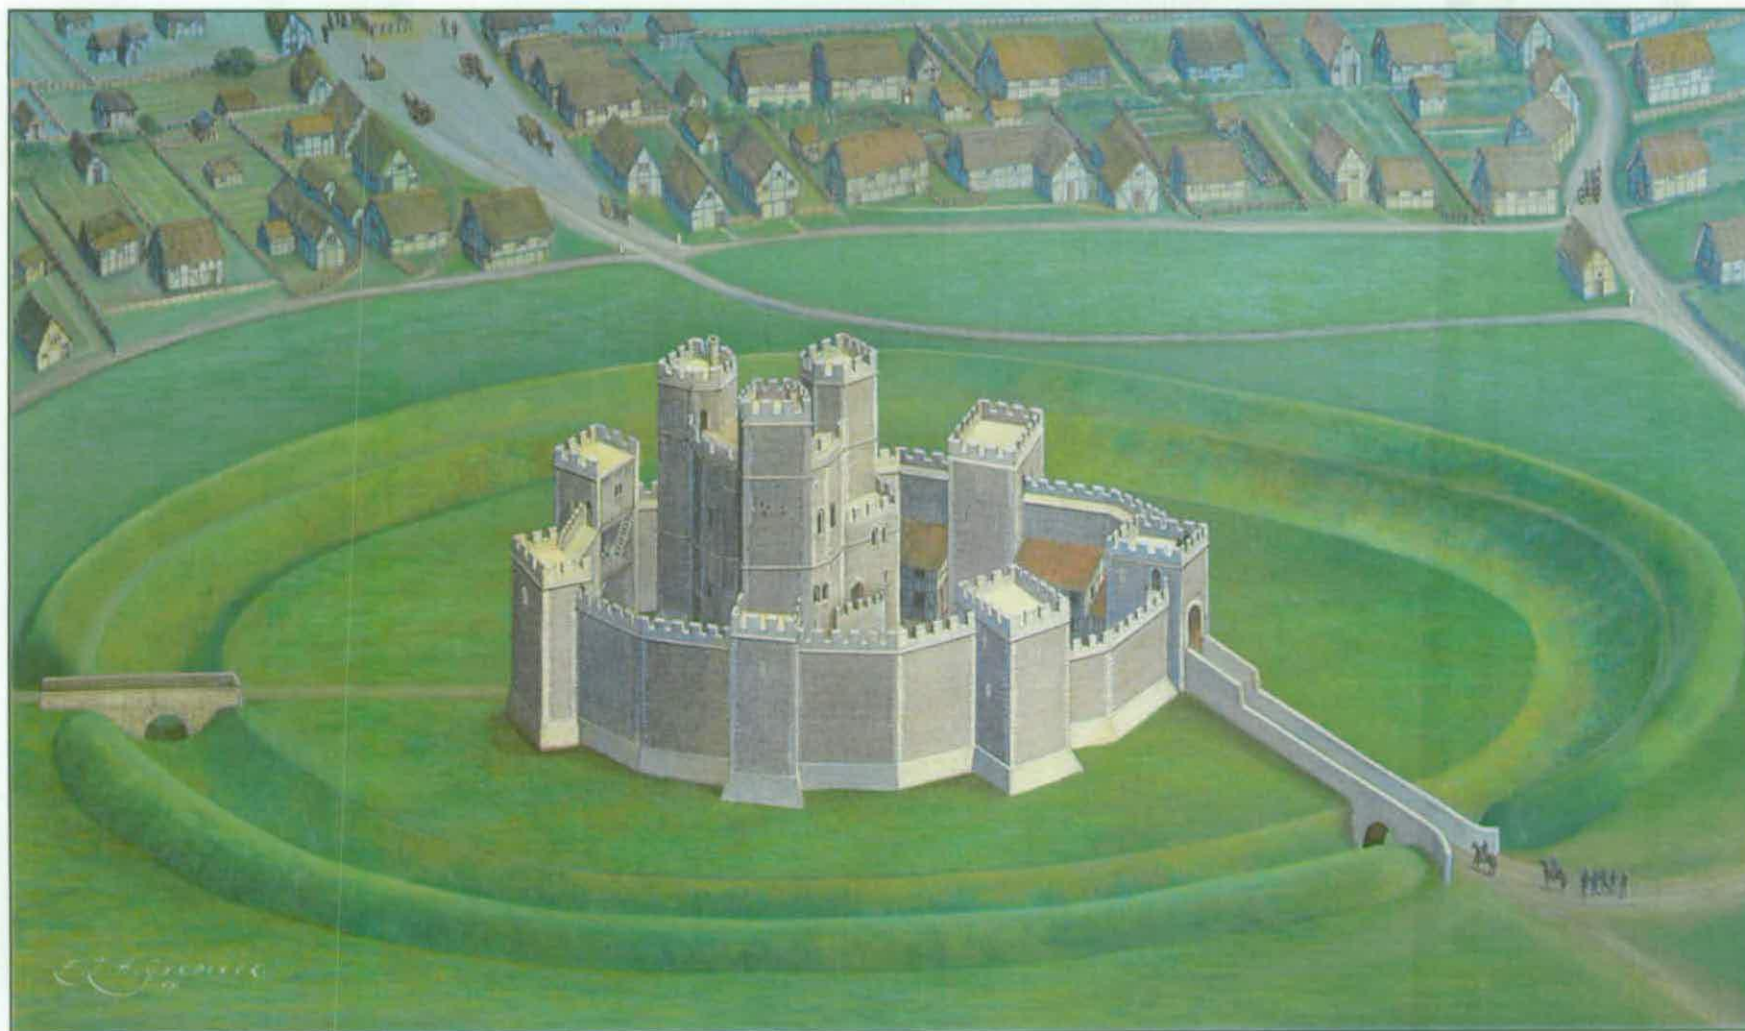
**Figure 47**  
*Reconstruction drawing of Orford Castle as it may have appeared around 1300. This drawing by Frank Gardiner is based on the results of the recent archaeological investigations as well as from early illustrations of the castle (© English Heritage)*

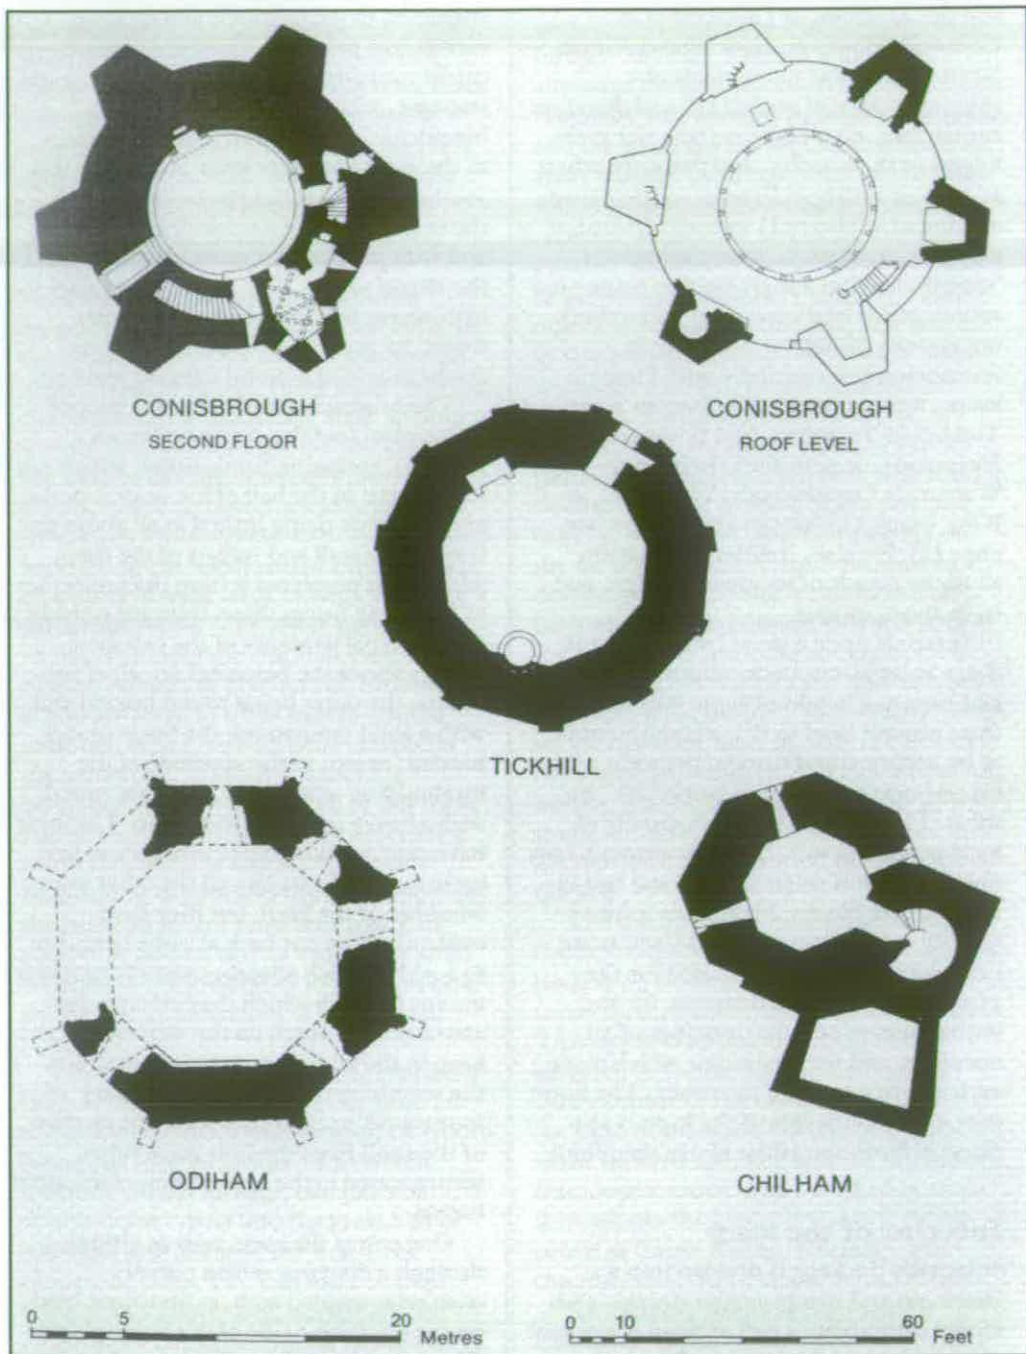
**Figure 49**  
Comparative plans of  
12th-century keeps  
(© Crown Copyright)

The change from a rectangular to a circular keep was primarily defensive. The inherent defect in any rectangular keep was the dead ground at its angles, where it was difficult to see what an enemy was doing and almost impossible to interfere with their activities. The polygonal form of the central tower at Orford was therefore stronger defensively but the addition of the three rectangular turrets and a forebuilding negated this and would have provided an obvious target to an enemy which managed to break through the outer defences. It seems, therefore, that the unique design of the Orford keep owes as much to domestic planning as that of military engineering. Given that the bailey at Orford is small, the keep needed to house a large proportion of the castle's accommodation which would have been

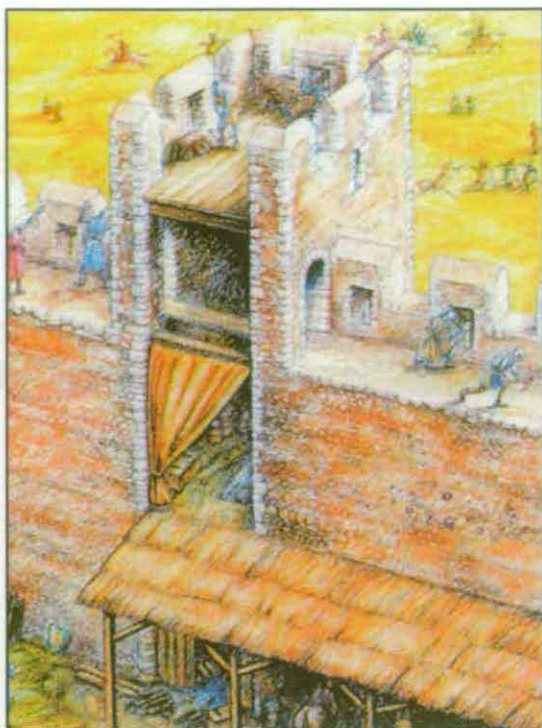
**Figure 51**  
Reconstruction of how  
one of the mural  
towers at Framlingham  
Castle may have  
looked  
(© English Heritage)

their logical positioning in relation to the keep (the turrets of the keep could be used as fighting platforms, so generally required clear views out over the curtain wall between the towers) and each other. With the exception of the two towers either side of the gatehouse, they are thought most likely to have resembled those at Framlingham, being relatively small and open backed (Fig 51). These may well have had temporary back walls, in the form of a wooden barrier, or a simple curtain, with each floor accessed via a ladder. The floors would most likely have been wooden gangways which could be easily removed in time of attack, thereby isolating an enemy which had succeeded in getting onto the wall-walk. The top of

each tower would have contained the main fighting gallery, although additional arrow loops may have been located at a lower level.
