ORFORD CASTLE  
Orford, Suffolk

SURVEY REPORT

**ORFORD CASTLE,  
ORFORD, SUFFOLK**

Archaeological Investigation Report Series AI/22/2004

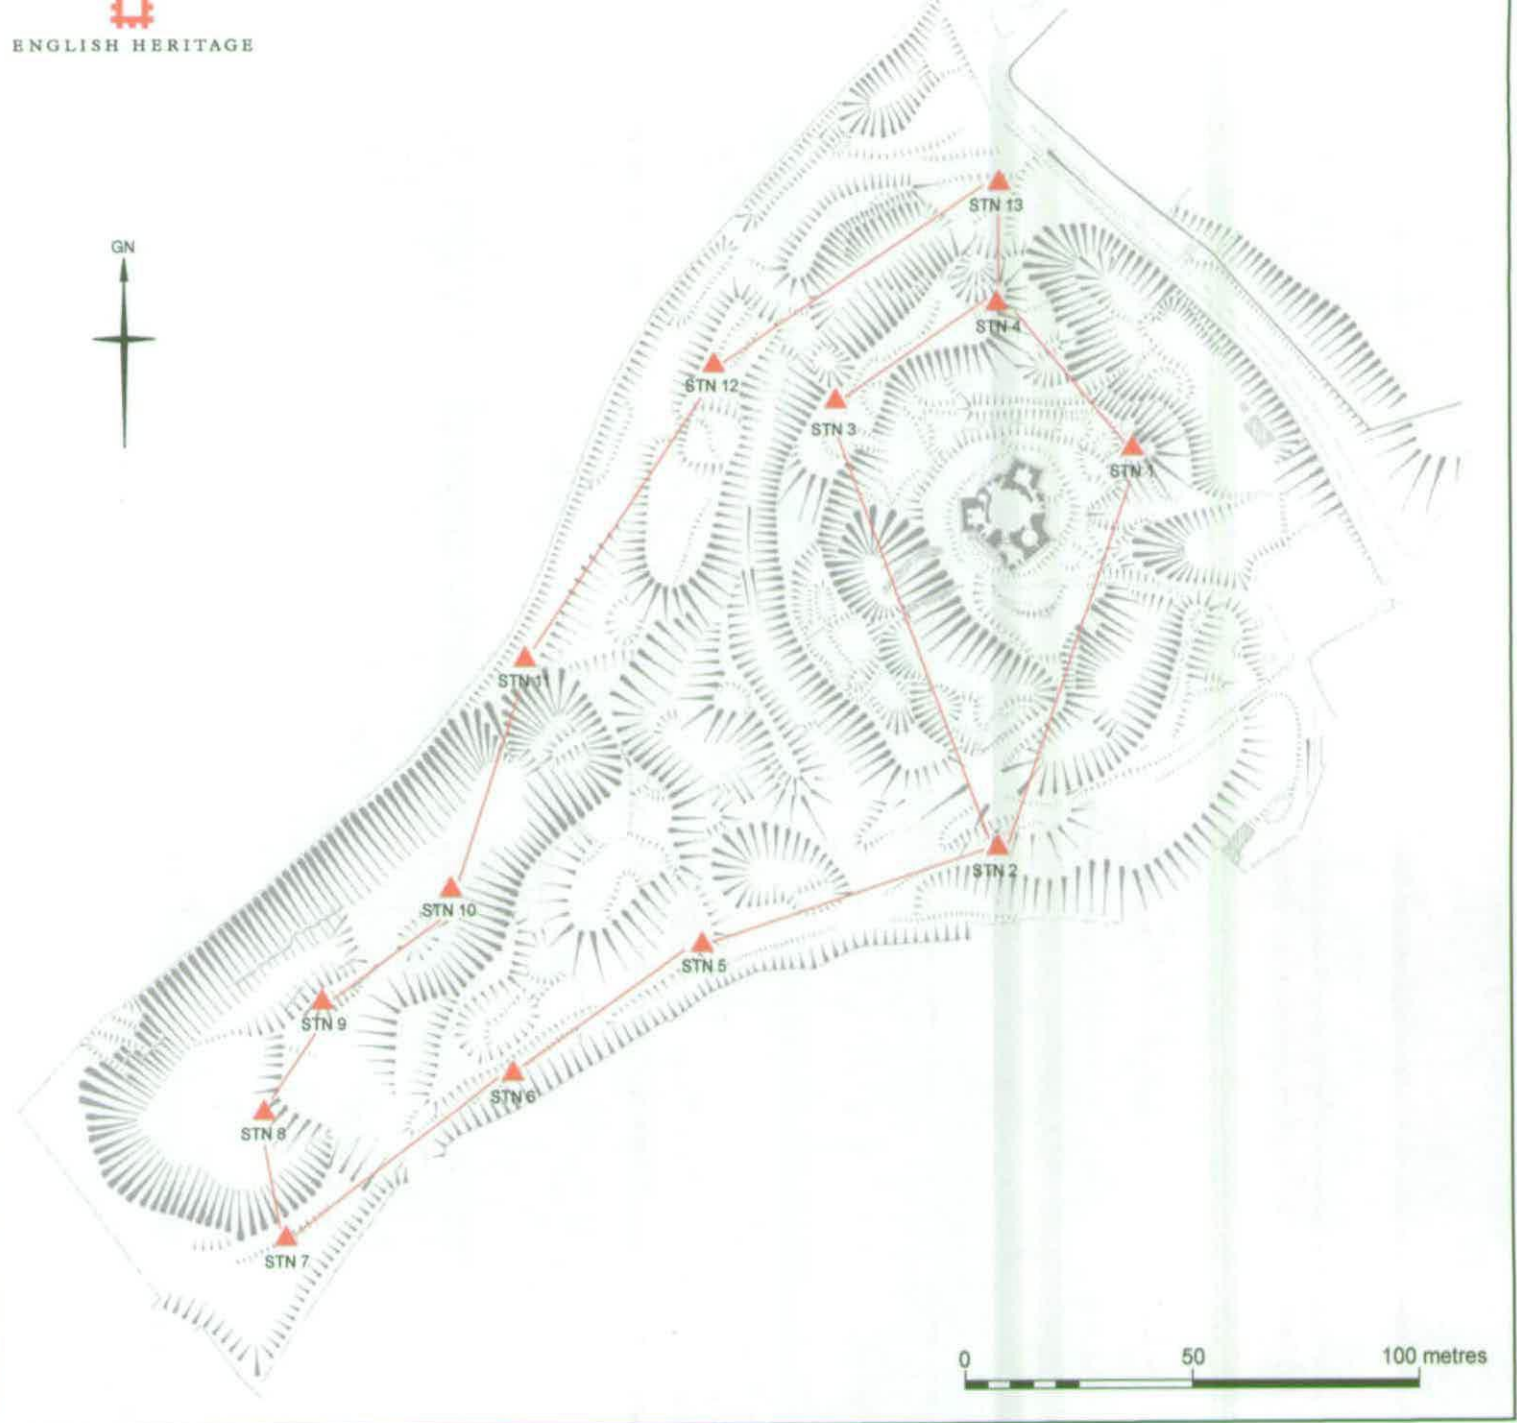
**Figure 52**  
Survey Methodology:  
Traverse diagram
