The 'Trendle'
Hillslope Enclosure
and the Bicknoller
Cross-ridge Dyke,
Bicknoller, Somerset

SURVEY REPORT

An archaeological survey by English Heritage

County:	Somerset
District:	West Somerset
Parish:	Bicknoller
NGR:	ST 1181 3935
SAM no:	SO 407
NMR no:	ST 13 NW 3/29
SMR no:	Somerset 33201/34701
Surveyed:	March 2002
Report by:	Phil Newman
Surveyors:	P Newman, E Jamieson
Illustrations:	Elaine Jamieson

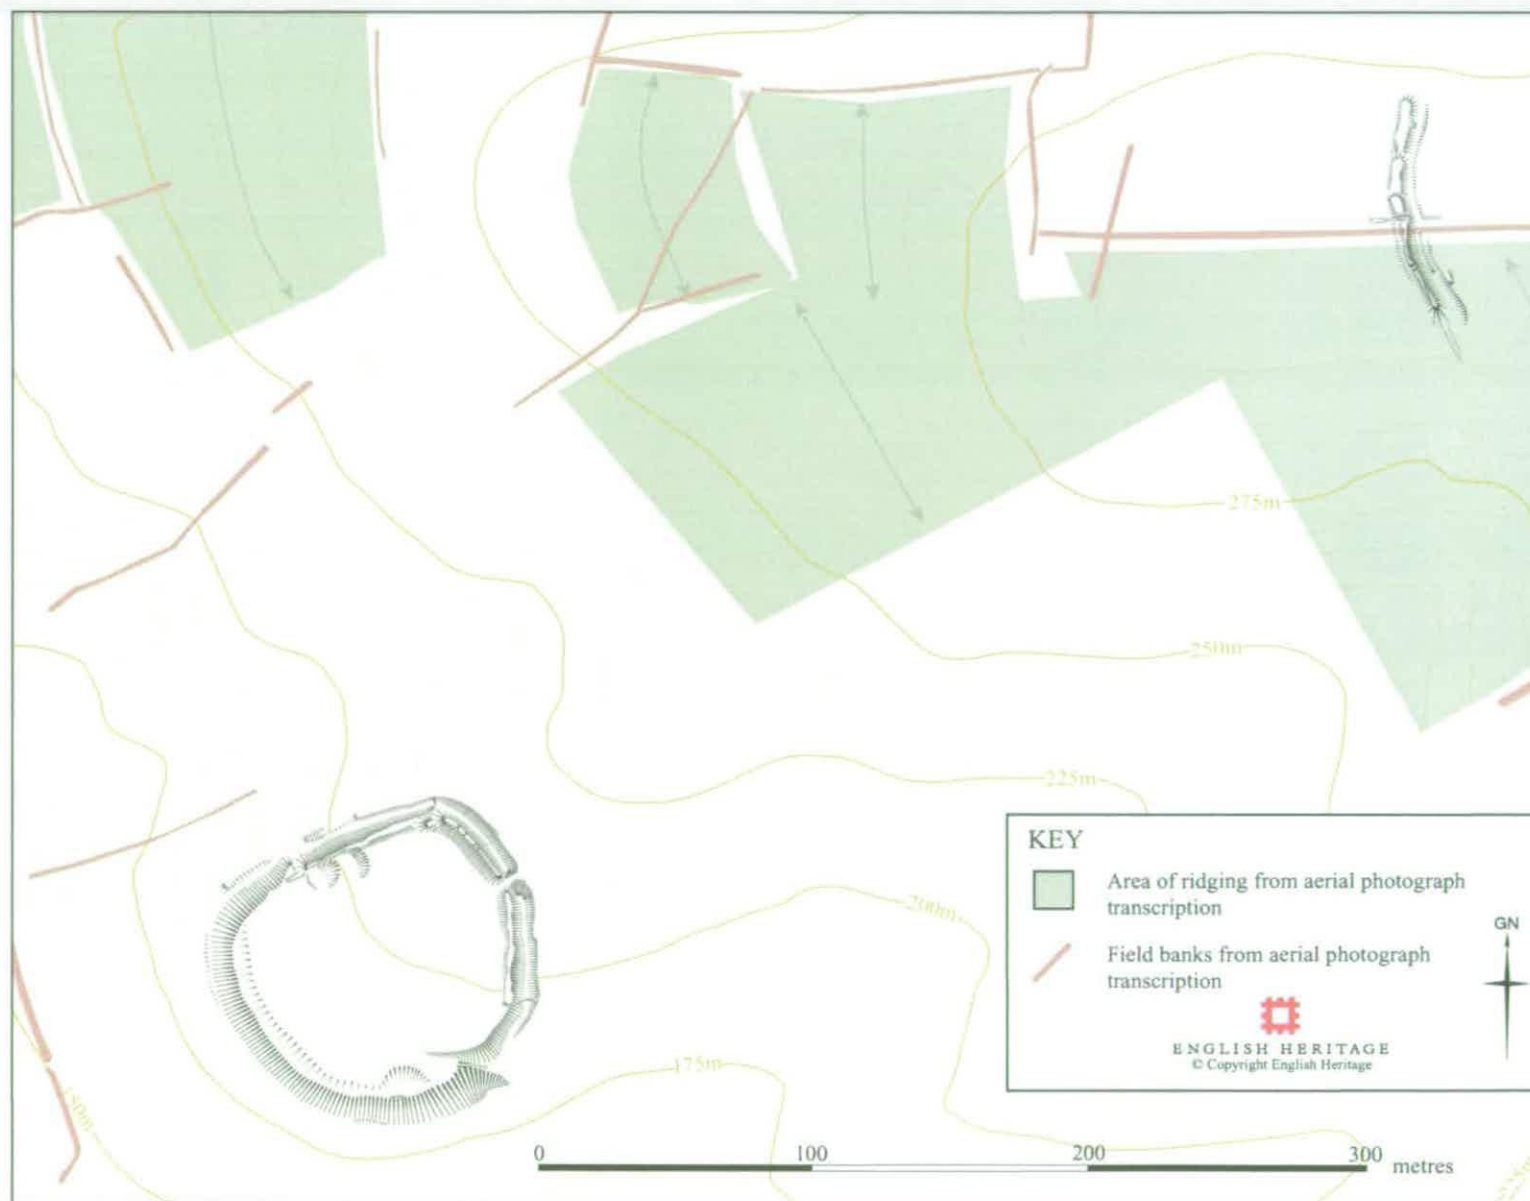
Fig. 2. The enclosure and the cross-ridge dyke.

is visible to the north-west and south Wales can be seen on a clear day. To the east however, the view is obscured by the steepness of Bicknoller Hill on whose lower slopes the Trendle is located, on a spur protruding from the main hillslope at a height between 175 and 210m above OD. A second earthwork in the form of a cross-ridge dyke and bank is sited to the north-west at ST 1219 3964 at a height of 283m above OD and is considered likely to be an outwork associated with the same period as the occupation of the Trendle.

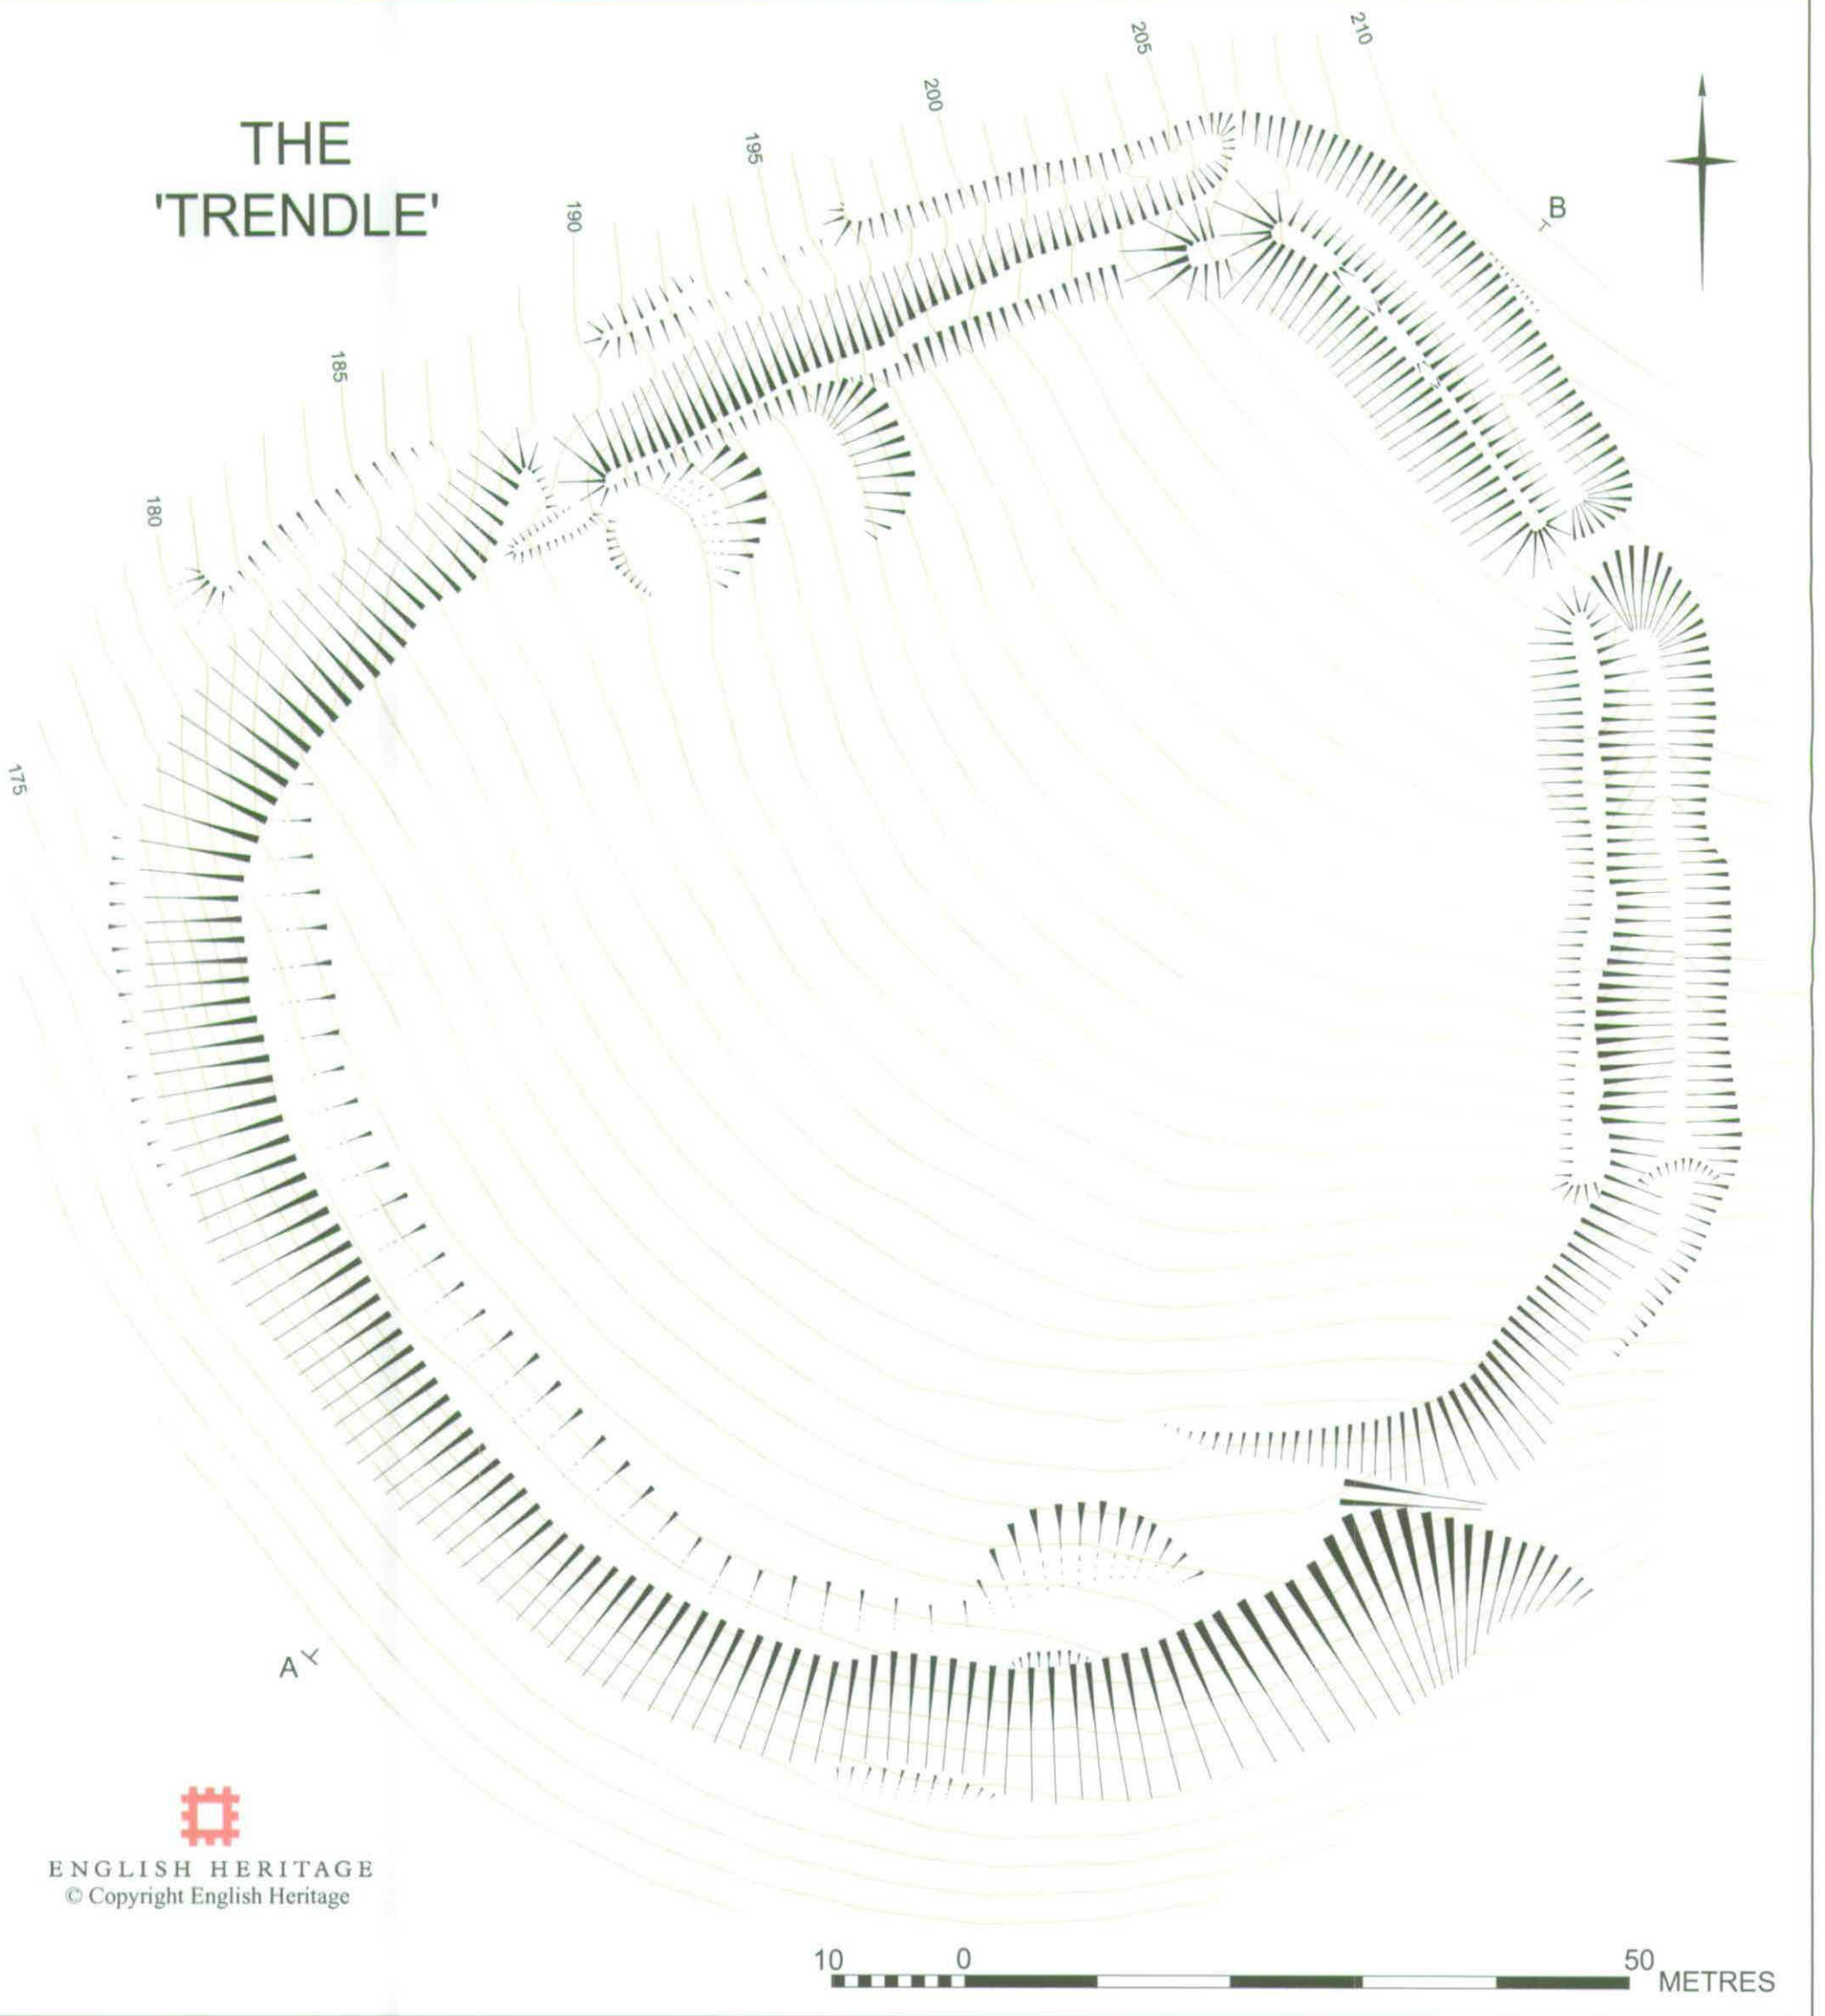
Fig. 3. English Heritage 1:500 scale earthwork plan of the enclosure.

The enclosure is sub-circular in shape, wider on the lower south-western end and narrowing to an angular corner at the northern point. The total enclosed area is 0.72ha. The defences may be described as two sections of distinctly different appearance, each of which has been built to take advantage of the steep slope, creating an upstanding rampart. The upper portion at the north-eastern end comprises a single bank with external ditch, while the lower parts of the circuit, consist only of an artificial scarp which serves to exaggerate the steepness of the natural hillslope.

which runs from the northernmost tip of the enclosure and follows a curving course down the east side, where the ditch continues for a further 13m beyond the terminal of the bank. At its highest point the bank stands to 1.3m above the bottom of the ditch and measures 9m across. It is constructed from earth and small stone rubble and is likely to have been built only from materials resulting from the excavation of the ditch. Near the eastern terminal the bank is of slighter proportions standing only to approximately 0.4m high. The maximum depth of the ditch below exterior ground level is 2.5m, and it is up to 8m wide.

A further section of bank with a slight ditch runs west downslope from the northern point. The bank here is of lesser proportions and the ditch is much shallower with a maximum depth of only 0.4m diminishing to virtually nothing at the western extremity. There is a distinct western terminal on the bank and like that on the eastern side its proportions are much diminished near the terminal. A small breach in the bank at this point is unlikely to be an original entrance and appears to be a result of later disturbance. There is some indication of later strengthening of the larger bank at the northern point where it overlies the lower bank to the west; a change in levels along the top of the bank is emphasised by the bull-nosed appearance of the higher bank and the lower section apparently runs beneath it.

Beyond the southern terminals of the bank and ditch section, the defensive circuit on the lower slope continues as a steep scarp of up to 5m high. There is no bank and no external ditch,

nor would they have been needed, as the creation of the scarp by strengthening the natural slope has created a formidable obstacle to any aggressors facing the bank from below. On the interior however, at the top of the defensive earthwork, there is a shallow quarry scarp from where material has been removed, perhaps to provide level standing behind a palisade which may once have surmounted the edge of the defensive scarp. At the foot of the main defensive earthwork is a narrow band of level ground caused by the steepening of the slope which then falls away and is absorbed back into the natural slope of the hillside.

There are two openings in the perimeter likely to have been part of the original construction phase. On the north-eastern side, the bank and ditch both have clear terminals creating a narrow causeway across the ditch and an opening in the bank. This is almost certainly an original feature and is well positioned to provide access to the upper slopes of Bicknoller Hill. A second likely entrance on the south-east side

comprises an inturn of the ditch earthwork where it meets the scarp of the southern section, creating a narrow, obliquely-sloping ramp across the defences.

The remainder of the interior is mostly featureless other than apparently natural undulations and two circular features adjacent to the northern section of bank. These shallow earthworks, both approximately 10m diameter, have roughly level floors and either could be considered candidates for hut platforms. Substantial platforms such as these would certainly have been necessary for any form of habitation in this extraordinarily steep enclosure where the height falls from 206m OD to 169m (37m total) over a distance of 100m.

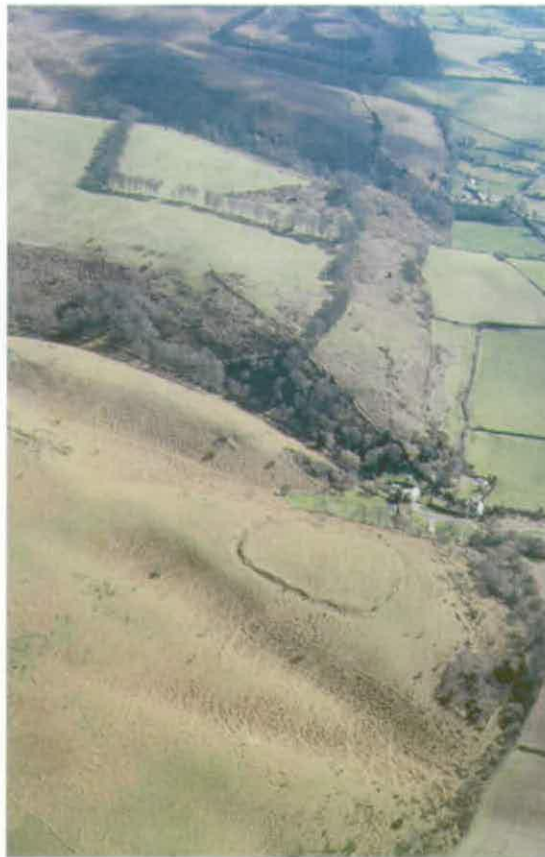
*Plate. 1. Aerial view
of the Trendle.
NMR 15858/22
© Copyright English
Heritage.*

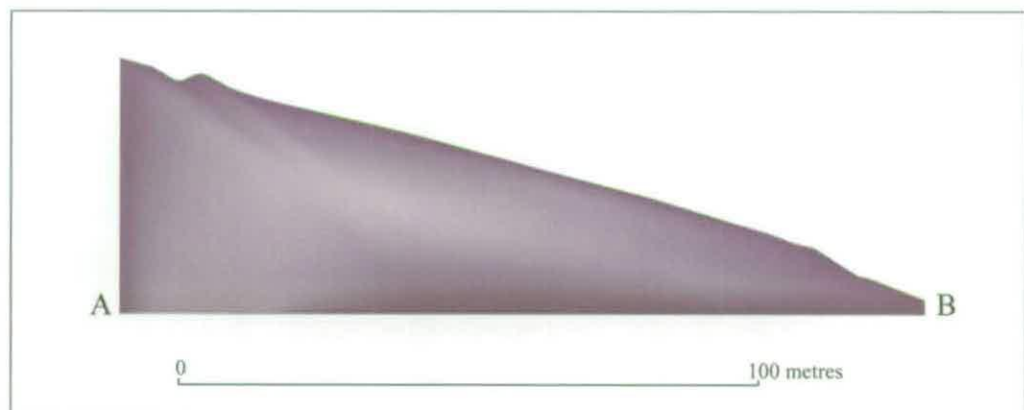
*Fig. 4. Enclosure
profile AB.*

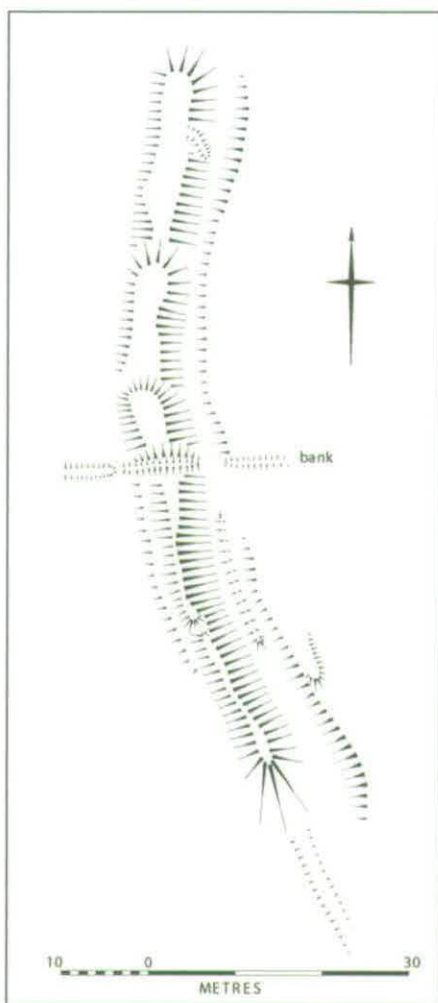
Fig. 5. English Heritage 1:500 scale earthwork survey of the cross-ridge dyke (reduced).

Three hundred and eighty-seven metres north-east of the Trendle at an altitude some 80m above it, an 88m-long, slightly curved, bank and ditch cross the neck of the spur which forms the summit of Bicknoller Hill. It does not extend down the steeper slopes of the hill. The area has been subject to ploughing, probably during the late-medieval or early post-medieval period and the earthwork has a flattened appearance as a result. A disused field boundary also traverses the earthwork at 90 degrees. The bank stands to a maximum of 1.1m high. Only a slight trace of the ditch survives on the eastern side.

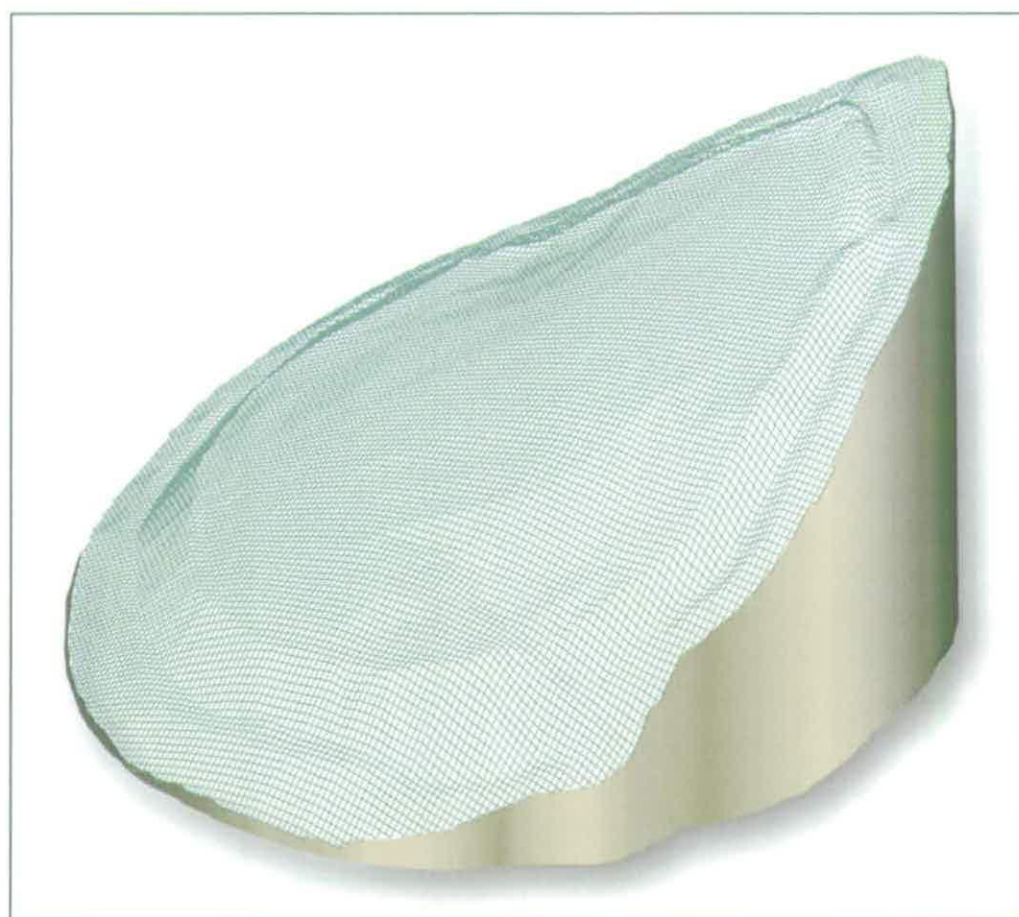
Fig. 6. Digital ground model showing view from the south.
