# THE WESTERN HEIGHTS DOVER, KENT

Report No 6: The Entrances to the Fortress:  
19th-century infantry and artillery fortifications

**THE ENTRANCES TO THE FORTRESS**

**19TH-CENTURY INFANTRY AND ARTILLERY FORTIFICATIONS**

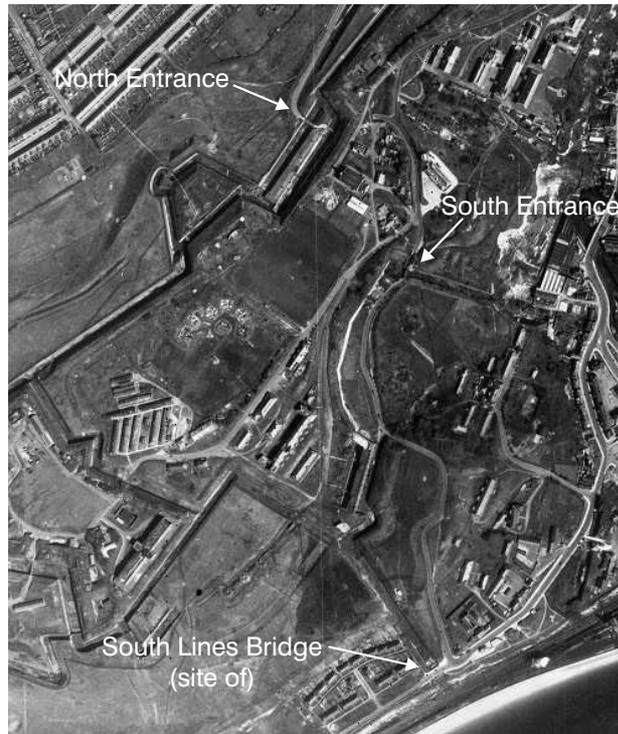
**Figure 3**  
*Part of the Western Heights in 1946, showing the North and South Entrances and the site of the South Lines Bridge (NMR: 106G/UK/1442/4 102)*

Despite several changes in tactical role, the Western Heights remained in military hands until the 1950s; all of the entrances were still in use during the Second World War, though by then the bridge over the South Lines had been replaced by a permanent stretch of road on a causeway (Fig 3; NMR: 106G/UK/801/ partIII/ 6177-8). In 1963 the imposing Archcliffe Gate was demolished and the South Entrance Ditch was partially infilled, although some of its associated features survive. At the same time, the North Entrance

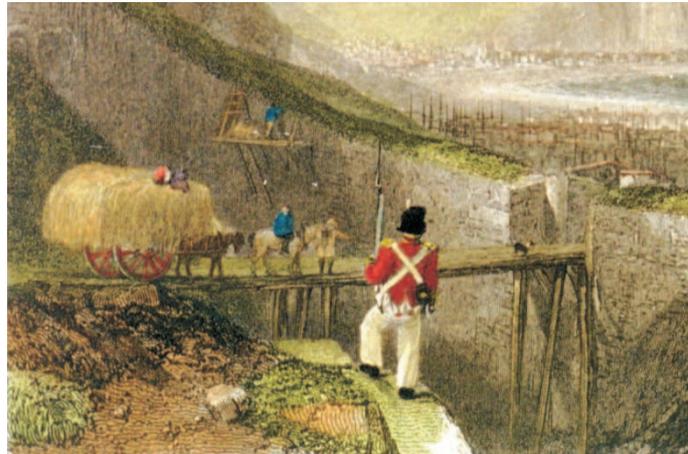
**Figure 5**  
*The South Lines Bridge in 1826, showing part of Dover Harbour in the background. Detail from a watercolour by Turner (Dover Museum D0006, reproduced by kind permission of Dover Museum)*

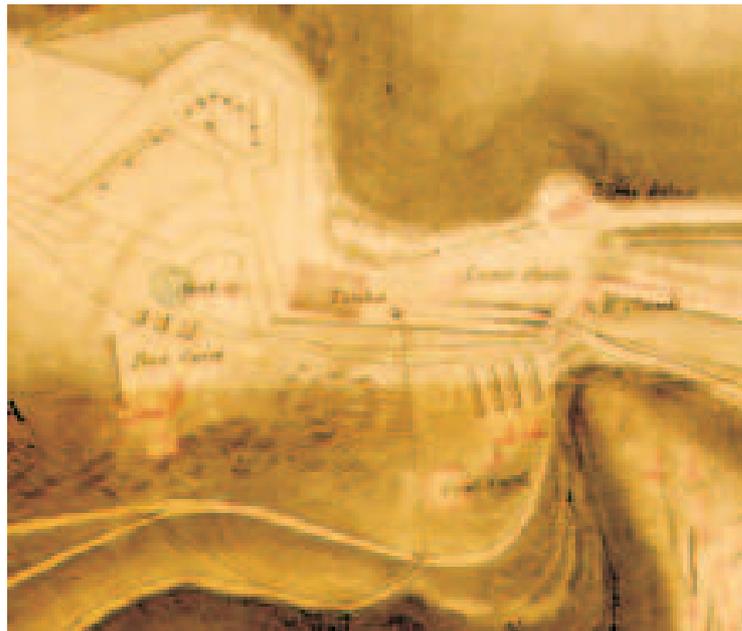
**Figure 6**  
*The Western Heights showing the North Entrance as it was in 1815 (extract from PRO: MR/1346, reproduced by kind permission of the Public Record Office)*

The clearest documentary record of the early phase of the North Entrance is a plan appended to a report of August 30<sup>th</sup> 1815, dispatched to General Mann at the Board of Ordnance (Fig 6). By this date, the Lines which ran along the northern edge of the ridge were in an advanced state, connecting the Citadel, North Centre Bastion and the Drop

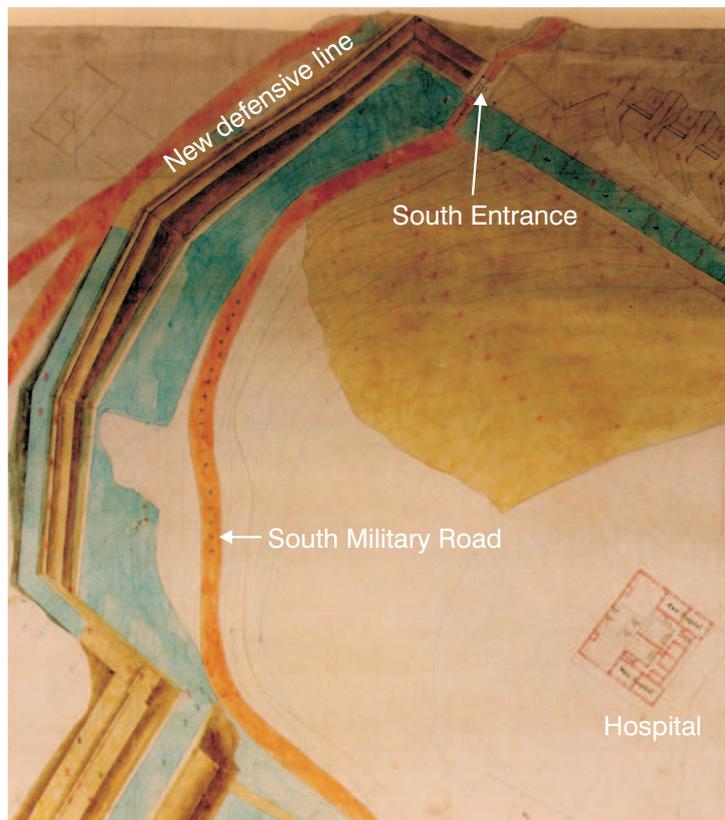
**Figure 7**  
*The proposed work  
around the South  
Entrance in 1860.*  
*Blue = cut;*  
*yellowy-brown =*  
*fill. Text in white is*  
*added by the*  
*authors (extract*  
*from PRO:*  
*MR/1300/3,*  
*reproduced by kind*  
*permission of the*  
*Public Record*  
*Office)*

A plan of 1860 shows the proposals for the south front of the Fortress (Fig 7). The main tactical aim was the further closure of the south-west flank by a new Line and a new entrance higher up the ridge. The new Line headed north-east from the existing gun rooms of the South Lines along the crest of the slope, keeping above the South Military Road, then turned south-east to run to the cliff face; the road would cross this last stretch by a drawbridge, with a gatehouse beyond. The slope above the road would be cut back to produce a sheer chalk face and the excavated spoil used to carefully grade the ground to the south, so that it could be entirely commanded by firing positions on the new Line. Much of this proposal was carried out and was further enhanced by the construction of gun rooms to cover the new entrance and by the addition of new casemated barracks in the South Front (Pattison & Williams 2001).

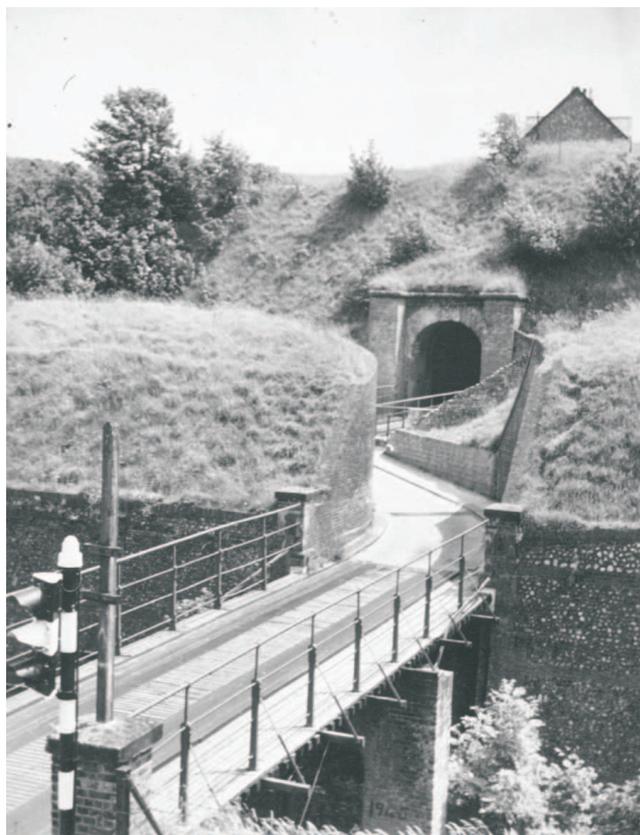
**Figure 11**  
*The North Entrance, outer entrance from the outer bridge in 1958* (Dover Museum: D07871, reproduced by kind permission of Dover Museum)

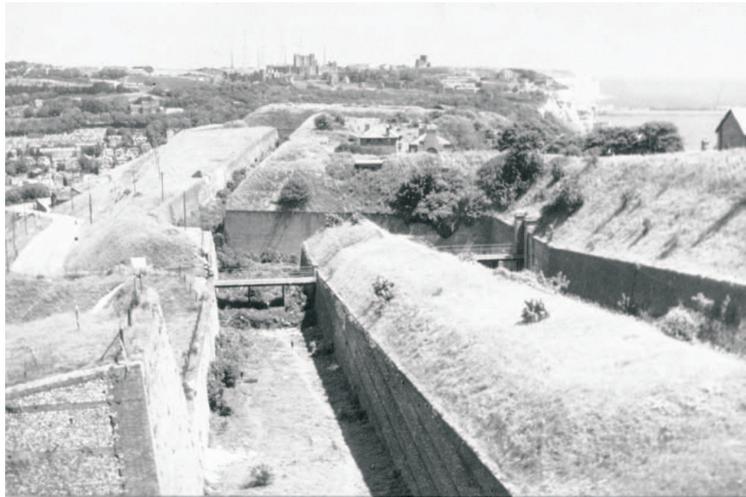
**Figure 13**  
*A view along the tenaille in 1958, showing both bridges, with the Drop Redoubt and Dover Castle in the background (Dover Museum: D07902, reproduced by kind permission of Dover Museum)*

The *tenaille* is formed partly from a long rectangular island of natural chalk, left from the excavation of the twin ditches: the inner ditch follows the Napoleonic line, the outer ditch dates to the 1860s (Fig 13). The ditch sides are revetted in brick or coursed flint with a slight batter. Above the revetment of the *tenaille* an earthwork capping is profiled to create a *banquette* at the rear and a shallow scarp at the front, to enable small arms fire against an attacker approaching the counterscarp. At the western end the *tenaille* incorporated a recessed section to allow the gun rooms in the North Centre Bastion to sweep the ditch and counterscarp of the Detached Bastion.

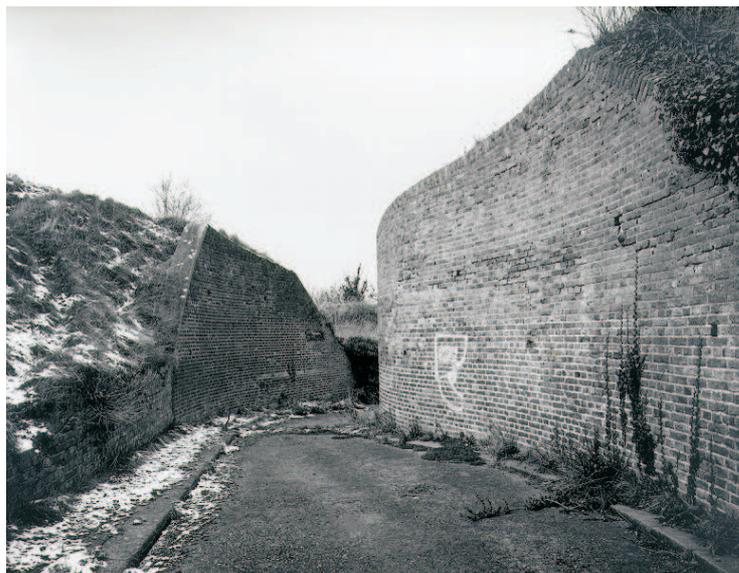
**Figure 14**  
*The road in its cutting through the tenaille (NMR: AA00/9825)*

The North Military Road crosses the *tenaille* in a deep cutting describing an elongated ‘S’ in plan, with revetted brick walls in English bond (Fig 14). The form of this cutting is deliberate, providing protection against shell-fire, cutting down on ricochet and making it impossible for an enemy field gun or infantry sited at the outwork to take clear shots at the outer entrance.

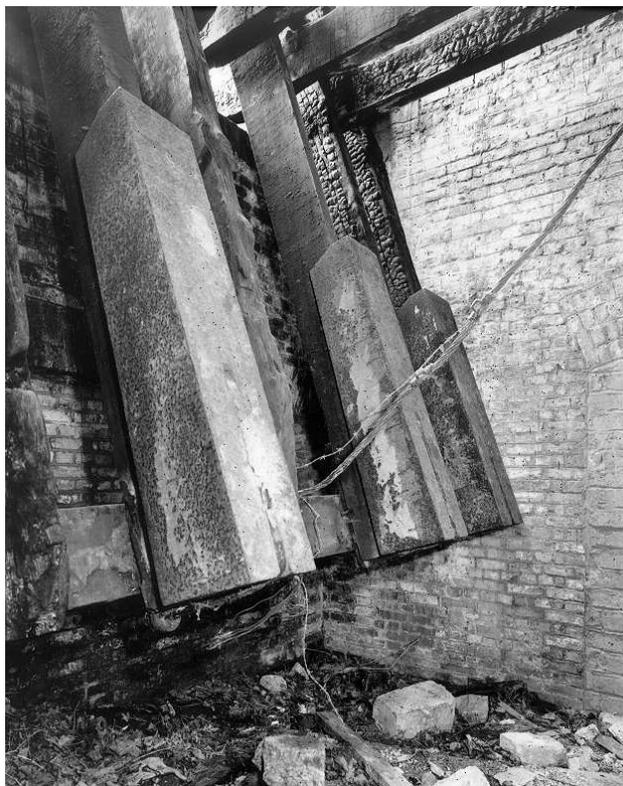
**Figure 17**  
*The counterweight  
recess with the  
bridge counterpoise  
weights in position*  
(NMR:  
AA00/9846)

The drawbridge closed against the curtain wall to form an outer gate, which sealed the entrance chamber. Beneath this chamber is the **counterweight recess** which accommodates the huge cast-iron weights attached to the end of the drawbridge. The recess also contains the surviving mechanism for the drawbridge, comprising a hand-operated winch mounted on the floor in a shallow, segmental-arched apse in the rear wall (Figs 17-18). Steel cable from the winch was connected to the counterweights

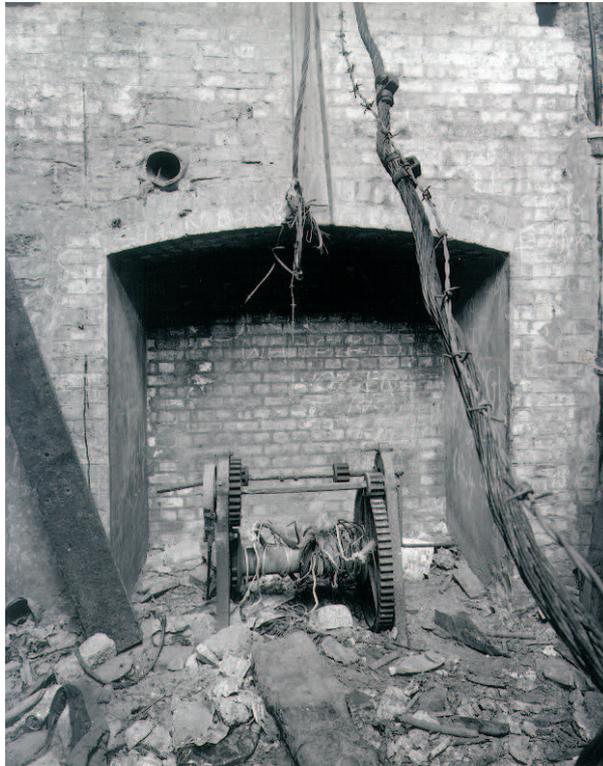
**Figure 18**  
*The winch in the counterweight recess (NMR: AA00/9847)*

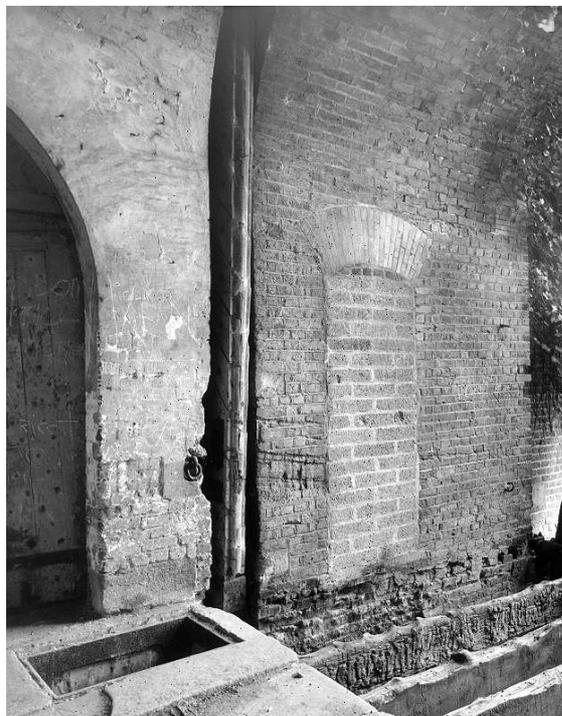
**Figure 20**  
The blocked doorway to the winch room, with the remains of the bridge in the foreground (NMR: AA00/9842)

system was in place, mounted in a small **winch room** at road level on the western side of the entrance chamber. The doorway is now bricked-up but retains a rubbed-brick segmental head (Fig 20). A small hand-winch in this room was connected to the pivot via a geared-shaft running through the wall, and the winch raised or lowered the drawbridge by turning the pivot, assisted by a counterweight. This method would have put a lot of pressure on the winch, which might explain the later arrangement with the winch in the counterweight recess. Following the installation of the new mechanism, a cast-iron spiral staircase inserted into the winch room provided access down to the counterweight recess. A semicircular-headed doorway with a gritstone keystone arch in the eastern end of the counterweight recess led directly to the musketry gallery, though it has since been blocked.

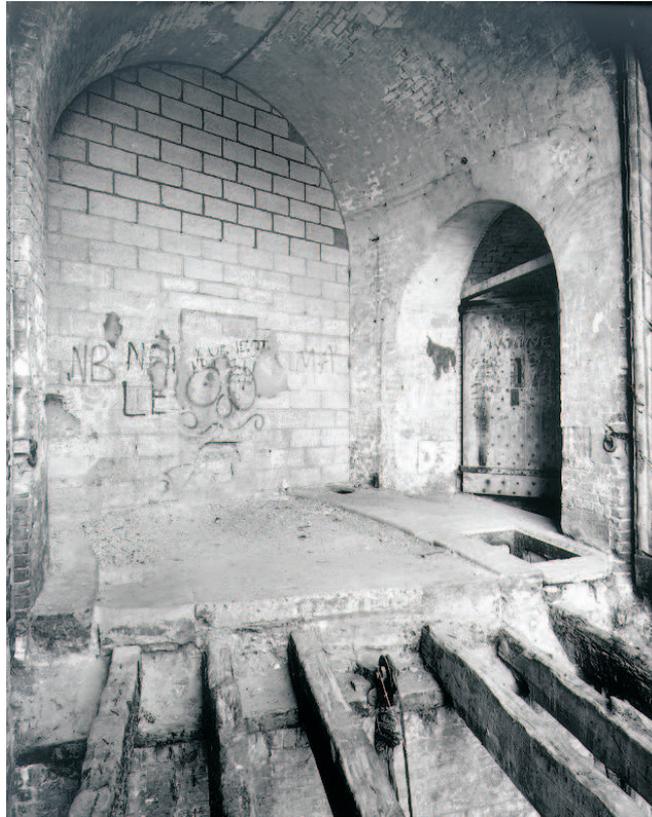
**Figure 21**  
*The blocked road tunnel and doorway to the postern gate, with the remains of the bridge in the foreground (NMR: AA00/9840)*

The drawbridge closed against a semicircular arch of two plain orders flanked by projecting piers topped with rounded stone copings. A pair of heavy sliding wooden doors form an inner gate which enabled the entrance chamber and the bridge to be closed off from the **tunnel**. The doors are strongly constructed with raked boarding and rise to the full height of the tunnel entrance with the tops shaped to fit against the vault (Fig 21).

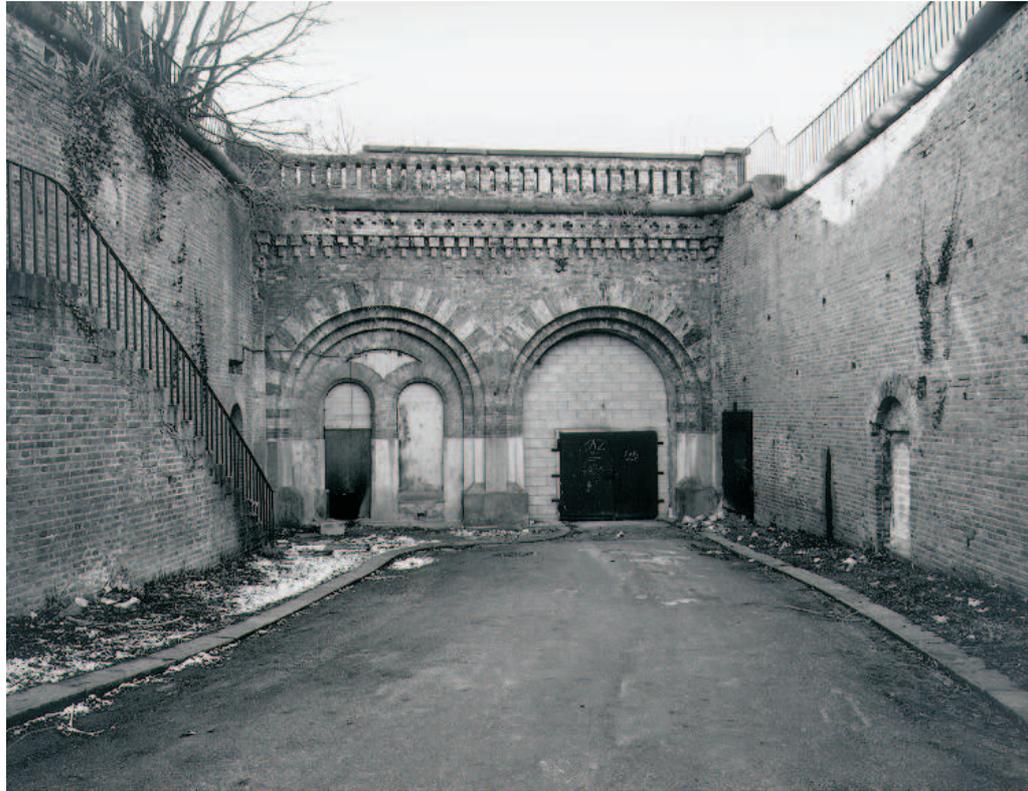
**Figure 27**  
*The Inner Entrance, showing the road tunnel and the guard room; the blocked doorways on the right flank wall lead to the water tanks (NMR: AA00/9818)*

The entrance elevation comprises two semicircular arches of three orders with sandstone plinths and polychrome brickwork in buff, red and cream (Fig 27). The right-hand arch is the entrance to the tunnel, while the left-hand arch contains the guard house. Door and window openings and the outer order of the arches have red-brick jambs and heads, and the entrance is topped by false machicolations in red-brick with cross details in courses placed below a sandstone coping with a roll moulding. The front wall of the guard house is set back in the archway and contains a door and window with arched and chamfered

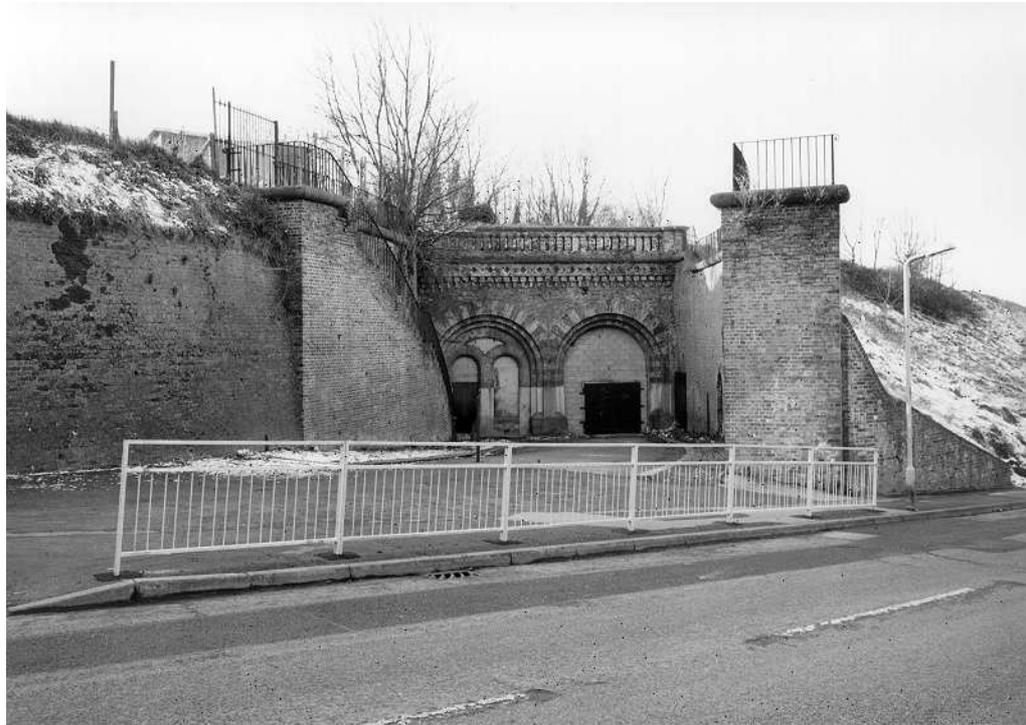
**Figure 30**  
*The Inner Entrance, showing the new route of the Centre Road which by-passes it (NMR: AA00/9815)*

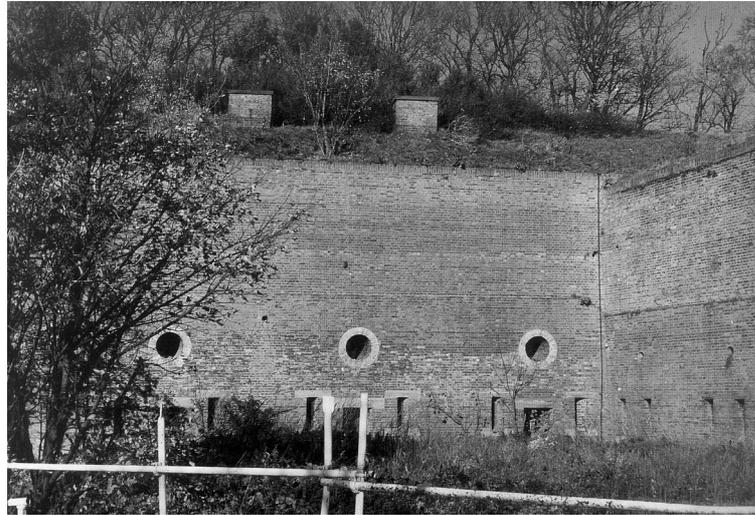
**Figure 32**  
*The scarp  
revetment of South  
Entrance Ditch in  
1959, with the  
circular smoke  
vents, carronade  
embrasures and  
musket loopholes of  
the gun rooms  
clearly visible*  
(NMR: A.5513/6)

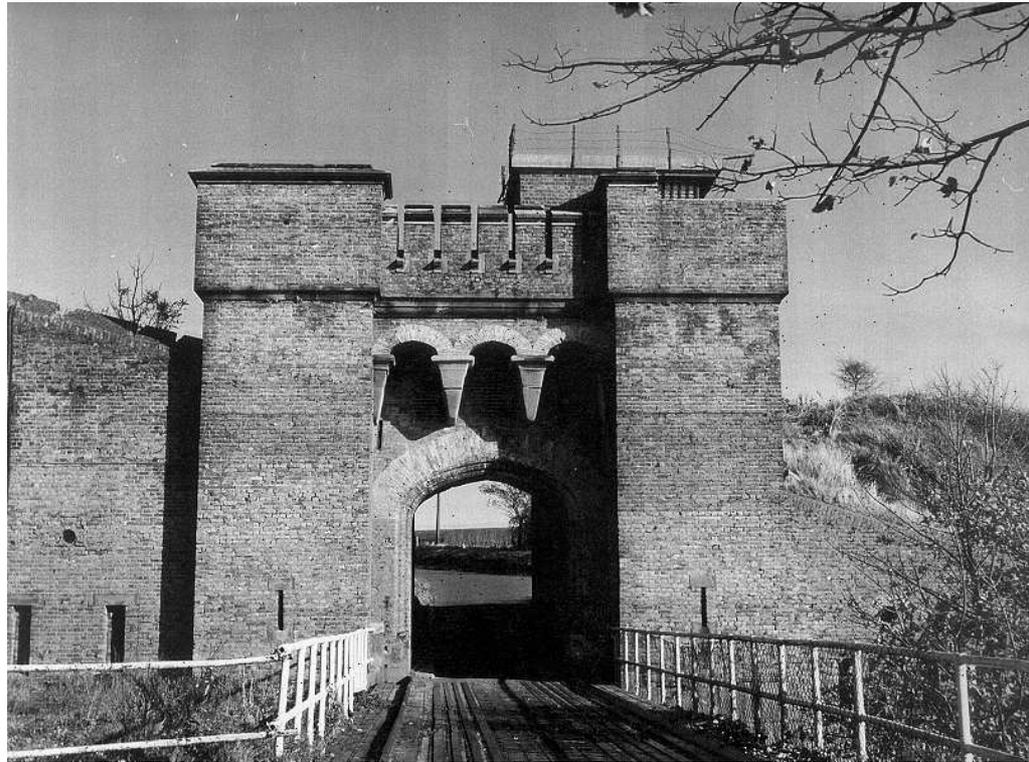
**Figure 35**  
*Archcliffe Gate in 1959, showing the Second World War observaton post on top (NMR: A.5513/5)*

Very little survives of the gatehouse above ground. However, a plan of 1876 and several fine photographs, including one taken in 1959, provide the basis for the following description (Figs 35 and 36).
