# THE WESTERN HEIGHTS DOVER, KENT

## Report No 7: North Centre and Detached Bastions: 19th-century fortifications

SURVEY REPORT

ARCHAEOLOGICAL INVESTIGATION SERIES 28/2001

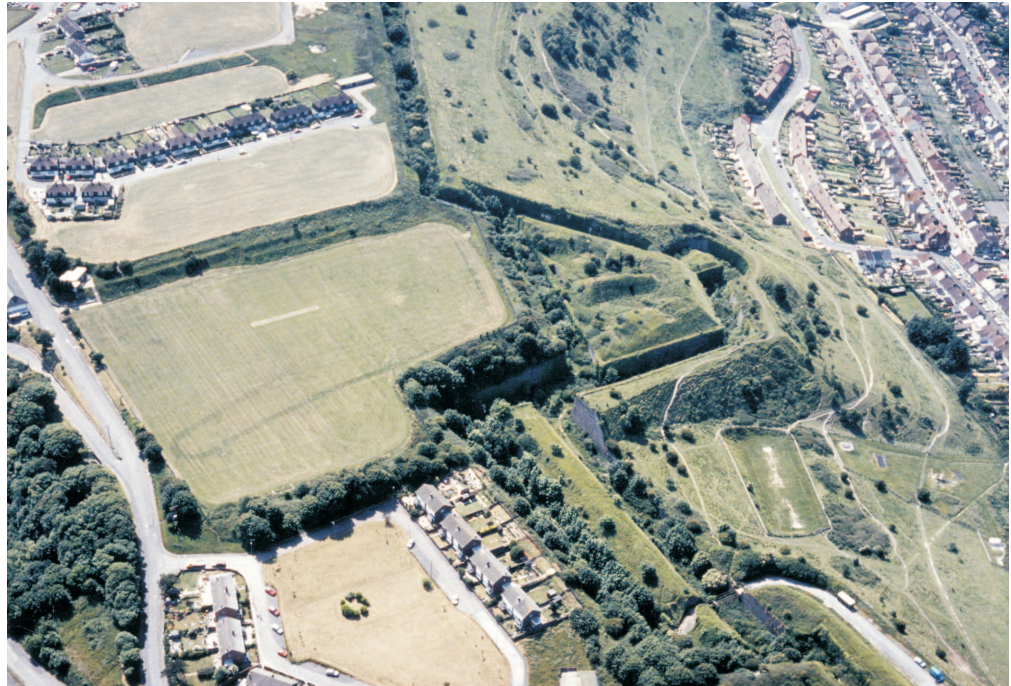
*North Centre and Detached  
Bastions from the air in 1994,  
showing the prominent northward  
projection (the right of the photo)  
in order to flank the slope of  
Western Heights (©NMR: TR  
3140/10, 30th June 1994)*

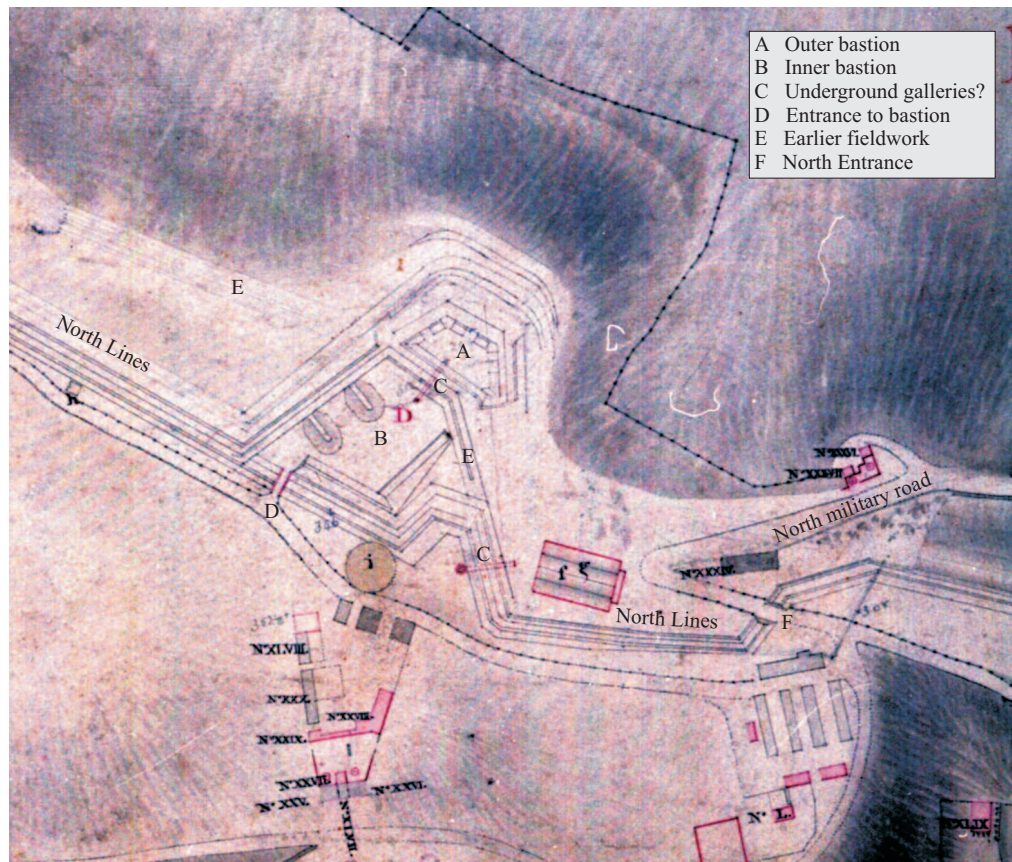
**Figure 3**  
*Plan of North Centre Bastion, showing the principal features in 1810. Text in black, excluding Roman numerals, is added by the author (extract of MR1/1349 © The Public Record Office)*

The extent and nature of the Napoleonic construction is shown on several plans, dating to 1810, 1811 and 1830 (Fig 3; PRO: MR/1/1349; MPH/1/506; WO/55/2562). The plan of the bastion, which projected from the linear defences (the North Lines) along a short natural spur, resembled a triangle with a truncated tip, with longer east and west flanks tapering to a shorter northern face. Its purpose was defence of the land front, particularly to provide flanking fire along the north slope of the Heights. In form it was an unrevetted earthwork which had incorporated an earlier linear fieldwork, dating probably from the American War of the 1770s and 80s, which was aligned east to west along the north face of the Heights, outside and parallel to the later North Lines (Pattison 2001). The huge ditch and rampart of the bastion were constructed across this older work, producing two tiers of defence, each of which could be defended independently. The outer bastion was closed off from the inner by the modified rampart and ditch of the earlier linear work and connected to it by what appears to be an underground gallery. The inner bastion contained two traverses, projecting inwards at right angles from the west flank, while the gorge incorporated a dog leg such that the entrance could be flanked from inside the Heights.

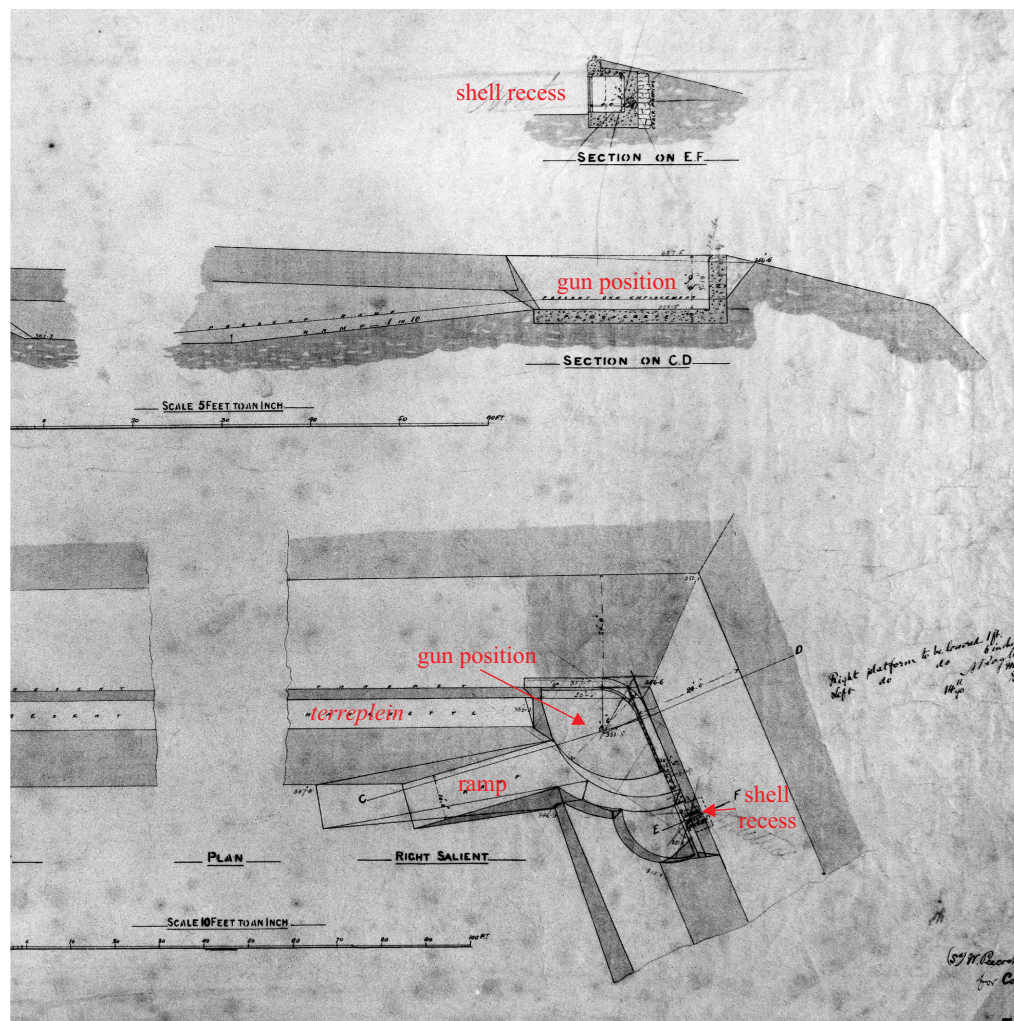
**Figure 5**  
North Centre Bastion,  
one of two gun  
emplacements for  
40-pdr RBL guns  
established on the  
terreplein in 1890, this  
one in the north-east  
salient. Text in red is  
added by the author  
(extract of WD/2309 ©  
English Heritage)

However, on the *terreplein* of North Centre Bastion, the three artillery positions (nos 11-13 on Fig 4) covering the east flank of Detached Bastion had been removed before 1881 and a single emplacement added to the north-east salient (NMR: WD/2300). This new emplacement was approached up a long ramp and may have been intended for a moveable artillery piece, possibly a 40-pdr RBL. It was altered in 1890, when a similar position was established in the other salient, at which time both had concrete gun floors and vertical *barbettes* to support the 40-pdr RBLs recommended in 1886; overbank carriages were required to fire over the high infantry parapet, which nevertheless was given embrasures. Ready-use shell recesses were made in the rampart for each emplacement. Despite these alterations, no artillery was allocated to the bastion in the armament return of 1892, although in 1900, each salient could nominally support two 40-pdrs (Fig 5; NMR: WD/2309; 2310; PRO: WO/33/2775).

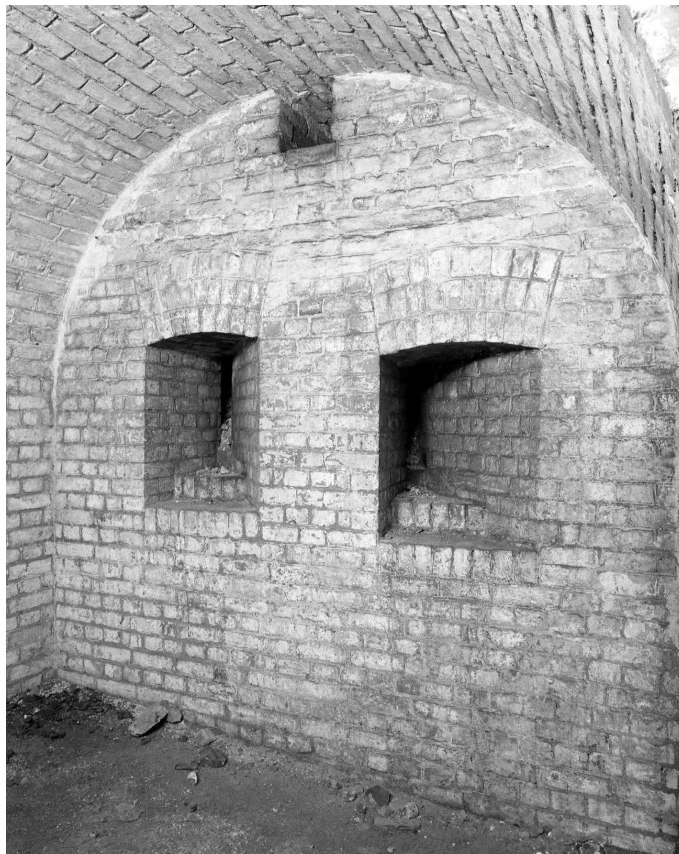
**Figure 9**  
*North Centre Bastion;  
photo of the face wall of  
a casemate in the  
shorter western portion  
of the west gallery,  
showing two musket  
loopholes with angled  
splays and a smoke vent  
over (NMR: AA008610  
© Crown Copyright  
1998)*

This was approached down a moderately steep stairway from the *terreplein* but the entrance is sealed. The brick steps have stone treads, with low stone wheeling platforms on the flanks to facilitate hauling of artillery and supplies. The side walls at the head of the stair show no traces of the iron rings through which the hauling ropes passed. At the base of the stair there is a small landing, from which two shorter flights lead west and north respectively. The west flight of three narrow steps leads down into the short western portion of the gallery, comprising four musketry casemates connected by central rectangular openings in the party walls, each with a large rectangular gritstone lintel. The first casemate is slightly smaller because its rear wall is finished, whereas in the remaining three there is unrevetted chalk rock. The front walls are prominently battered and contain two vertical musket loops each, splayed to cover the west ditch northwards to the cross ditch and south *caponier*; the angle of splay becoming more acute westwards (Fig 9).

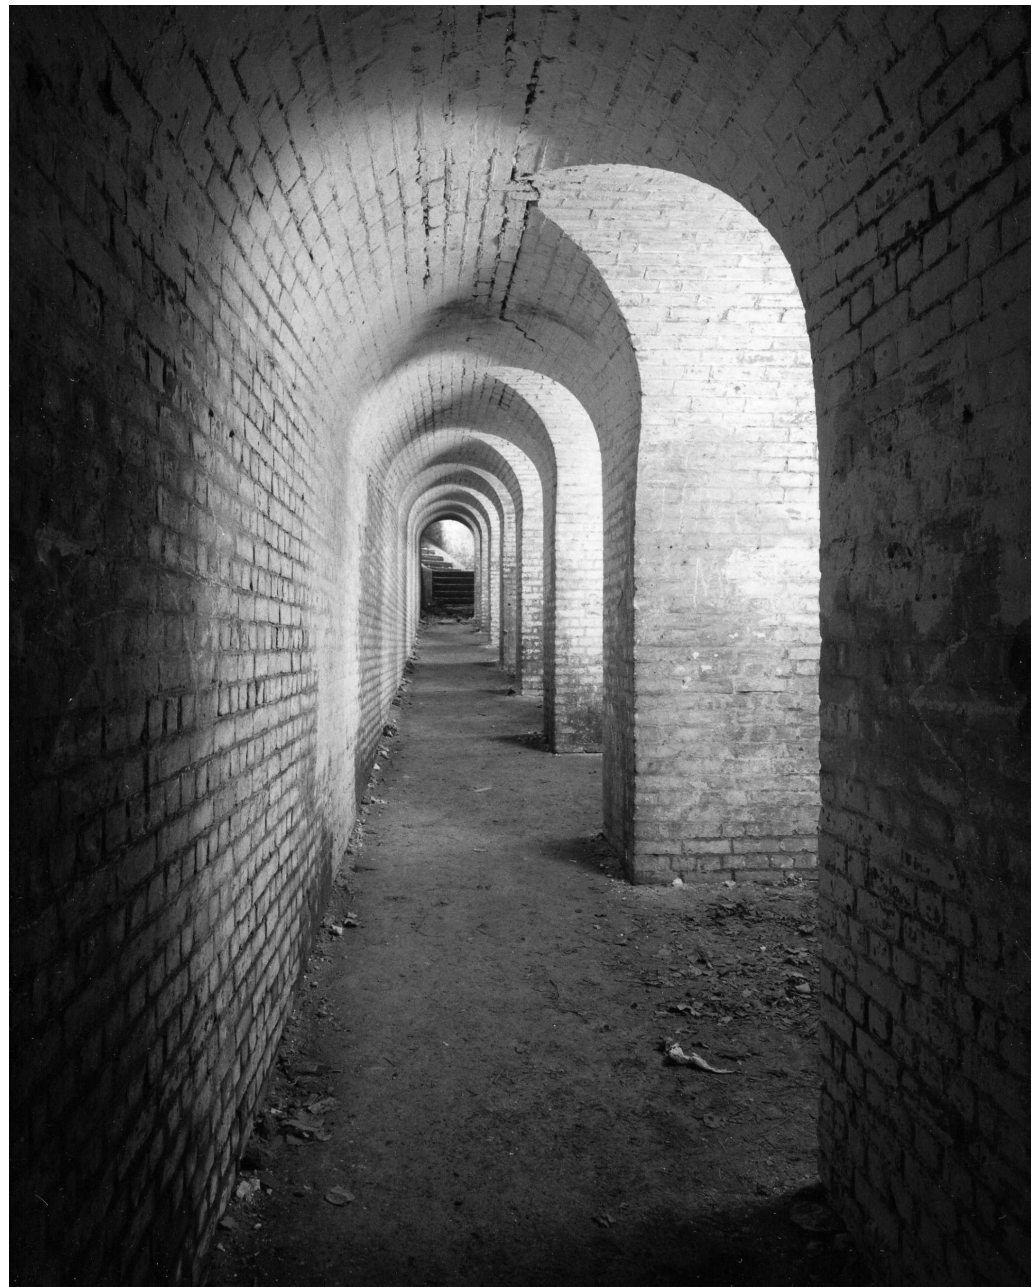
**Figure 10**  
*North Centre Bastion;  
photo of the main  
section of the west  
musketry gallery,  
looking west. The  
musketry positions are  
in the bays along the  
right of the picture and  
the steps to the  
terreplein at the far end  
(NMR: AA008609 ©  
Crown Copyright 1998)*

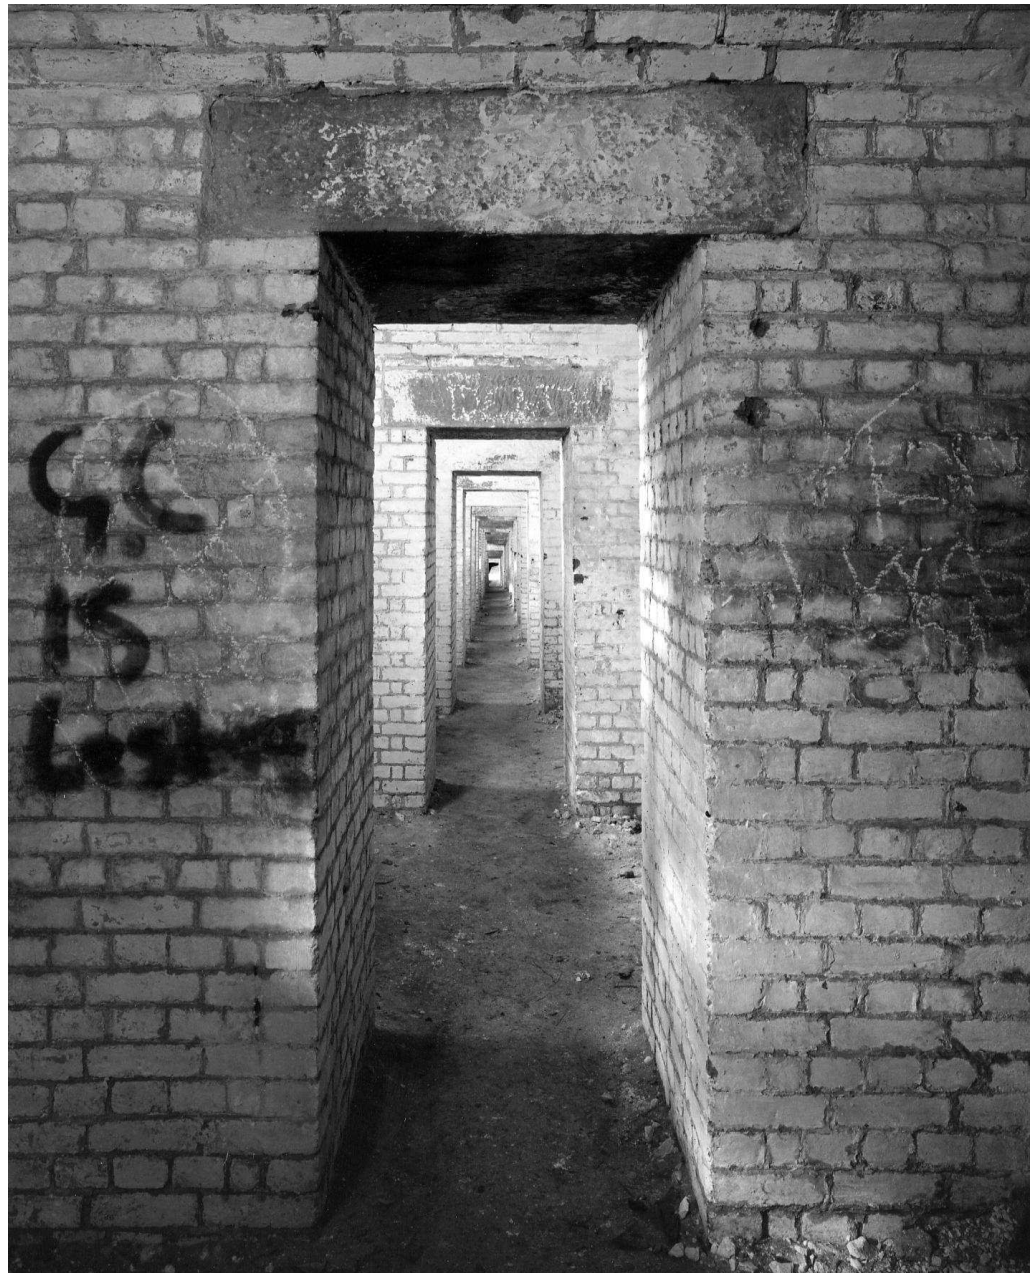
**Figure 11**  
*North Centre Bastion;*  
*photo looking east*  
*along the north*  
*musketry gallery,*  
*showing the flat-headed*  
*doorways between the*  
*casemates (NMR:*  
*AA008612 © Crown*  
*Copyright 1998)*

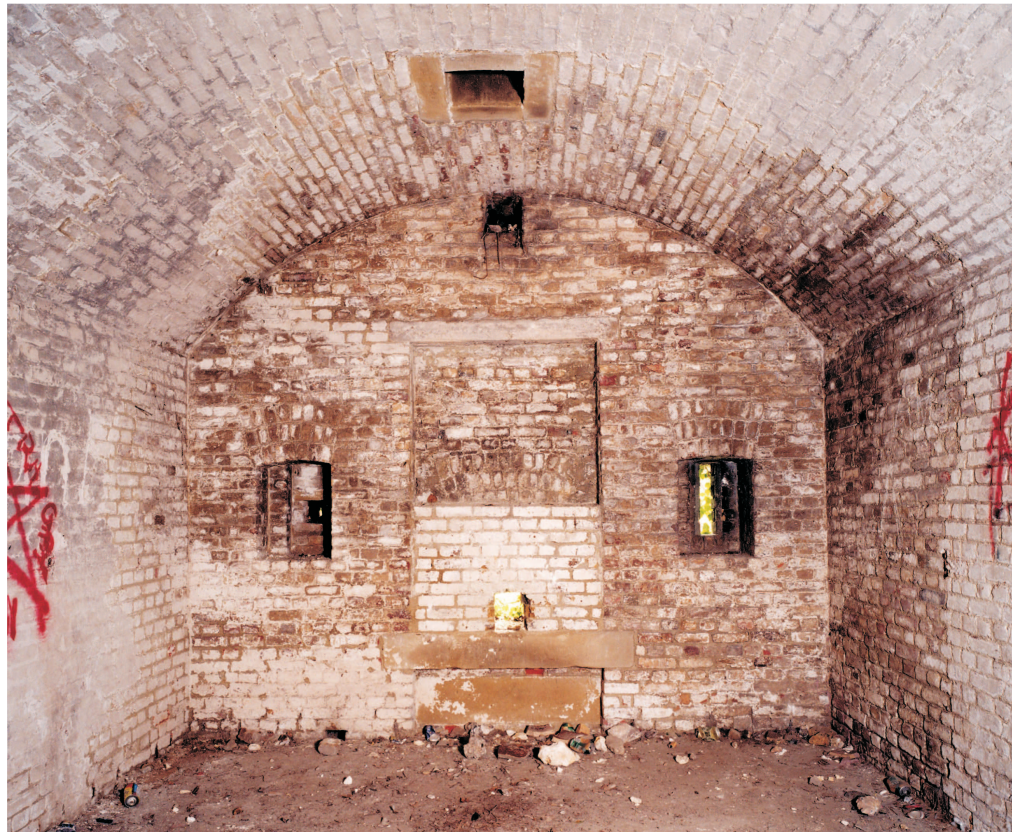
**Figure 12**  
*North Centre Bastion;*  
*photo of one of three*  
*gunrooms in the east*  
*gallery, showing the*  
*central carronade*  
*embrasure flanked by*  
*musket loops and smoke*  
*vents in the vault*  
(NMR: BB 029684 ©  
Crown Copyright 1998)

width by brick piers; the straight joints are obvious. These piers support large gritstone lintels, with arched upper surfaces and brick relieving arches over, and may be repairs of 1863. Each gunroom contains one carronade embrasure flanked by two musket loops in the front wall, all blocked. Each embrasure has a semi-circular arched head and a sandstone sill situated in the lower half of a rectangular panel, recessed one brick thickness. The panel itself also has a sandstone sill and lintel and formerly contained a wooden mounting which enabled the gun to be elevated and depressed. Each vault contains a ferrous ring for handling the heavy gun. There are two smoke vents to each casemate, one in the usual place in the front wall and a second, larger one defined by sandstone slabs, in the vault itself. One of the musket loops retains evidence of an iron fitting, comprising a small iron drum rotating in a vertical iron plate, itself anchored into the sandstone loop. The drum has a central circular hole through which the gun muzzle was inserted; the drum traversed by gentle pressure applied with the muzzle, to create an arc of fire in the ditch outside. Basic facilities in each gunroom comprise a ferrous bracket for a wall lamp and, in the rear wall, a fireplace with an iron lintel and a shutter vent over, and a stone lintel above it in the top of the vault. A stove flue, narrowing of the fireplaces and fittings for electric lighting are alterations probably of the 20<sup>th</sup> century.

Next is a suite of three large identical gunrooms with stone flag floors (Fig 12). The doorways, towards the rear of the party walls, have flat heads. They have been reduced in

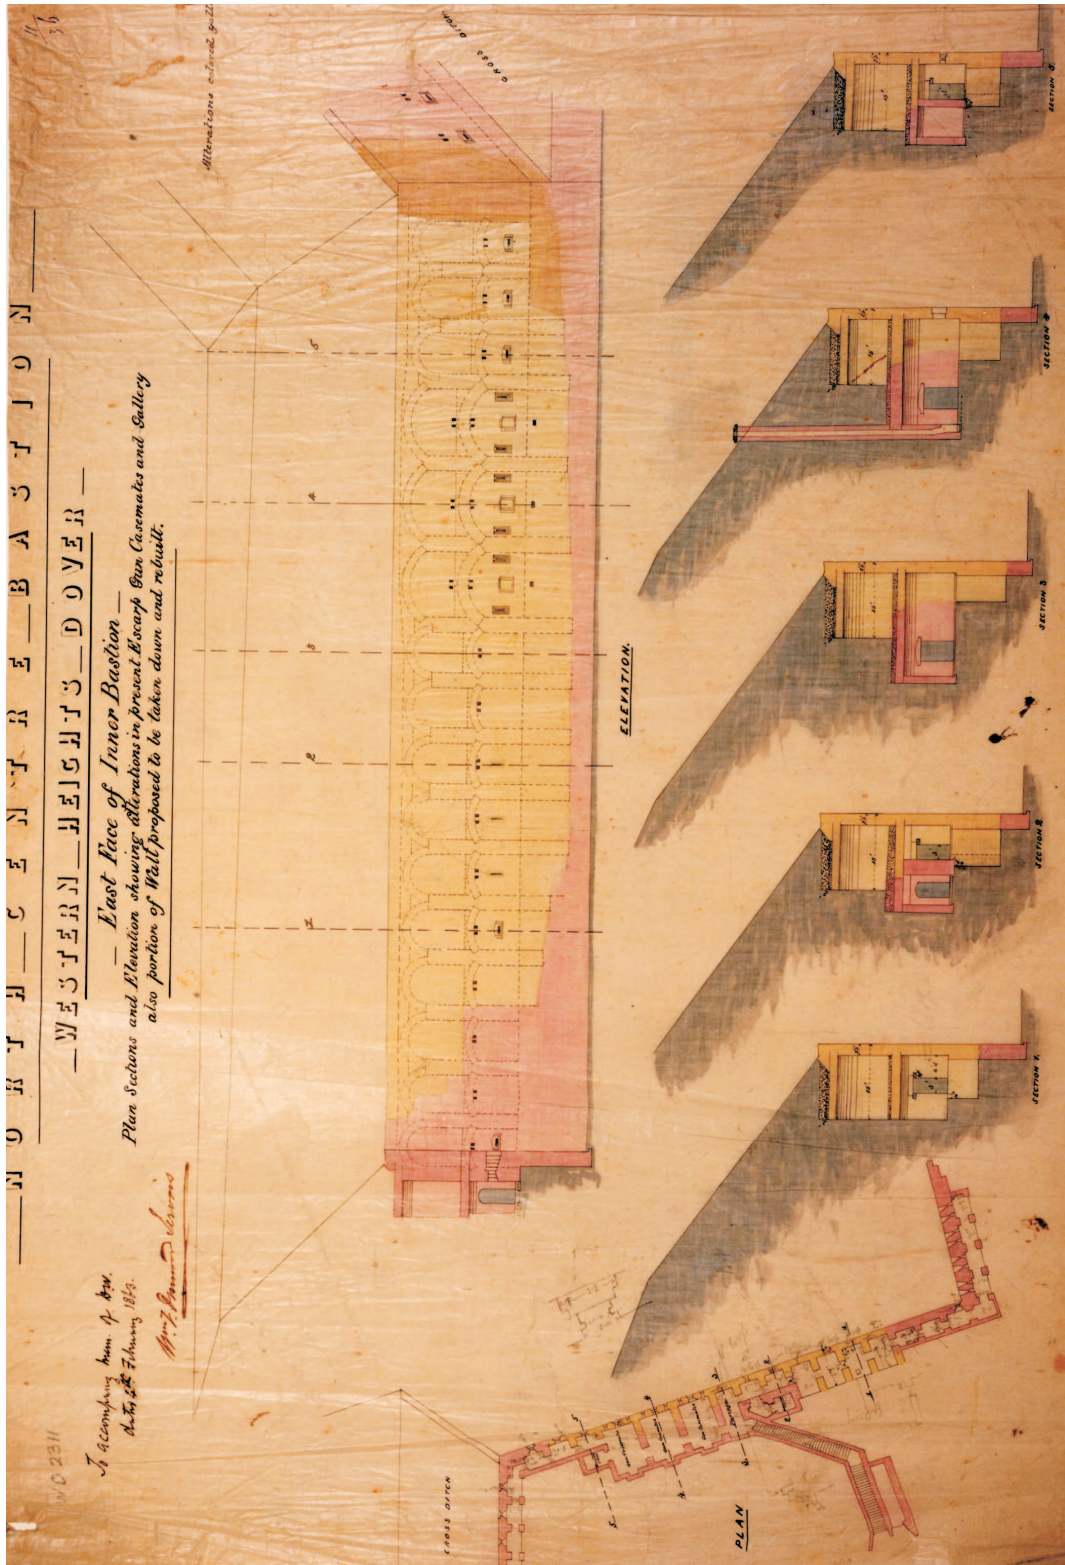
**Figure 13**  
North Centre Bastion; east flank in 1863 (yellow tint shows extent of rebuilding required following structural failure in 1862 (NMR:  
WD/2312 © English Heritage)

sequence southward, three musketry casemates, an expense magazine, three gun rooms for carronades, a single musketry casemate with steps up to the *terreplein*, another expense magazine, five musketry casemates, a well passage and nine musketry casemates. This complexity reflects the important role in covering the ditches and bridges on each side of the *tenaille* protecting the North Entrance to the Heights, as well as the east ditch of the bastion itself. It is also this face of the bastion which experienced structural failure leading to the repairs of 1863, involving the rebuilding of some  $\frac{3}{4}$  of the scarp revetment and parts of the casemates behind it (Fig 13; NMR: WD/2311; 2312)

- WD/2312 *North Centre Bastion. Western Heights Dover. East Face of Inner Bastion. Plan, Sections and Elevation showing fractures in present Scarp Gun Rooms and Gallery also portion of a Wall proposed to be taken down and rebuilt.*

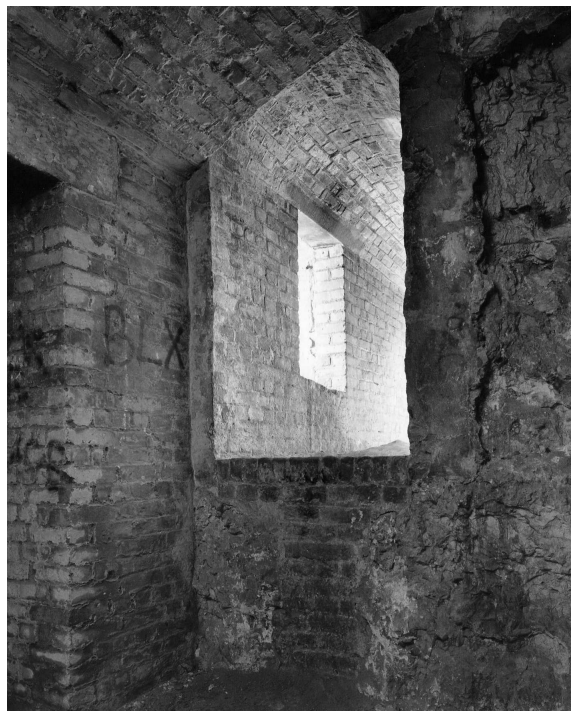
**Figure 14**  
*North Centre Bastion;*  
*photo in the east*  
*gallery showing the*  
*entrance to the well*  
*passage at the rear of a*  
*musketry casemate*  
*(NMR: AA008614 ©*  
*Crown Copyright 1998)*

The entrance to the well passage is raised 1.0m (3ft 3in) off the gallery floor (Fig 14). It has a semi-circular vault and is cut horizontally for 15.9m (52ft 1in) into chalk bedrock, ending in the circular chamber of **no 1**. The chamber rises to the surface as a brick column

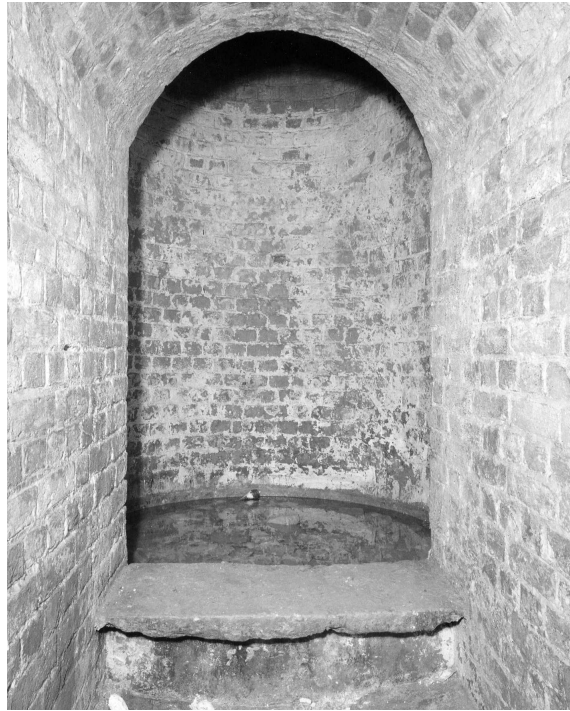
**Figure 15**  
*North Centre Bastion;  
photo of well no 1, at  
the west end of the well  
passage (NMR:  
AA008616 © Crown  
Copyright 1998)*

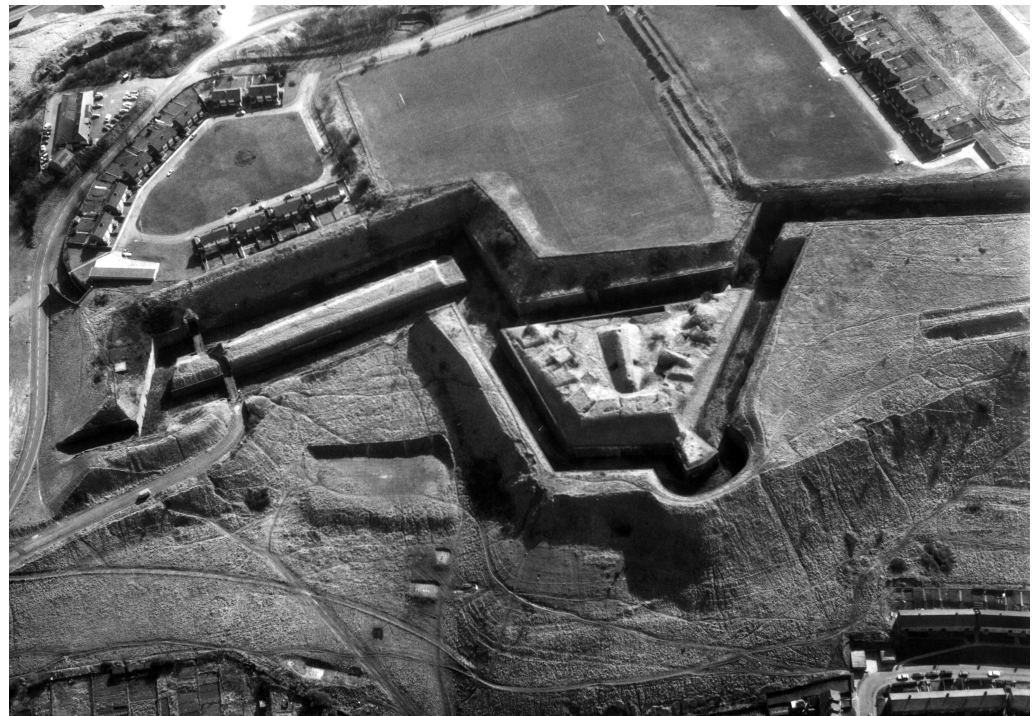
**Figure 16**  
*North Centre and  
Detached Bastions,  
from the air in 1978  
(NMR: TR3040/4/147  
© Crown Copyright)*

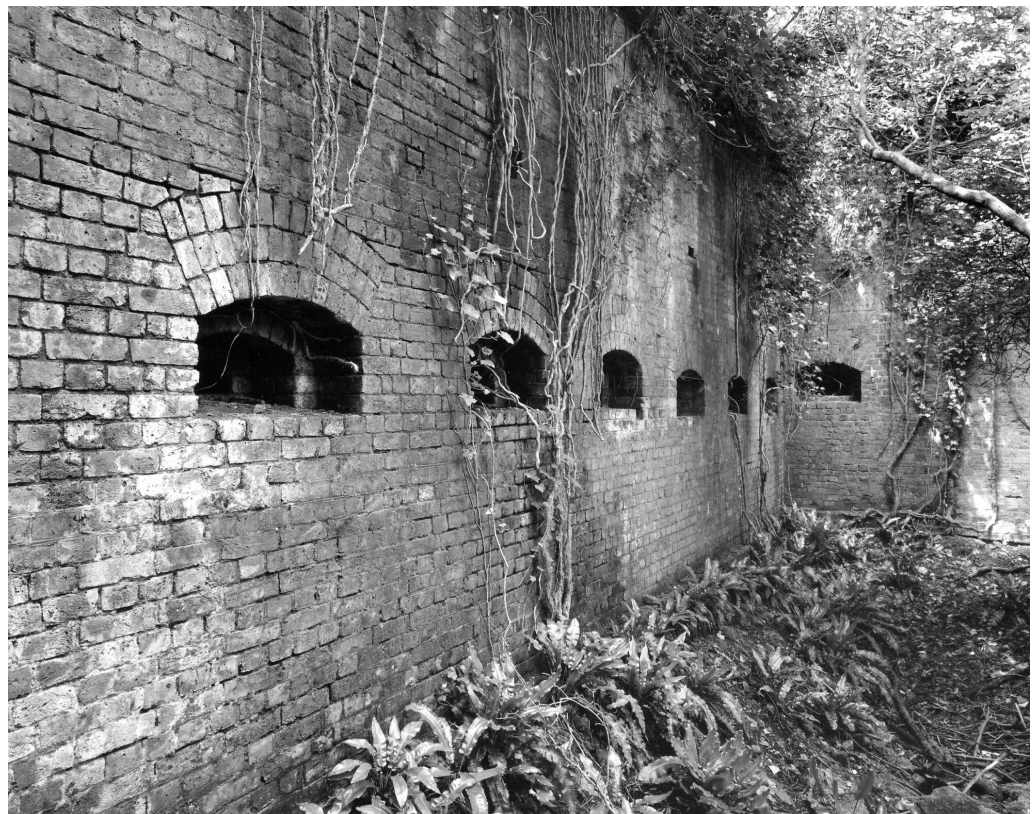
**Figure 17**  
*Detached Bastion;  
photo of the south  
caponier, east face  
exterior, showing  
horizontal musket  
loopholes (NMR:  
AA008604 © Crown  
Copyright 1998)*

This *caponier* linked the bastions and gave flanking fire for the cross ditch (Fig 17). It is a plain passage with brick walls, 1.4m thick, and a semi-circular vault. Both sides have musket loops, above which a stone cordon at the top of the external walls gives onto a roof pitched at a very shallow angle. Enemy access to the loops was prevented by drop ditches and strained wire fences on both sides. The eastern drop ditch is some 2.5m (8ft 2in) wide and 0.7m (2ft 3½in) deep, the western one 3.5m (11ft 6in) wide and 1.40m (4ft 6in) deep. Several ferrous fence supports lie abandoned in the ditch bottoms.

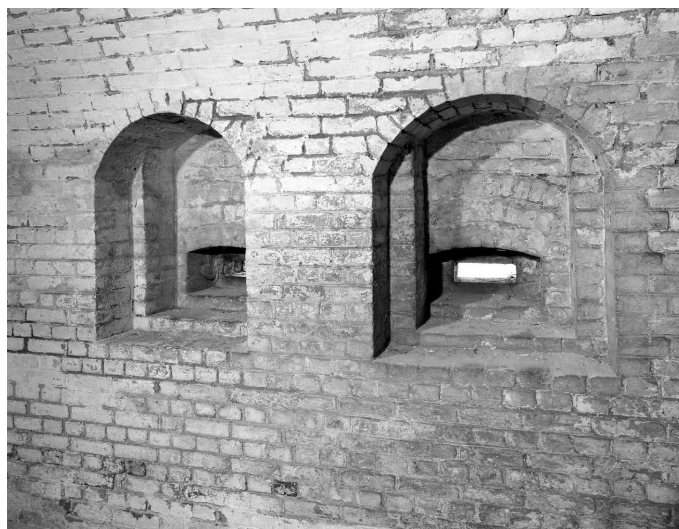
**Figure 18**  
*Detached Bastion;*  
*photo of the south*  
*caponier, east face*  
*interior, showing*  
*horizontal musket*  
*loopholes (NMR:*  
*AA008607 © Crown*  
*Copyright 1998)*

The east wall of the *caponier* is original and has eight horizontal musket loops, which look straight along the cross ditch between the two bastions; the southern two could be used only with the drawbridge down. The loops have sandstone sills and lintels and internally, they have stepped sides and bases, with segmental arched heads (Figs 18-19a; NMR: WD/2307). Five in the west wall form the alterations proposed in 1862, of which the three northern examples are identical to those on the east wall. The other two are

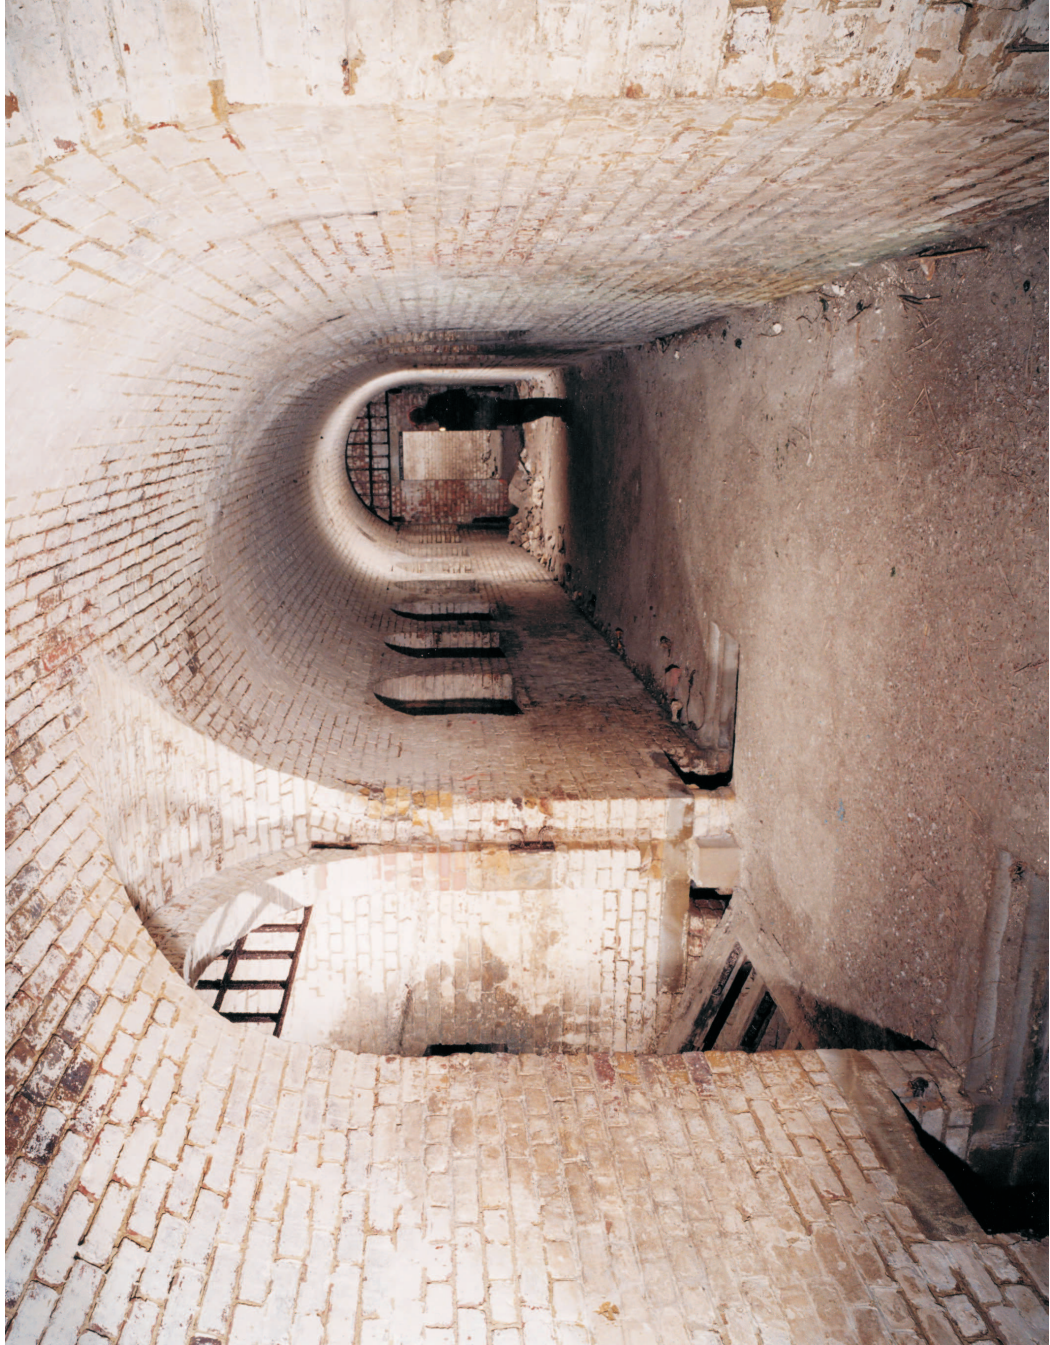
**Figure 19a**  
*Detached Bastion; the interior of the south caponier, looking south; at left is the entrance to a ramp leading up to the terreplein (NMR: BB 029680 © English Heritage 2001)*

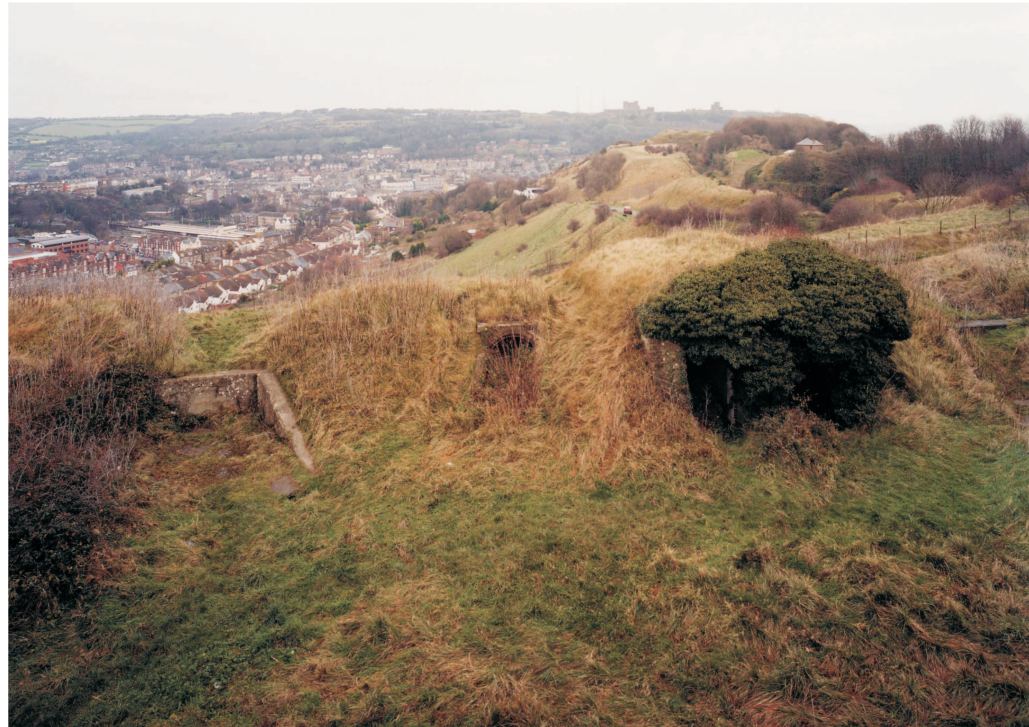
**Figure 21**  
*Detached Bastion;*  
*photo of the east*  
*terreplein, showing*  
*emplacement no II (at*  
*left), for 7-inch RBL*  
*gun, c 1890, together*  
*with its shell recess*  
*(centre) and the*  
*entrances to the*  
*artillery store and east*  
*gallery (NMR: BB*  
*029679) © English*

There are four identical **gun emplacements** let into the *talus*, **nos I to IV**. Each emplacement is made in concrete with a vertical front wall forming a *barbette* 1.35m (4ft 5in) high and 0.6m (2ft) thick, with flank walls ramped down and splaying to the rear, and a level gun floor (Fig 21). The floors each incorporate two steel racer arcs for guns

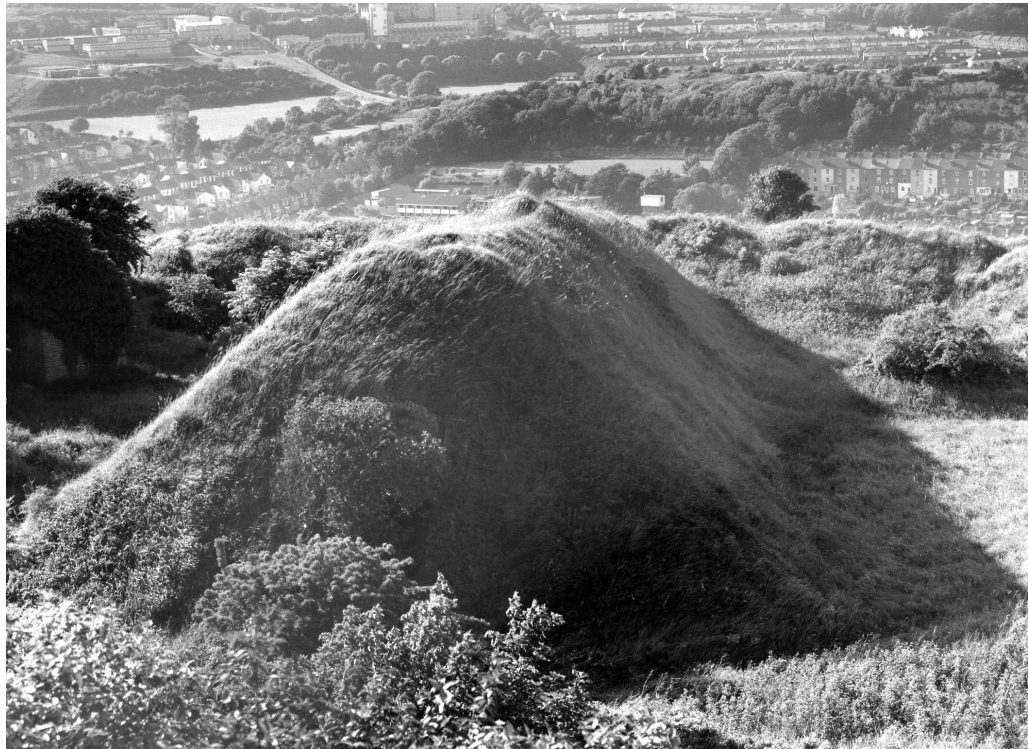
**Figure 23**  
*Detached Bastion;*  
*photo of the troop*  
*shelter, from the south*  
*(NMR: AA008624 ©*  
*Crown Copyright 1998)*

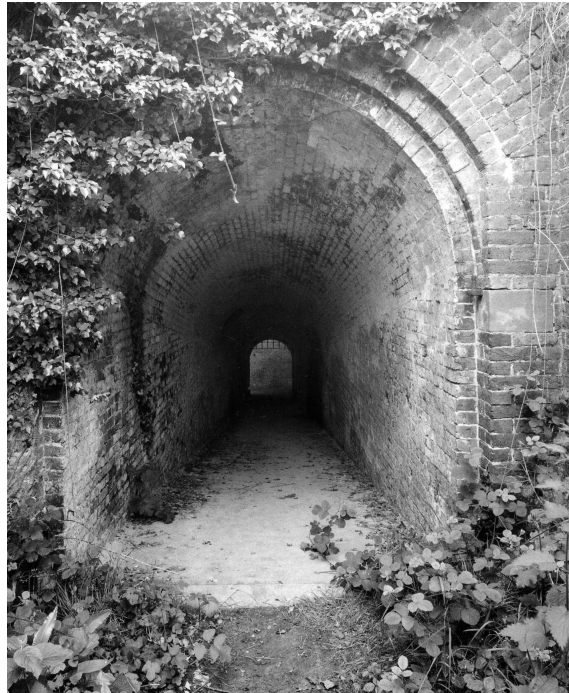
**Figure 25**  
*Detached Bastion;*  
*photo of the southern*  
*entrance to the west*  
*musketry gallery from*  
*the terreplein, showing*  
*the typical entrance*  
*arch and, centre right,*  
*a pintle hinge for the*  
*door, in its stone*  
*anchor block (NMR:*  
*AA008628 © Crown*  
*Copyright 1998)*

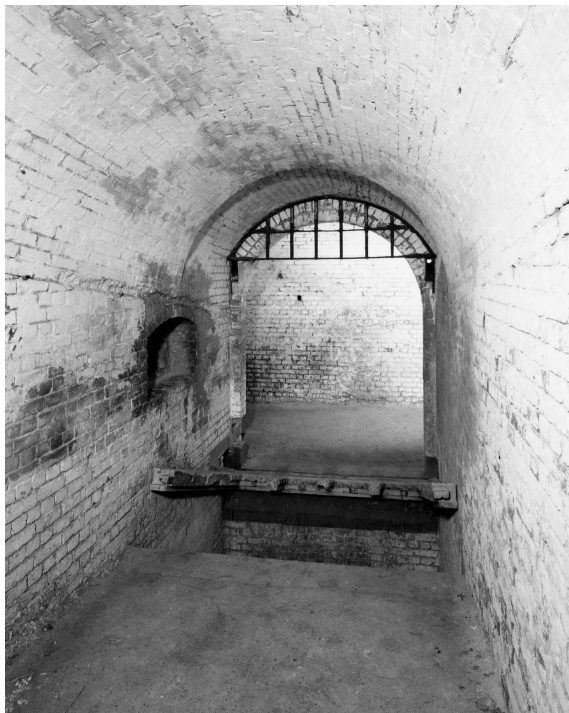
**Figure 26**  
*Detached Bastion::*  
*photo of the drop pit*  
*and lifting bridge at the*  
*end of the southern*  
*entrance to the west*  
*musketry gallery from*  
*the terreplein (NMR:*  
*AA008629 © Crown*  
*Copyright 1998)*

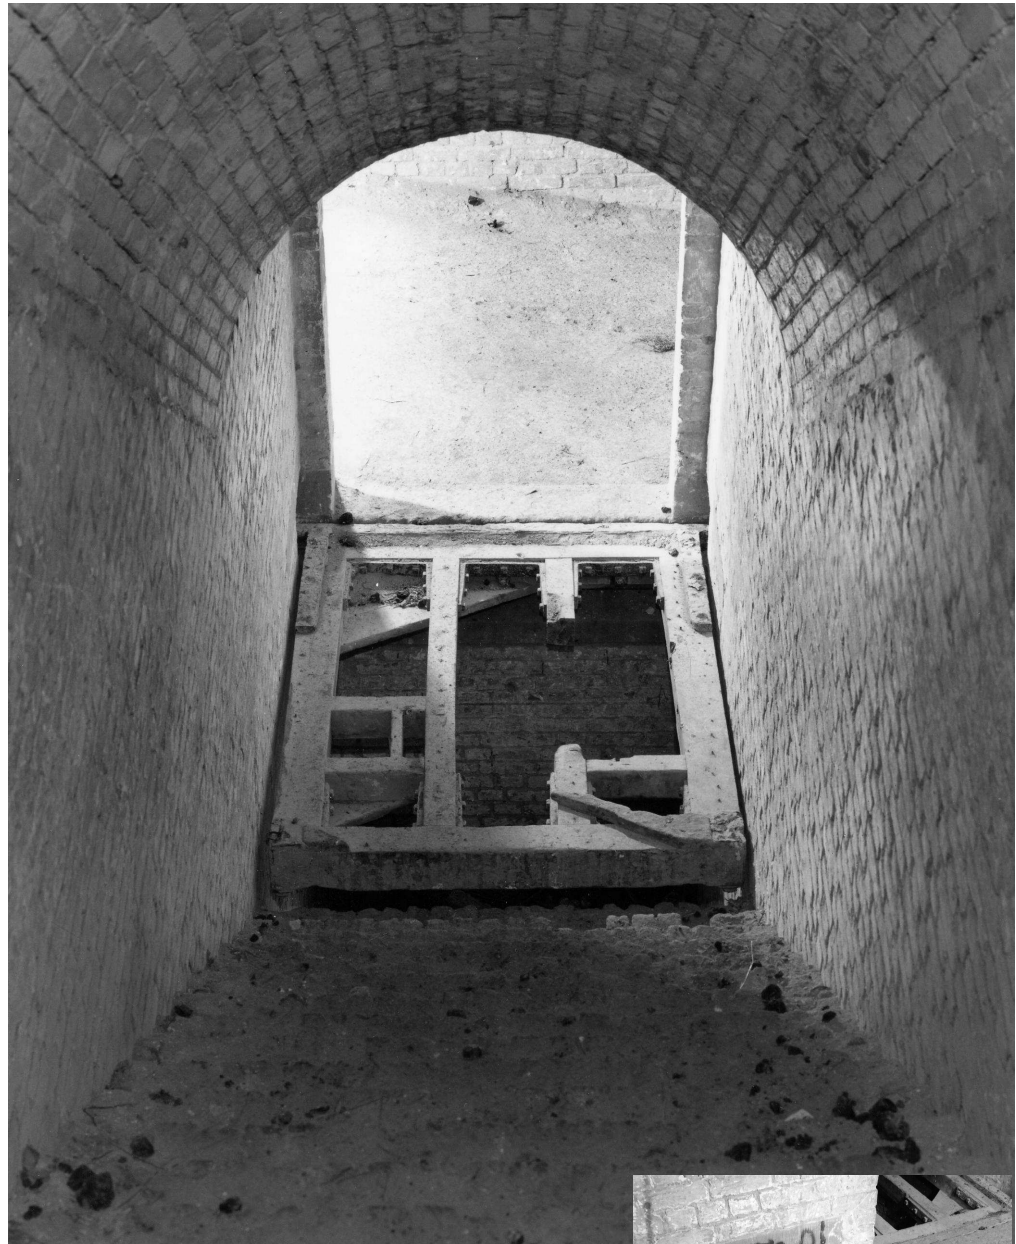
**Figure 28**  
*Detached Bastion; photo of the drawbridge guarding the northern entrance to the west musketry gallery, at the base of the passage from the terreplein (NMR: AA008632 © Crown Copyright*

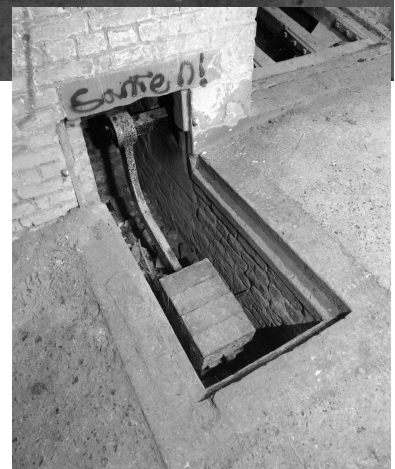
**Figure 27**  
*Detached Bastion; photo of the counterweights for the drawbridge guarding the southern entrance to the west musketry gallery from the terreplein (NMR: AA008633 © Crown Copyright 1998)*

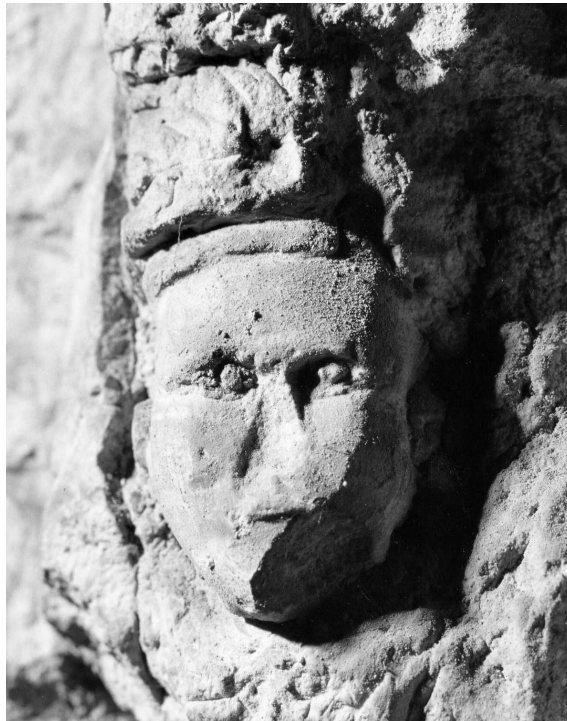
**Figure 29**  
*Detached Bastion:*  
photo of a head cut in  
relief into the chalk  
rear wall of a casemate  
in the west musketry  
gallery (NMR:  
AA008641 © Crown  
Copyright 2001

down a moderate incline, through semi-circular arches in the centre of the party walls. Only the top casemate has a rear wall finished in brick; the others have bare chalk on which are several relief carvings of faces and figures, of unknown date (Fig 29). The first nine casemates have two horizontal loops each, looking straight out into the west ditch, while the last three casemates have three vertical loops each. The eighth casemate gives access to the *terreplein* and the last one to the first floors of the north-west *caponier* and west gallery via a ramp, guarded by a wrought iron handrail in a stone base (Fig 30).

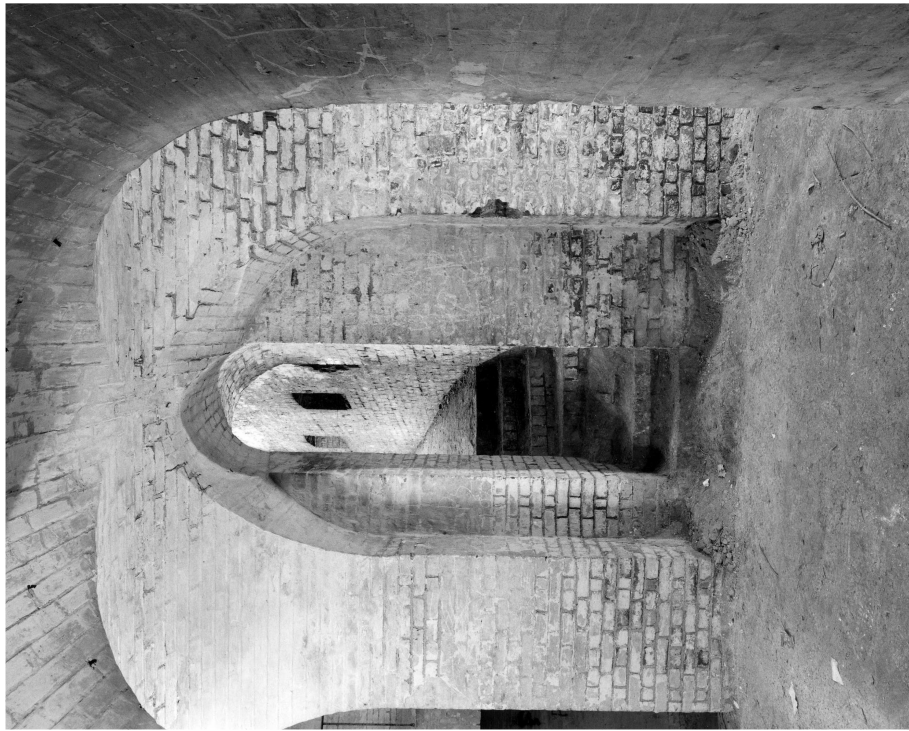
**Figure 31:** Detached Bastion; photo of the entrance to the west musketry gallery upper floor, viewed from the rear of the north-west caponier, showing elaborate brick vaulting (NMR: AA008636 © Crown Copyright 1998)

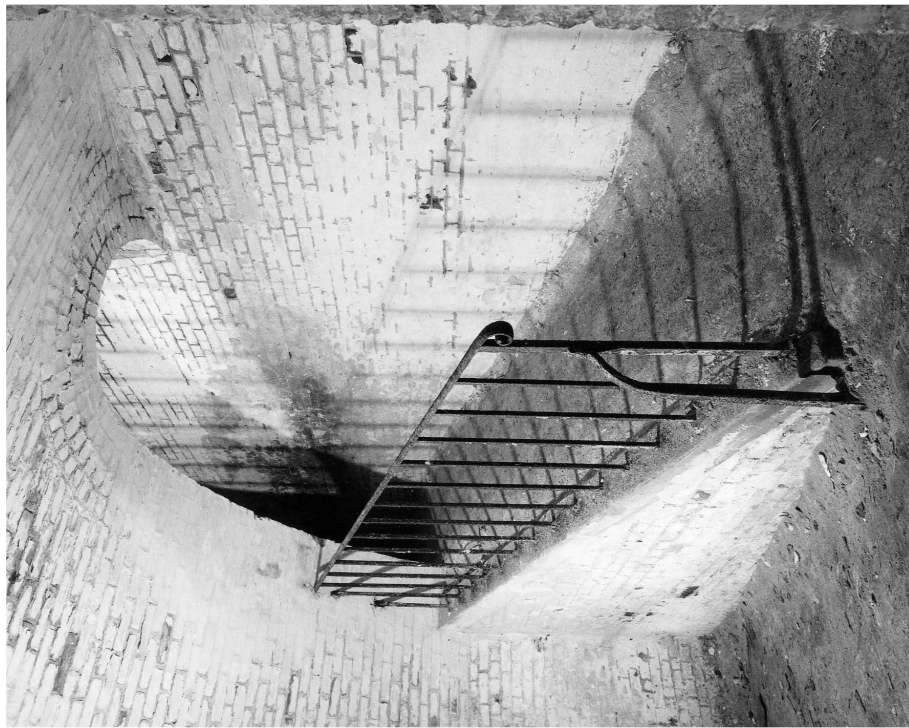
**Figure 30:** Detached Bastion; photo of the ramp between the lower and upper floors of the west musketry gallery (NMR AA008635 © Crown Copyright 1998)

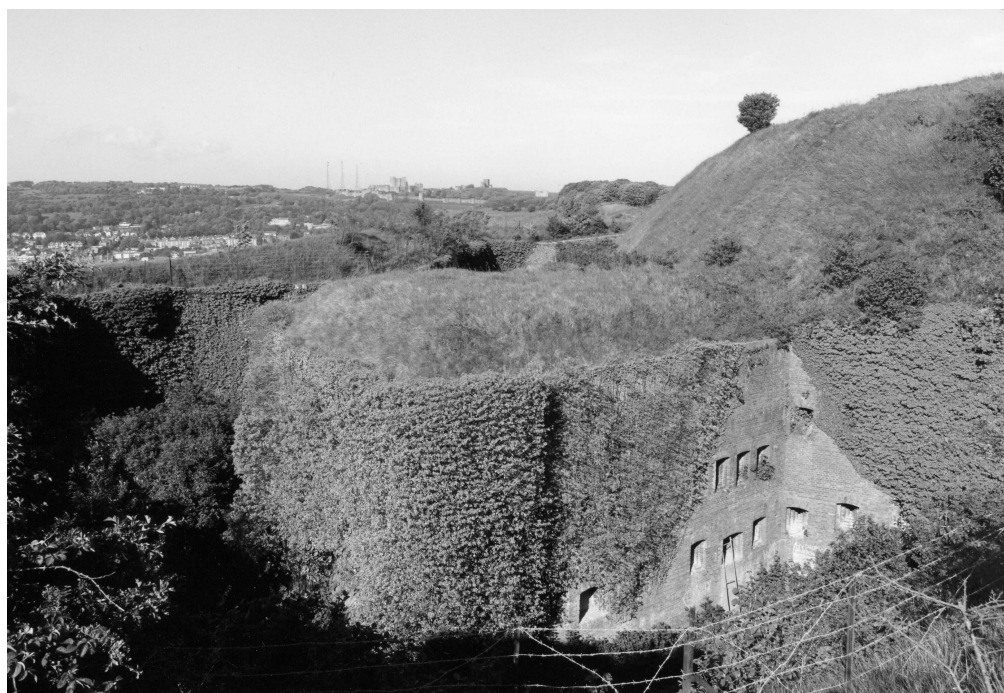
**Figure 32**  
*Detached Bastion;  
external view of the NW  
caponier, from the west,  
showing musket loops  
and carronade  
embrasures (NMR:  
AA008621 © Crown  
Copyright 1998)*
