# THE WESTERN HEIGHTS DOVER, KENT

## Report No 7: North Centre and Detached Bastions: 19th-century fortifications

SURVEY REPORT

ARCHAEOLOGICAL INVESTIGATION SERIES 28/2001

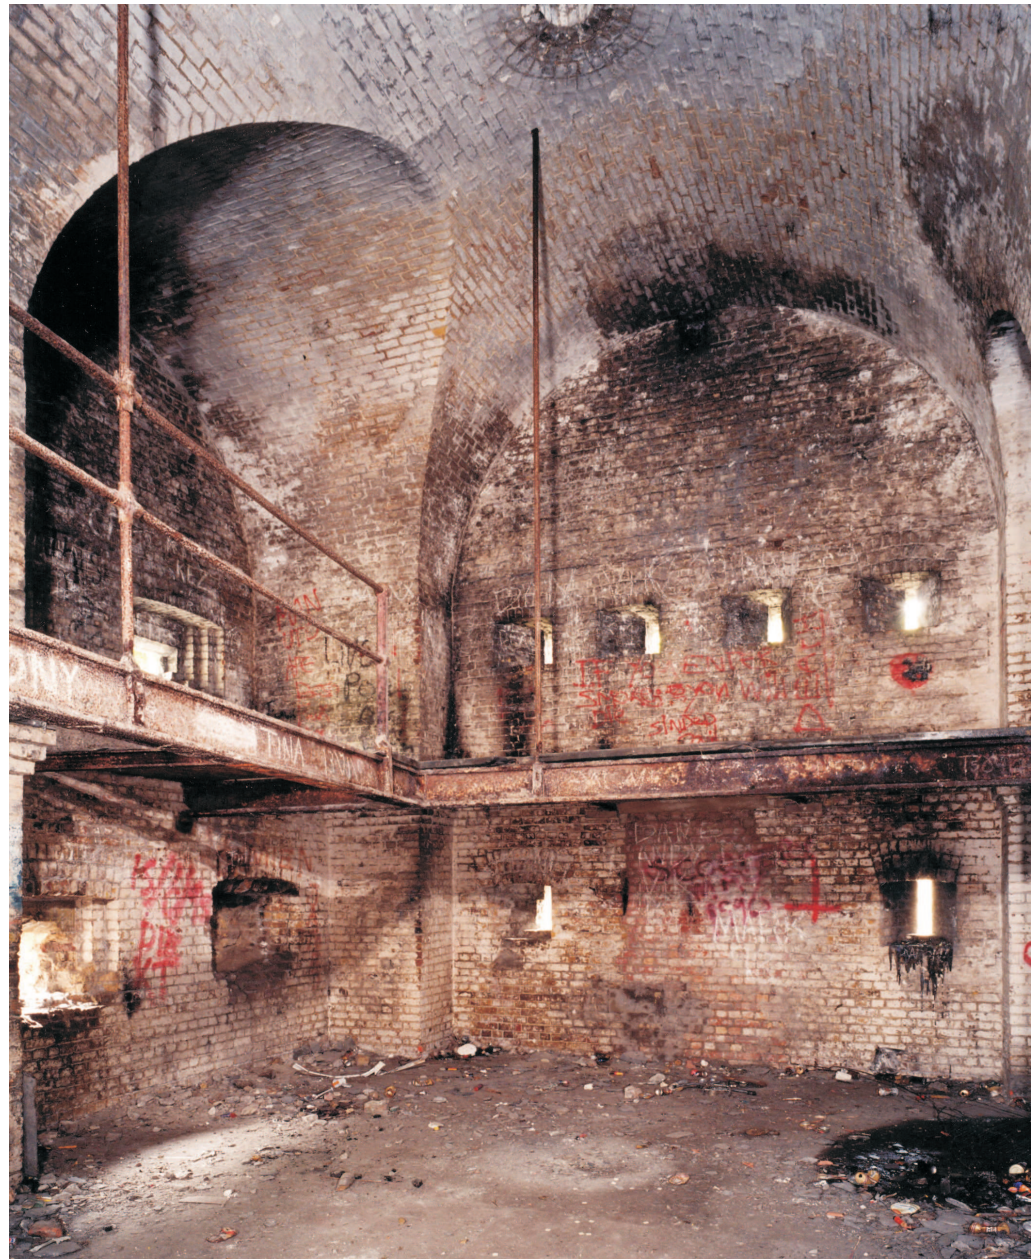
**Figure 33**  
*Detached Bastion:*  
*photo showing the*  
*interior of the NW*  
*caponier, from the west*  
*(NMR: BB 029681 ©*  
*English Heritage 2001)*

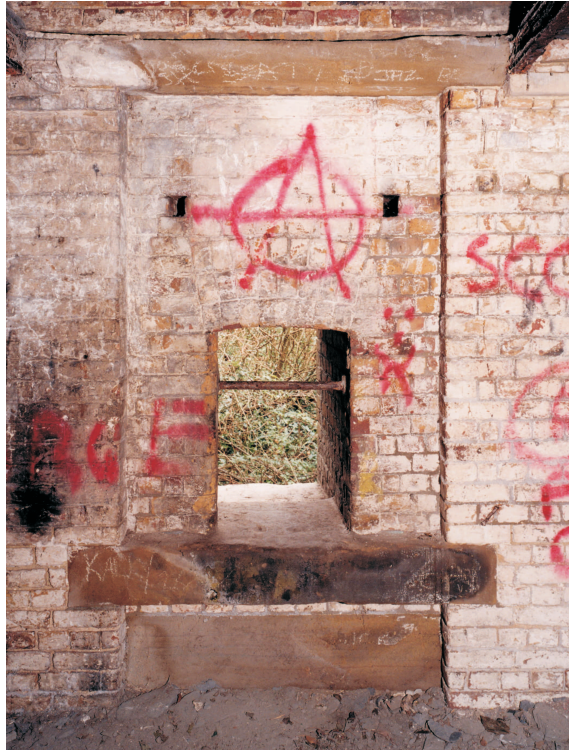
**Figure 34**  
*Detached Bastion; a carronade embrasure and mounting in the west flank wall of the north-west caponier (NMR: BB 029682 © English Heritage 2001)*

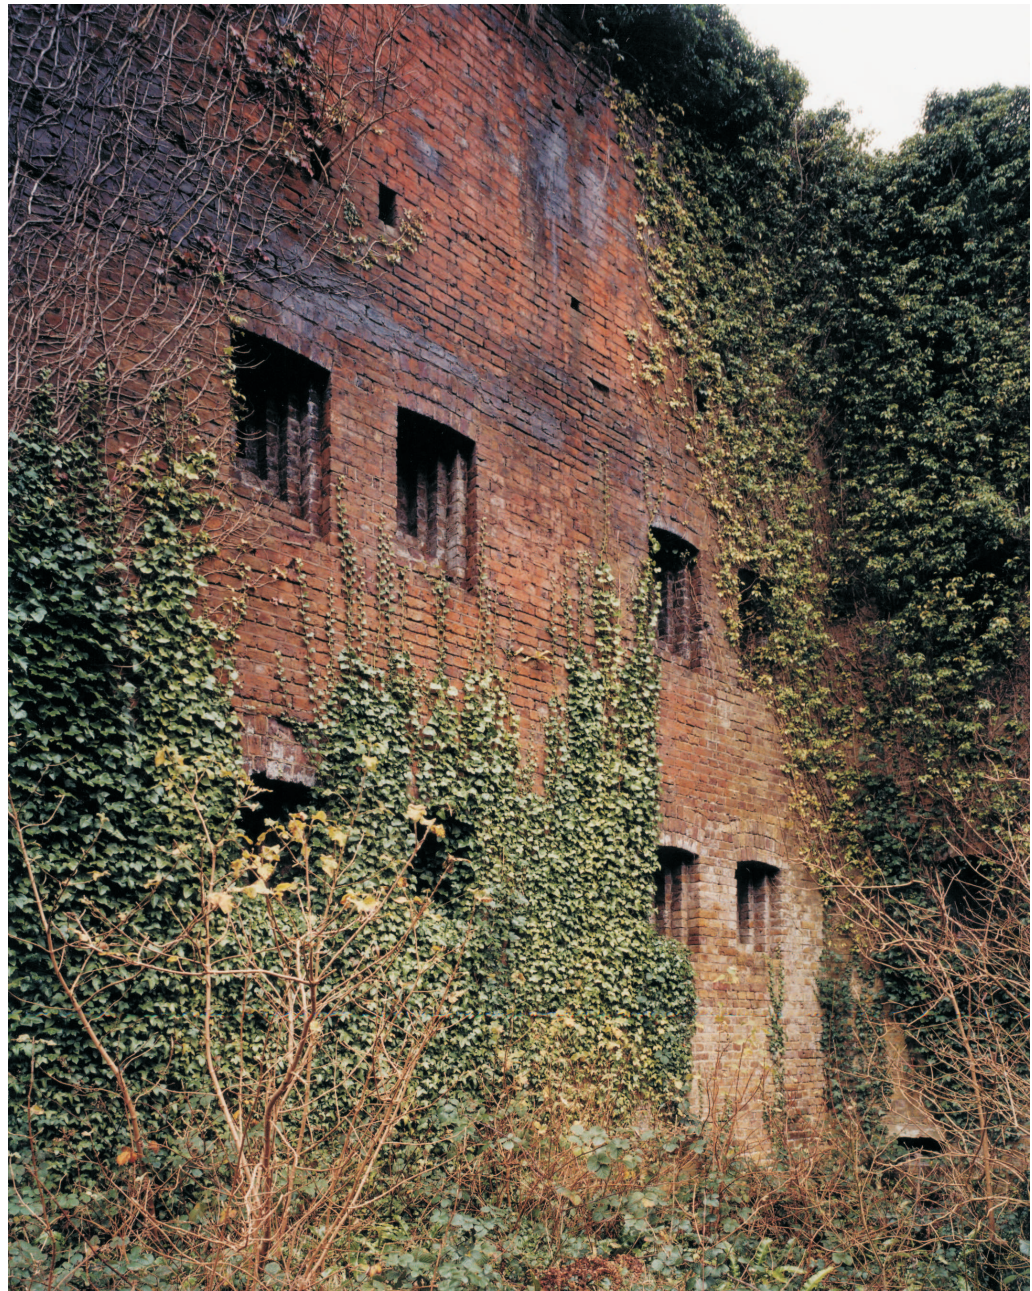
**Figure 35**  
*Detached Bastion;  
musket loopholes of the  
north musketry gallery,  
seen from the north  
ditch of the bastion  
(NMR: BB 029678 ©  
English Heritage 2001)*
