THE WESTERN HEIGHTS DOVER, KENT

Report No 9: South Front Barracks Later 19th and 20th-century barracks complex

SOUTH FRONT BARRACKS

ARCHAEOLOGICAL INVESTIGATION REPORT SERIES 30/2001

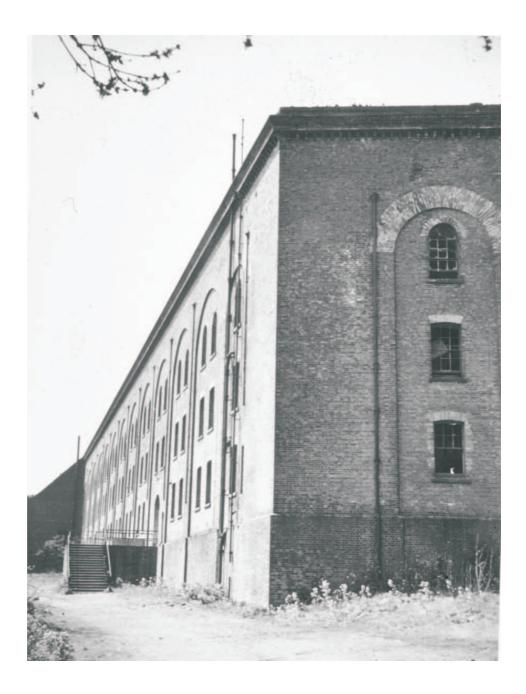
The Casemated Barracks at South Front c 1958; looking south-west along the south-east elevation, within the ditch of the defensive Line (© Dover Museum, ref D07880)

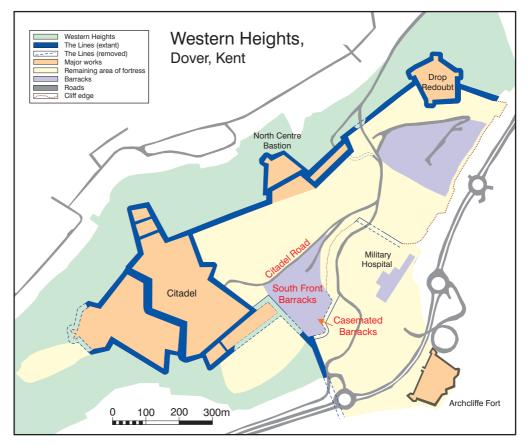
Figure 2 Plan of Dover Western Heights, showing the position of South Front Barracks

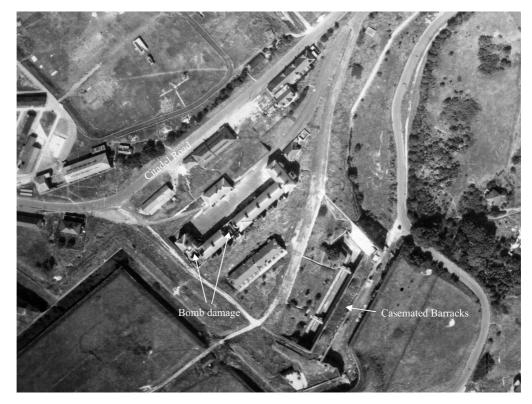
Figure 3 South Front Barracks, as seen from the air in 1945. Text in white is added by the authors (extract of NMR: 106G/UK/610/6362, by kind permission of the MOD)

The Married Quarters were damaged during the Second World War (Fig 3).

Aerial photographs reveal that it had a gabled roof (Fig 3). Nothing now remains above ground although the site is not built over.

Aerial photographs show that this building had skylights in both slopes of the roof - still identifiable by the darker slates used to fill them in - suggesting that it might have been used as a garage for the light repair of military vehicles (Fig 3).

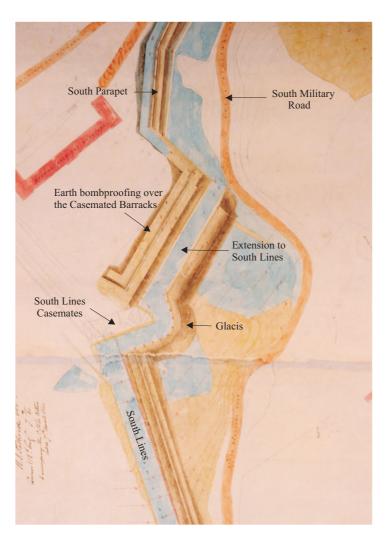
Figure 4

Plan showing initial proposals for a new South Front to the Western Heights, dated 1860. Blue and yellow represent cut and fill respectively. North is at the top of the drawing, while text in black is added by the authors (extract of PRO: MR/1/1300 © The Public Record Office)

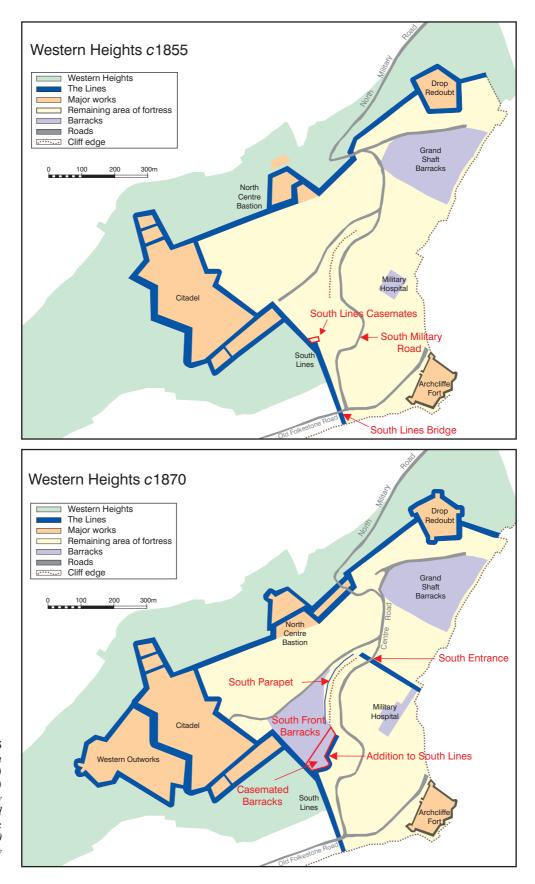
Figure 5

Plans of the Western Heights before (above) and after (below) completion of the new South Entrance and South Front Barracks, c 1855 and 1870 respectively which are shown on a plan of 1810 (PRO: MR/1/1349). These three casemates covered the lower part of South Lines to the bridge where the Old Folkestone Road entered the fortress. They are depicted before alteration on plans of 1855, with segmental vaults, each room divided into two floors (NMR: WD/2325 and 2326). Two later sketch plans, *c* 1860, show their *proposed* eastward extension to provide a powerful *caponier* covering both the old South Lines and the new ditch running north-east to the South Military Road. Work began shortly afterwards, on new gunrooms built to a design similar to the sketches of 1860, forming the south end of the new Casemated Barracks (PRO: MR/1/1300/1-2).

An important element of the 1860s work involved re-designing the south-western approach to the Western Heights, including the provision of a new defensible entrance higher up the ridge than the original south entrance (See Brown and Williams 2001). A proposal plan of 1860 shows the new design (Fig 4). The approach would be closed by a new defensive line, running north-east, above the South Military Road, from the South Lines Casemates , then turning south-east to the cliff face above the harbour. The road would cross the last stretch on a drawbridge, through a gatehouse, into the fortress. The chalk face above the road would be cut back and surmounted by a new rampart, South Parapet, and spoil used to grade the ground to the south, so that it could be commanded by firing positions on the new line. Much of this proposal *was* carried out (Fig 5).

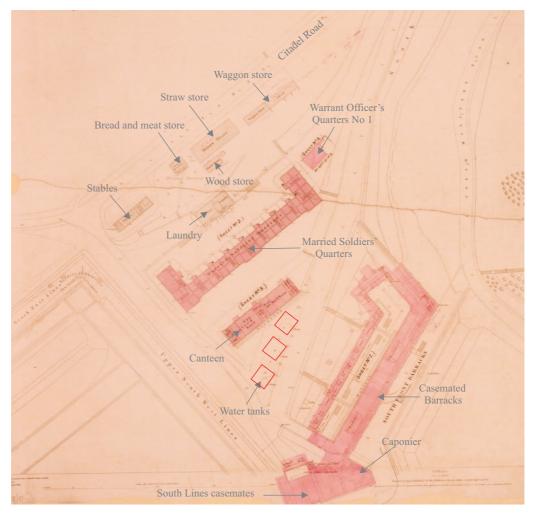
Figure 6 Plan of South Front Barracks, dated 1897. Text in grey and the water tanks, emphasised in red, are added by the authors (extract of PRO: WO/78/2426/2 © The Public Record Office)

In 1871, the other buildings of the complex stood on terraces north-west of the Casemated Barracks up to and along Citadel Road. These comprised a Canteen and Recreation building (1st terrace); Married Soldiers' Quarters (2nd terrace), a Laundry (3rd terrace) and Stables and a Bread and Meat Store (Citadel Road)(PRO: WO/28.2755/9). By 1897 a Warrant Officer's Quarters had been added on the 2nd terrace, while a Straw Store, Wood Store and Waggon Store had been added on Citadel Road (Fig 6). By 1903, changes on

Built after 1871, only the rectangular outline of these two buildings is shown on the 1897 plan and their depiction suggest a wooden construction (PRO: WO/78/2755/9; Fig 6). By 1903 the Wood Store had been removed and the Straw Store replaced, or perhaps converted into a Troop Stable and Store for Mobilization Equipment and Vehicles (see below).

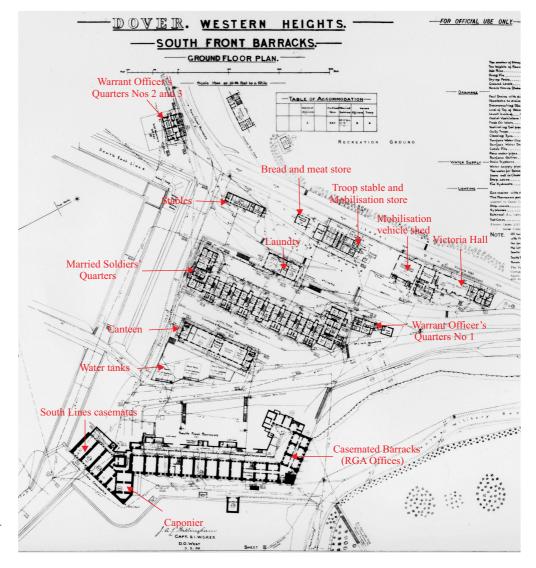
Figure 7 Plan of South Front Barracks in 1927. Text in red is added by the authors (extract of NMR: WD (1927a)

bedroom connected by new doorways in the party walls, with a scullery and WC contained in new structures projecting from the south-east elevation (Fig 7). In the wings, there were similar groupings of rooms, including three- and four-room apartments for the NCOs, also with new sculleries and WCs (known as 'B' and 'C' type quarters). The old communal lavatories were disused and the school for infants was no longer here; a new school had been built near Grand Shaft Barracks. A table reveals that the overall accommodation in 1927 was for 57 men and their families, of which 21 were NCOs.

A detached house for a Warrant Officer formerly stood just to the north-east of the Married Quarters (Fig 7), having been built at some time between 1871 and 1897 (PRO: WO/78/2755/9; WO/78/2426/3). It was named No 2 in 1896 but re-designated no 1 by 1903, following the construction of quarters for two more warrant officers on Citadel Road shortly before 1900 (see below) (PRO: WO/78/2426/3; NMR: WD/2320; WD/231). As built, it was a bungalow with a central through passage incorporating a lobby. Three bedrooms were located on the south-west side of the passage, with a scullery, kitchen and living room on the other side. A yard with WC, ash tub and coal store adjoined on the north-east. Although the house has been demolished, subsidence of ground in the garden of a modern semi-detached house on the site has revealed what might be its foundations.

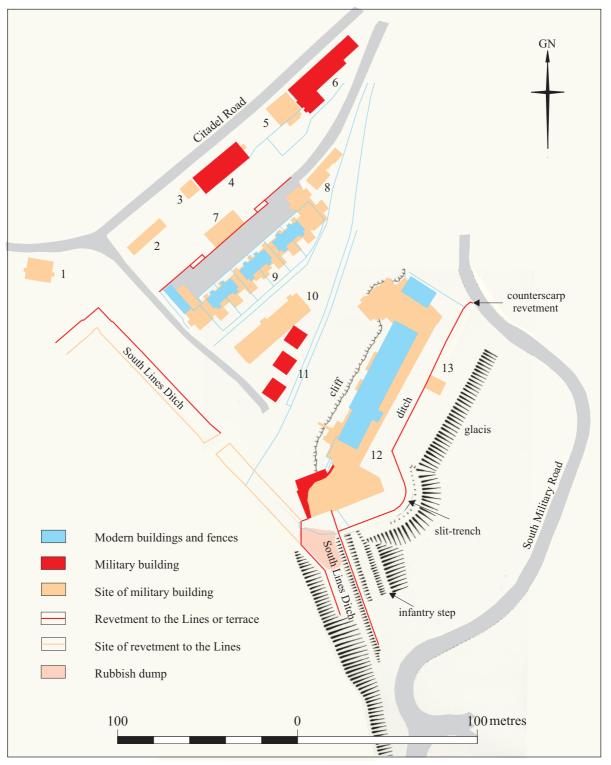
Figure 8

Plan showing surviving elements of South Front Barracks, with the location of demolished buildings from the plan of 1927

- 1 Warrant Officers' Quarters nos 2 and 3
- 2 Stables
- 3 Bread and Meat Store
- 4 Motor Transport Shed, on the site of: Troop Store and Mobilisation Store
- 5 Mobilisation Vehicle Shed
- 6 Victoria Hall

- 7 Laundry
- 8 Warrant Officer's Quarters no 1
- 9 Married Soldiers Quarters
- 10 Canteen
- 11 Water Tanks (underground)
- 12 Casemated Barracks
- 13 Coal Store (behind revetment)

In the following description, for words and letters in **bold**, refer to figure 8.

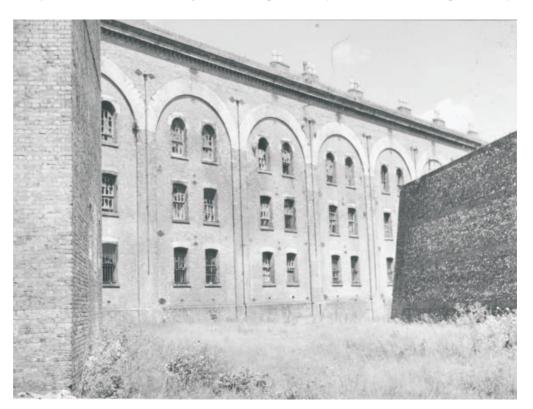
Figure 9 The Casemated Barracks, a photo of the south-east elevation from the ditch, with the edge of the caponier at extreme left. Taken c1958 (© Dover Museum, ref D07879)

The Casemated Barracks were built inside the fortress against the new Line, with the south-east elevation also forming the revetment to the scarp of the ditch (Fig 9). A steep *glaçis* beyond the counterscarp of the ditch provided protection for the *caponier* and barracks against bombardment from the south-east.

This, the principal barrack, was a three-storey casemated range forming a truncated L-shape abutting the gun rooms of the extended South Lines Casemates. These gunrooms continued to cover the South Lines Ditch, while the extension formed a *caponier* which projected into the ditch of the new Line, thereby providing flanking fire along the barracks, whose south-east elevation formed the escarp of the ditch (Fig 9).

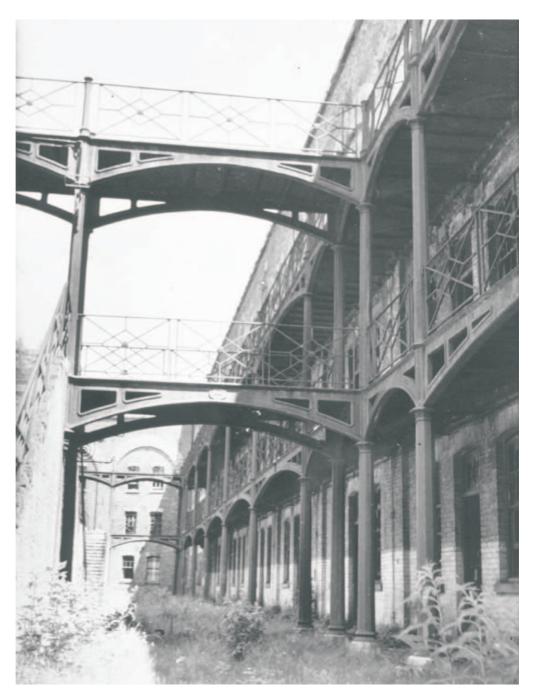
Figure 10

The Casemated Barracks, a photo of the gorge, looking north-east, showing the elaborate iron verandas and bridges allowing communications along and between the ranges. Taken c1958 (© Dover Museum, ref D07875)

The barracks comprised three floors of casemated rooms around the sides and ends of a long rectangular gorge, in this case effectively a protected courtyard, created by cutting deeply into the chalk rock of the hillside. All of the rooms faced onto this courtyard. Communication between the casemated rooms of the south-east range and across the courtyard to the north-west range was made possible by elaborate steel companionways

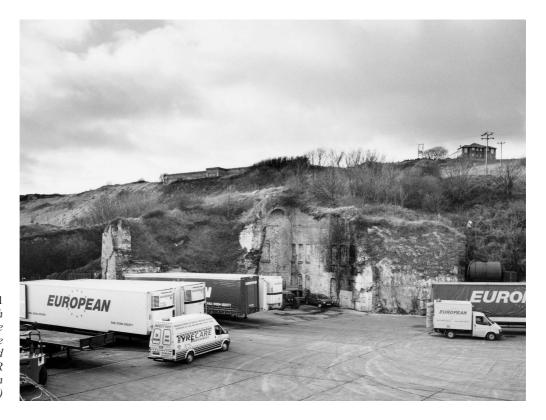
Figure 11 The remains of the South Lines Casemates, at the south-western end of the former Casemated Barracks (NMR AA028134 © Crown Copyright 1998)

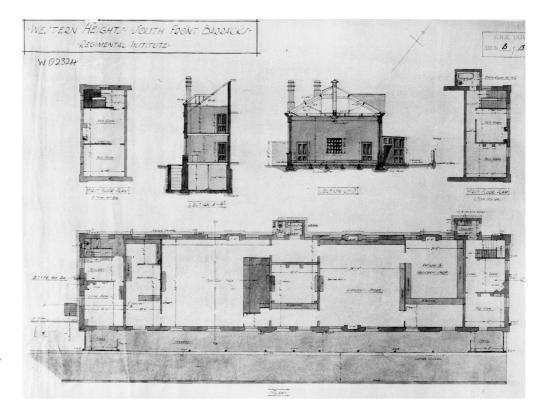
Figure 12 Record drawings of the Regimental Institute, dated 1929 (extract of NMR: WD/2324)

and faced in red brick (PRO: WO/78/2426/2 and 5). A later plan, of 1929, shows that it had a pitched slate roof incorporating gabled ends over the two-storey bays (Fig 12). The 1896 plan reveals that the south-western half of the hall still contained the Canteen, comprising a tap room with a stage, a bar and a coffee bar, while the other end contained both a Reading Room and a Recreation Room. By 1909, the north-eastern part had been converted to a Grocery Store and a Ration and Grocery Shop (NMR: WD (1909)). In 1927, the building is referred to as the Regimental Institute (NMR: WD (1927)).

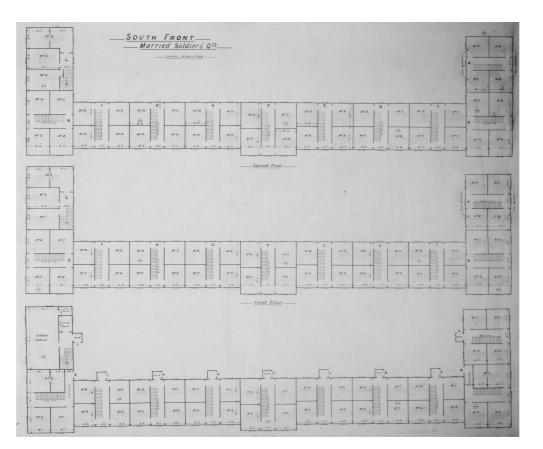
Figure 13 Block plan of the Married Soldiers' Quarters in 1896 (extract of PRO: WO/78/2426/4 ©The Public Record Office)

A plan of the Married Quarters, dated 1896, shows a long three-storey range, with short wings projecting north-west from each end, entirely unheated. On the south-east face, both wings and the central three bays projected forward slightly from the main elevation (Fig 13). The central range comprised, on each floor, seven groups of four rooms, divided into pairs by central stairways accessed through porches in the ground floor of the north-west elevation. With no connecting doorways in the party walls between the room pairs, the range appears to have been entirely divided into single room units; 84 in total. The wings were organised in a similar fashion except that half of the south-west wing contained an Infant School on the ground floor, while four rooms on both the first and second floors of the north-east wing were grouped into pairs, probably for the more senior NCOs. Indeed a plan of 1895 reveals that Serjeants and Staff Sergeants occupied rooms in the wings and the central projecting part of the main range (NMR: WD/2374). Overall, the wings contained 32 individual rooms and four twin-room flats, giving a total of 36 units. This meant that in 1896 there was accommodation in the whole block for 120 married soldiers and their families (PRO: WO/78/2426/3).

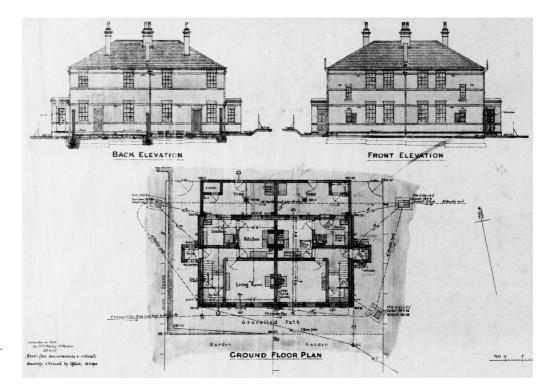
Figure 14 Record drawings of Nos 2 and 3 Warrant Officers' Quarters, dated 1900 (extract of NMR: WD/2320)

This building was constructed after 1897 (PRO: WO/78/2426/2) and before 1900, when a detailed record plan was made (Fig 14). The record plan shows that they were built as semi-detached houses for Warrant Officers, No 3 on the west and No 2 on the east. Both houses were well-appointed, comprising kitchen, scullery and living room on the ground floor, with flat-roofed porched entrances in the east and west walls respectively, and three heated bedrooms and WCs on the first floor. There were yards to the north, incorporating a coal store, and small enclosed gardens on the south.

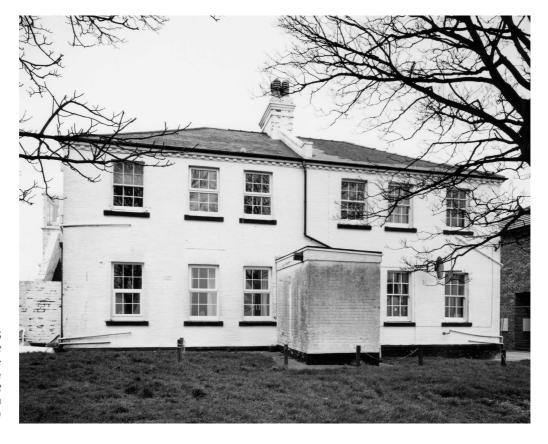
Figure 15 *Photo of the Warrant* Officers' Quarters Nos 2 and 3, south *elevation, in 1998* (*NMR: AA028136* © Crown Copyright 1998)

These brick houses face north on a small area of level ground on the south side of Citadel Road just west of the South Lines. They are double-fronted, of two storeys and three-by-three narrow bays with a hipped slate roof and a centrally placed dividing wall carried clear of the roof as a fire break (Fig 15). White paint obscures the original grey brickwork with its red brick bands at plinth, ground-floor window head, first-floor window head and eaves level. The porches survive along with the large shared, central stack (smaller stacks probably for coppers in the sculleries and the grates in the rear bedrooms have been demolished).

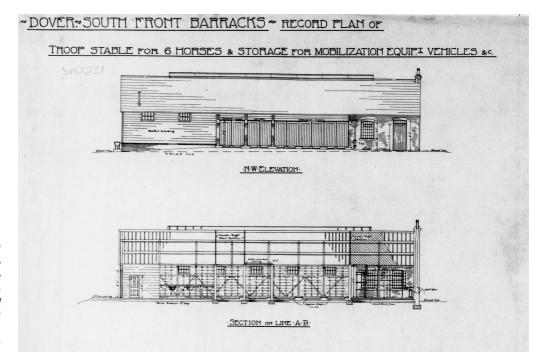
Figure 17 Record drawings of the Troop Stable and Store for Mobilization Equipment and Vehicles, dated 1903 (extract of NMR: WD/231)

This structure, replaced by the surviving Motor Transport Building after 1927, is shown on a record plan of 1903 as a seven bay, single storey building with a pitched slate roof incorporating a ridge ventilator (Figs 16 and 17; NMR: WD (1927)). The entire building stood on a concrete base with the posts of the timber-framed Mobilisation Store standing on concrete pads (WD 231). It seems likely that these survive in the western four bays of

The Mobilisation Store, which contained all the minor equipment required for war but not needed in peacetime, and a Gun Shed, were located in the five timber-framed, weather boarded bays forming the south-western two-thirds of the building. The brick stable for the transport horses occupied the remaining bays at the north-east end.

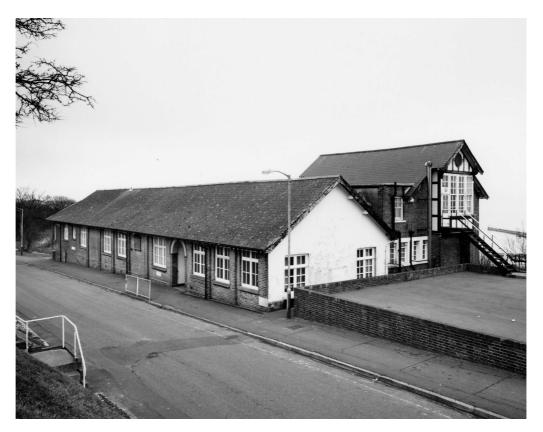
Figure 18 Photo of the Victoria Hall Establishment, from the east in 1998 (NMR: 028135 © Crown Copyright 1998)

Victoria Hall is located on the south side of Citadel Road, at the very top of the slope overlooking the site of the other buildings of South Front Barracks. It is currently in use as the Young Offenders' Institution Officers' Recreation Club and is in reasonable condition. There have been only a few alterations, comprising suspended ceilings and an additional door from the lobby to the hall, to an otherwise original fabric. It is the last standing example of the wide range of institutional buildings formerly provided for the garrison of the Western Heights (Fig 18).

It is a brick-built, thirteen-by-three bay single-storey building of pier and panel construction in English bond, with an oversailing pitched roof. The 1903 extension consists of a two-storey three-by-four bay wing built at the south-west end, with a lean-to veranda along two-thirds of the south-east wall of the 1898 building. The south-east elevation has also been considerably altered probably after the completion of the veranda (Fig 19).

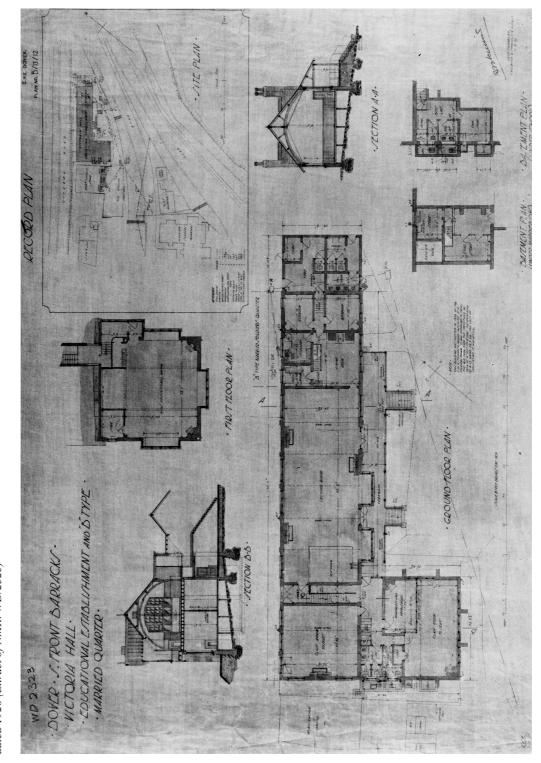
Figure 19 Record drawings of the Victoria Hall Establishment, dated 1926 (extract of NMR: WD/2323) semicircular arch with brick jambs and a stone head and imposts. The interior of the porch has an encaustic tiled floor and a close-boarded ceiling. The 1926 plan shows double doors leading to a lobby between the classroom and hall; a single door has replaced these doors although the fanlight may be original. It is probable that a similar porch was present in the south-east wall but if so this has been removed by the work for the 1903 extension. On the south-west side of the entrance is a dedication stone laid on December 8th 1898, by Lord Roberts of Kandahar VC. Lord Roberts was revered as a model of the Victorian Christian military hero and the placing of his dedication stone in such a prominent position may have been intended to remind the soldiers entering the Institute of the values its builders subscribed to. A similar stone, dedicated to another such hero, General Gordon of Khartoum, is situated further along the wall.

As built in 1898, Victoria Hall formed a long rectangular range comprising a central six-bay hall with a three-bay room at its south-west end and a four-bay Married Quarters at the north-east end. The difference in function between the sections of the building is emphasised by the fenestration; large tripartite casement windows originally lit the room and hall, four of which survive - two in the Citadel Road elevation and two in the south -west gable end; the Married Quarters are lit by smaller domestic size windows of the same pattern, with a single sash window in the north-easternmost bay. This was originally provided (according to the 1926 plan) for a bedroom.
