New Forest Rapid Coastal Zone Assessment Survey Stage II: Field Assessment

**NEW FOREST
RAPID COASTAL ZONE ASSESSMENT SURVEY
PHASE 2: FIELD ASSESSMENT**

Report ref.: 72201.1

December 2010

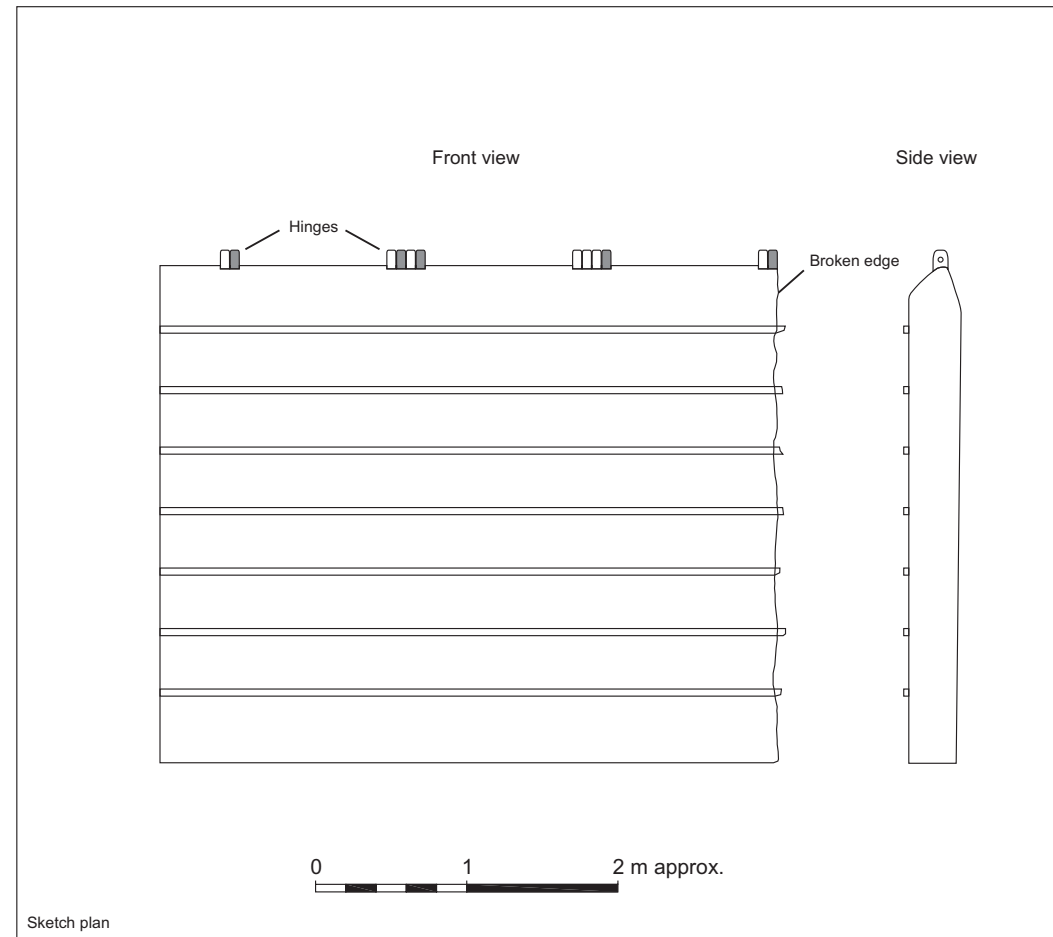
D: Ramp door hinges

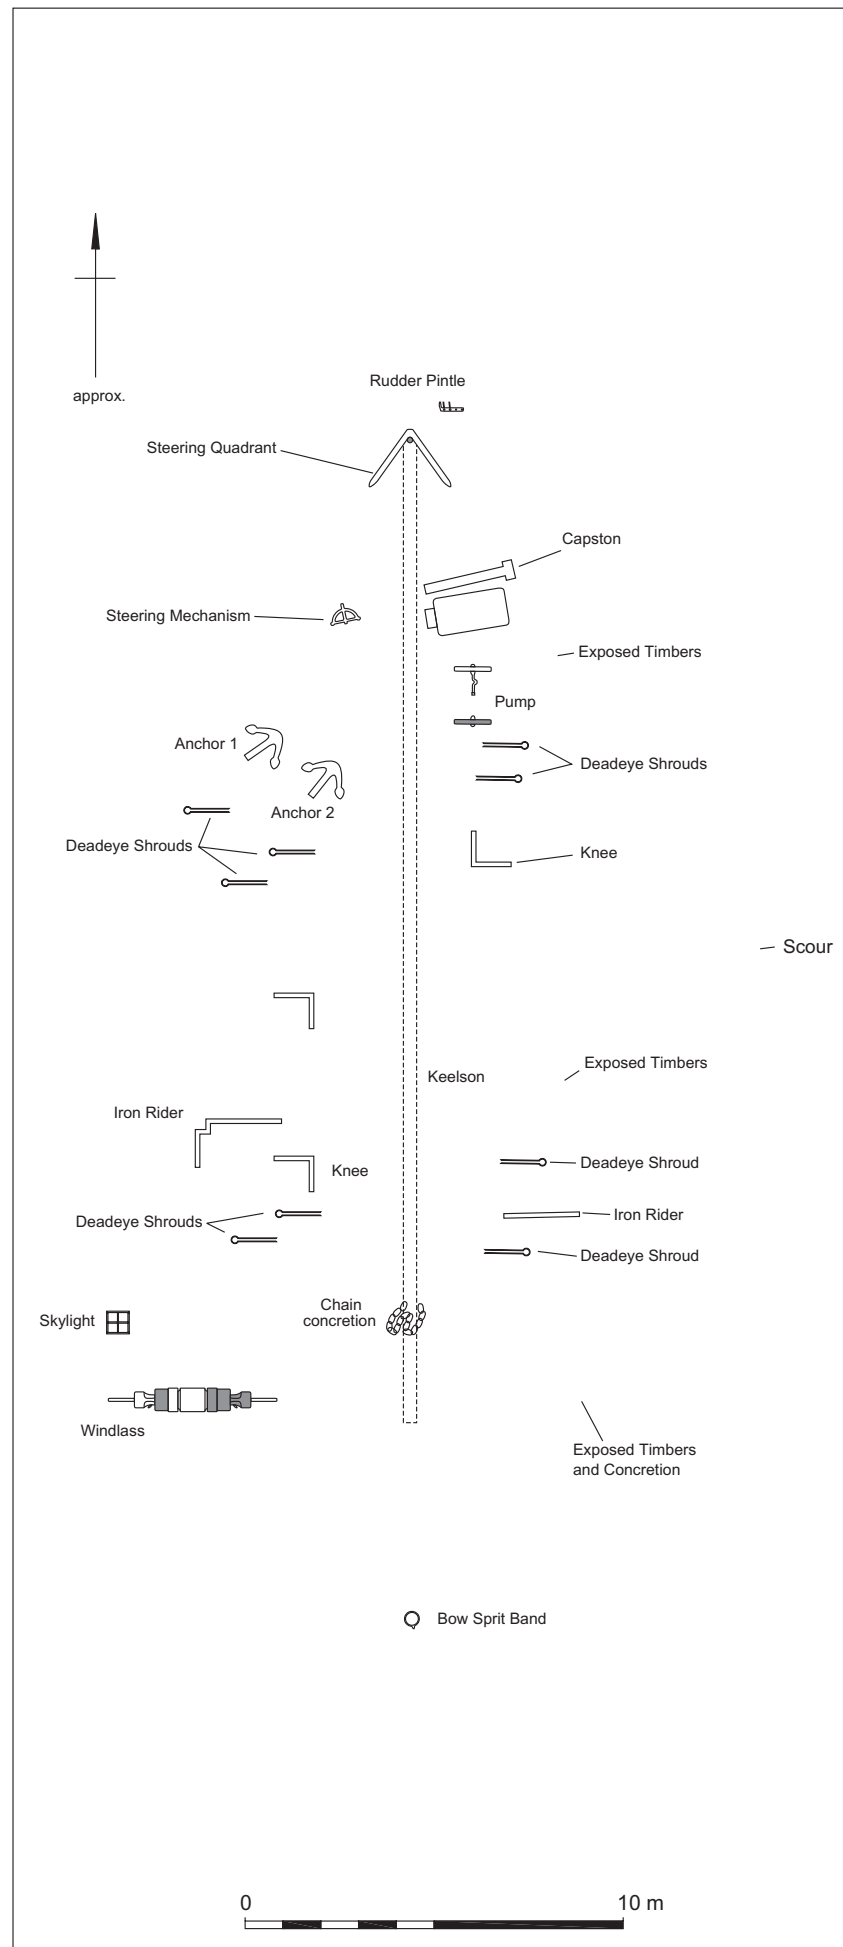
G: Rudder Pintle

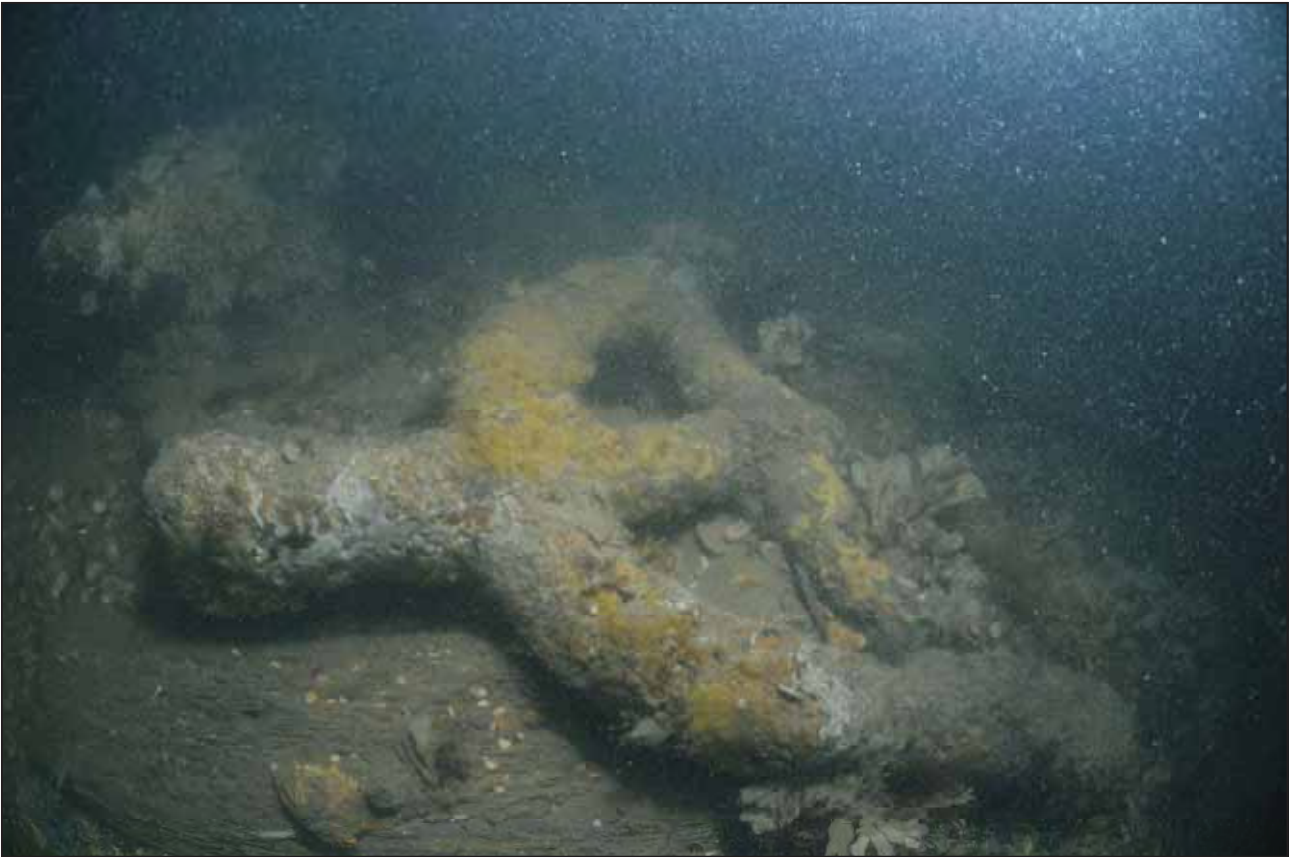
Steering mechanism

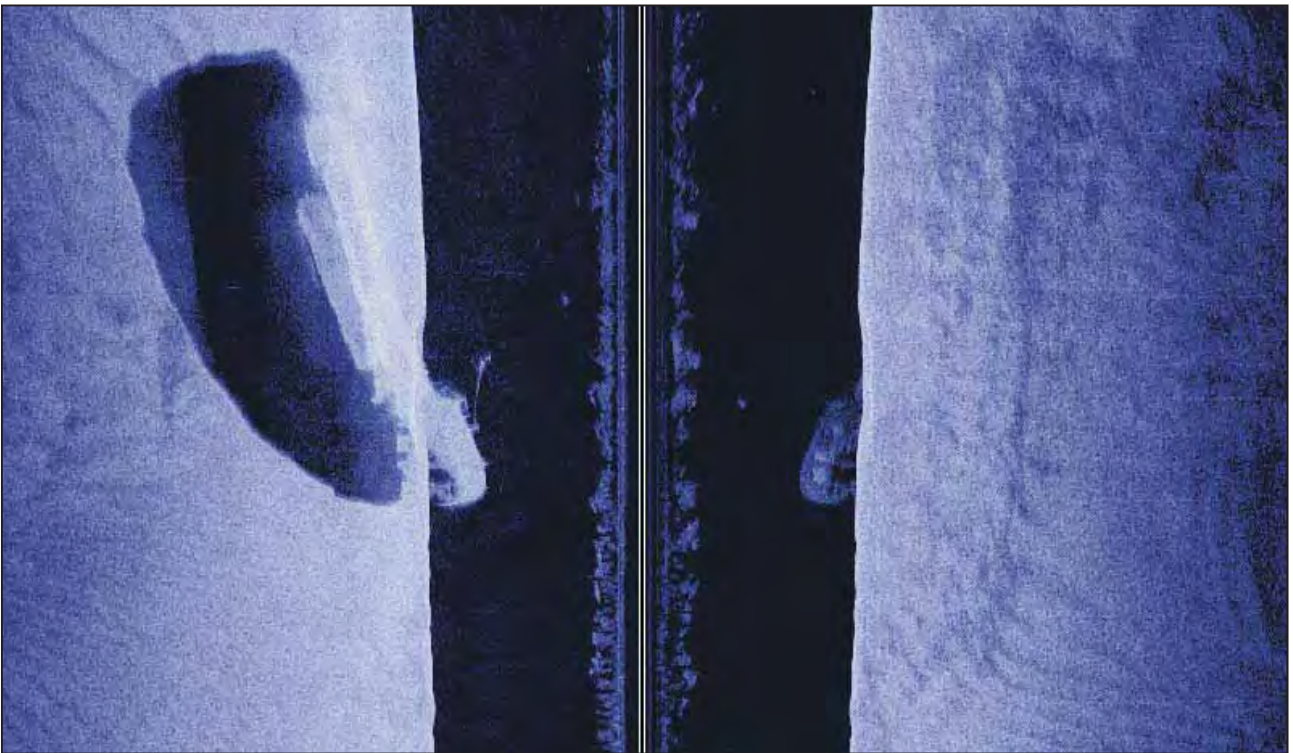
C: Sidescan sonar image of the *Margaret Smith*

- 2.5.16. The remains of the *Margaret Smith* (**WA6009**) were surveyed, and considerable superstructure was shown to still exist. The survey established the nature and extent of the remains, and observed the seabed processes impacting upon the site's physical longevity. Although the site is a modern wreck (1973) and arguably not archaeologically significant, there is good scope for research into the wreck's site formation over time. This has the potential to inform on a wide range of future conservation management issues in the marine zone, especially with regard to metallic deterioration.

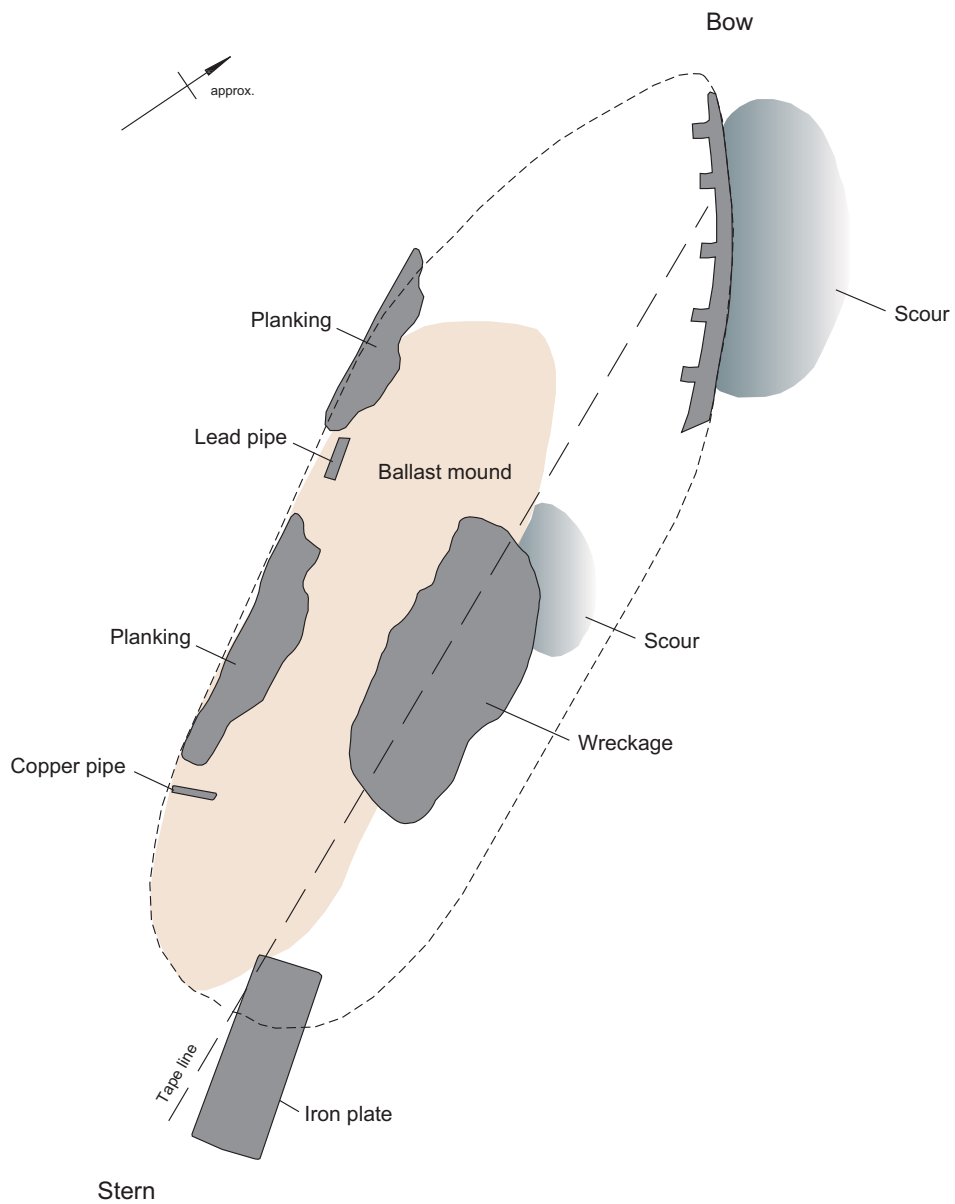
Diver sketch plan

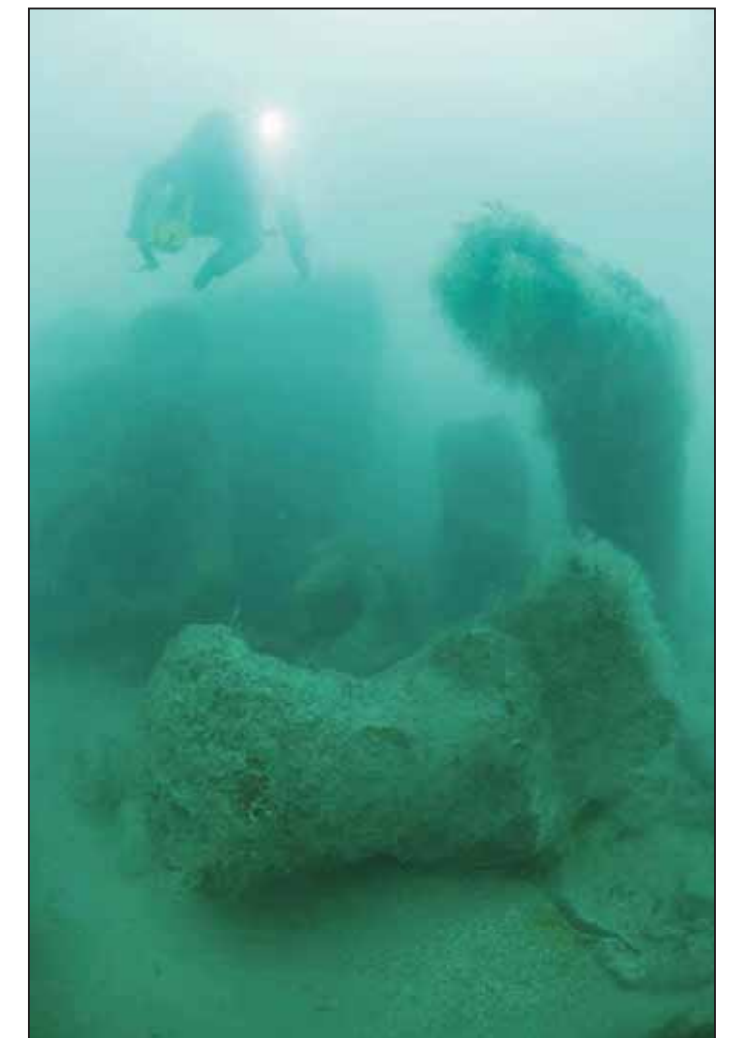
F: Bitt and hawse pipe

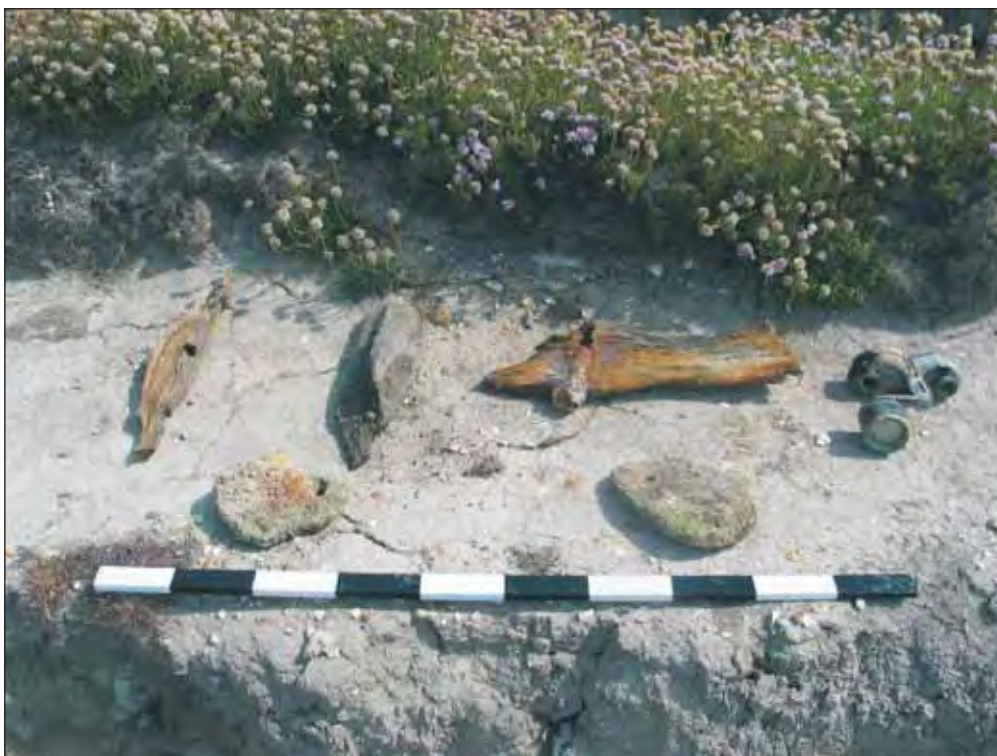
Plate A4: **WA1012**. Artefacts recovered from a small fissure adjacent to an observation post. Finds included the remains of a pair of 1940s binoculars

- 3.2.16. Sites **WA1011** and **WA1012** illustrate this potential. **WA1010 (Plate A3)** is a typical concrete base for an artillery gun. A number of potentially associated finds were located in a small fissure (created by erosion) adjacent to the concrete base. These included the remains of a set of WWII-era binoculars, drilled wood components, and fishing weights (**WA1012; Plate A4**). These suggest at least some wooden component to this particular structure, with observation being at least a minor function.

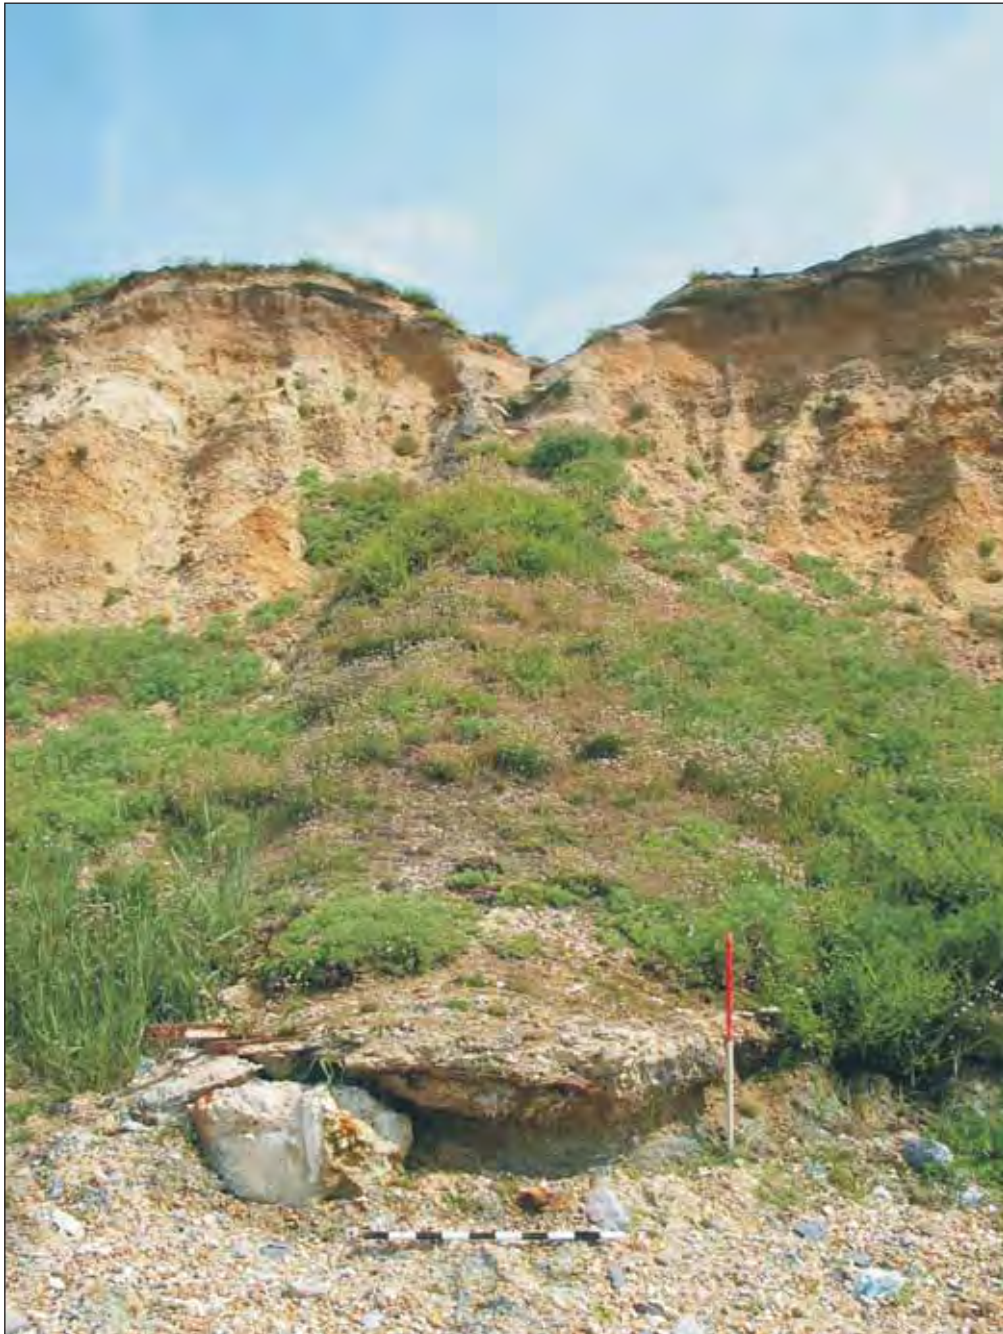
Plate A5: **WA1017**. Probable remains of a WWII observation post, which have been undermined by a combination of freshwater erosion and marine incursion

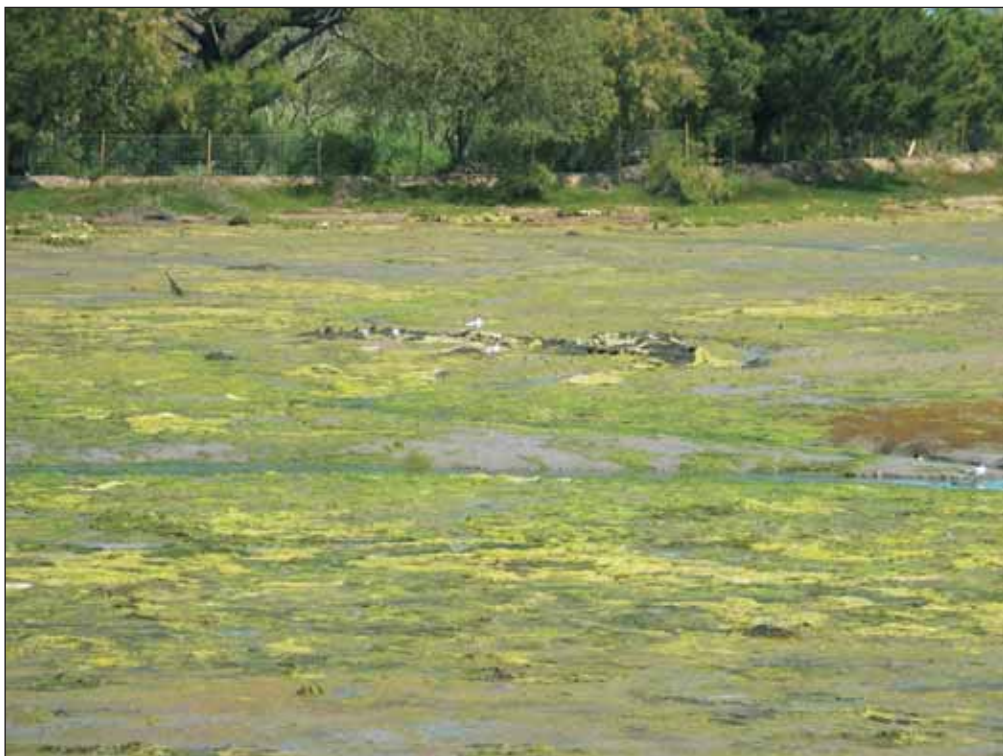
Plate B6: **WA2038**. Possible wooden wreck, in the intertidal muds adjacent to the Ferry Terminal on the Lymington River

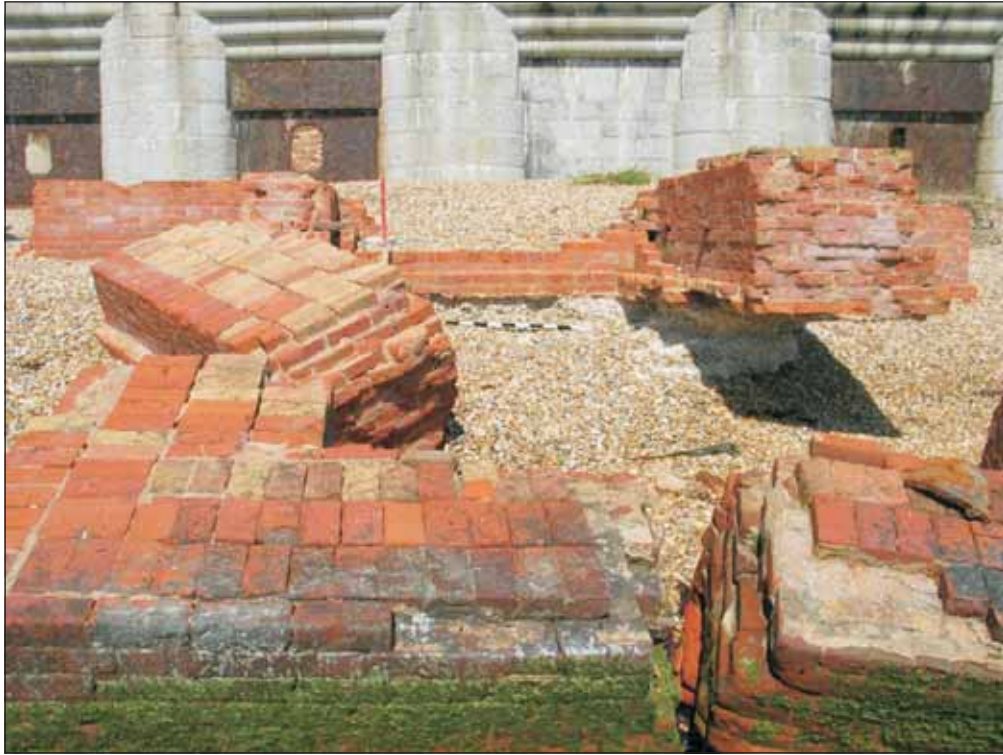
Plate B7: **WA2048**. Red brick, mortar and concrete structure, probably defensive fortifications, adjacent to Hurst Castle

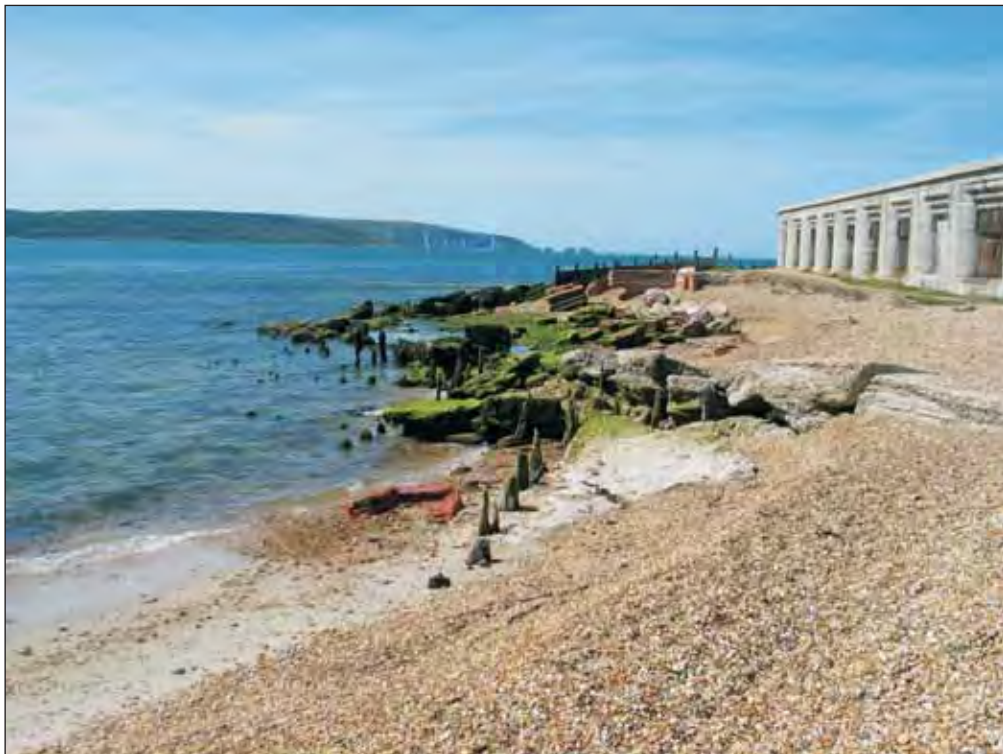
Plate B8: **WA2051**. An array of wooden and concrete former sea defences, to the seaward of Hurst Castle

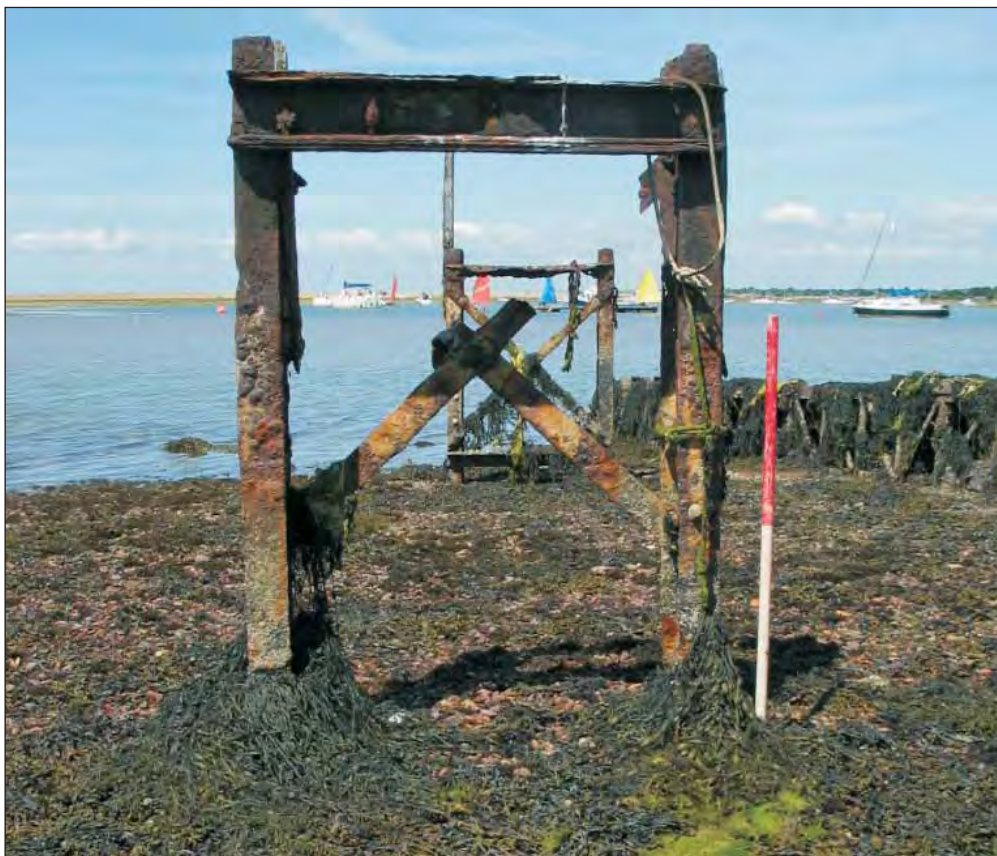
Plate B10: **WA2056**. Wooden and metallic remains of large former jetty or landing pontoon, the north of the castle on Hurst Spit

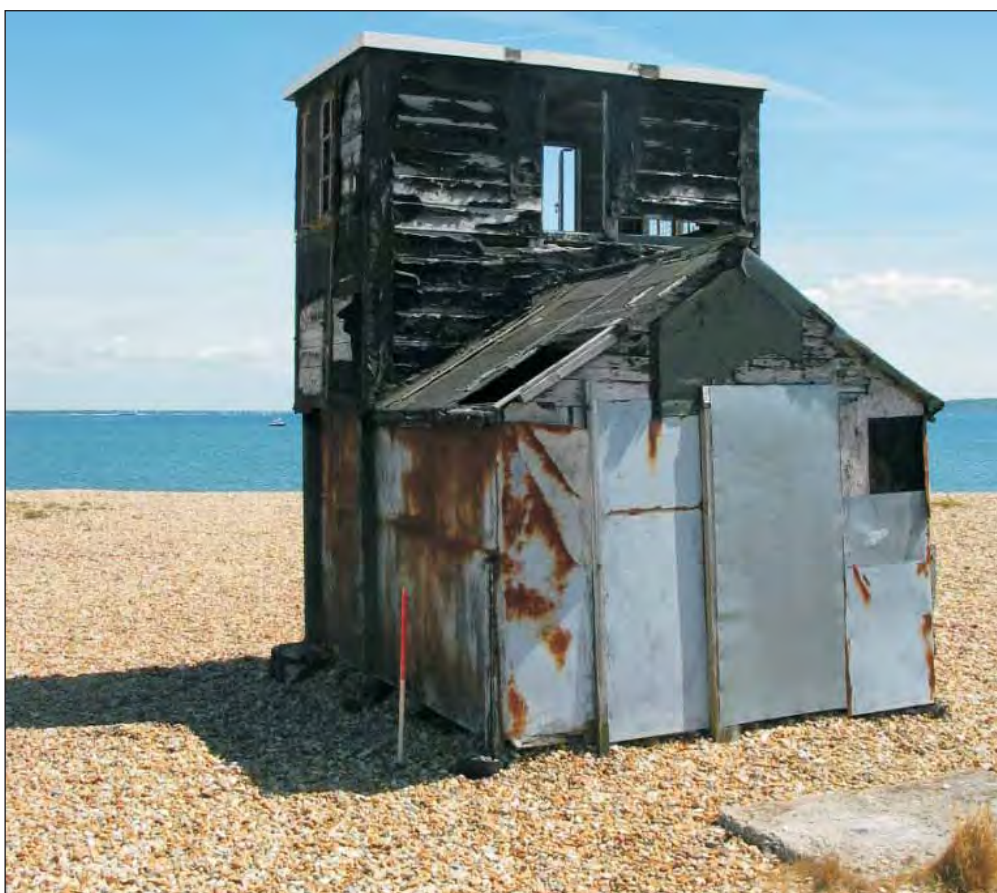
Plate B12: **WA2059**. Former coastguard hut, possibly reused as a store shed

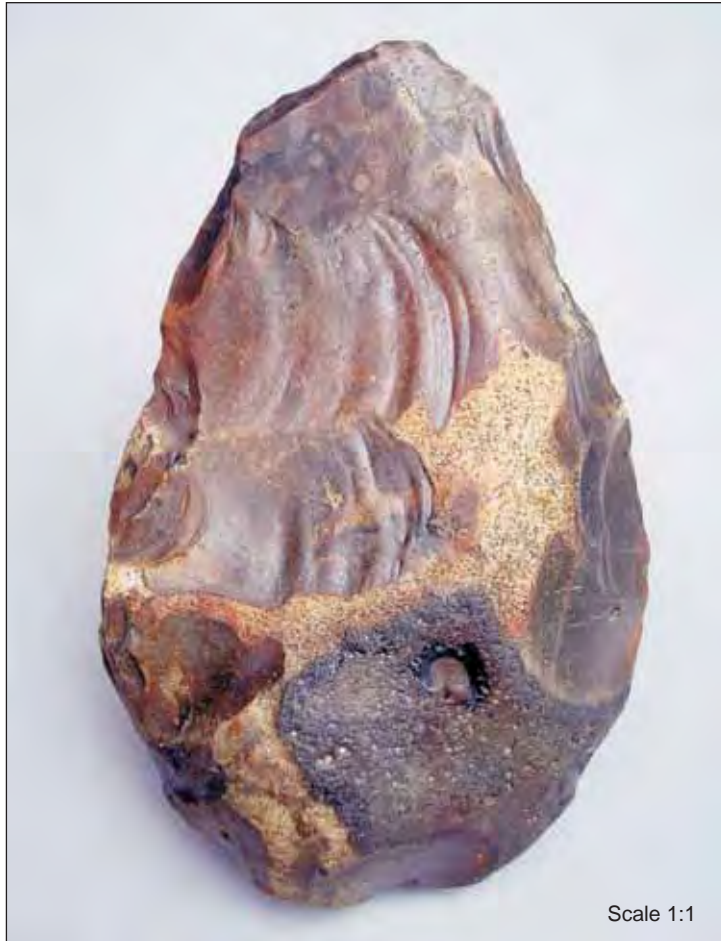
Plate C1: **WA3001**. Lower Palaeolithic Acheulian hand axe found on the foreshore at Pitts Deep (photo taken by David and Marion Nesbitt)

Plate C1: WA3001. Lower Palaeolithic Acheulian hand axe found on the foreshore at Pitts Deep (photo taken by David and Marion Nesbitt).

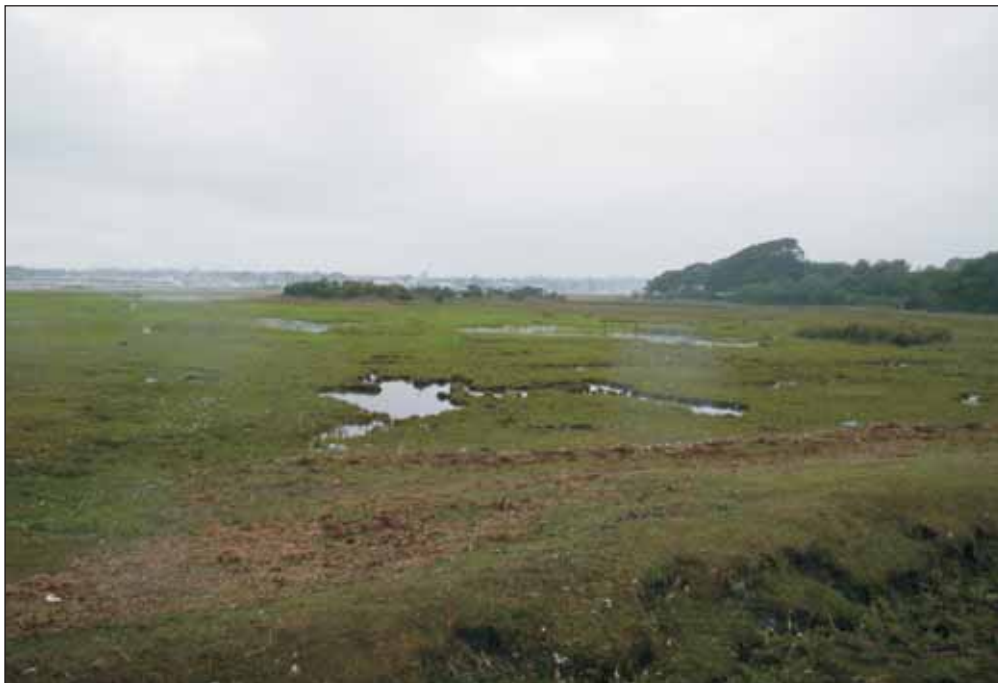
Plate C2: **WA3003**. Remains of a saltworks site comprising a flat area of land surrounded by an earthwork bank at Lisle Court

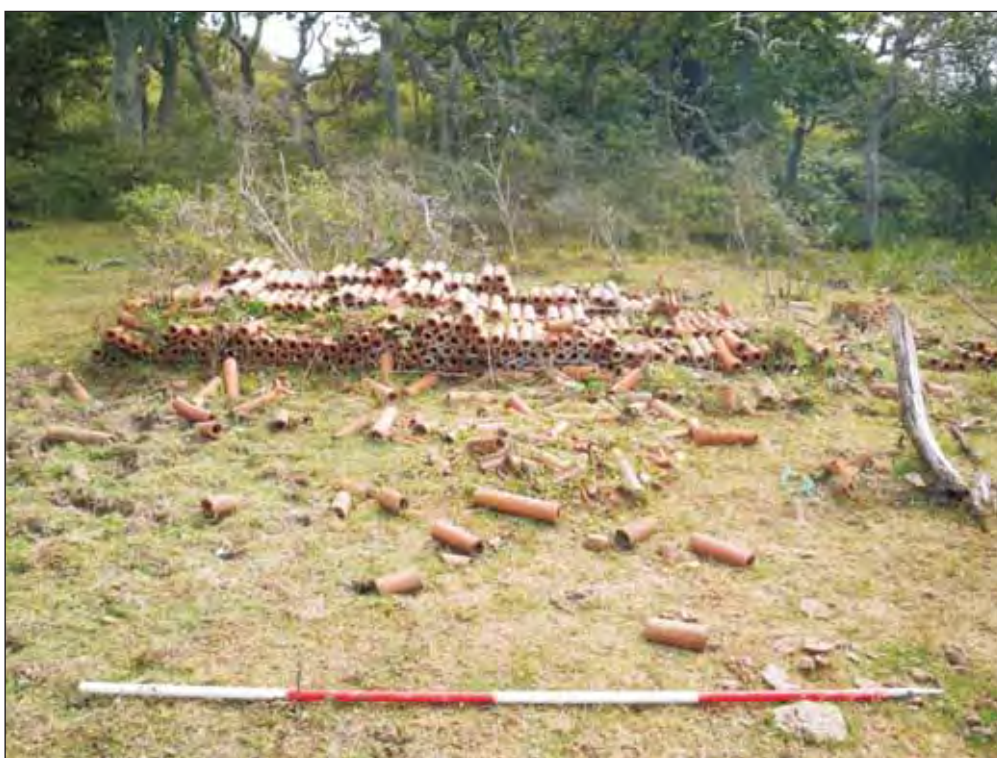
Plate C4: **WA3033**. Stack of pipes associated with the brickworks at Pitts Deep

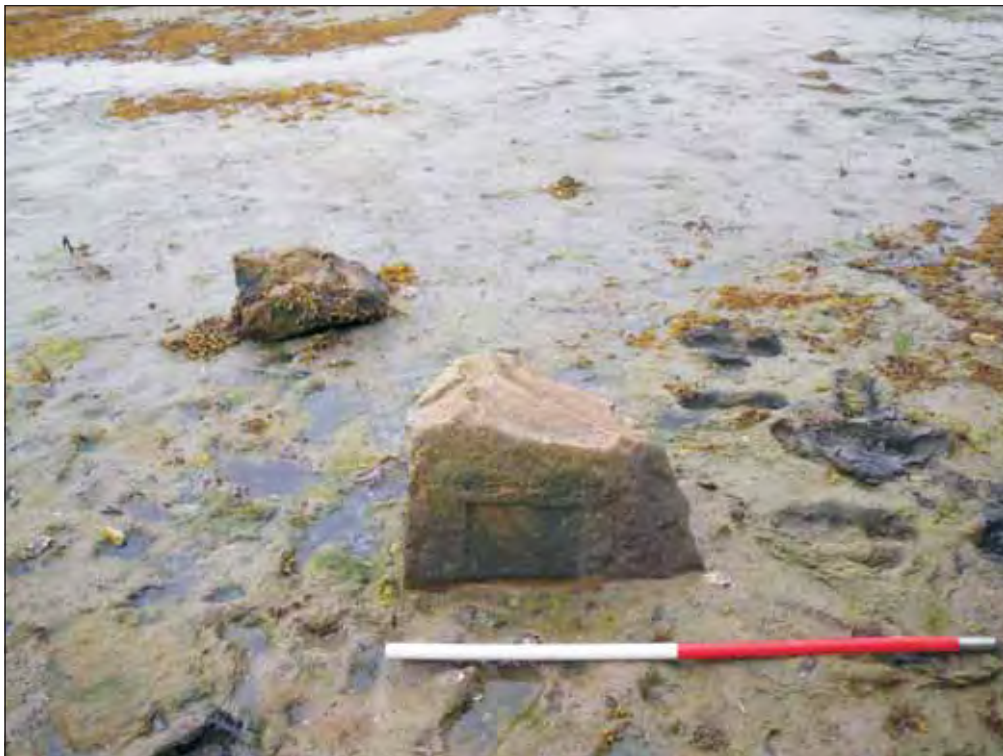
Plate C10: **WA3015**. A possible sarsen sandstone with one faced side, observed on the foreshore at Pylewell

Plate C10: WA3015. A possible sarsen sandstone with one faced side, observed on the foreshore at Pylewell.

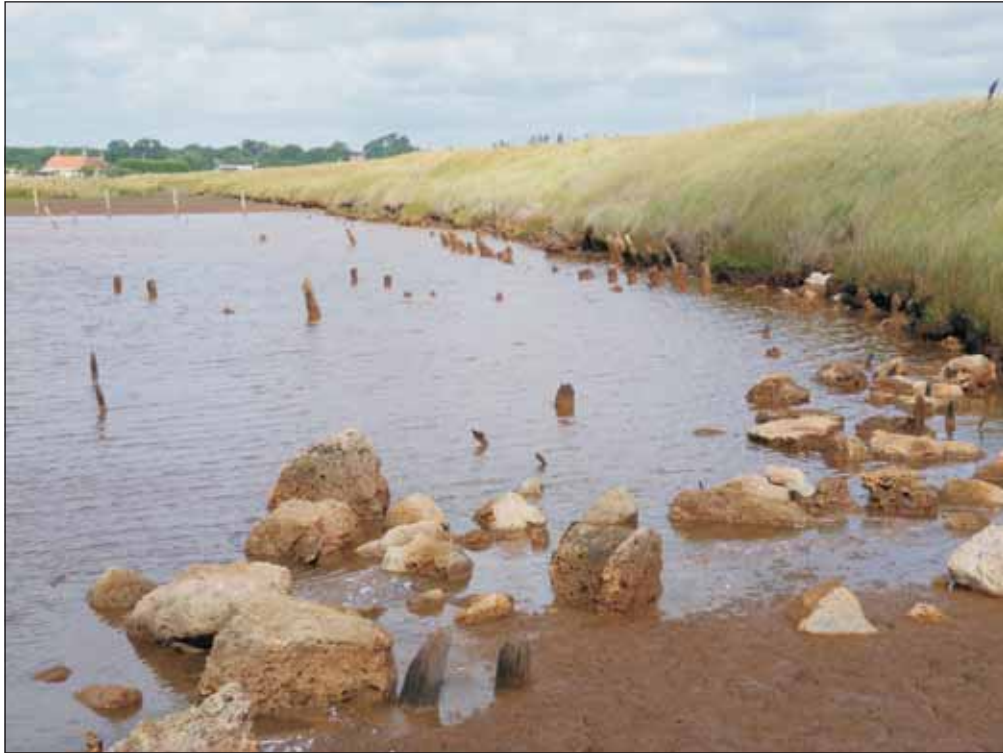
Plate C11: **WA3026 & WA3049**. Numerous wooden posts, some of which function as revetment, along with a discrete length of stone deposit, all observed at the eastern extent of the salt works north of Needs Orr

Plate C11: WA3026 and WA3049. Numerous wooden posts, some of which function as revetment, along with a discrete length of stone deposit, all observed at the eastern extent of the salt works north of Needs Orr.

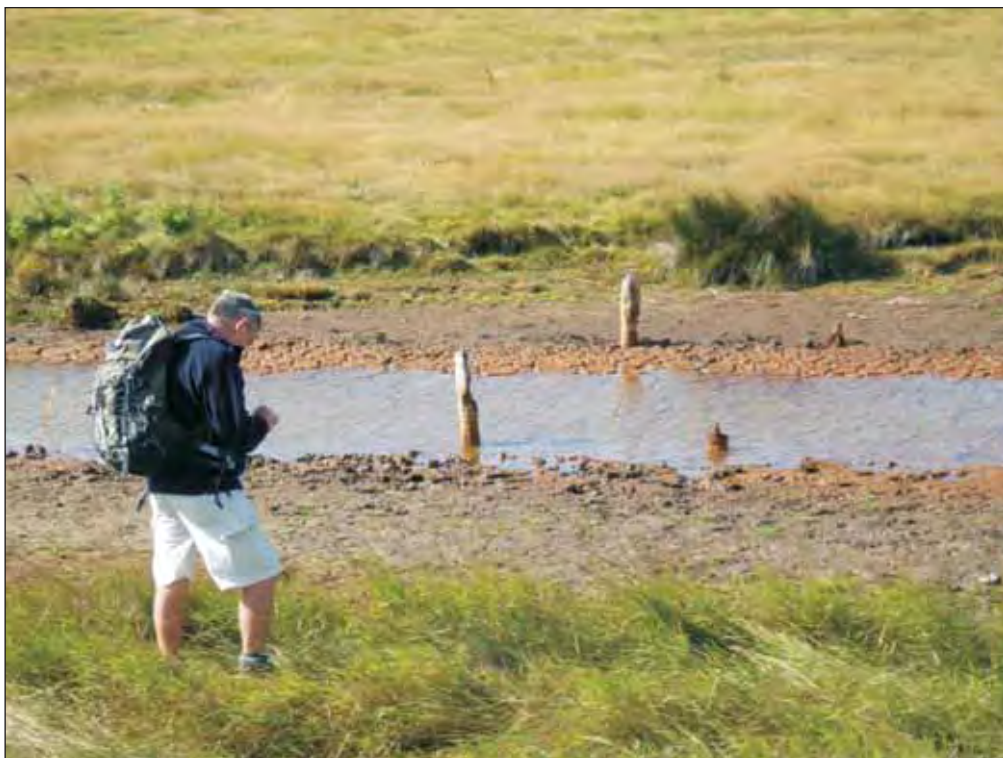
Plate C12: **WA3044**. Four wooden posts possibly forming part of a crossing point across a water channel within a salt works site at Needs Orr

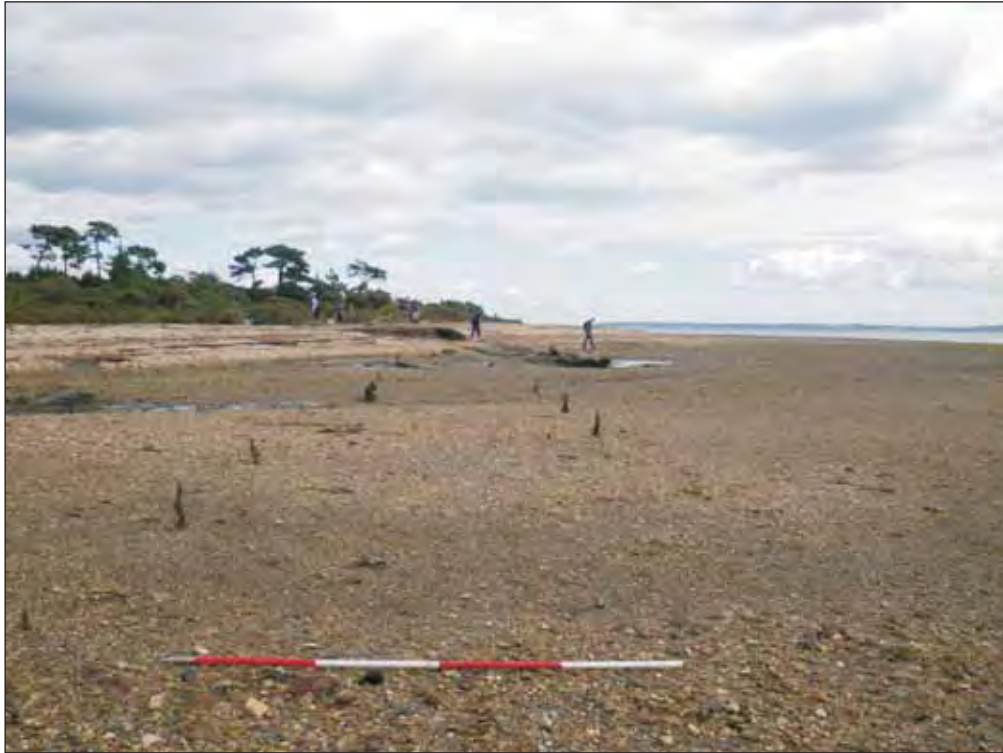
Plate C13: **WA3021**. Two alignments of wooden posts forming a possible causeway across the mouth of Sowley Marsh

Plate C13: WA3021. Two alignments of wooden posts forming a possible causeway across the mouth of Sowley Marsh.

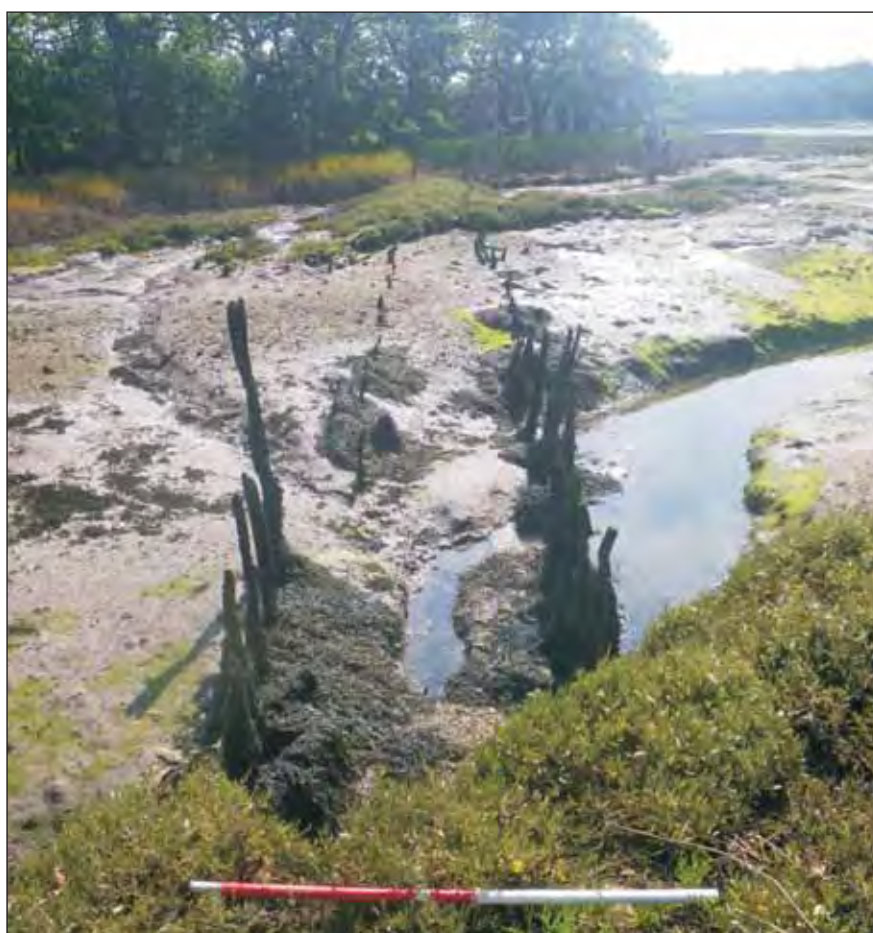
Plate D8: **WA4083**. Bridge across an inlet on the Beaulieu River

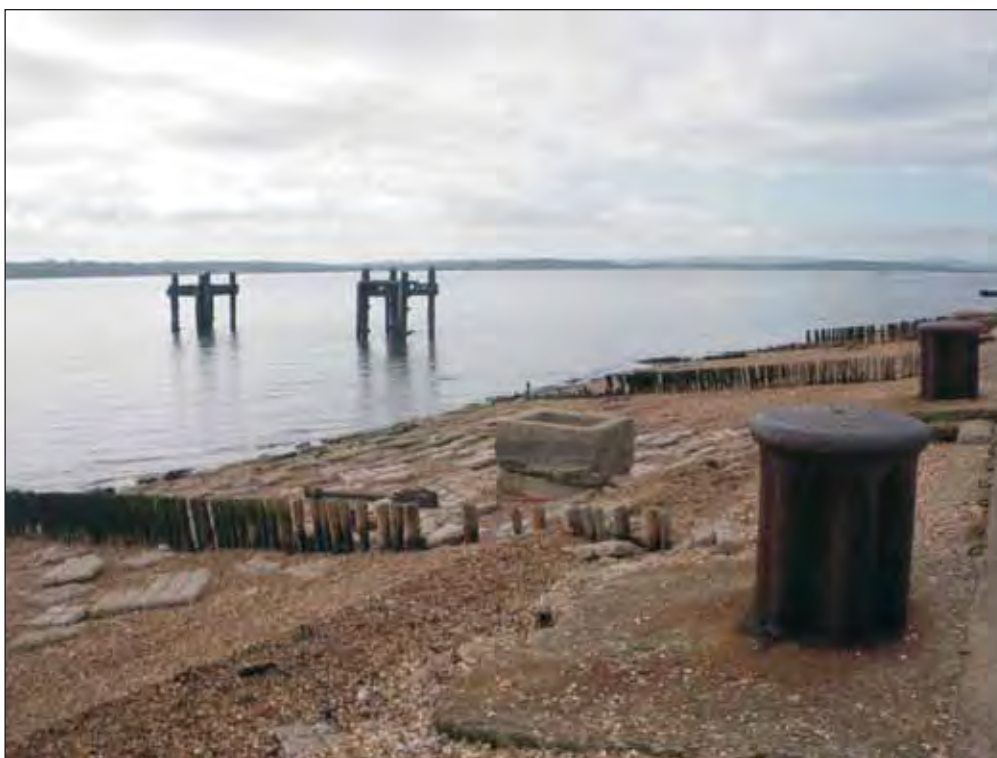
Plate D10: **WA4157 & WA4159**. Two offshore WWII 'Dolphins' along with concrete hardening mats and bollards along the coast at Lepe

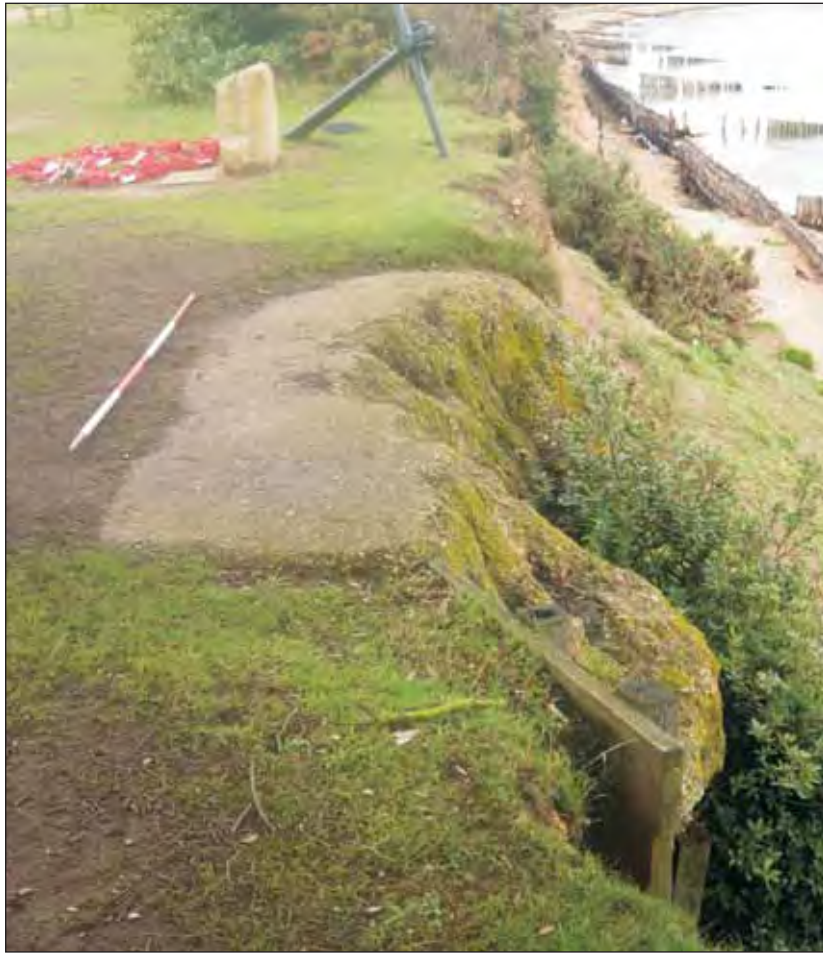
Plate D11: **WA4152**. Remains of a WWII concrete structure, eroded from the top of the cliff at Lepe

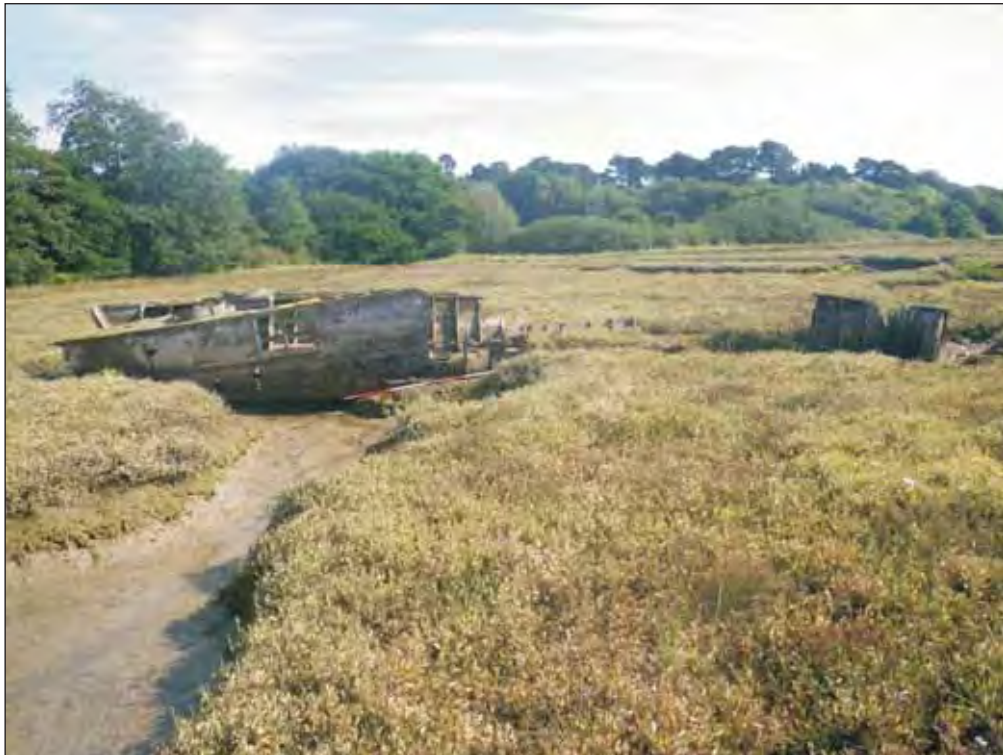
Plate D12: **WA4143**. Remnants of a wooden WWII landing craft on the bank of the Beaulieu River

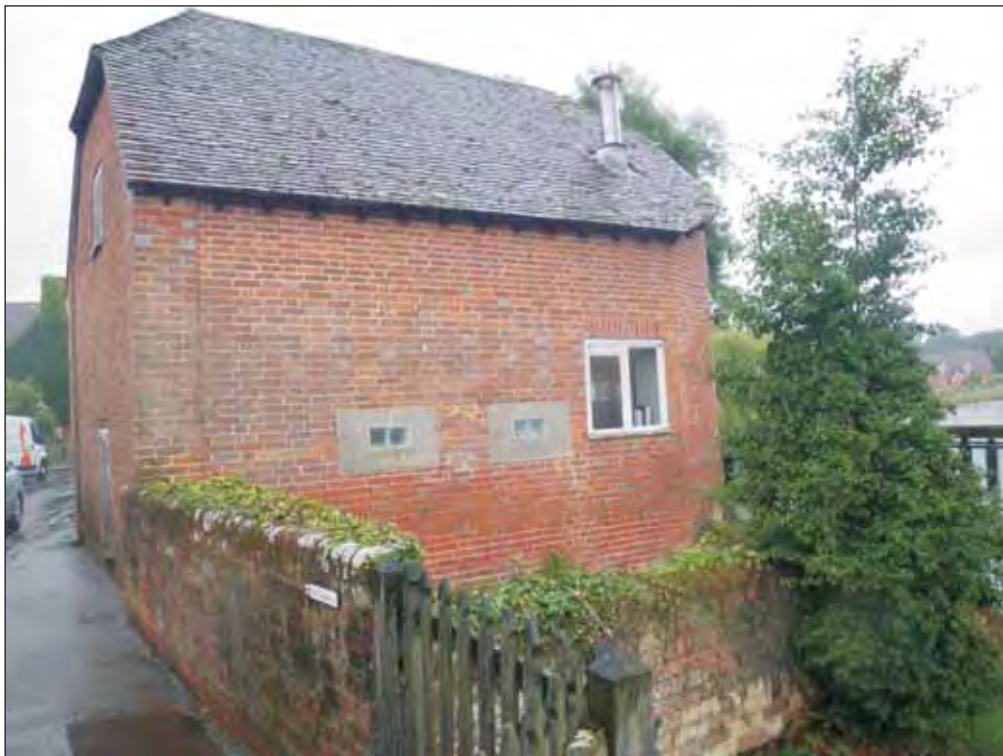
Plate D14: **WA4133**. Former pillbox in Beaulieu
