New Forest Rapid Coastal Zone Assessment Survey Stage II: Field Assessment

**NEW FOREST
RAPID COASTAL ZONE ASSESSMENT SURVEY
PHASE 2: FIELD ASSESSMENT**

Report ref.: 72201.1

December 2010

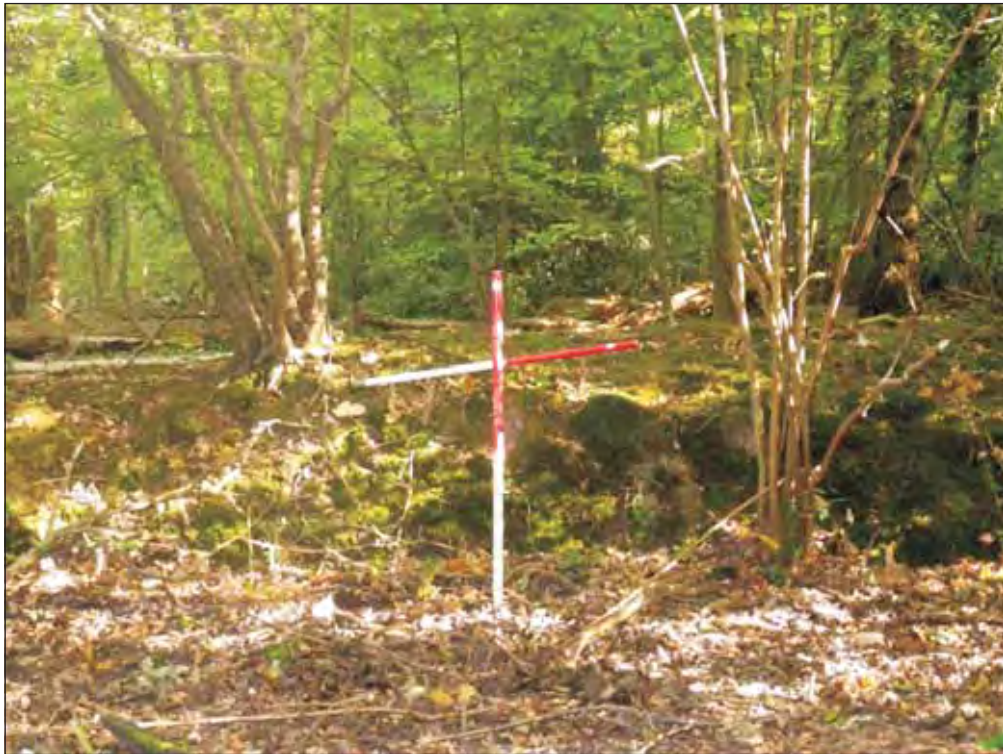
Plate E1: **WA5002-5004**. Lammas Wood: Banks and ditches near Cadland Creek

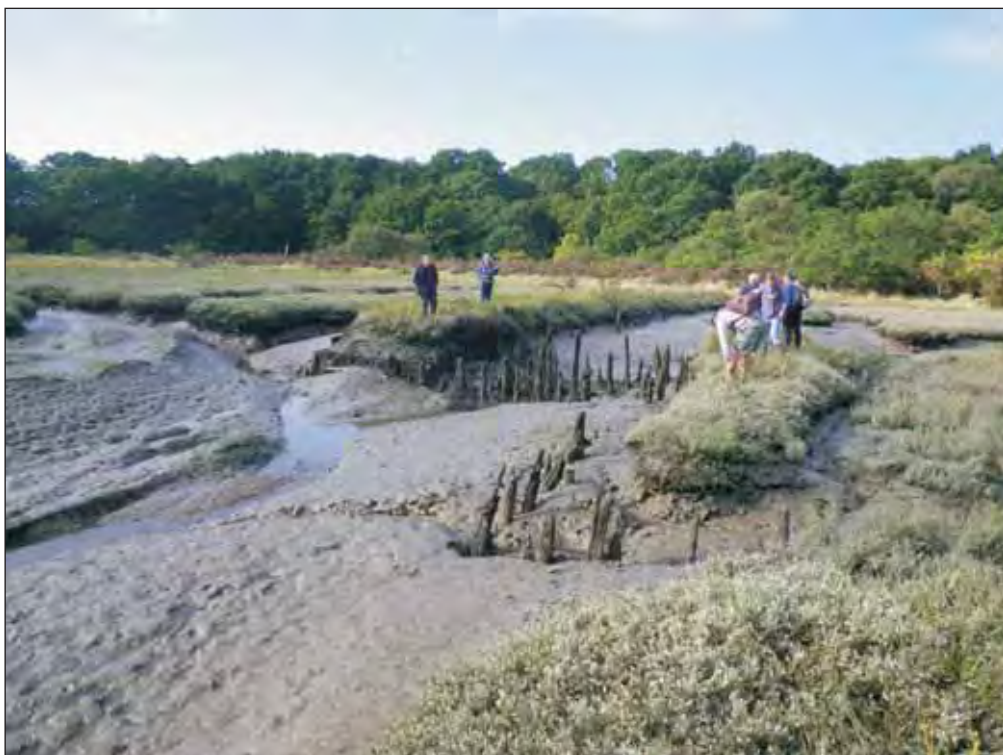
Plate E2: **WA5008**. Langdown Saltern: Sluice and revetments

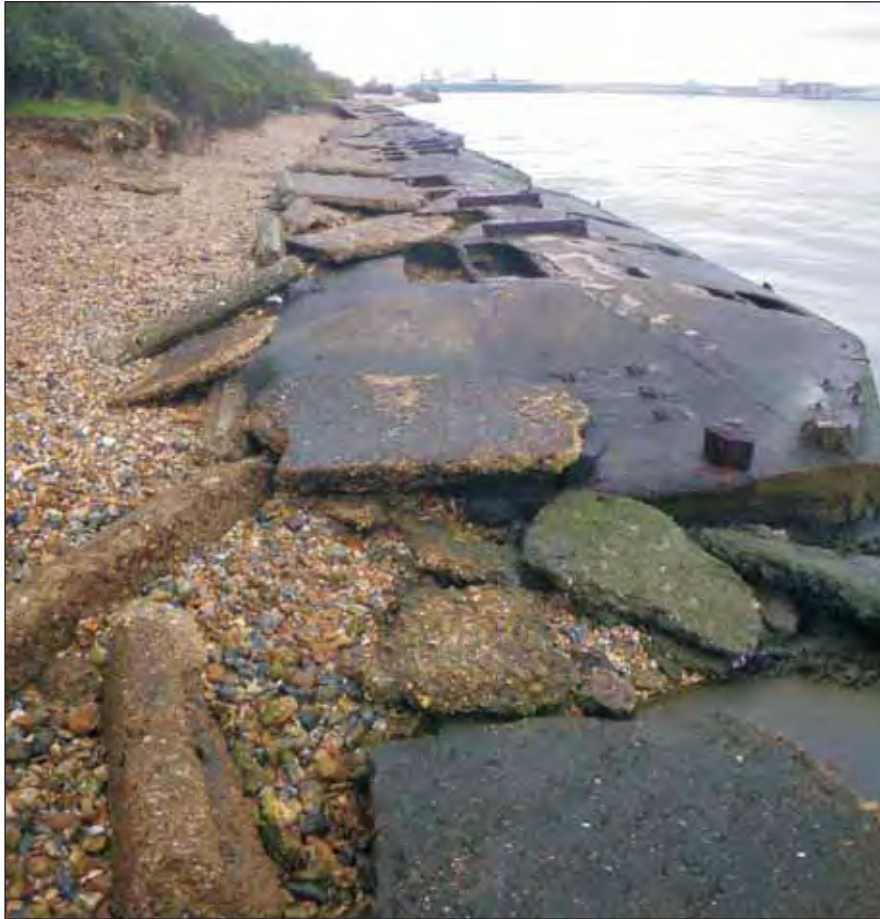
Plate E15: **WA5069-5098**. Looking up river at the beetles laid up end to end as beech defences

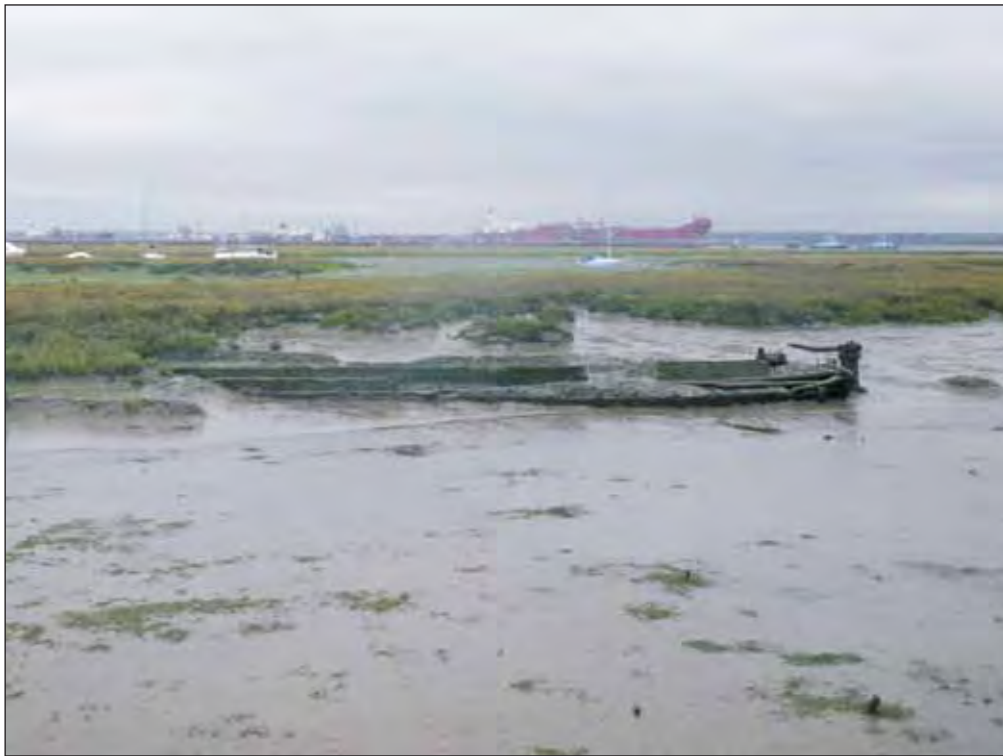
Plate E20: **WA5051**. Remains of a wooden barge located in the intertidal area at Ashlett. The vessel is between 10m and 15m long and is in a deteriorated state. There are remains of metal fittings on the interior and the wooden rudder is still intact

Plate E20: WA5051. Remains of a wooden barge located in the intertidal area at Ashlett. The vessel is between 10m and 15m long and is in a deteriorated state. There are remains of metal fittings on the interior and the wooden rudder is still intact.
