## ANALYTICAL EARTHWORK SURVEY REPORT

CONISBROUGH CASTLE,  
SOUTH YORKSHIRE

ENGLISH HERITAGE

NAA 09/23  
June 2009

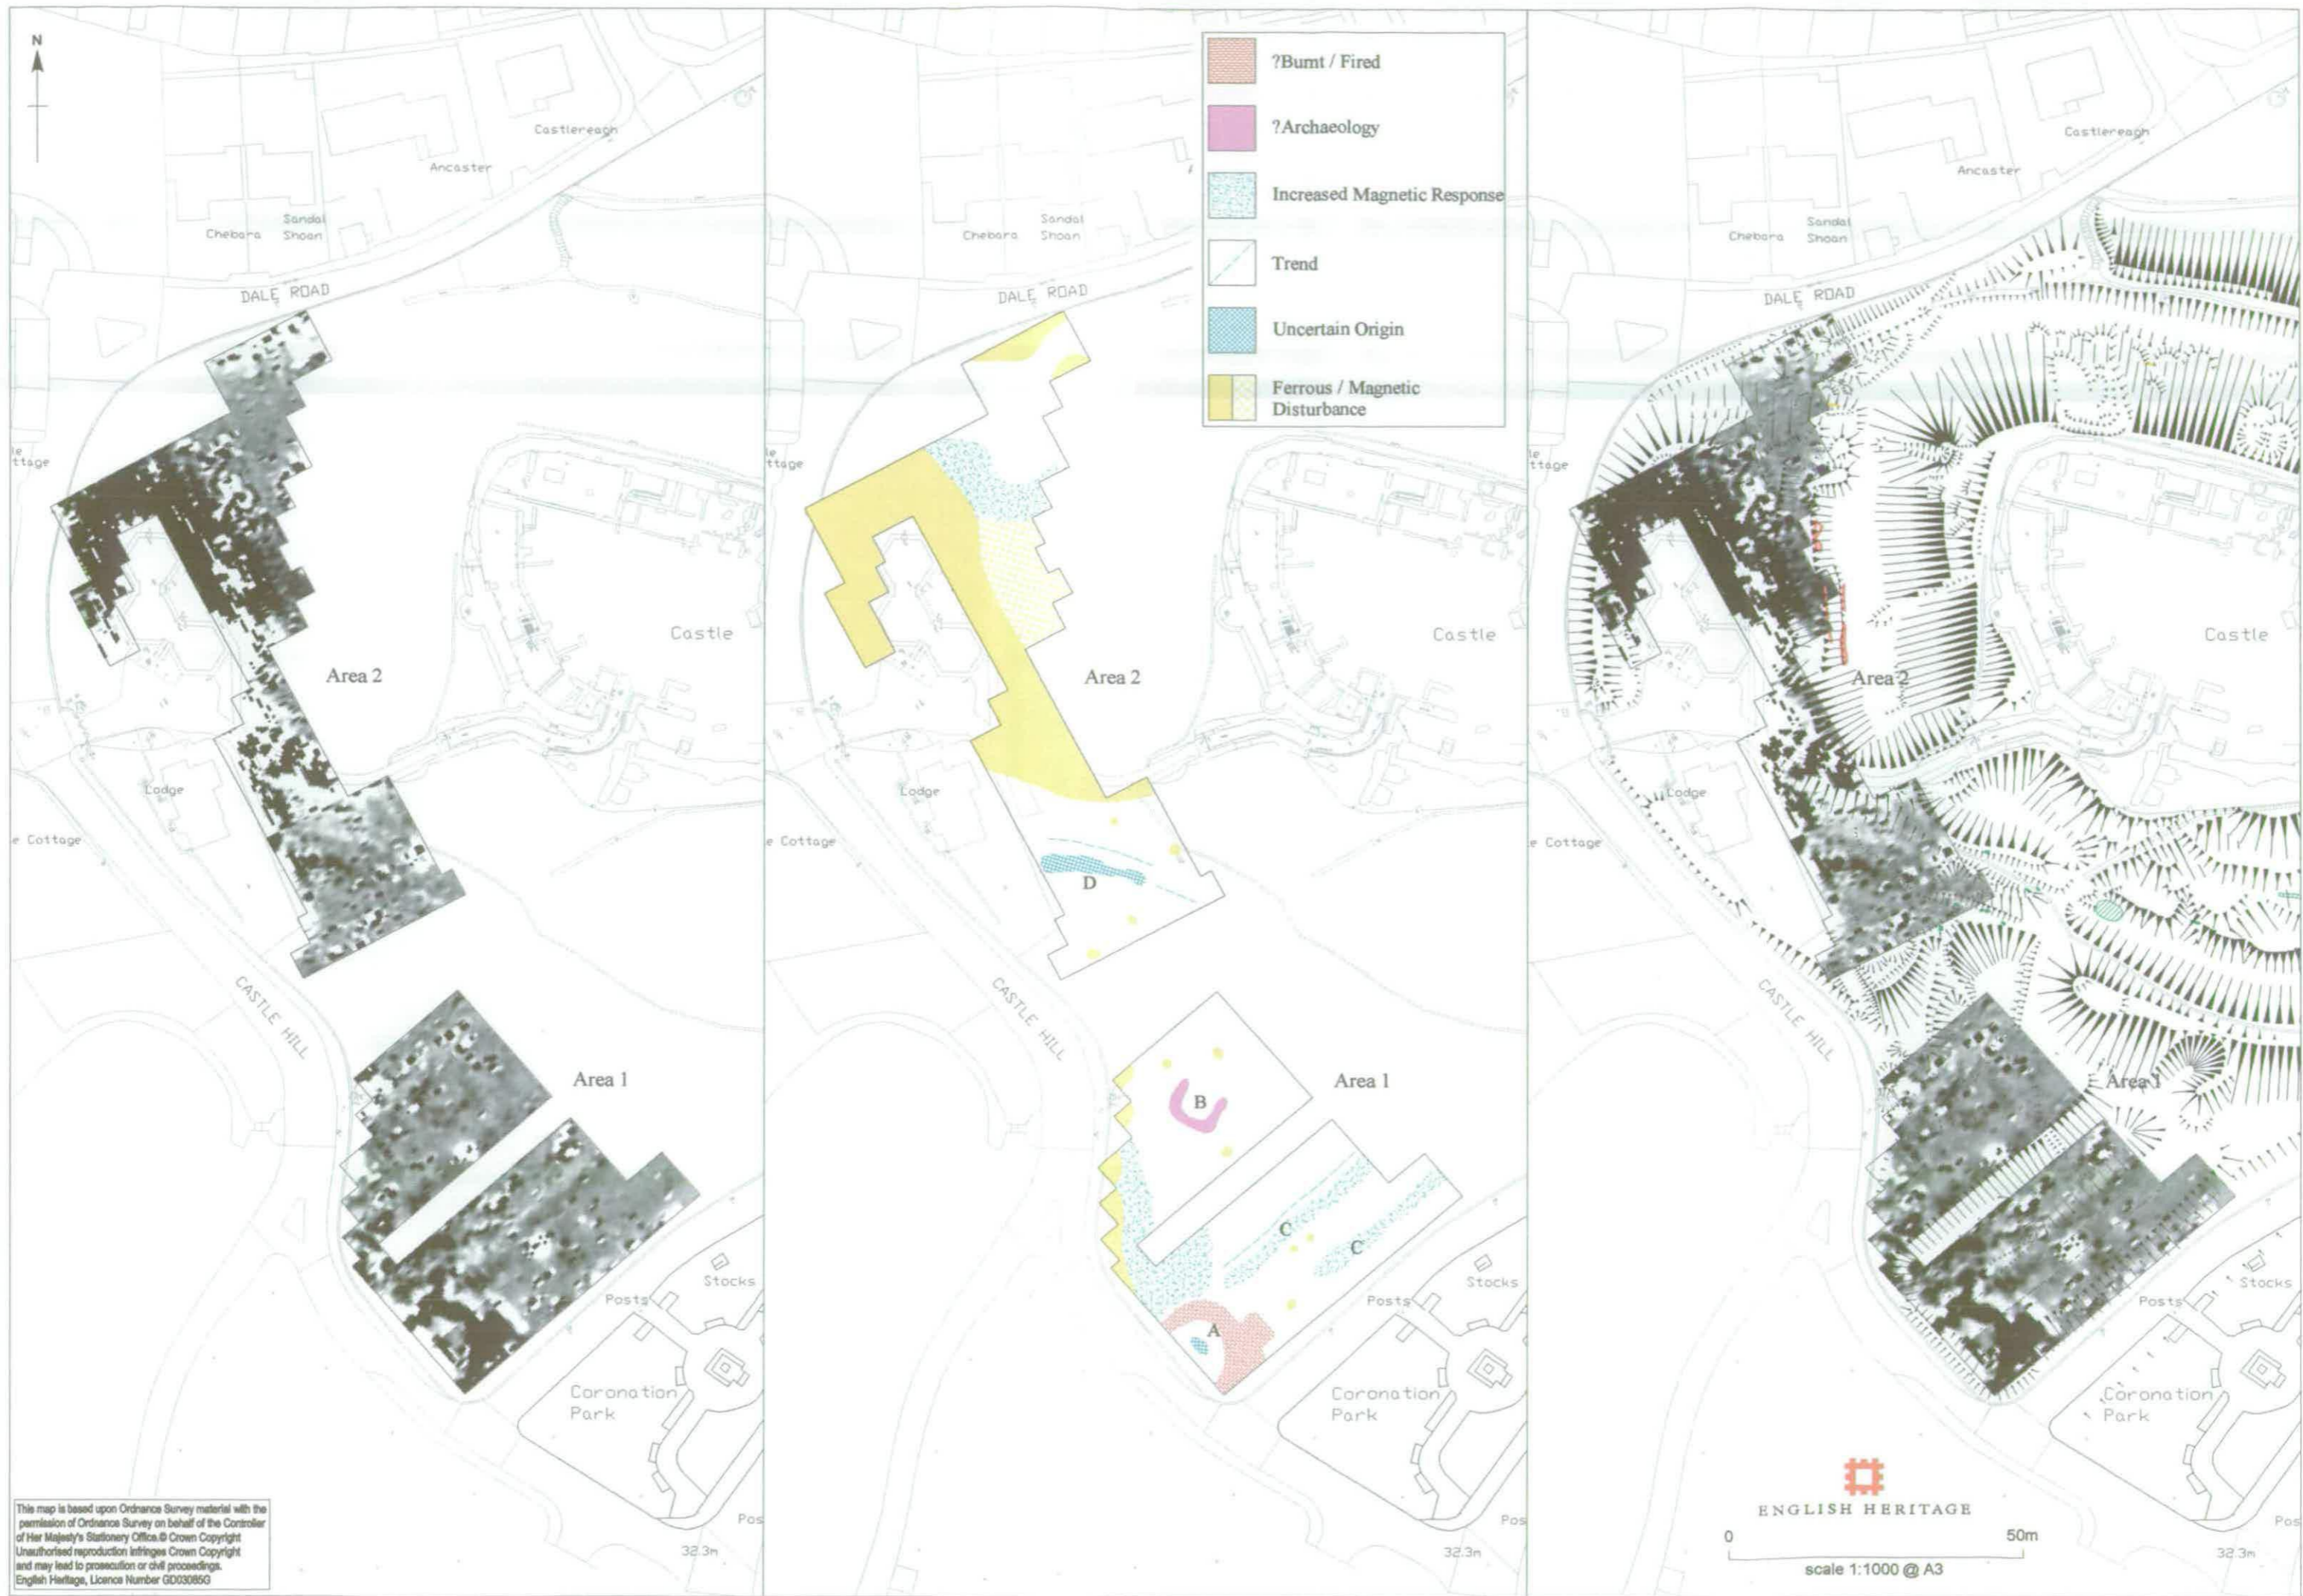
Figure 10 Conisbrough Castle: magnetic survey results, greyscale, interpretation and hachure overlay

- 1.2 The c.15m diameter annular form (with a projection to the side) of a strong positive anomaly at (A), albeit truncated by the wall and sunken road to the west, suggests an anthropogenic origin, and whilst the magnitude of the responses might indicate a ferrous cause, the response shape is more characteristic of fired material. The anomaly may therefore represent the remains of a structure, although this interpretation must be treated with caution. The positive response within anomaly (A) may be associated, due to its proximity, but is slightly eccentric and has therefore been categorized as *Uncertain*.

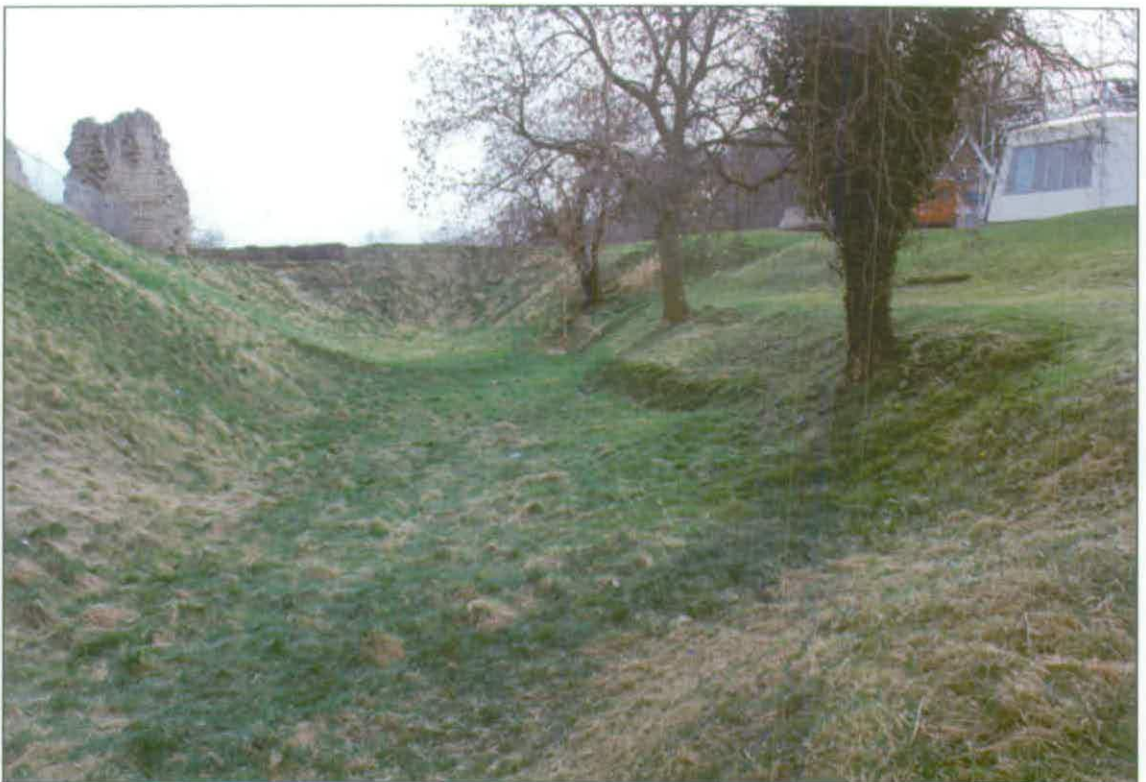
*Plate 2 Conisbrough Castle: ditch 2, western section facing south*

- 6.5 What may be the earliest surviving ditch, ditch 2, (Plate 2) is approximately 235m long and extends from the causeway of the present access road into the castle (feature 11), and encloses the western, northern and part of the eastern sides of the castle knoll before petering out adjacent to the terminals of ditches 7 and 8 in the east. Ditch 2 generally has a flat bottom and is bounded on its outside by a relatively low bank with a short counterscarp on its inner face (feature 3). The exception to this is seen on the westernmost section of the ditch, where it appears to be much deeper than elsewhere. Here there is no evidence for a bank beyond the ditch cut but the counterscarp on the western side of the ditch has been remodelled at a later date to create a terrace (feature 5) projecting outwards from mid-slope (Plate 3). A stone revetment at the base of the terrace is visible at its southern end (Plate 4). The southern terminal of ditch 2 in this area is almost certainly false, resulting from the creation of the causeway over the ditch which now carries the access road.

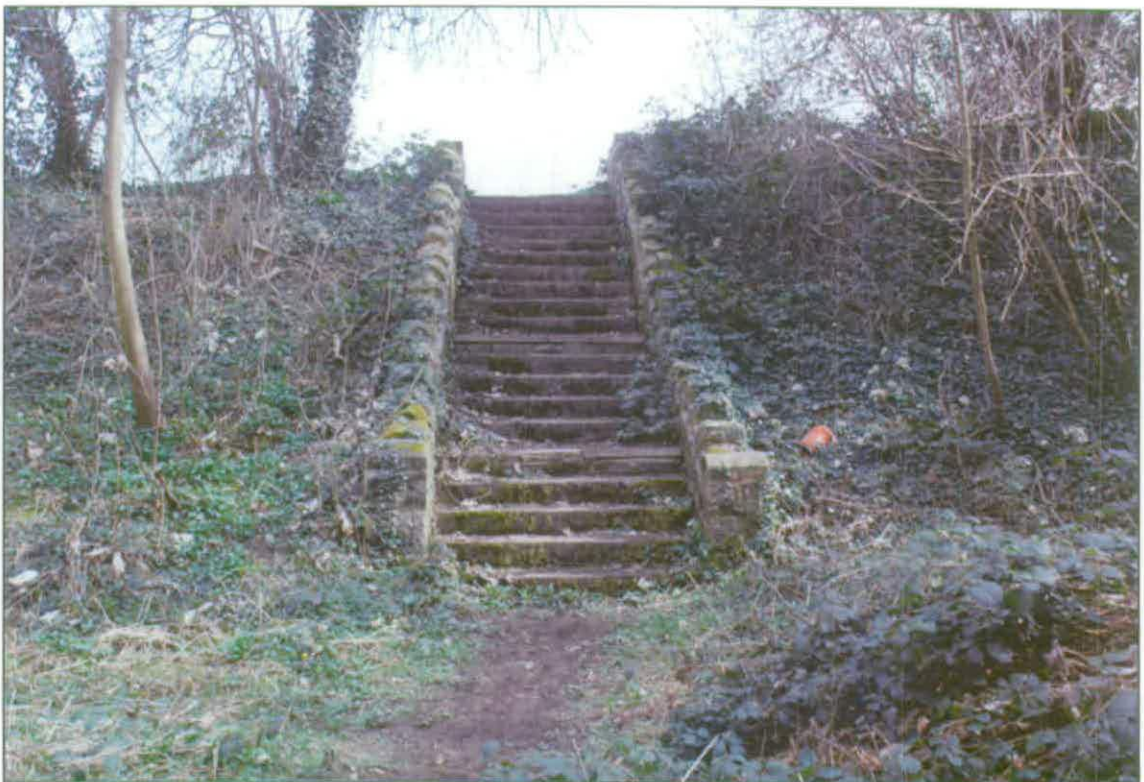
*Plate 32 Conisbrough Castle: view of eastern steps into former quarry, facing east*

- 6.21 Access to the former quarry from the castle area is by two flights of steps (38 and 39) at either end of the quarry. These clearly post-date the closure of the quarry in 1848 (Plates 32 and 33) and show traces of relatively recent maintenance. However, the remains of an earlier footpath (47) leading through woodland from the footpath on top of bank 13 survives as a shallow hollow-way (Plate 34). This presently terminates in a precipitous drop into the quarry but it is possible that an earlier flight of steps once existed in this area which were replaced by the more gently rising eastern steps (38) and the footpath rerouted along the top of the south-eastern lip of the quarry (40). A small mound (41) to the south of the footpath on top of bank 13 is likely to have resulted from the rerouting of the footpath.

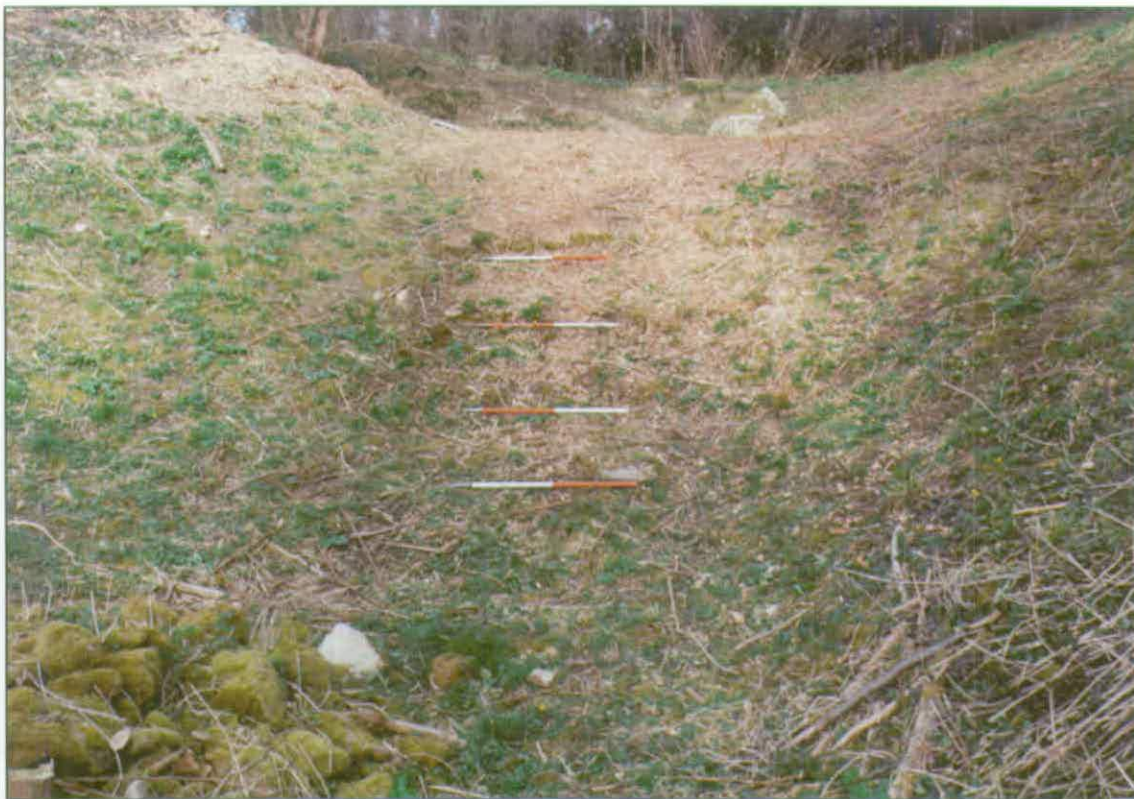
*Plate 11 Conisbrough Castle: flight of steps at northern terminal of ditch 9*

- 6.43 As noted above, the site is traversed by a network of footpaths which may have their origin in this period. Features such as the stone steps (14) in the terminal of ditch 9 are likely to have been constructed to facilitate movement around the site. The terrace (5), perhaps a viewing platform, cut into the counterscarp of ditch 2 was revetted with masonry to ensure its stability. There were more garden features once present at the site than survive today. Plate 38 depicts part of the castle at its most picturesque, with a decorative pond placed where the visitor centre is now situated, and what appears to be a bench or a table in the background. The visible remains of further garden features may be represented of the low earthworks on terrace C, in particular features 30 and 31 which may be another pond. Feature 46 may have been cut into bank 13 in order to insert a flight of steps to facilitate access to the top of the bank from terrace C, and Hengist's Grave, feature 29, may also be a deliberate addition to the bank. Feature 16 may also represent an undated recreation structure situated by the side of a former footpath that once crossed ditch 9.

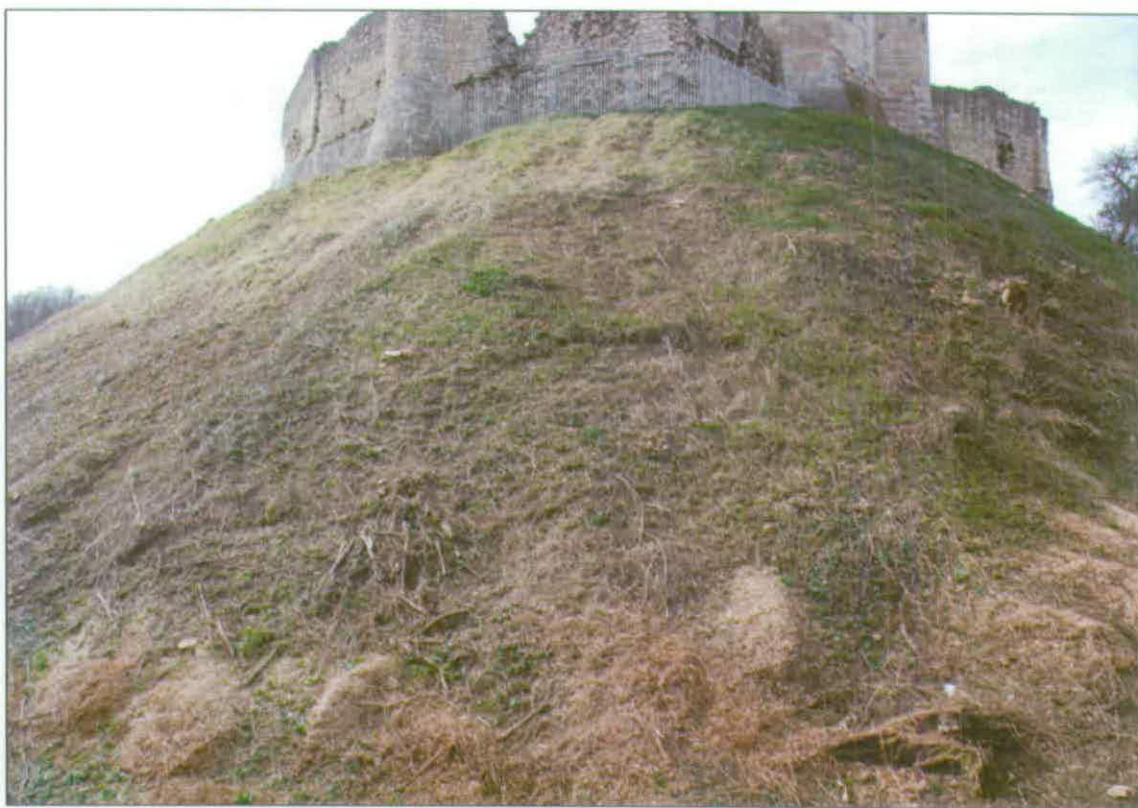
*Plate 15 Conisbrough Castle: line of former footpath on the castle knoll*

- 6.10 Other features noted within the body of the knoll include feature 18, a former footpath (Plate 15), a quarry pit and associated dump of spoil (feature 19) and an area containing several lobes of historic soil-slippage and tree-boles (features 20) the knoll once being more densely wooded than it is now (for example Plate 16).
